# Stillwater Building Inspection Summary

Prepared by the City of Billings – Facilities Division

8/11/2021

# **Structural Condition Assessment Report**

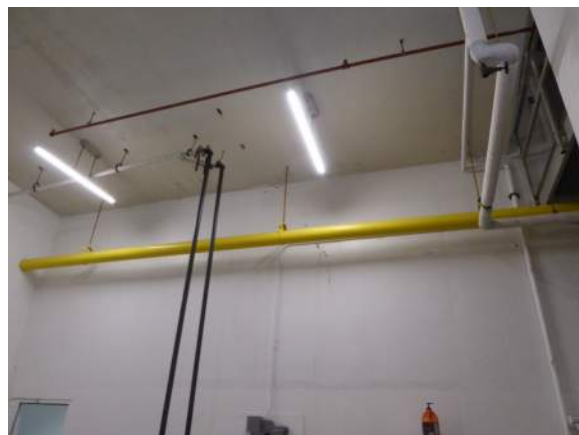
P15: sub basement bottom of vehicle drive ramp slab; concrete crack transverse is possibly a normal cold joint/construction joint or thermal crack

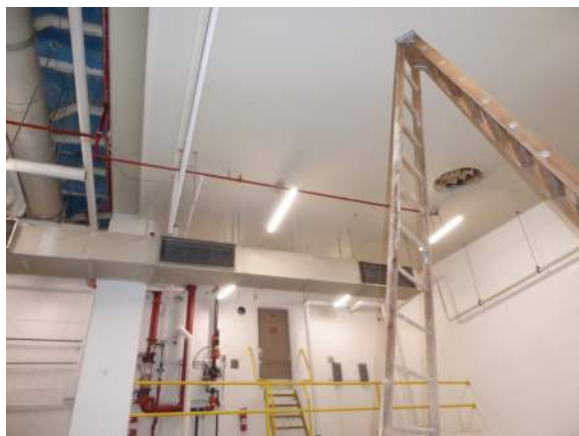
P16: sub basement wall cracks have been sealed

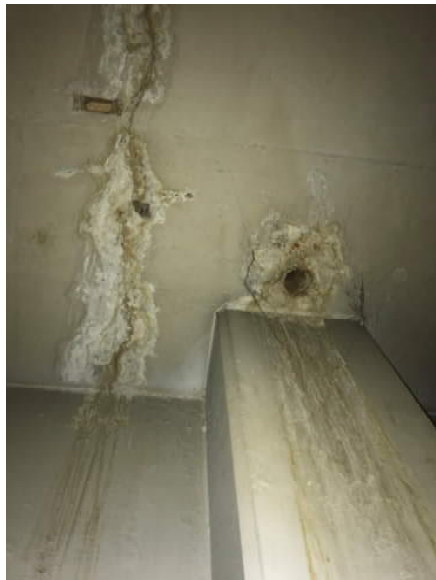
P19: Concrete cracks & stains with efflorescence

The cracking with efflorescence under the sidewalk slabs in the parking garage should be remediated. If allowed time, the cracking could get larger allowing spalling and loss of section to occur.

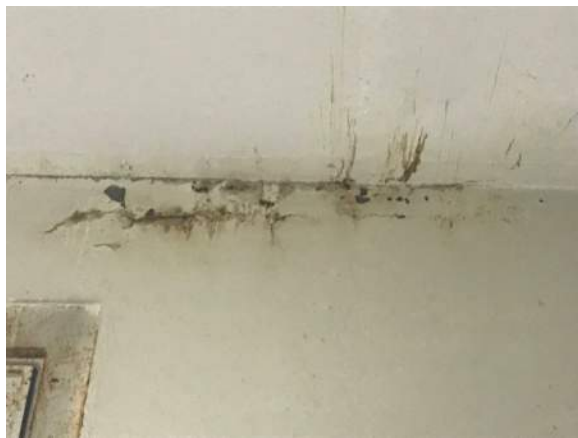
P22: Concrete cracking with delamination near top of wall at north side of the parking garage

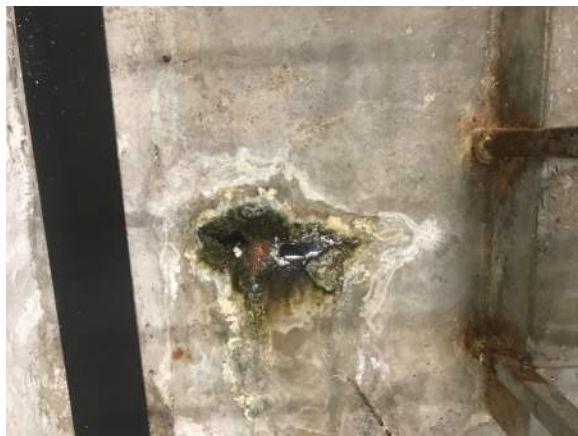
P24: floor spall and leaking fluids

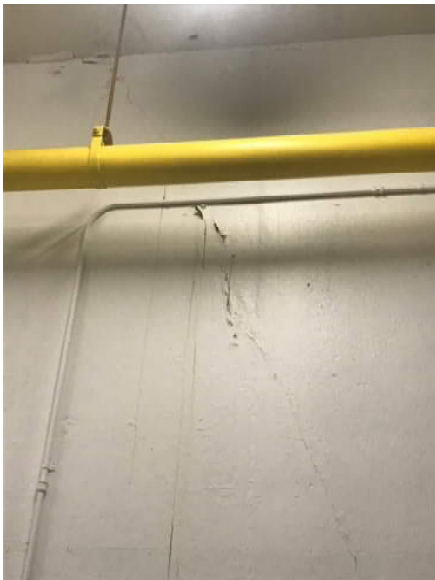
P27: concrete wall crack

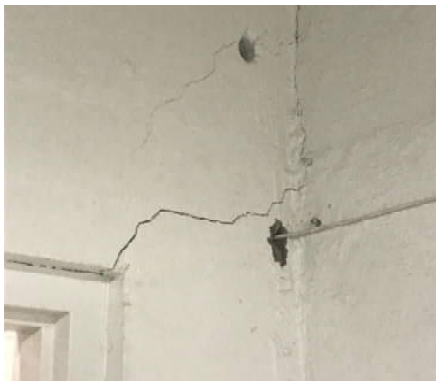
P29: concrete wall crack

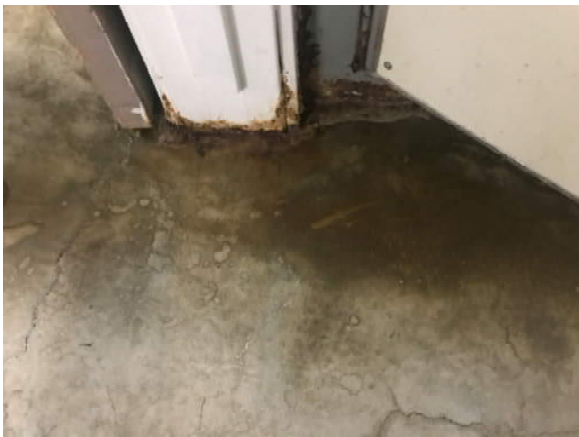
P30: floor stain; possibly moisture intrusion

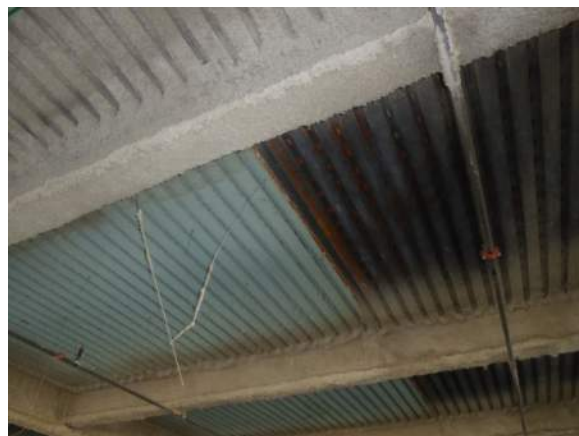
P34: blue fire protection with deck corrosion

The metal deck corrosion observed on every floor appeared to be limited to surface rust. However, we advise to be vigilant for rust going through the decking. If any is encountered it should be mitigated immediately.

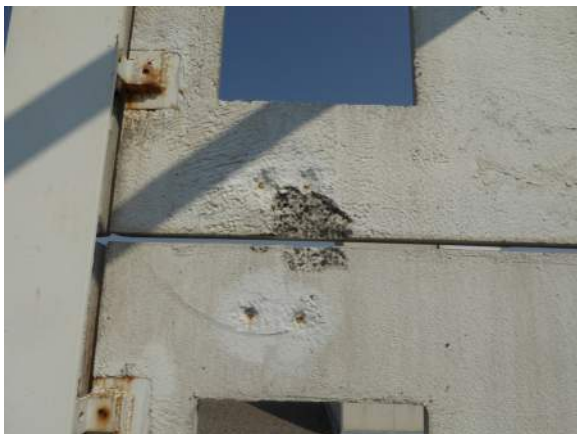
P43: Precast concrete panel joint with minor spalling concrete

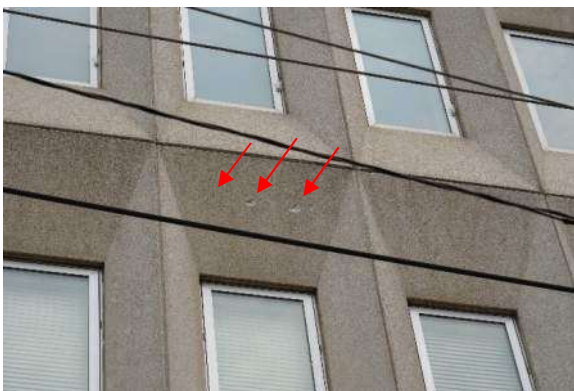
**Photo #11** Minor spalling of the precast wall panels indicated with red arrows.

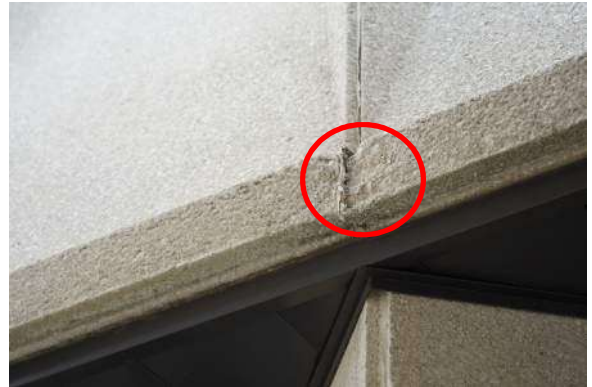
**Photo #14** Small area of apparent freeze-thaw damage at the second-floor eyebrow indicated by the red oval.

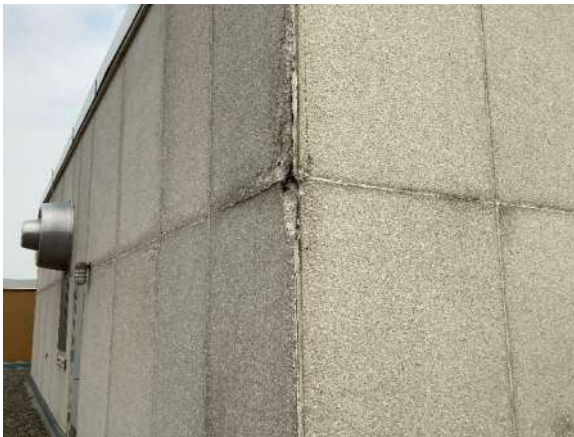
On the roof we noted an area just outside of the door, at the south west corner of the penthouse, where the cladding had spalled and broken off. This should be repaired to prevent moisture infiltration behind the cladding.

**Photo #15** Area of concrete deterioration at the southwest corner of the penthouse.

With regards to the outer shell of the building, any loose spalling on the exterior cladding, like observed on the roof should be repaired.

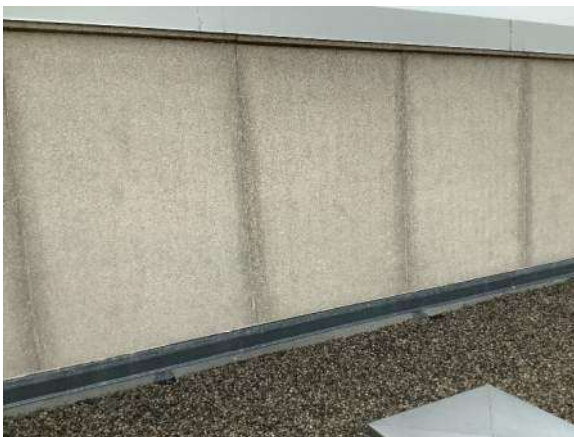
**Photo #17** Discoloration of the penthouse precast wall panels adjacent to the sealant joints.

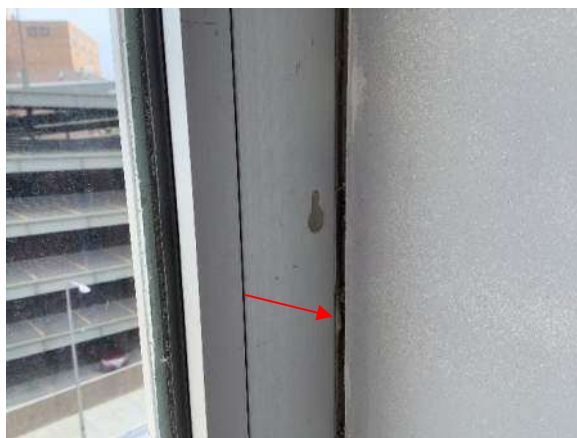
**Photo #27** Sash latch key holes have been filled with sealant. Sash crack is visible behind drywall indicated by red arrow.

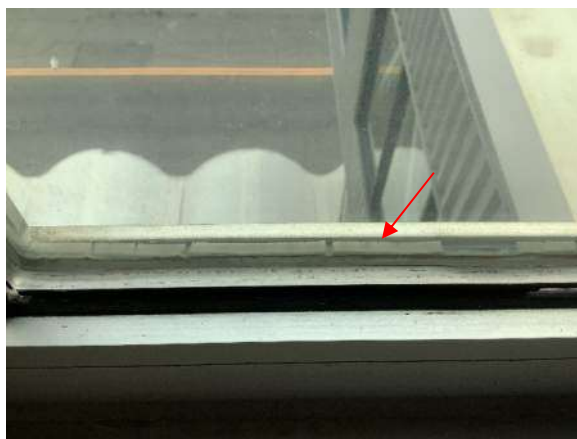
**Photo #29** Original compound glazing was observed to be in very poor condition from the building interior indicated by red arrow.

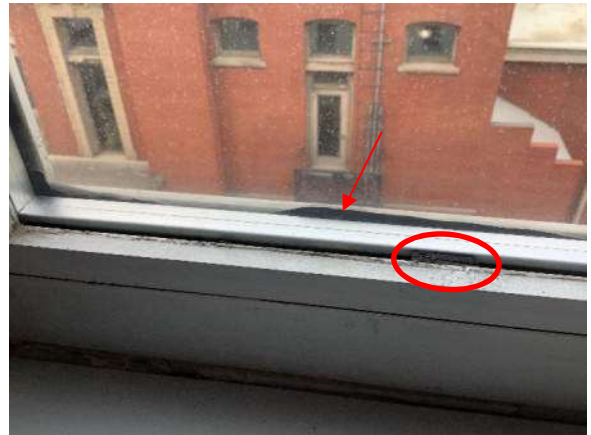
**Photo #32** Butyl tape exterior glazing at recent IG unit replacement indicated by red arrow. Shim location indicated by red oval.

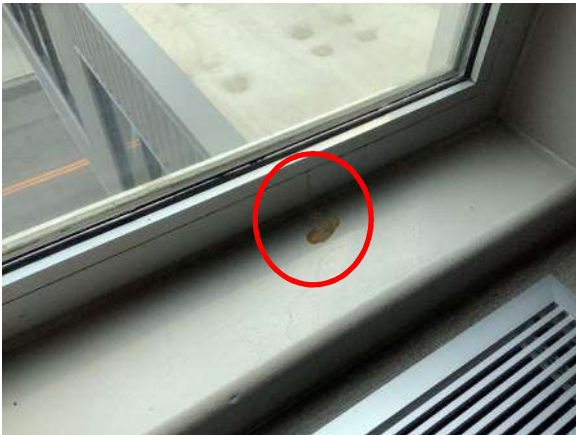
**Photo #37** Staining consistent with water leakage originating between the glazing stop and the sash indicated by red oval.

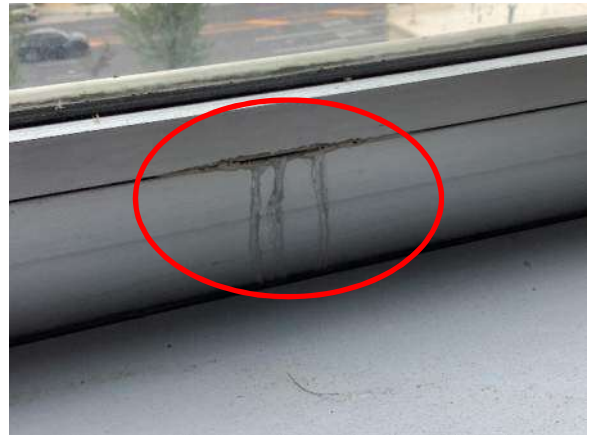
**Photo #38** Staining consistent with water leakage originating between the glazing stop and the sash indicated by red oval.

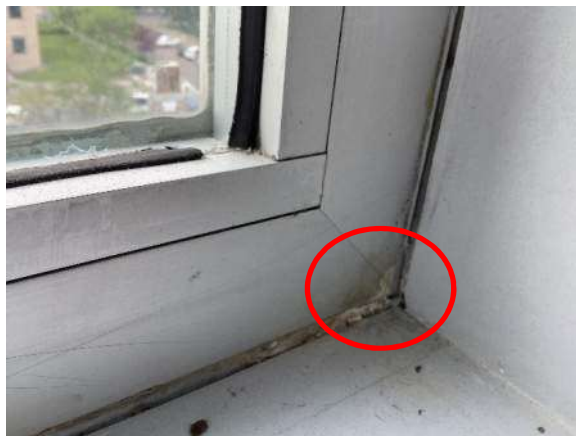
**Photo #39** Staining consistent with water leakage originating at the corner of the sash indicated by red oval

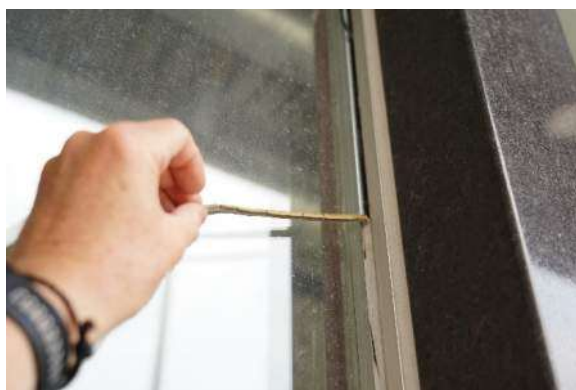
**Photo #41** Original compound glazing overcaulked with polyurethane sealant at the first floor.

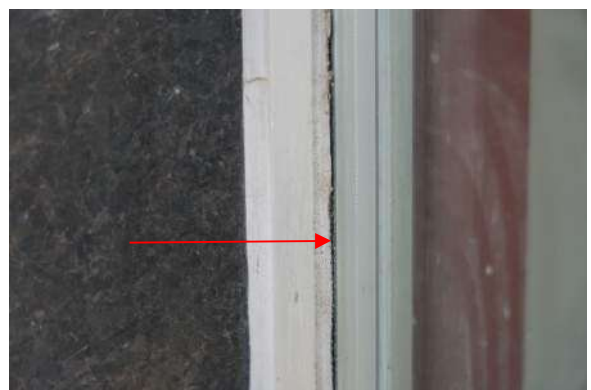
**Photo #42** Failed glazing sealant at the first floor fixed windows indicated by red arrow.

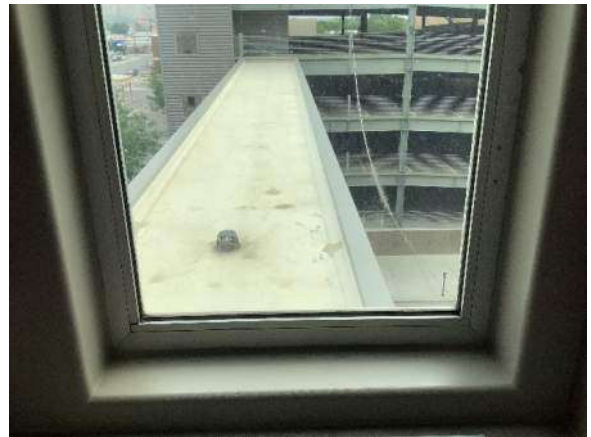
**Photo #46** Broken IG unit at the east elevation on the fourth floor.

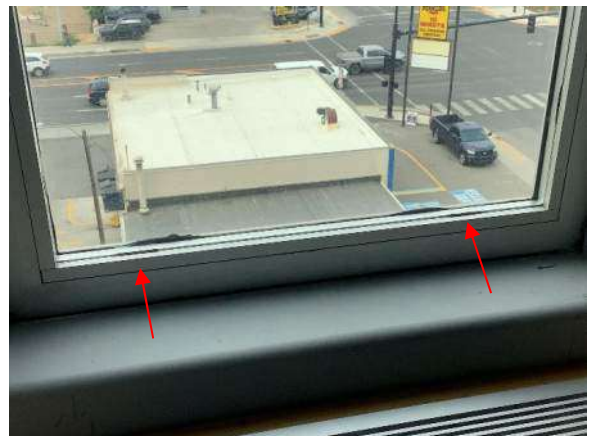
**Photo #52** Butyl glazing tape bulging from the exterior glazing joint at the shim locations indicated by the red arrows.

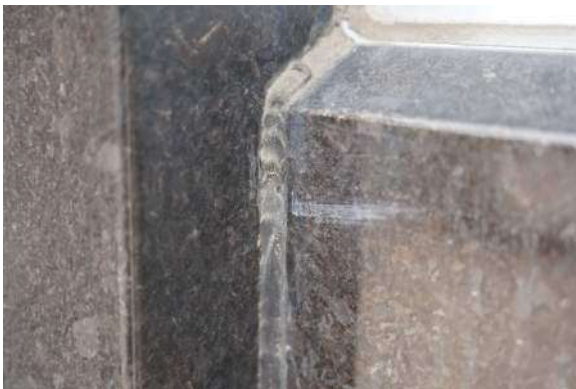
**Photo #57** Sealant at the granite panels was typically not tooled but otherwise in serviceable condition.

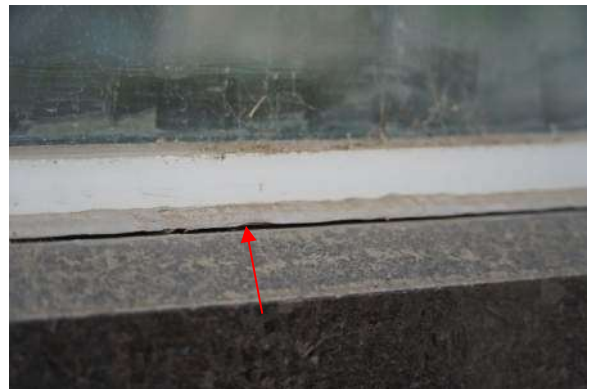
**Photo #58** Adhesive failure at first floor window perimeter sealant indicated by red arrow.

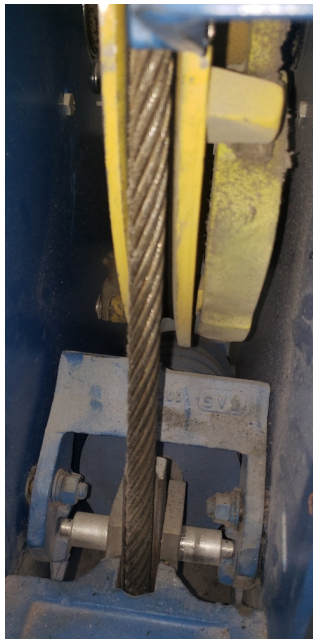
Governor Rope. No presence of rogue (rust) and not worn.

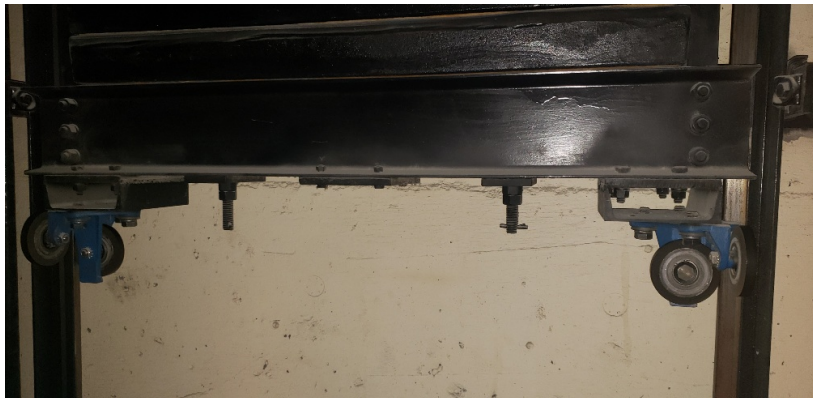
Counterweight rollers and rails are in good shape.

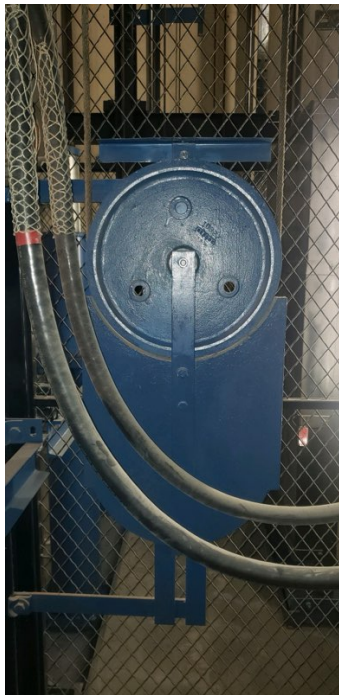
Traveling cables are in good shape with no visible wear.
