## WORK SESSION AGENDA

August 16, 2021

# **Structural Condition Assessment Report**

Subject: Stillwater Building Preliminary Condition Assessment

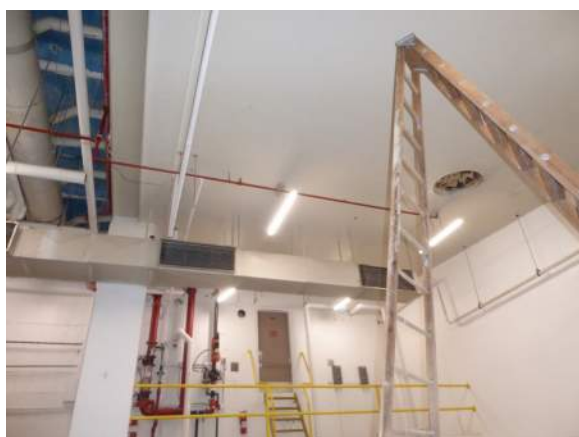
P16: sub basement wall cracks have been sealed

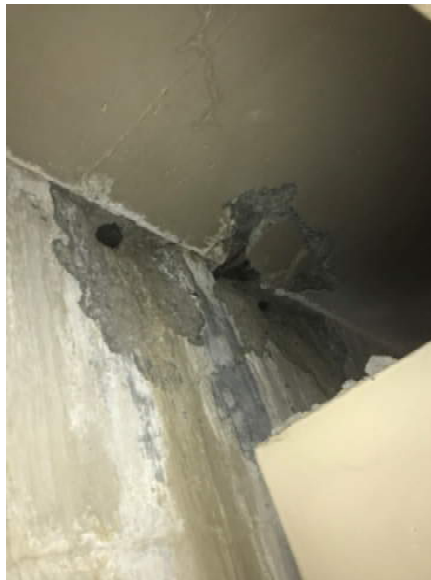
The parking garage is in relatively good condition with some limited concerning areas. The bays under the exterior sidewalk have cracks at each column line with efflorescence appearing at each crack (see photo P19). One major spalling area was noted (see photo P20); rebar could be seen where the column joins the spanning beam. It is difficult to discern the exact cause of the spall. Possibly there could have been a mishap during construction at this location. While this spall is large it doesn't appear to be impacting the structure significantly. It is however, recommended the spall be repaired in a timely manner. The exposed rebar is susceptible to corrosion and further spalling and delamination could expose the wide flange column encased in the concrete.

P19: Concrete cracks & stains with efflorescence

The cracking with efflorescence under the sidewalk slabs in the parking garage should be remediated. If allowed time, the cracking could get larger allowing spalling and loss of section to occur.

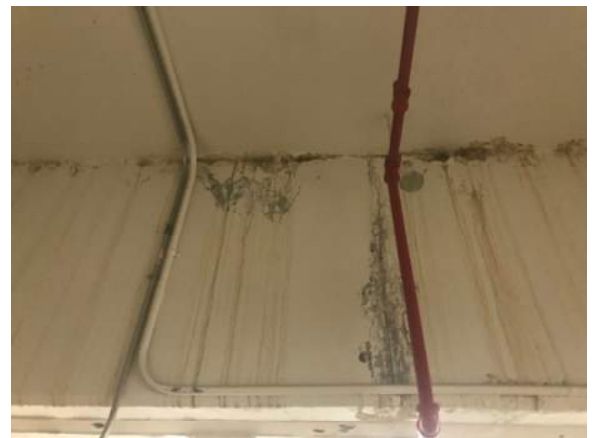
P22: Concrete cracking with delamination near top of wall at north side of the parking garage

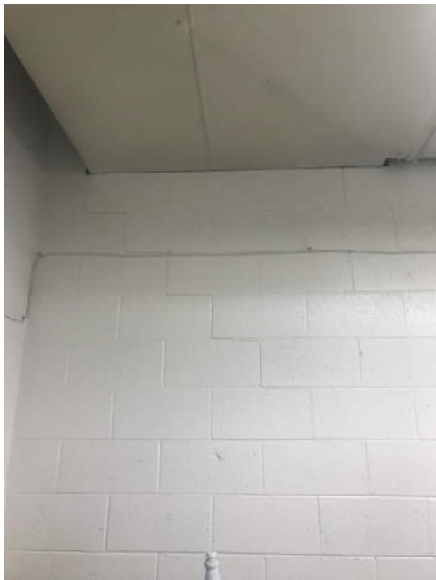
P25: ceiling concrete cracks

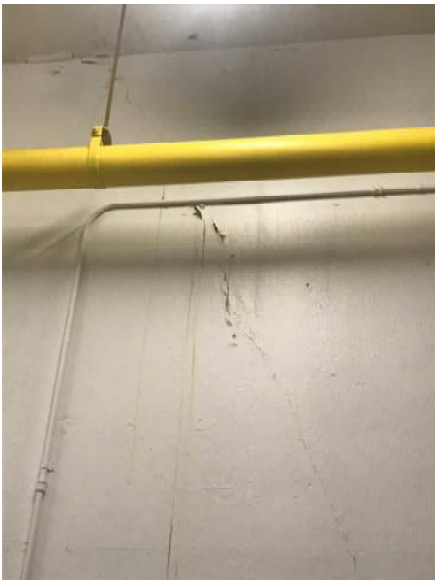
P26: masonry wall crack

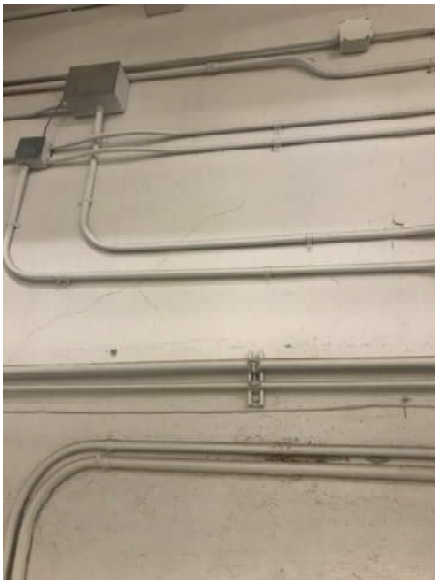
P27: concrete wall crack

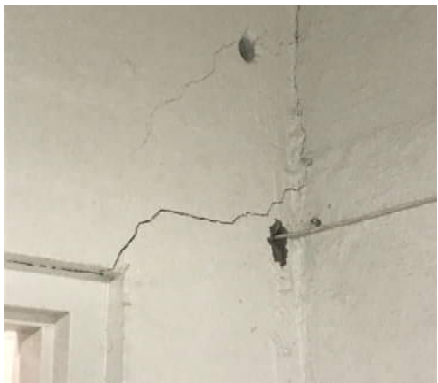
P28: concrete crack

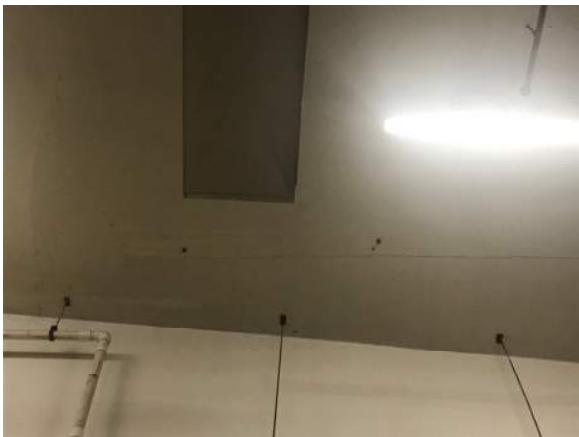
Cracks were common in all elevated slabs on each floor. It appeared the slab cracked over the top of girder beams and some infill beams. This is not worrisome and should be considered normal cracking for a structure this age and with this type of construction.

P31: concrete slab ceiling crack

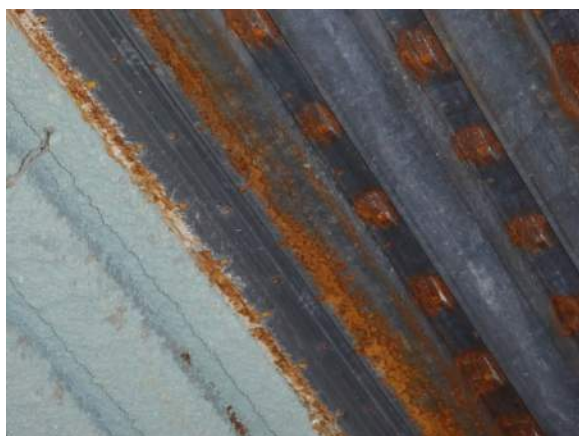
Upper Floors: Consistently throughout the upper five floors, corrosion appeared in some bays of steel deck. Most, if not all, of the corrosion appeared to apply to the surface of the deck. It's possible that the old fire-protection is the cause of this corrosion. The fire-protection may have been applied incorrectly or with a questionable mixture, but we don't know. We surmise the fire-protection entrapped moisture to the metal deck. We think that as long as the cause of moisture entrapment has been eliminated, the metal deck corrosion should not advance.

P34: blue fire protection with deck corrosion

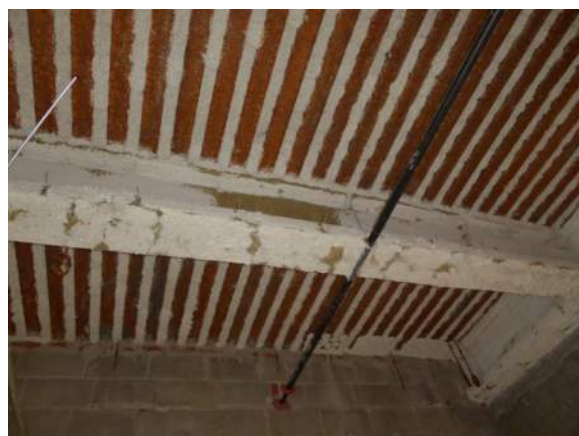
P35: blue fire protection with metal deck corrosion

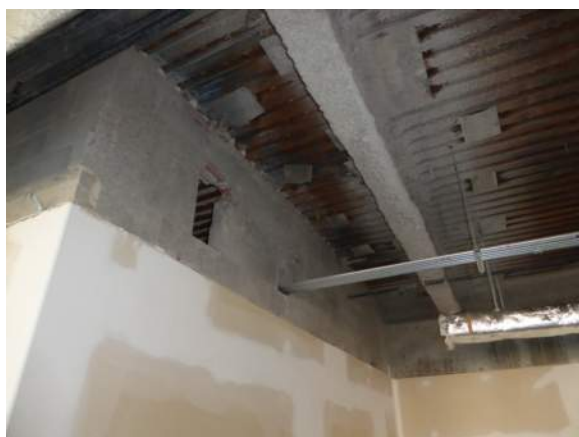
P36: Significant deck corrosion in the masonry room

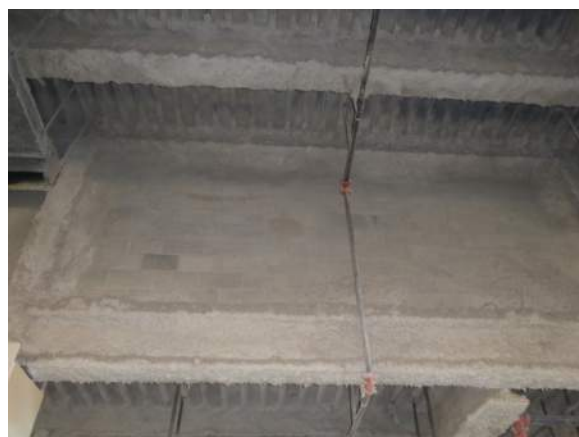
P37: Masonry room with deck corrosion

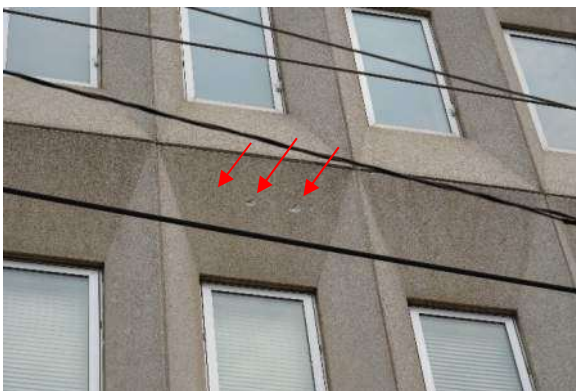
**Photo #11** Minor spalling of the precast wall panels indicated with red arrows.

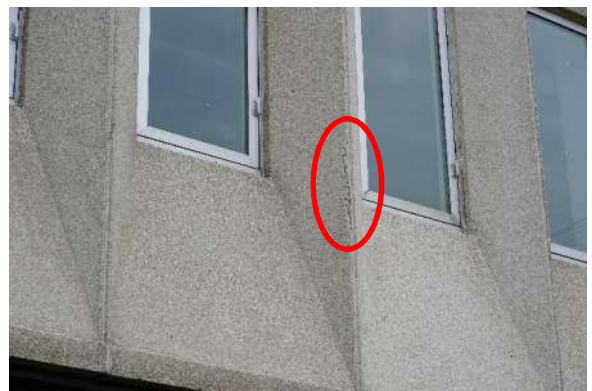
**Photo #12** Small crack in precast concrete wall panel indicated by red oval.

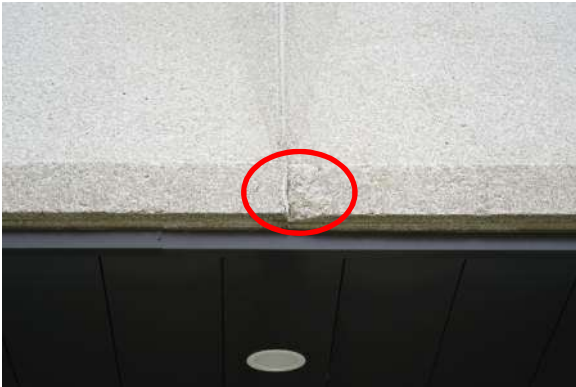
**Photo #13** Small area of apparent freeze-thaw damage at the second-floor eyebrow indicated by the red oval.

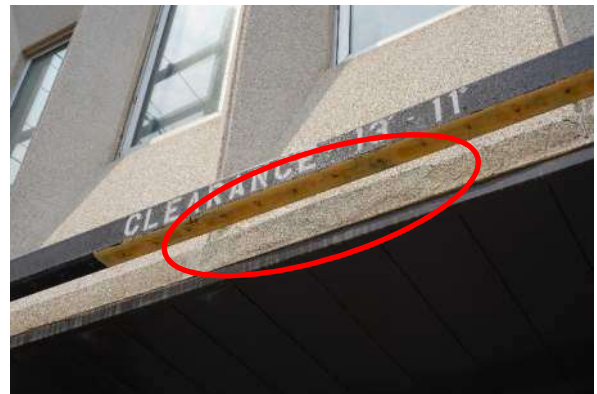
**Photo #16** Area of concrete repair at the south elevation overhead door indicated by the red oval.

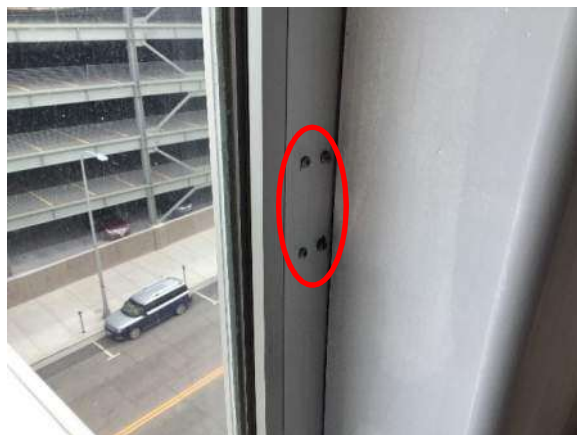
**Photo #26** Interior handle has been removed from the operable sash indicated by the red oval. Note the sash crack is not visible.

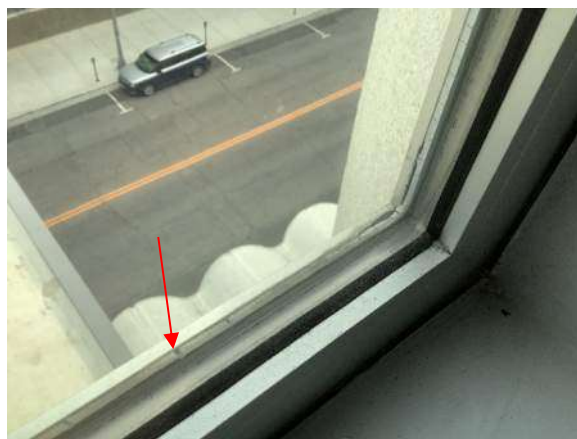
**Photo #30** Original compound glazing was observed to be in very poor condition from the building interior indicated by red arrow.

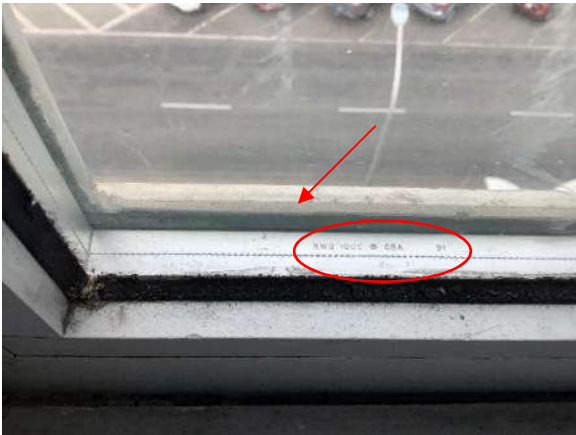
**Photo #31** Exterior glazing sealant at circa 1991 IG unit replacement (red arrow). Note "91" IGCC spacer stamp (red oval).

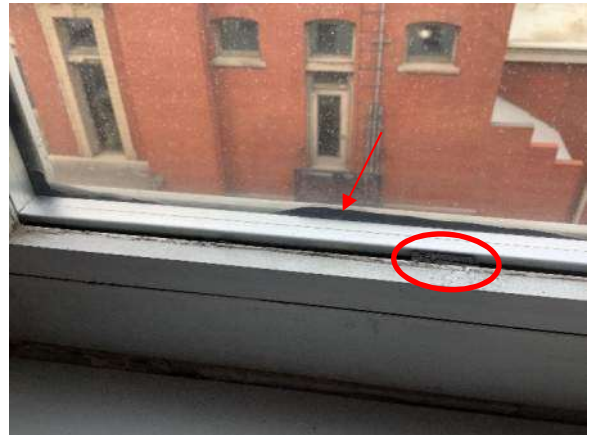
**Photo #32** Butyl tape exterior glazing at recent IG unit replacement indicated by red arrow. Shim location indicated by red oval.

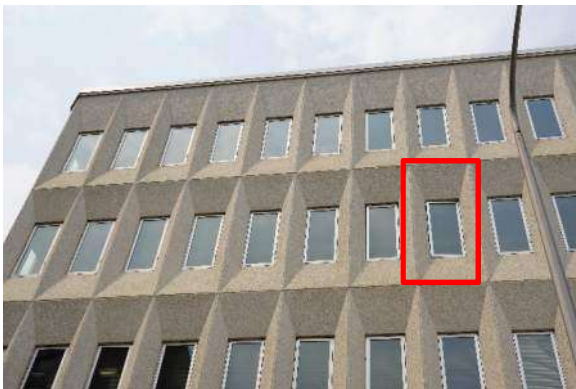
**Photo #33** Location of the open sash at the fourth floor on the south elevation indicated by the red rectangle.

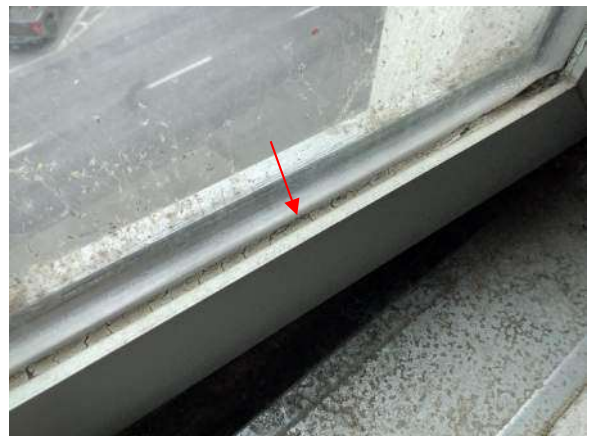
**Photo #40** Condition of the exterior compound glazing at the open sash indicated by the red arrow.

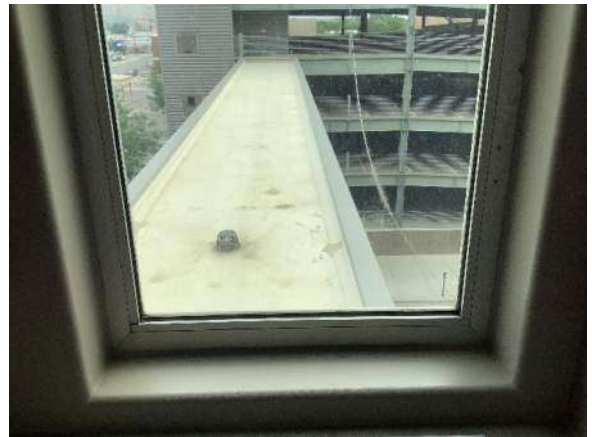
**Photo #46** Broken IG unit at the east elevation on the fourth floor.

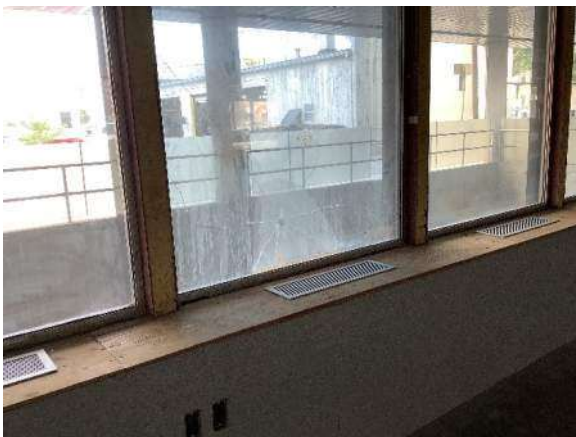
**Photo #47** Broken IG unit at the west elevation on the first floor.

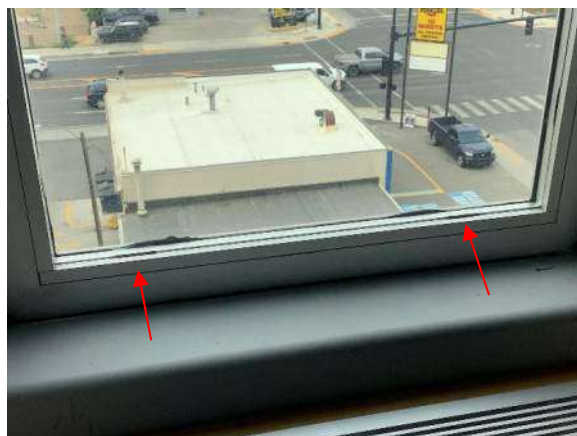
**Photo #52** Butyl glazing tape bulging from the exterior glazing joint at the shim locations indicated by the red arrows.

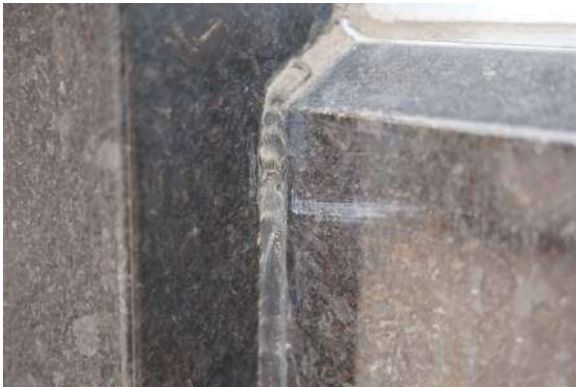
**Photo #57** Sealant at the granite panels was typically not tooled but otherwise in serviceable condition.

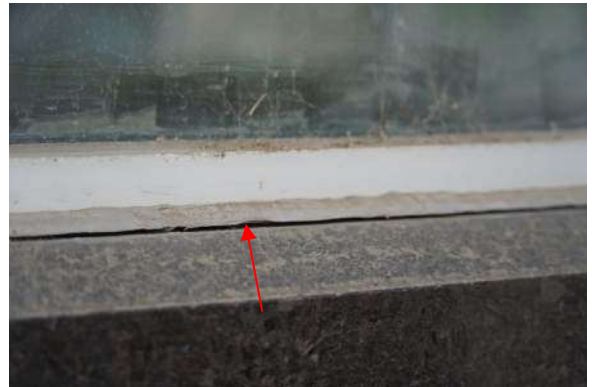
**Photo #58** Adhesive failure at first floor window perimeter sealant indicated by red arrow.

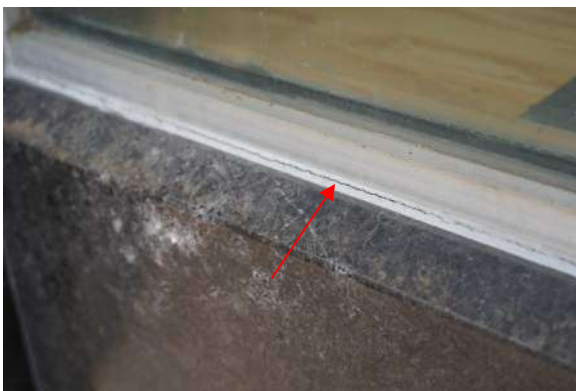
**Photo #59** Cohesive failure at first floor window perimeter sealant indicated by red arrow.

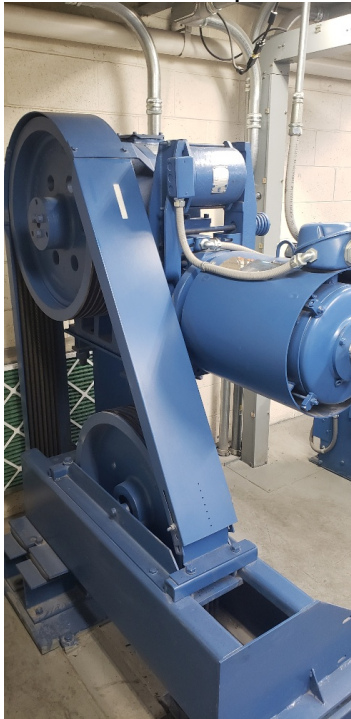
Machine, motor, cables, etc. All in good condition and functionally sound

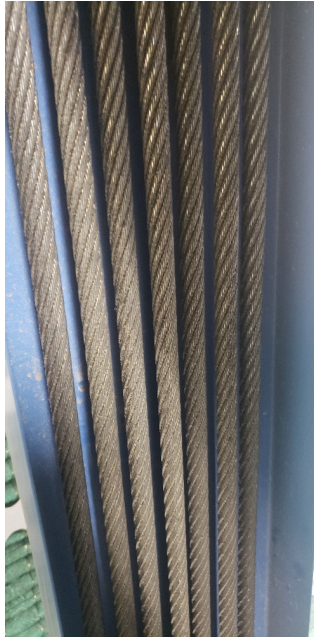
Elevator Cables. Original, but in good shape with minimal wear and no rogue (rust).

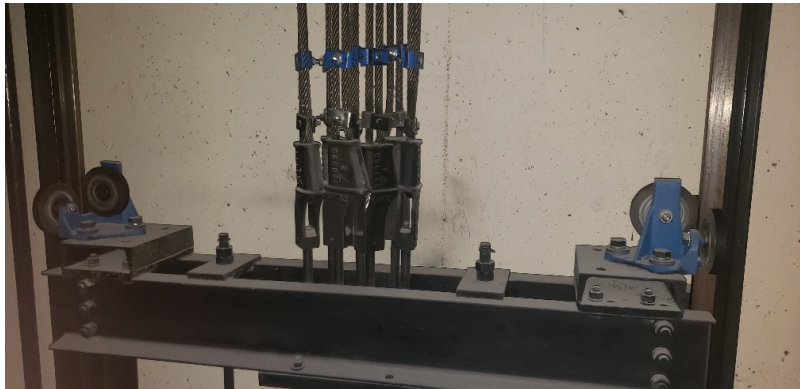
Shackles in good condition and code compliant.

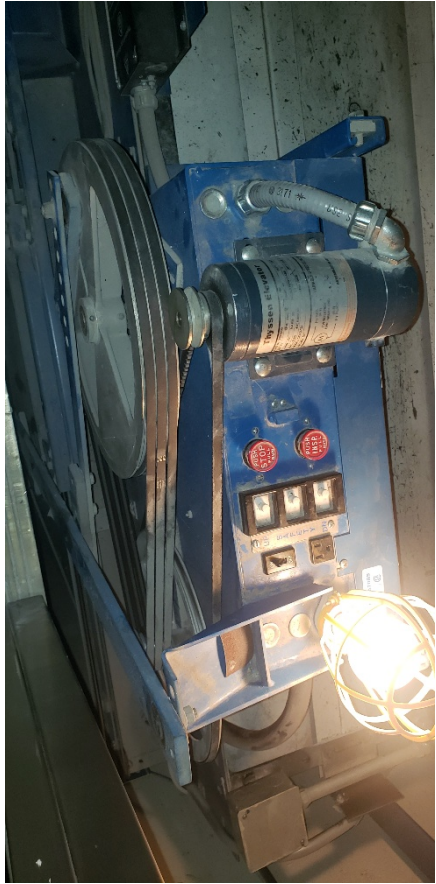
Door operator belts in good condition. Cartop Inspection Station functionally sound.

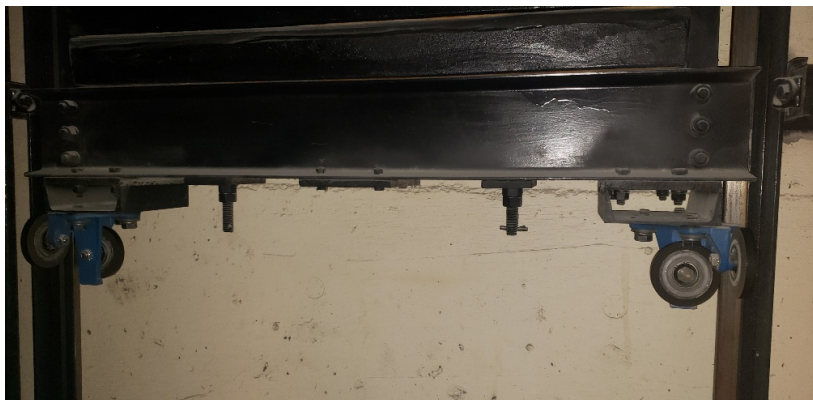
Counterweight rollers and rails are in good shape.

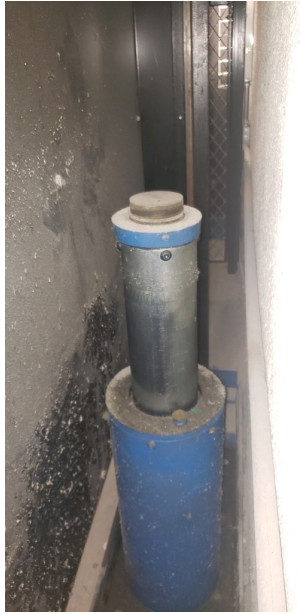
Oil buffers are code compliant
