October 18, 2022

Re: 760 Lake Elmo Drive  
Pre-Purchase Roof Inspection

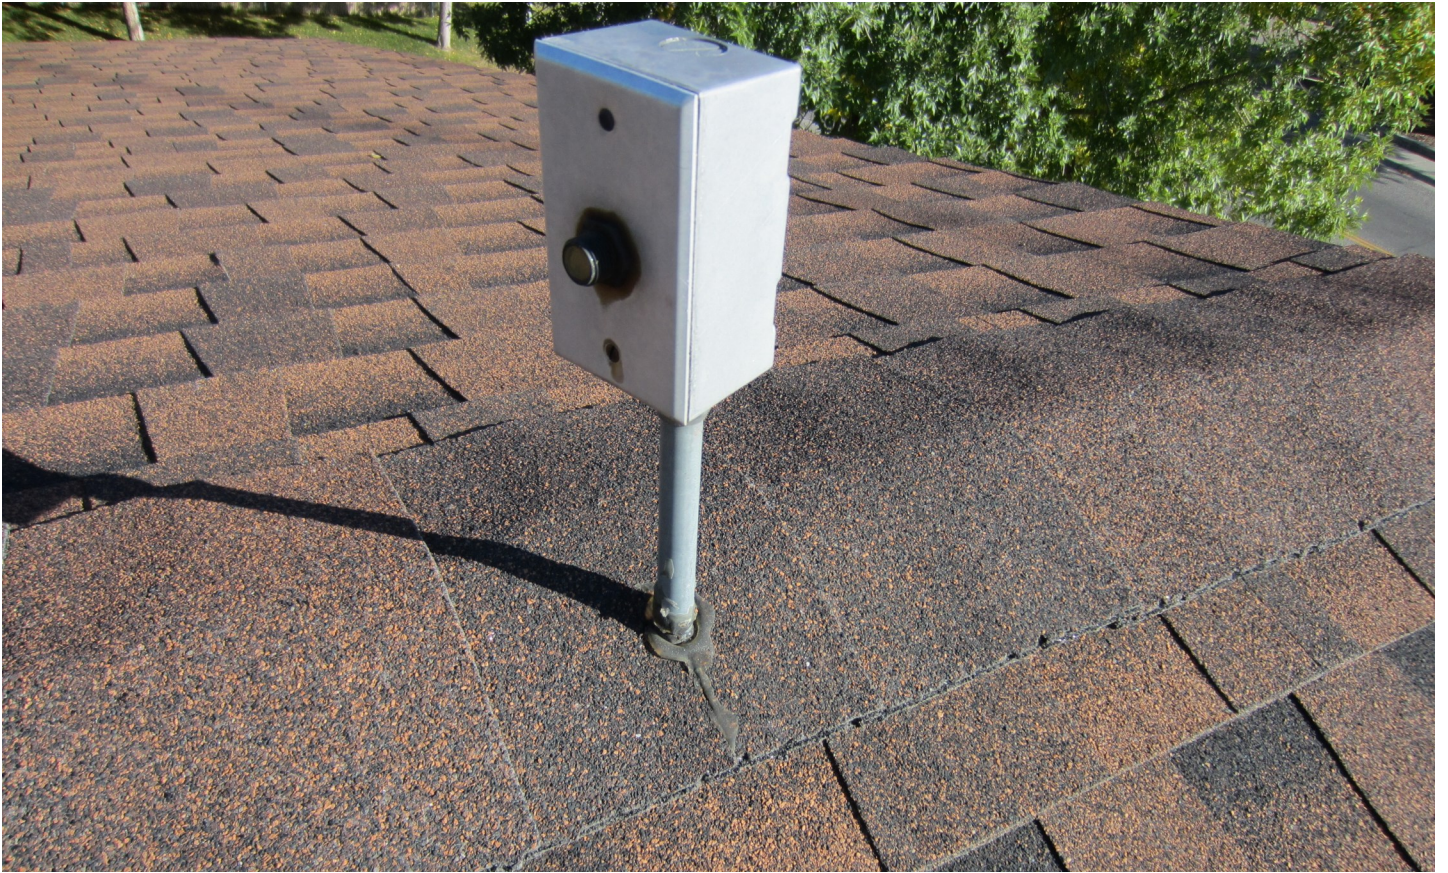
PIC #1

1. There is a photocell conduit pipe penetration right at the top of the ridge on the east side that does not have a proper flashing installed. The conduit penetrates the roof and has sealant installed at the roof level. This pipe needs a flashing installed. ***See Pic #1***

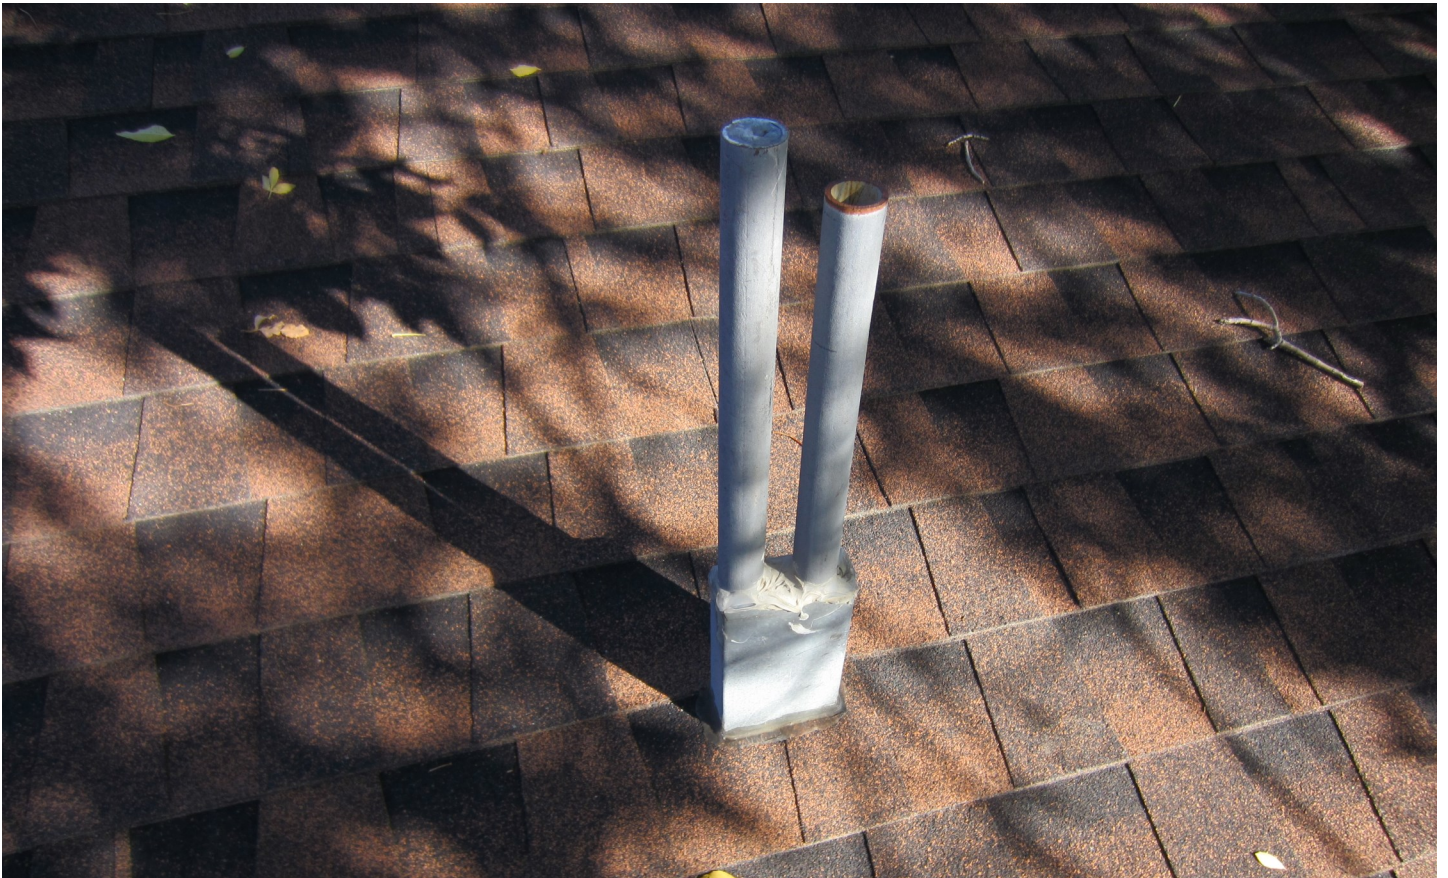
PIC #2

2. There is a small rectangular sheet metal box penetration installed through the roof with two galvanized pipes coming through the box and sealant with silicone. The sheet metal box is sealed at the roof level as well. The one pipe has been sealed off at the top and the other appears to be abandoned. If this is the case, this entire assembly should be removed from and the roof patched. If not, this box needs to be flashed into the roof system. ***See Pic #2***

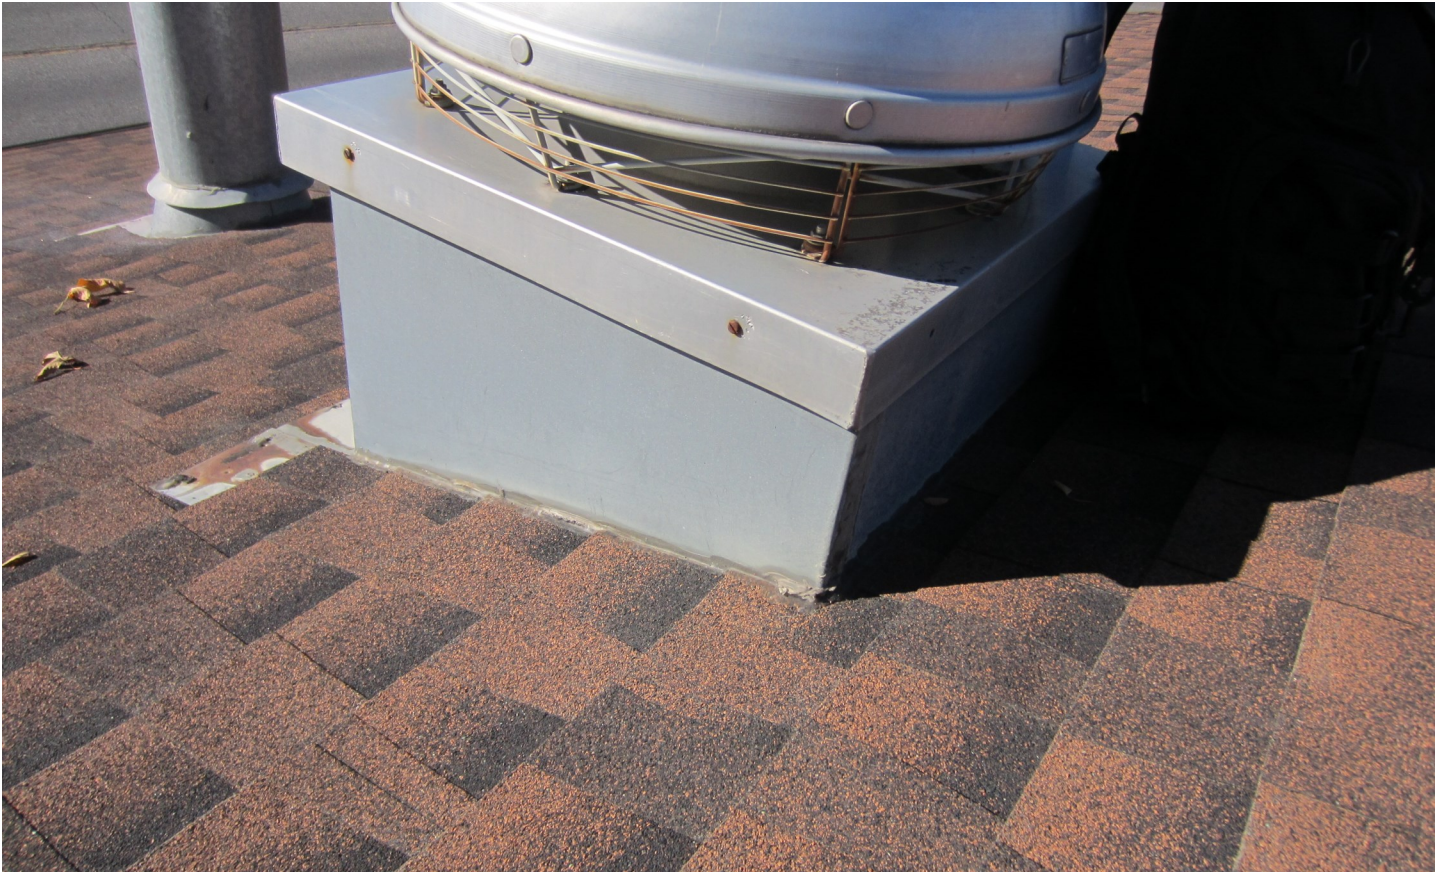
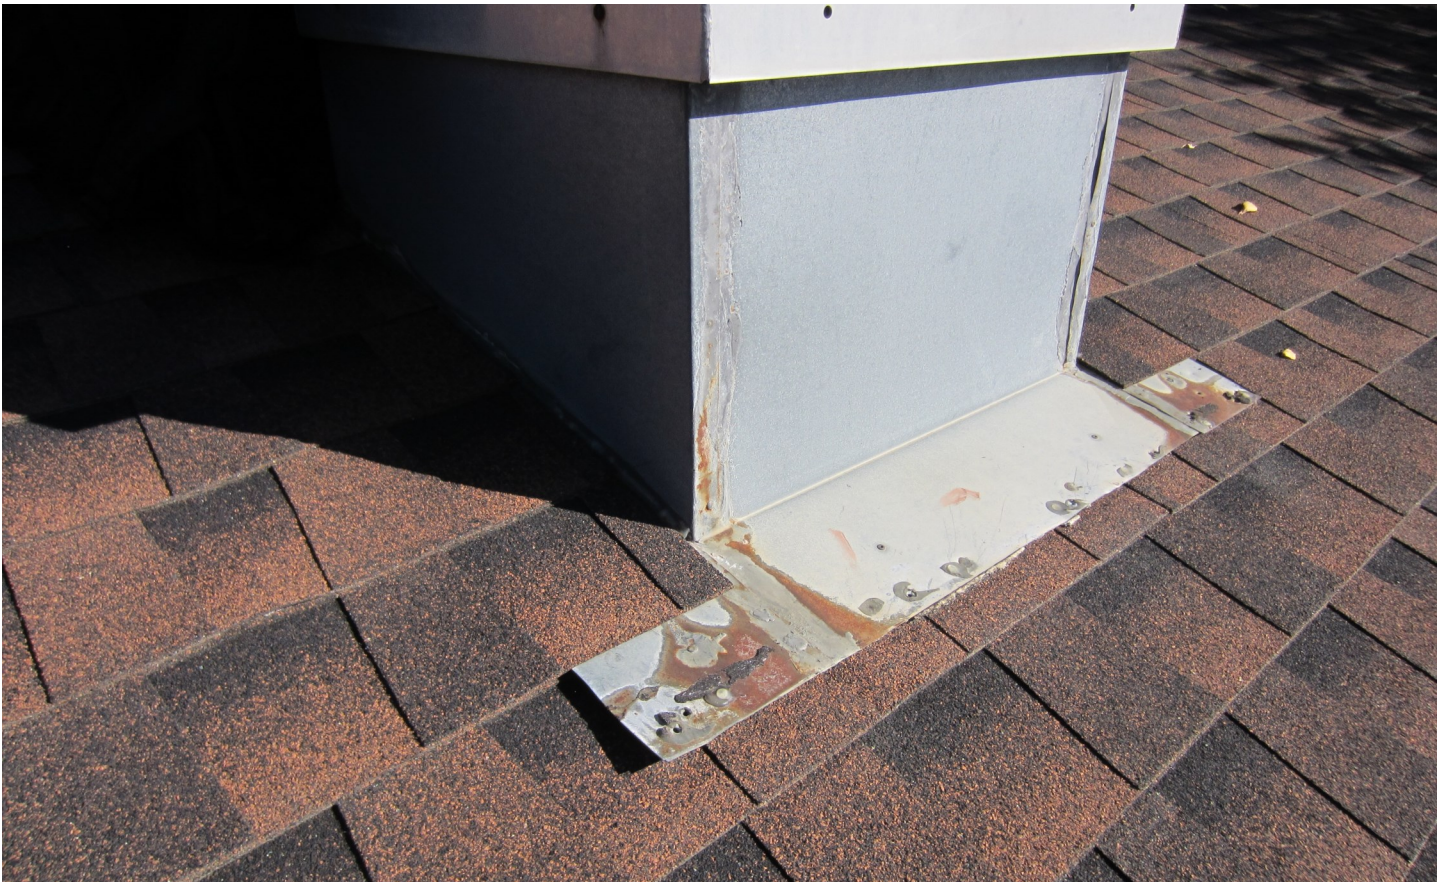
3. Along the 2'x2' curb, there are no step flashings along the east and west sides. Any area where the roof meets a wall or curb, these locations require one (1) step flashing per each row of shingles. Once these are installed, a counterflashing will be required to cover the tops of the step flashings. ***See Pics #3 and #4***

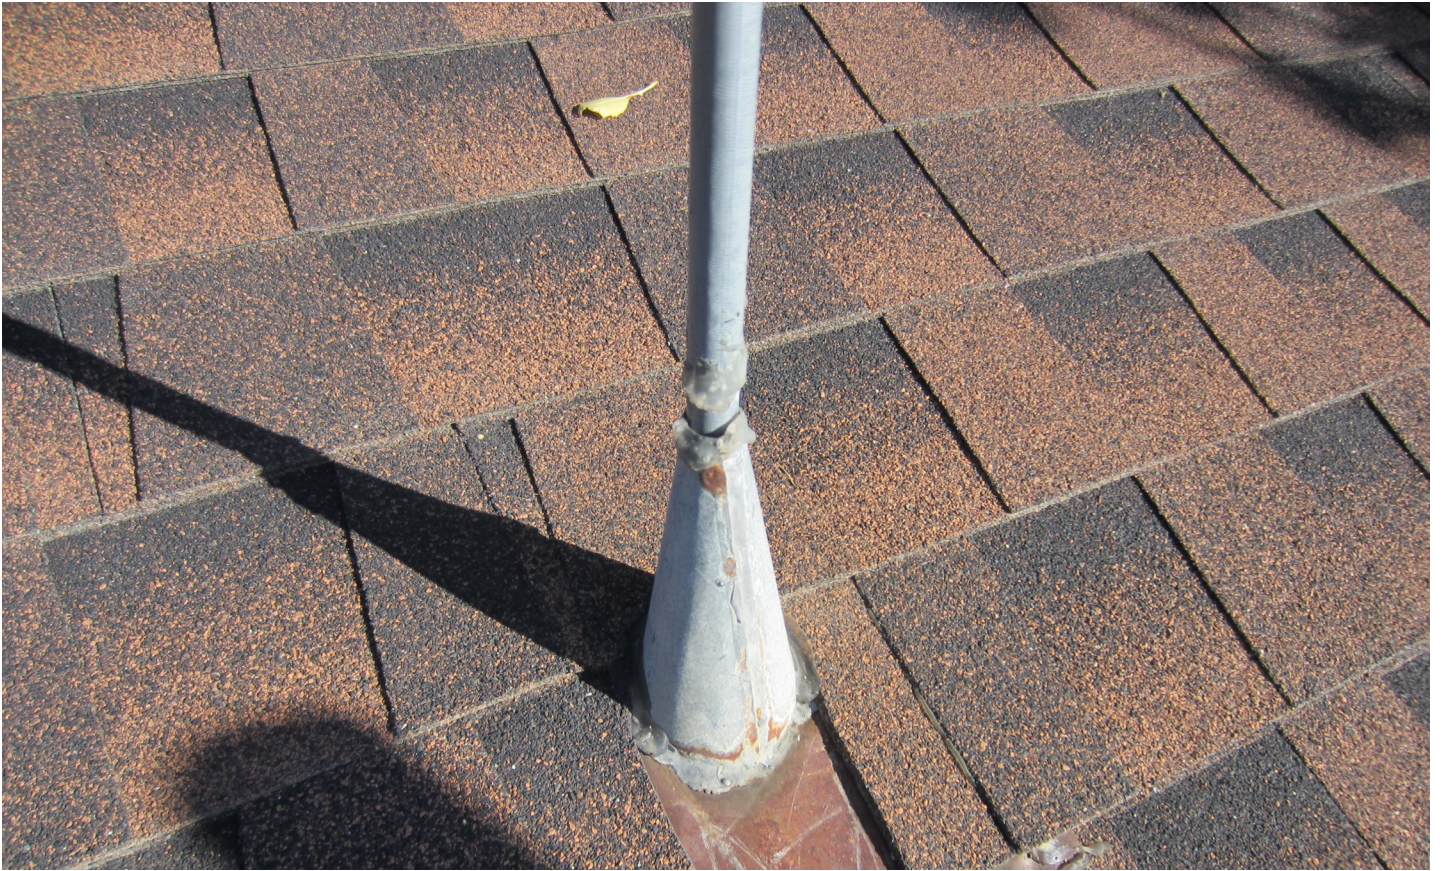
PIC #5

4. There is a 1/2" photocell conduit with a sheet metal flashing that needs to be sealed at the top. We would also recommend installing a storm collar. ***See Pic #5***

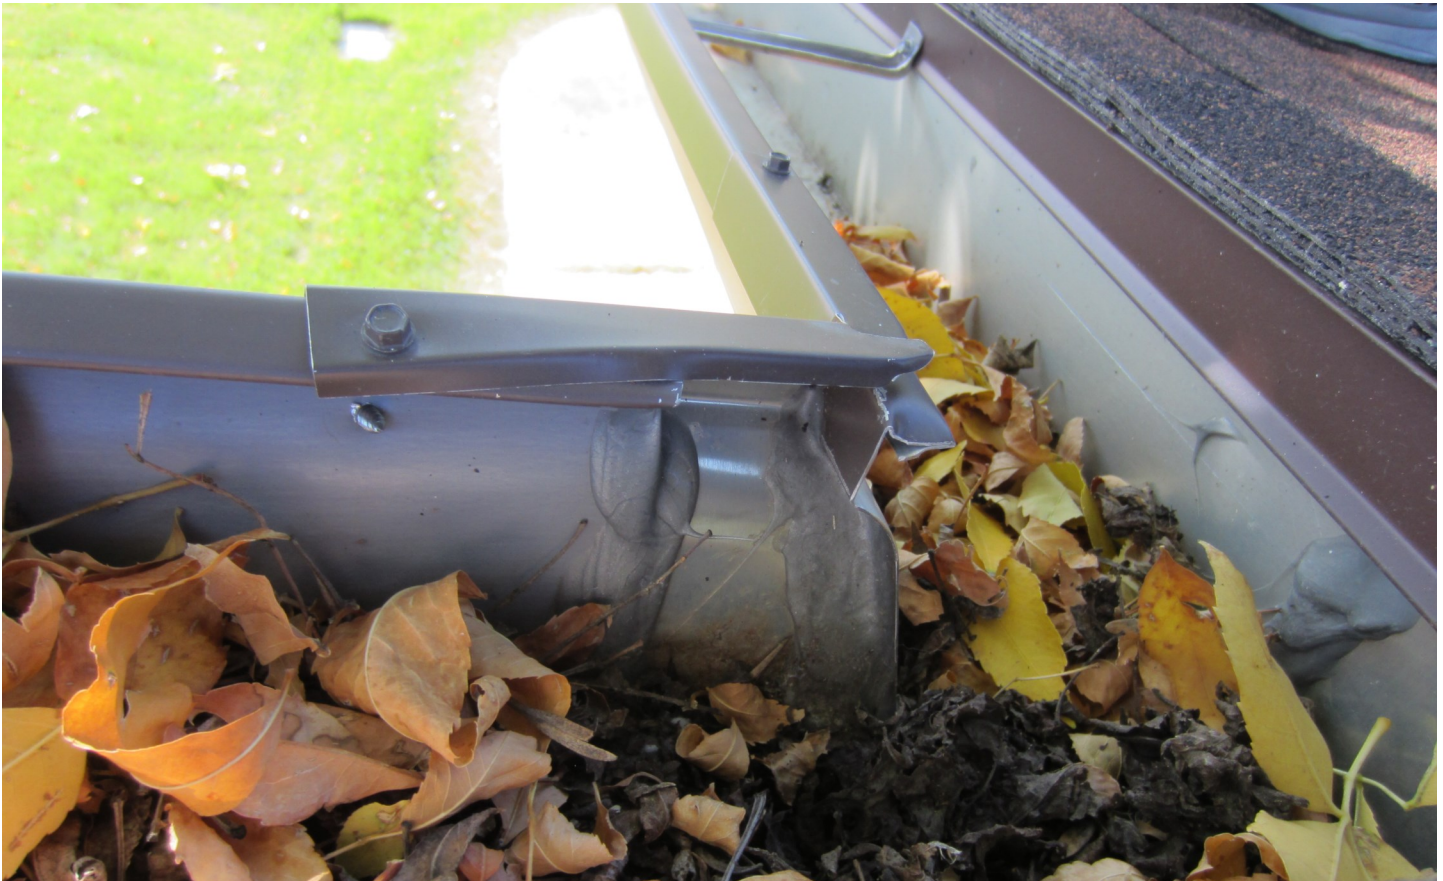
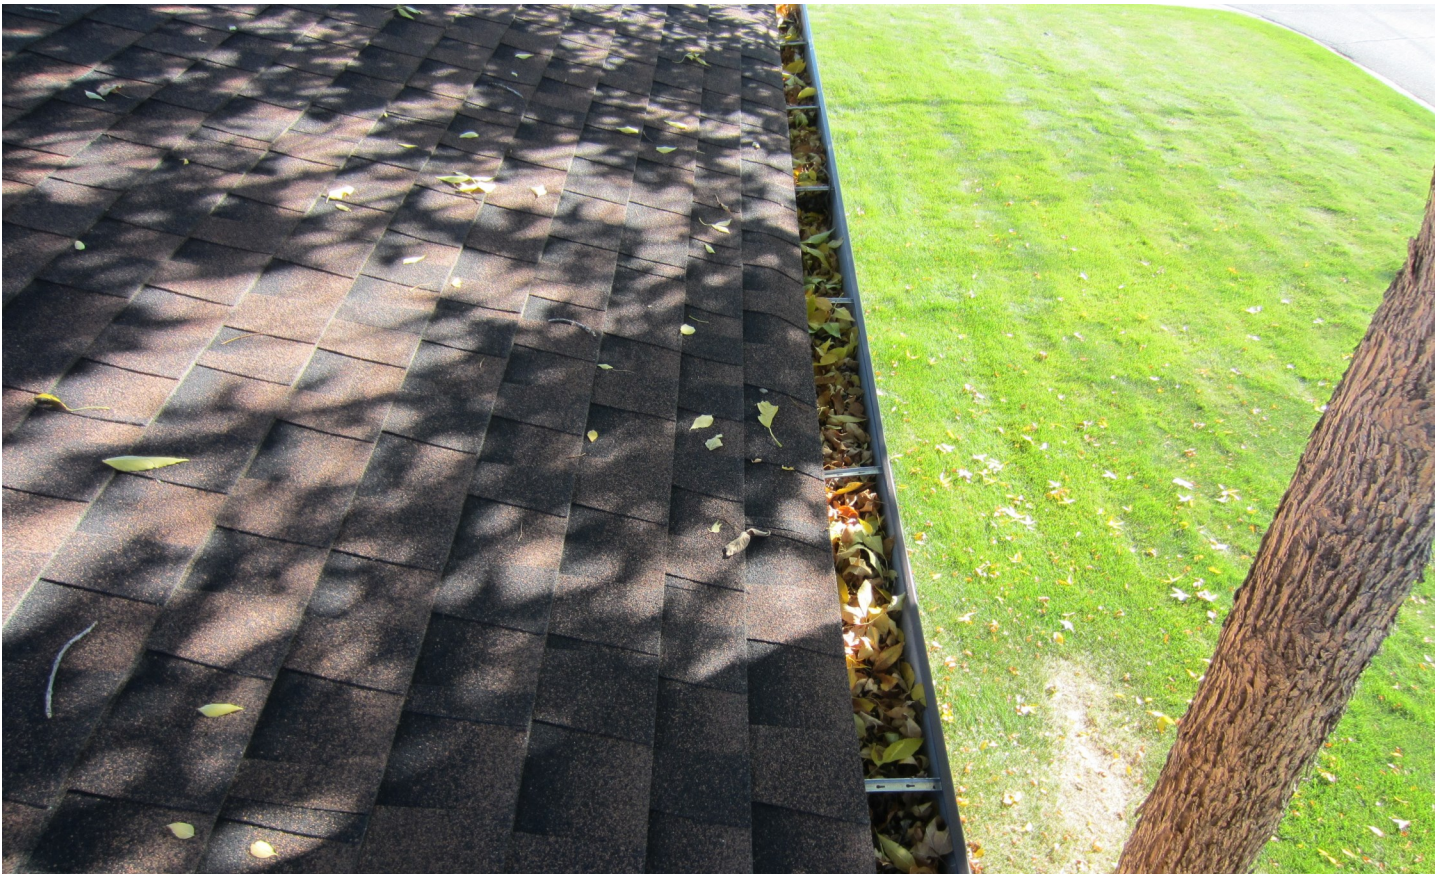
5. The gutters along the south side of the building are full of leaves/debris from the tree in the corner of the building. These need to be removed to allow the water to properly drain and prevent backing up. *See Pics #6 and #7*
6. Back of gutter has been notched out at the corner. There needs to be slip flashing installed to keep water from running back behind gutter and against the fascia. *See Pic #8*
7. Corner of 'D' Style edge metal needs slip flashing installed at corner to extend over back of gutter. *See Pic #9*

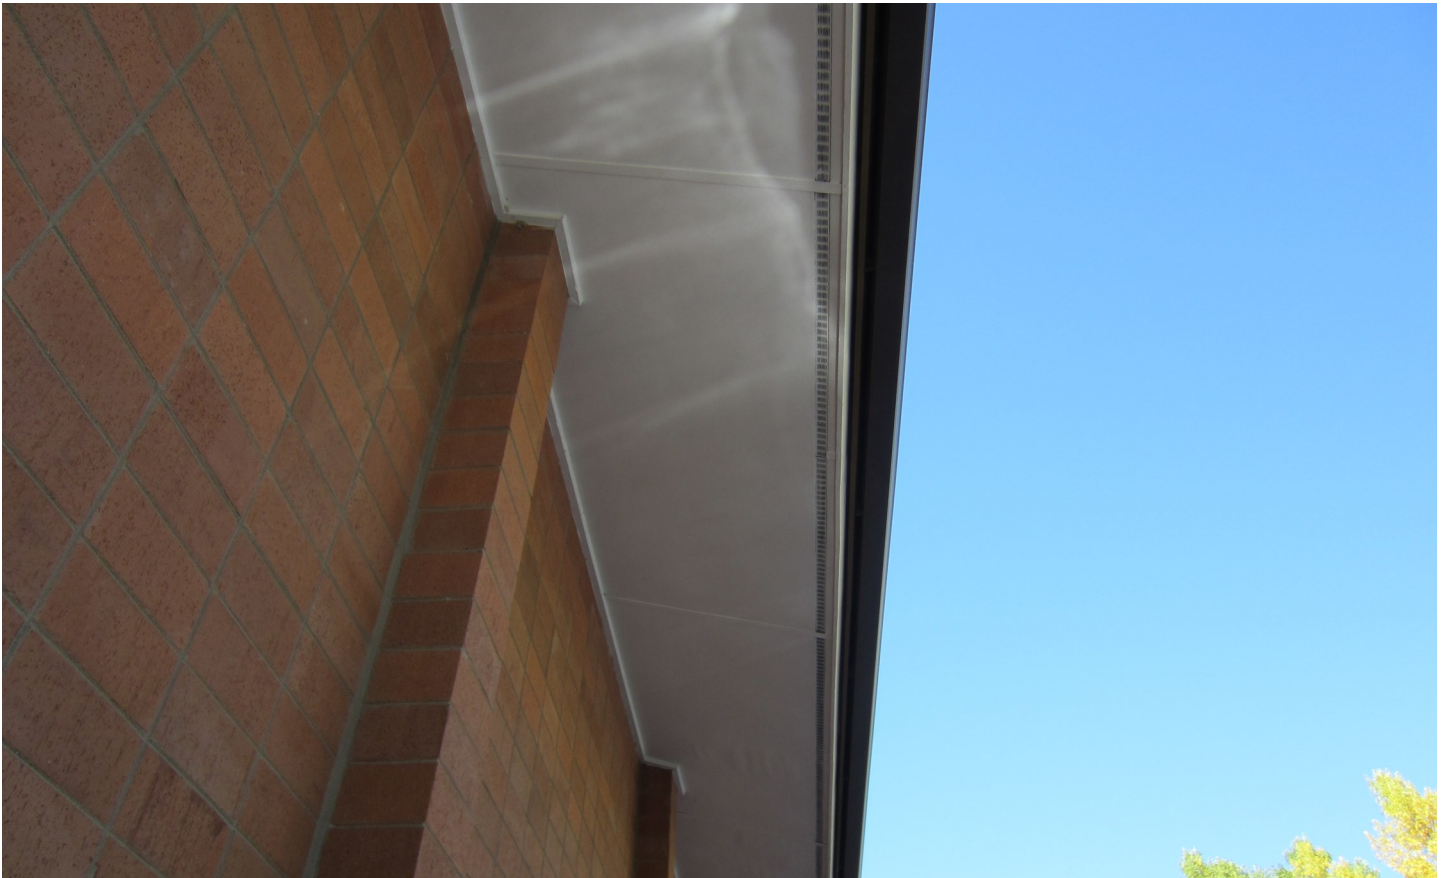
PIC #10

- The eave soffits have venting channels, but there is no venting along the ridge. Buildings require venting at both the eaves and ridges. Over time, this can lead to early deterioration of the shingles due to excessive heat. We would recommend installing vented ridge during next reroof project. *See Pic #10*

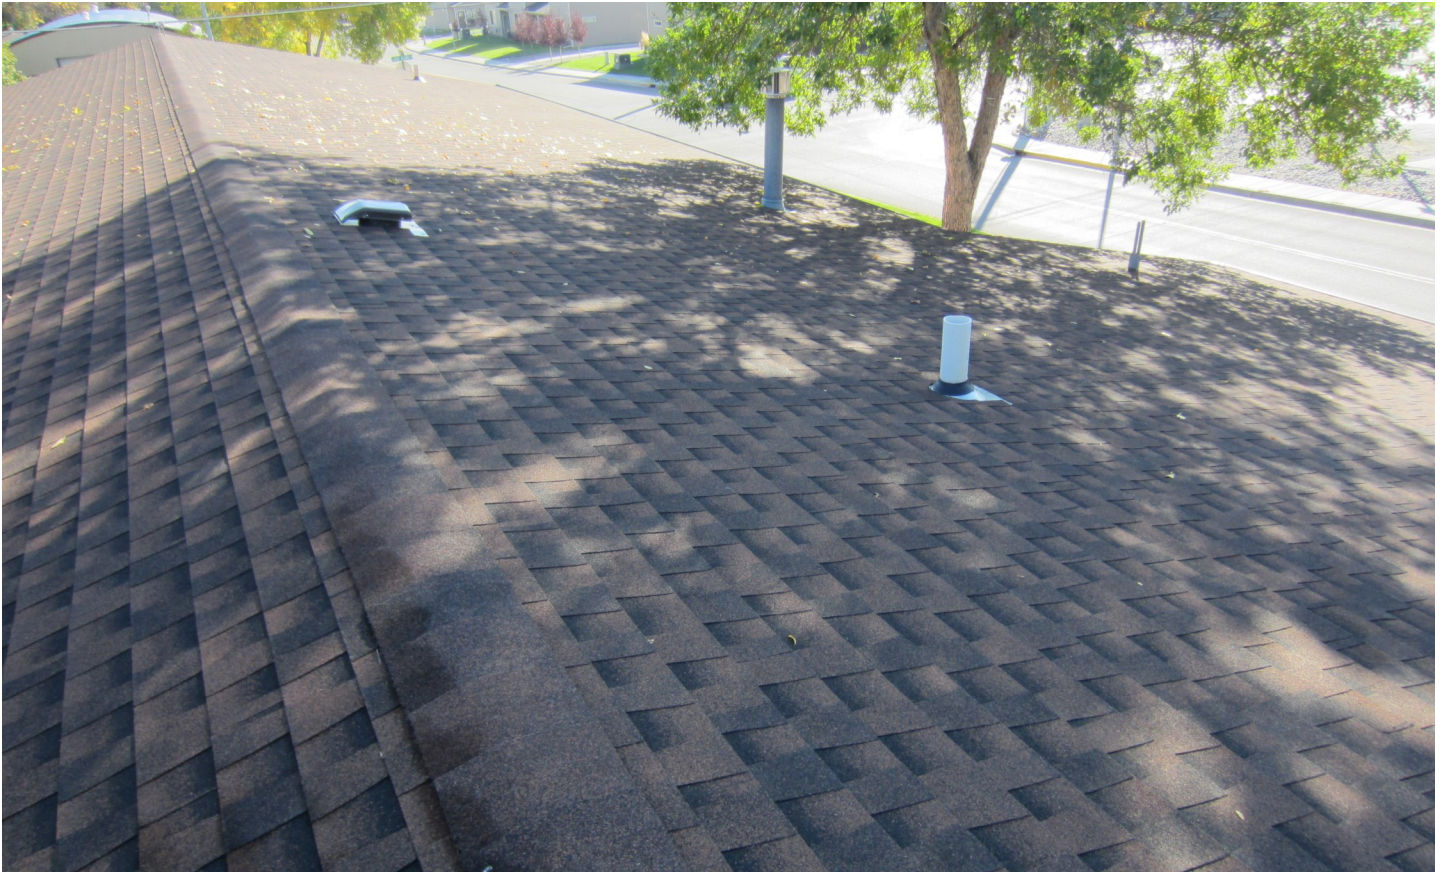
PIC #11

- Ridge does not have proper ventilation. *See Pic #11*
- Where we were able to visually inspect along the eave and rake edges, there has been ice and water shield installed at these locations. *See Pic #12*

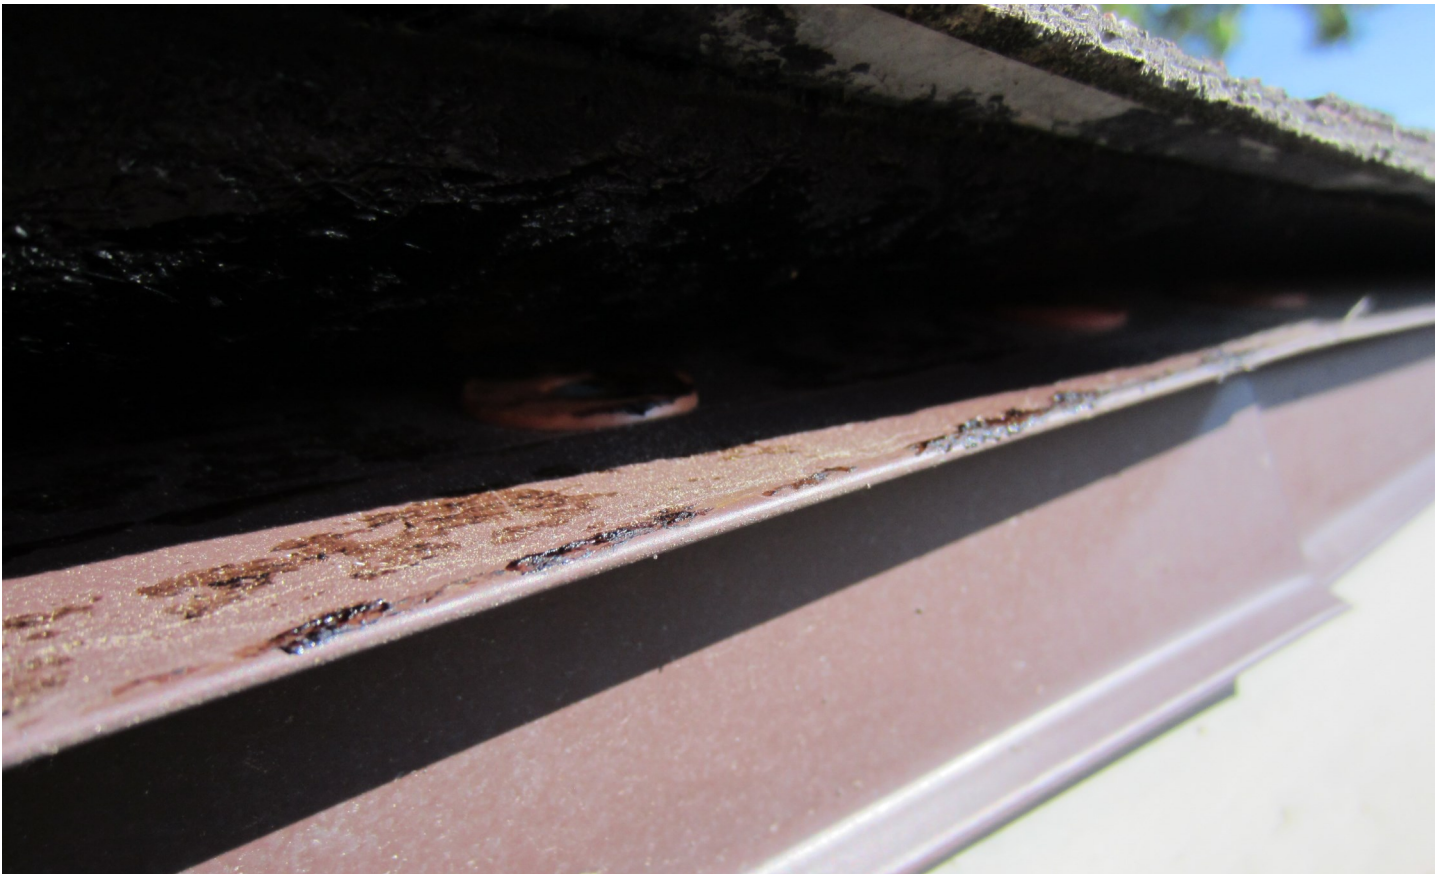
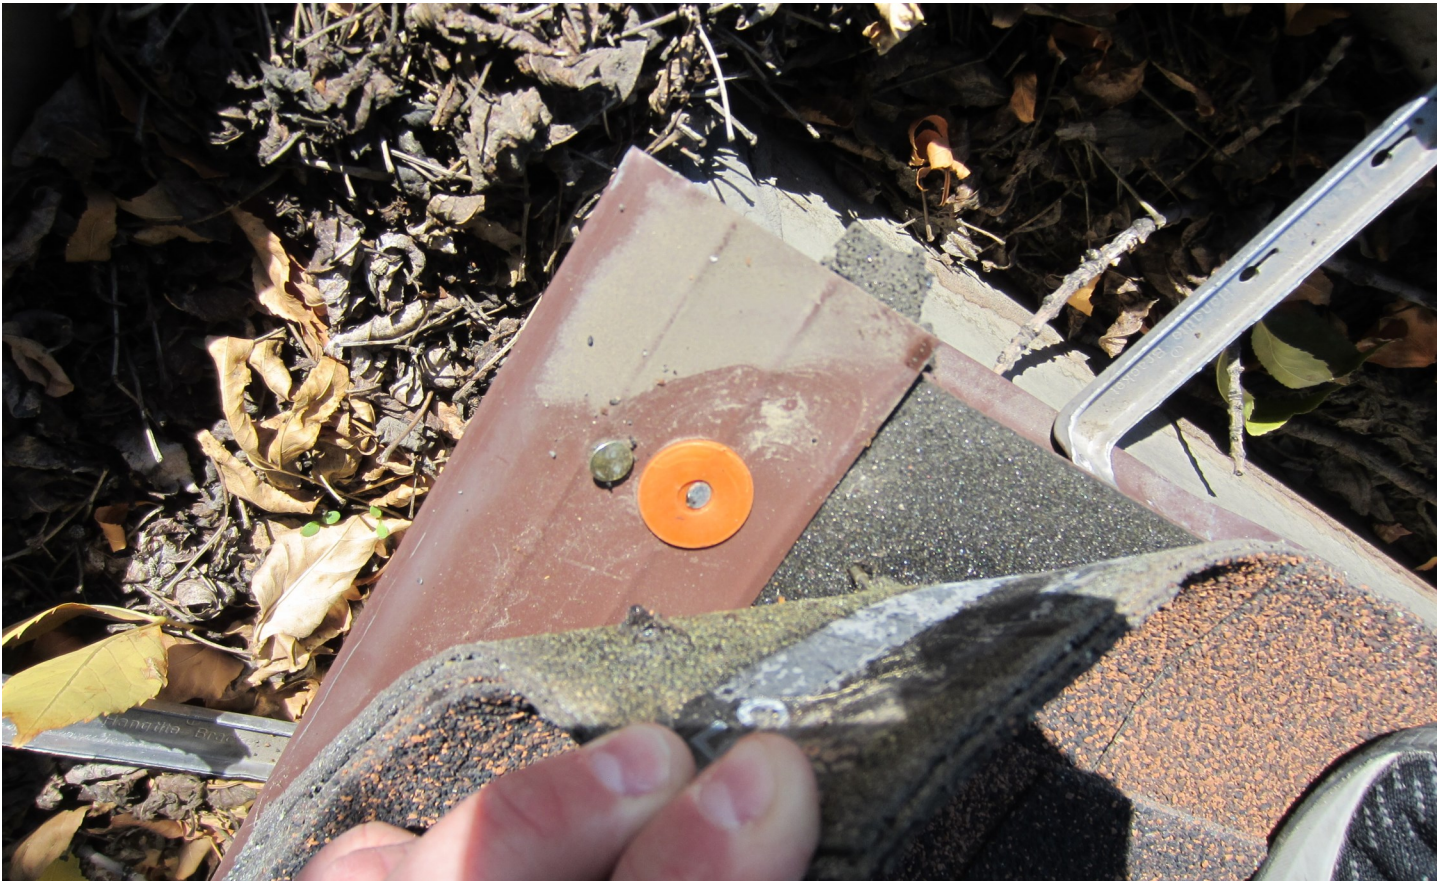
- The 'D' style drip edge has been installed using plastic cap nails. Manufacturers require standard roofing nails to attach edge metal. The reason for this is to allow the shingles to sit flat on the edge metal and seal down properly. During the inspection, it appeared that most areas along the eave and rake edges were adhered. Over time, there is a potential for winds to lift the shingles and possibly break them off. Wind driven rain and snow also have the potential to enter under at these locations. Continually monitor these areas. *See Pics #13 and #14*

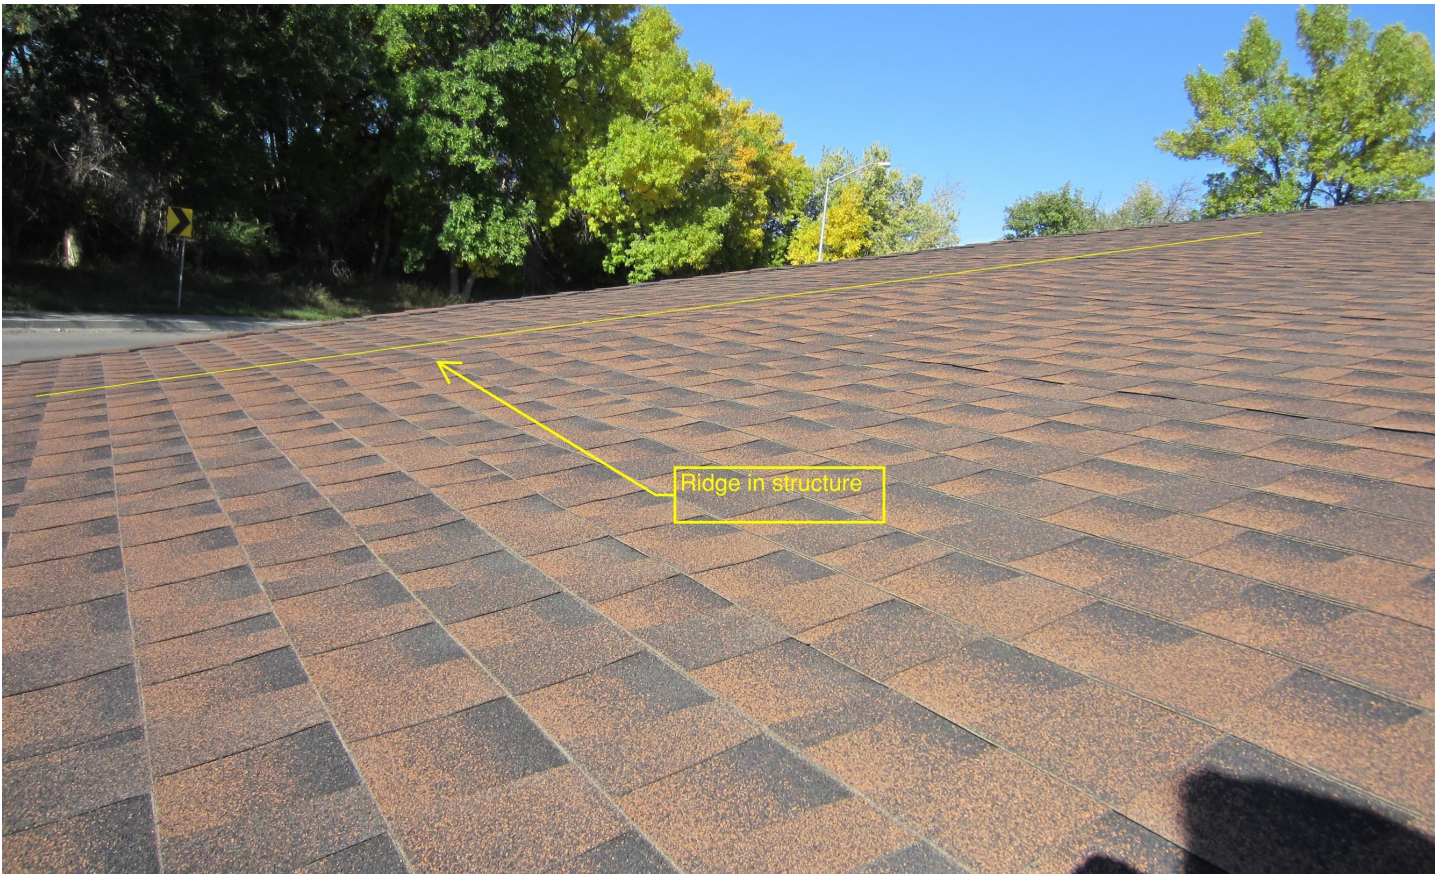
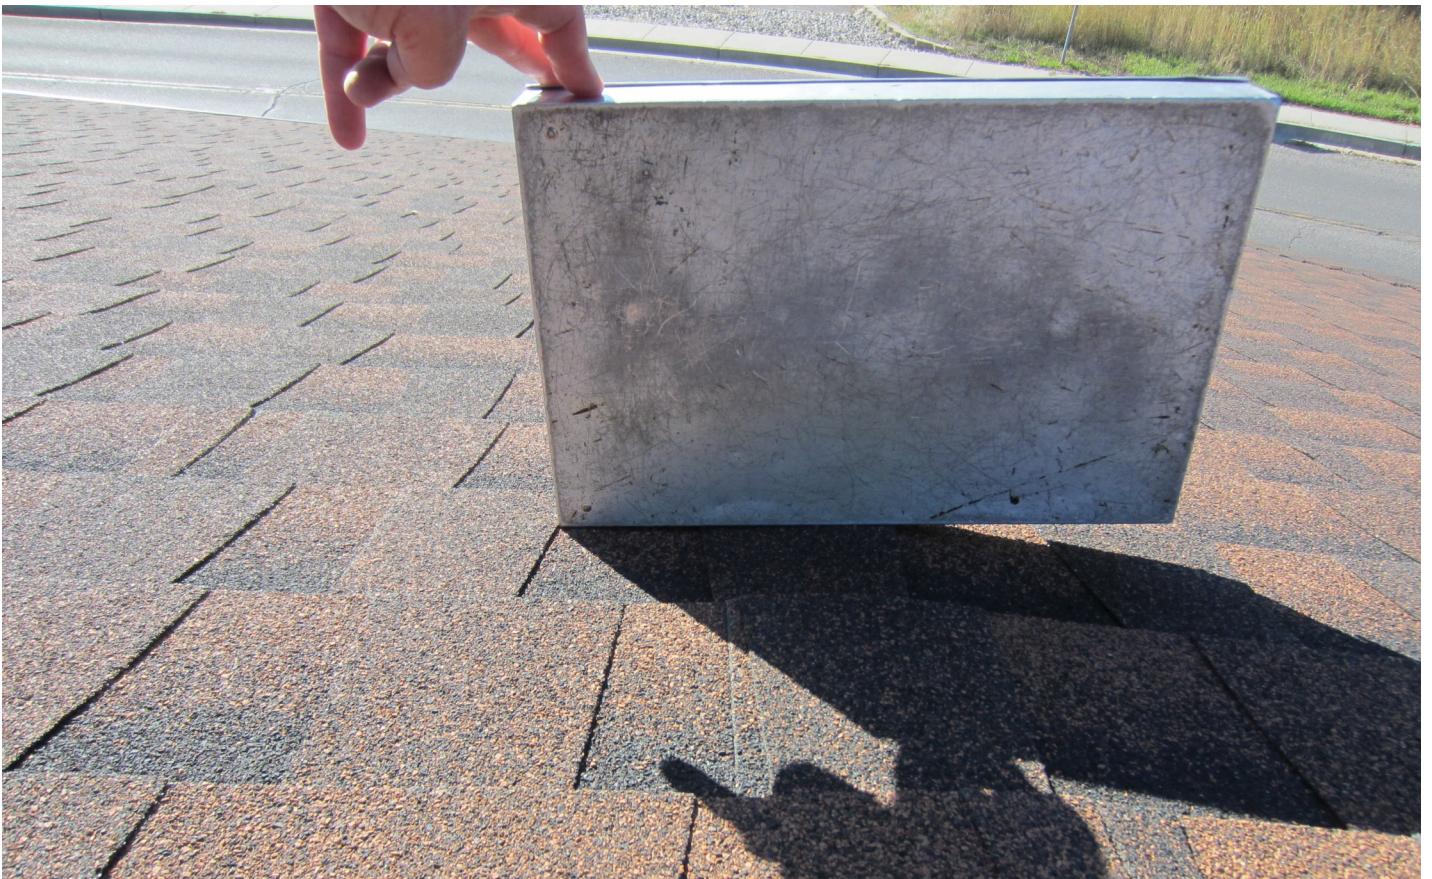
- There is a ridge/buckle approximately 8' in from the west corner that runs north/south. It appears to be in the decking and/or structure. There does not appear to be any damage or concern at this time. Recommend continually monitoring and inspecting this area during next reroof project. *See Pic #15 and #16*
