December 22, 2023

RE: **Babcock Theatre Marquee Assessment**
2812 2nd Avenue North
Billings, MT 59101

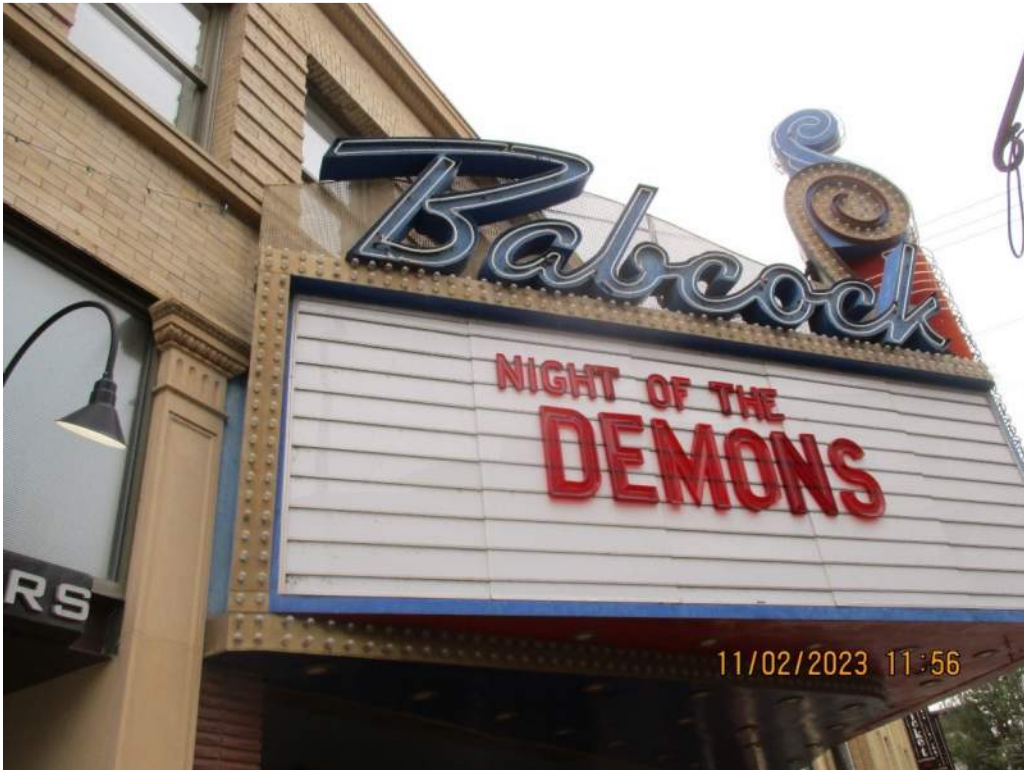
Figure 2: Overview of Babcock Theatre Marquee from Street

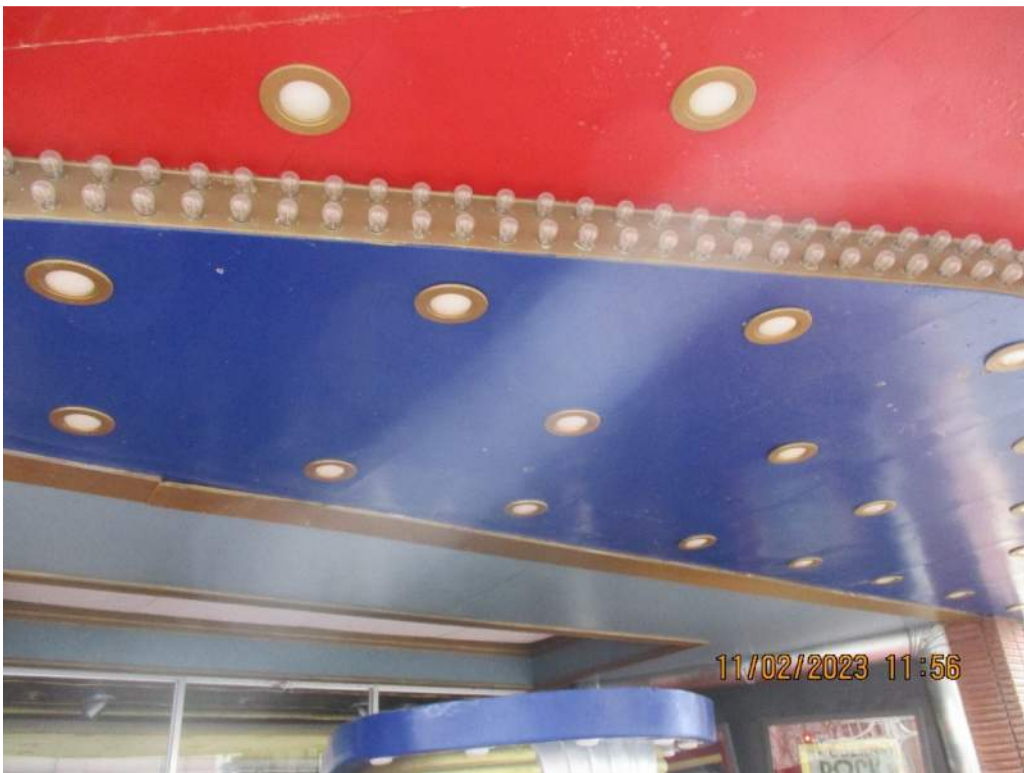
Figure 3: Overview of Babcock Theatre Marquee Underside

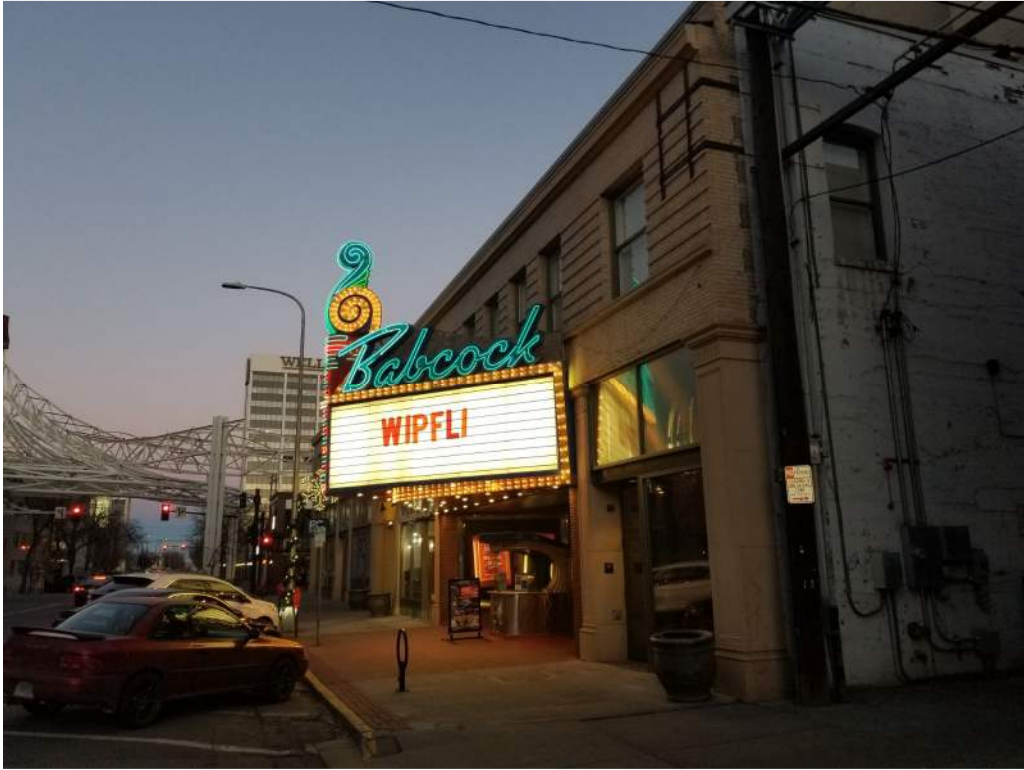
It is believed components making up the exterior marquee's visible signage are largely original. The street facing sign was constructed using painted sheet metal components which surround a sign rail board that lights up from behind and holds removable lettering. The underlying soffit area of the marquee was also constructed with sheet metal installed over the signs structure. Inset can lights hang within the soffit area while hundreds of light bulbs line the perimeter of the sheet metal signage. Along with the light bulbs, neon lighting accents are inlaid in the metal "Babcock" lettering and also wrap the vertical volute above the signs center. After viewing the sign lite up at nighttime, the neon lettering and accents was observed working throughout. The underside soffit lights were also all on with one light appearing dimmer than the others. Seven of the accent bulbs on the west side of the sign and two accent bulbs on the east side of the sign were observed not working, most likely burnt out.

Figure 4: Nighttime View of Sign's West Side

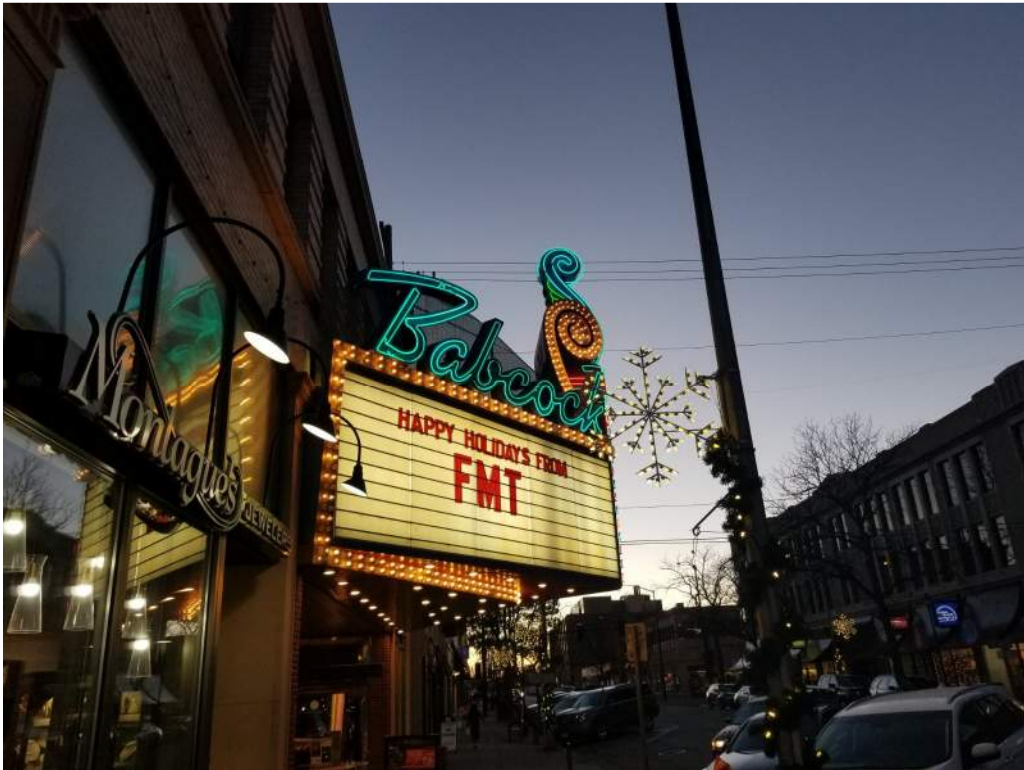
Figure 5: Nighttime View of Sign's East Side

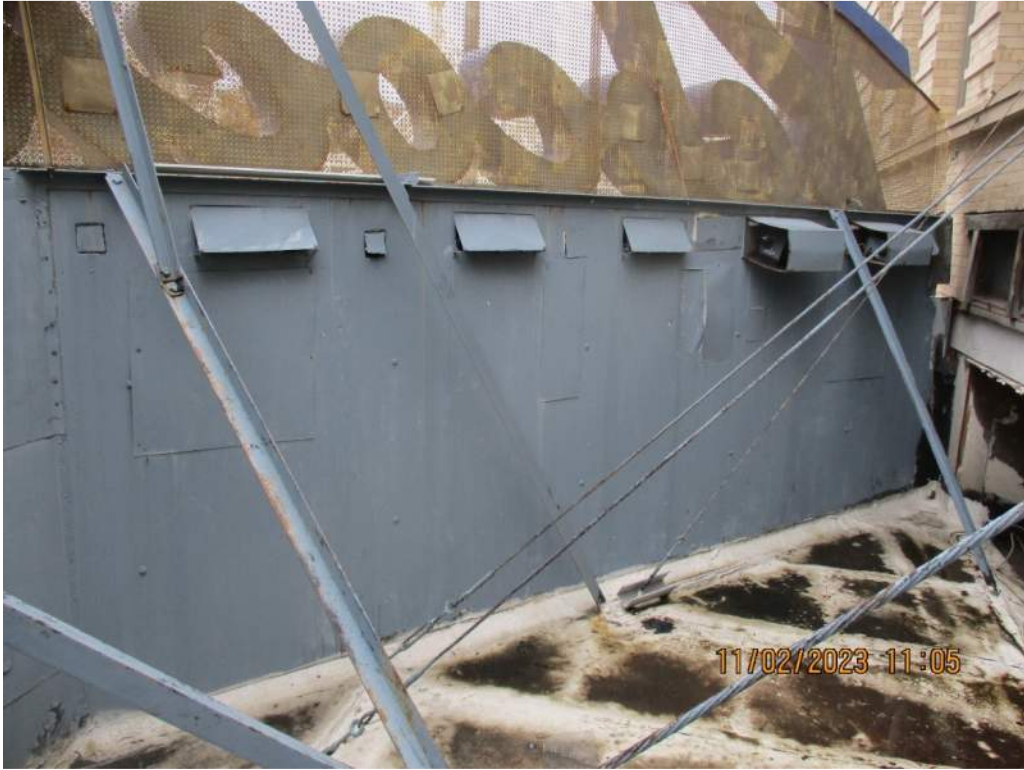
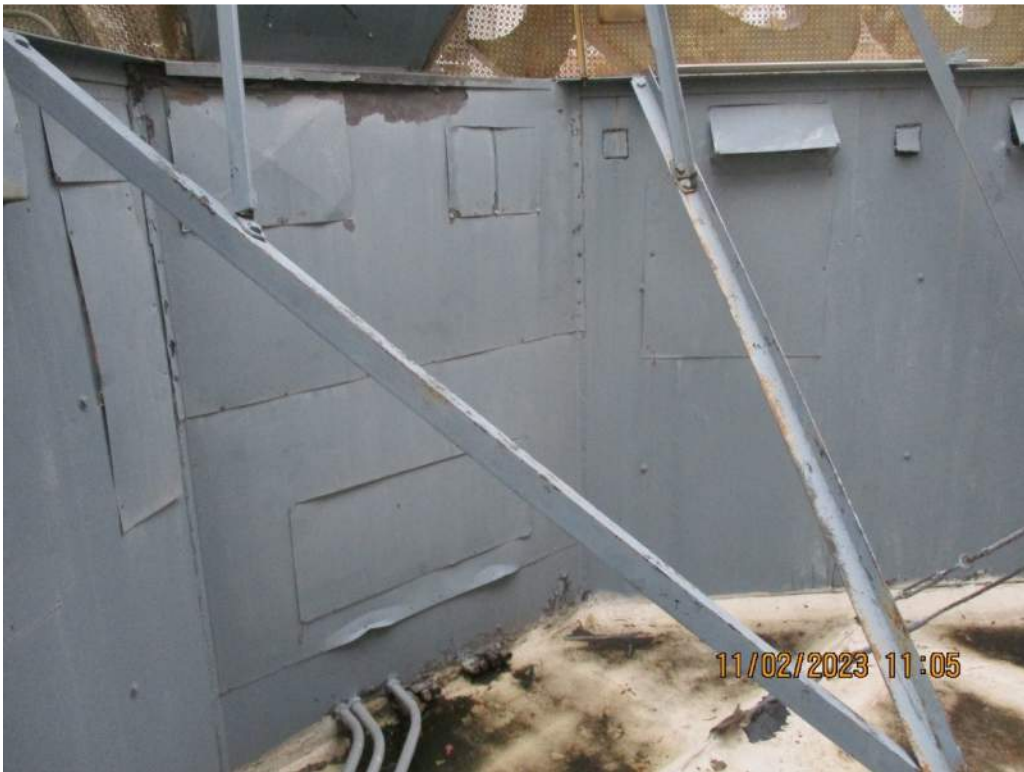
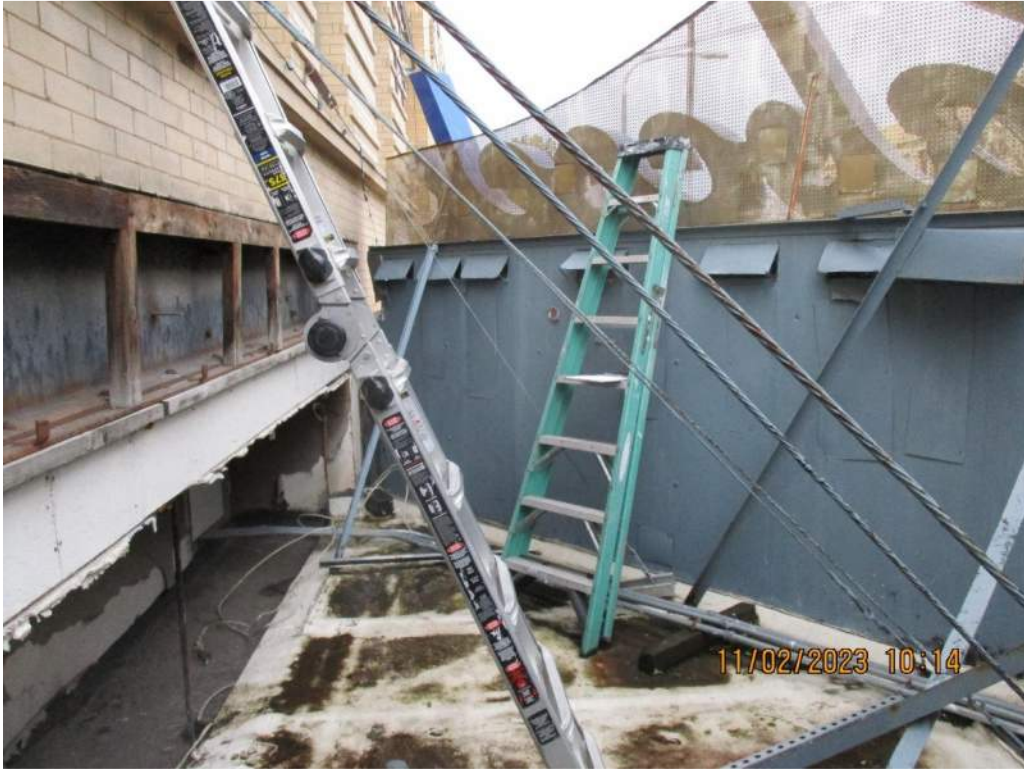
Painted sheet metal paneling covers the interior facing portions of the marquee sign. Access panels and openings are located throughout these panels which provide access and protection to the internal electrical components used to light the exterior signage. The metal paneling was observed to remain in sound condition with only minor surface wear observed. However, as referenced above, the paneling does not provide a watertight transition to the roof nor do the panels appear to keep the signs electrical components adequately protected from the weather.

Figure 6: Overview of Marquee Interior East Side Metal Paneling

Figure 7: Overview of Marquee Interior North Side Metal Paneling

Figure 8: Overview of Marquee Interior West Side Metal Paneling

Removal and replacement of the signs internal paneling will be necessary to ensure a water-tight transition at the signs new roof to wall transition. New paneling will also protect the signs somewhat exposed, underlying electrical components. Achieving this would require a design and installation that permits the panels to be easily removed or with access points matching those currently in place to allow for service and or future replacement of enclosed electrical components. A Premanufactured, exposed fastener, metal panel with sheet metal transition

flashings could be installed throughout to accomplish this. Since the metal paneling occurs on the interior sides of the sign, it is not believed modifications to the panels will affect any historical appearance or significance of the sign.

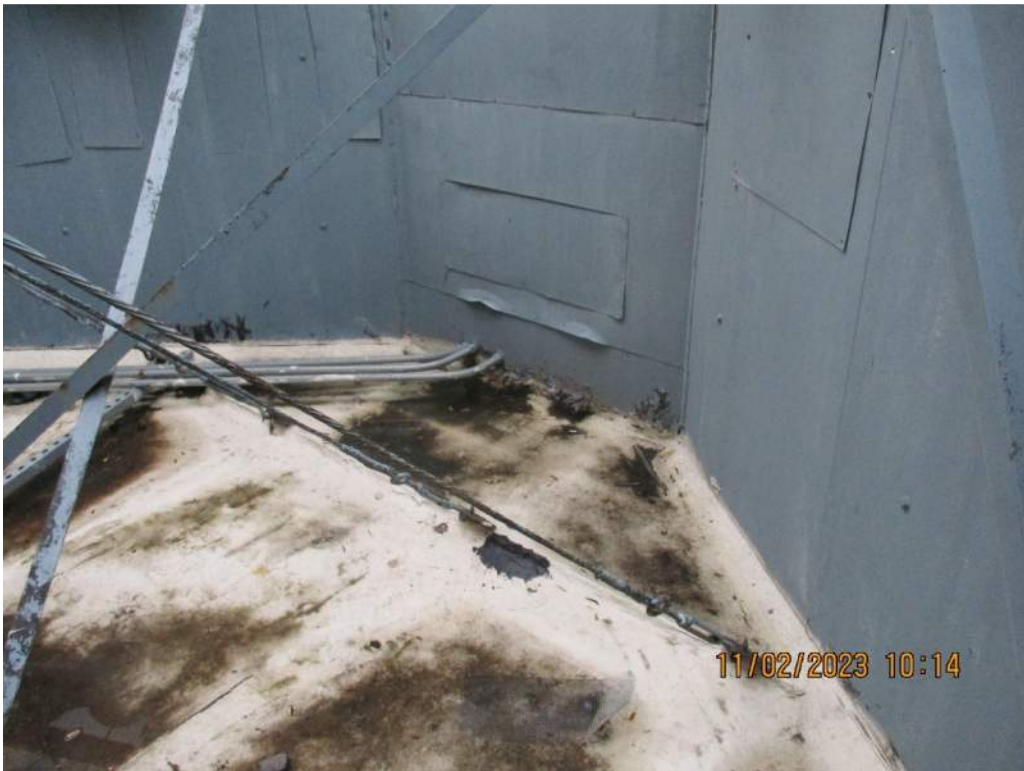
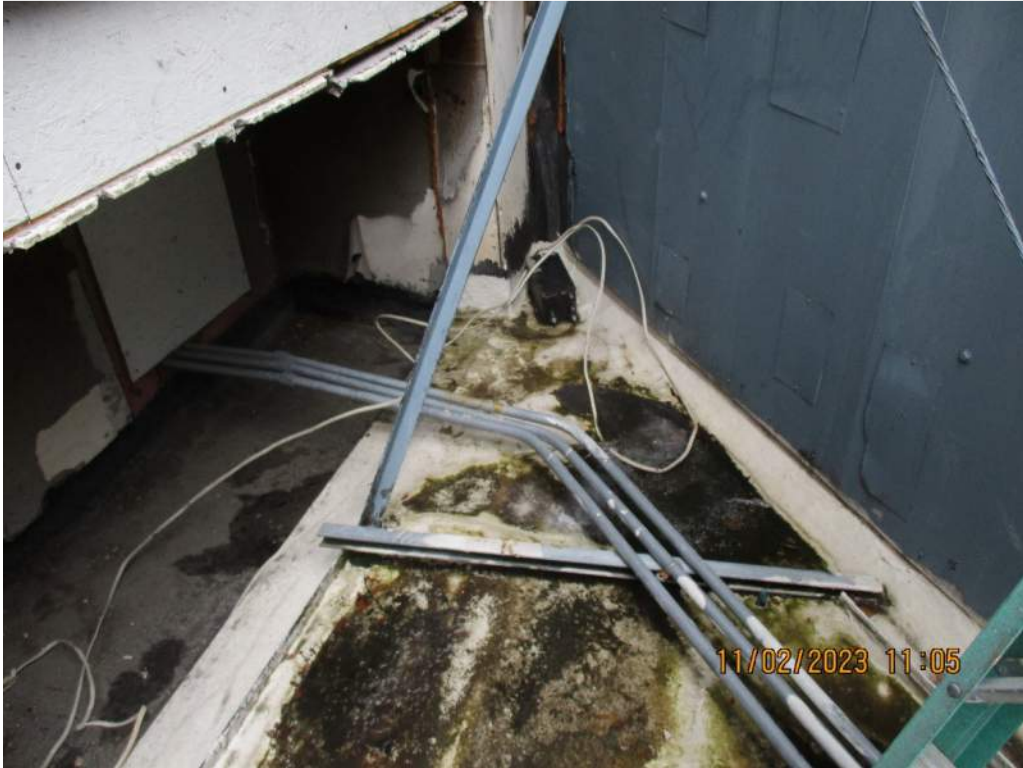
The roofing/waterproofing system of the interior of the marquee was installed utilizing a hot asphalt, moped in place roofing system installed directly over a sheet metal deck attached to the signs underlying structure. The asphalt roofing system was also observed with an elastomeric coating applied over top of the asphalt. The installed elastomeric coating is most likely not original to the built-up roofing system and was probably installed many years ago in response to previous leaks and deterioration to the underlying roofing. While on site, both the elastomeric coating and the asphalt built-up roofing were observed to be in poor condition with considerable deterioration to both throughout. Water was also observed dripping through the bottom side of the marquee and onto the sidewalk below.

Figure 9: Deteriorated Built-Up Roofing system with Elastomeric Coating over Marquee Steel Roof Decking

Figure 10: Deteriorated Built-Up Roofing system with Elastomeric Coating over Marquee Steel Roof Decking

In response to the poor condition and water infiltration observed throughout the marquee roof, Cushing Terrell recommends the system be removed and replaced throughout the signs main roof area and internal gutter. In addition to removal of the roofing system, it is recommended that the wall substrates adjacent the building also be removed and replaced.

Removal and replacement of the roofing system could be accomplished by tearing off the existing roofing system in its entirety down to the existing sheet metal decking. Prior to installation of a new roof membrane, tapered insulation, installed sloping from north to south should be utilized to help promote drainage of the sign's roof area. Tapered insulation should also be installed throughout the internal gutter area to further promote drainage to the outlet. Upon installation of the tapered insulation throughout, Cushing Terrell recommends a primed gypsum cover board such as Densdeck Prime be mechanically fastened throughout the roof area with a 60-mil, reinforced Ethylene Propylene Diene Terpolymer (EPDM) single ply membrane adhered to the cover board throughout.

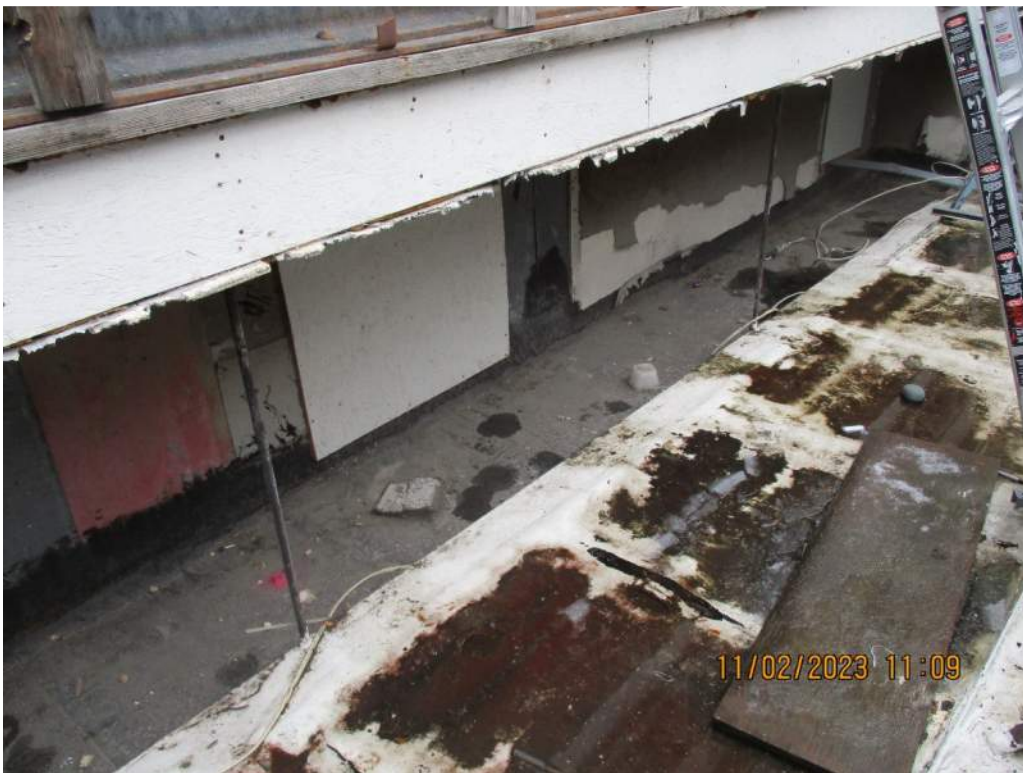
The internal gutter within the space inset in the wall was also observed to have been roofed using a moped in place built-up roofing system. This gutter area, however, did not include the added elastomeric coating over the asphalt roofing. The roof system installed through the internal gutter was found in poor condition similarly to the roofing installed throughout the main roof area of the marquee.

Figure 11: Deteriorated Built-Up Roofing at South End of Marquee Along Transition to Internal Gutter

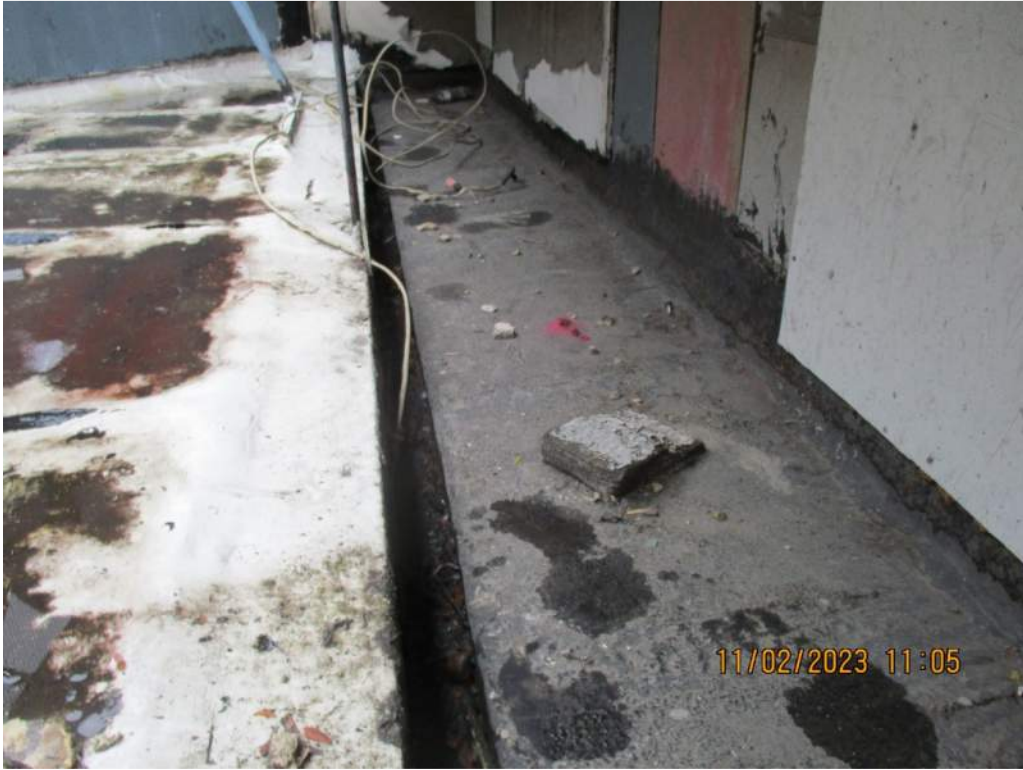
The main roof area of the marquee drains back towards the building (to the south) and into an internal gutter that sits within the exterior wall line of the building. The internal gutter runs east and west along the entire width of the sign. One small, approximately one inch in diameter, drain outlet is located on the far east side of the internal gutter. While on site, this drain outlet was found mostly blocked with debris and appears inadequate in size to drain the approximate 270 square feet of sign roof area. The connecting piping of the drain outlet was located while on site and was found ran through the ceiling and exterior wall cavity of the Babcock Theatre's adjacent business to the East (Montague's Jewelers). Any recommended revisions to the marquee's drainage system would prove difficult given the drain lines inadequate sizing and rout path through the adjacent space.

Figure 12: Internal Gutter Underneath South Wall of Marquee

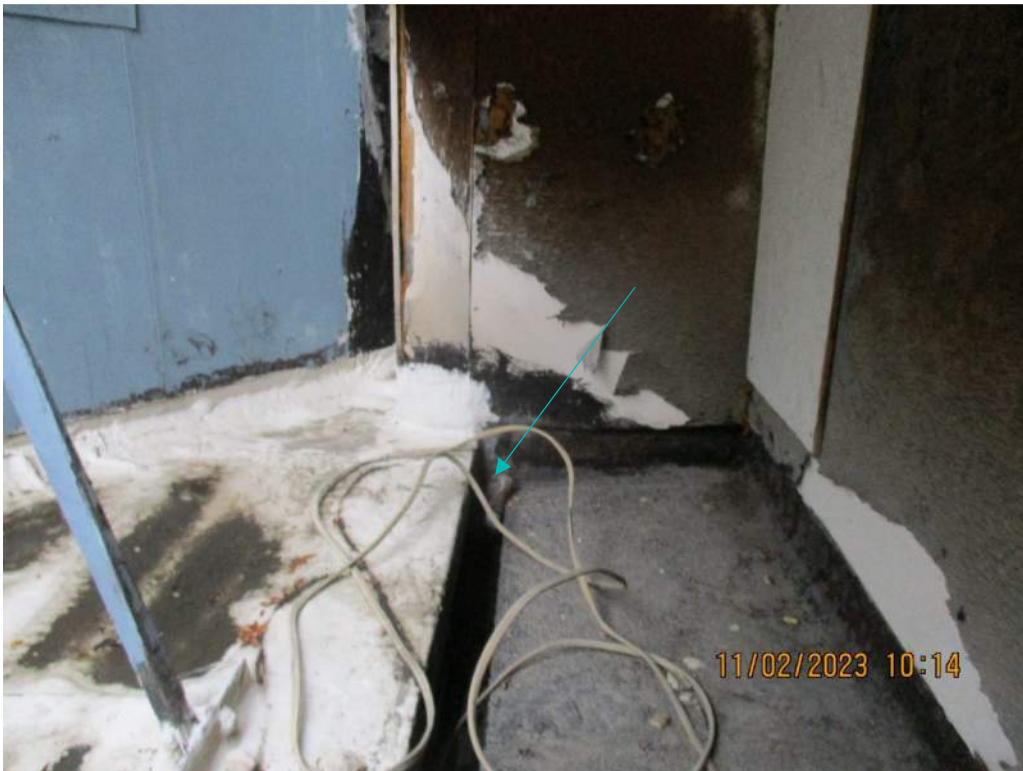
Figure 13: Location of Small Drain Outlet in East Corner of Internal Gutter

Revisions to the roof drain outlet would also be necessary when the marquee is re-roofed. Removal of the sheet metal decking around the drain outlet will most likely be necessary so a drain body can be attached to the outlet piping. A drain assembly will help adequately seal the new roof system to the drain outlet and will also help prevent debris from clogging the drain pathway, further promoting proper drainage of the system.

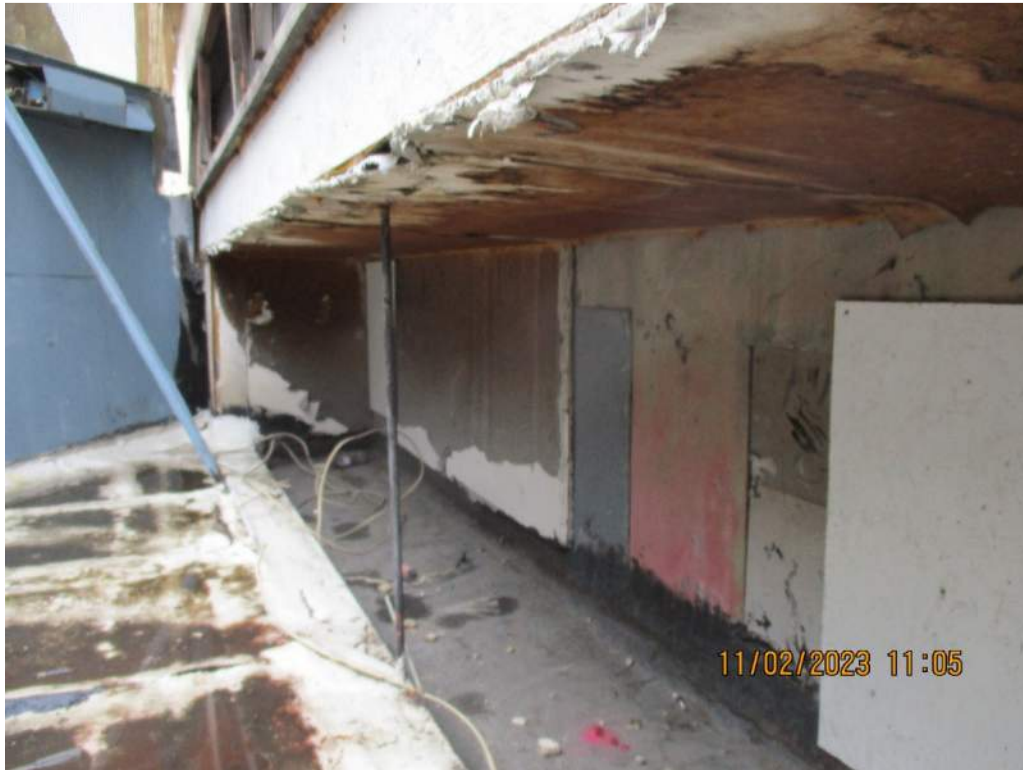
A plywood wall substrate board is attached to the building at and above the roof to wall transition where the internal gutter meets the building. The observed wall substrate boards were also visibly deteriorated and in poor condition throughout. The condition of the roof to wall transition and its adjacent wall substrates most likely contributes to the water infiltration currently observed through the sign.

Figure 14: Condition of Deteriorated Wall Substrate Boards Above Internal Gutter

Along with installation of the Densdeck and EPDM throughout the roof area, it is recommended that Densdeck be used to replace the wall substrate boards behind the internal gutter with EPDM baseflashings adhered over the top. This will adequately protect and waterproof the roof to wall area at the building. EPDM baseflashings will also need to be installed underneath the inside wall face paneling to ensure a watertight connection between the new roofing system and the paneling.

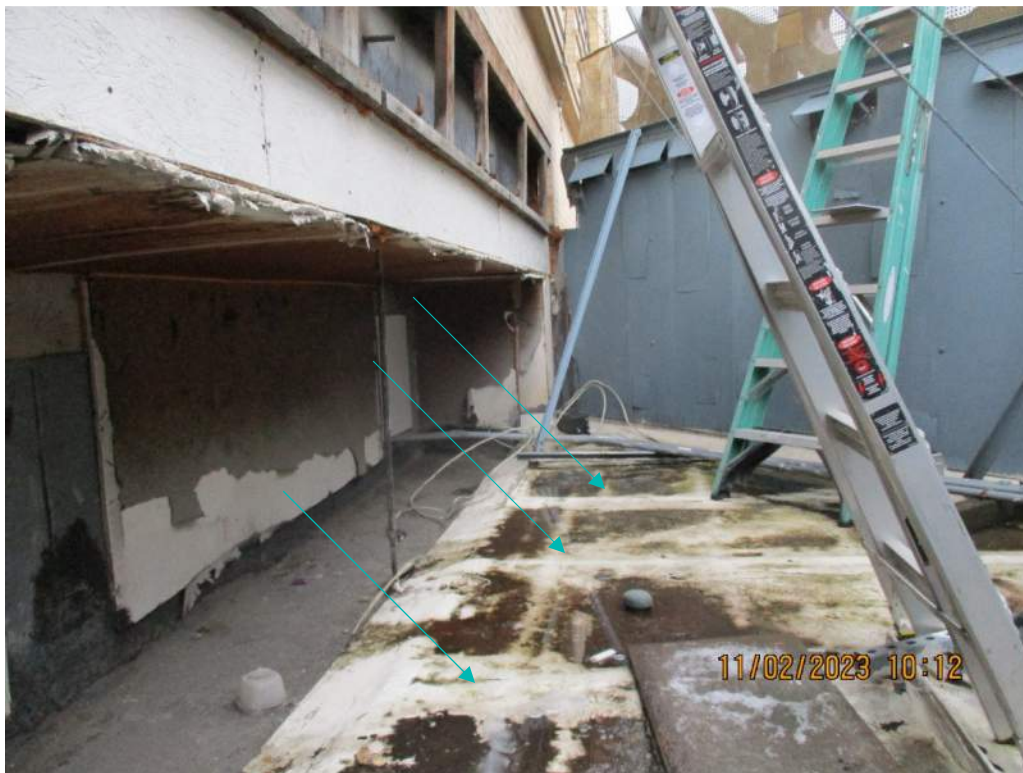
The underlying structural framing of the marquee is believed to be in good condition with only minor surface corrosion observed to the steel cabling, angle iron bracing and connection points.

Figure 15: Locations of Underlying Structural Elements Supporting Metal Roof Decking and Exterior Marquee Paneling (Approximately 4' O.C.)

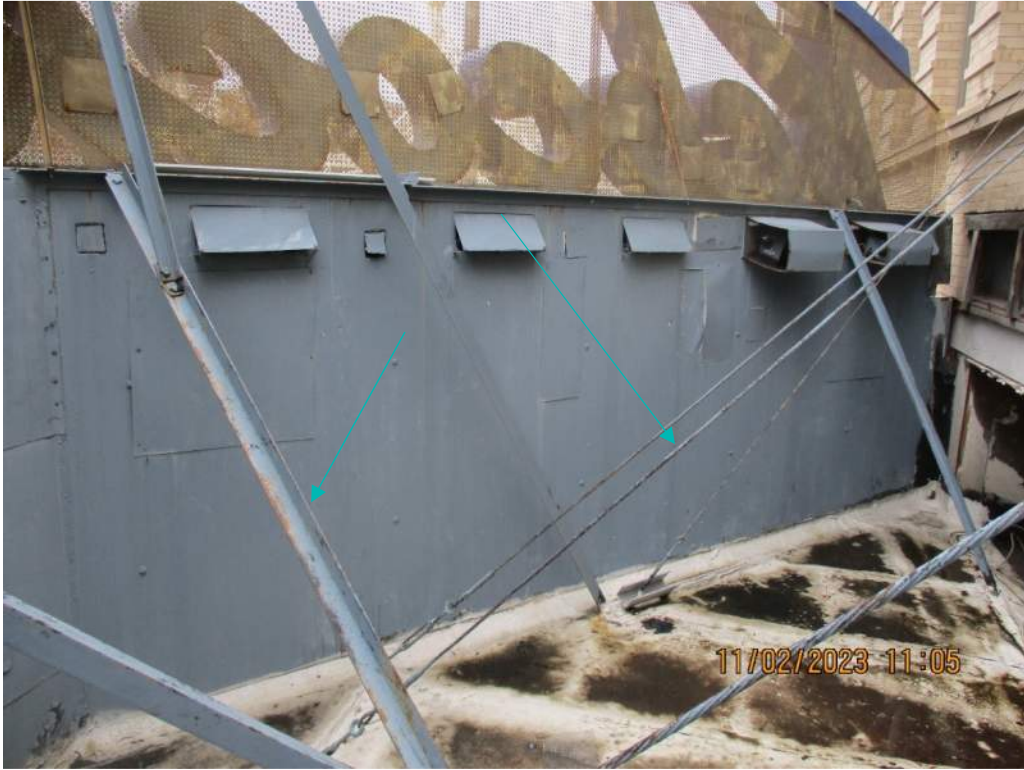
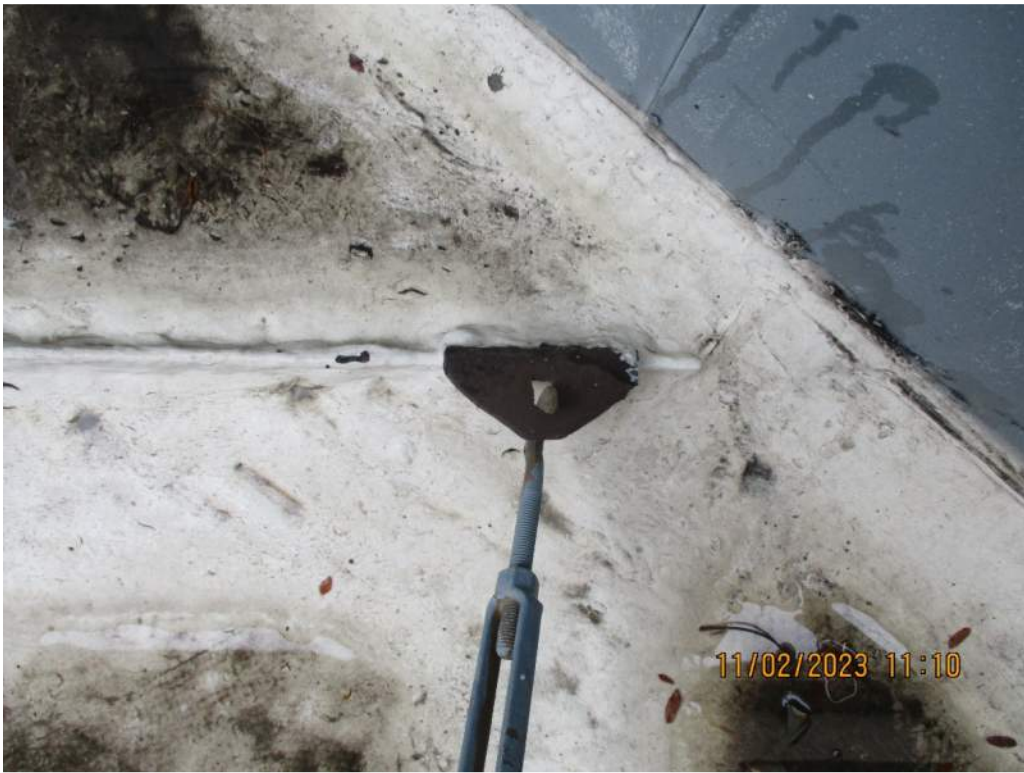
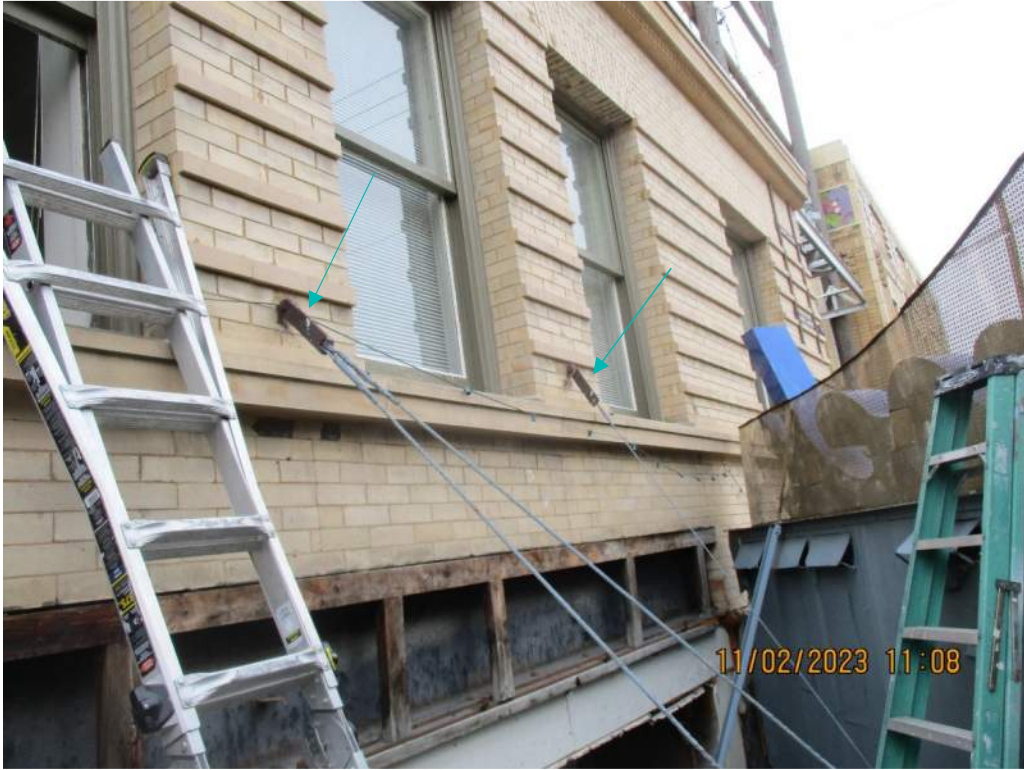
The structural frame of the marquee extends from the wall of the building approximately 12 feet utilizing what is believed to be a steel support framing with a sheet steel roof decking secured over the top. The support structure was then tied back to the brick wall using six steel cables attached at the wall and outer perimeter of the marquee structure. These steel cables are attached to 2" by 2" by 3/16" angle iron which is anchored directly to the steel roof deck supports.

Figure 16: Marquee Support Cabling and Angle Iron Bracing

Figure 17: Cable Tie Back Connection at Roof Level

Figure 18: Cable Tie Back Connections at Exterior Wall

In conjunction with replacement of the marquee roofing system, Cushing Terrell recommends the existing support cabling be cleaned free of rust and deterioration prior to installation of a cold galvanizing repair paint over the entirety of the existing cables.

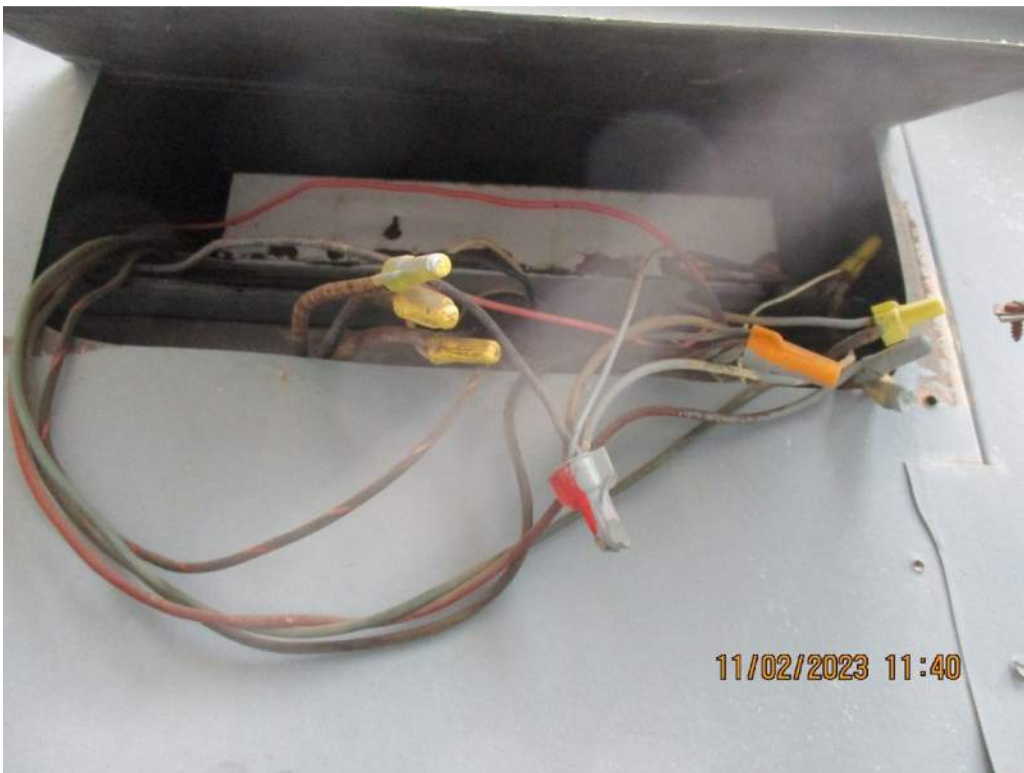
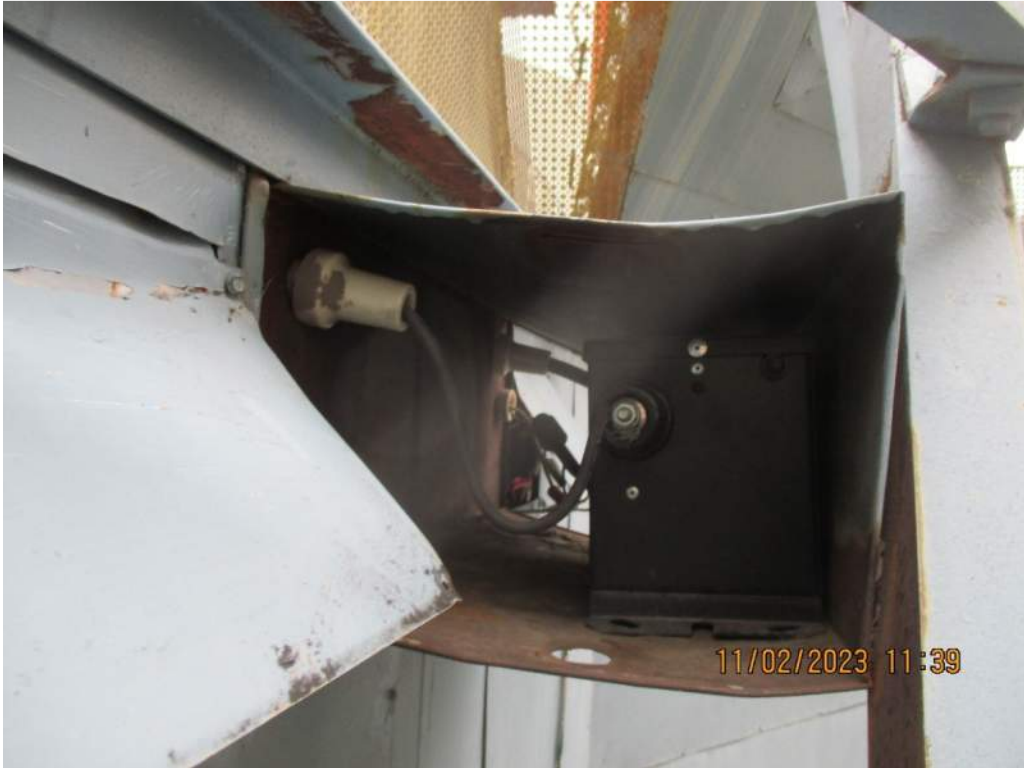
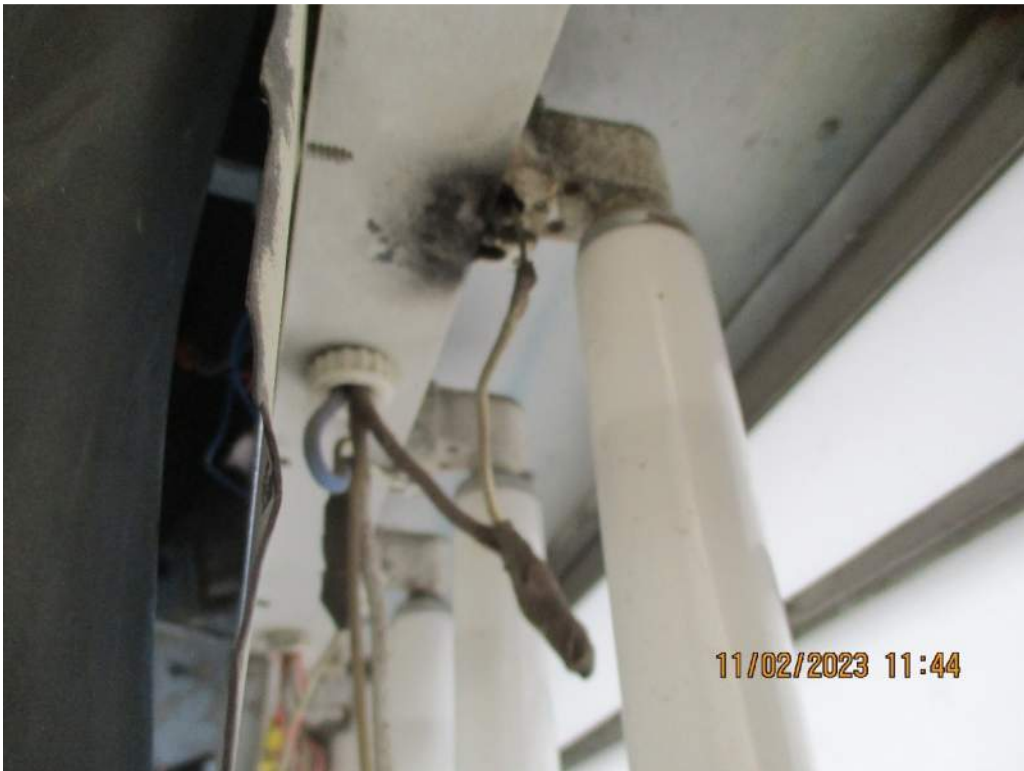
Some of the original/older looking wiring is believed to be coated with asbestos and would most likely require abating prior to any replacement of signage electrical components.

Observing the sign at nighttime indicates the electrical components currently in place are working. However, functionality of the sign long term will require a full replacement of the marquee's electrical components and wiring at some point in the near future.

Figure 19: Electrical Wiring Within Interior Paneling Access Locations - Typical

Figure 20: Typical Light Ballast Under Protective Cover at Interior Paneling

Figure 21: Interior Lighting Withing Exterior Paneling of Marquee

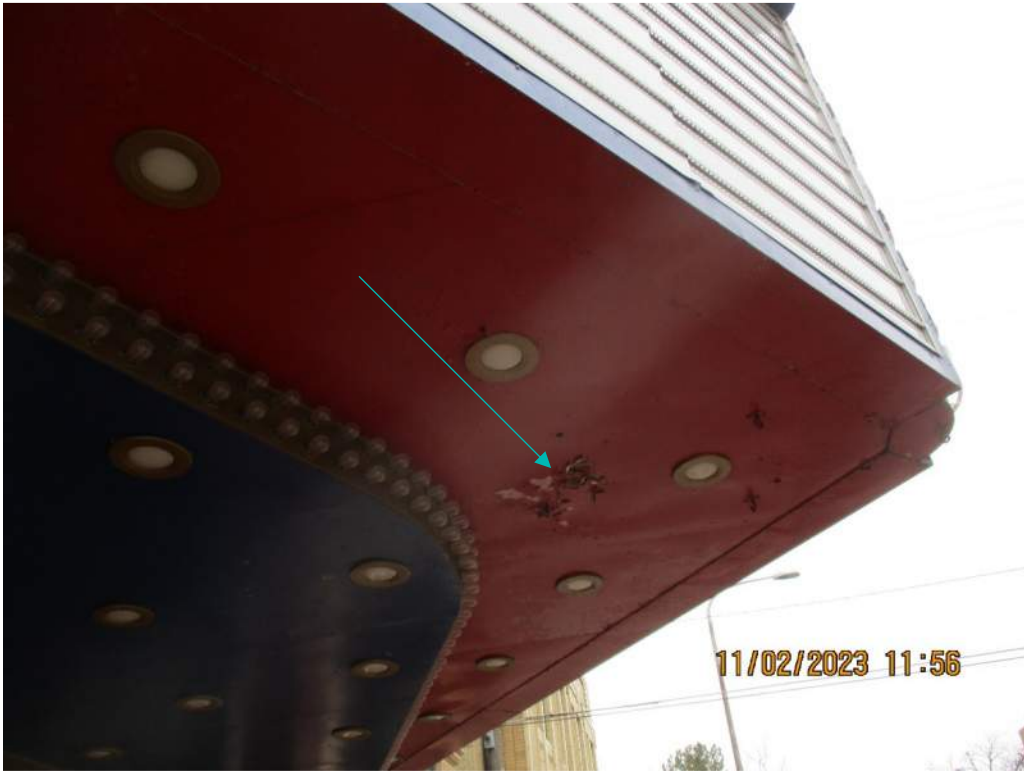
The sheet metal paneling of the sign mostly appears in fair condition with only surface degradation to the paint and some rusting of the bottom sides of the "Babcock" lettering observed throughout. One, approximately 1' by 1' area of the underside soffit, where water was observed dripping through, was found in bad condition, and rusted through. The sheet metal in this area could easily be pushed through if hand pressure was applied to the metal. It is believed the sign was originally painted utilizing lead-based products. An assessment of the paint's makeup should be performed by a qualified industrial hygienist prior to any exterior signage remediation.

Figure 22: Deteriorated Soffit Metal Below Observed Water Leaking

At minimum, Cushing Terrell recommends the deteriorated sheet metal at the underside of the sign be cut out with new metal stitched in its place. This would require the underside soffit area, currently painted red, to be repainted throughout to ensure a seamless appearance over the sheet metal repair. Abatement of the lead paint throughout this area may also be required if analysis indicates lead is present in the current materials.

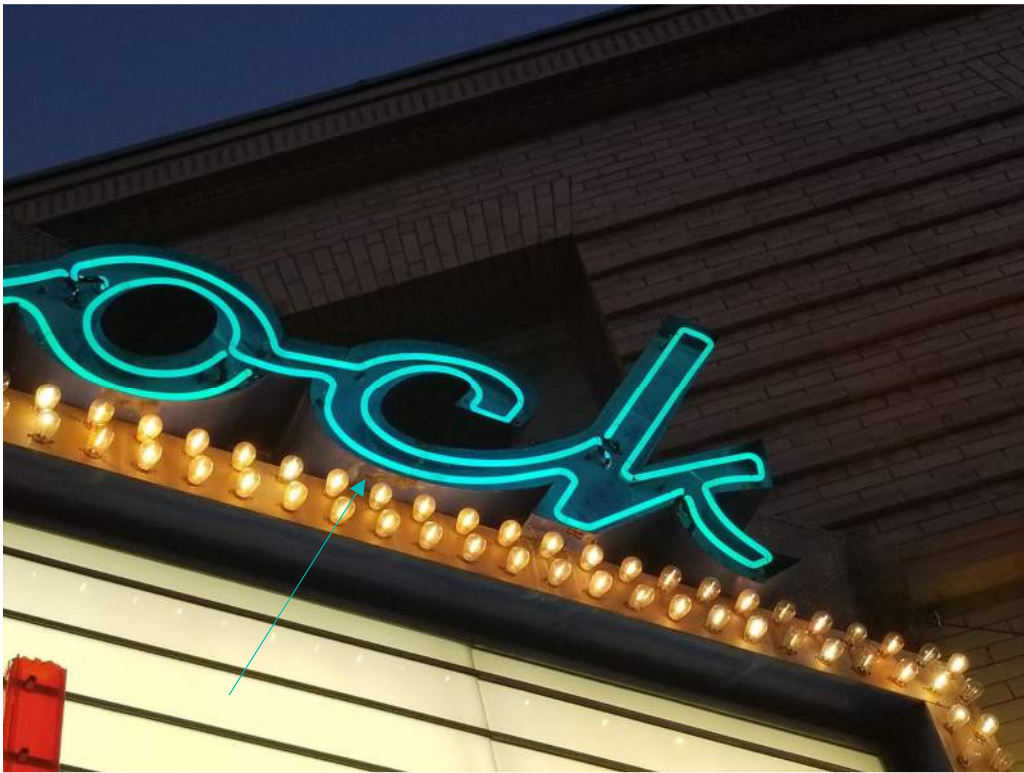
Figure 23: Observed Deterioration at Underside of "Babcock" Lettering

A full restoration of the sign's exterior would be much more in depth. Restoration would require removal of all the signs exterior light fixtures and neon. Removal of those components would be necessary so all existing paint could be stripped from the sign, exposing the raw metal. This would allow for repairs on the sheet metal skin throughout. Upon completion of the repairs, the sign could then be re-painted using care to match the original sign's appearance throughout with new light fixtures and neon installed upon paint/repair completion.
