## **ANALYSIS OF BROWNFIELD CLEANUP ALTERNATIVES**

**MEAT HOUSE AND LOCKERS  
802 YELLOWSTONE AVENUE  
BILLINGS, MONTANA 59101**

Big Sky Economic Development  
Brownfields Program  
201 North Broadway  
Billings, MT 59101

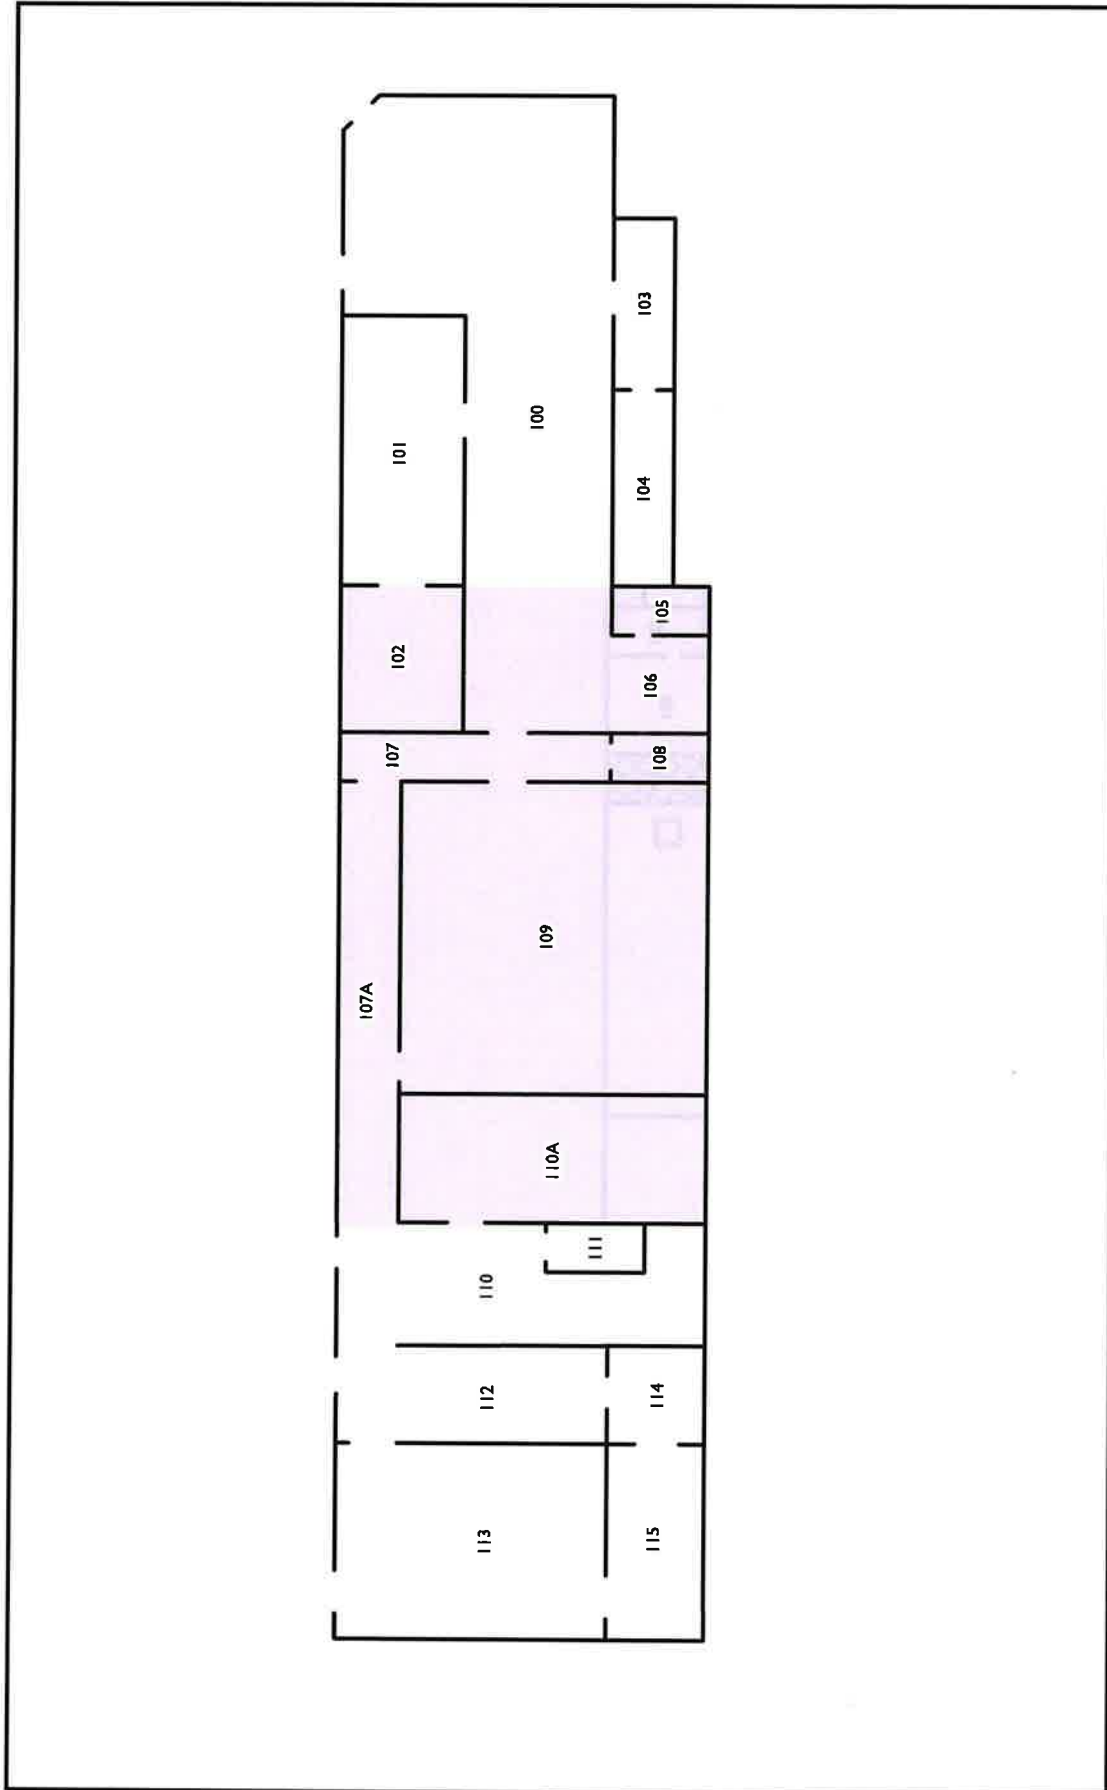
Figure 4 – Asbestos in Roofing Materials  
 Meat House Property  
 802 Yellowstone Avenue  
 Billings, MT 59101

ACY Built-up Roof

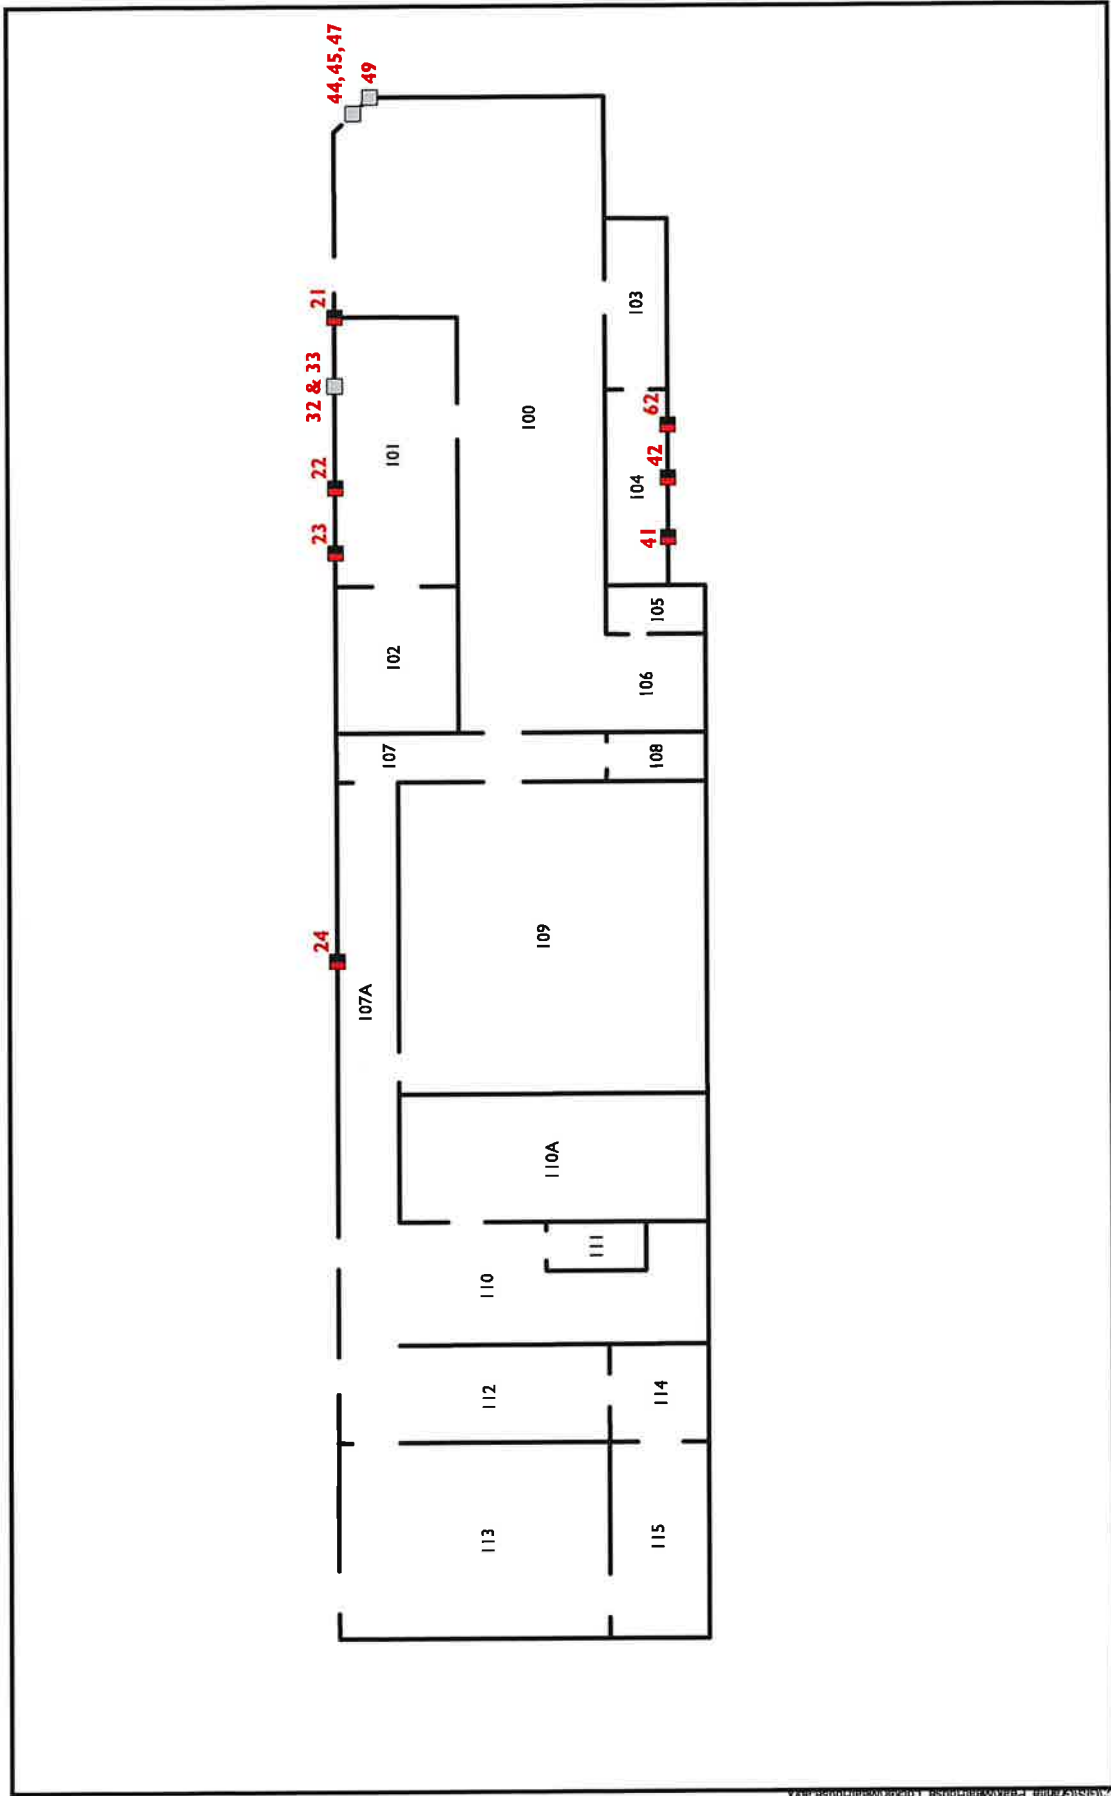
**Figure 5 – Lead-based Paint Results**  
 Meat House Property  
 802 Yellowstone Avenue  
 Billings, MT 59101

- Sample location positive for Lead-Based Paint
- Sample location positive for Lead-Containing Paint

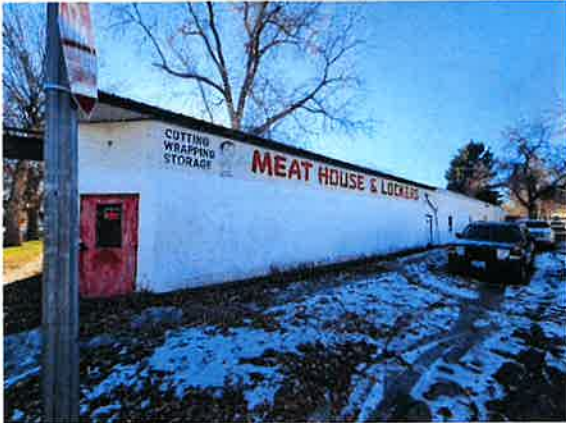
1) Meat House and Lockers building looking southwest. Select areas of white paint on CMU tested positive for lead.

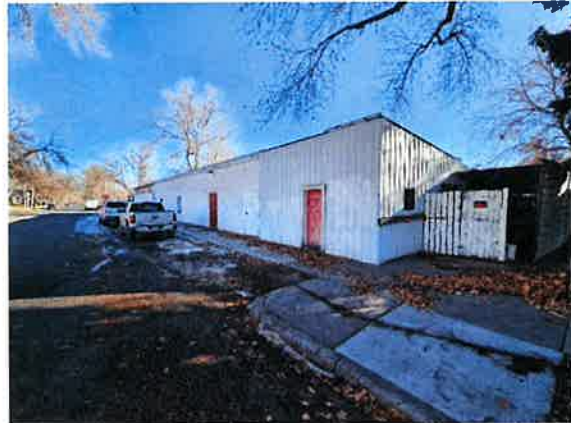
3) Meat House and Lockers building looking southeast. All substrates tested negative for lead.

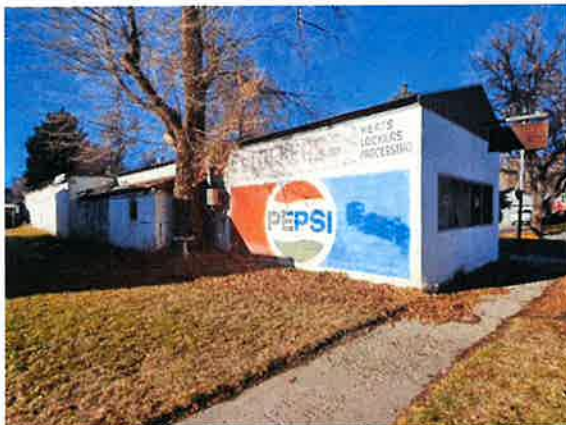
2) Meat House and Lockers building looking northwest. Red paint of the Pepsi logo tested positive for lead. One 5-point composite soil sample was collected underneath the logo. Window glazing positive for asbestos on the east facing windows.

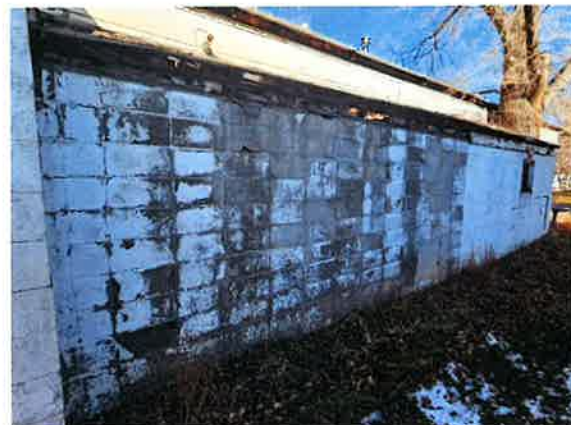
4) Meat House and Lockers building looking northeast. White peeling paint on CMU tested negative for lead.

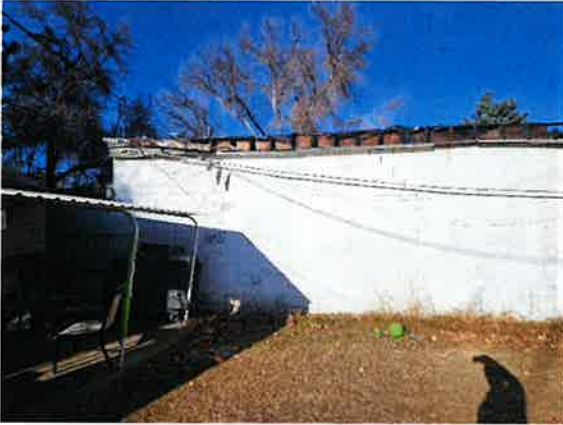
5) Meat House and Lockers building looking north at the west end of the building. White paint on CMU tested negative for lead.

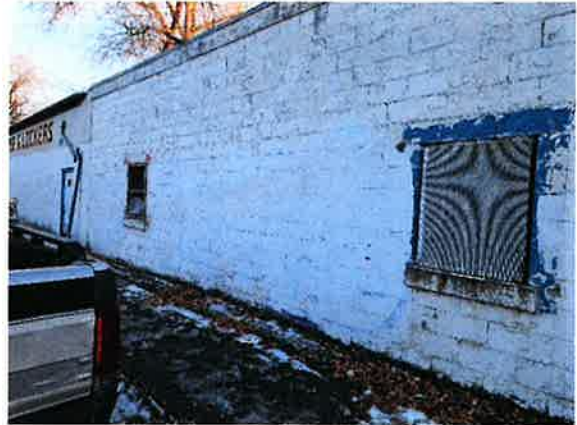
7) Close-up of the southwest exterior corner of the Meat House and Lockers building looking east. White paint on CMU, and blue and red paint on wood tested negative for lead.

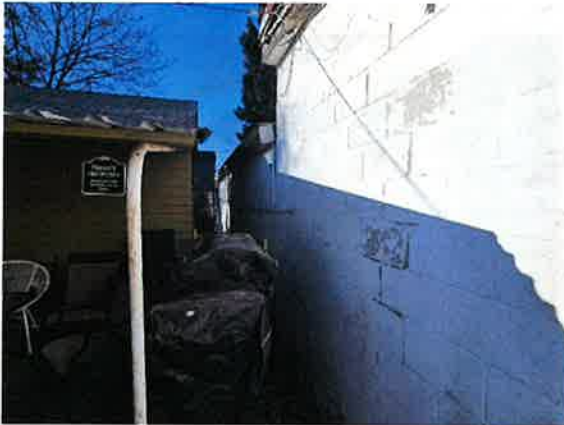
6) Close-up of the southwest exterior corner of the Meat House and Lockers building looking west. White paint on CMU tested negative for lead.

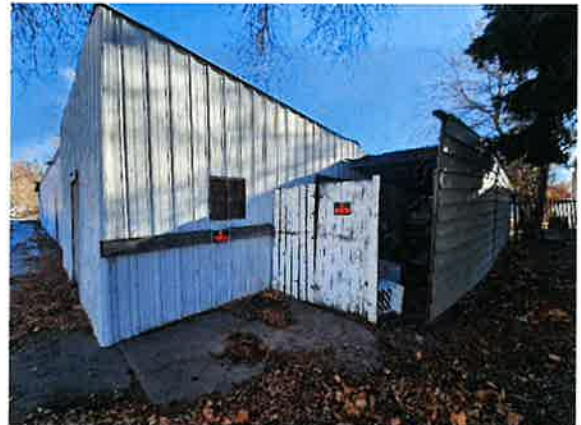
8) Photograph of the east end of the building. Exterior corrugated sheet metal siding is negative for lead.

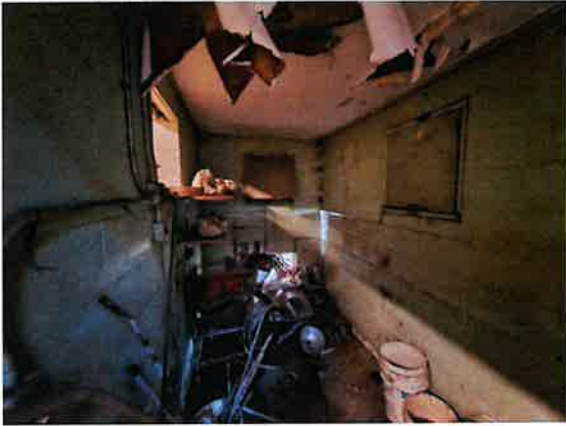
9) Water damaged sheetrock ceiling confirmed in the south storage area. Green paint on CMU tested negative for lead.

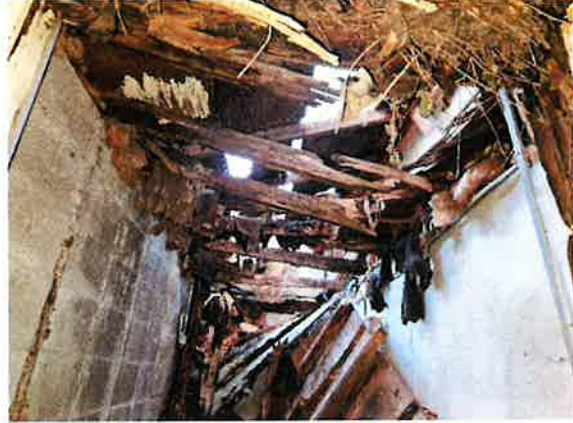
11) Close-up of collapsed roof looking west from the south storage area.

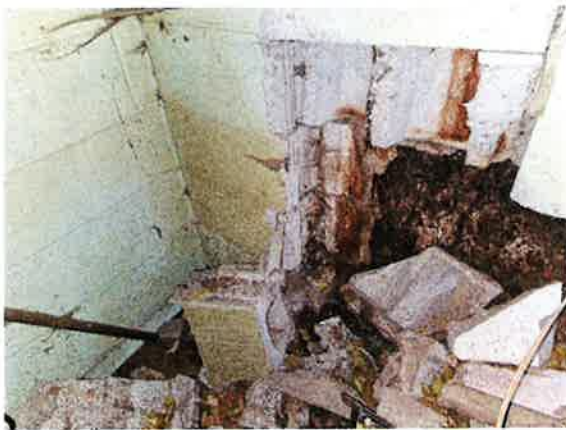
10) Close-up of damaged CMU wall looking west from the south storage area.

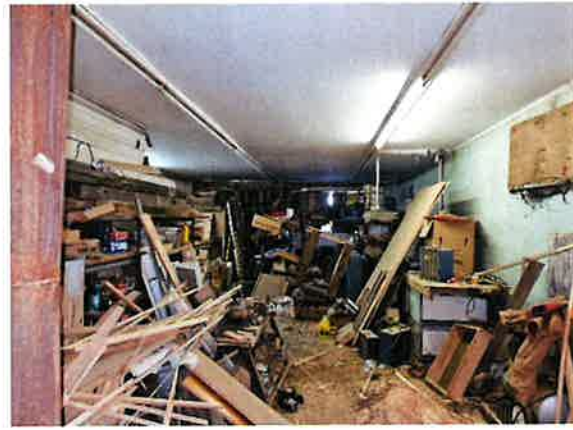
12) Photograph taken inside the east end of the building, looking east. Sheetrock ceiling contains <1% asbestos.

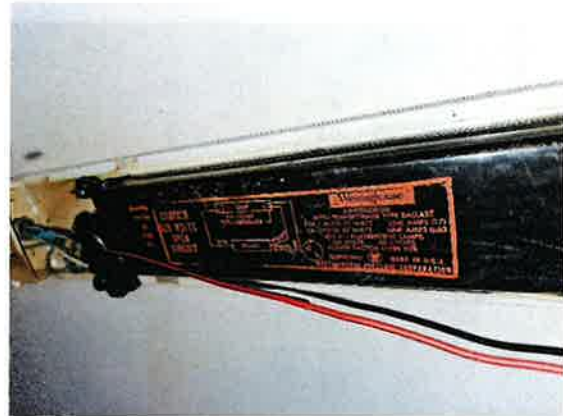
15) Photo of one type of light ballast presumed positive for PCB's.

- *Universal Wastes* – The fluorescent light tubes and presumed PCB-containing light ballasts would be removed and disposed of in accordance with solid waste regulations.

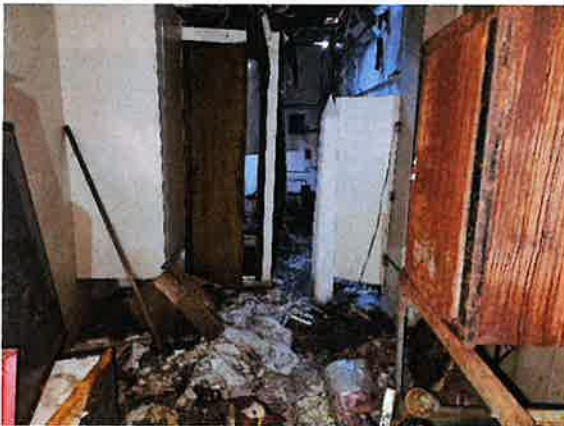
14) Photograph showing the poor conditions within the building that may include biological hazards.

- *Biological Hazards* – All biological hazards would be removed from the site during building demolition.

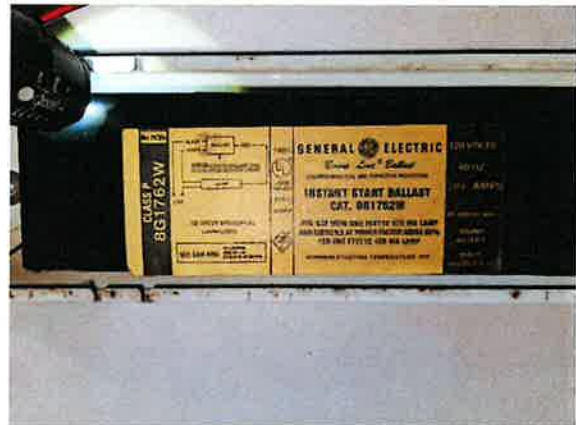
16) Photo of one type of light ballast presumed positive for PCB's.

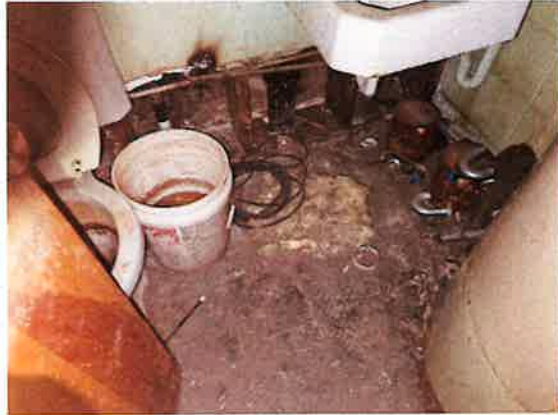
19) Photograph of the eastmost bathroom. Sheetrock materials contain <1% asbestos.

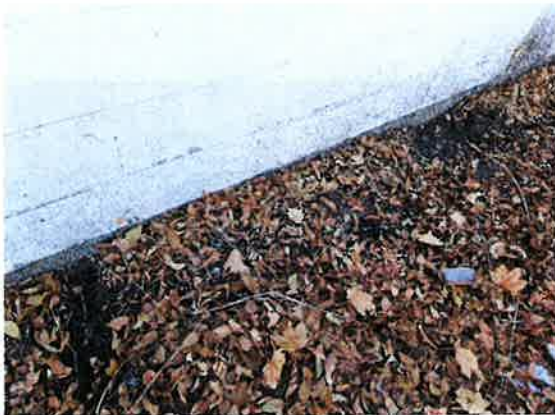
18) North side of the building underneath the areas that tested positive for lead. Confirmed the LBP is above the concrete sidewalk.

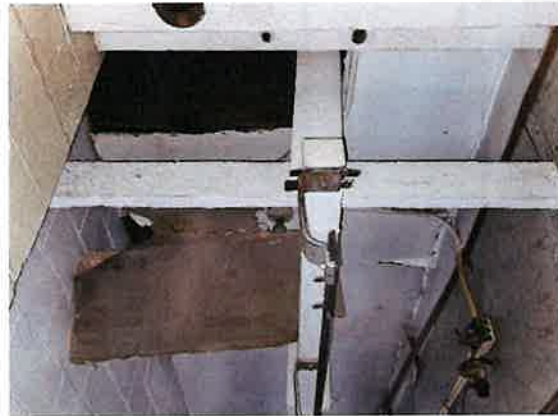
20) Photograph within the east to west hallway. Sheetrock materials contain <1% asbestos.
