Cushing
Terrell®

BABCOCK THEATRE BUILDING

Building Assessment Report

Babcock Theatre Site Survey and Audio System Recommendations

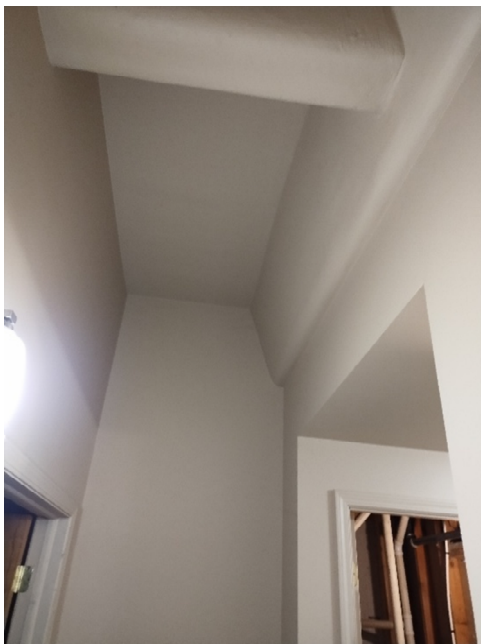
- The Green Room is fully sprinklered, except for, basement hallway area near kitchen and restrooms. Additional sprinklers will need to be provided in this area for proper coverage in accordance with NFPA 13. (Photo #1)
- Ceiling tiles are missing in the Kitchen area and need to be reinstalled. The effectiveness of the pendent sprinklers is compromised by the missing ceiling tiles delaying the sprinkler activation by allowing heat to escape. (Photo #2)
- Pendent sprinklers in kitchen area are missing the escutcheon. (Photo #2)

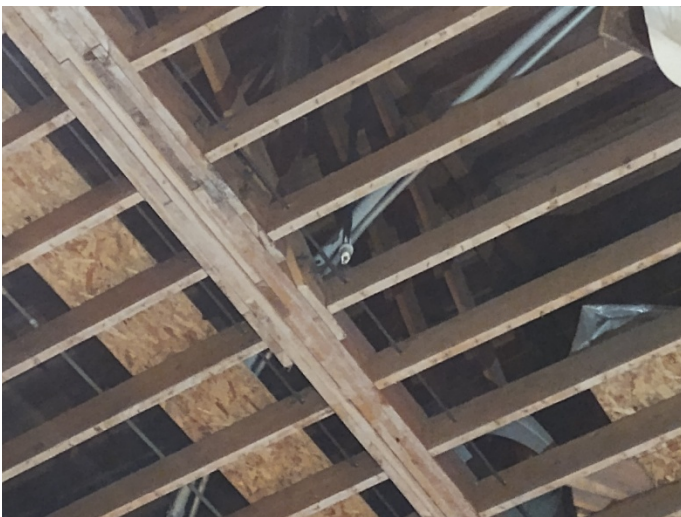
- Due to the partial ceiling collapse, four of the pendent sprinklers in the upper ceiling have deflectors that are missing or damaged. The pendent sprinklers will need to be replaced due to the ceiling failure. (Photo #4) Several pendent sprinkler escutcheons are also missing at various locations throughout theatre seating area.
 - o \$700 Total of 4 Pendent sprinklers and escutcheons.

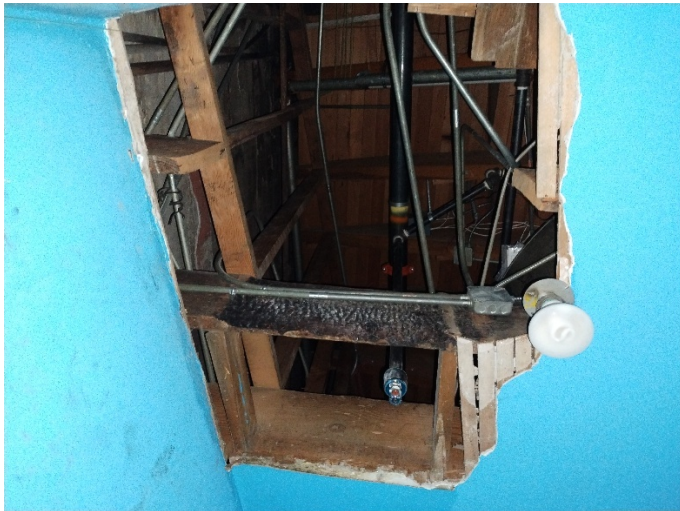
- The closet located adjacent to the upper lobby is missing the ceiling. The ceiling in the closet needs to be replaced as the effectiveness of the pendent sprinkler is compromised by the missing ceiling, delaying the sprinkler activation by allowing heat to escape. A new escutcheon for the pendent sprinkler will also need to be installed. (Photo #5)

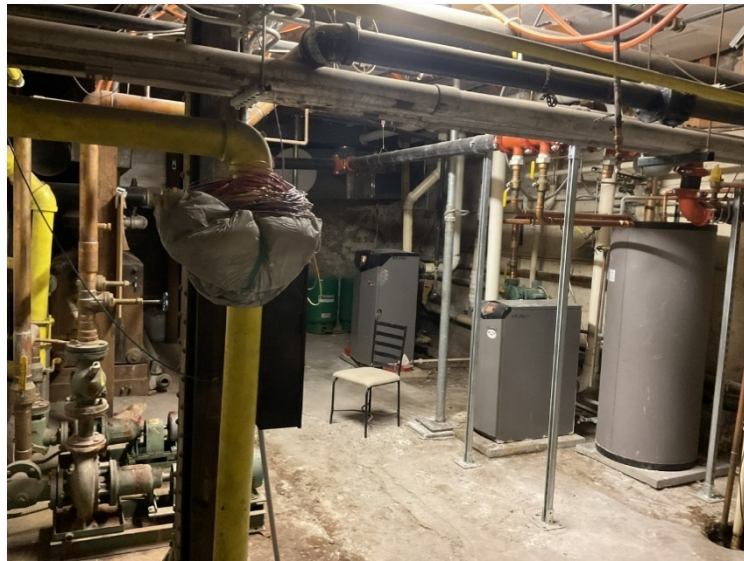
- A portion of the intake combustion air pipe on the boilers is open to the boiler room. ROM \$5000 if booster fan is needed.
 - o Verify that adequate transfer air is provided for boilers to utilize the volume of the space for combustion air. If not, verify adequate sizing and routing of the intake combustion air from the outdoors and design a booster fan if needed.

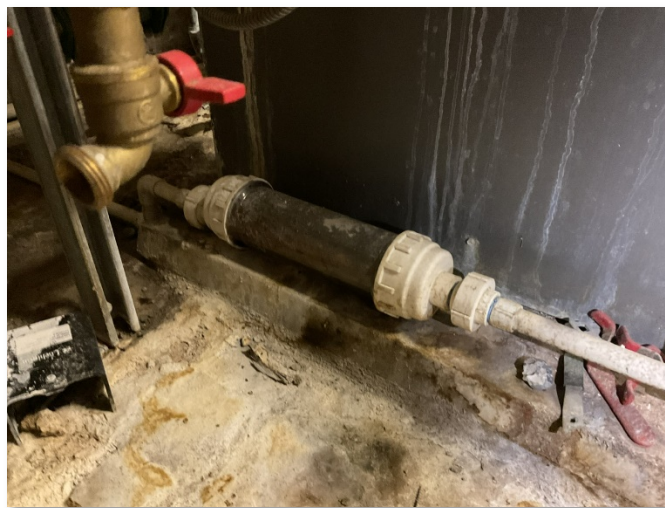
- Replace condensate neutralization kits on boilers
 - o Condensate neutralization kits change the PH of the boiler condensate to avoid acidic condensate terminating at the floor drains and eroding the drain fixture or drain piping.
 - o The existing condensate neutralization kits appear to be well-used and should be replaced or cleaned and reinstalled with new media.

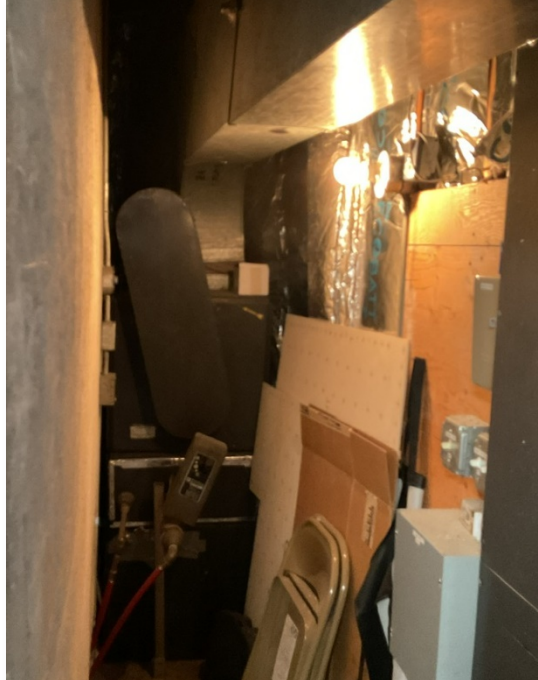
- Monitor the Westinghouse supplemental air handler serving the lobby and vestibule area for future replacement.
 - o ROM \$30,000

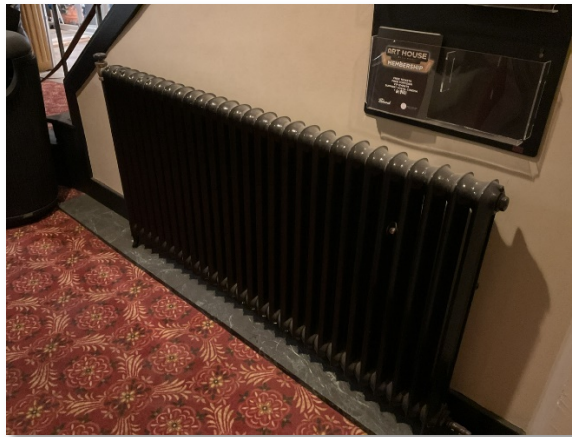
- Verify that the ticket booth has adequate heat utilizing what appears to be an original steam heater connected to the heating water loop.
 - o ROM \$1000 for verification

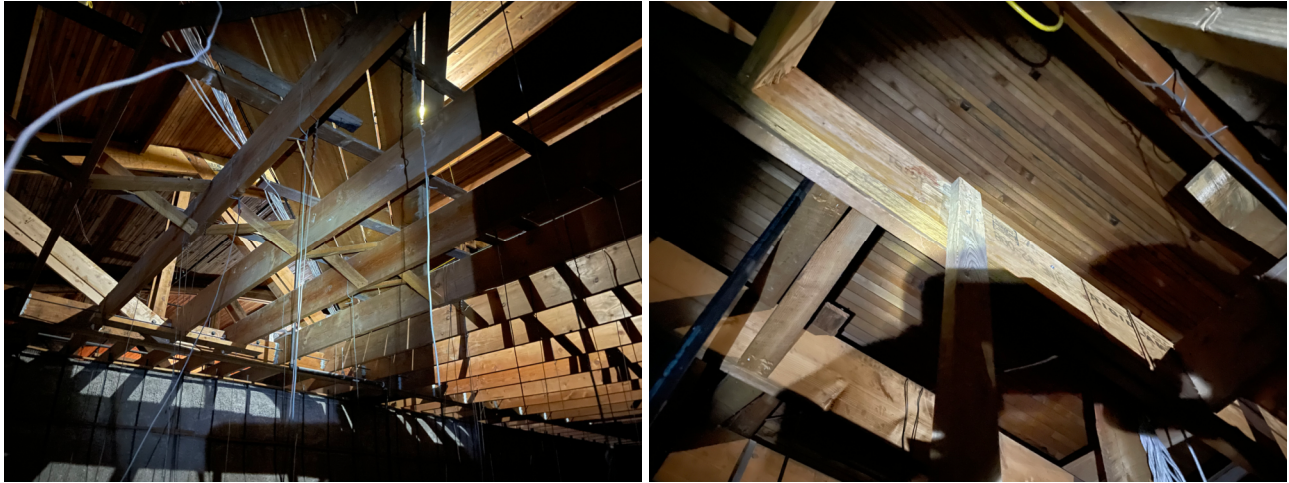
supports (or an approved method to span the existing supports) to safely handle the anticipated load of the loudspeakers may be required. For a performance venue of this size, K2 would commonly expect to see a medium format (stereo) line array loudspeaker system used. These systems are rigged from overhead using chain hoists so they can be adjusted and serviced at floor level and typically utilize rigging points rated for 2000 lbs. working load limit (WLL). Due to the existing structural framing, it may be more appropriate to more precisely match the additional supports required with a load rating that more closely matches the anticipated load—something on the order of 1000 lbs. WLL.

Picture 1 & 2: General Attic Framing Over Loudspeaker/Audience Areas and Engineered Lumber Beam Framing for Catwalk

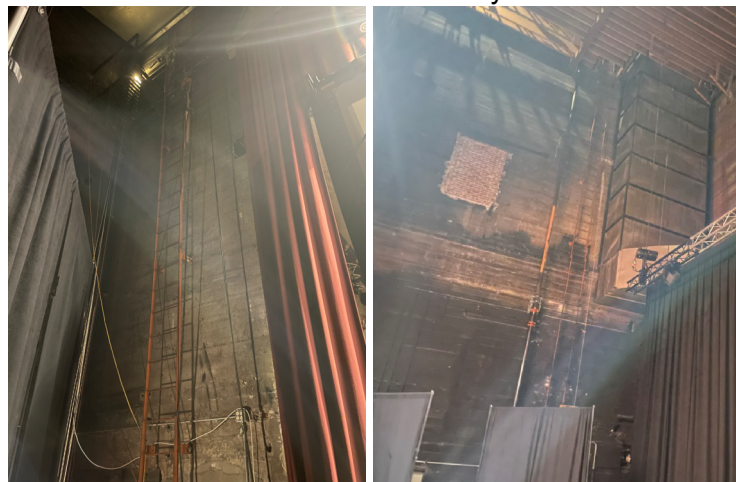
- K2 observed that the two permanent stage access ladders are likely not OSHA compliant. As of 2017, OSHA 1910.28 requires all fixed ladders over 24'-0" long be equipped with personnel fall arrest systems. K2 did not specifically measure the stage left access ladder but visually referenced it to the proscenium opening (which is approximately 28' high) it appeared to be greater than 24' in length. Based on the drawings provided of the venue, the stage right fixed ladder to the grid is estimated to be 55'+ in length. K2 noted that both ladders appeared to be structurally sound and securely attached to the wall. This should be verified however and corrected if any issues are found.

Picture 3 & 4: Stage Left Ladder to Attic and Stage Right Ladder to Grid

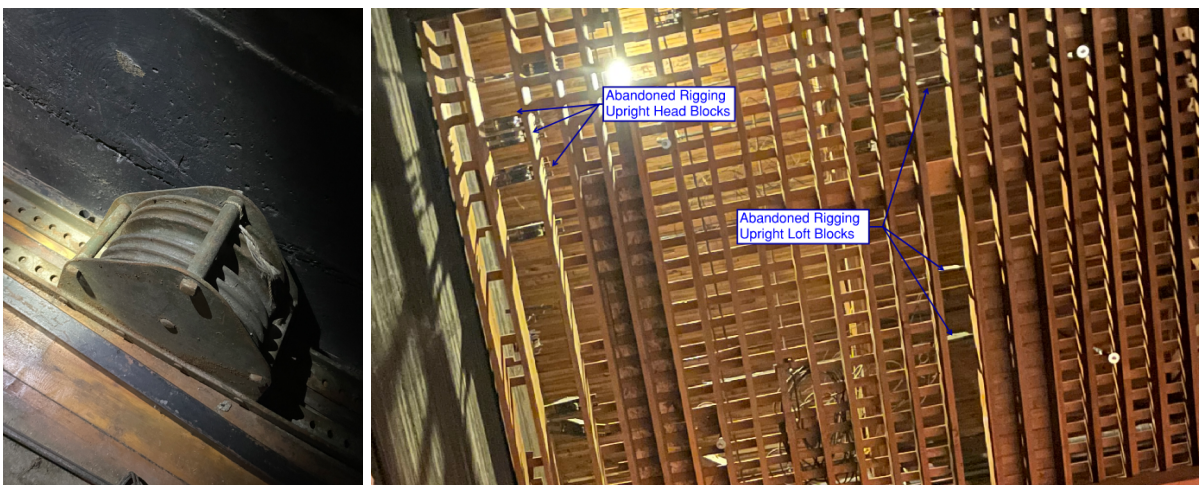
The wood grid is currently being used for spot rigging a few lightweight curtains and a length of lighting truss using temporary chain hoists. The hoists appear to be rigged from one of the overhead beams using a chain sling around the beam with a towel or some other piece of fabric/foam around the beam to protect it from damage from the chain. However, given the unknown design criteria of the beams and supports, the structural load capacity of the grid and various wood beam members is currently unknown therefore this may not be a safe method to employ. The grid should be fully evaluated and documented by a qualified structural engineer before any additional overhead rigging is undertaken. The results may indicate safe working load limits that can be applied to future overhead rigging on the stage.

Picture 5 & 6: Demolished Head Block on Stage Floor and Abandoned Rigging Equipment on Grid

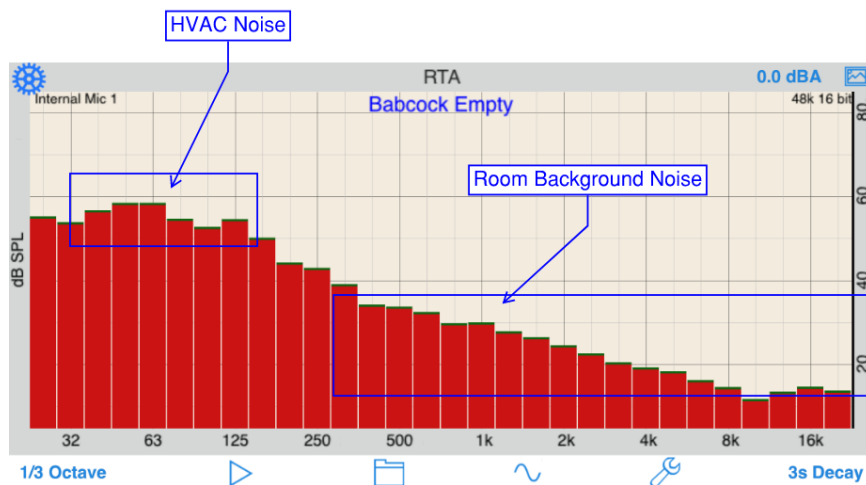
K2 measured the volume level of the rumble using an iPhone-based RTA/SPL meter (see Figure 1 below). Between 40Hz and 125Hz K2 measured between 56dBa and 58dBa SPL. The overall level decreases consistently between 125Hz and 1kHz, however the level is still significantly above what would be a typical background noise level for a performance venue. Typical noise criterion (NC) for a performance venue like the Babcock Theatre would be between NC-30 to NC-35. K2 believes that for the Babcock Theatre to be a viable venue for live performances in the future the HVAC system background noise should be addressed.

Figure 1: Sound Frequency Graph of Babcock Theatre (Empty with HVAC Running)
