Proposal #158959

Roof Section: Main Section

Proposal Date: 01/18/2018

Burnet County Courthouse  
220 South Pierce Street  
Burnet, TX

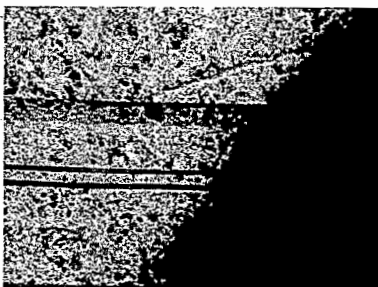
Holes (Emergency) - 10/18/2017  
Quantity: 2 EA

Deficiency: Holes caused by physical damage to the roof surface.

Corrective Action: Repair holes as needed.

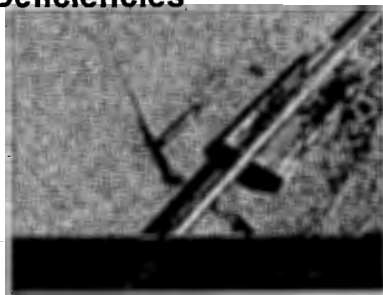
3

Membrane: Open Seams (Emergency) - 10/18/2017  
Quantity: 2 EA

Deficiency: Open seams in the waterproofing membrane are typically caused by failed seam adhesives coupled with membrane shrinkage and stress on the seams. Cold welds are more typical for single ply systems.

Corrective Action: Clean and prep the area around the open membrane seam or cold weld. Install compatible roofing materials according to the specific manufacturers' recommendations and per minimum industry standards.

**Estimated Repair Cost: \$300.00**
