## McQueen Road Settlement Investigation/Repairs ST2311.401

## Final Report

**Project Scope:** The scope of this project included shoring existing asphalt around manhole with steel plates for safety concerns, removal/replacement of asphalt, curb & gutter, sidewalk, provide traffic control, and exploratory investigation into the cause of settlement of the roadway on McQueen Road south of Queen Creek Road.

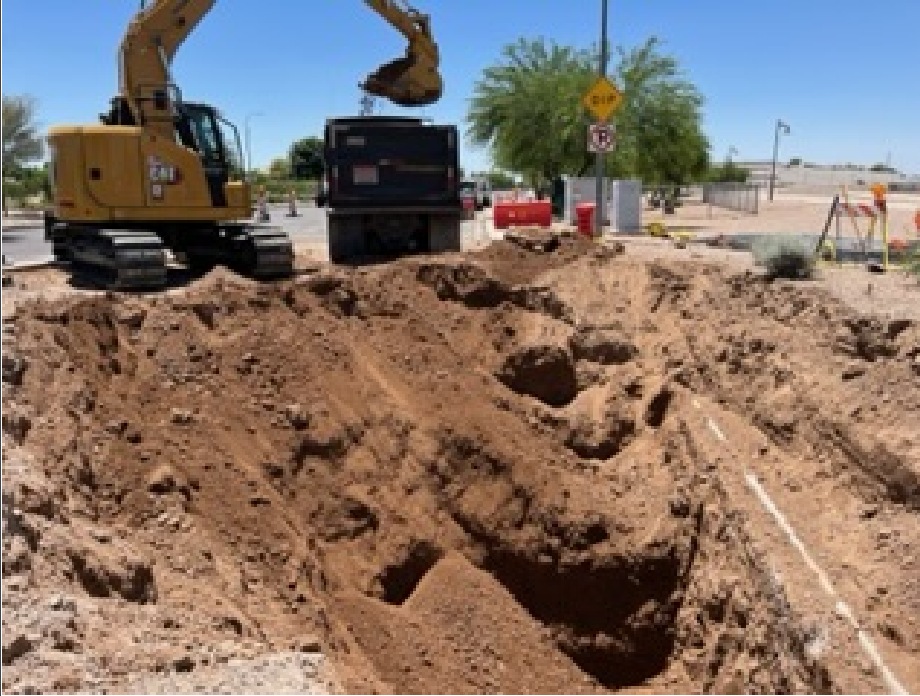
**Photo:** Picture 1

**Comments:** Trench hole on McQueen

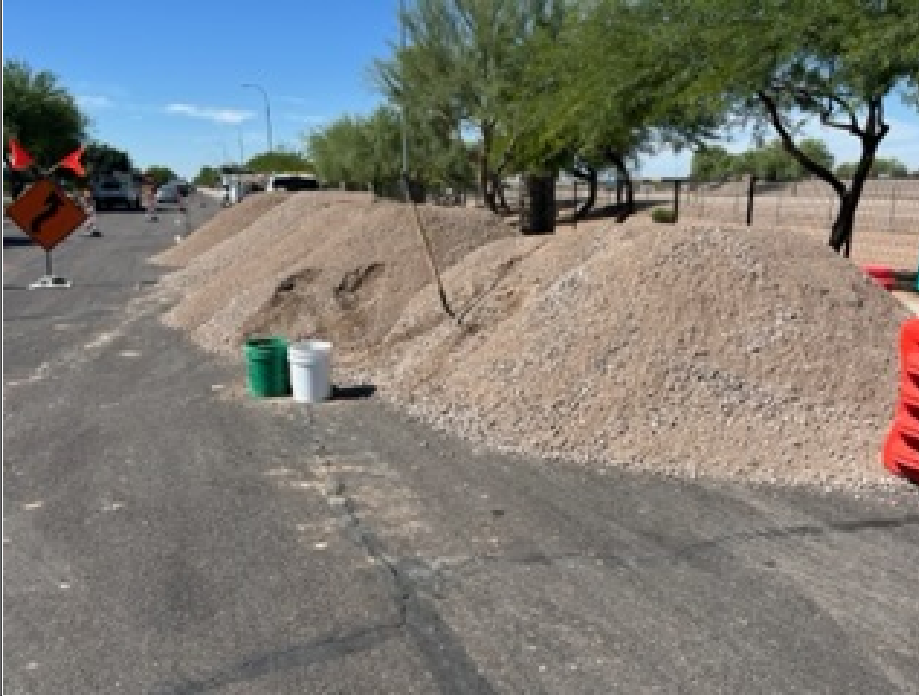
**Photo:** Picture 1

**Comments:** Collected AB sample from stock piles

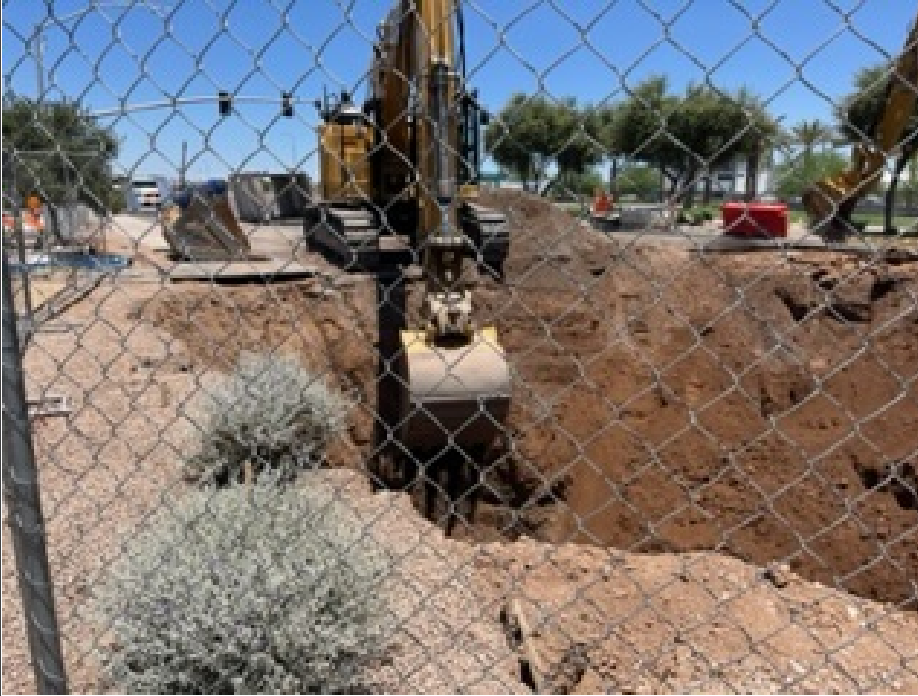
**Photo:** Picture 1

**Comments:** Placing backfill materials in to trench on McQueen road

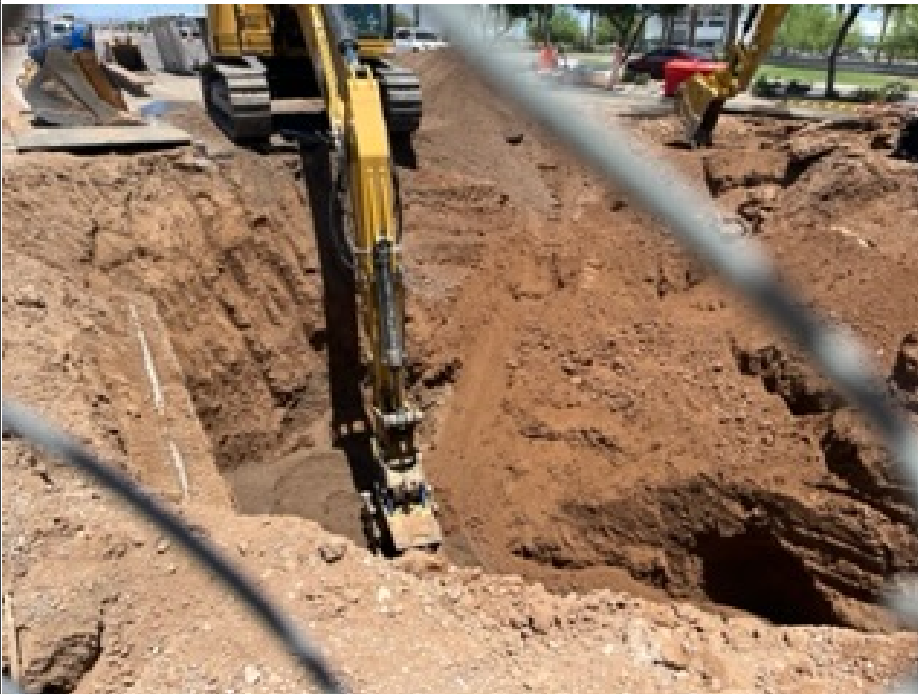
**Photo:** Picture 2

**Comments:** rolling and compacting backfill materials in to trench on McQueen road

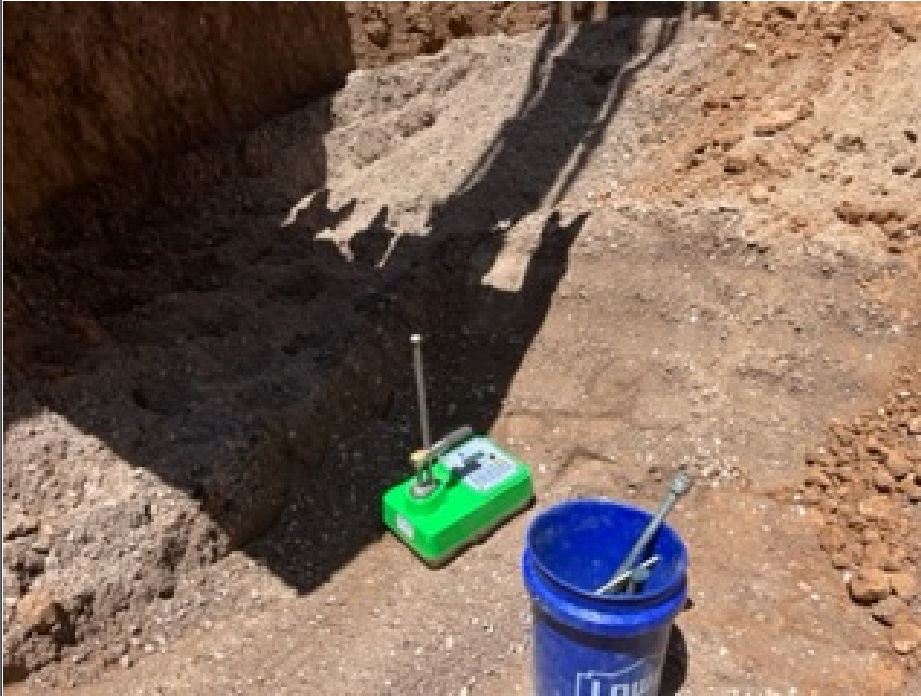
**Photo:** Picture 3

**Comments:** Density and moisture test on backfill materials in to trench on McQueen road

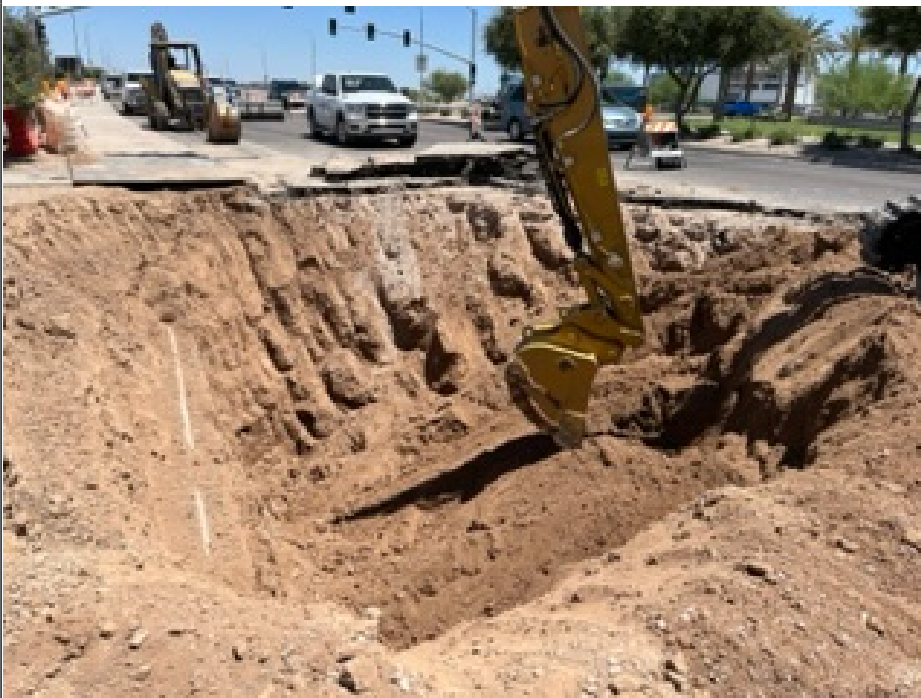
**Photo:** Picture 4

**Comments:** Excavation on trench on McQueen road

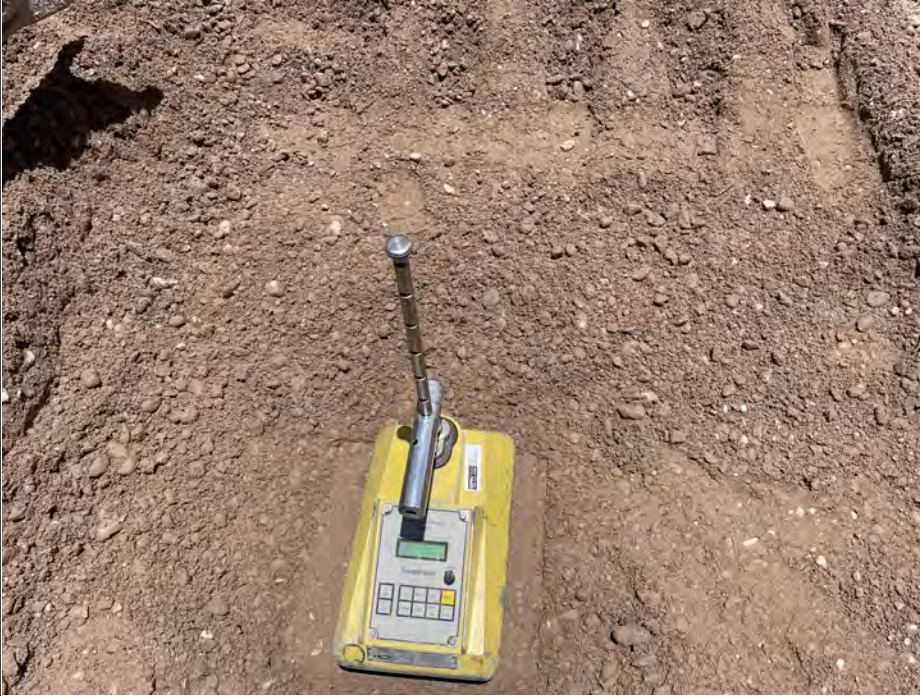
Photo: 1

Comments: Density testing for backfill

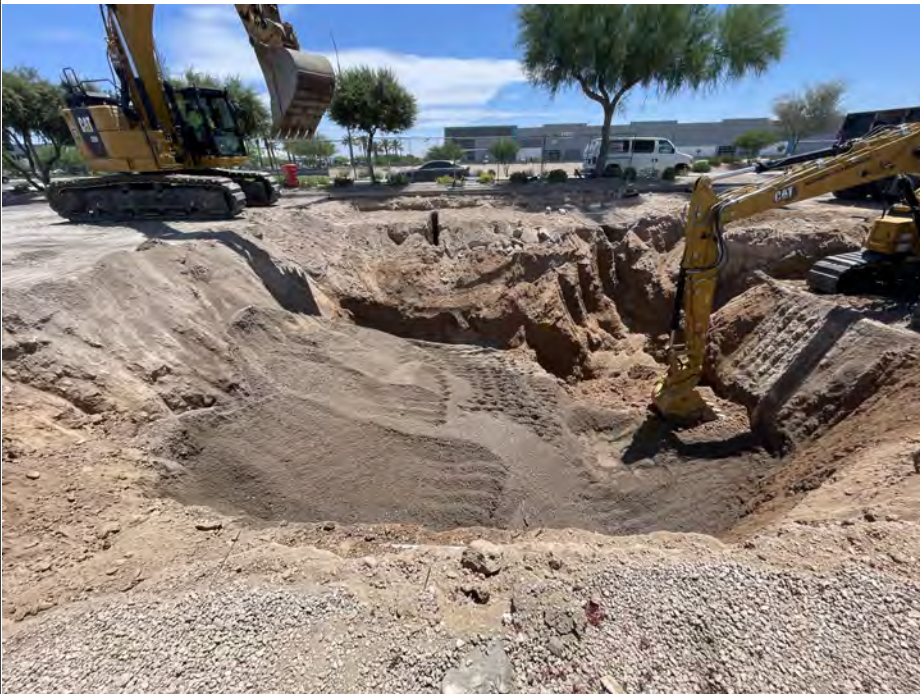
Photo: 2

Comments: Ongoing backfill operation

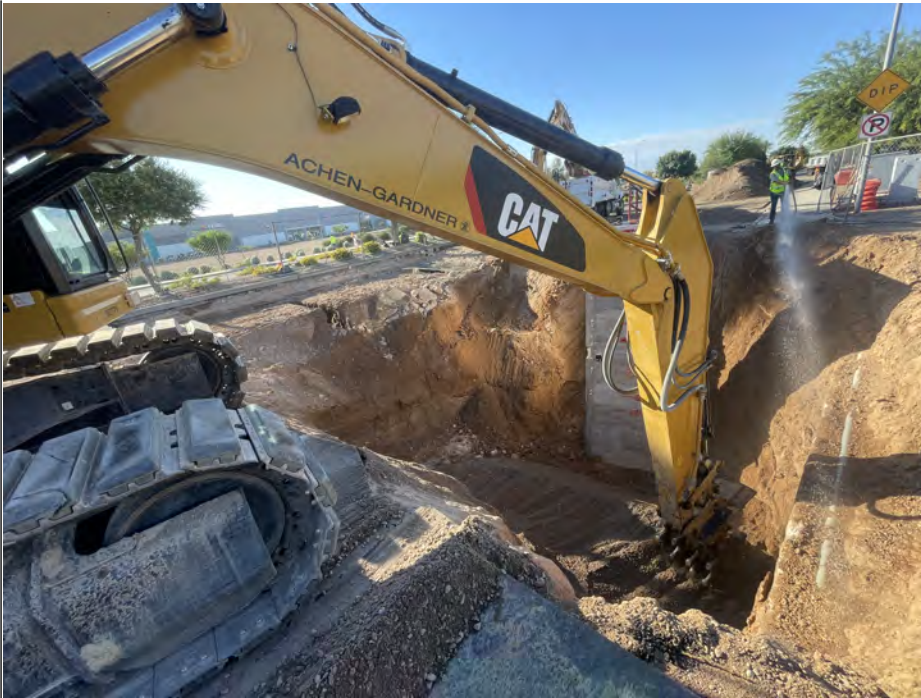
Photo: 3

Comments: Achen using CAT 315 with sheep's foot attachment to compact material in place

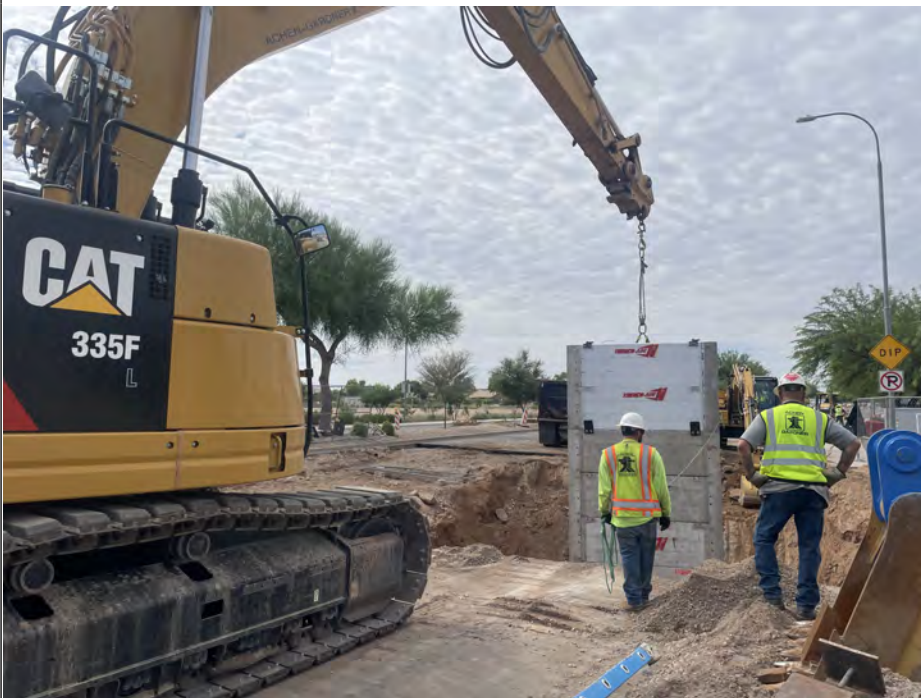
Photo: 4

Comments: Achen crew transporting trench box so I can test

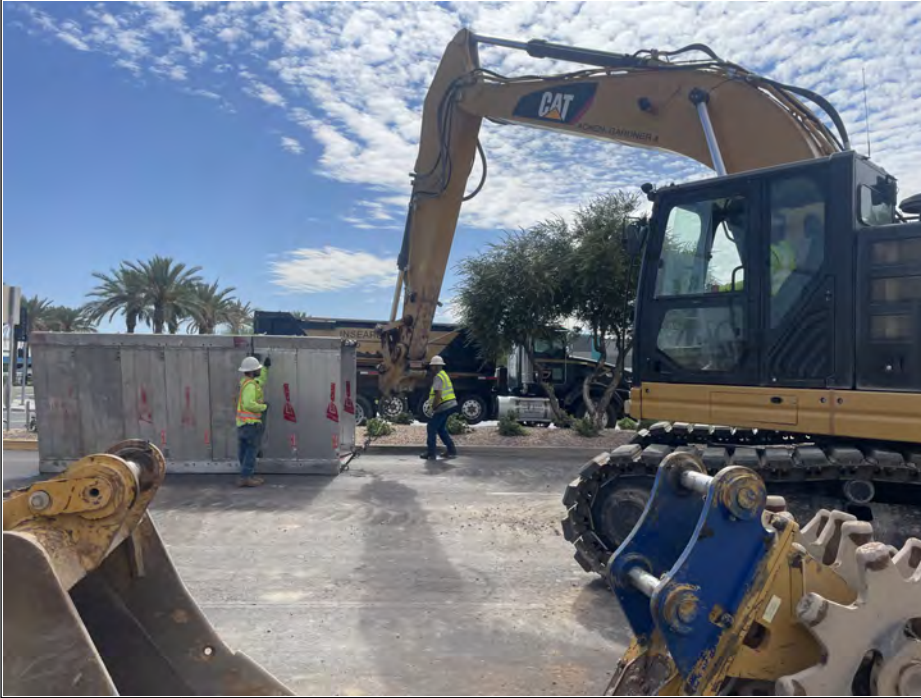
Photo: 5

Comments: Crew breaking down trench box

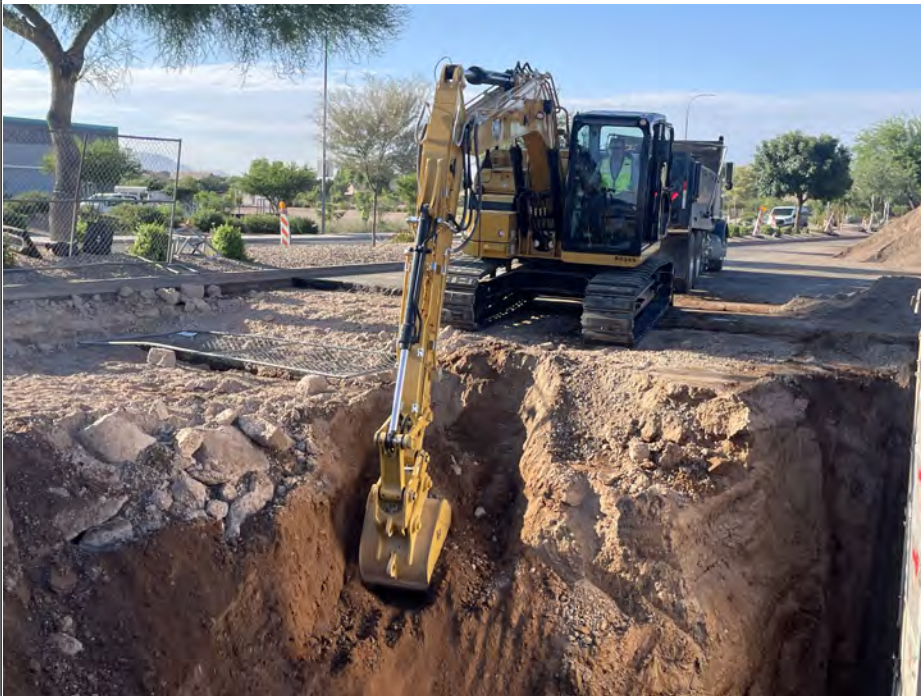
**Photo:** 6

**Comments:** Crew using CAT 335F to remove debris and native material

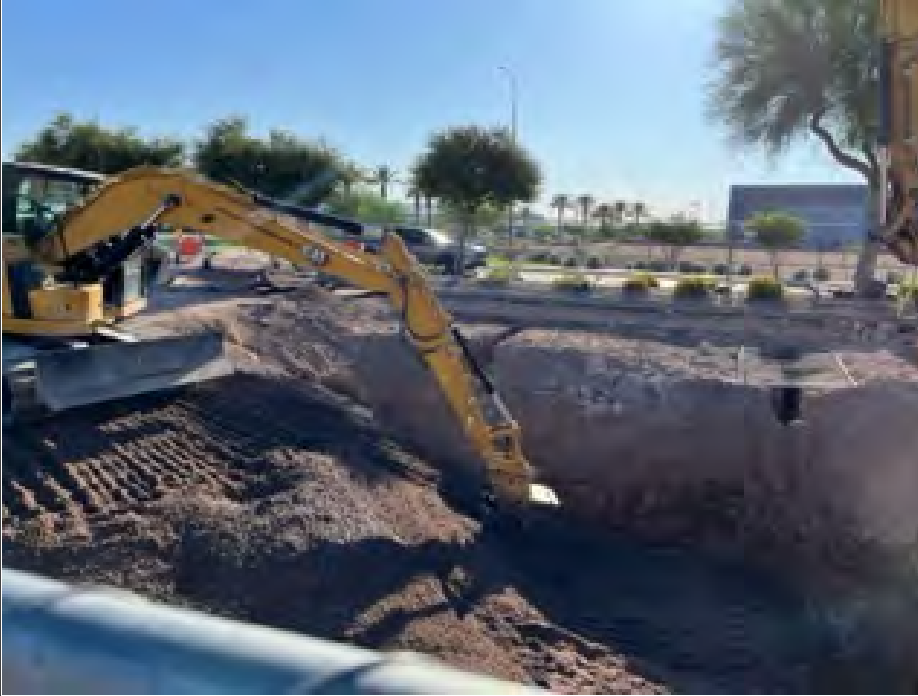
**Photo:** Picture 1

**Comments:** Rolling and compacting for trench and manhole backfill on McQueen road

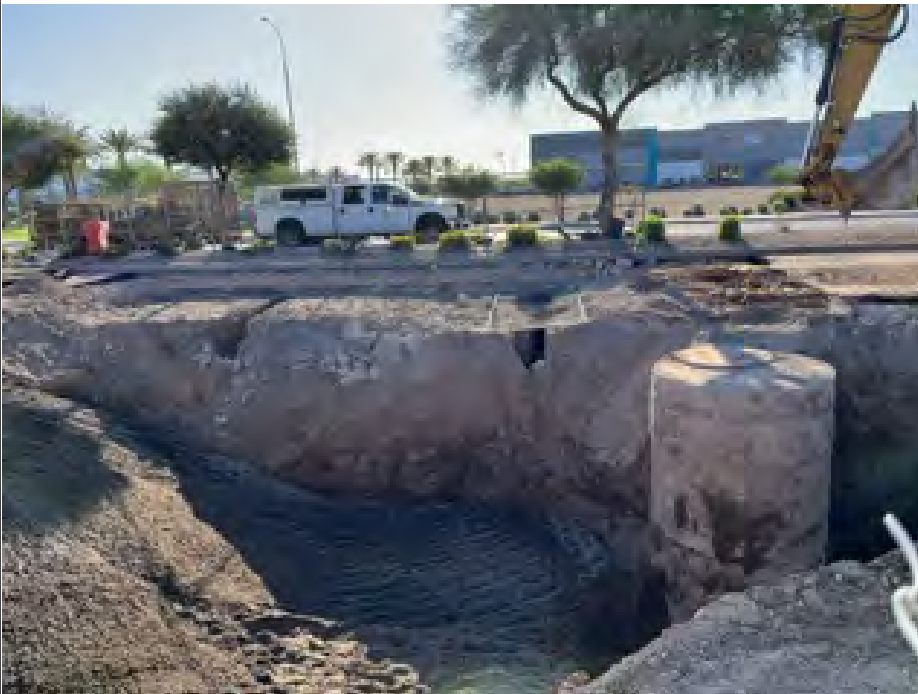
**Photo:** Picture 3

**Comments:** Rolling and compacting for trench and manhole backfill on McQueen road

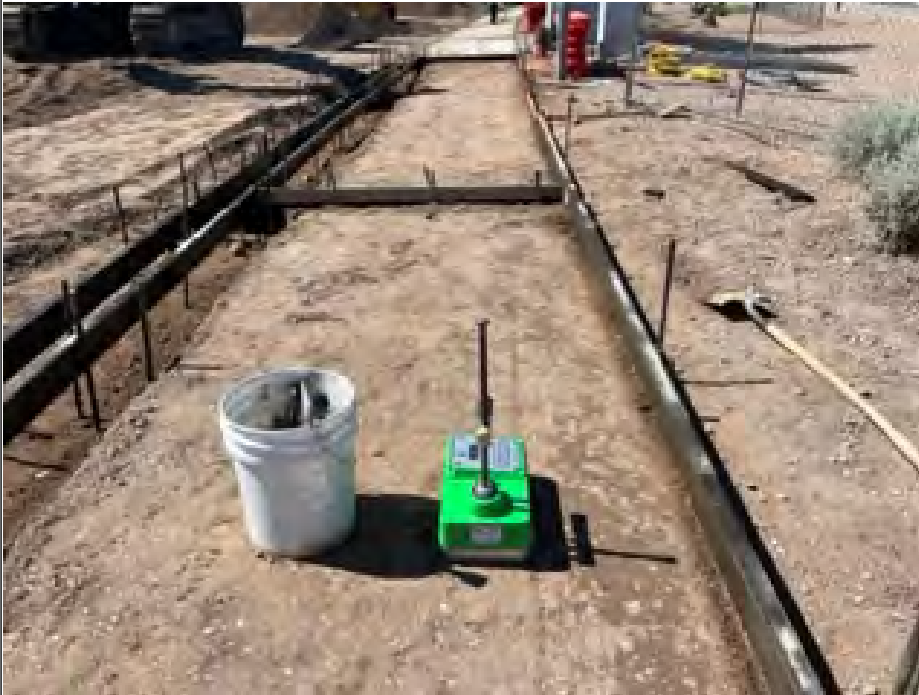
**Photo:** Picture 1

**Comments:** Sidewalk subgrade density test

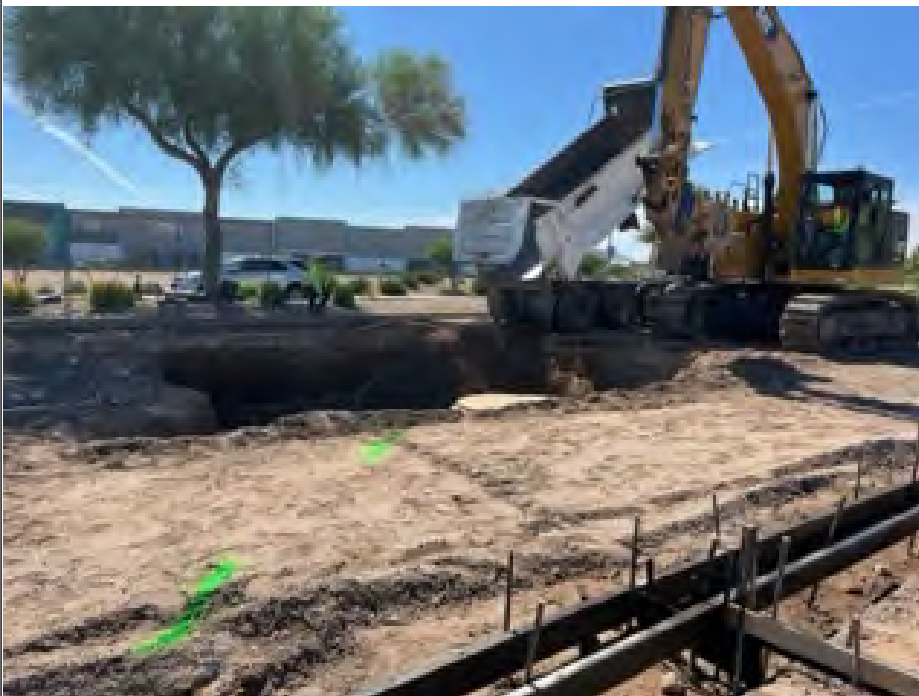
**Photo:** Picture 2

**Comments:** AB backfill on south bund lanes on McQueen road

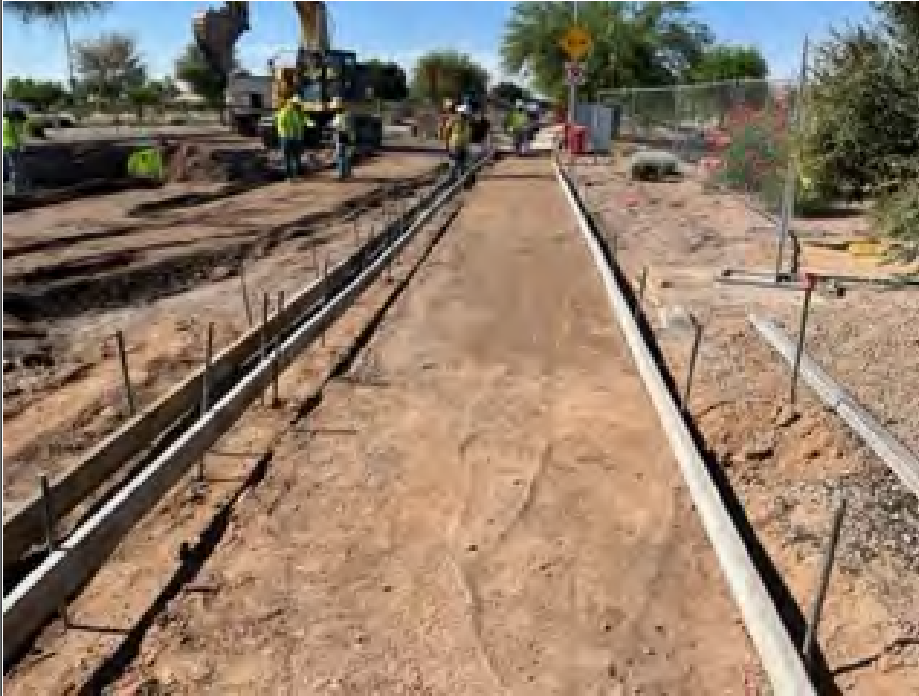
**Photo:** Picture 3

**Comments:** Sidewalk subgrade prior to concrete placement

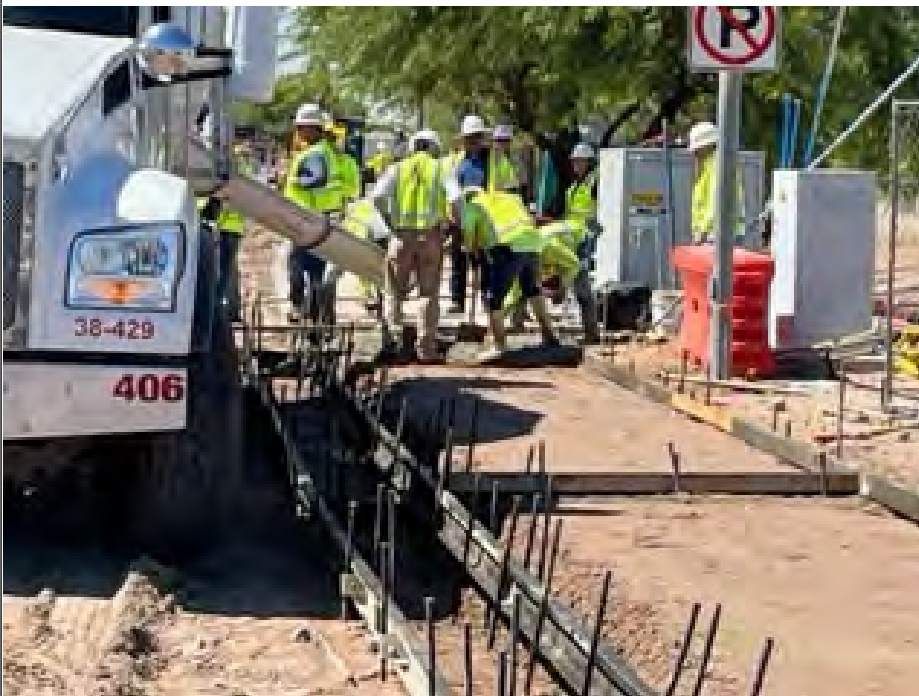
**Photo:** Picture 4

**Comments:** Placing concrete for sidewalk on south bund lanes on McQueen road

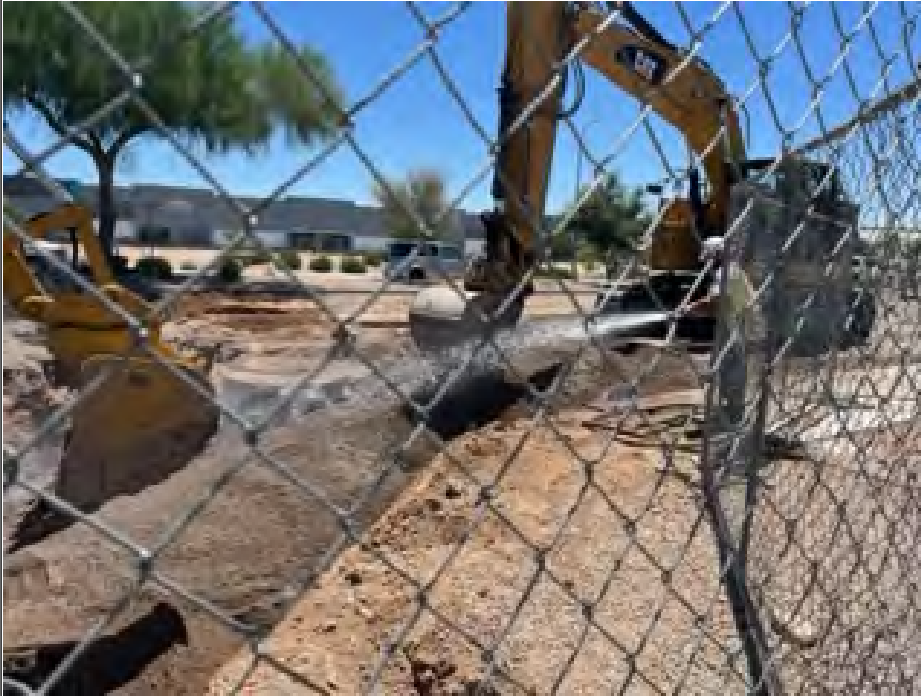
**Photo:** Picture 5

**Comments:** Rolling and compaction for backfill on south bund lanes on McQueen road

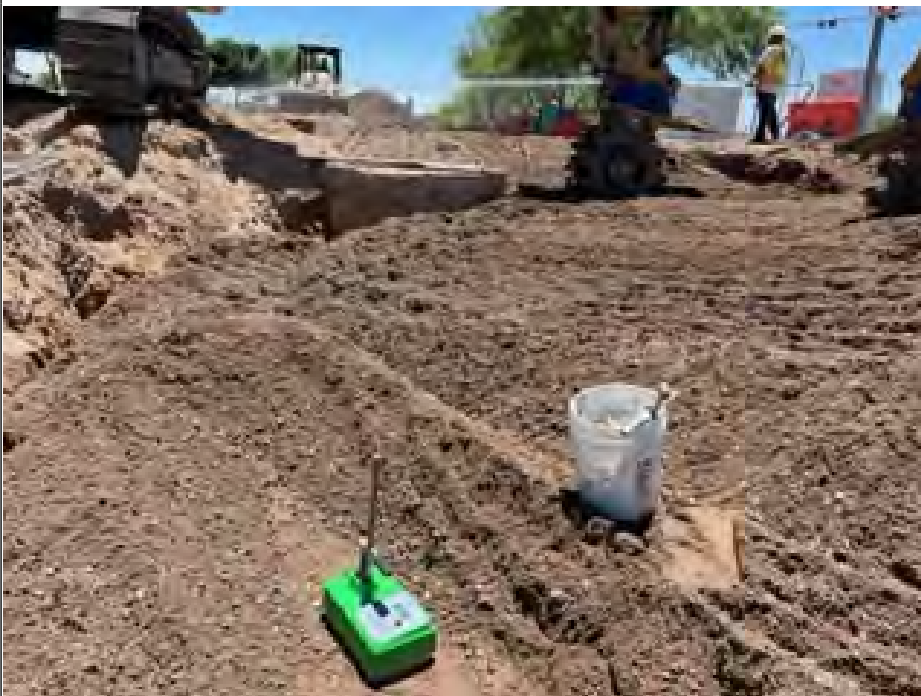
**Photo:** Picture 6

**Comments:** Density and moisture test for backfill on south bund lanes on McQueen road

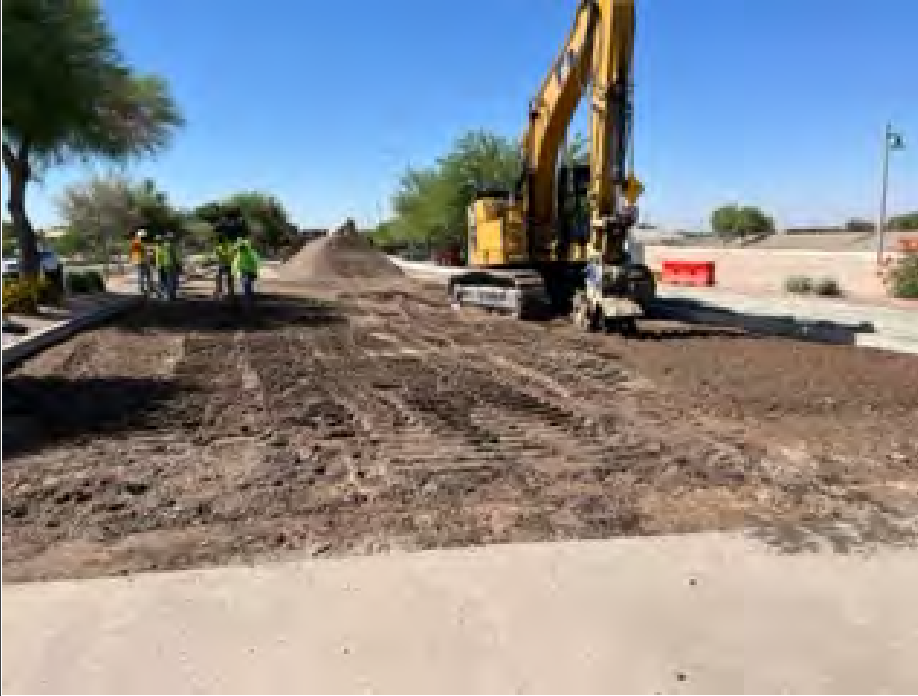
**Photo:** Picture 1

**Comments:** Compacting aggregate base on south bound lanes on McQueen road

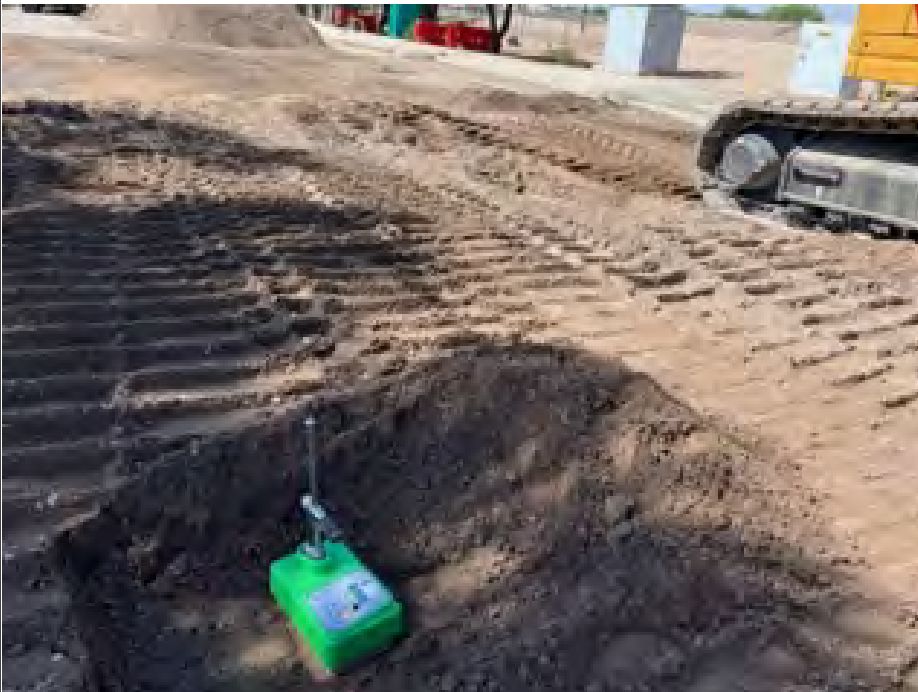
**Photo:** Picture 2

**Comments:** Compaction test for aggregate base on south bound lanes on McQueen road

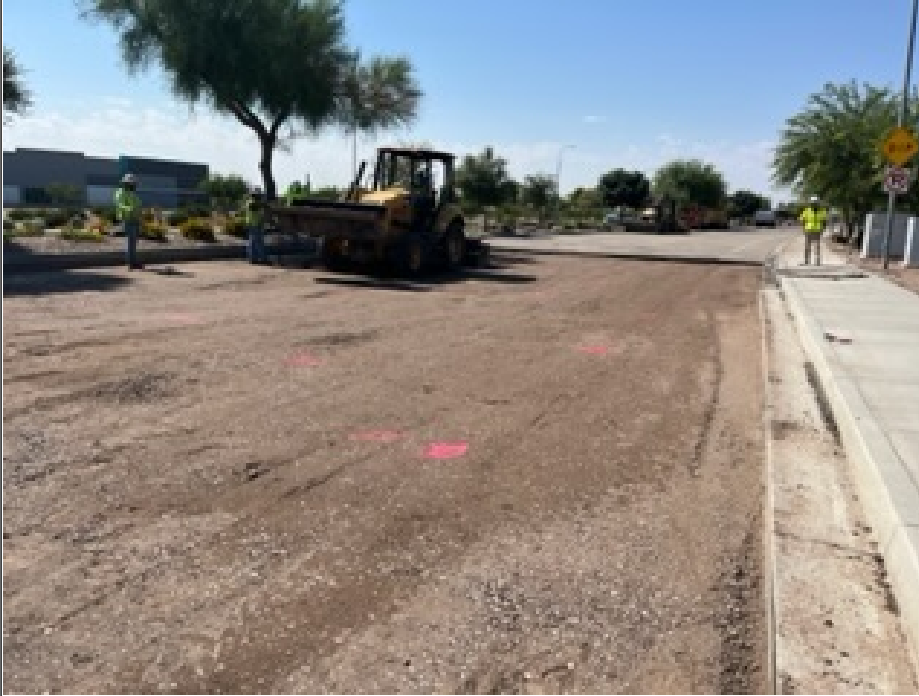
**Photo:** Picture 1

**Comments:** Final grade (aggregate base) southbounds lanes on McQueen road between Ocotillo & Queen Creek road

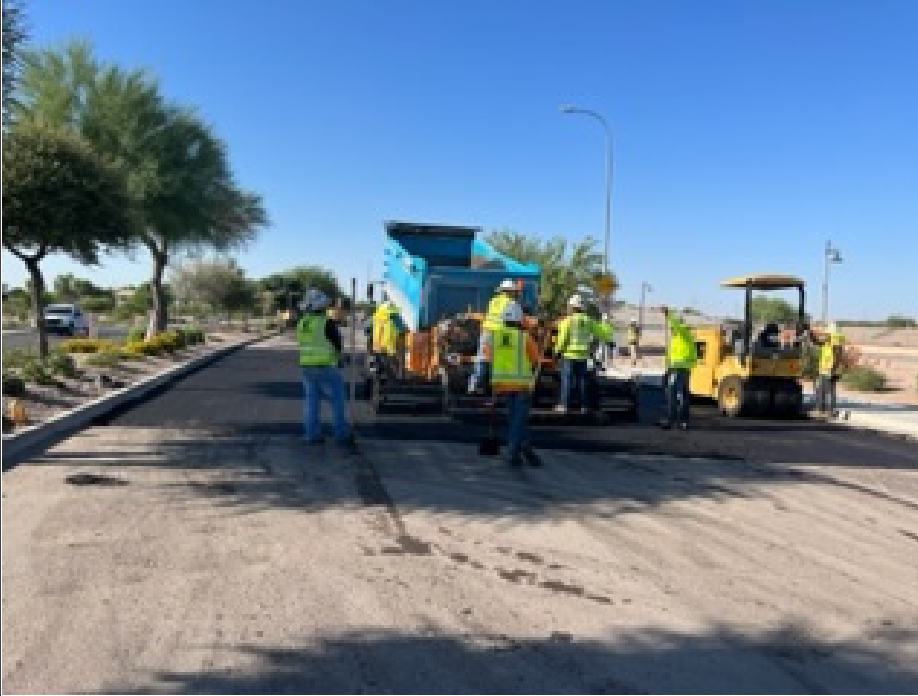
**Photo:** Picture 1

**Comments:** Placing asphalt on southbound lanes on McQueen road

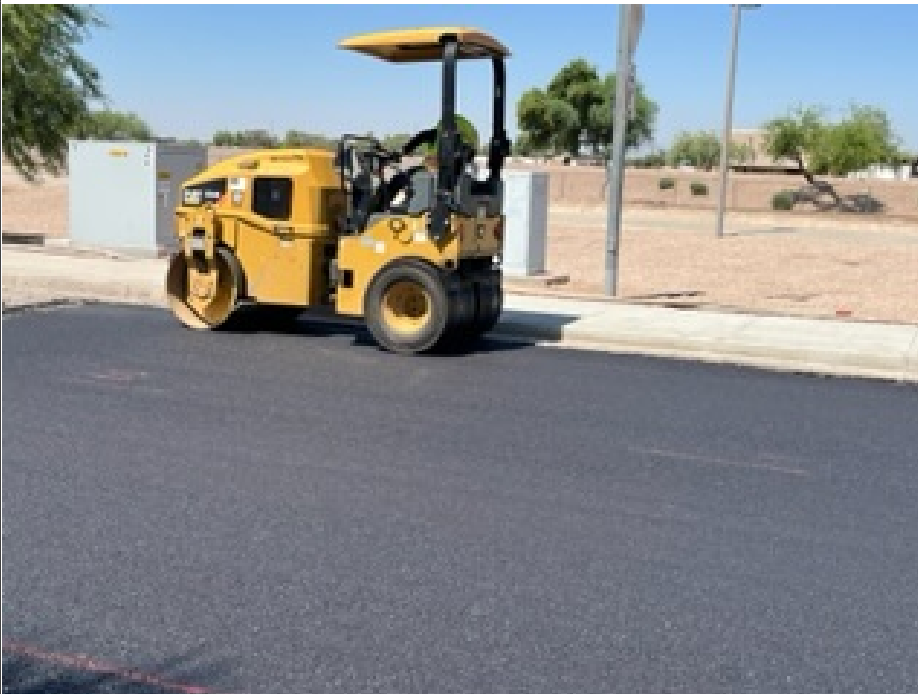
**Photo:** Picture 2

**Comments:** Rolling and compacting top lift on asphalt placed on southbound lanes on McQueen road

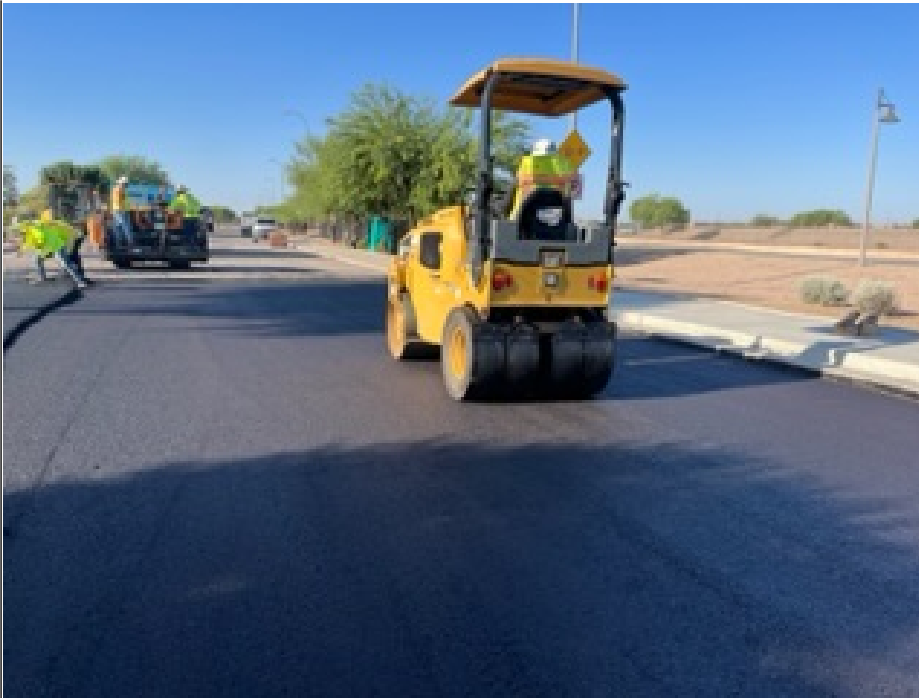
**Photo:** Picture 3

**Comments:** Rolling and compacting bottom lift on asphalt placed on southbound lanes on McQueen road

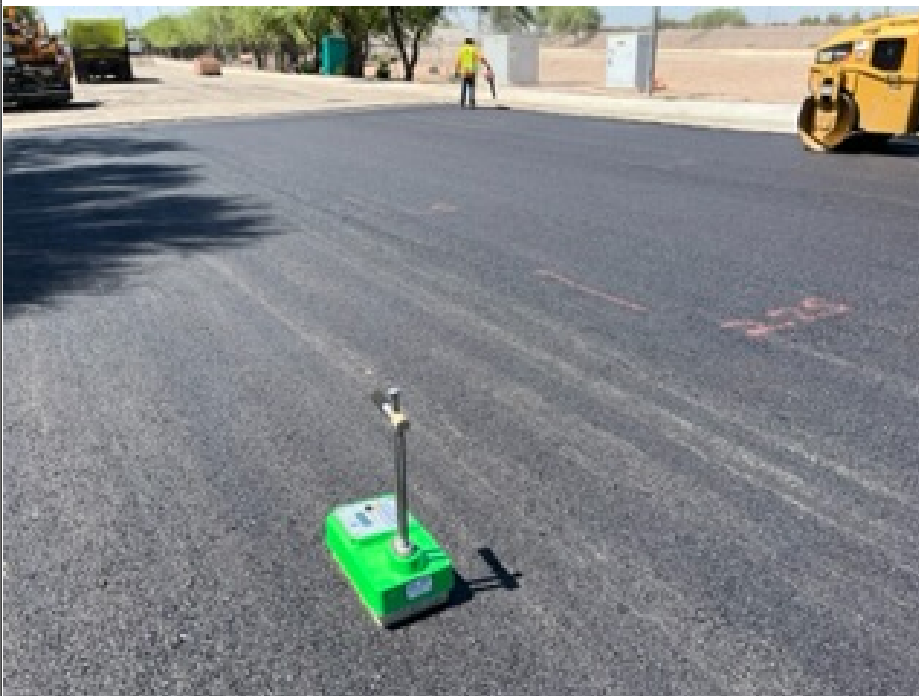
**Photo:** Picture 4

**Comments:** Density testfor top lift on asphalt placed on southbound lanes on McQueen road
