ATTACHMENT "U"

CONTRACT CHANGE ORDER NO. 1

AIRPORT: Cochise County Airport

DATE: November 3, 2021

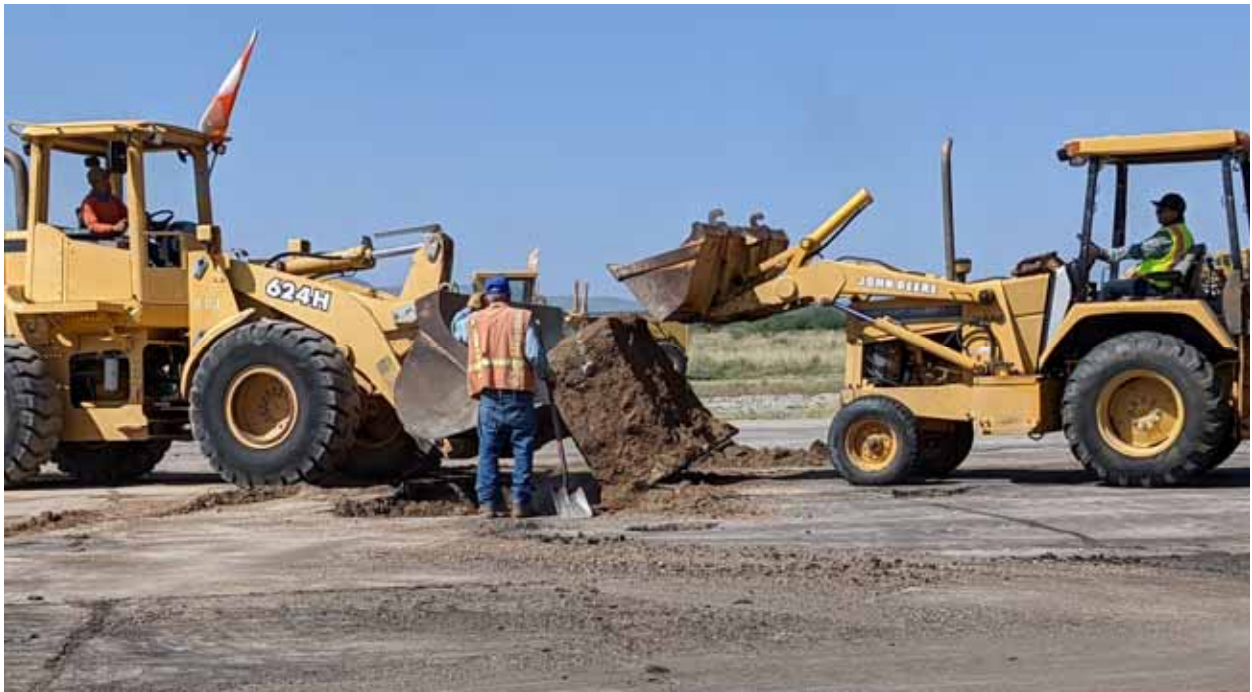
During removal operations, prior to pavement pulverization, very large concrete blocks were found

about 3 to 4 inches below the existing pavement surface. The proximity of these blocks to the pavement surface will prevent pulverization of the pavement as well as be exposed above the proposed pavement elevations if kept in place. To facilitate the pulverization and grading operations on the project, this change order proposes the removal of all 27 of these concrete blocks, and back filling the resulting voids with imported aggregate material to the existing pavement surface elevation. This will allow the pulverization equipment to proceed through the area and further be able to grade to proposed plan grades.

CO1.1 Concrete Block Removal

This item cover costs for removal of 27 large, underground concrete blocks found during removal operations and covers cost for the import and placement of aggregate material in the large voids created by the concrete block removal.

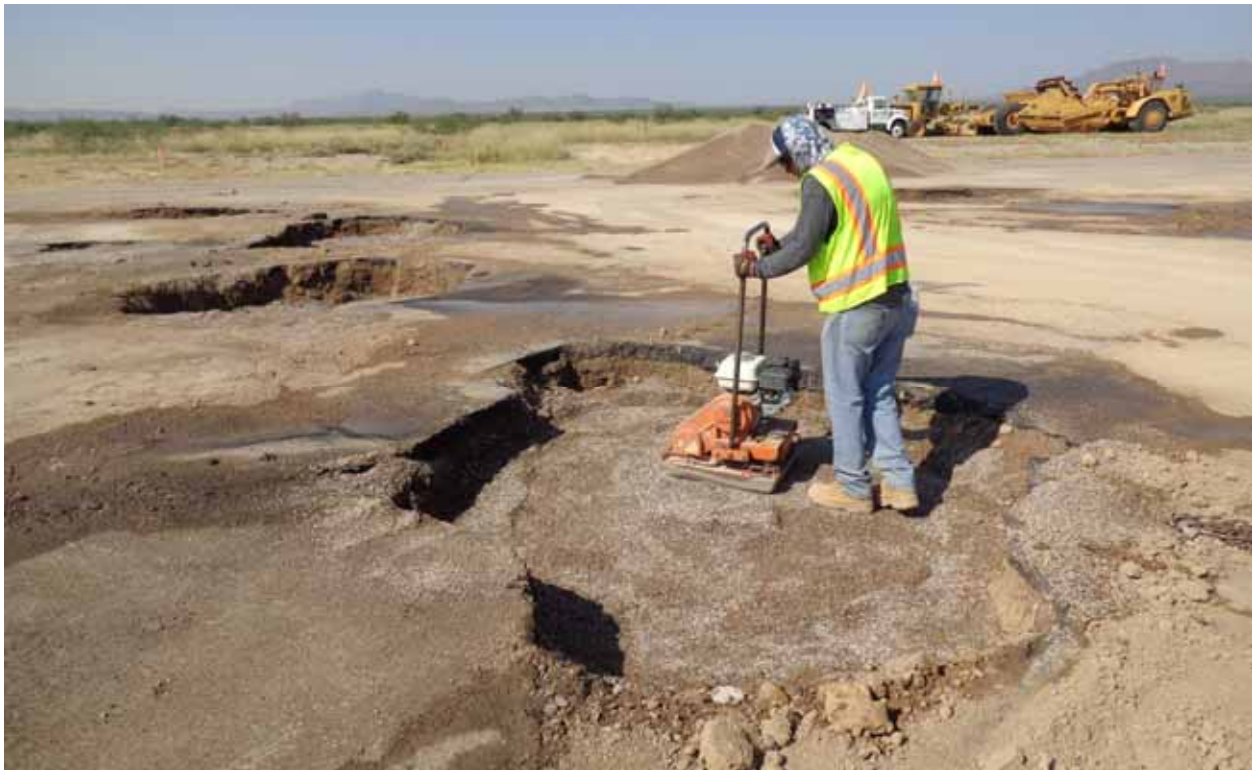
CO1.1 Backfill Placement and Compaction

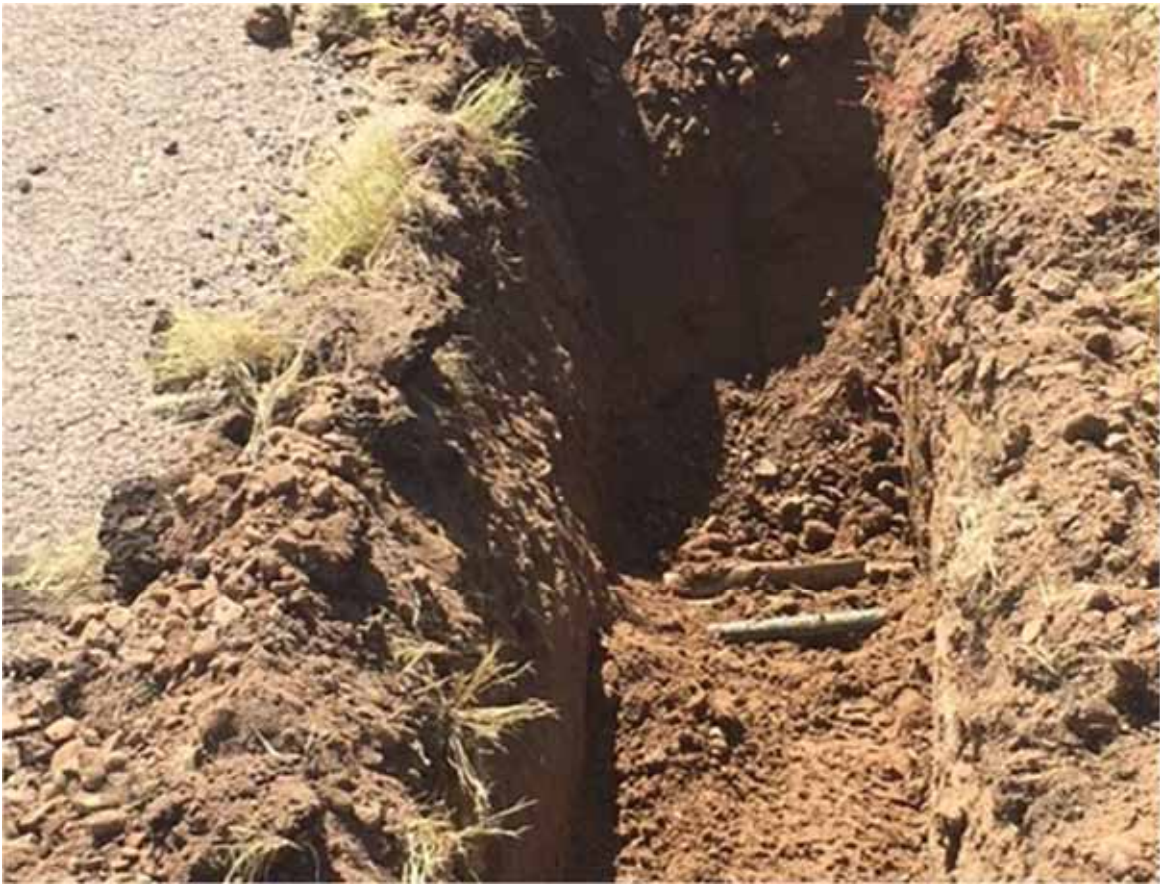
During removal operations, prior to pavement pulverization, an existing unmarked electrical crossing was found between the terminal and hangar buildings. The existing crossing was not enclosed in conduit and was direct buried about 10 inches below the existing pavement surface. These electrical lines will prevent pulverization of the pavement and will be damaged if left in place during subgrade treatment and pavement placement. To maintain power to the hangar, a new crossing of two PVC conduits, one for the existing electrical connection and a spare, is proposed to replace the existing direct buried service. The PVC duct crossing will be lowered to provide clearance below the proposed cement treated subgrade.

CO1.2 Existing Electrical Crossing

This item covers the removal of an existing, shallow electrical utility corridor between the terminal and the hangar found during removal operations and the installation of a new utility crossing and electrical lines.

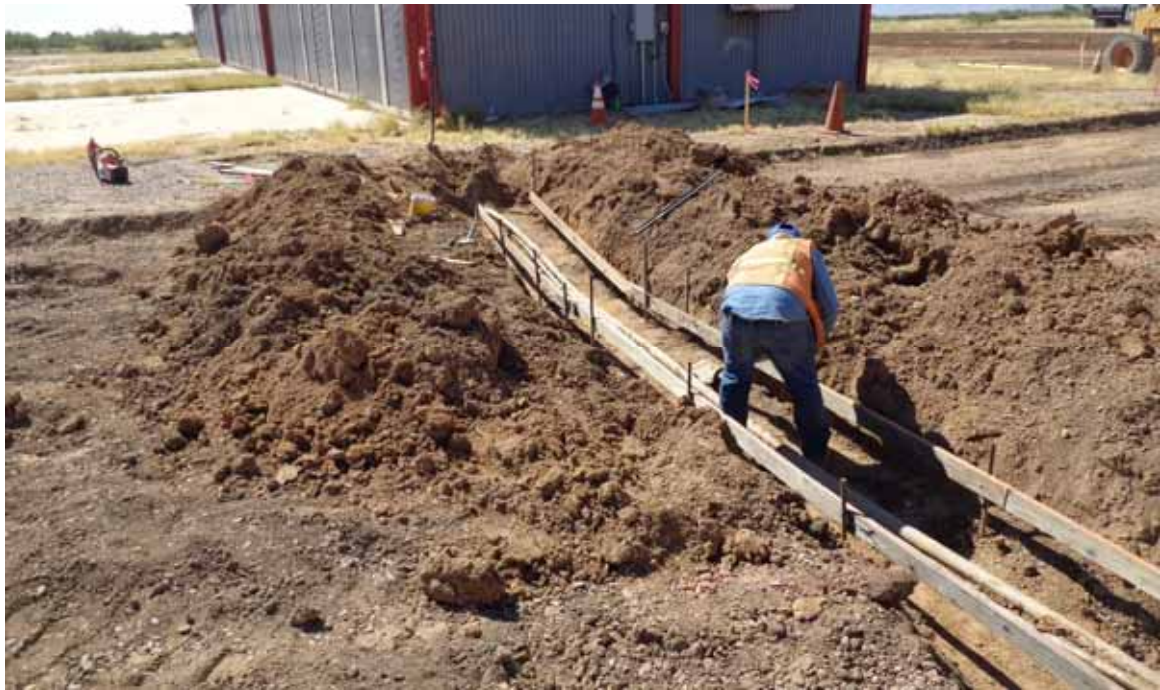
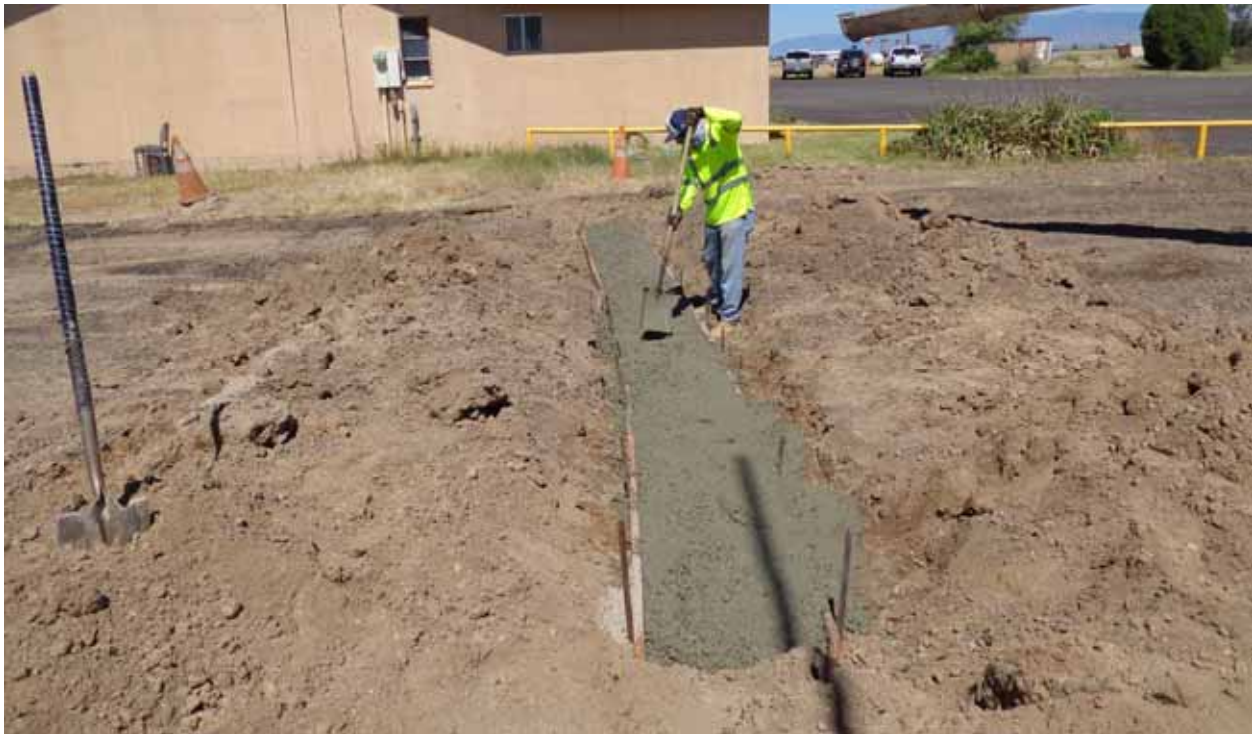
CO1.2 New Electrical Crossing

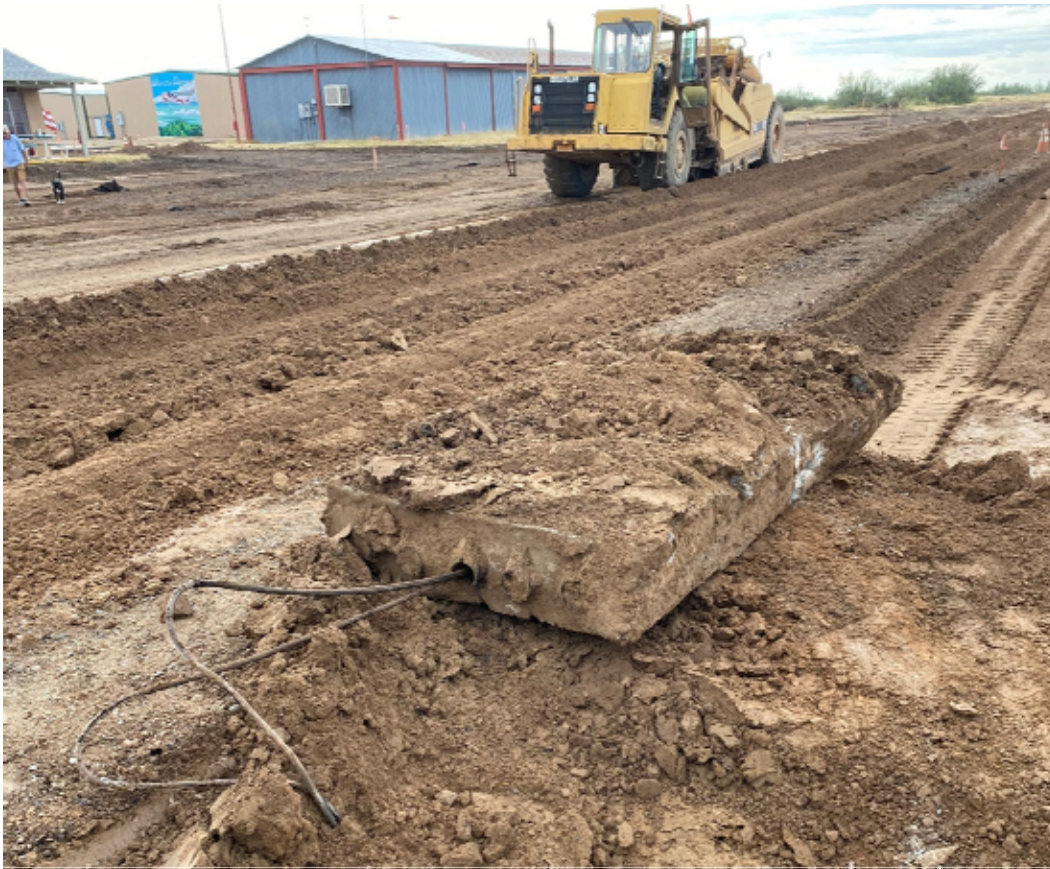
After removal operations and during subgrade excavation, a large 59ft x 4ft x 16inch abandoned concrete encased duct bank was found. This concrete duct bank is not connected to any service on the airport, but is inside the proposed aggregate base of the pavement section. To facilitate a uniform subgrade stabilization and base course placement, this change order proposes the removal of the entire concrete encased duct bank.

While excavating to get to the final subgrade elevations, we encountered buried, concrete-encased duct bank which is 4' wide and apx 16" deep (see attached pictures) and it runs east to west, across the apron, approximately 50' north of the corner of the FBO building towards the first tank in the infield area. A couple of the conduits have cable in them, but it is my guess that the cables are old runway lighting wires, and that system has since been replaced with new conduit and wires.

The concrete duct bank has to be removed since it is higher than our finished subgrade. I will send you a cost estimate once we uncover the whole length of this encasement later today.

CO1.3 Concrete Encased Duck Bank Removal

This item covers the cost for removing 27 sy (60ft x 4ft x 16inch) of abandoned concrete encased duct bank found during subgrade excavation operations. This duct bank was within the proposed cement treated subgrade and base course.

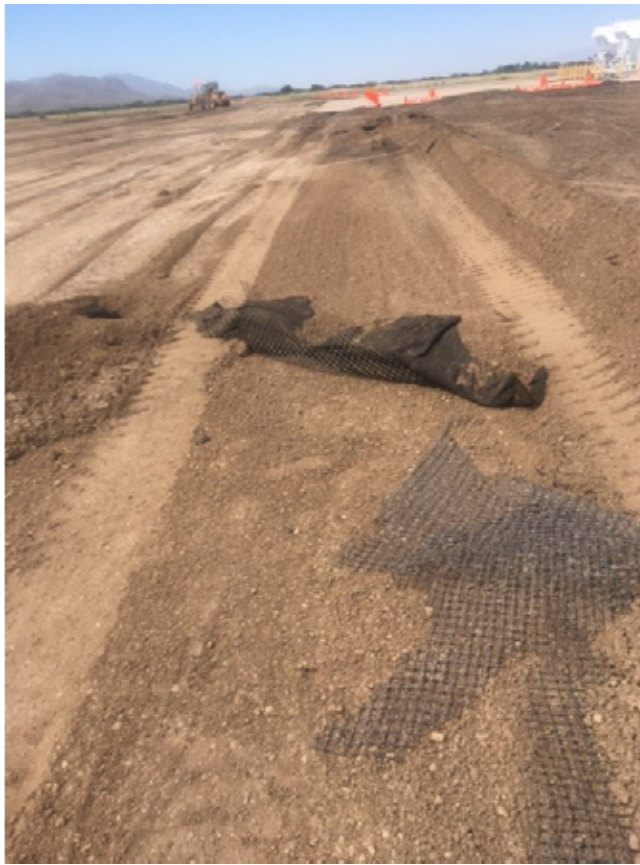
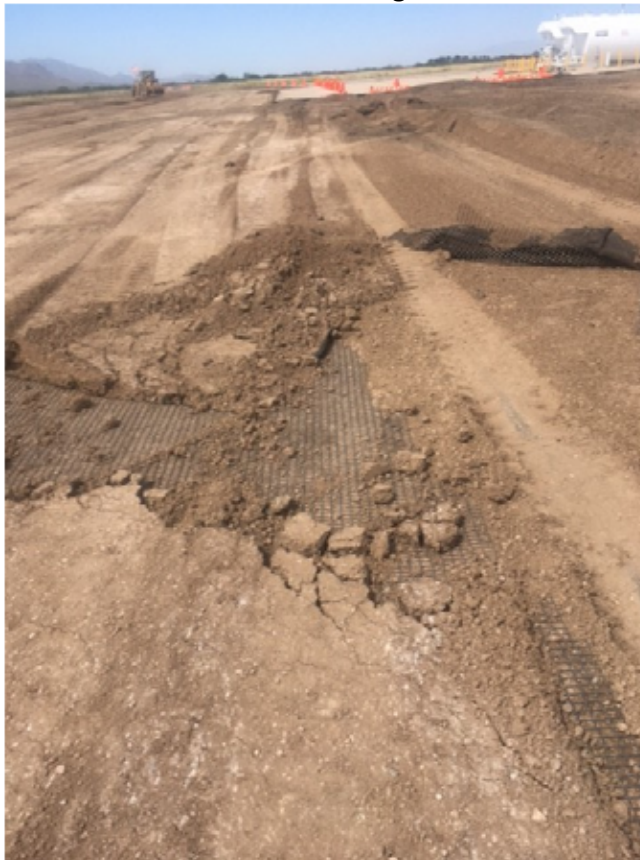
During the excavation process, geogrid and engineering fabric was discovered in layers several inches to a couple feet below the existing pavement section. There was no indication of geogrid or fabric in the geotechnical investigation or in the available record drawings. Several layers of material have been found during the excavation process. Should this material be in the 8" soil cement (P156), area it will be chopped up by the cementation process which will incorporate foreign material into the cemented layer and ultimately weaken the subgrade stabilization. This soil cement layer needs to be scarified to determine if there is fabric in the soil, and if fabric is found, it must be removed.

CO1.5 Fabric and Geogrid Found

This item covers the costs associated with the removal of 18,400 sy of civil engineering fabric and geogrid from the subgrade.

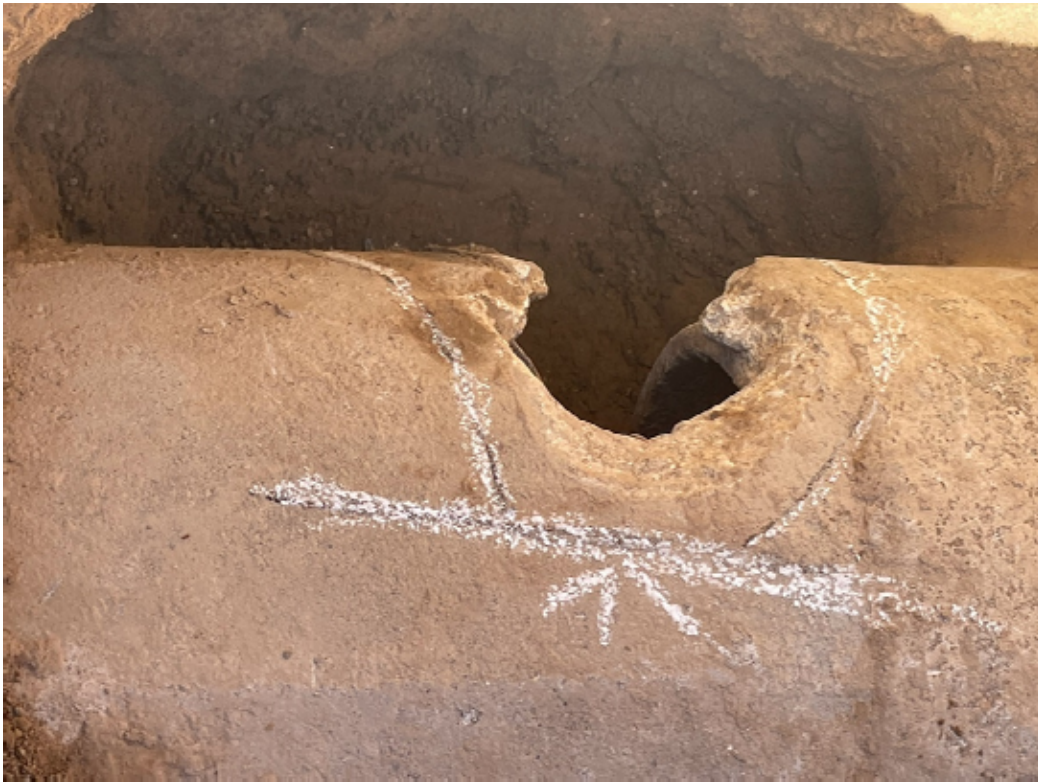
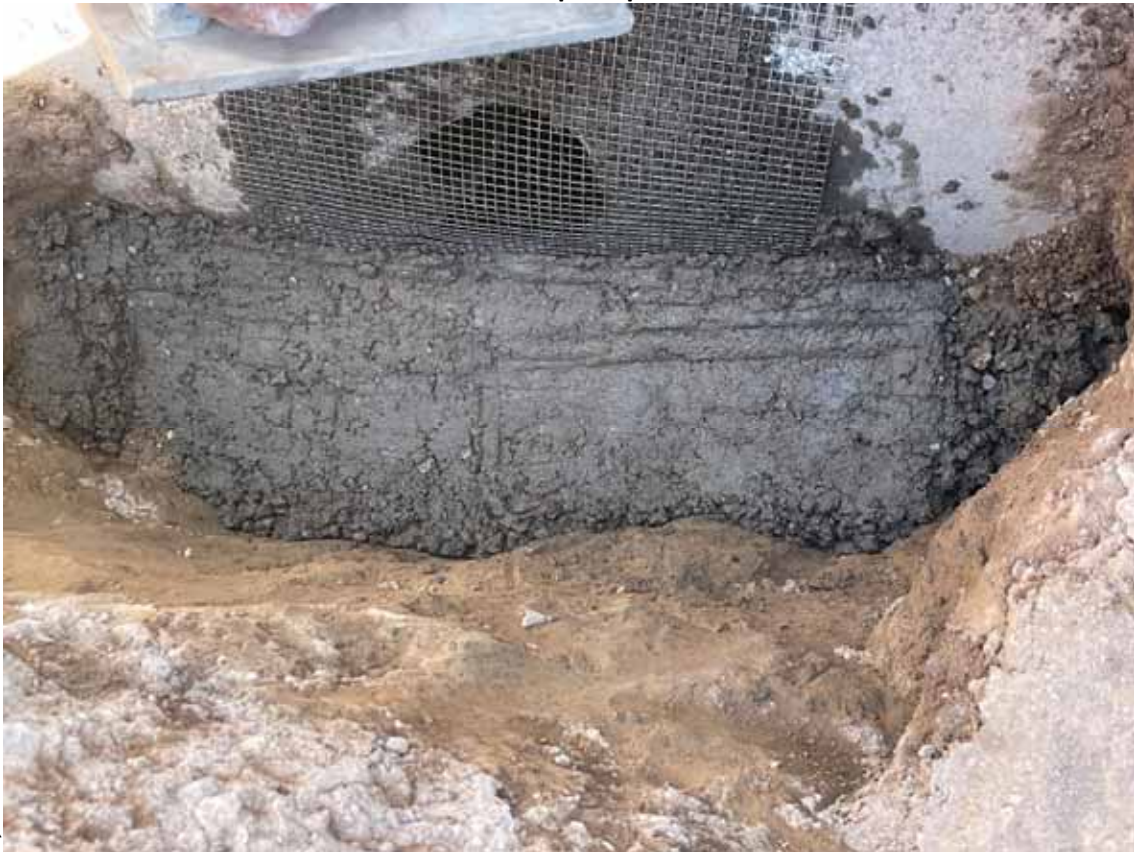
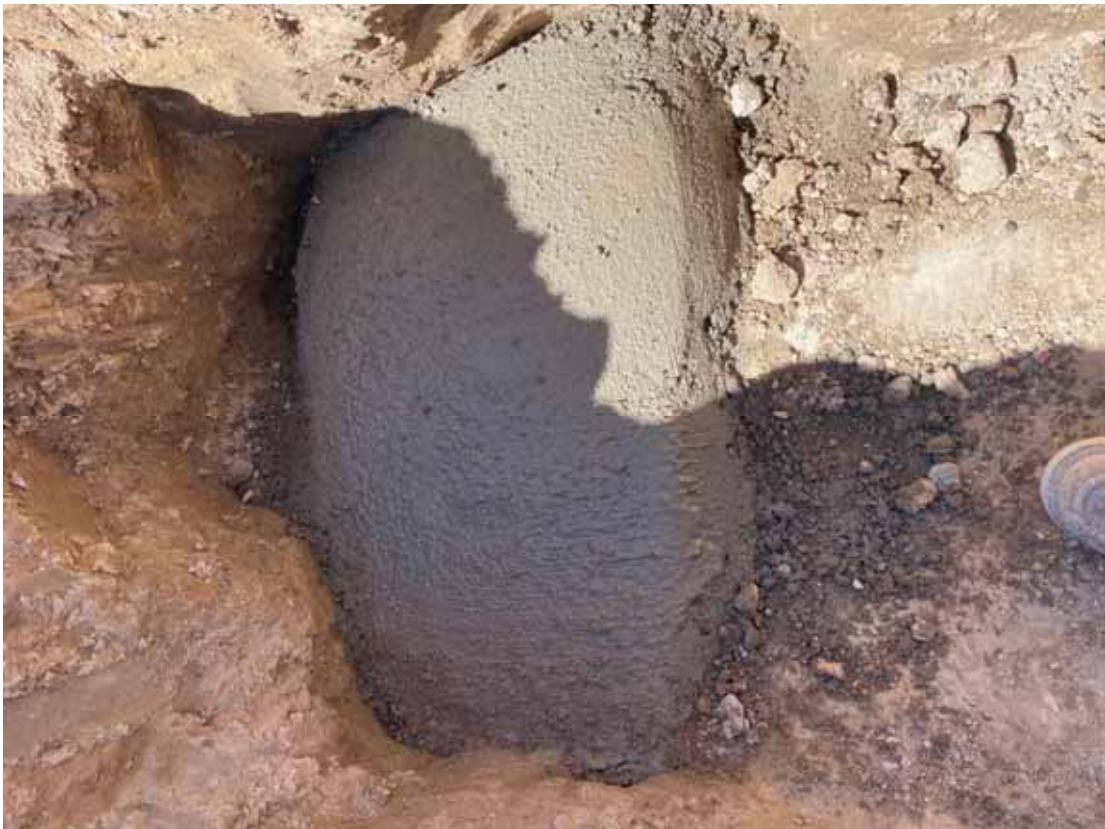
During excavation operations, it was discovered that a drainage pipe had a hole in it and it would not convey water without leakage. The damage was not done by the contractor. The hole will be covered and a concrete collar will be installed around the pipe to seal the hole.

CO1.7 Pipe Repair

This item covers the cost for repairing a damaged concrete storm sewer pipe.
This change order also adds 11 calendar days to the contract to do the proposed change order work.
