# *Southwest Building Inspection Service, Inc.*

## **Property Inspection Report Miracle Valley Campus**

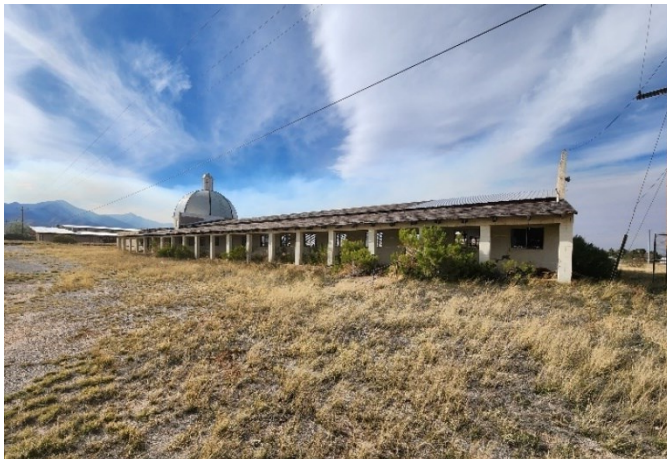
Overall Exterior View

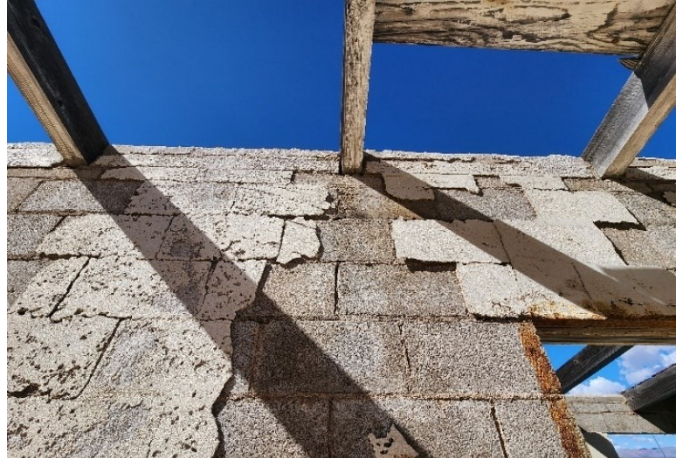
Deteriorated Masonry Finish

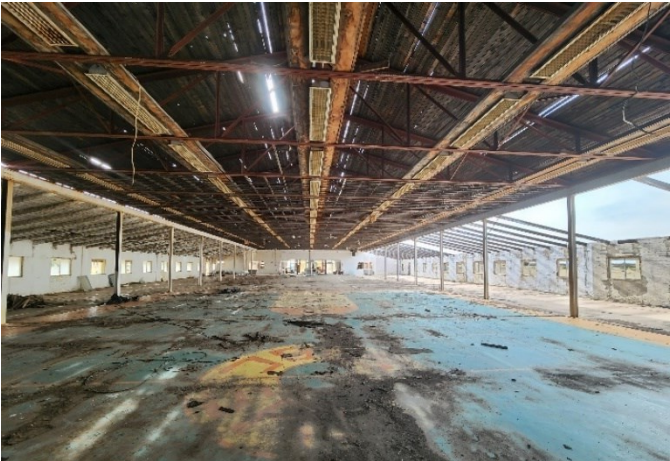
Overall Interior View of Main Auditorium

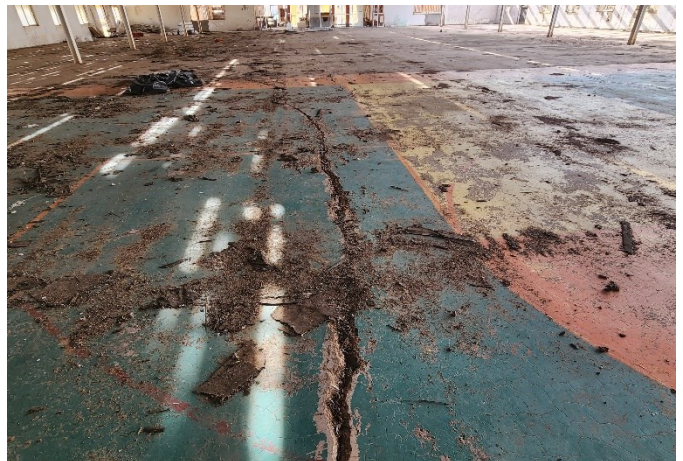
Severely Cracked Slab in Auditorium

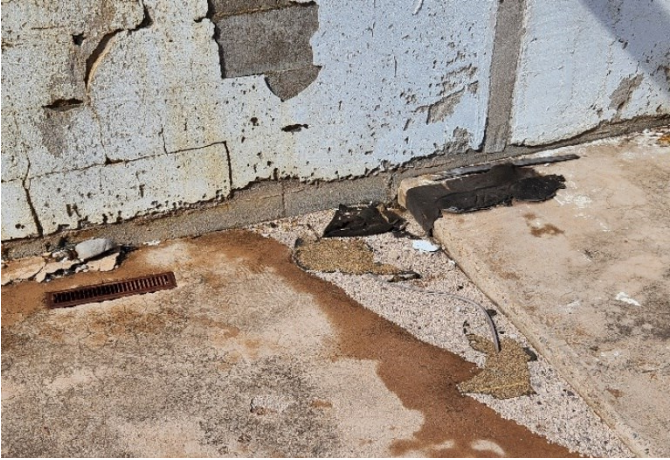
Concrete Slab Portion Depressed Down

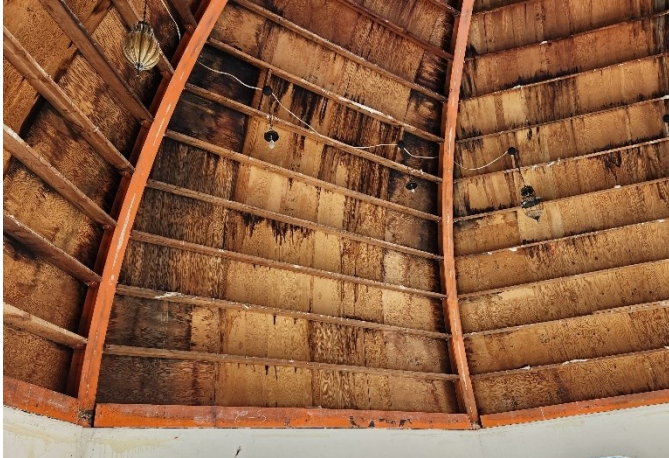
Interior Dome Water Stains

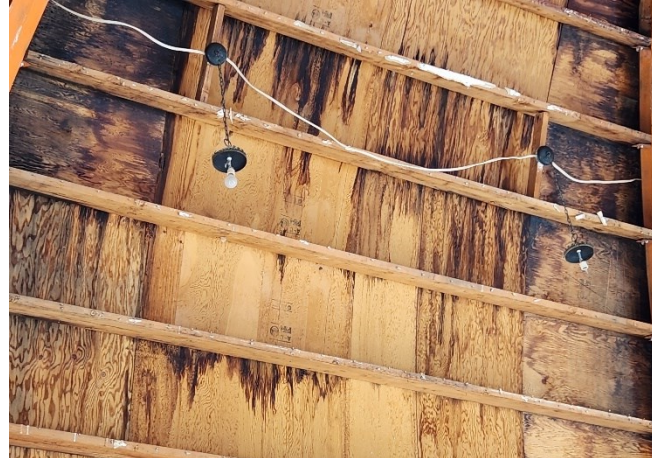
Interior Dome Water Stains

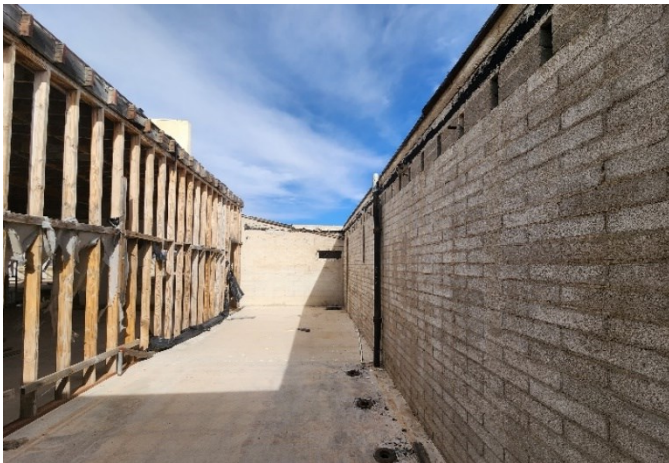
Overall View of Main Restroom

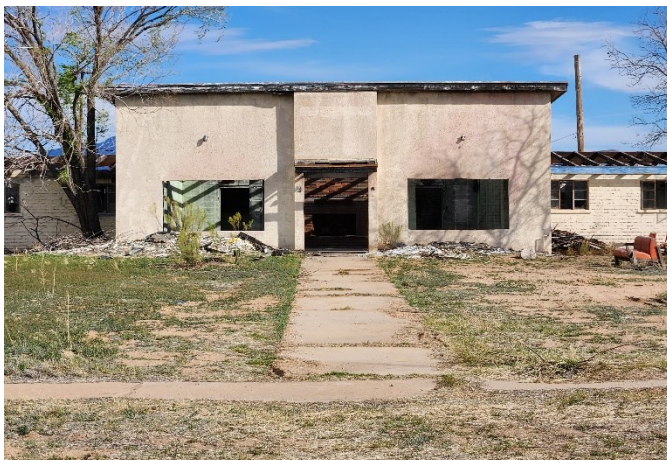
Overall Boys Dormitory Exterior Front View

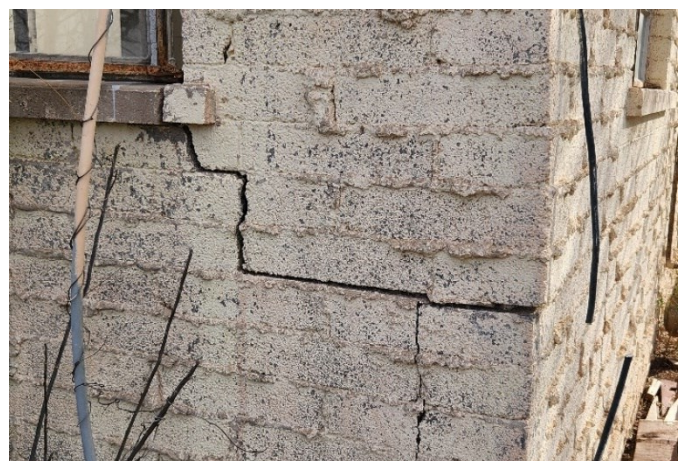
Boys Dormitory Crack in Exterior Wall

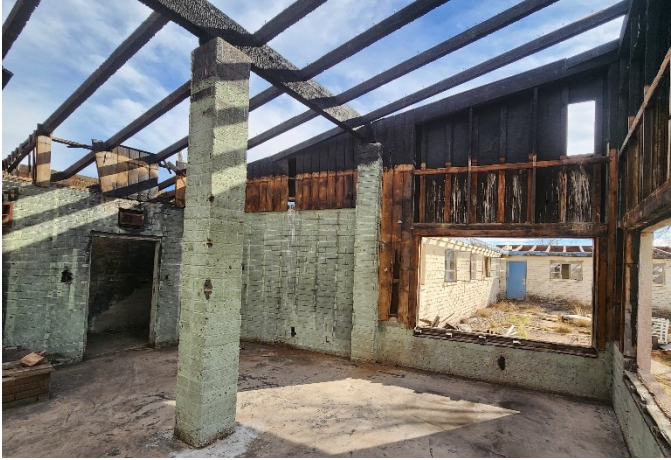
Boys Dormitory Front Lobby View

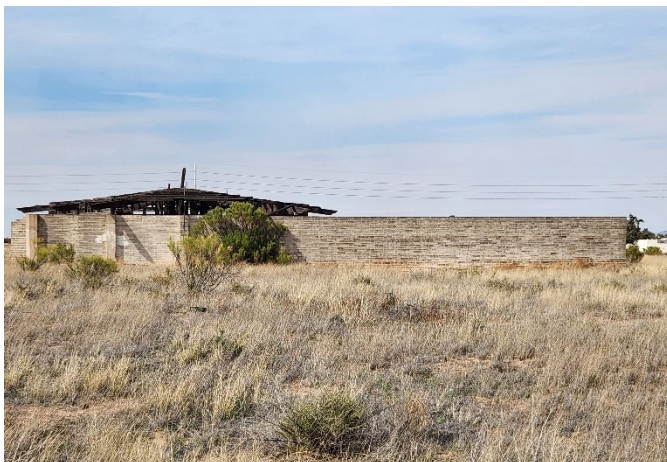
Overall Exterior View

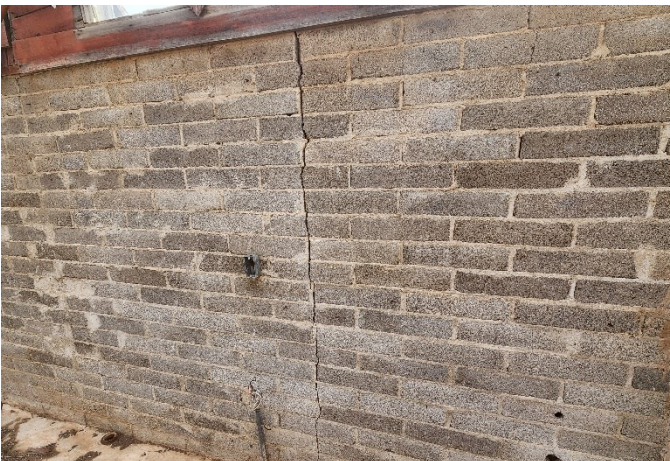
Masonry Structural Vertical Crack

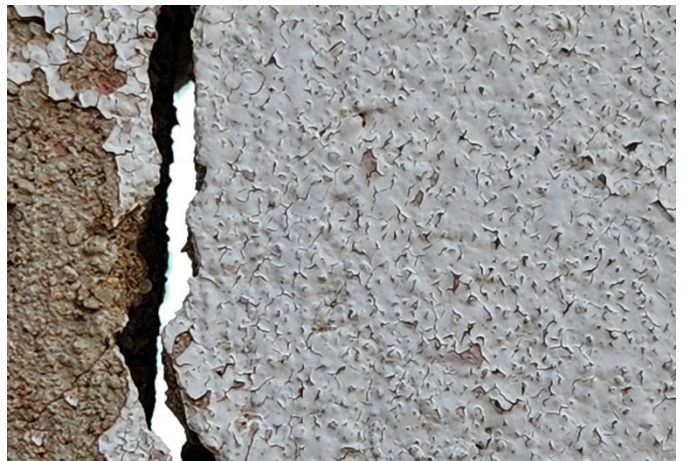
Closeup View of Masonry Vertical Crack

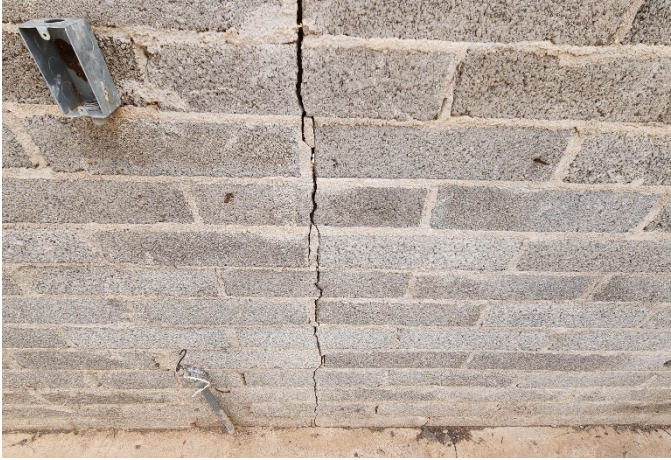
Masonry Structural Vertical Crack

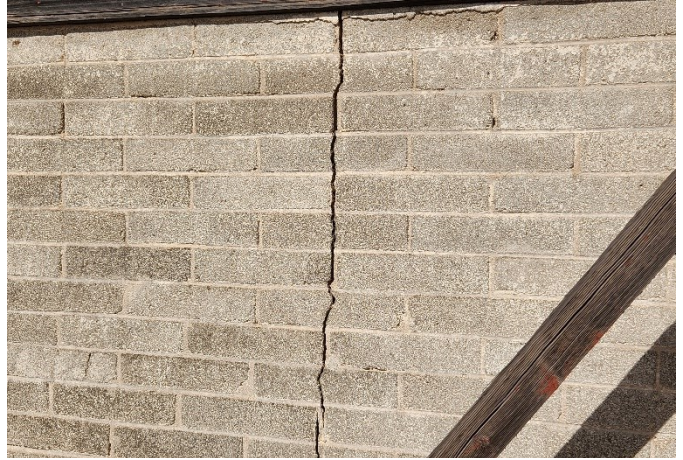
Structural Vertical Crack

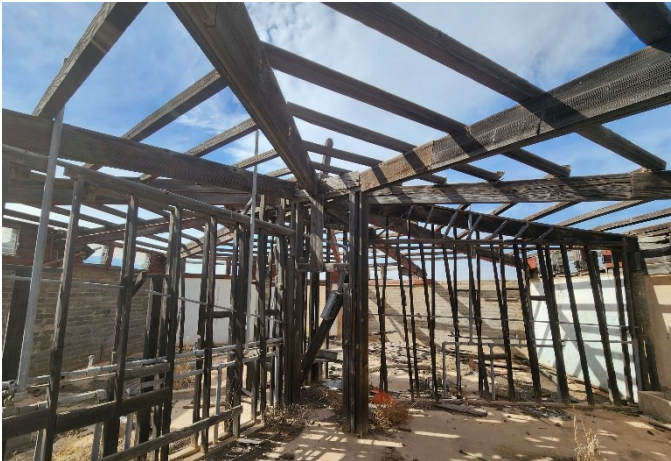
Overall Interior View
