Project Description

The Original structure at 606 N Beaver is 86 years old and a classic example of locally sourced malapai stone construction in Flagstaff. Additions were performed to add more square footage in 1971 and again in 1991. The property in its current state is a collaboration of 3 radically different time and style periods. The goal of this project is to keep the historic aesthetics from the original 1935 structure, while historically representing the rear additions for an overall aesthetically appealing property.

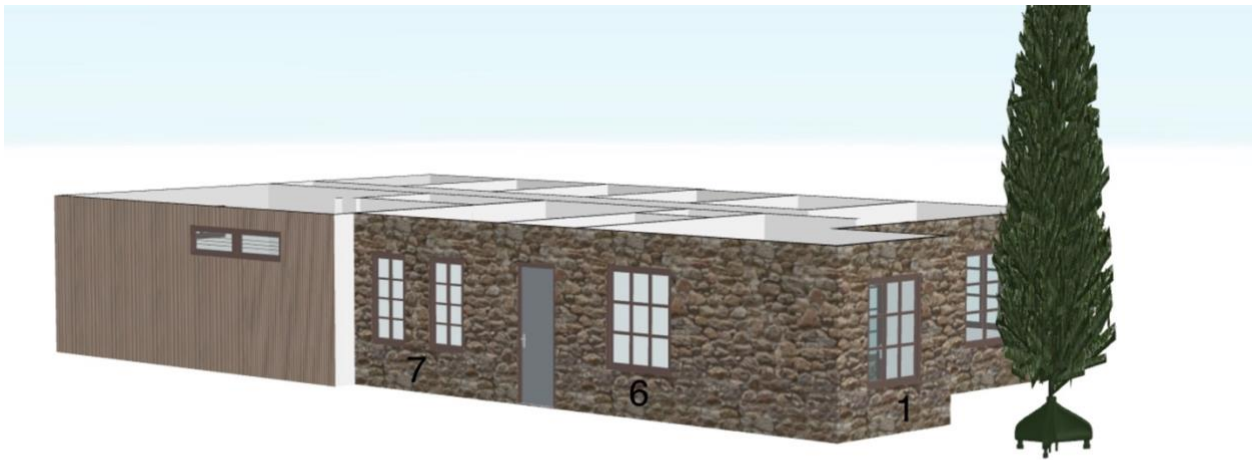
Window 1

Metal Windows Dividers were cut out and
Place with all glass taking away any historic
aesthetic

Because of the inoperability and aesthetics of multiple time periods of windows, I believe it would be best for a full replacement of windows throughout the entire structure. Attached is a proposal for Pella Lifestyle Casement Windows. They would have an aluminum-clad exterior in Putty Color with wood pine interior that can be stained to match trim of interior. Windows would be dual pane adding to energy efficiency of building. While unable to restore current windows because of their condition, I feel that adding hidden light windows will give project an overall historic feel of the original build date of 1935.

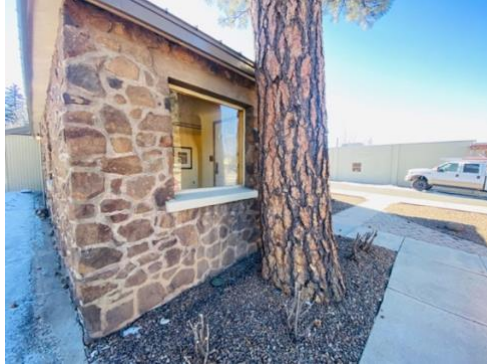
Window 2

Original Metal Window, but missing hardware and sealed shut

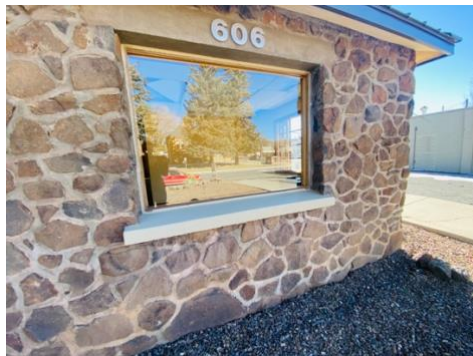
Window 3

Metal Windows Dividers were cut out and
Place with all glass taking away any historic
Aesthetic

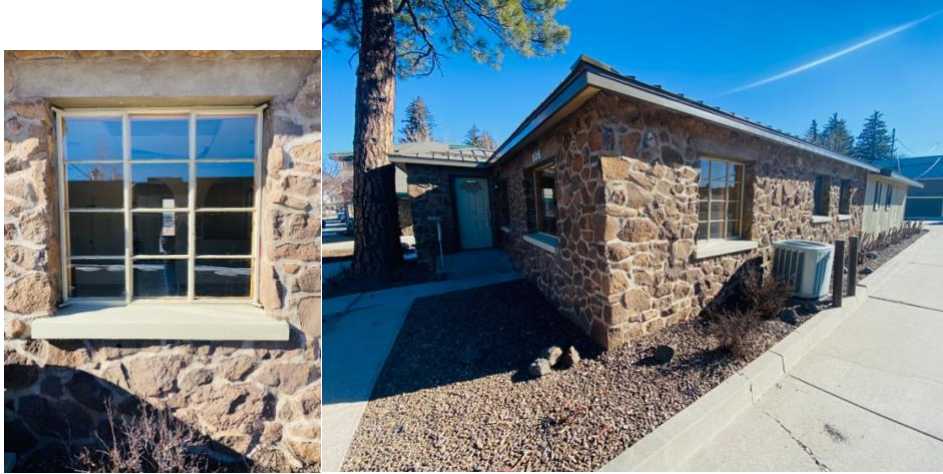
Window 4
Original Metal Window, but missing hardware
and sealed shut

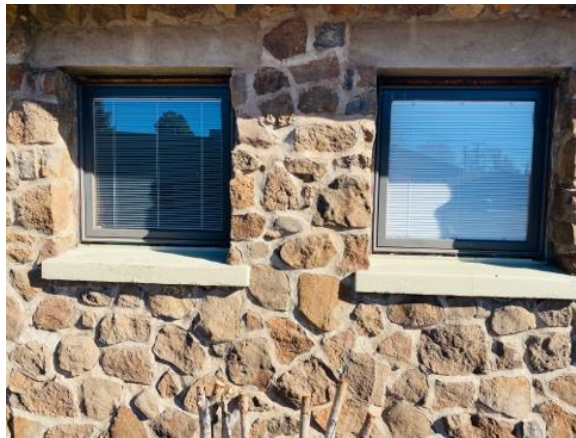
Windows 5
Metal Windows were poorly cut out and
Replaced with these fiberglass windows

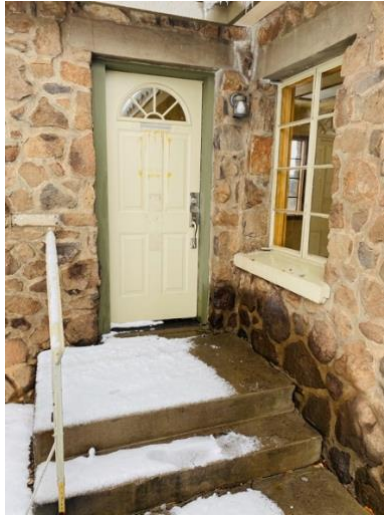
Current Front Door

The front door is not original and is made of a poor-quality fiberglass. Doors from this time period would be made of Wood. I would like to replace the Front Door with a more historically accurate wood door.

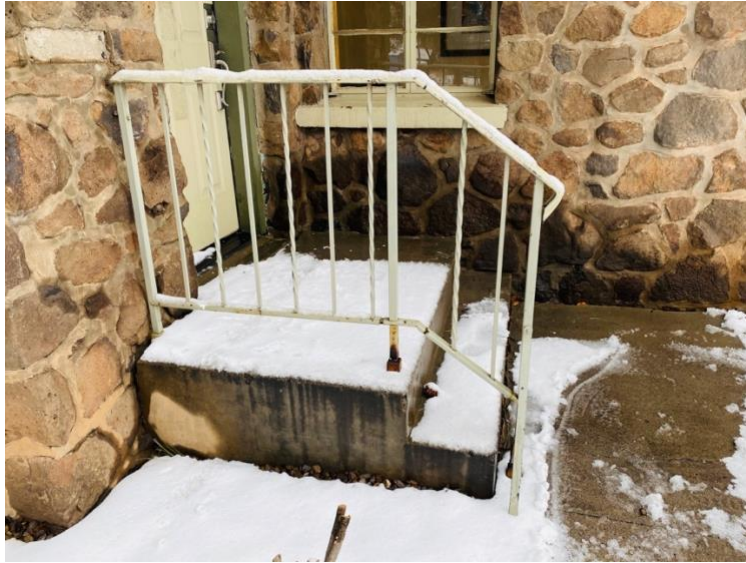
Current Handrail

The Front Railing appears to be original but is rusted and in unsafe condition. I would like to replace the railing with a historical replica of current railing by having a welder use similar spindles and shape to weld a new safe railing.

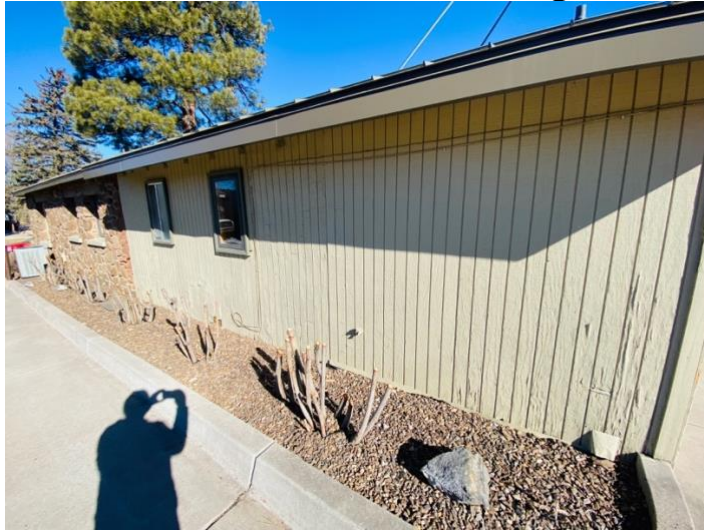
Current T-1-11 Siding

The rear part of house has T-1-11 siding, which was most likely installed in 1991 upon completion of addition. This T-1-11 siding has significant water damage and needs to be replaced. I would like to install Board and Batten Horizontal siding that would be a more historical example of what was used in 1935.
