APPENDIX C

Exterior Photographs of the David Babbitt House (319 North Beaver Street)

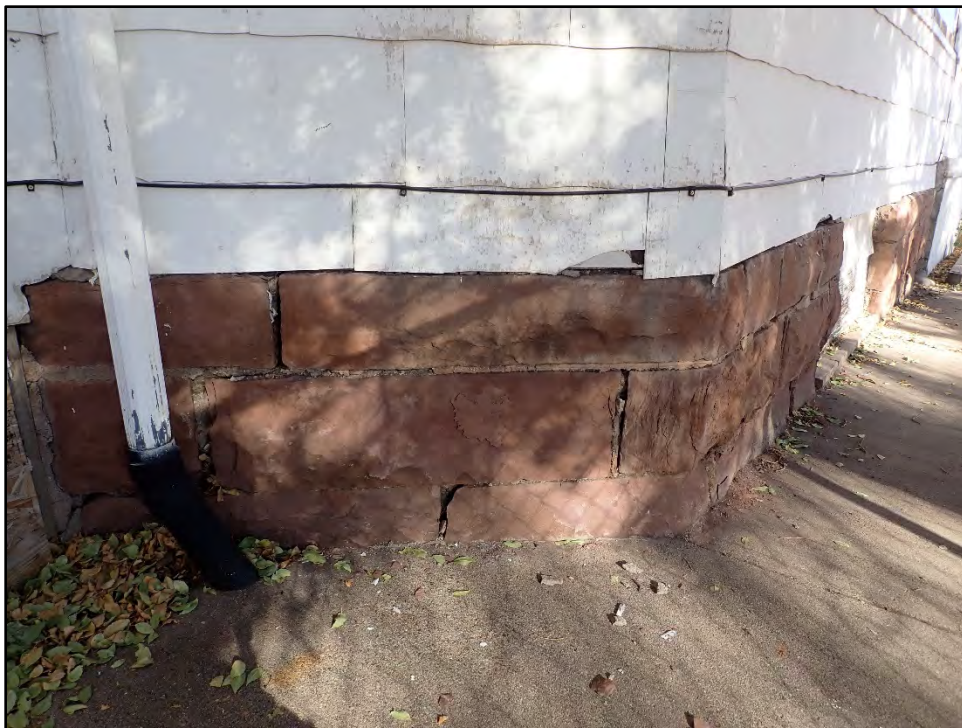
Figure C-36. Detail of the Moenkopi red sandstone foundation of the cant bay window of the formal living room, constructed between 1895 and 1901.

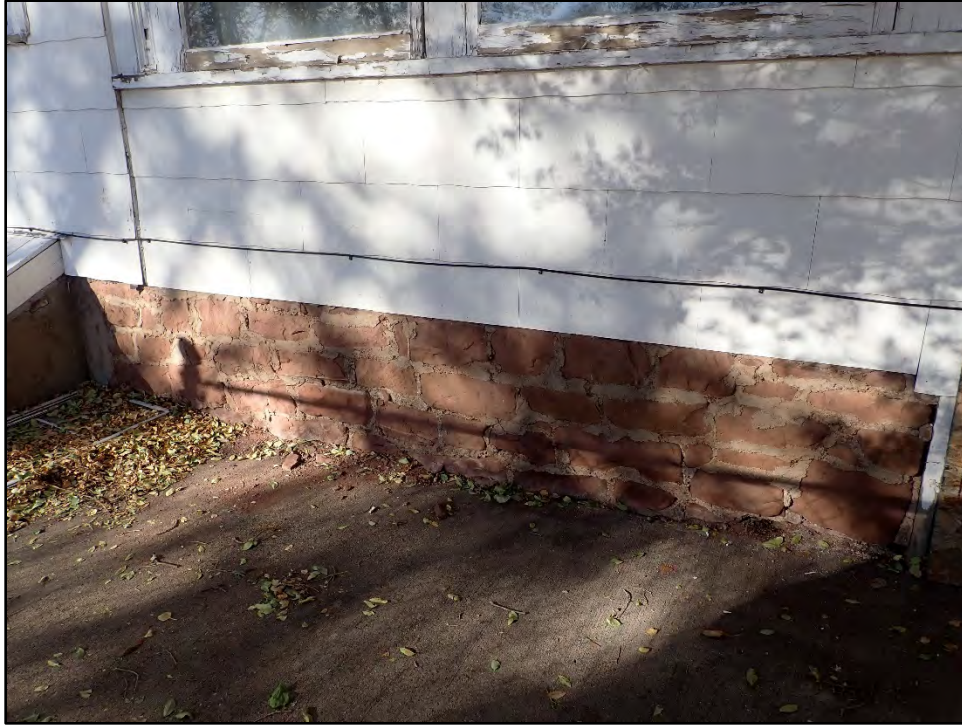
Figure C-37. Detail of the red sandstone foundation constructed to support the dining room and kitchen added to the southwest corner of the residence between 1910 and 1916.

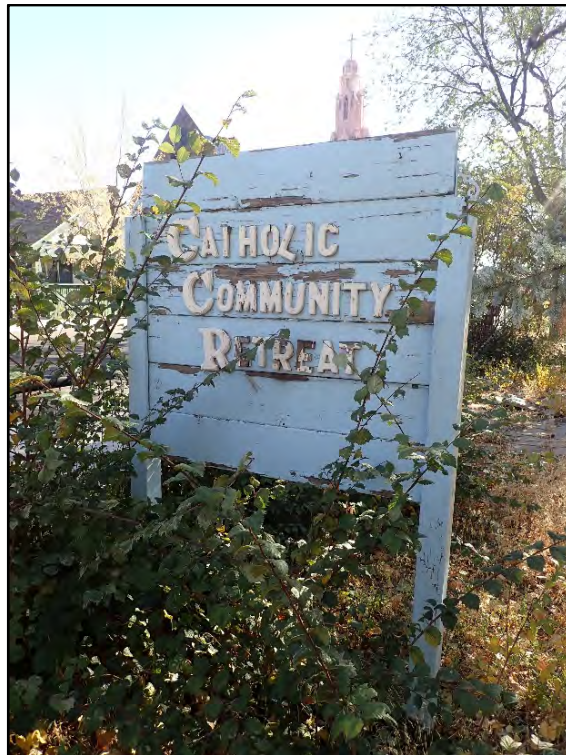
Figure C-38. View of the Catholic Community Retreat sign along North Beaver Street.

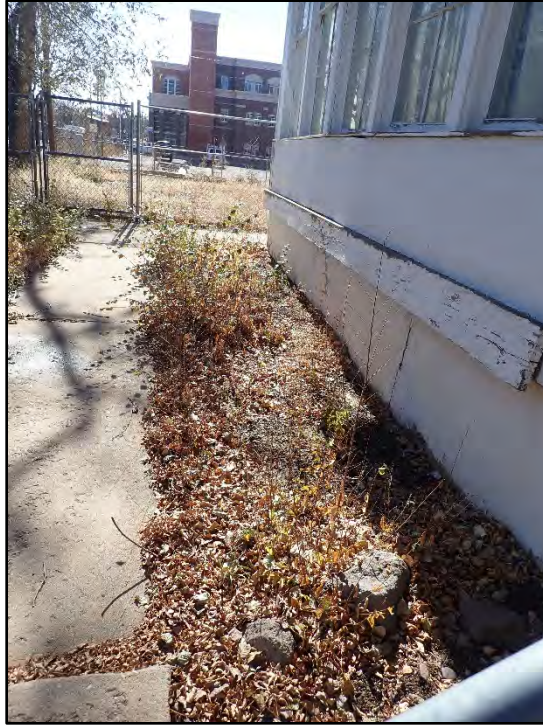
Figure C-41. Detail of the sidewalk and concrete foundation of the wrap-around porch (the new Flagstaff Municipal Courthouse towers in the background).

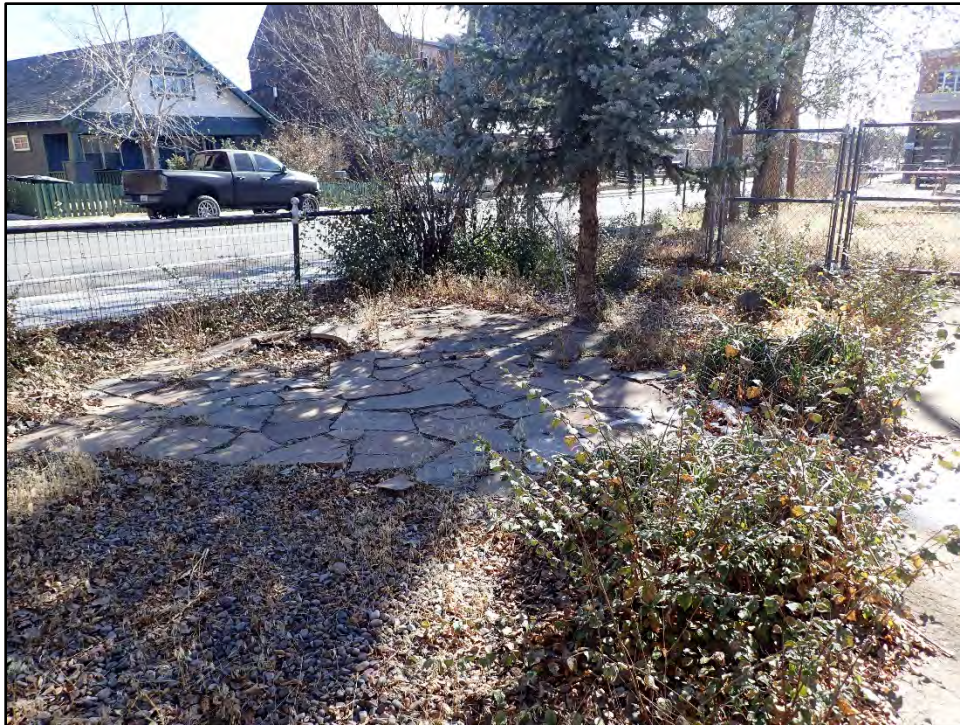
Figure C-42. Overview of a landscaped portion of the front yard along with the historic-era residence at 314 North Beaver Street visible in the background.

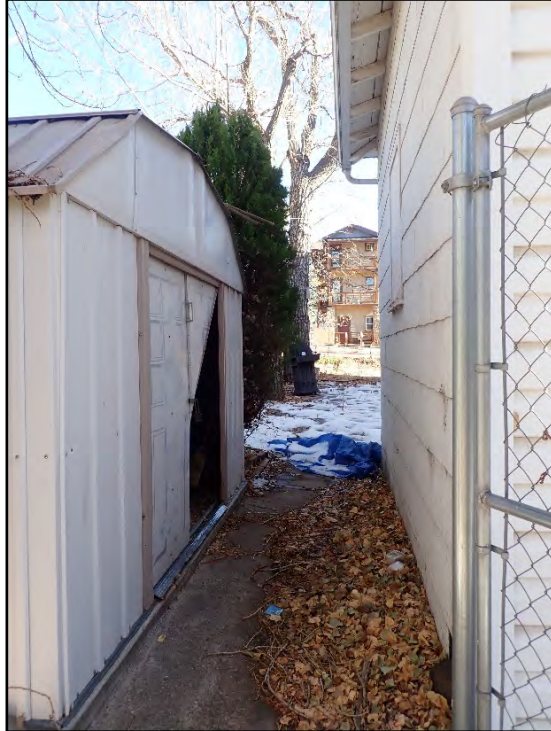
Figure C-53. Detail of the north side of the chapel extension with the modern shed (recently broken into while field documentation was occurring).

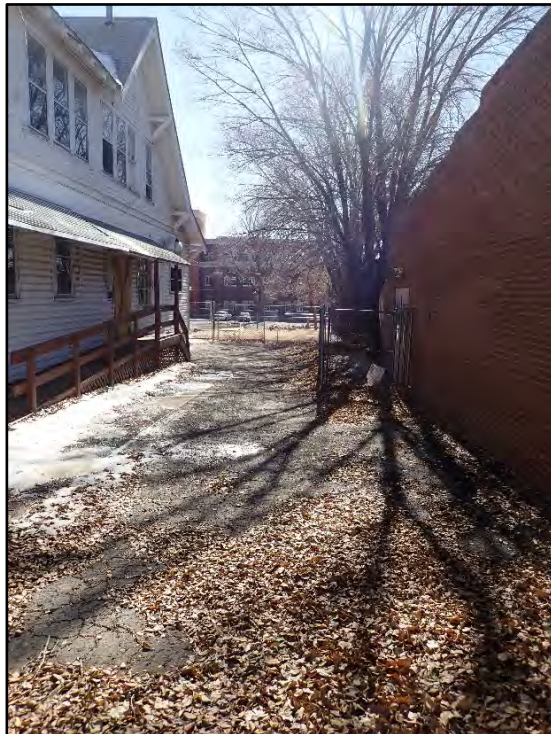
Figure C-54. Overview of the yard between the former Catholic school and the David Babbitt House.
