**APPENDIX D**

**Interior Photographs of the David Babbitt House  
(319 North Beaver Street)**

**Section 3 of 6**

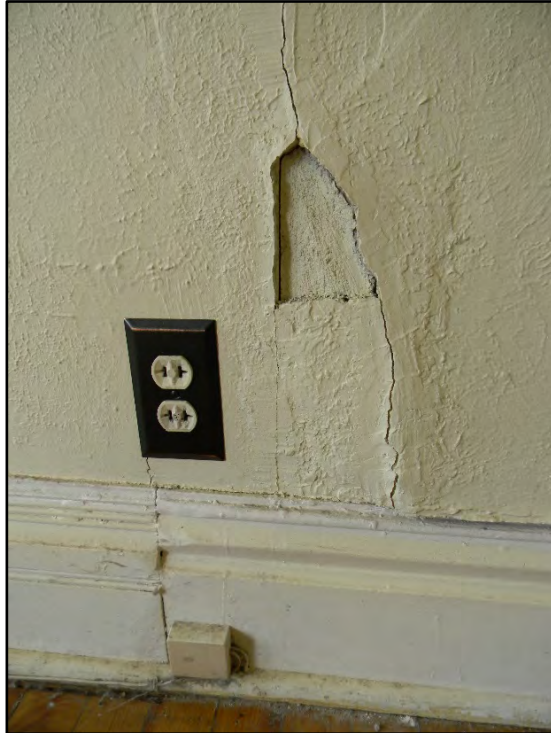
**Figure D-251. Close-up view of the cracked plaster wall finish (which was once an open door to the entrance hall, as indicated by the difference in baseboards).**

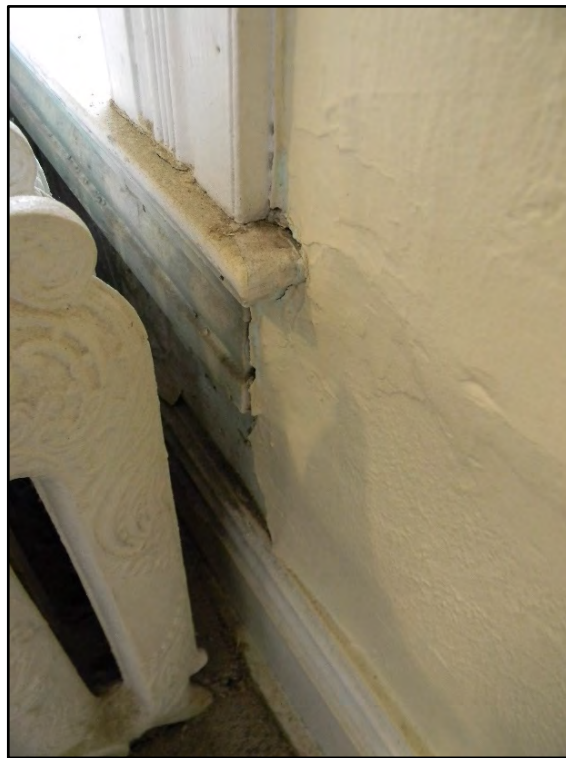
**Figure D-258. Close-up view of the damage around and under the window.**

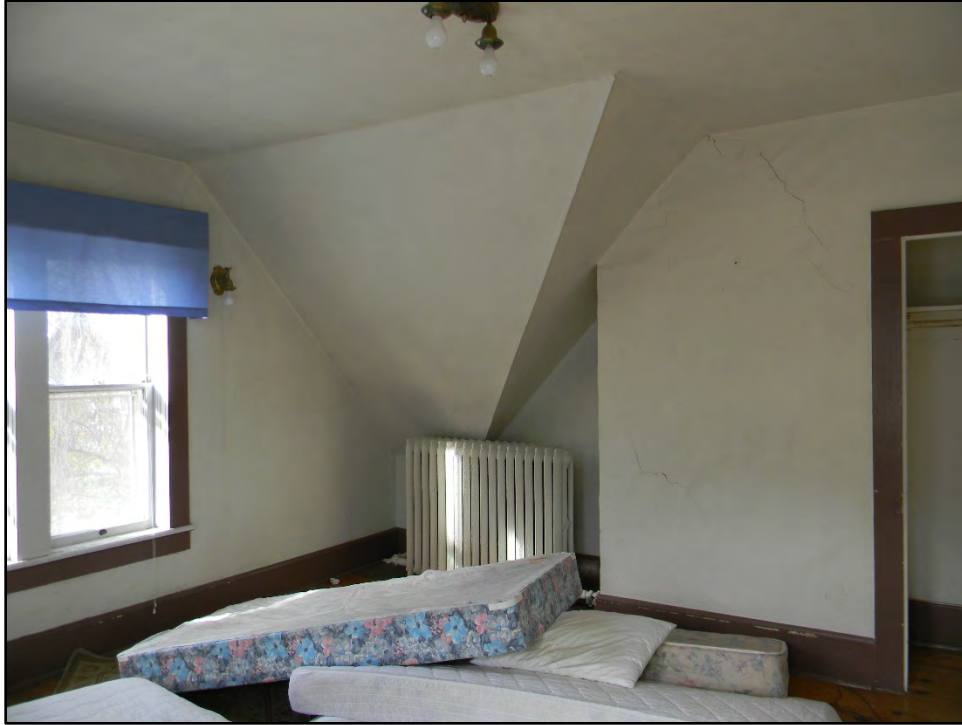
**Figure D-347. The edge of the gable cuts into the room (note the cracked wall at right).**

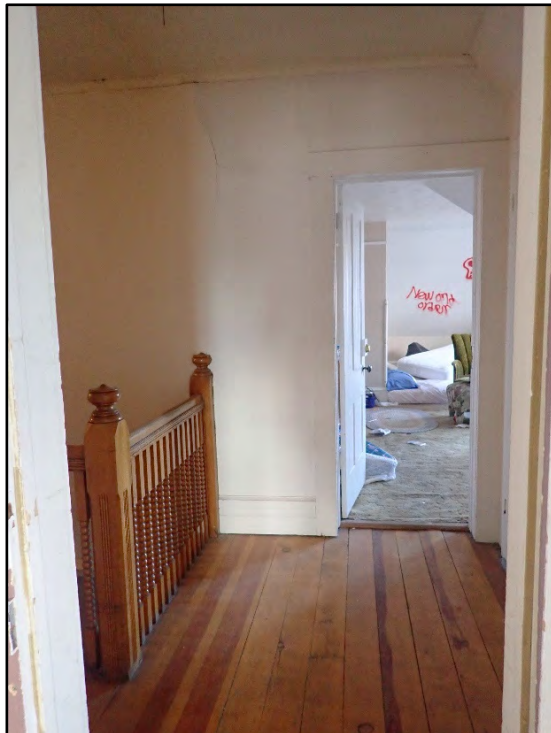
**Figure D-356. View back into the main hallway, with the second bedroom beyond (note the extensive cracking in the walls and ceiling in this part of the hallway).**
