APPENDIX D

**Interior Photographs of the David Babbitt House
(319 North Beaver Street)**

Section 4 of 6

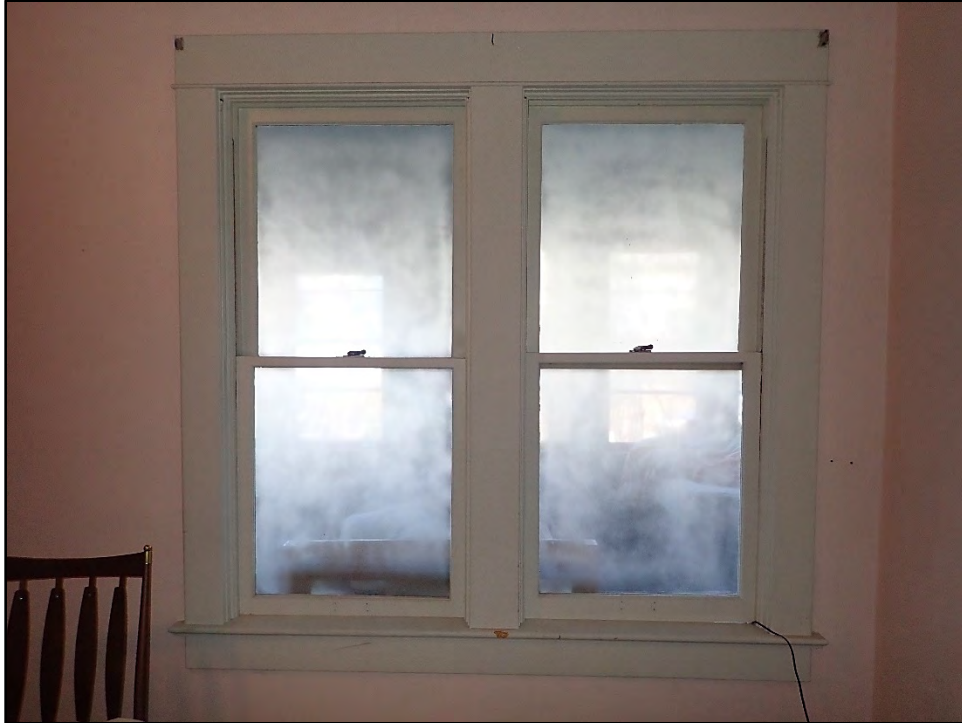
Figure D-421. Detail view of the formerly exterior, wood-frame windows of the interior bedroom, spray painted over to obscure the view.

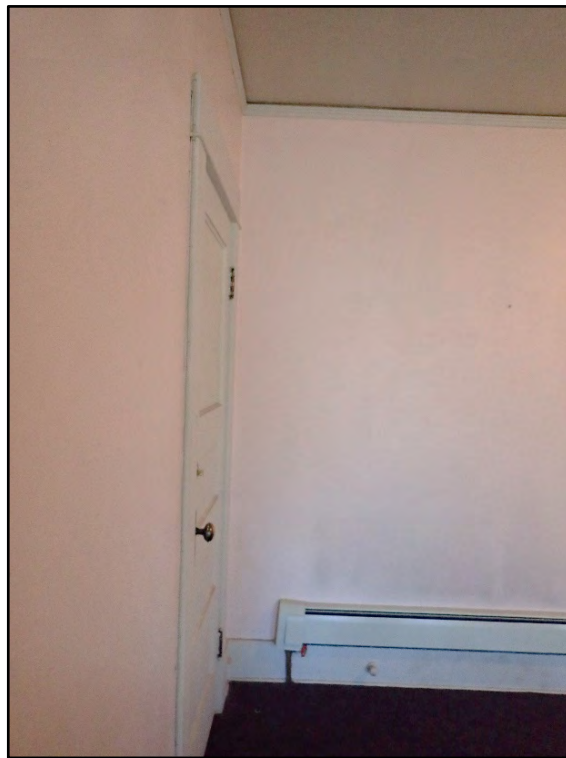
Figure D-424. A look back toward the hall door (note the visible gap between the top of the walls and ceiling, which are separating due to age).

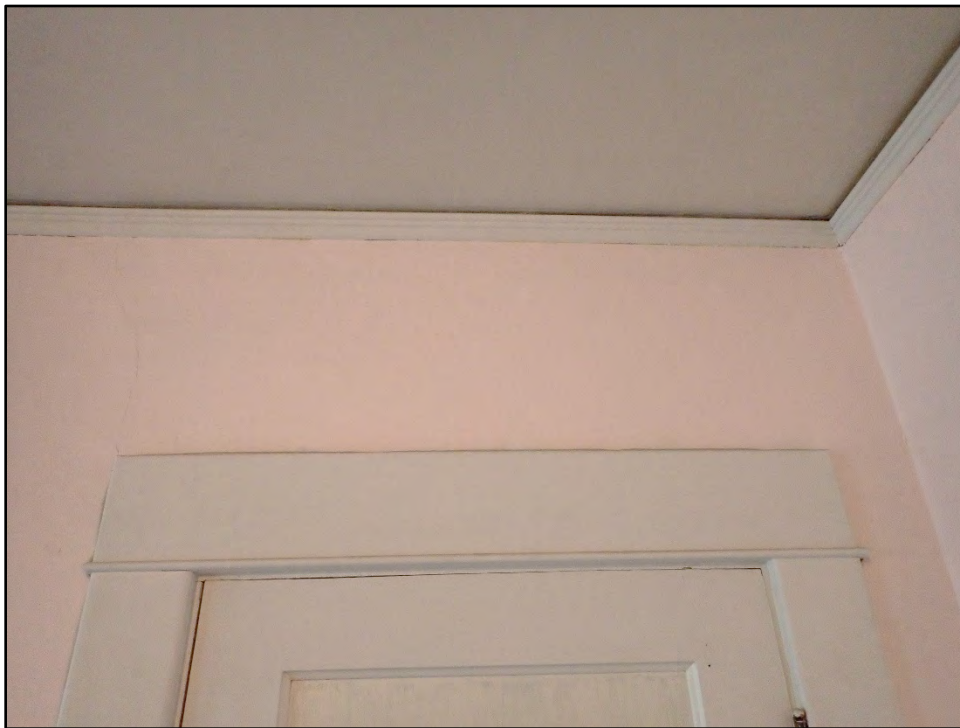
Figure D-438. Detail of the wood door trim as well as the upper molding which is indicating the ceiling may be separating from the walls.

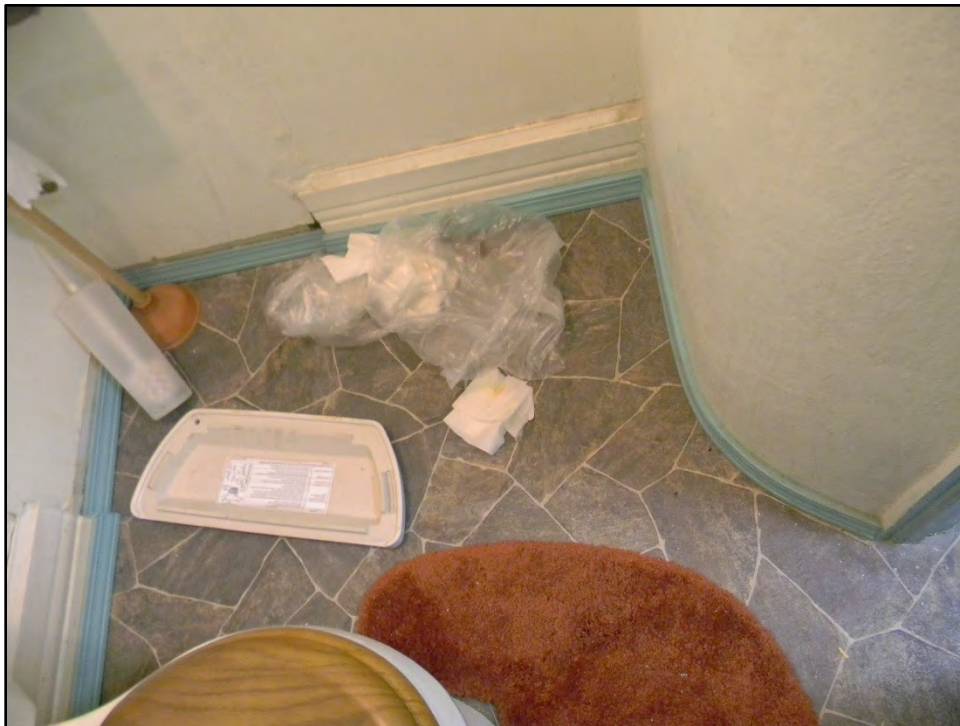
Figure D-518. Detail of the floor of the toilet area, showing the back of the curved wall (note the missing baseboard suggests this was reconfigured or renovated after it was completed).
