**APPENDIX D**

**Interior Photographs of the David Babbitt House  
(319 North Beaver Street)**

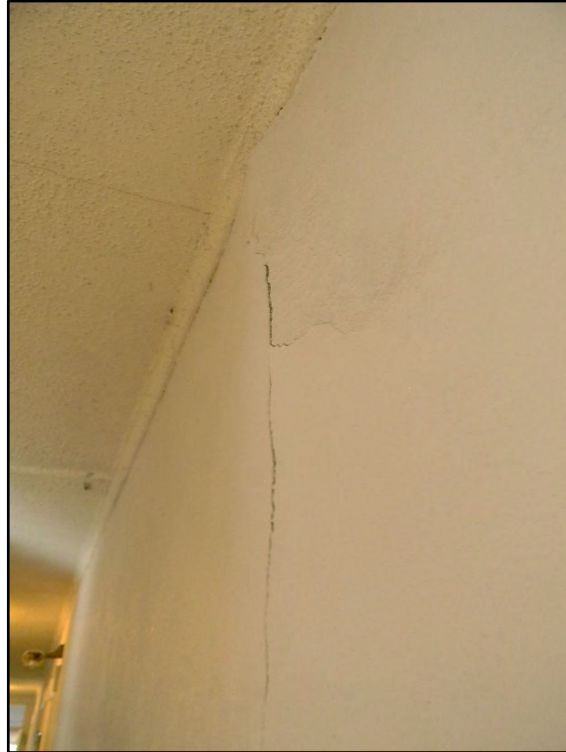
**Figure D-545. Cracks in the lath-and-plaster walls and ceilings on the second floor are visible.**

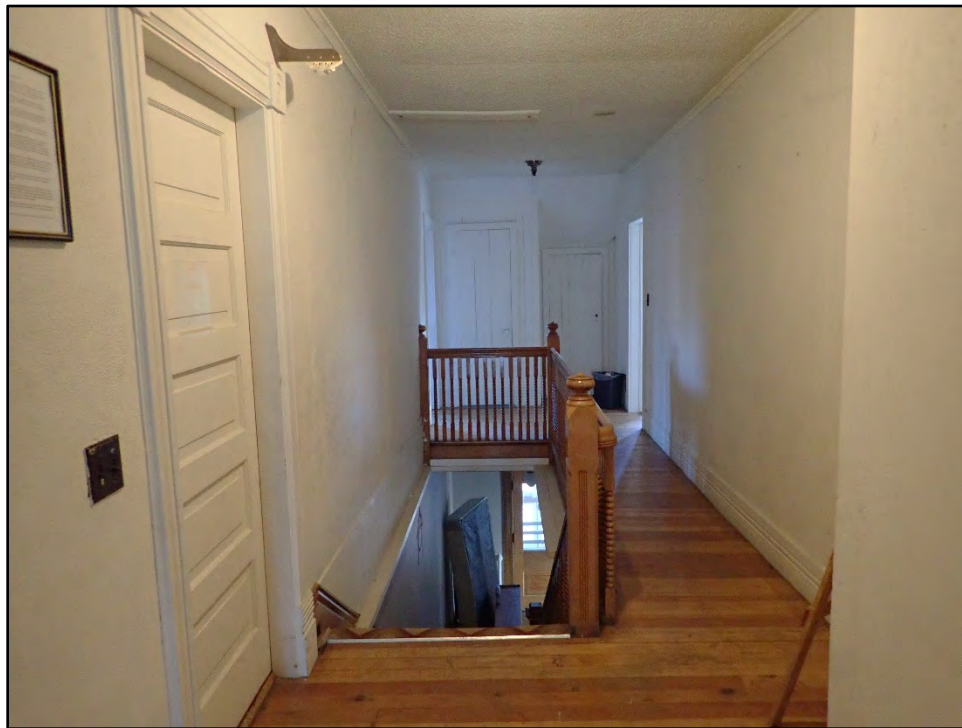
**Figure D-546. Another view of the east end of the second floor main hallway, with the door on the left to the third bedroom.**

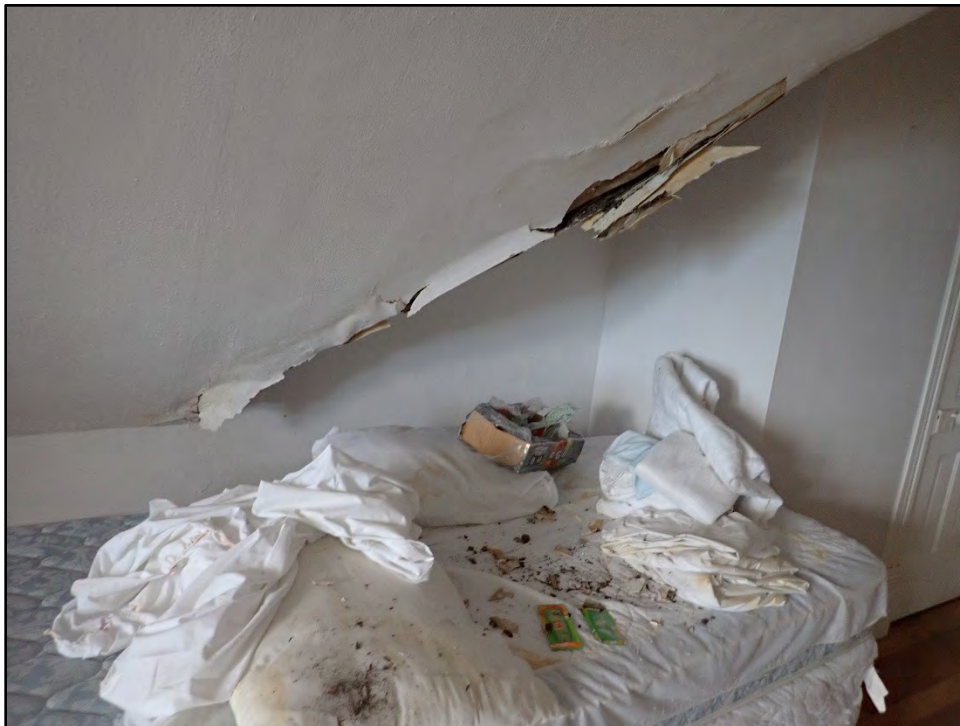
**Figure D-562. Detail view of the deterioration and water damage that is present in the fourth bedroom.**

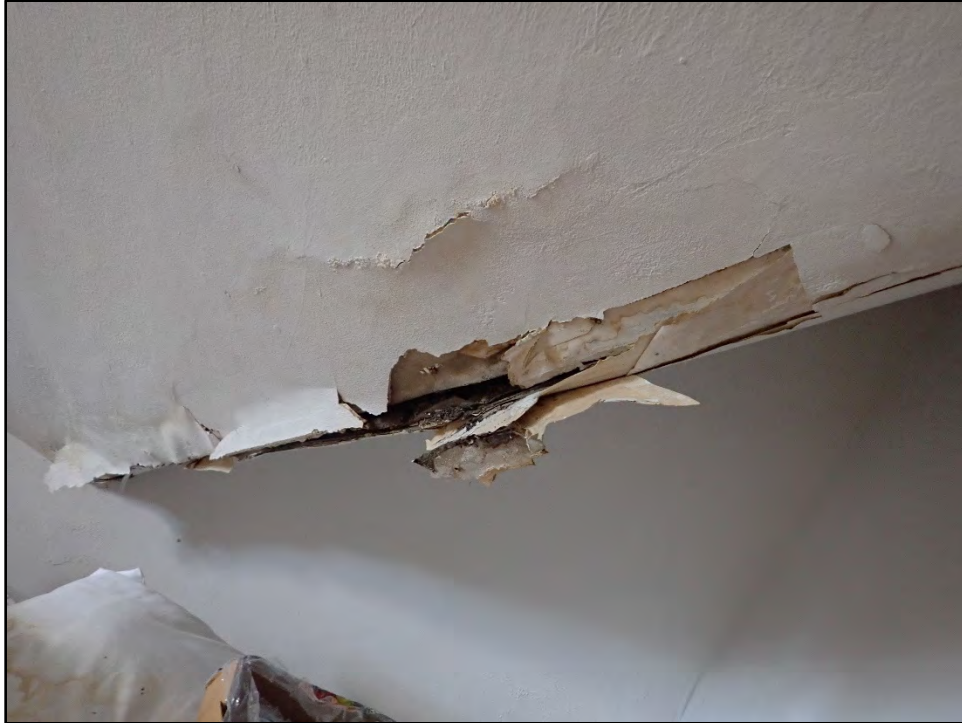
**Figure D-563. A close-up view of the rotting wood and ceiling damage.**

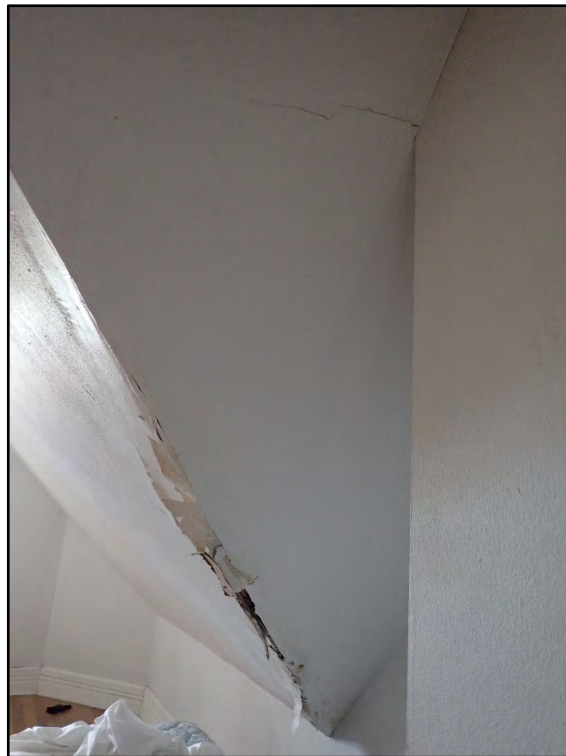
**Figure D-564. Alternative view of the damage to the ceiling as a result of a roof breach.**

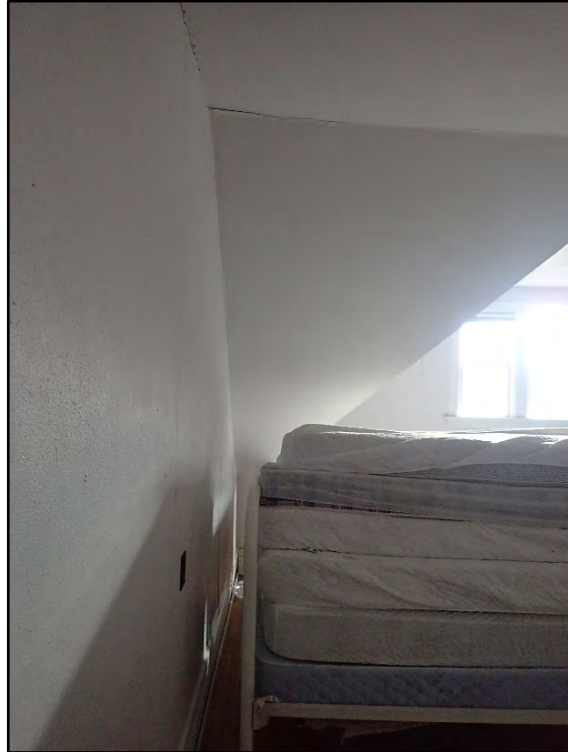
**Figure D-565. View of the angled ceiling and wall on the east side of the bedroom (note the cracking and separation at the ceiling juncture).**

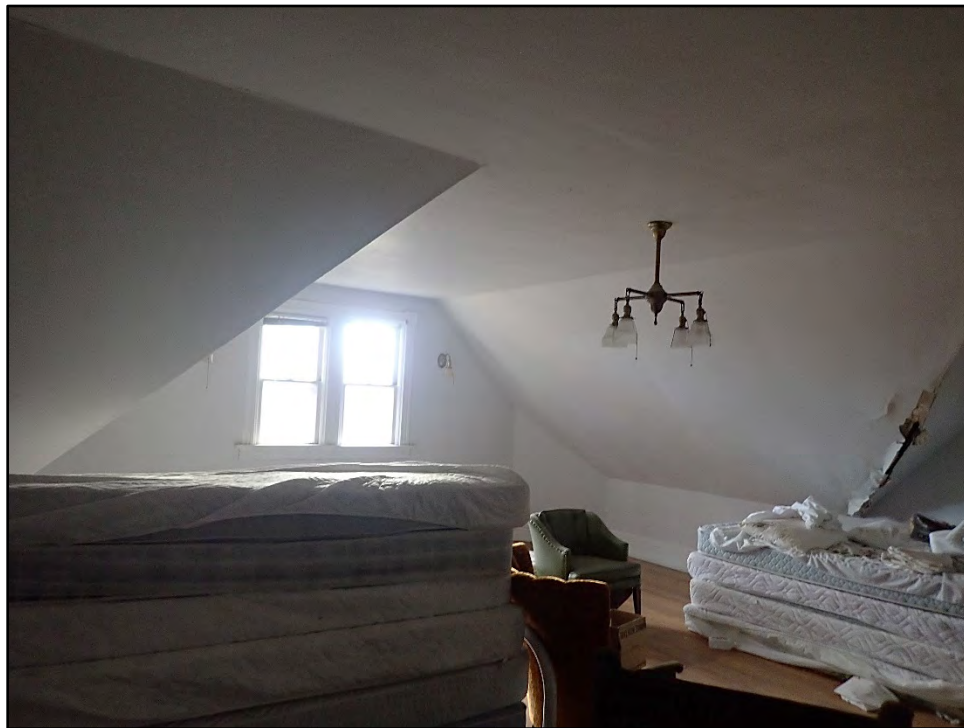
**Figure D-566. Alternate overview of the interior of the room.**

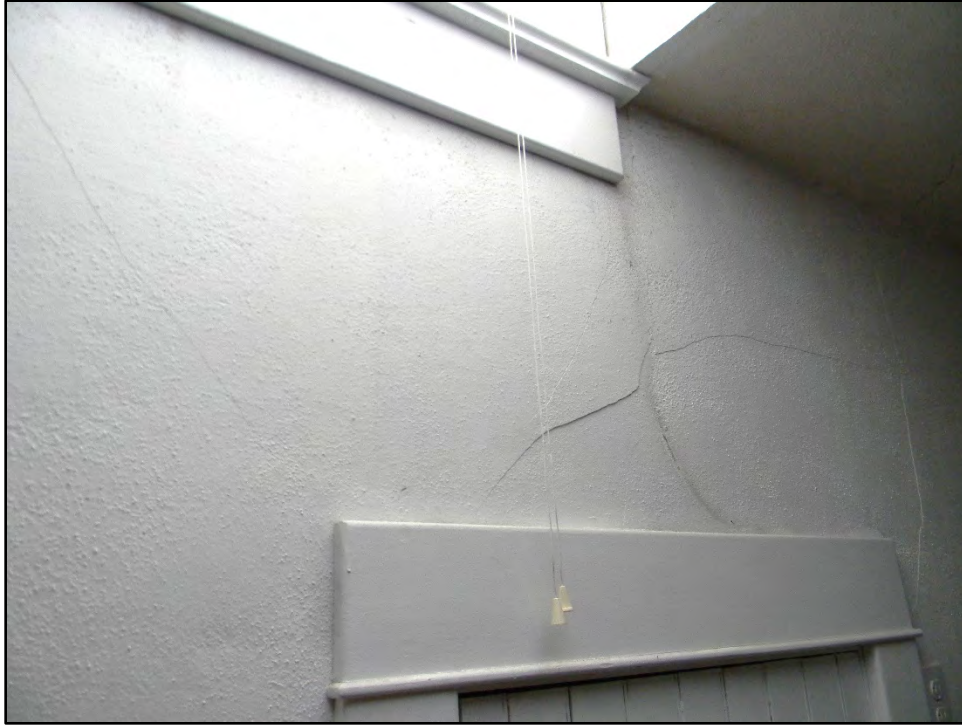
**Figure D-581. The sill and apron of the window and the cap trim of the door frame the cracking of the original lath-and-plaster walls.**

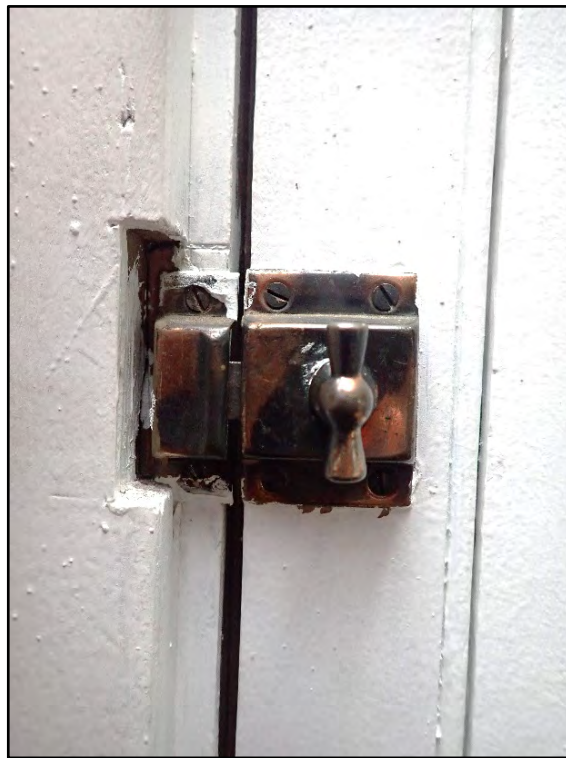
**Figure D-582. Close-up view of the latch on the batten door, which is the same as that on the window in the laundry room.**

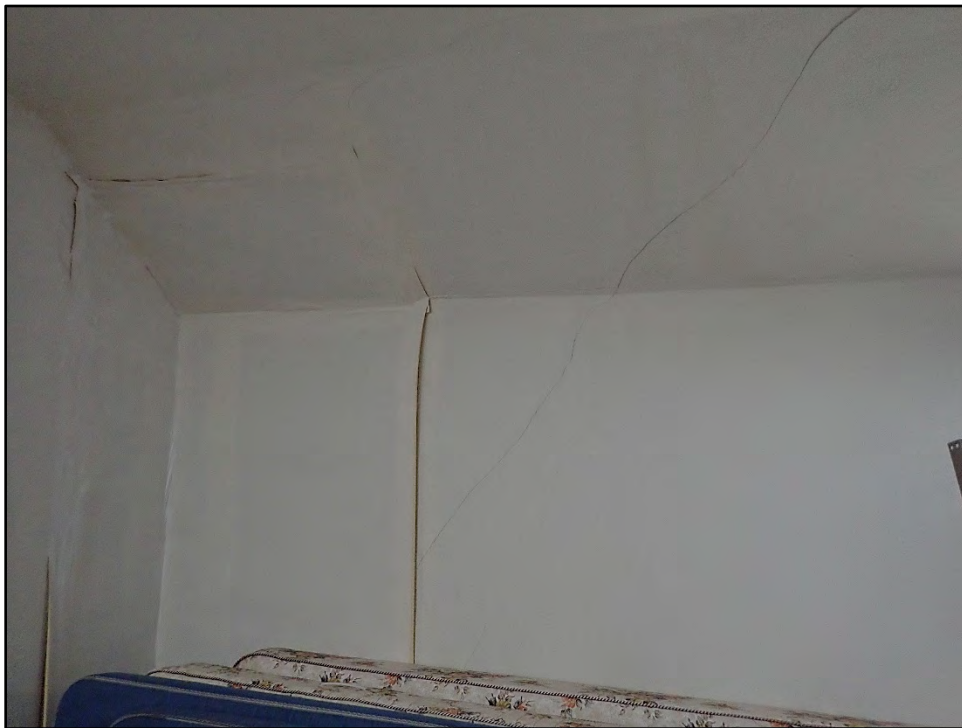
**Figure D-606. Cracks and peeled paper affixed to the wall show past repairs and the current condition of this section of the third floor at the northwest corner of the room.**

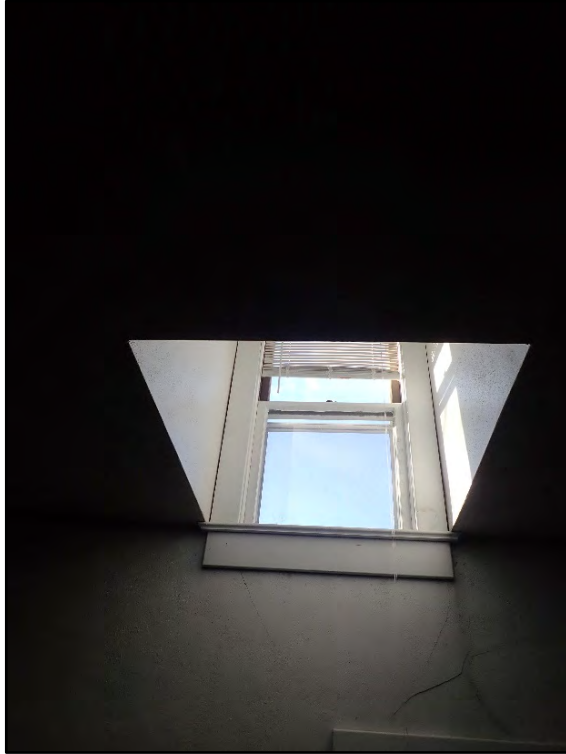
**Figure D-607. The outline of the ceiling of the third floor below the upper gable window.**

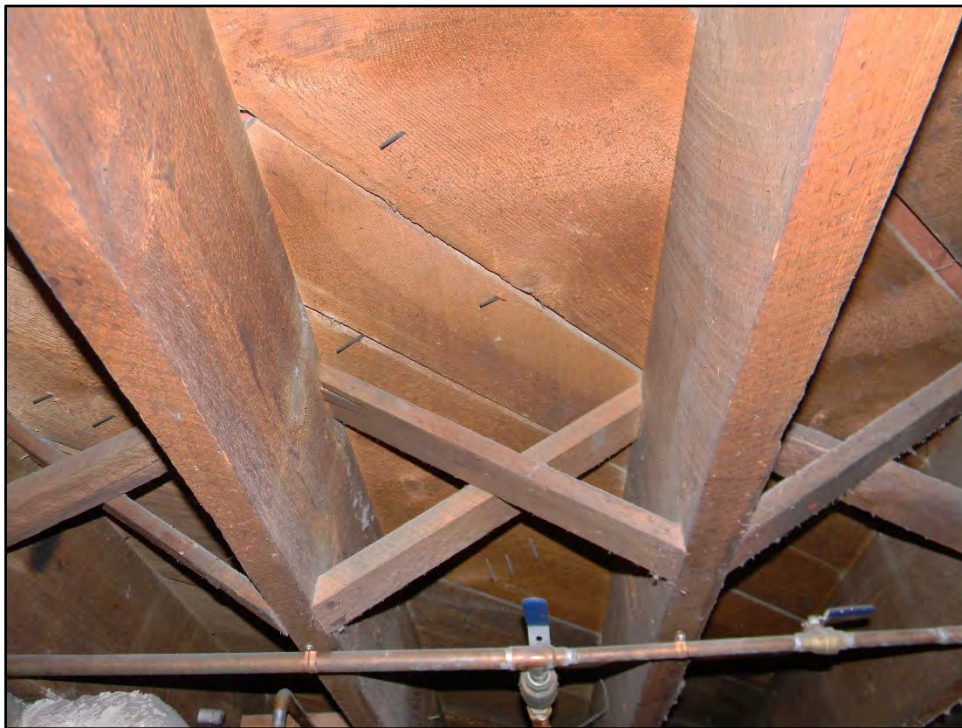
**Figure D-626. Flooring joists with crisscrossing diaphragms are visible under the formal living room, which is likely original to its construction (completed by 1901).**

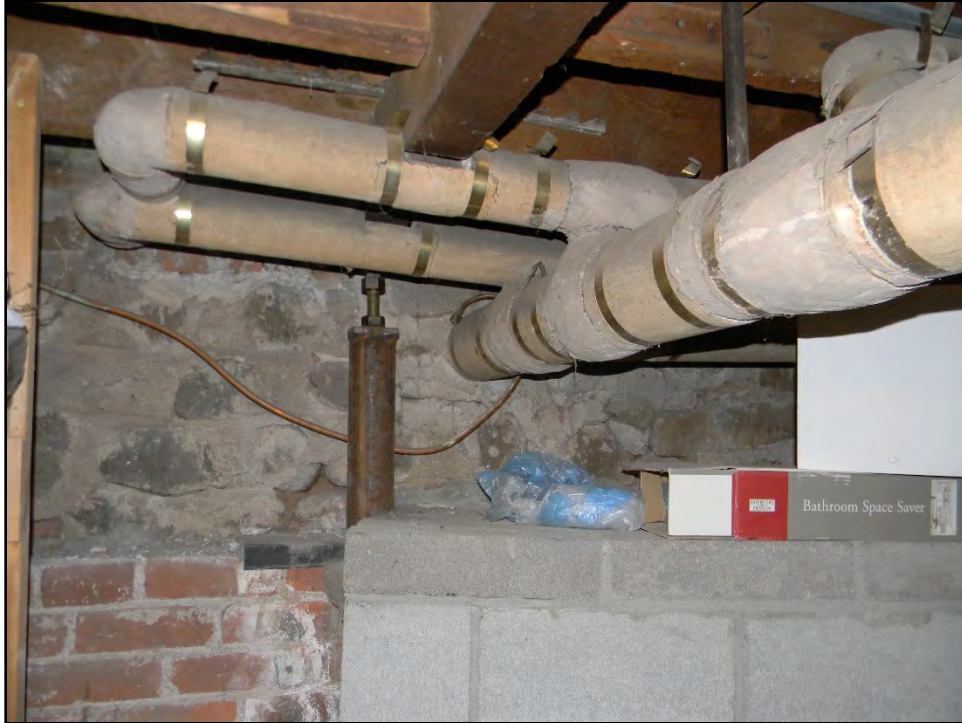
**Figure D-627. The patchwork of materials is also illustrated here with the historic-era wood, rubble-and-mortar, and brickwork, with the modern concrete block retaining wall (note the shoring jack at the back).**
