Façade Grant, Completion Report – 112 E Elm Ave

112 E. ELM ST.

122 E ELM St Façade Grant Rehabilitation

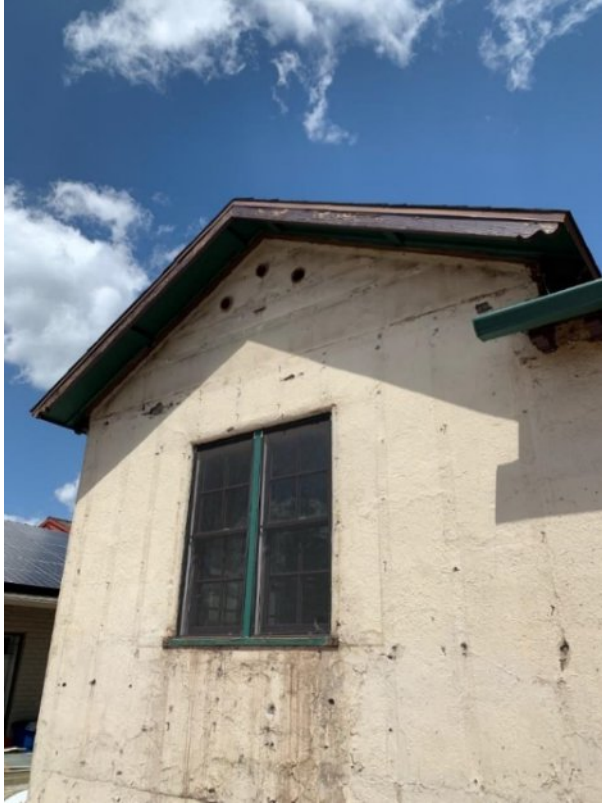
Stripped added stucco layer

Green Mountain Construction: We are currently working on a remodel at 112 E Elm Ave, please see the attached permitted plans. The project had also been approved by the HPC last year. I have corresponded with you previously in regard to this project. After removing the aluminum siding, we discovered that the original stucco actually goes all the way to the roof line and there are 3 clay tube details acting as gable vents. After revealing the original historic clay pipes, we are interested in trying to restore the historical style of the house (Spanish Colonial Revival?) . The homeowner is still on the fence about the change, so we wanted to get your input before making a final decision.

Therefore, we were wondering if it would be possible to get approval to do stucco all the way up to the roof line and maintain the clay pipes. We would no longer be doing the original gable detail that was shown on the plans. We would still do the rounded stucco wraps on the windows and the stone on the stemwall. Is this something you think you could approve without going back to the HPC? Please see the attached photo of the house after we removed the siding. Let us know what you think.

HPO Reavis: This is absolutely what you should do when you discover something that is historically accurate with the Spanish Colonial style. It was a very good assumption of what the gable looked like but with the siding removed and the reality uncovered this is what is required to maintain the grant. It is a historic preservation Façade restoration project and the original history should be maintained. Now looking at it uncovered makes more sense. The HPC did have some questions regarding the gable shingles. At this point I am also not sure about the eve support brackets that are more bungalow craftsman. What are your thoughts about them?

The stucco on the gable end is now a requirement in maintaining the grant.

To All; So clues were being taken from the adjacent houses to the east and looking at some craftsmen detailing such as the eve support brackets (Wood Corbels). Now looking at the lower-slope roof and the now uncovered Spanish details the installation of eave support brackets (plan set call them out as Wood Corbels) should not be installed – so that the style shifts to the now apparent Spanish Colonial Style.
