Re: 23 E Fine Avenue / Cultural Resource Study & Proposed Project Narrative

1. REPAIR SCOPE AREA #1 - SOUTH FOUNDATION WALL

2. REPAIR SCOPE AREA #2 - LEVEL 1 BAY WINDOW PROJECTION

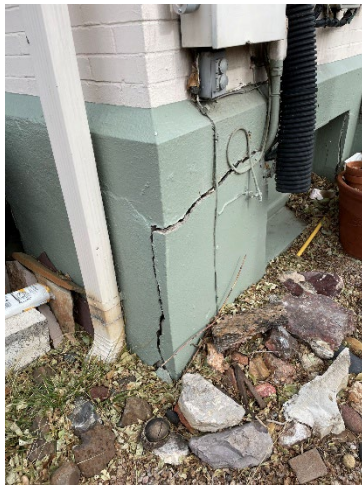
Photograph 1 – Foundation

- Based on visually observed damage patterns by the Architect and Structural Engineer, it is suspected that the 1-story bay projection's foundation footing and/or foundation stem wall was not constructed to the same depth as the 2-story portion of the existing structure or was constructed using an inadequate concrete mix, as the building's primary 2-story volume does not display visually observable signs of deterioration/damage.

- **Cast Concrete Foundation / Stem Wall**
 - Existing stem wall & footing has observable damage and will require removal. (See Photographs 1 & 2 below)
 - **The proposed re-construction would utilize contemporary steel reinforced concrete mixtures to replace the failing foundation stem wall with a new structurally adequate concrete stem wall. New construction is to match the existing profile and visual dimension(s) of the existing/damaged wall. (Concrete performance specification & and reinforcement design per Sirius Structures). Finish of the new concrete stem wall is proposed to match existing portions of the existing / adjacent foundation wall to remain, with the new stem wall painted to match existing.**

- Due to the advanced deterioration at this area and suspected inadequate foundation, demolition of the failing portion of the structure and subsequent in-kind re-construction of this area is proposed. Modifications as proposed would be classified as *repairs* or *alterations* as outlined by the *2018 International Existing Building Code*. No changes to building occupancy classifications or occupancy loads are proposed.

- New Reinforced Concrete Footing - minimum depth extends to 30" Frost Line or to depth as specified by Structure to ensure future stability.
 - New Reinforced Concrete Stem Wall - exterior detailing/forms to match existing exterior foundation stem wall to remain. Details include chamfered corner at transition to brick veneer wall above, interior notched bearing point for adjacent floor framing bearing, etc.

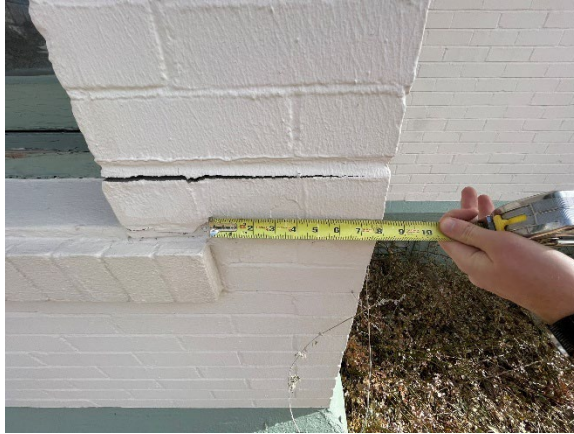
Photograph 3 – Typical Existing Brick Masonry

- **Brick Masonry – General Materials**
 - Existing exterior brick masonry utilizes non-modular full-sized bricks at the ground floor exterior walls in a 50/50 typical "running bond" pattern utilizing typical 3/8" mortar joints. These non-modular "Standard" sized masonry units (measuring 3-5/8" [D] x 2-1/4" [H] x 8" [L]), not typically utilized in contemporary masonry construction, can be difficult to source, with limited options readily available from material suppliers. The existing brick throughout the building's exterior has been previously painted and existing masonry finish appears generally consistent with contemporary "facing brick" - i.e., bricks intended for exposed installation where appearance is important. (See Photographs 3 & 4).

- The proposed re-construction would utilize more common contemporary "Modular" sized facing brick masonry units (Measuring 3-5/8" [D] x 2-1/4" [H] x 7-5/8" [L]) in 50/50 running bond, with standard 3/8" mortar joints, to allow for more readily available material sourcing. These contemporary brick dimensions will align with existing vertical coursing with only minimal (~3/8") variation in length when compared to the existing masonry. Length variation differences between the existing "Standard" and the new "Modular" units are expected to be visually indiscernible after new construction is painted to match existing portions to remain.

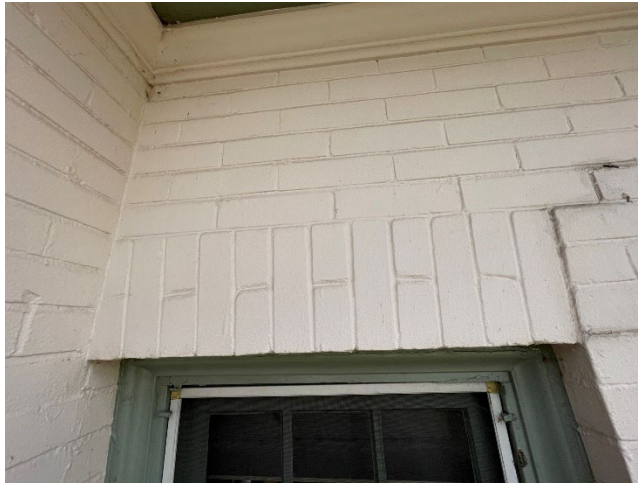
Photograph 5 - Existing "Flat Arch" Brick Masonry

- **Brick Masonry – Headers & Lintels**
 - Existing window openings at the historic residence utilize a "masonry flat arch" (also known as a "jack arch") structural technique for supporting brick cladding located above exterior window openings (see Photograph 5). This historic, self-supporting detail, utilizing gradual a gradually increasing installation angle of vertically oriented bricks, does not reflect present day masonry construction conventions, nor is it compatible with present Building Code requirements.

- **The proposed re-construction would utilize contemporary steel angles as lintels/headers to carry the weight of the proposed brick masonry veneer over window openings. All steel lintels are to be painted to match adjacent brick construction. To maintain visual consistency with adjacent brick masonry openings, non-structural brickwork at new openings is proposed to be installed in vertical "Soldier Course" orientation to remain visually consistent with adjacent masonry flat arch. Similarly to the modular brick sizing, this minor variation is expected to be visually indiscernible after new construction is painted to match existing portions to remain. (See Figures 1 & 2 on following sheet).**

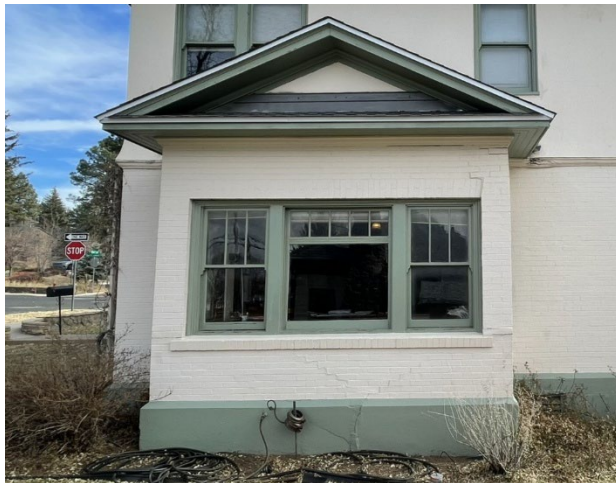
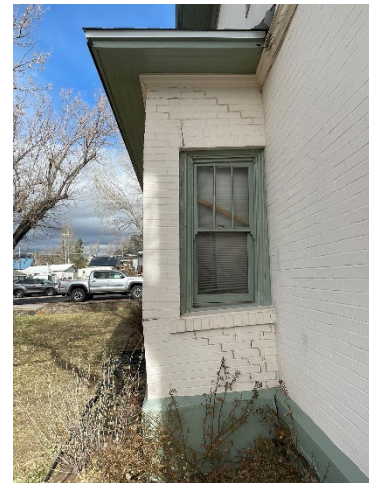
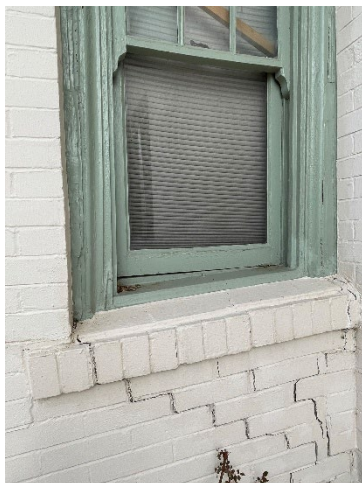
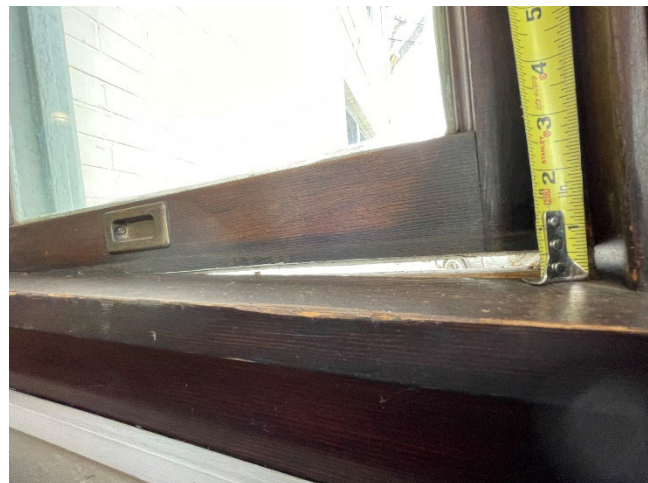
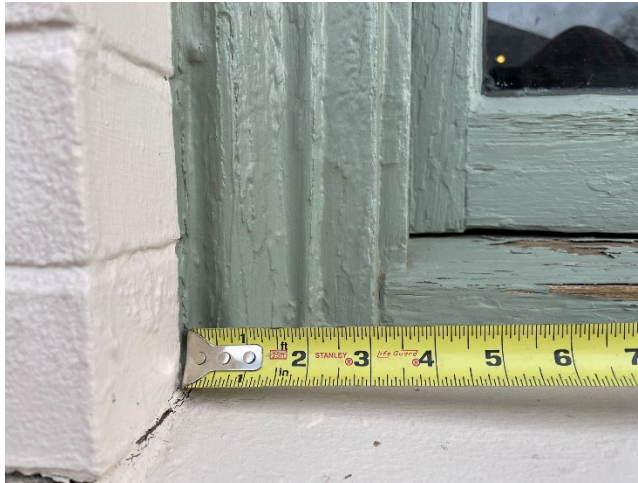
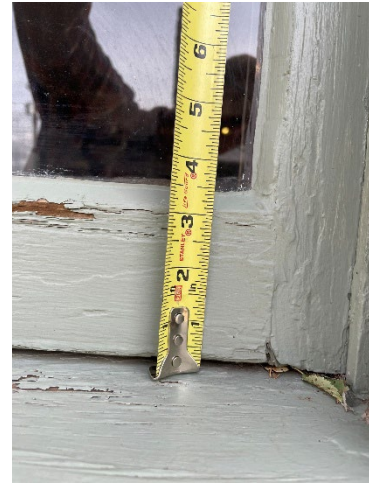
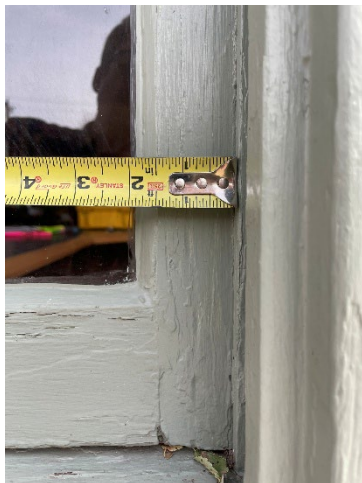
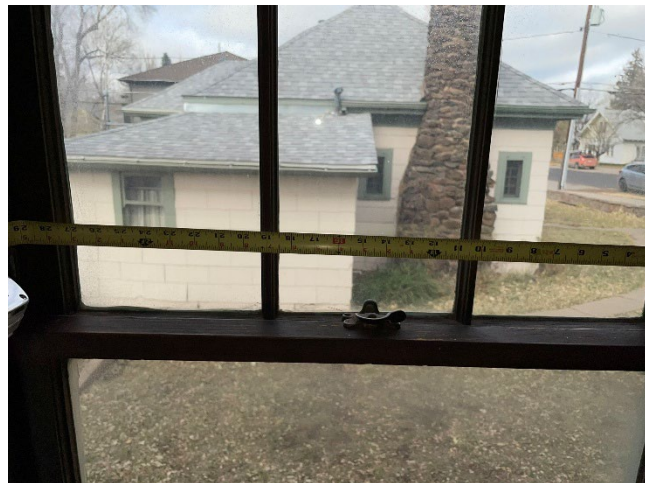
- Window frames at the north & south facades have racked substantially due to the building's differential settlement and are no longer plumb. Sashes in these locations are not operational and do not fully close, with open triangular air gaps at joint between lower sash and wood sill.

- The multi-unit western-facing window remains comparatively less skewed and without noticeable air gaps. However, this window is not vertically plumb due to foundation settlement and minor bucking of the surrounding exterior brick veneer. (See Photographs Below)

- The reconstruction proposes use of new historic reproduction wood windows to match the existing windows as closely as possible. Traditional Wood windows (wood at interior and exterior) are proposed (in lieu of more contemporary pre-finished aluminum-clad wood windows) to allow for exterior paint-matching to ensure new windows visually blend with the existing historic windows at adjacent portions of the property.
- Specific requirements of replacement windows are requested to be discussed with the HPO to aid in selection of an appropriate replacement product. Unless problematic with Heritage Preservation requirements, it is assumed that the historic replacement windows will conform to all applicable 2018 Building & Energy Code requirements and incorporate modern assemblies to the extent appropriate (insulated glazing to achieve Energy Code U-Factor criteria, etc.).
