March 7, 2025

Re: Structural Visual Review of EnviroSystems Building at 23 E Fine Dr in Flagstaff, AZ

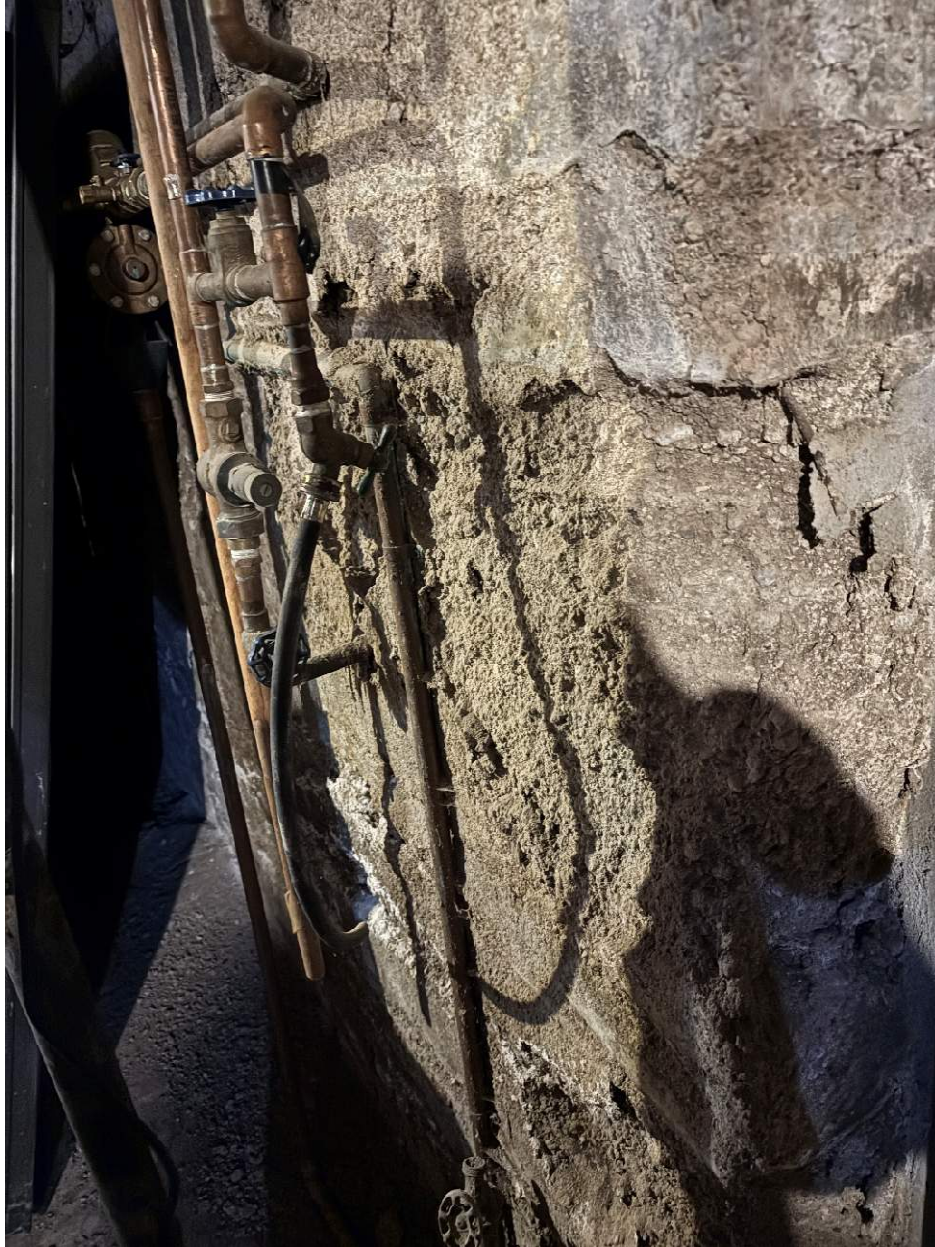
We observed signs of deterioration at the south basement retaining wall, see Figure 1 and 2. We observed a crack in the south basement wall in the area that appears to have been previously infilled. This crack, which appears to be a flexural crack due to overloading, as is shown in Figure 3. The exterior basement entrance walls have significant signs of deterioration, as shown in Figure 4. The basement entrance does not appear to be properly waterproofed and daylight is visible through the hatch.

Figure 1 - South Basement Wall Deterioration

The majority of structural deterioration and signs of distress observed are located on the south basement wall. It appears that at one point in time there was an addition and likely basement to the south of the southern basement wall. It appears that a door to the previous basement was infilled, and soil was added where it seems the previous basement likely was. It is possible that the concrete wall previously was not retaining any soil and when the suspected basement to the south of the existing southern basement wall was removed and replaced with soil, the loads on the current south basement wall increased significantly due to the added soil pressure, which may be a potential cause of structural distress we observed from the interior of the basement. A couple of other potential causes of the deterioration in the south wall, specifically at the south eastern corner (Figure 2), could be a poor concrete mix in that specific location and/or water intrusion. We recommend the entire south basement wall be reinforced and/or replaced and recommend waterproofing be installed on the exterior of the walls in order to prevent further deterioration of the existing walls. In order to minimize disruptions to the existing building, one potential option to reinforce the existing south basement wall could be to add a new concrete wall on the exterior of the building adjacent to the existing. The new wall would be connected to the existing wall and would be designed as a retaining wall to resist the soil pressures.

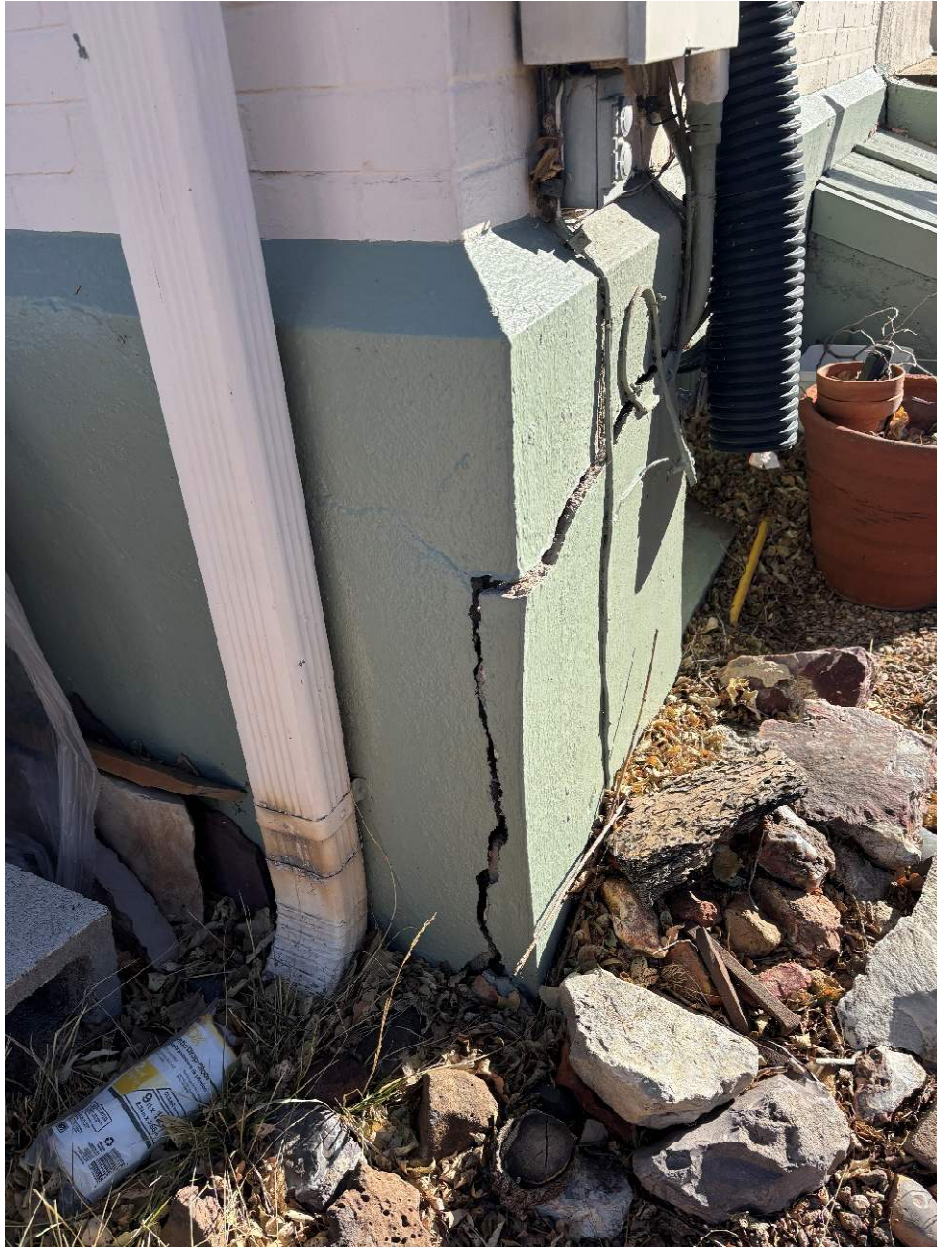
Figure 2 -Basement Wall at South East Corner

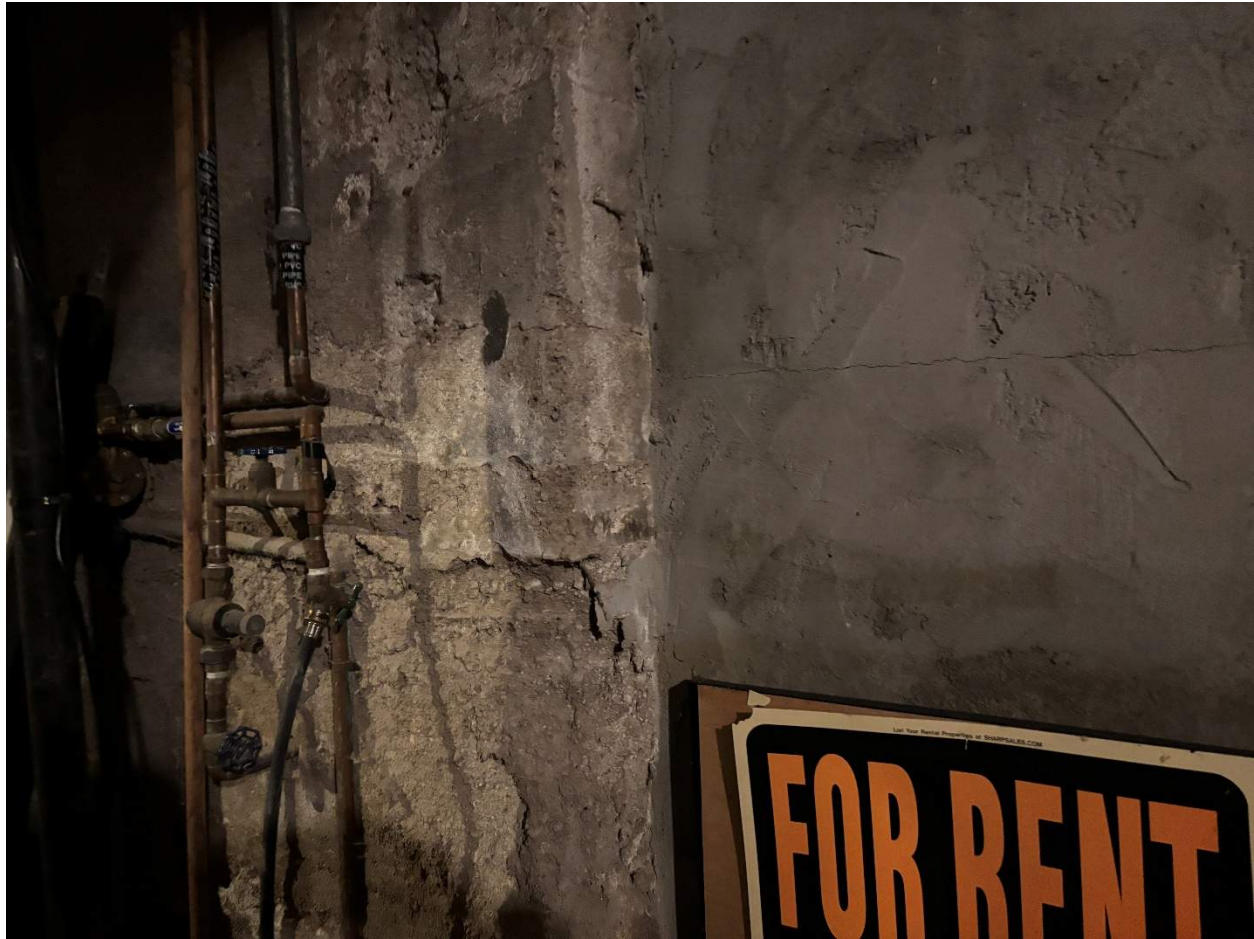
Figure 3 –Crack in South Basement Wall Infill

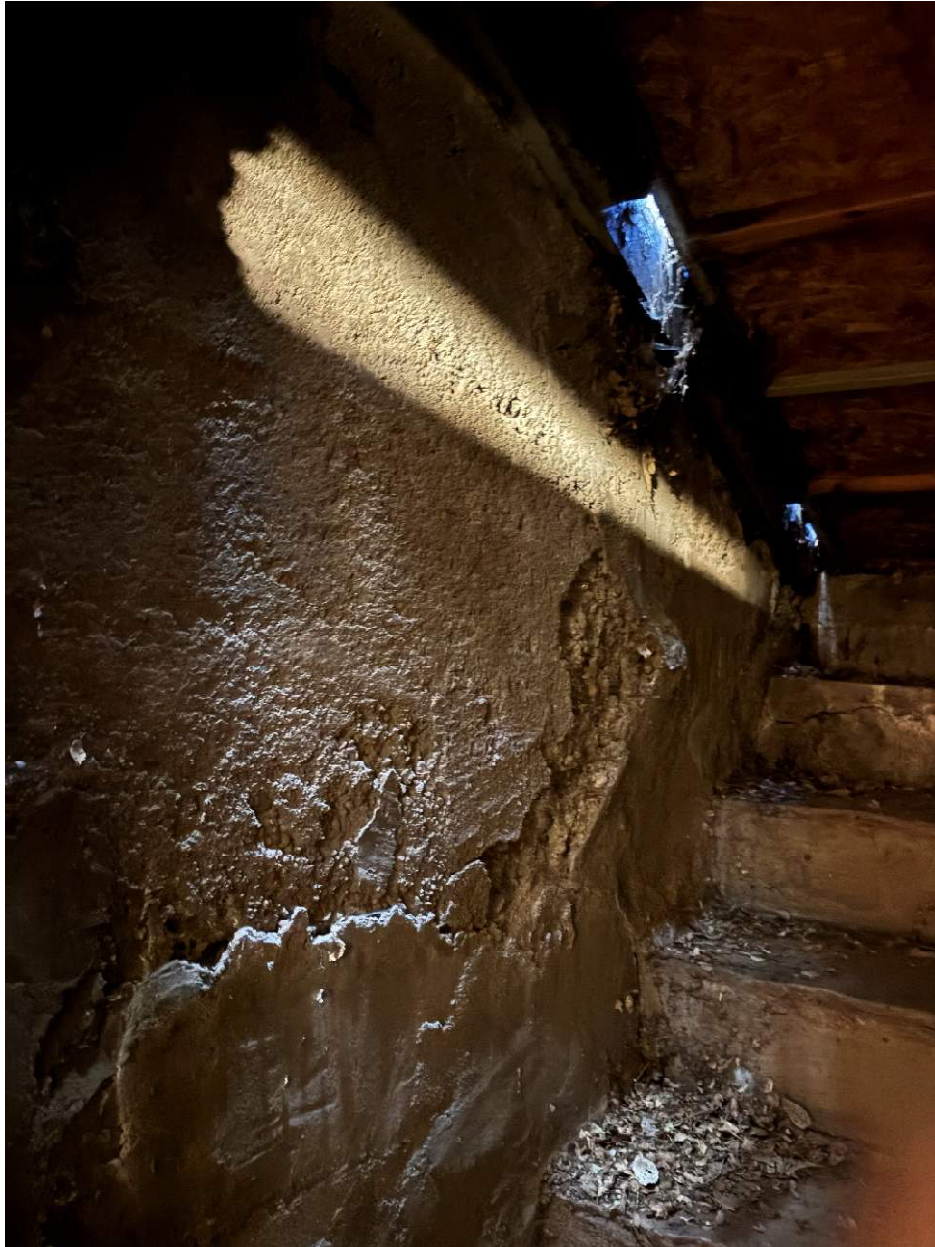
Significant signs of deterioration were observed at the basement entrance walls and we recommend they be replaced. The deterioration may be caused by an improper concrete mix and/or inadequate waterproofing in the area. If this is not addressed, the walls will likely continue to degrade and will eventually fail.

Figure 4 -Basement Entrance

It appears that the existing basement entrance walls are likely bracing the south basement wall, therefore, we would recommend the entrance walls be replaced after the main south basement wall has been replaced in order to prevent additional distress or failure if the basement entrance walls were removed prior to reinforcing/replacing the south basement wall.

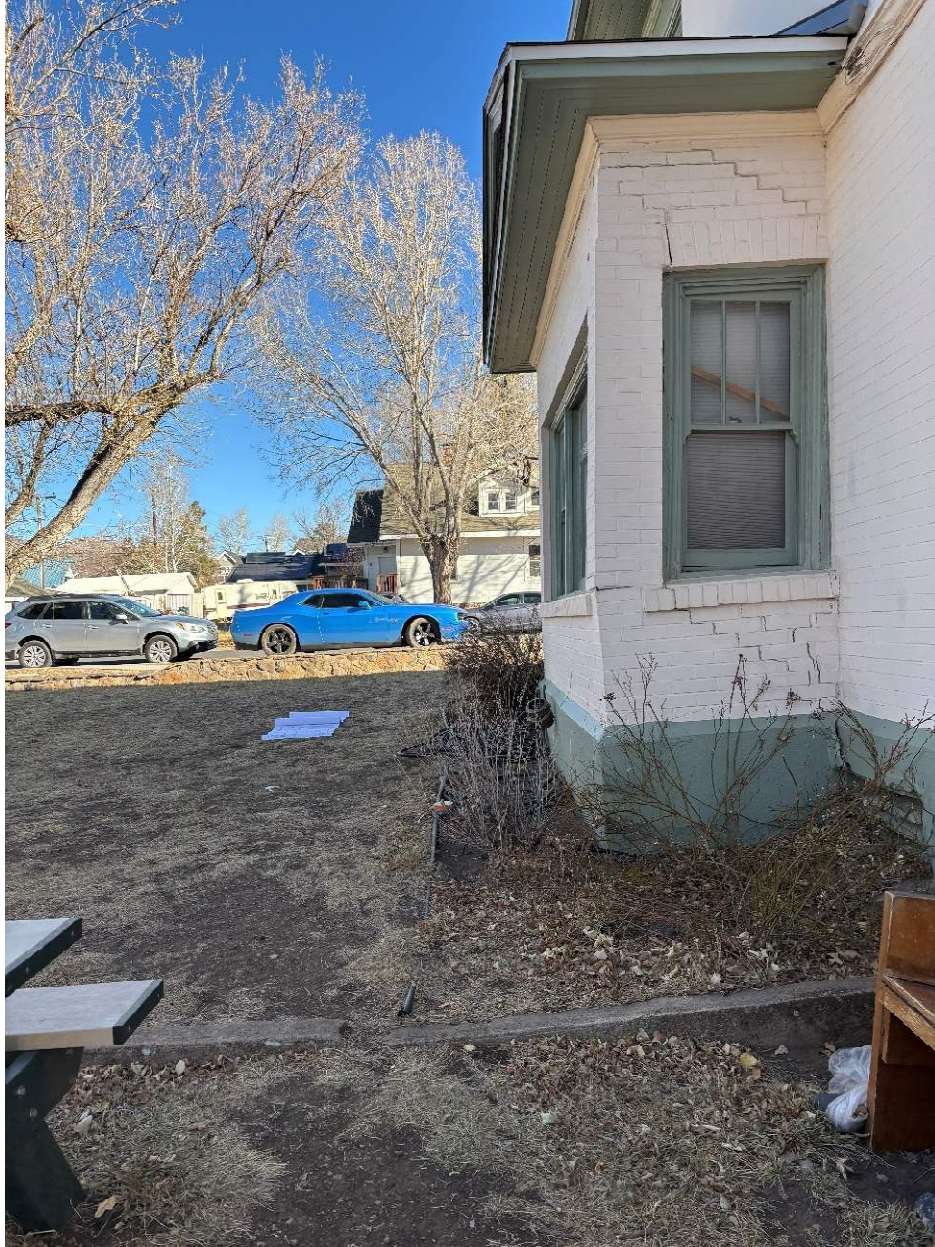
The wall framing in the "bump out" area has a visible bow, as shown in Figure 5. Significant cracks in the stem wall between the basement wall and the bump out were observed, as shown in Figure 6. Additionally, potential signs of water intrusion and voids in the soil were observed, as shown in Figure 7. At the corner of the bump out, it appears the corner of the stem wall has fallen off (with a visible patch that appears to have been applied at the SW corner), as shown in Figure 8.

Figure 5 - Bump Out

We recommend a new stem wall and footing be added, supported on properly compacted soils at the bump out area, with the new stem wall to be waterproofed from the exterior in order to help prevent further water intrusion. Additionally, we recommend piers integral with the stem wall be added these locations in order to adequately support the floor beams and framing from above. The bowing of the wall framing in the "bump out" area is indicative of a structural issue, which may be caused due to the foundation settlement/movement, we would recommend the framed walls in this area be replaced.

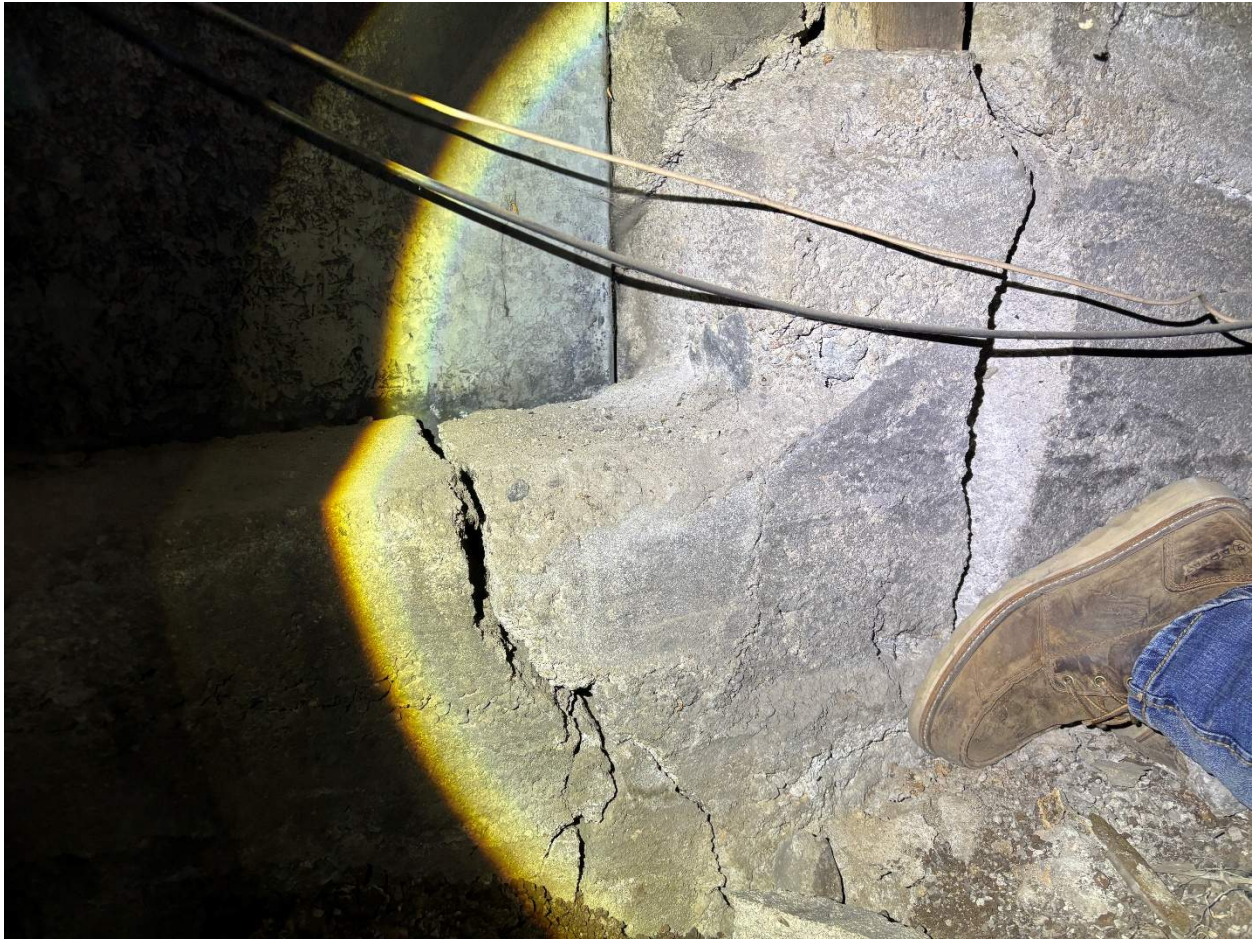
Figure 6 – Stem Wall Cracking

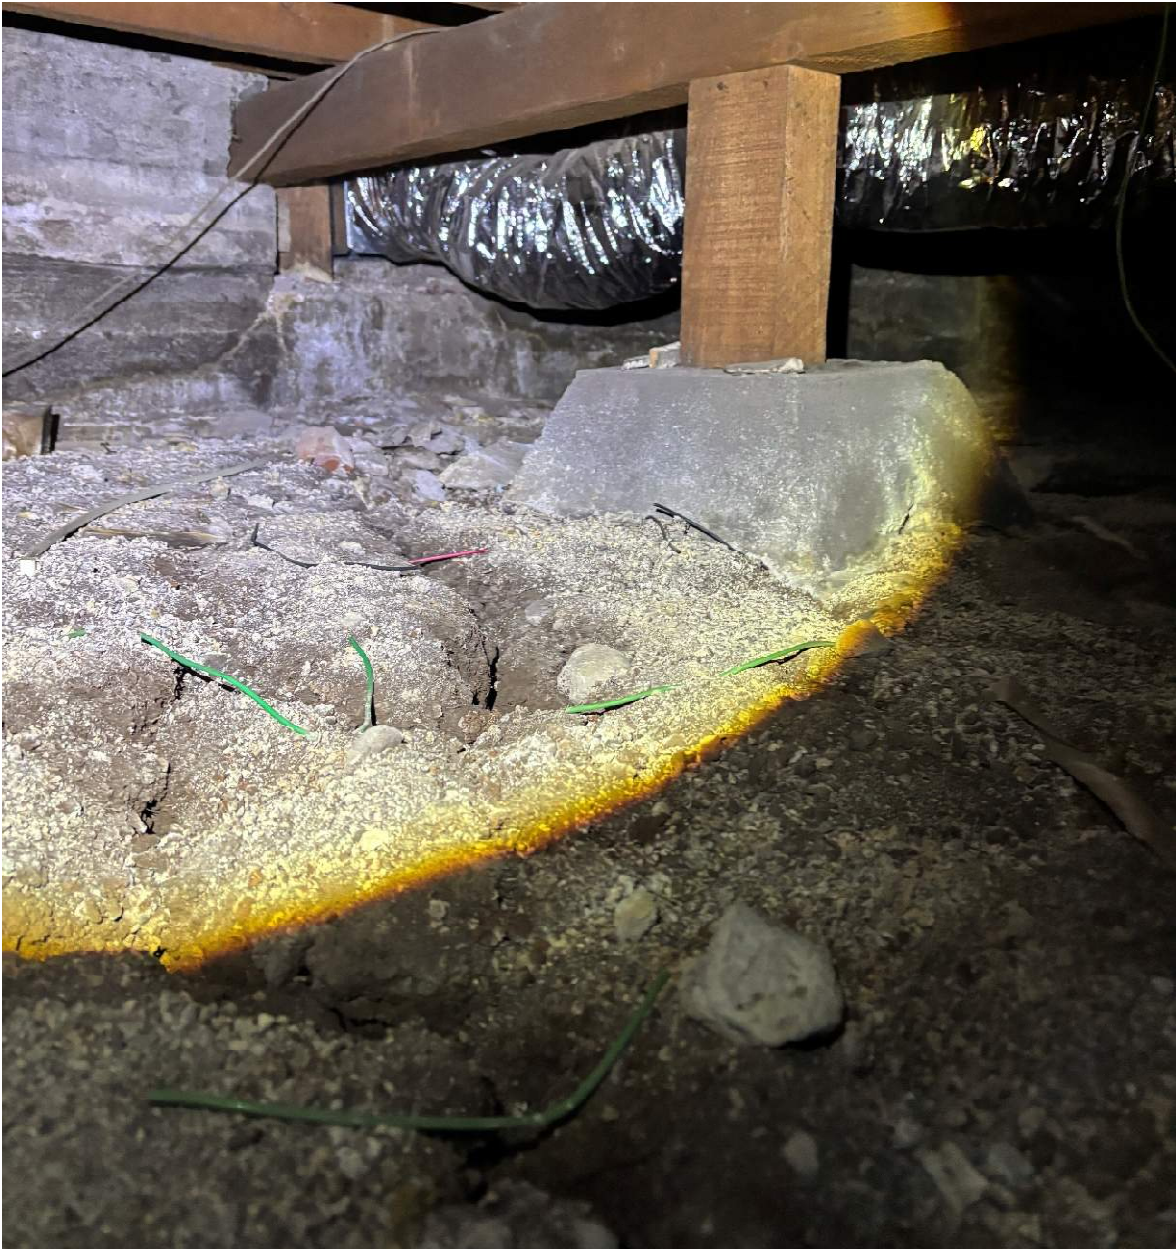
Figure 7 – Soil in Crawl Space

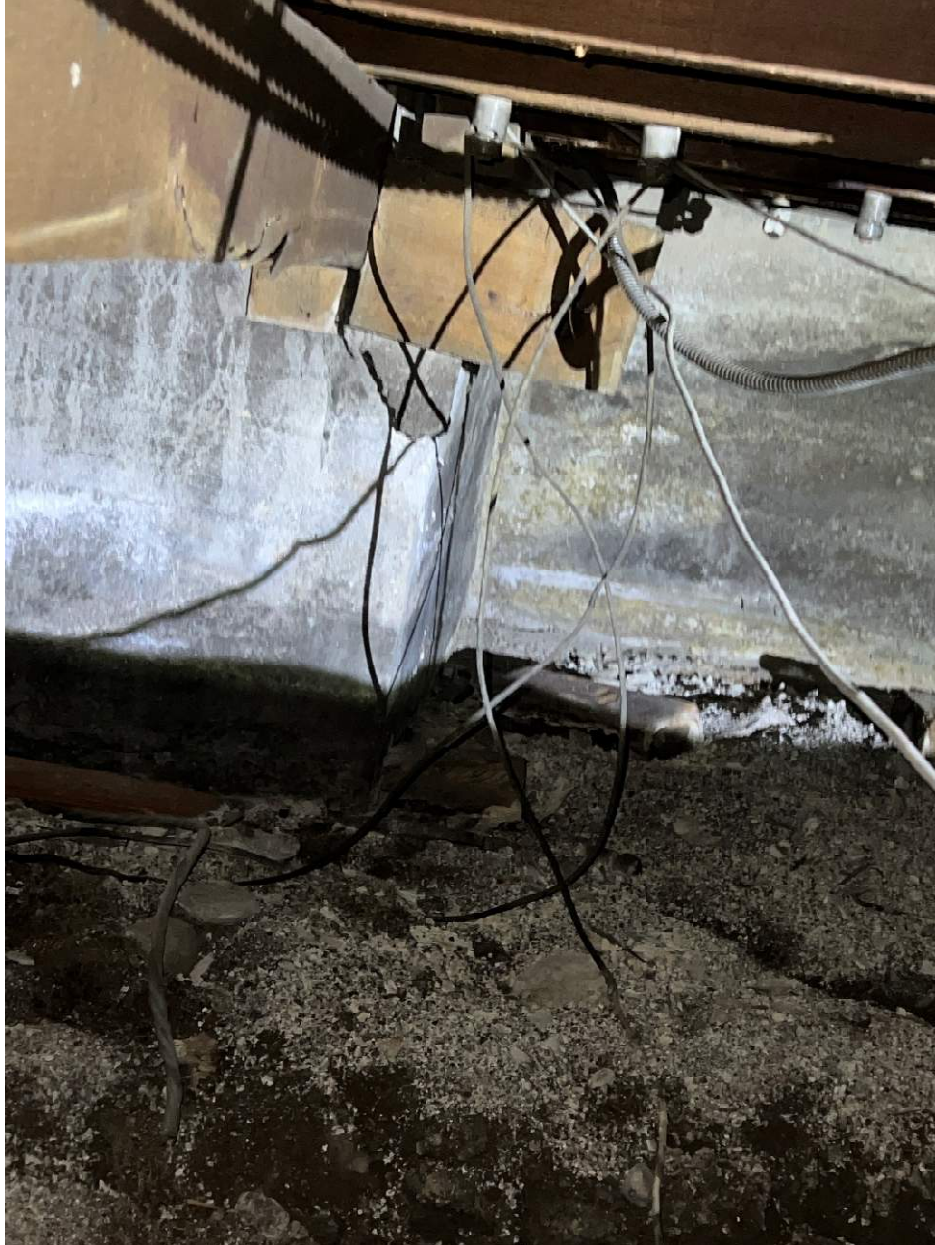
Figure 8 - Beam at Wall
