# D. R. Stoneworks Property Due Diligence

## Phase I Environmental Site Assessment Report

January 2003

**Re: *Environmental Site Assessment  
D. R. Stoneworks Property  
3204 Ohio Avenue, Fort Pierce, Florida***

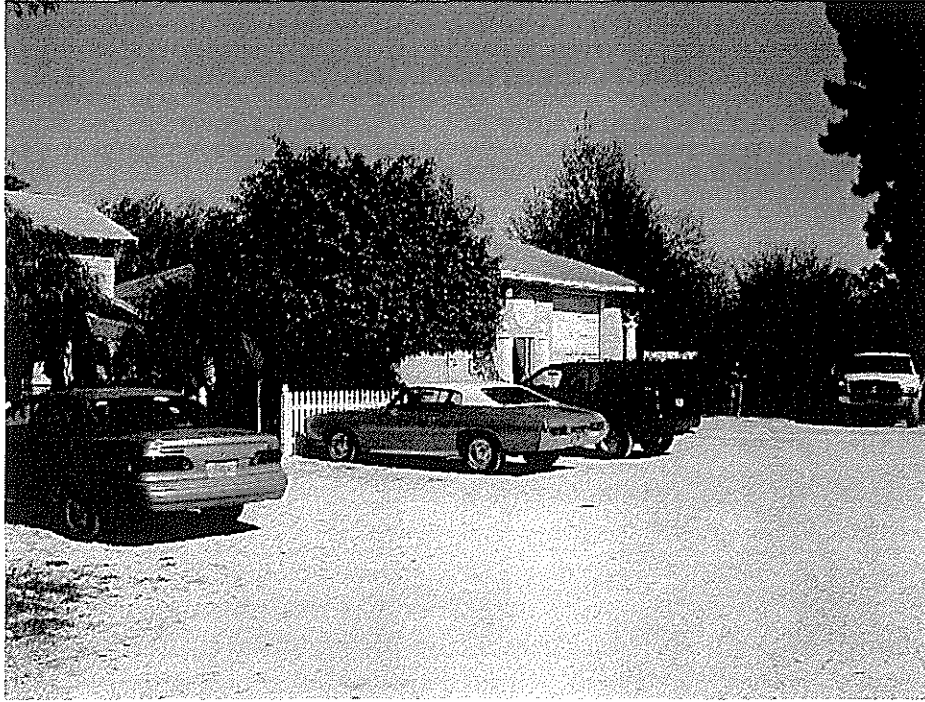
Photo 1. View of site from southwest, showing part of house and garage.

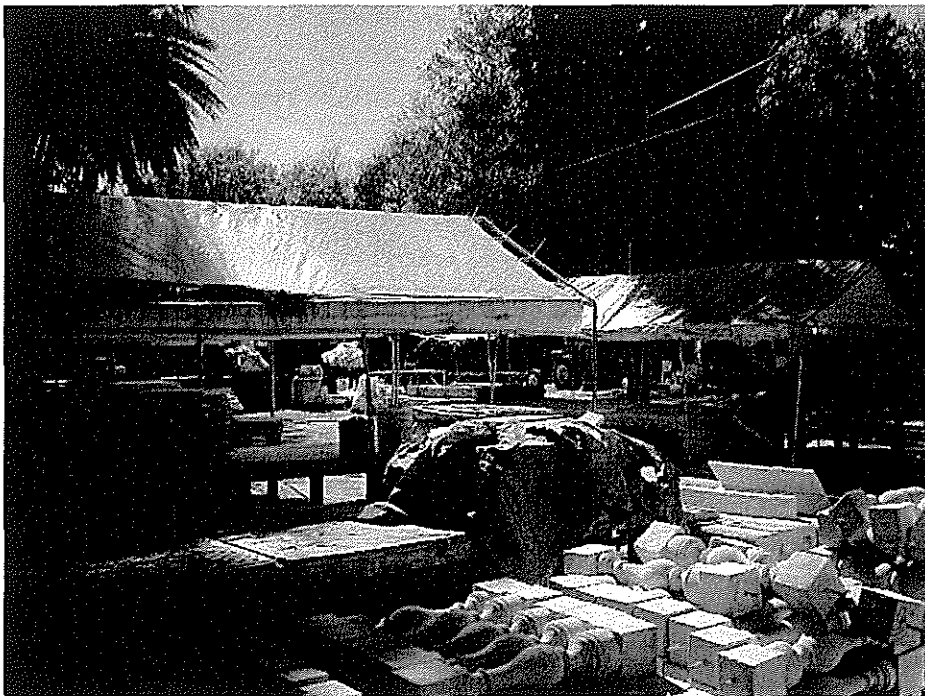
A few 55-gallon barrels of the form release agent were stored in a lean-to behind the garage, adjacent to an air compressor. Inside the garage were stored containers of various other chemicals, oils and products used on the site. The garage had a poured concrete floor. No floor drains were present. Completed castings, seconds and dry materials used in the slurry were stored in the yard area. Several pole tents in the yard area sheltered work areas. Sawing of wood frames for the molds was conducted in one of these work areas.

Photo 2. View of site from northeast, showing storage areas in yard.

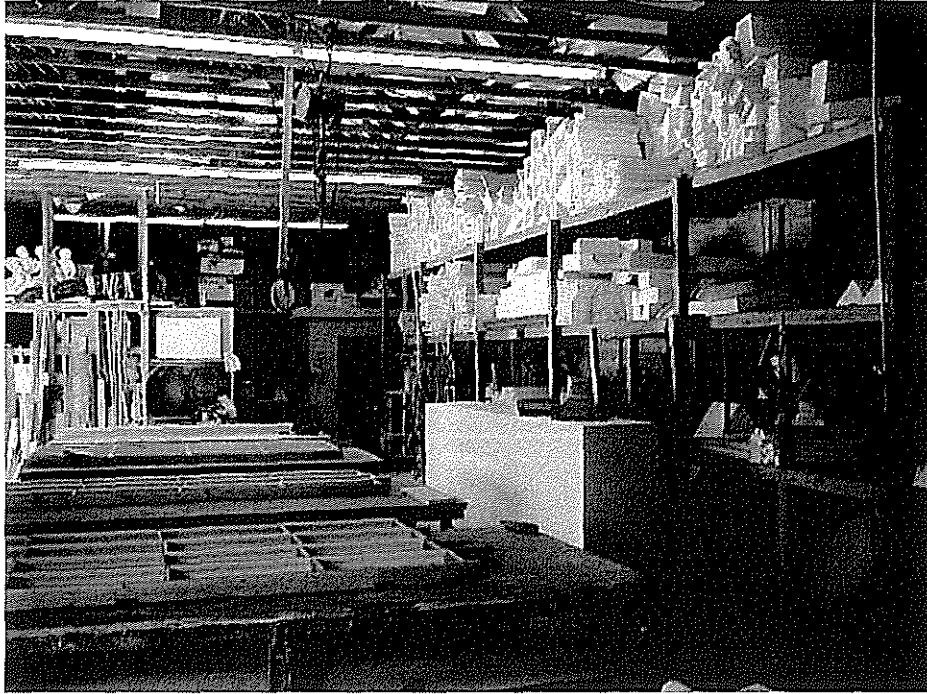
Photo 5. General view of interior of garage, looking from south to north.

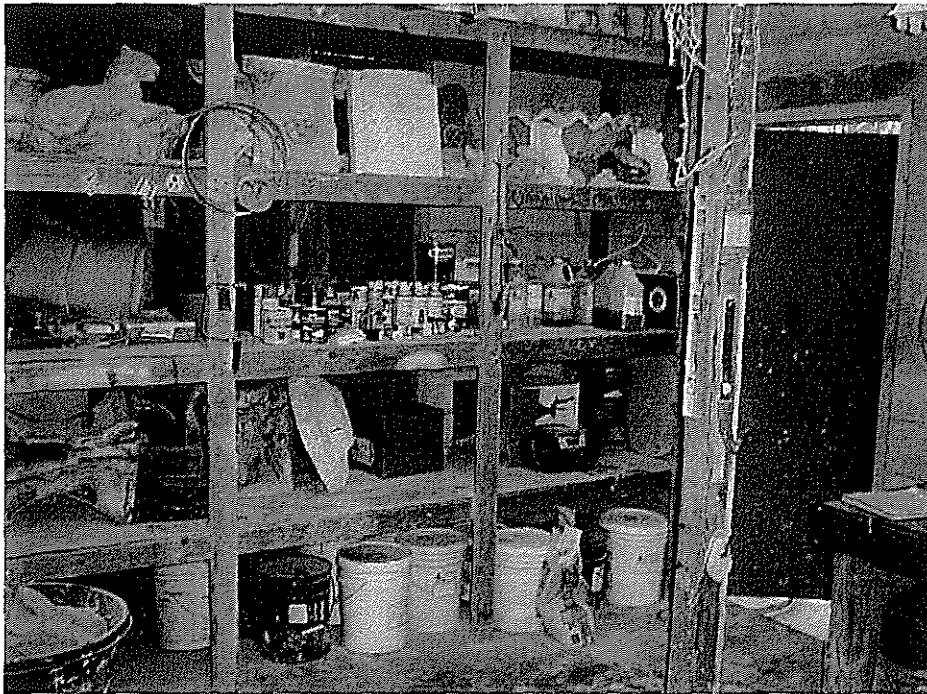
As noted, the form release agent used in the fabricating process was a biodegradable, non-hazardous solvent. Potentially hazardous substances, such as gasoline, other petroleum products, paints and polishes, were present in small quantities in the on-site garage. The capacities of the largest containers of these materials did not exceed 5 gallons.

Photo 6. Detail of interior of garage, showing storage of paints, oils and other products.
