**FINDINGS REPORT
LIMITED PHASE II ENVIRONMENTAL SITE ASSESSMENT REPORT
PROPOSED STORE LOCATION
2600 & 2704 OKEECHOBEE ROAD
FORT PIERCE, FLORIDA**

O'Reilly Automotive Stores, Inc.
Springfield, Missouri

December 13, 2013

RE: Limited Phase II Environmental Site Assessment Report
Proposed Store Location
2600 & 2704 Okeechobee Road
Fort Pierce, Florida
CEA Project No. 28913

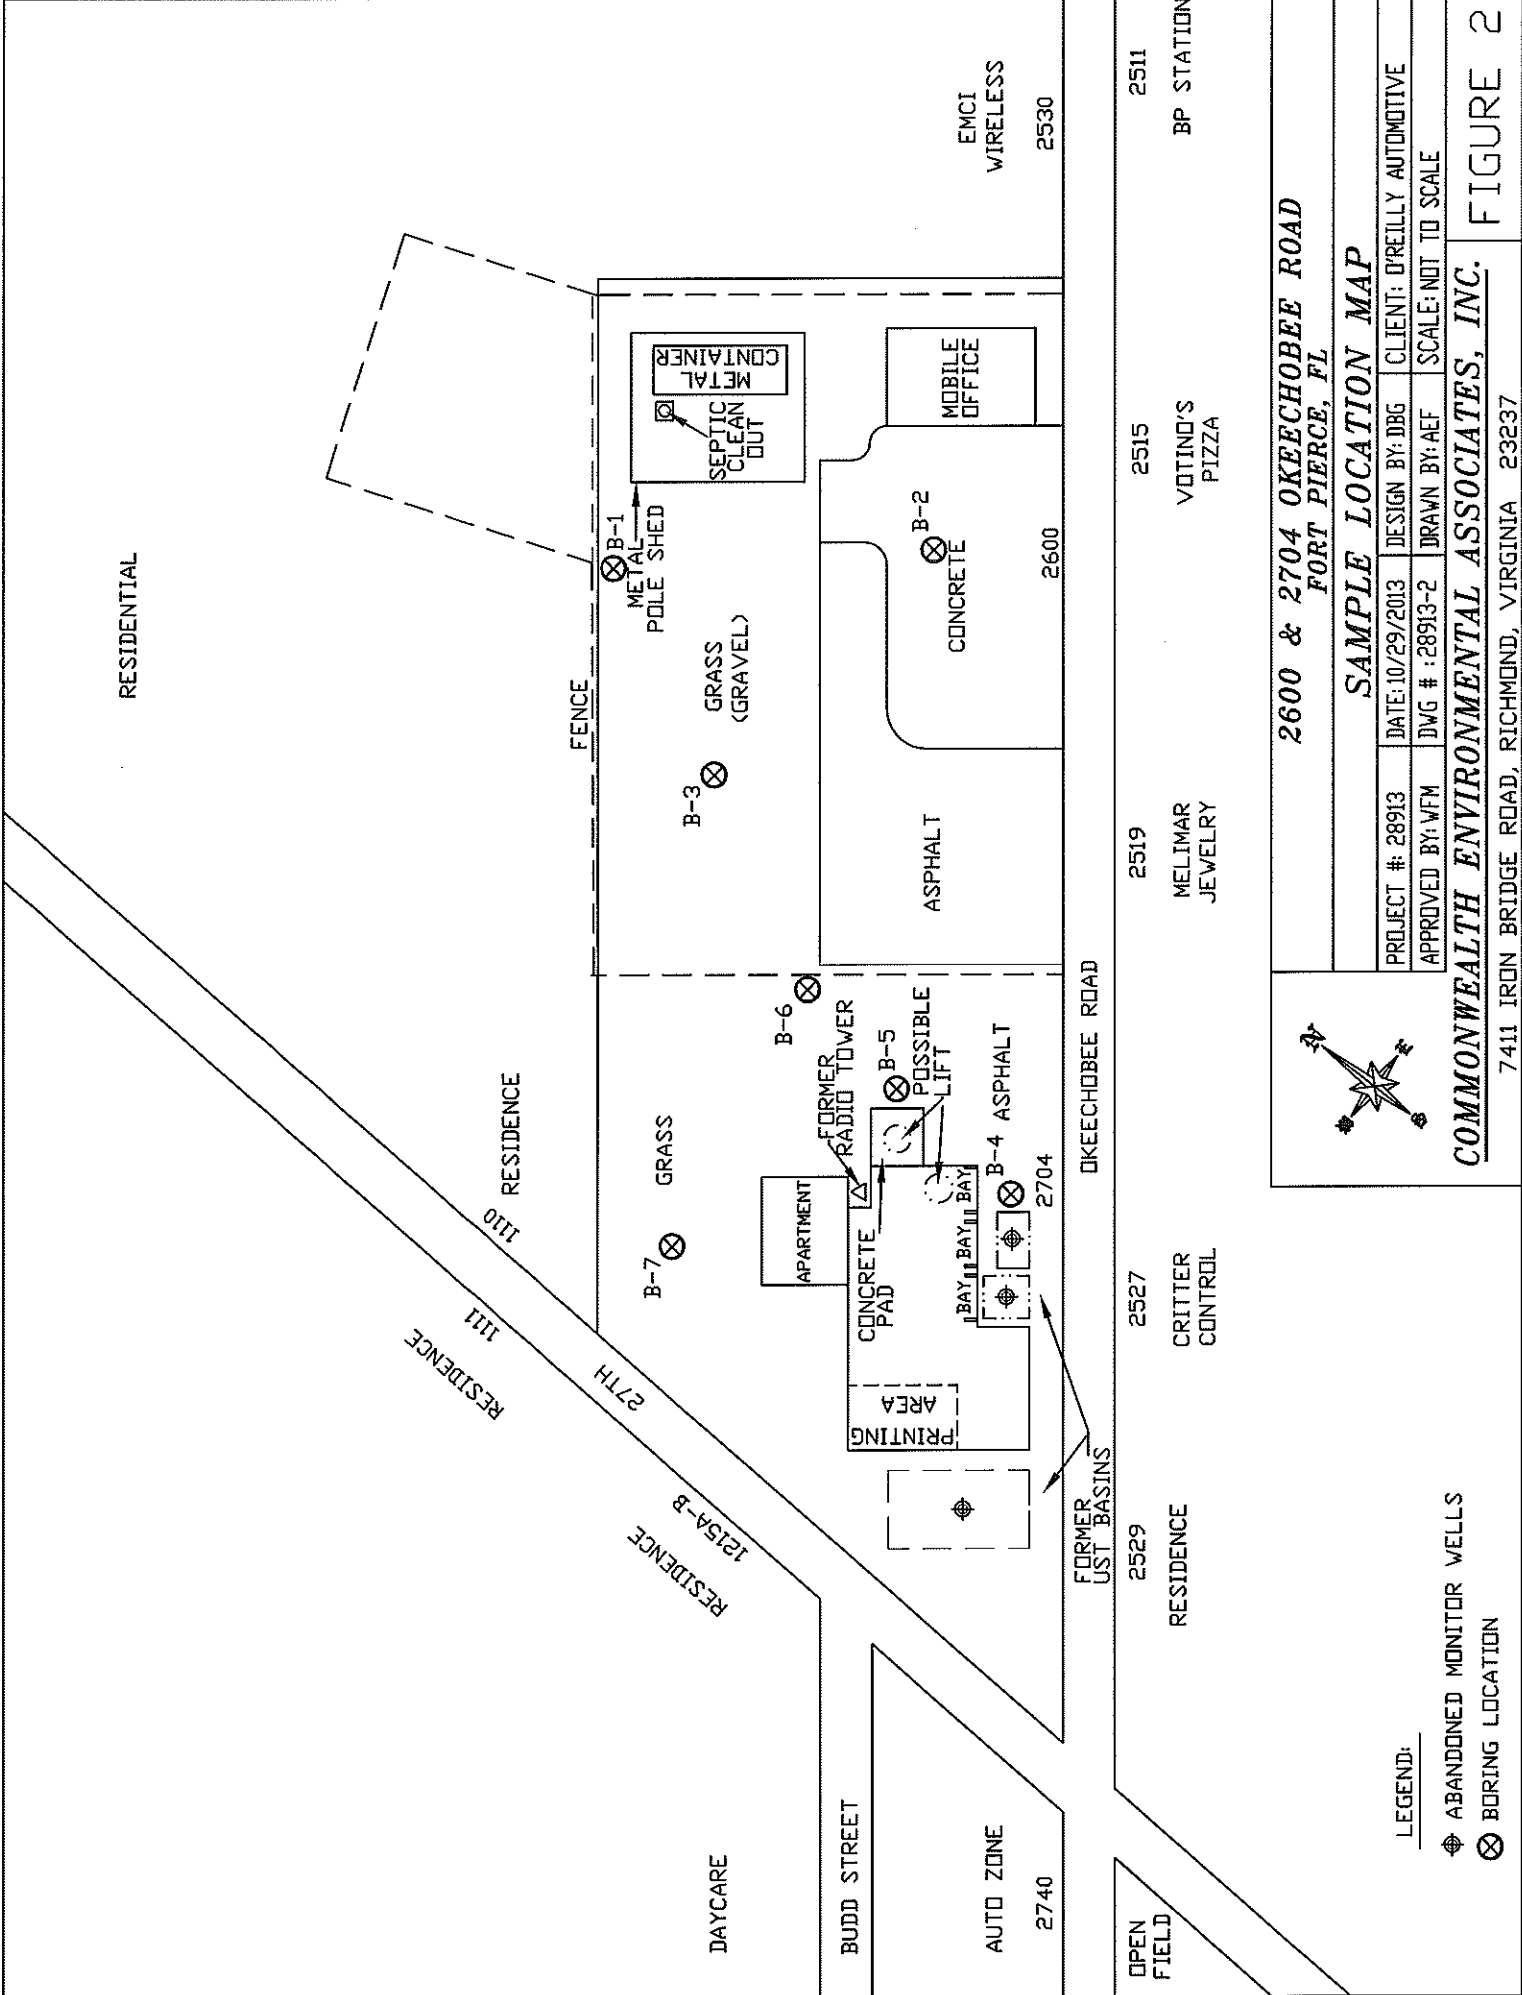
FIGURE 2

A map illustrating the general location of the site and soil boring locations is presented as Figure 1 and 2 in Attachment A.

Boring B-4 was completed adjacent and to the northeast of the UST basins located to the southeast of the service station structure. Boring B-4 was advanced to a depth of fifteen (15) feet. The soils collected from the boring were screened with a PID. No elevated PID readings were noted. No odors or soil staining was noted within the soils collected during the completion of the soil boring. The soils consisted of brown to tan fine sands. Groundwater was not encountered during the completion of this boring.

Boring B-5 was completed to the northeast of the service station structure and adjacent to the outside hydraulic lift location. Boring B-5 was advanced to a depth of fifteen (15) feet. The soils collected from the boring were screened with a PID. No elevated PID readings were noted. No odors or soil staining was noted within the soils collected during the completion of the soil boring. The soils consisted of brown to tan fine sands. Groundwater was not encountered during the completion of this boring.

Boring B-6 was completed toward the middle of the northeast property boundary of the parcel located at 2704 Okeechobee Road. Boring B-6 was advanced to a depth of fifteen (15) feet. The soils collected from the boring were screened with a PID. No elevated PID readings were noted. No odors or soil staining was noted within the soils collected during the completion of the soil boring. The soils consisted of brown to tan fine sands. Groundwater was not encountered during the completion of this boring.

Boring B-7 was completed toward the north property boundary of the parcel located at 2704 Okeechobee Road. Boring B-7 was advanced to a depth of fifteen (15) feet. The soils collected from the boring were screened with a PID. No elevated PID readings were noted. No odors or soil staining was noted within the soils collected during the completion of the soil boring. The soils consisted of brown to tan fine sands. Groundwater was not encountered during the completion of this boring.

The borings B-1, B-2 and B-3 were all completed on the parcel located at 2600 Okeechobee Road. The borings were advanced to a depth of fifteen (15) feet. The soils collected from the boring were screened with a PID. No elevated PID readings were noted. No odors or soil staining was noted within the soils collected during the completion of the soil borings. The soils consisted of brown to tan fine sands. Groundwater was not encountered during the completion of these borings.
