RE: Bridge Inspection Report Submittals to Local Owners  
District Four Bridge Inspection Report

Structure ID: 940047

INSPECTION DATE: 12/15/2016 GAUE

### CR-707 (Citrus Ave.) over FEC Railroad

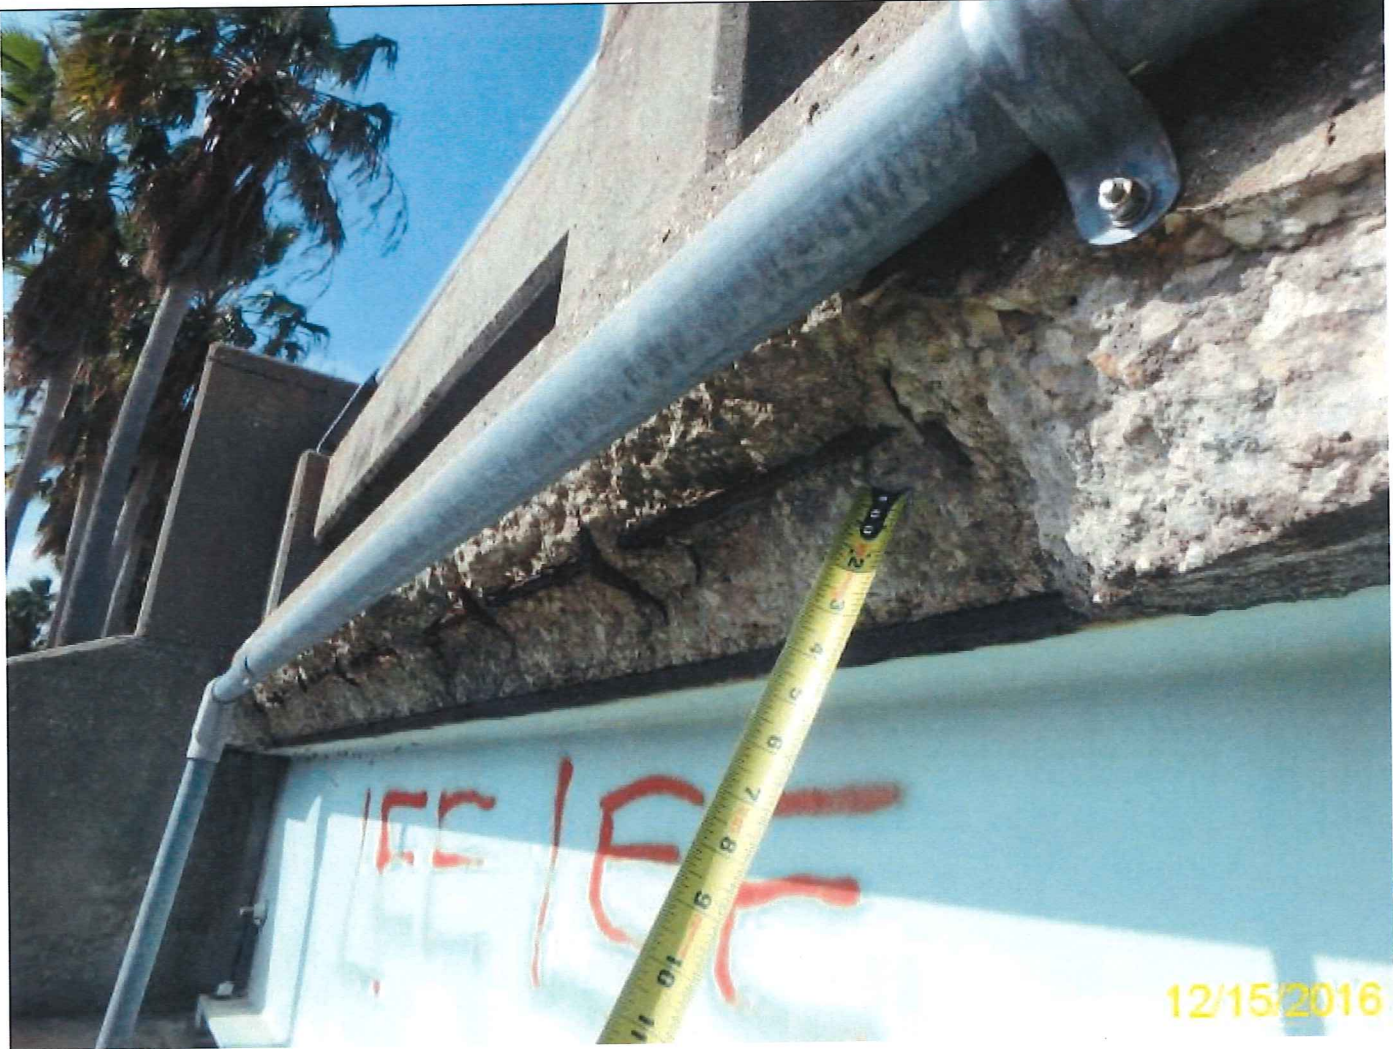
**Photo 1 - Element 12 Re Concrete Deck**

The right fascia in Span 1 has a 13ft. x 16in. x 6in. spall/delamination with one exposed longitudinal rebar and eight exposed stirrups with moderate to heavy surface corrosion, starting at the beginning of the utility connection – NO CHANGE. Refer to photo 1.

Spall/delamination in the right fascia in Span 1

CONDITION STATE	PRIORITY
3      MMS Quantity: 50 sf    Element Estimated Quantity: 50 each	3
WORK ORDER RECOMMENDATION: Repair the spalls and delaminations in the right fascia in Spans 1 and 8. 10MH	
3      MMS Quantity: 50 sf    Element Estimated Quantity: 50 each	3
WORK ORDER RECOMMENDATION: Repair the spalls and delaminations in the deck top. 10MH

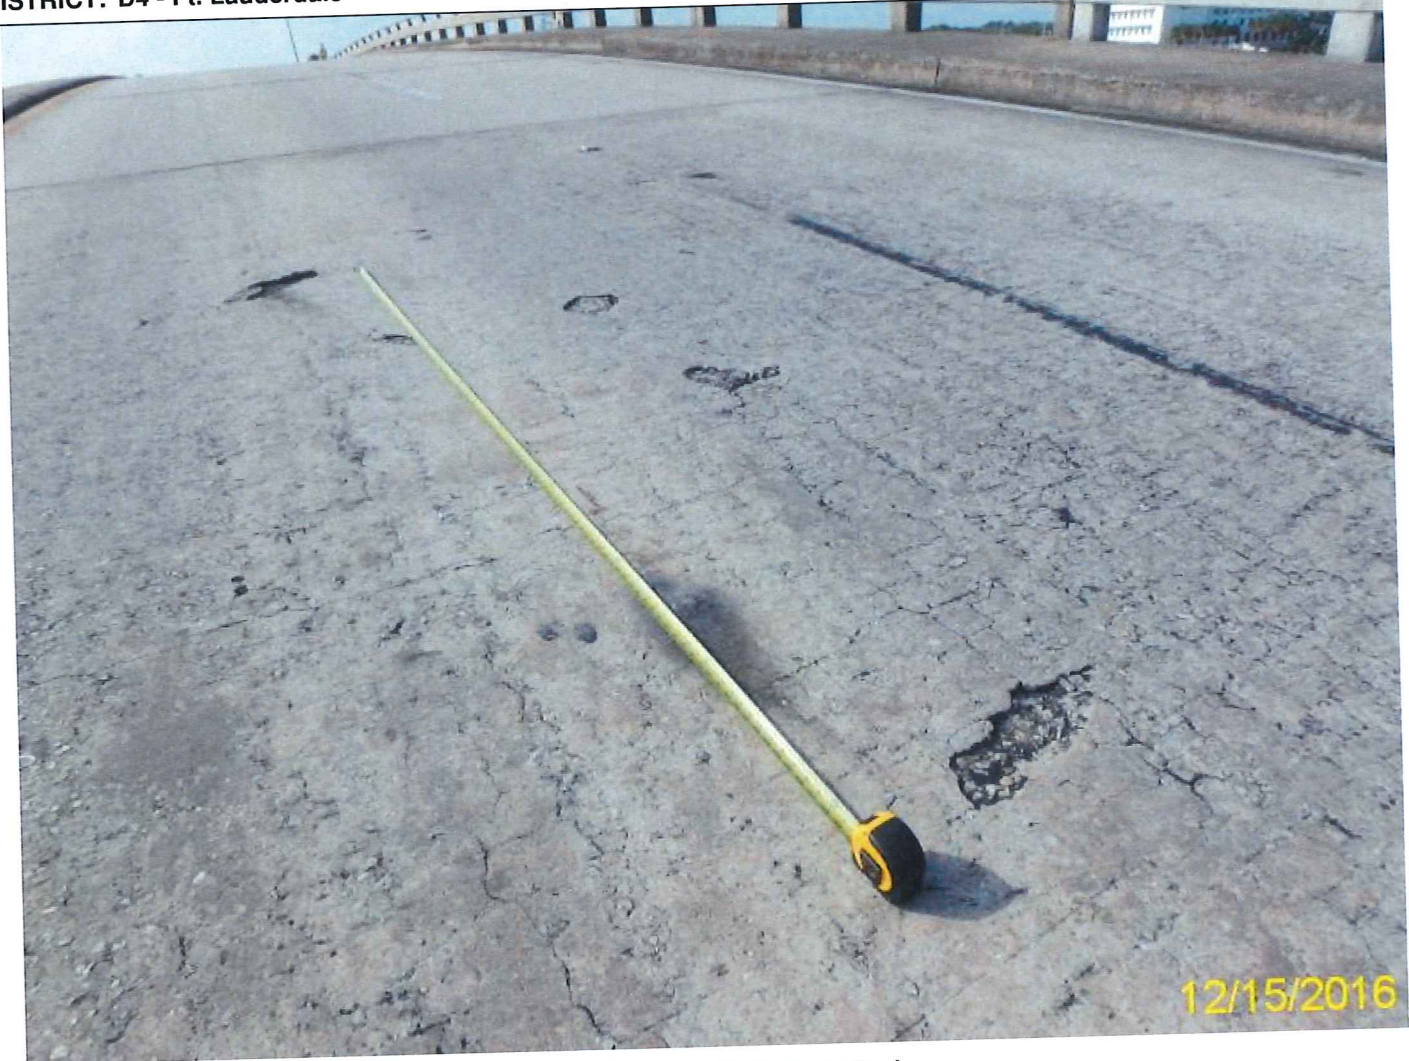
**Photo 2 - Element 12 Re Concrete Deck**

Span 9 westbound, Lane 2 has five spalls up to 1ft. x 6in. x 1in. and associated delaminated concrete around the spalls up to 15.5ft. long x 6ft. wide in between the first and second construction joints – NO CHANGE. Refer to photo 2.

Spalls and delaminations in the deck top of Span 9

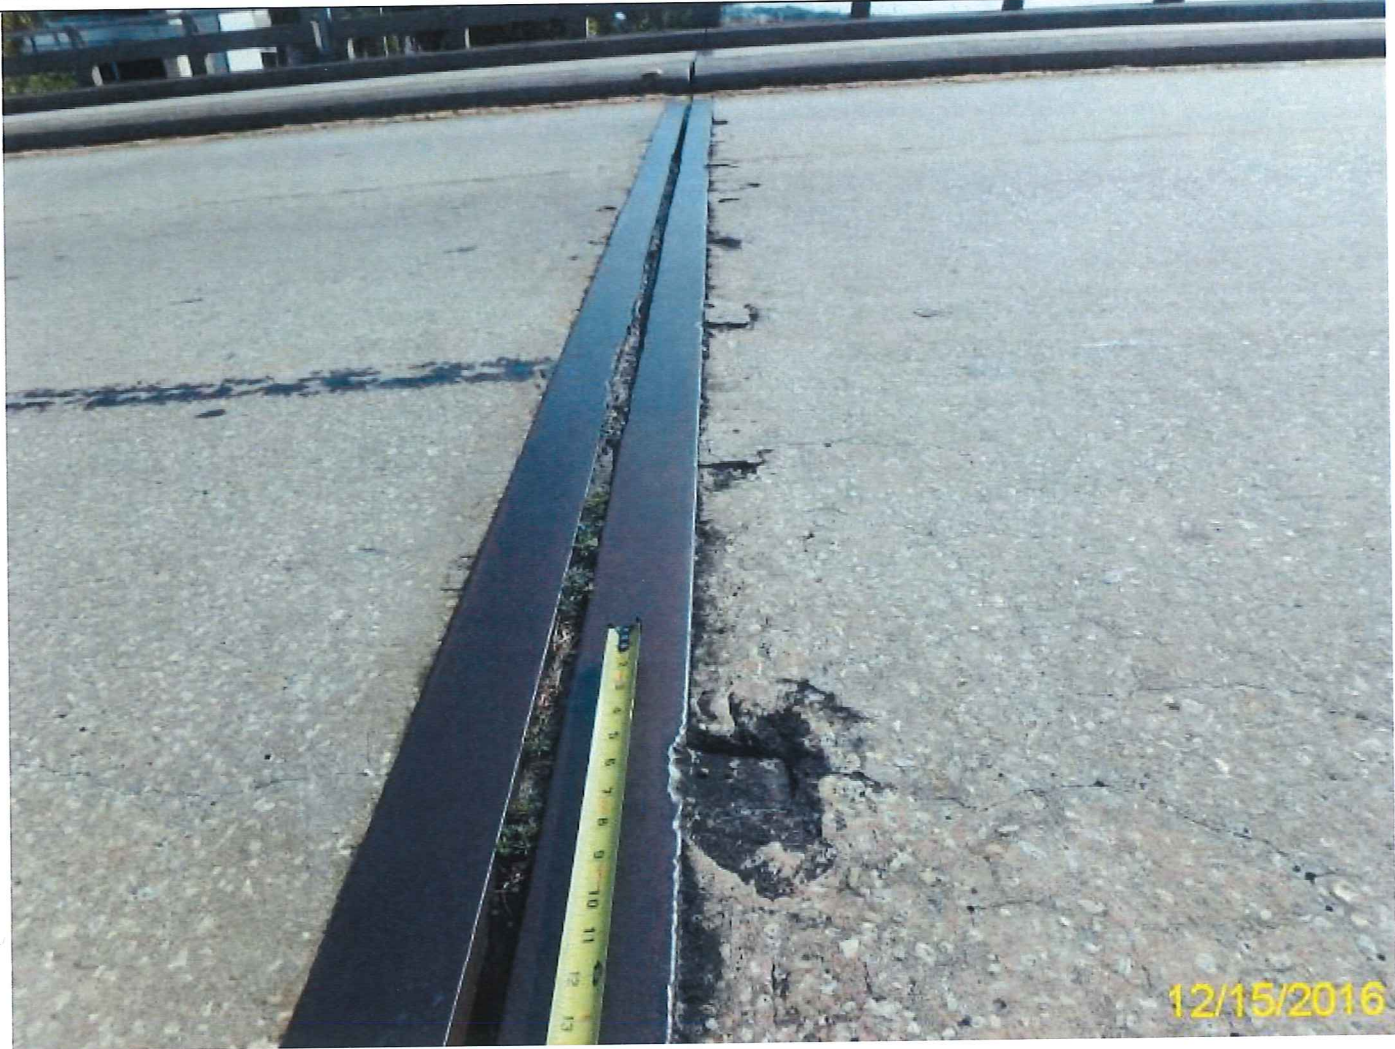
**Photo 3 - Element 12 Re Concrete Deck**

In Spans 2 through 10 along the joint adjacent to the steel headers of the compression seals, there are isolated areas of delaminations and spalls up to 9in. x 5in. x 1-1/4in., with the worst being at Bent 10 - NO CHANGE. Refer to photo 3.

Typical spalls and delaminations along the joint headers (Bent 10 joint shown)

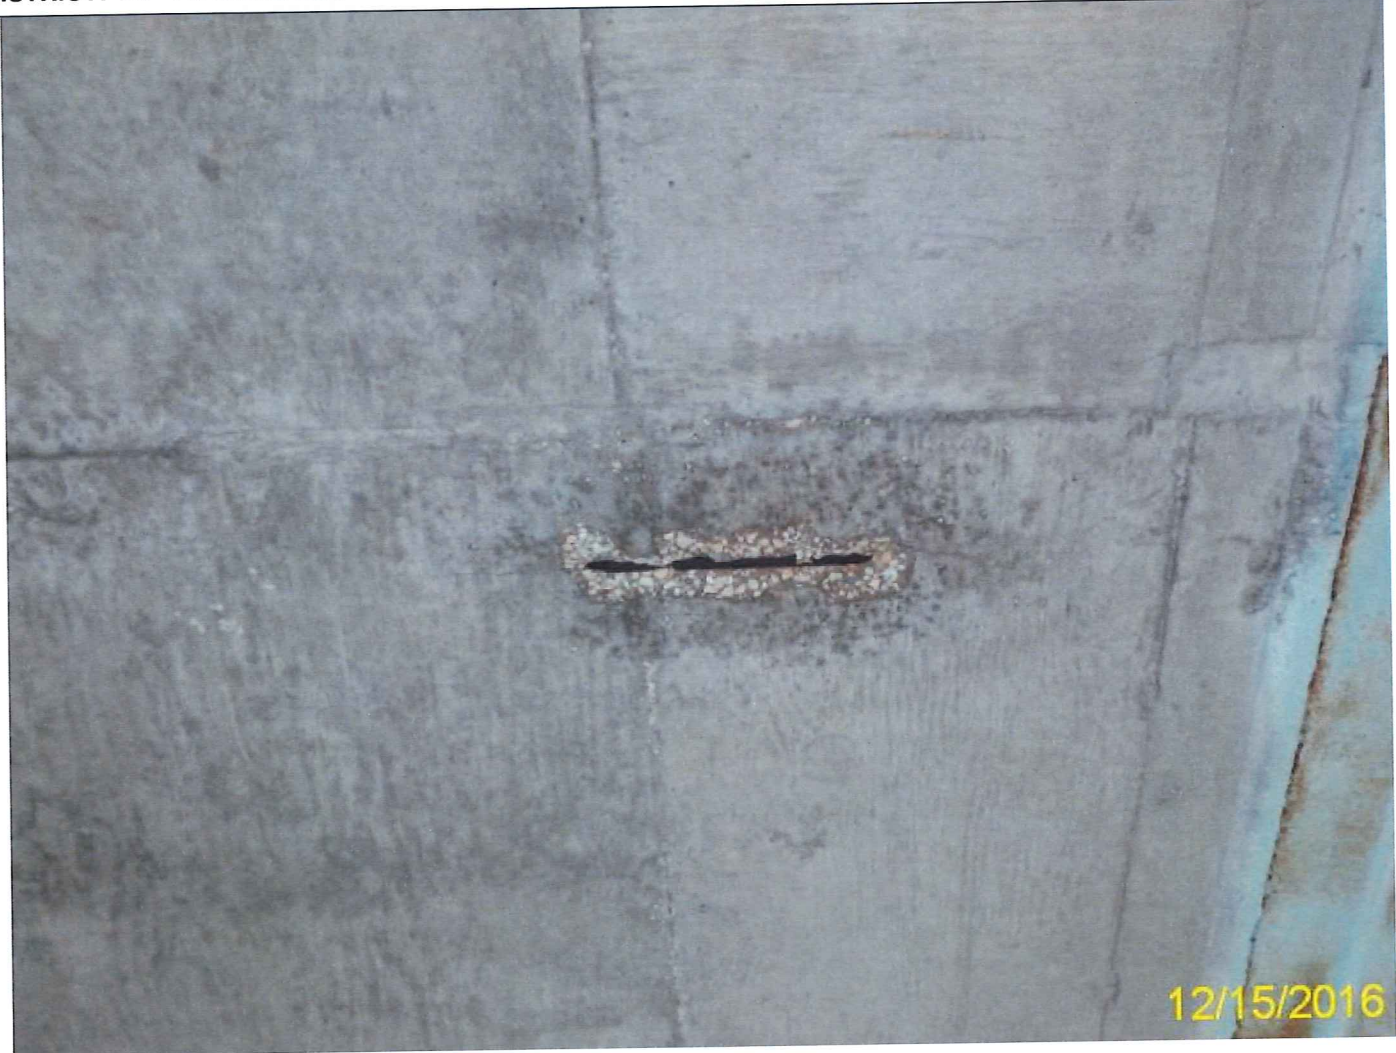
**Photo 4 - Element 12 Re Concrete Deck**

The deck underside in Bay 6-2 has a 14in. x 3in. x 3/4in. spall with exposed rebar, 12ft. west of Bent 7 - NO CHANGE. Refer to photo 4.

Spall with exposed rebar in the deck underside in Bay 6-2

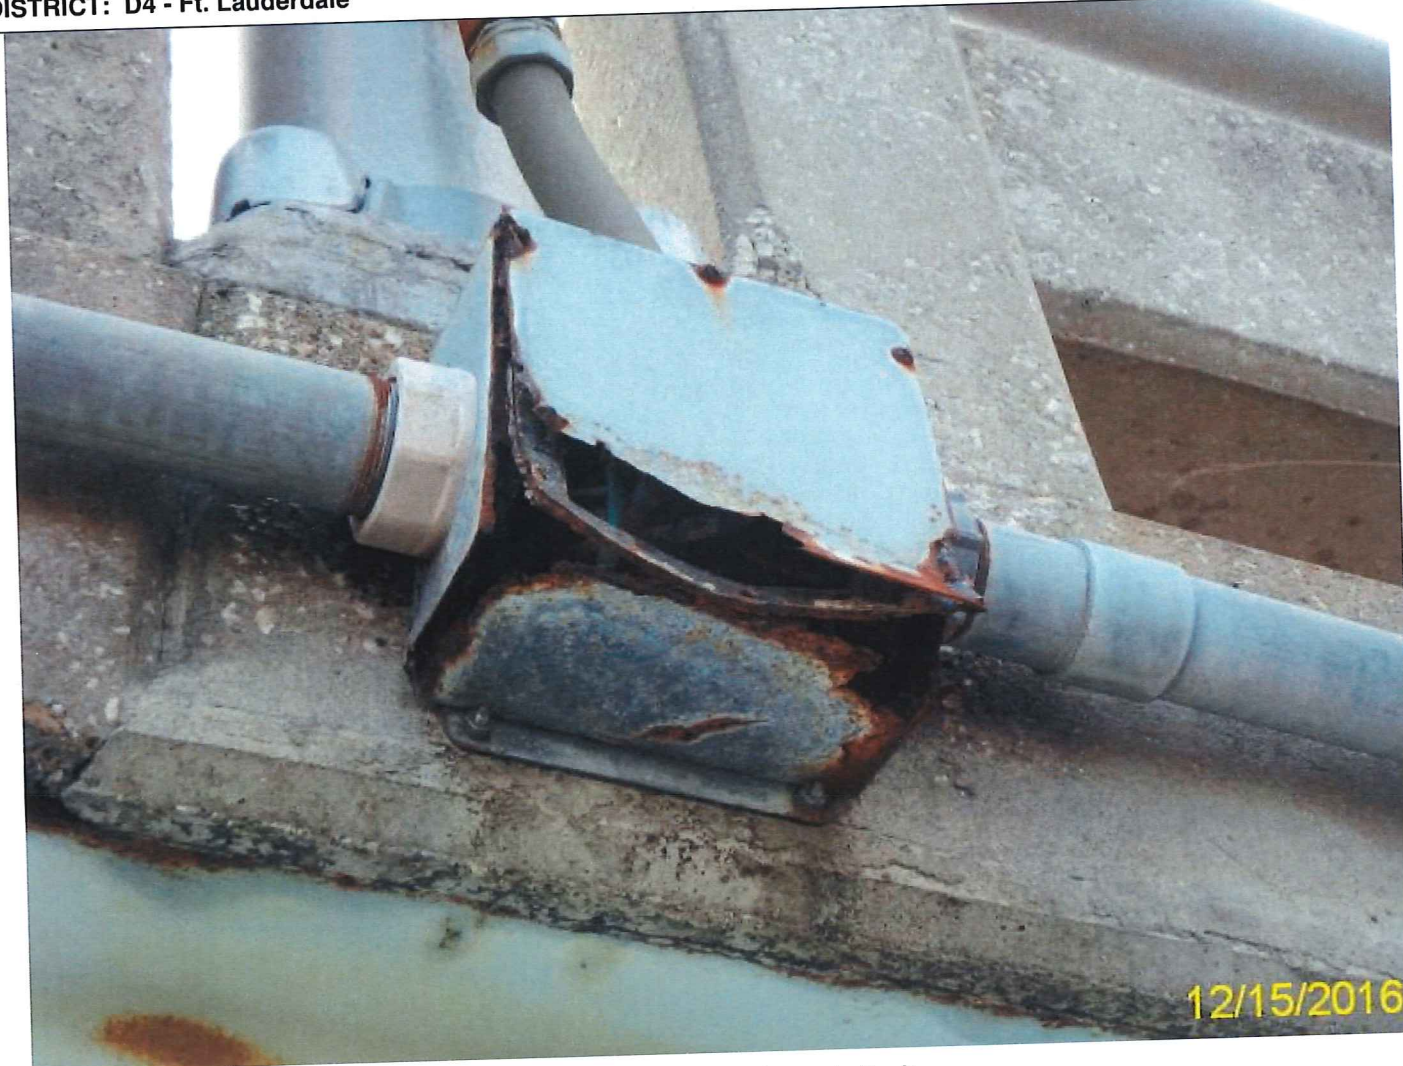
**Photo 5 - Element 12 Re Concrete Deck**

The electrical junction box attached to the left fascia in Span 4 is heavily corroded with 100% section loss - NO CHANGE. Refer to photo 5.

Corroded junction box on the left fascia of Span 4

CONDITION STATE	PRIORITY
3      MMS Quantity: 1 sf    Element Estimated Quantity: 34739 sq.ft	3
WORK ORDER RECOMMENDATION: Replace the corroded junction box on the left fascia of Span 4. 10MH

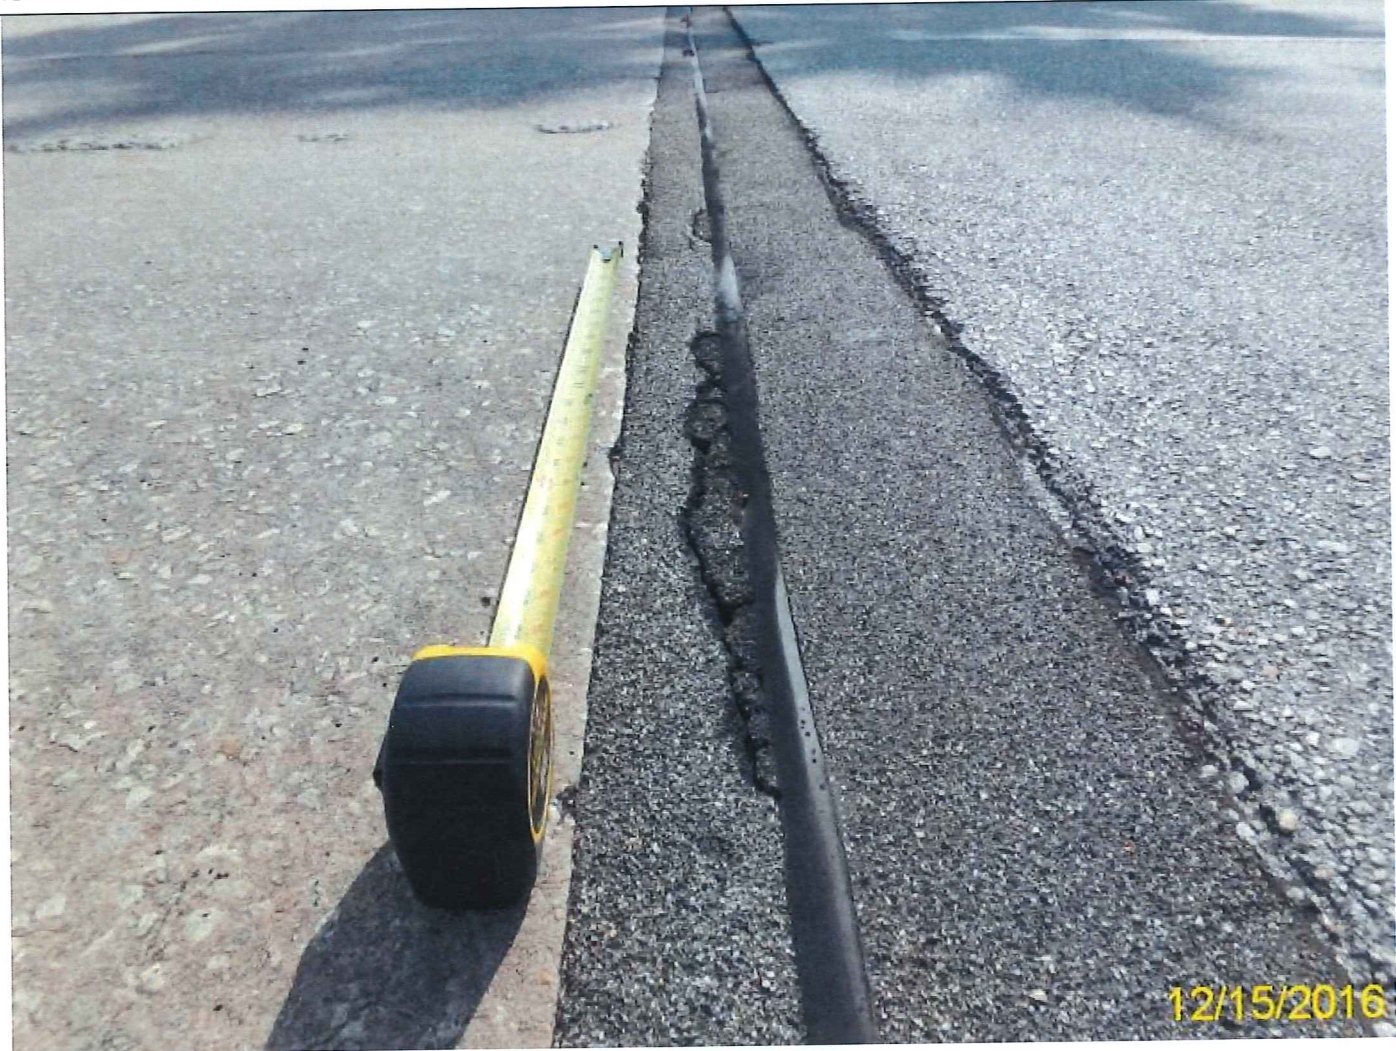
**Photo 6 - Element 301 Pourable Joint Seal**

CS2:  
The east joint header at Abutment 1 has three spalls/delaminations up to 1-1/2ft. x 1-1/2in.; two in Lane 3 and one in Lane 4 - NO CHANGE. Refer to photo 6.

Spalls and delaminations in Abutment 1 joint header

Repair the spalls and delaminations in Abutment 1 joint header. 10MH

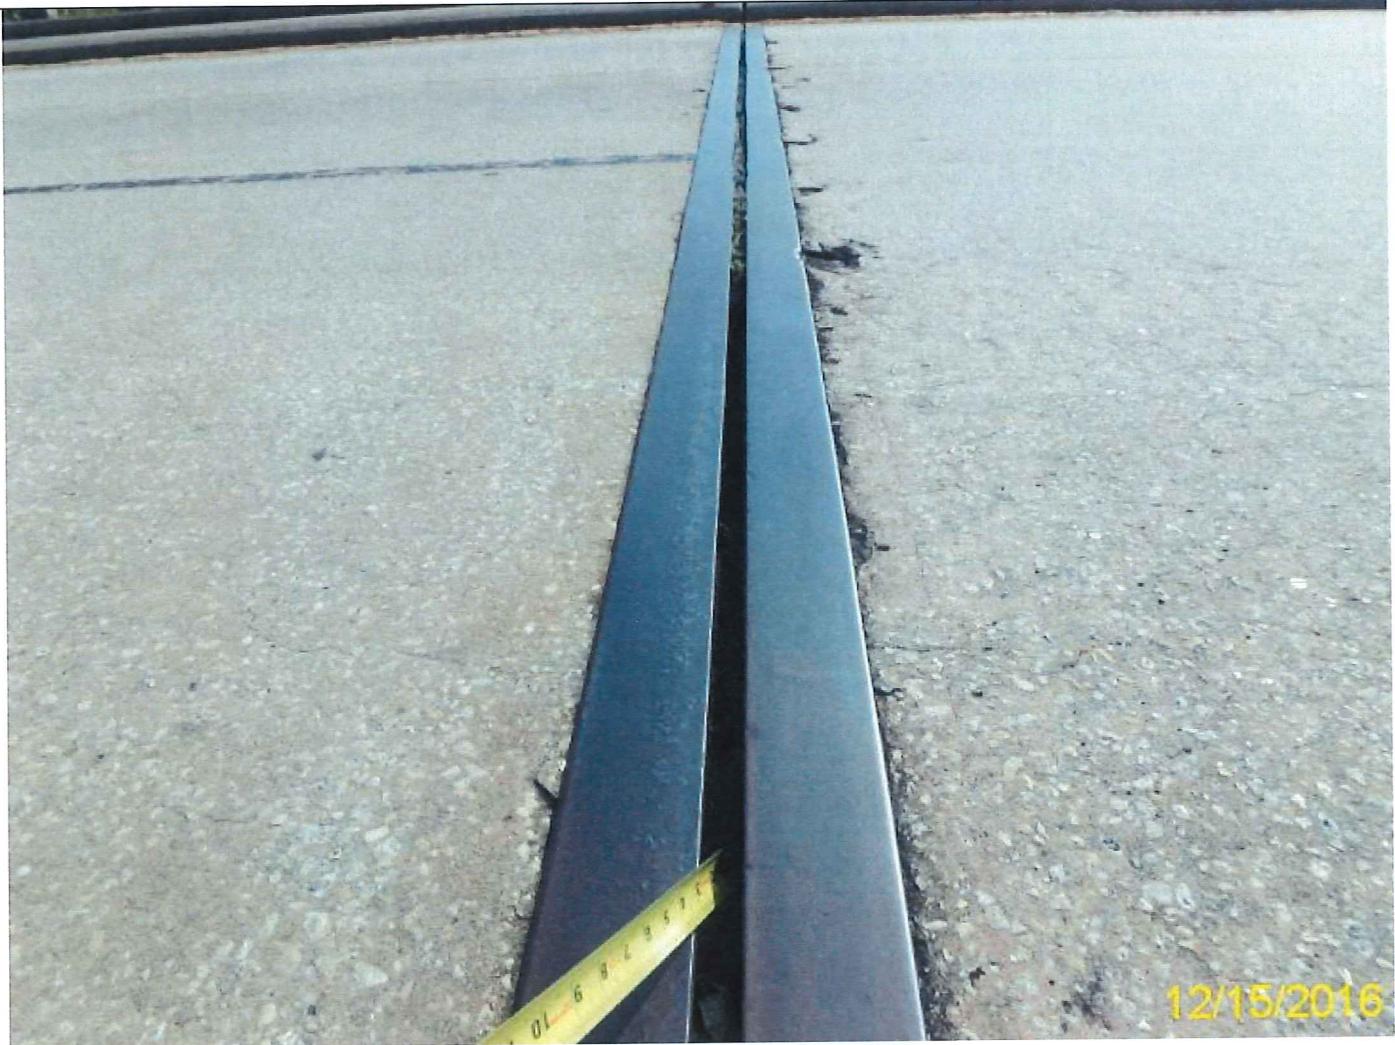
**Photo 7 - Element 302 Compressn Joint Seal**

302 / 3      CS3:  
The intermediate expansion joints (Bents 2 through 10) have major adhesion failures and/or missing seal along the length of the compression joint seals for the full roadway width - NO CHANGE. Refer to photo 7.

Typical deteriorated and/or missing compression seal (Bent 10 joint shown)

Repair the failed seals throughout Bents 2 thru 10. 80MH

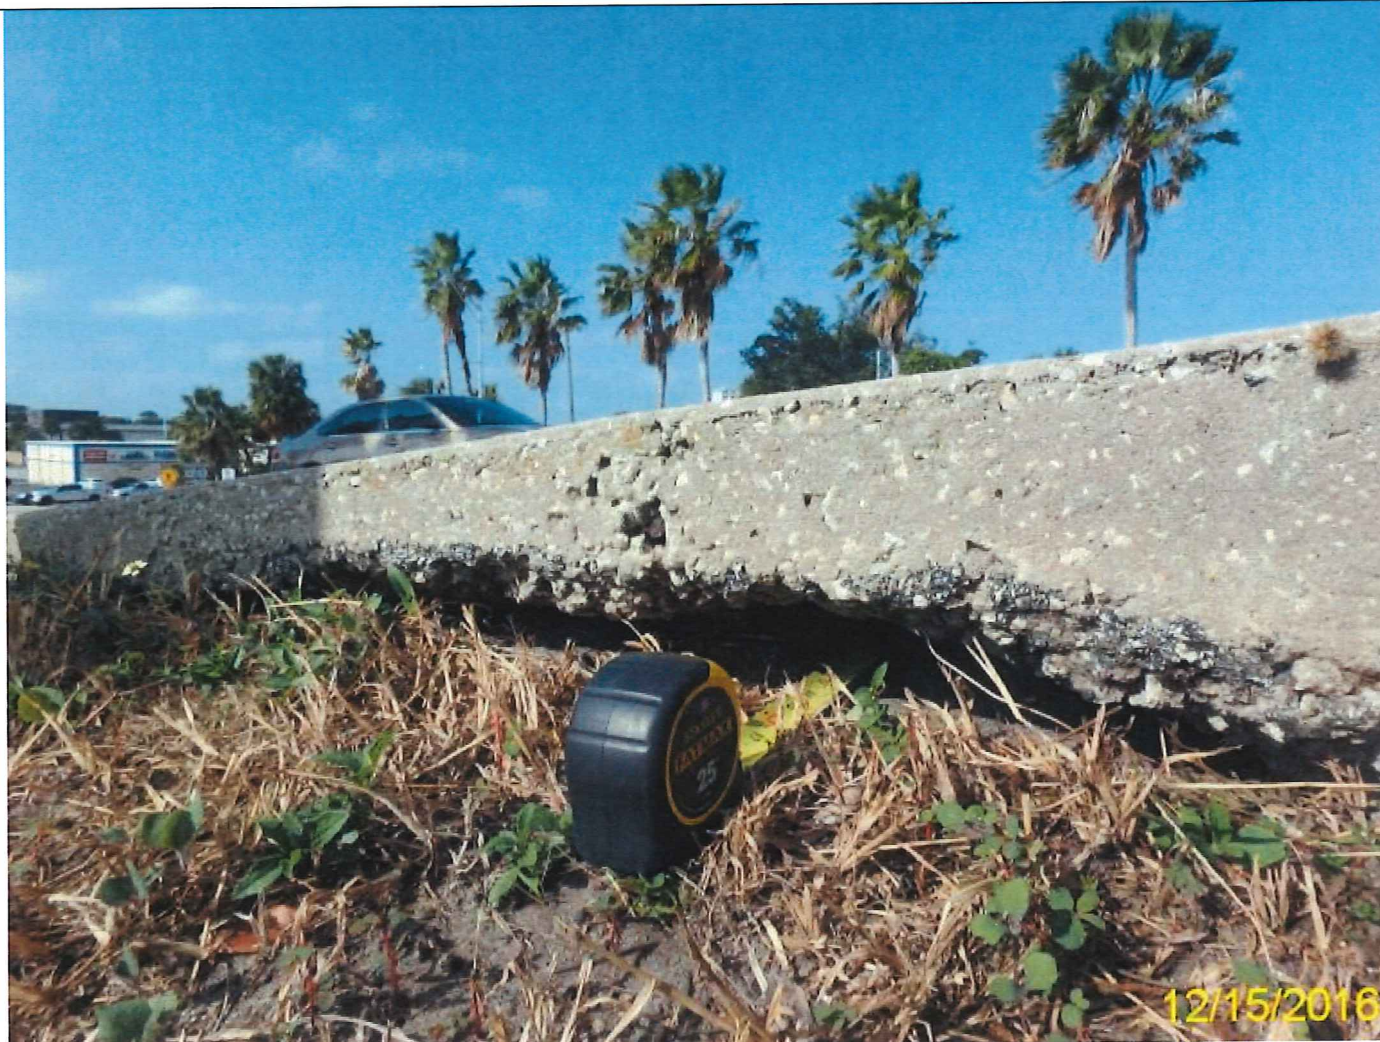
**Photo 8 - Element 321 Re Conc Approach Slab**

Undermining along the southwest approach sidewalk

CONDITION STATE	PRIORITY
1      MMS Quantity: 2 sf    Element Estimated Quantity: 2760 sq.ft	3
WORK ORDER RECOMMENDATION: Repair the undermining along the southwest and southeast approach sidewalks. 8MH

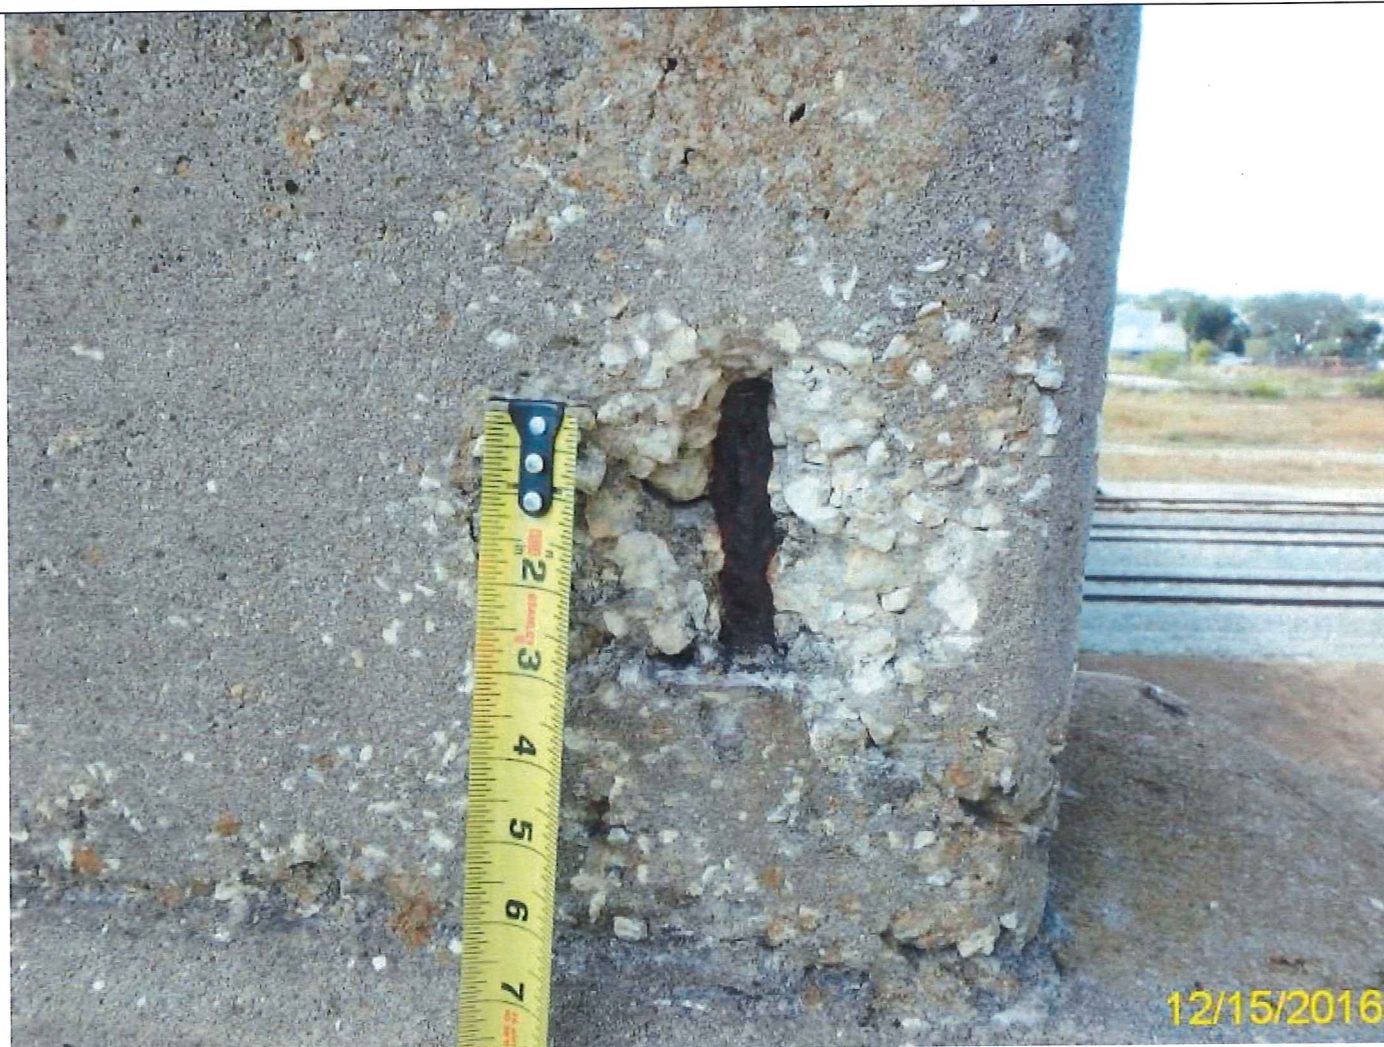
**Photo 9 - Element 321 Re Conc Approach Slab**

The northeast end post has a 5in. x 4in. x 1/2in. spall with exposed rebar in the east face - NO CHANGE. Refer to photo 9.

Spall with exposed steel in the northeast end post

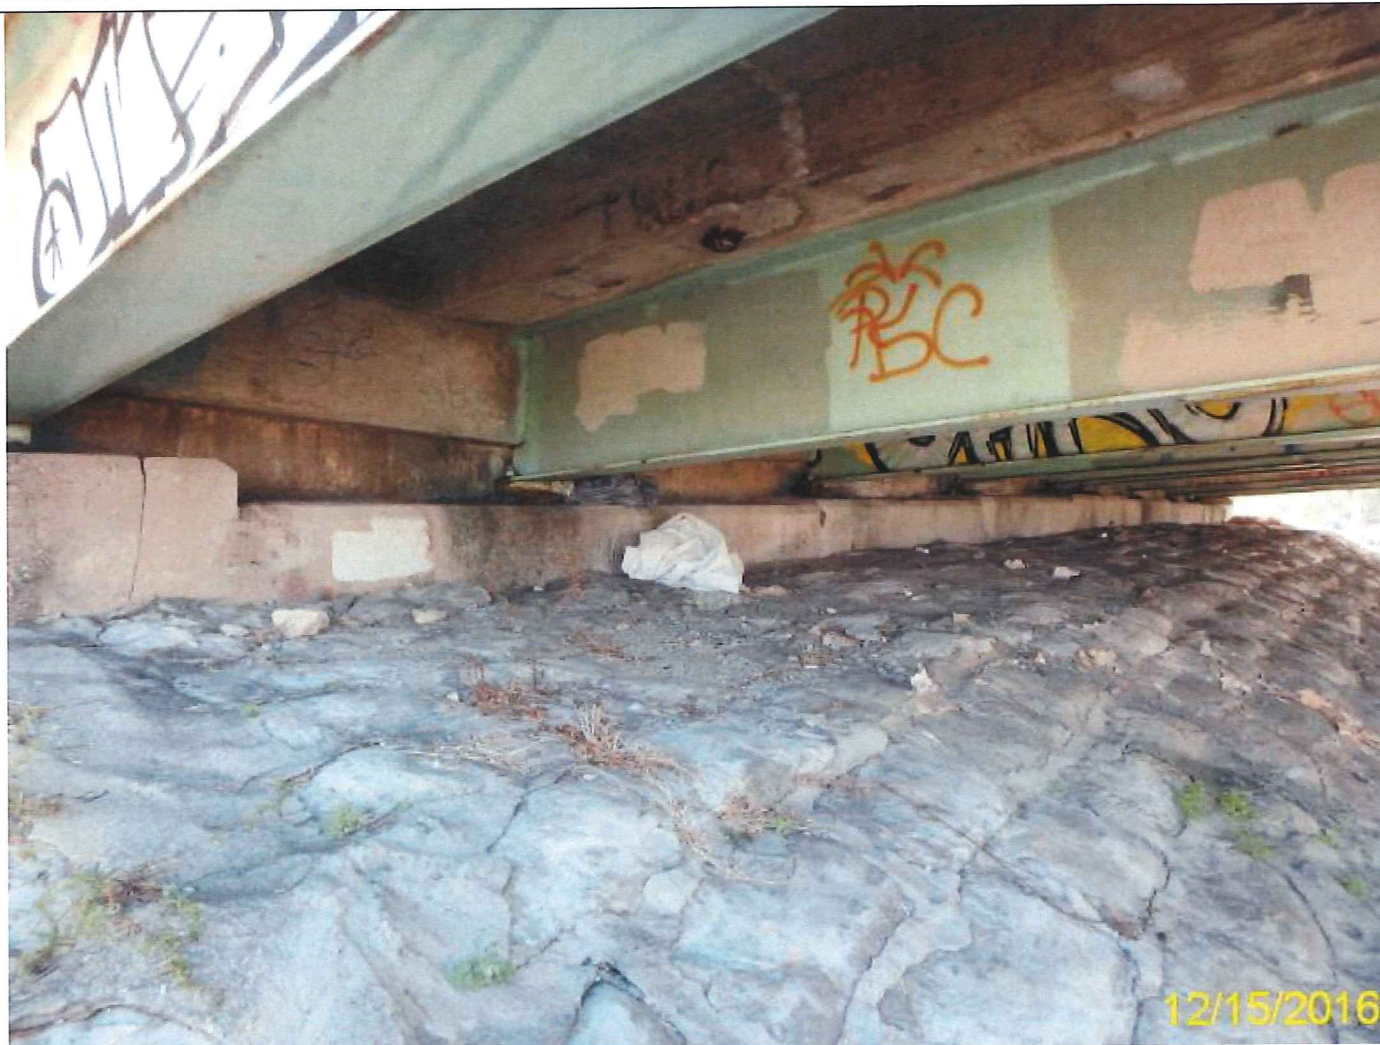
**Photo 10 - Element 215 Re Conc Abutment**

Trash on Abutment 11 cap

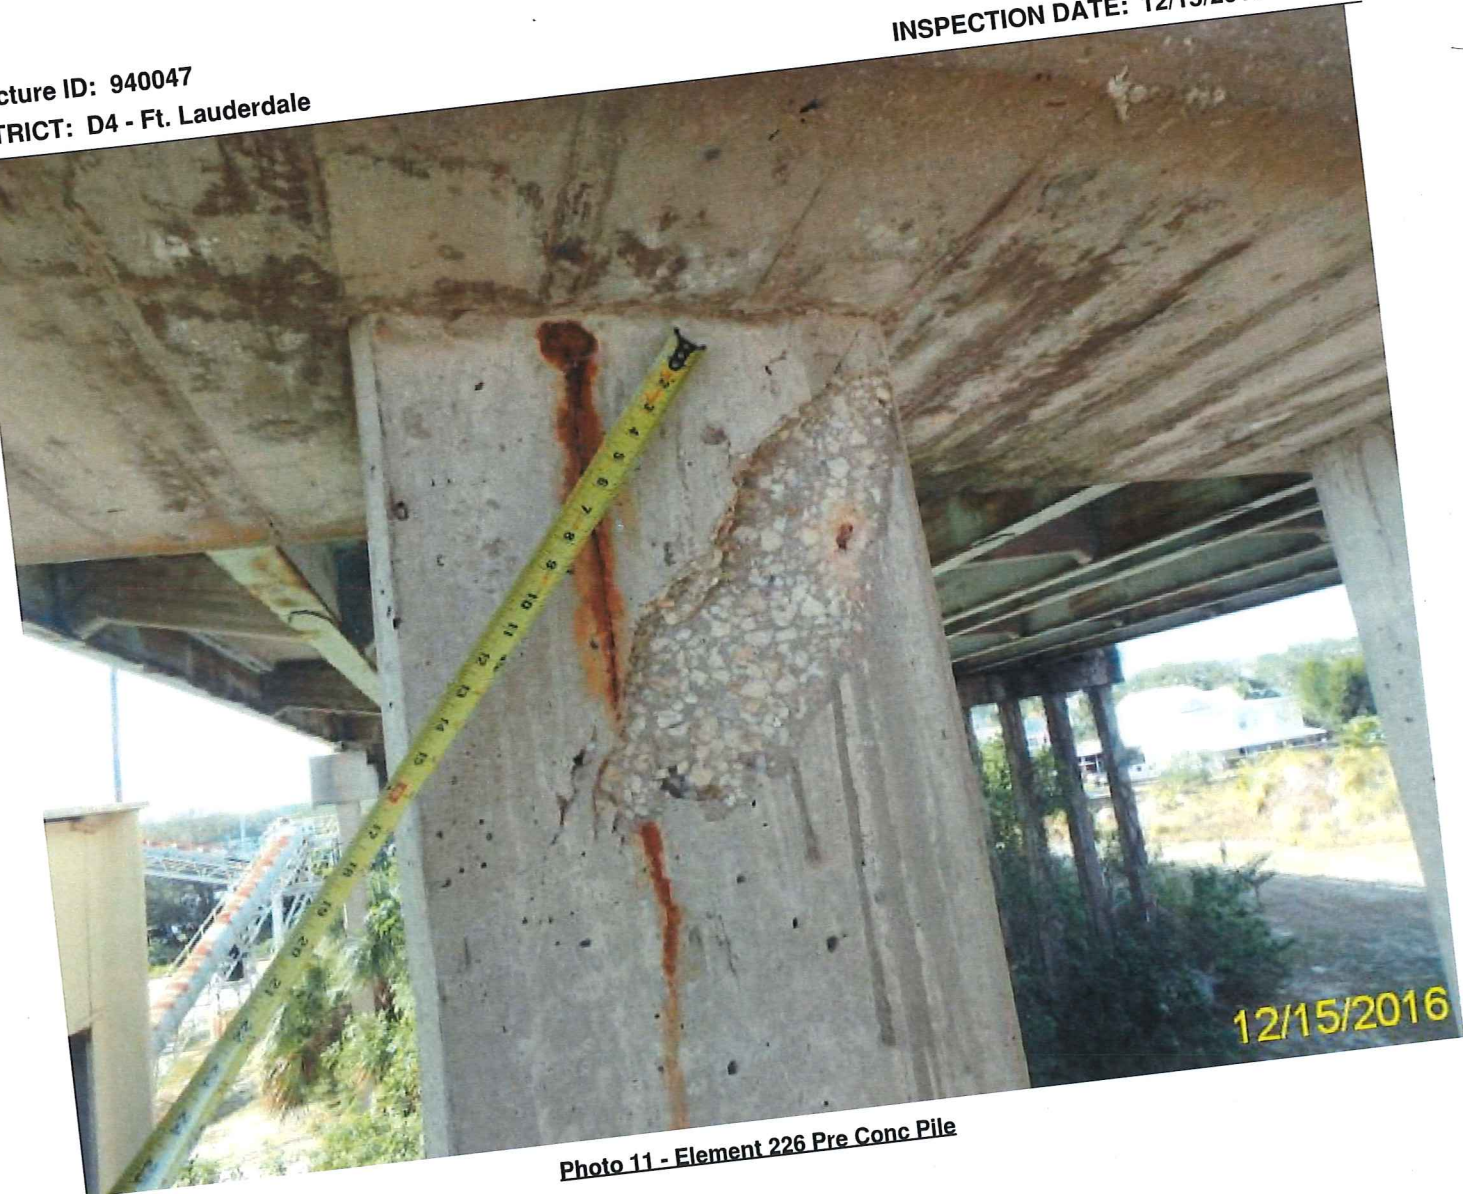
**Photo 11 - Element 226 Pre Conc Pile**

Pile 7-12, east face has a 18in. x 18in. x 1-1/2in. spall/delamination with a 1in. diameter area of corrosion staining at the cap - NO CHANGE. Refer to photo 11.

Spall/delamination in the east face of Pile 7-12

Repair the delaminations and spalls in Piles 5-12 7-12 10-1 and 10-7. 10MH

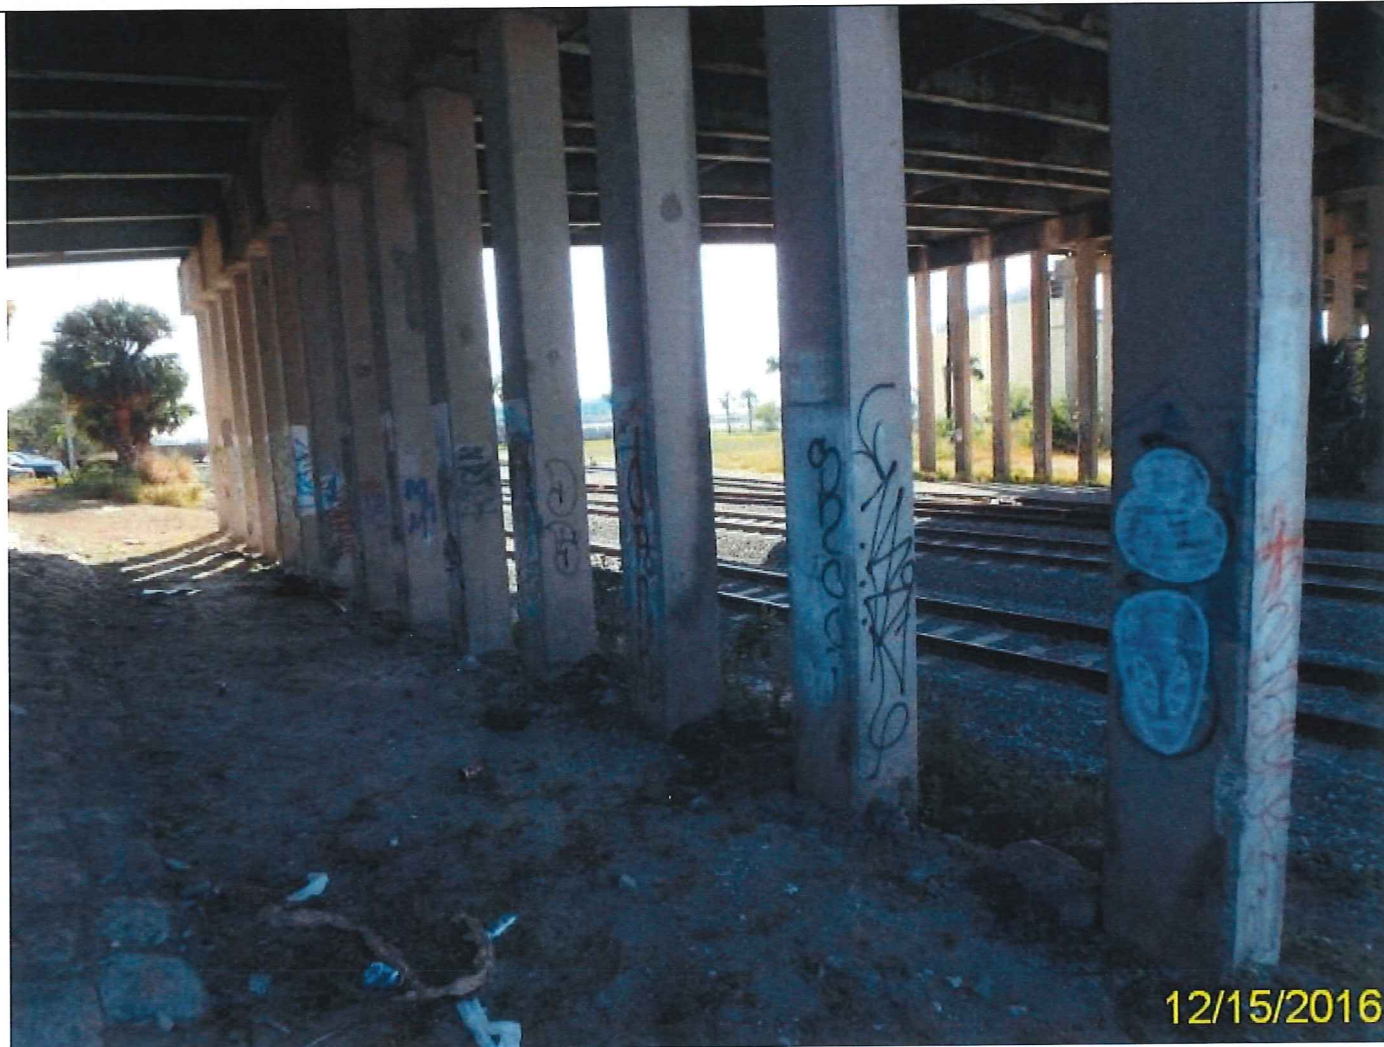
**Photo 12 - Element 226 Pre Conc Pile**

Graffiti on Bent 10 piles

CONDITION STATE		PRIORITY
1, 3	MMS Quantity: 20 mh    Element Estimated Quantity: 5020 ft	3
WORK ORDER RECOMMENDATION: Remove the graffiti on the beams in Span 10. 8MH		
1, 3	MMS Quantity: 36 mh    Element Estimated Quantity: 5020 ft	3
WORK ORDER RECOMMENDATION: Remove graffiti on Bent 8 9 and 10 piles. 16MH

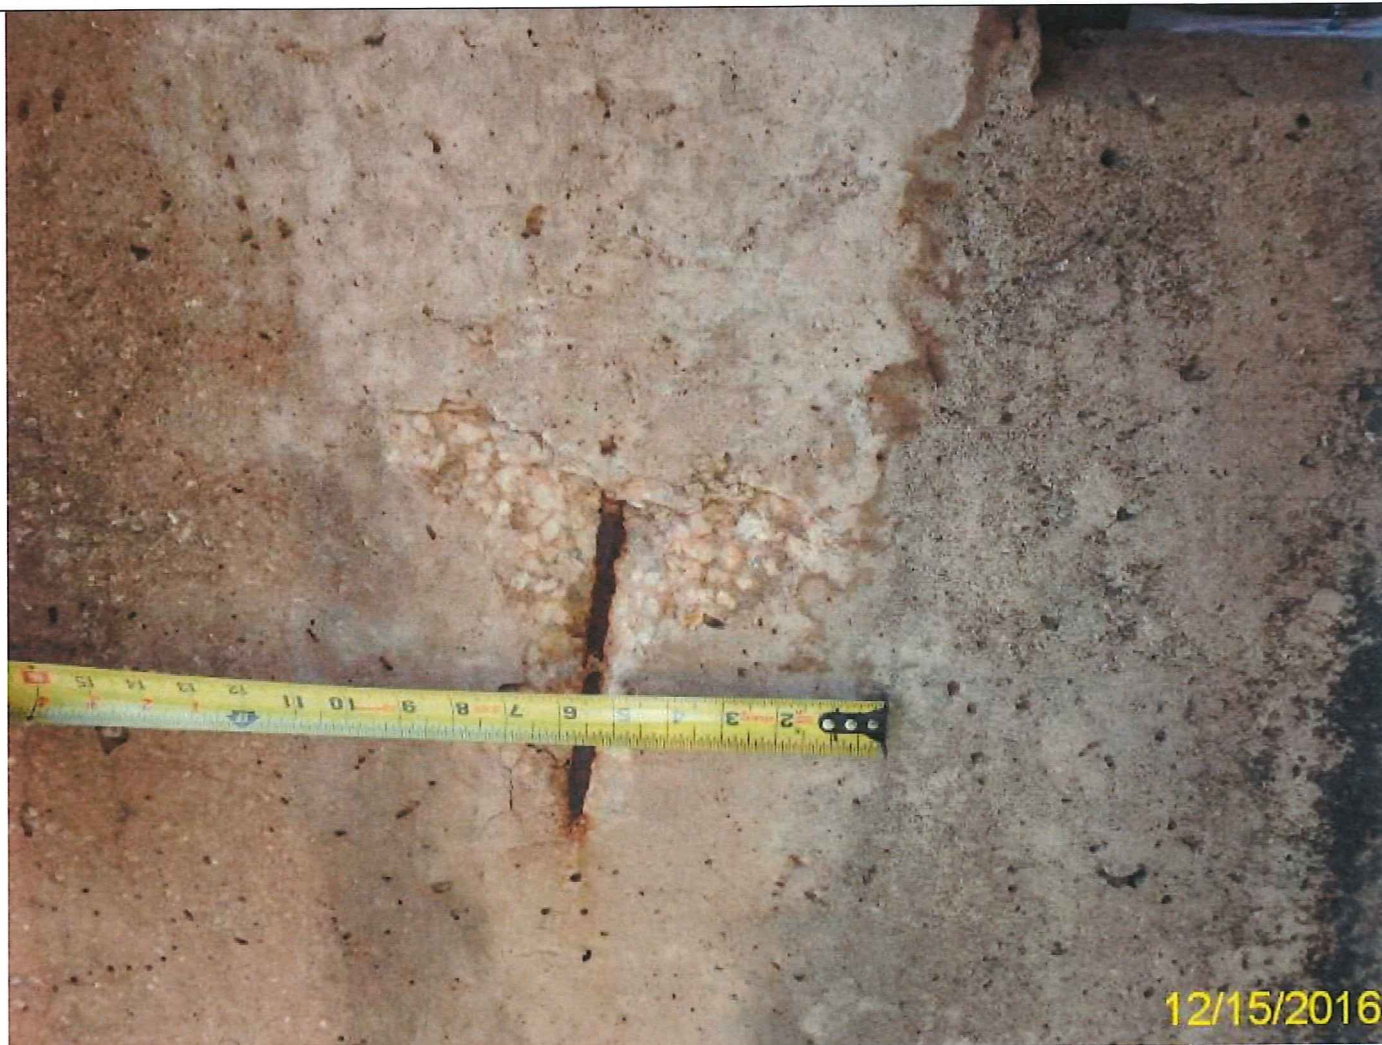
**Photo 13 - Element 234 Re Conc Pier Cap**

234 / 3      CS3:  
Bent 9 cap, east face has a 12in. x 7in. x 3/4in. spall/delamination with exposed rebar over Pile 9-14 - NO CHANGE. Refer to photo 13.

Spall/delamination with exposed rebar in the east face of Bent 9 cap over Pile 9-14

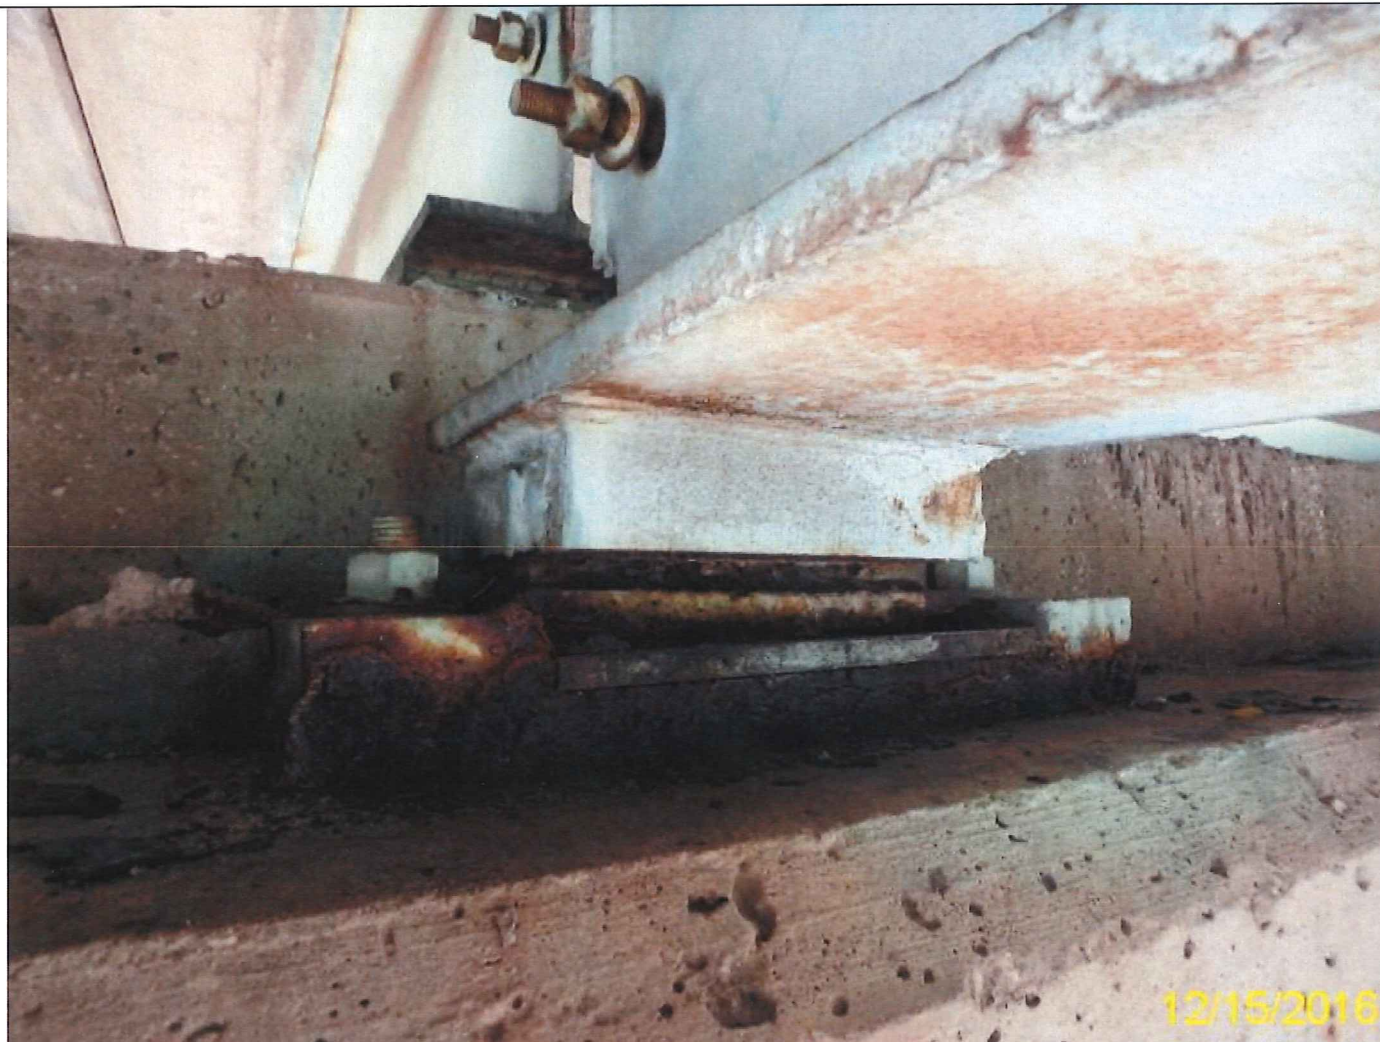
**Photo 14 - Element 311 Moveable Bearing**

The bearings at Bent 9 show heavy flaking corrosion and pitting on the masonry plates and bearing assemblies throughout - INCREASE. Refer to photo 14.

Heavy flaking corrosion and pitting on Beam 9-5 bearing over Bent 9

CONDITION STATE	PRIORITY
2      MMS Quantity: 1200 mh    Element Estimated Quantity: 1200 (SF)	3
WORK ORDER RECOMMENDATION: Clean and paint all moveable bearings. 80MH
