RE: Bridge Inspection Report Submittals to Local Owners  
District Four Bridge Inspection Report

Structure ID: 940047

INSPECTION DATE: 12/15/2016 GAUE

### CR-707 (Citrus Ave.) over FEC Railroad

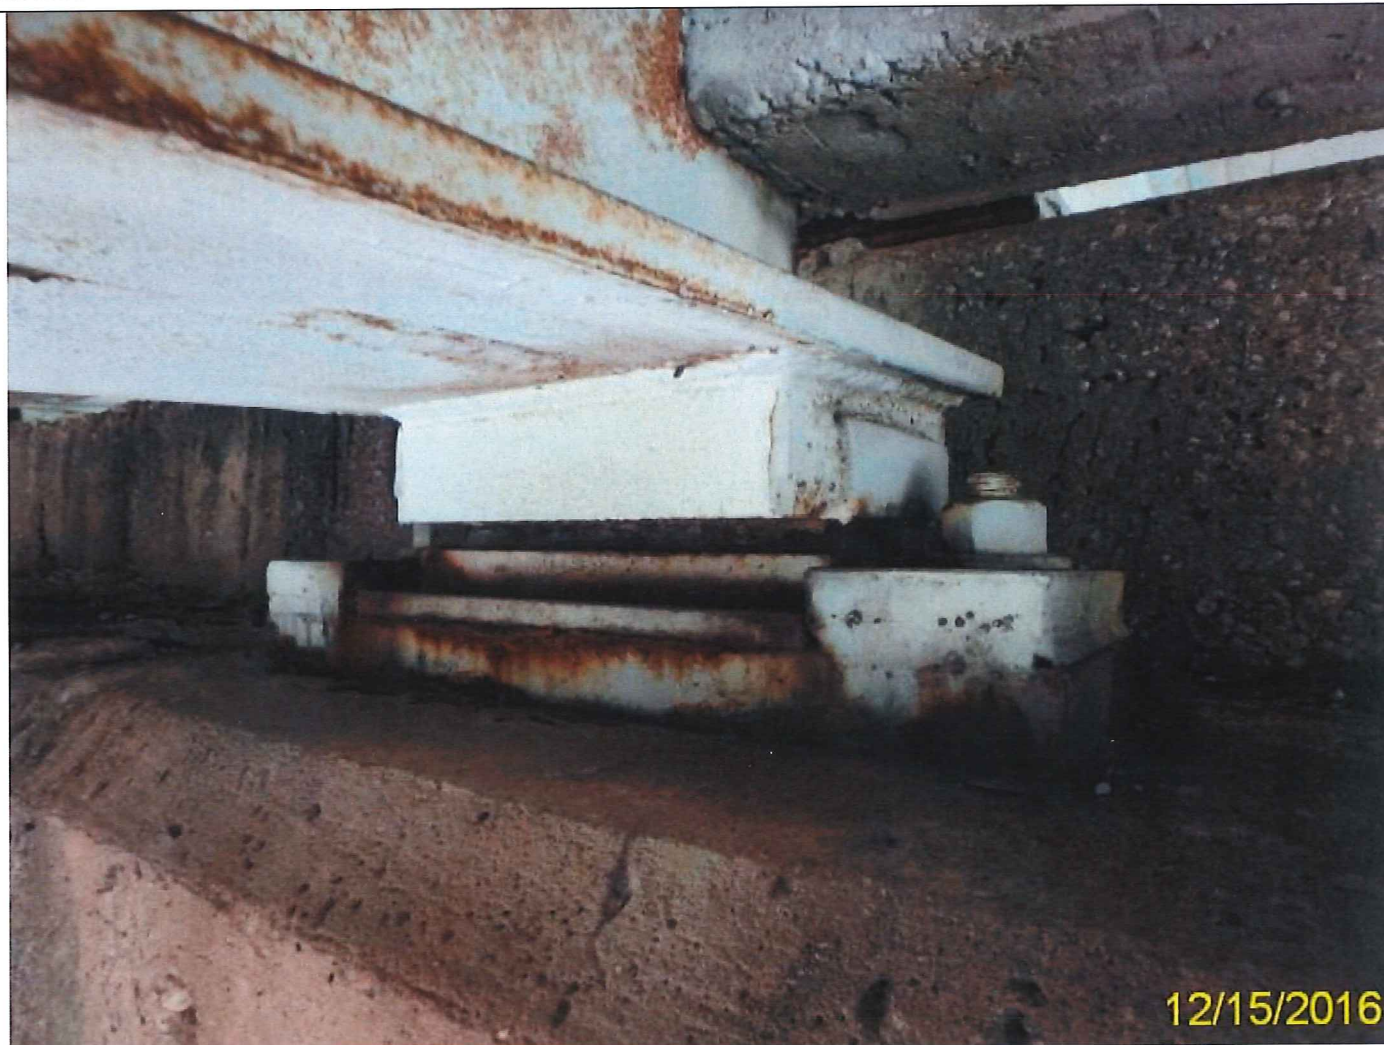
**Photo 15 - Element 311 Moveable Bearing**

Typically, the bearings at the intermediate bents have light to moderate surface corrosion on the masonry plates and bearing assemblies with isolated bearing anchor bolts having moderate to heavy surface corrosion - INCREASE. Refer to photo 15.

The protective coating is deteriorated throughout, with areas of peeling, bubbling and chalking paint along the masonry plate and bearing assemblies - INCREASE. Refer to photo 15.

Typical corrosion on the moveable bearings

CONDITION STATE	PRIORITY
2      MMS Quantity: 1200 mh    Element Estimated Quantity: 1200 (SF)	3
WORK ORDER RECOMMENDATION: Clean and paint all moveable bearings. 80MH

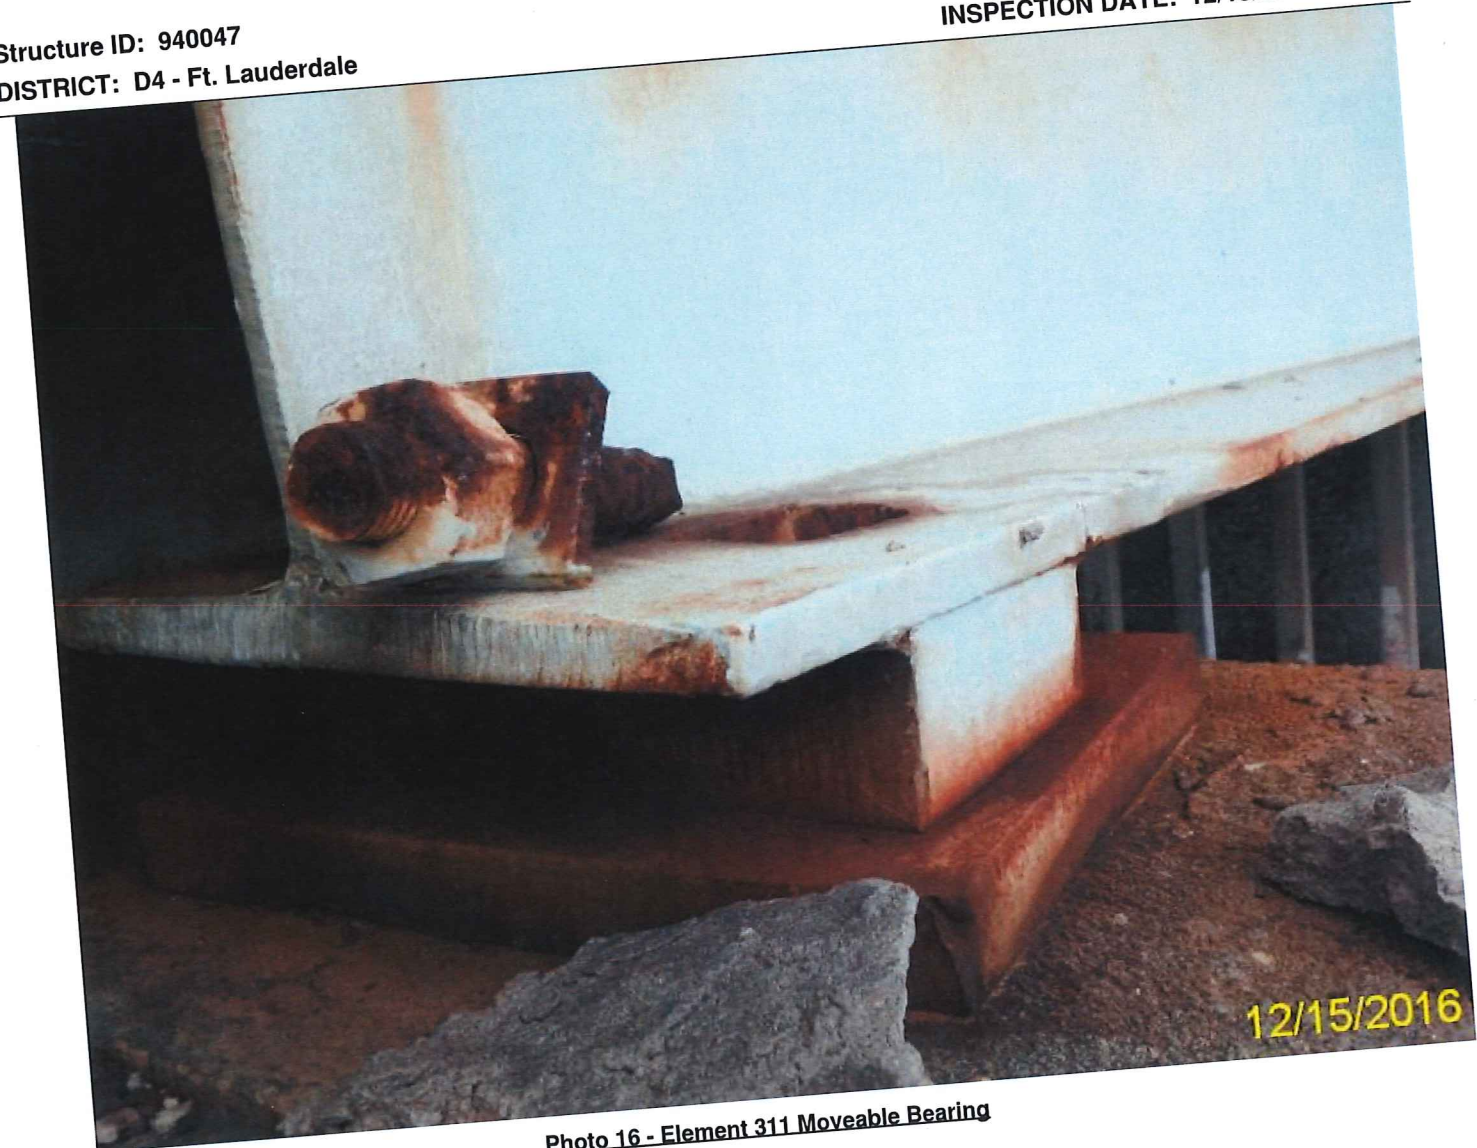
**Photo 16 - Element 311 Moveable Bearing**

South anchor bolt for Bearing 9-10 sheared

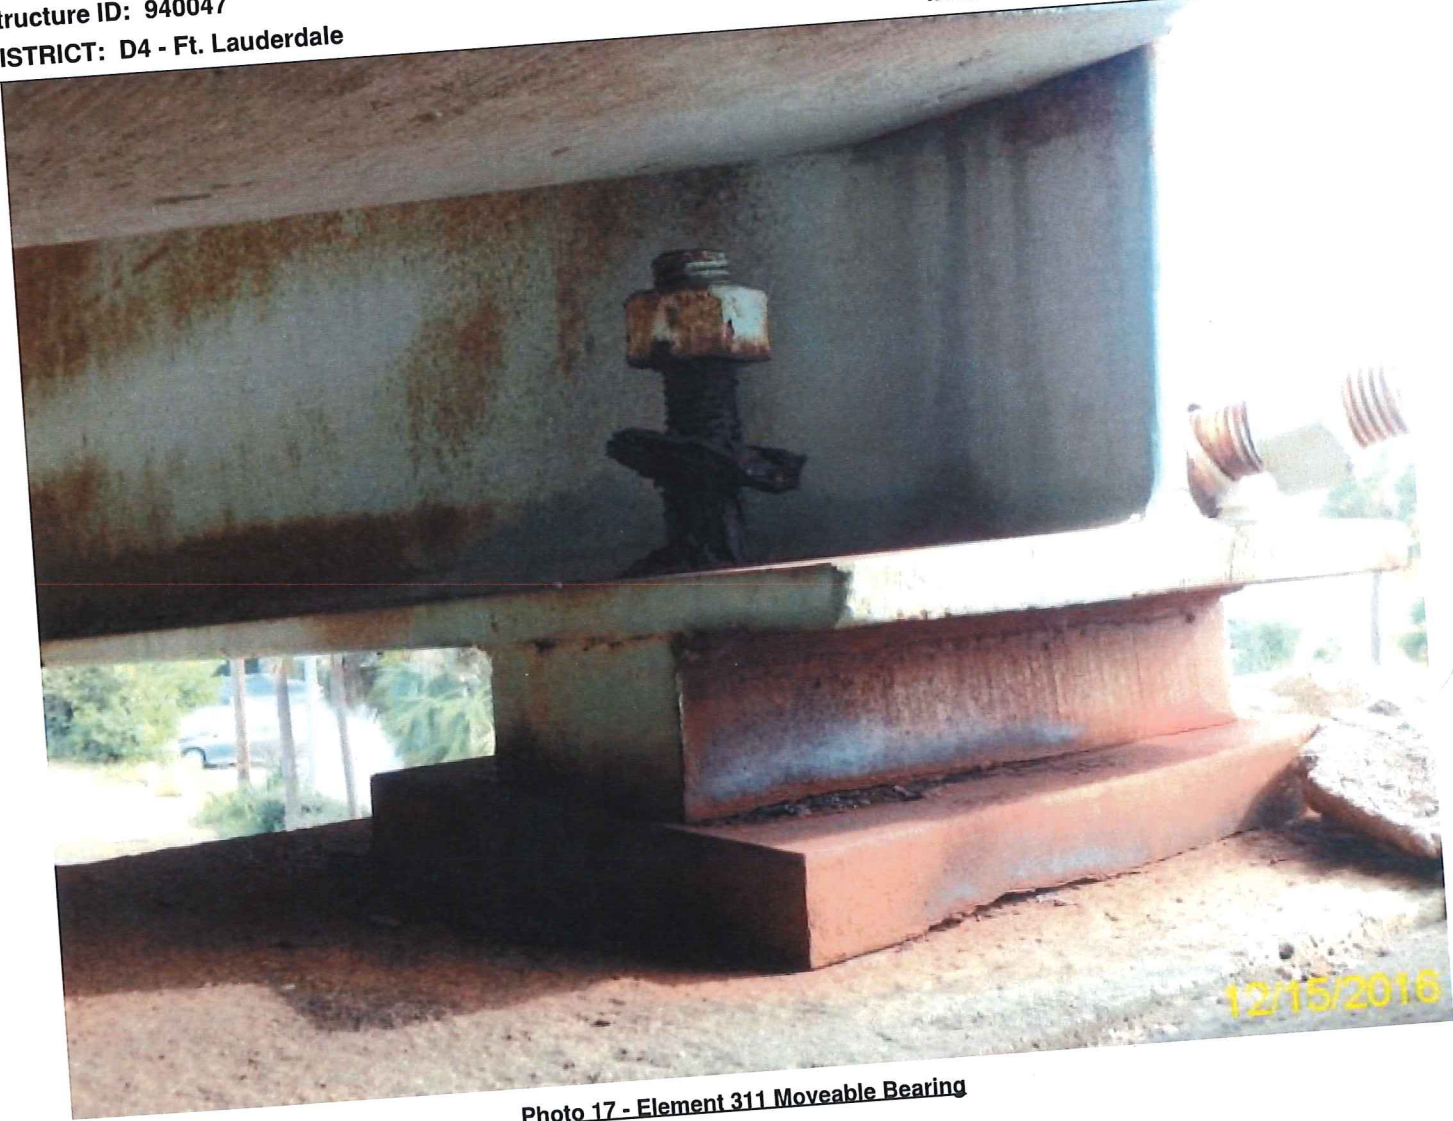
**Photo 17 - Element 311 Moveable Bearing**

The north anchor bolt nut for Bearing 9-10 is not fully seated and the bolt has heavy surface corrosion - NO CHANGE. Refer to photo 17.

North anchor bolt for Bearing 9-10 not fully seated

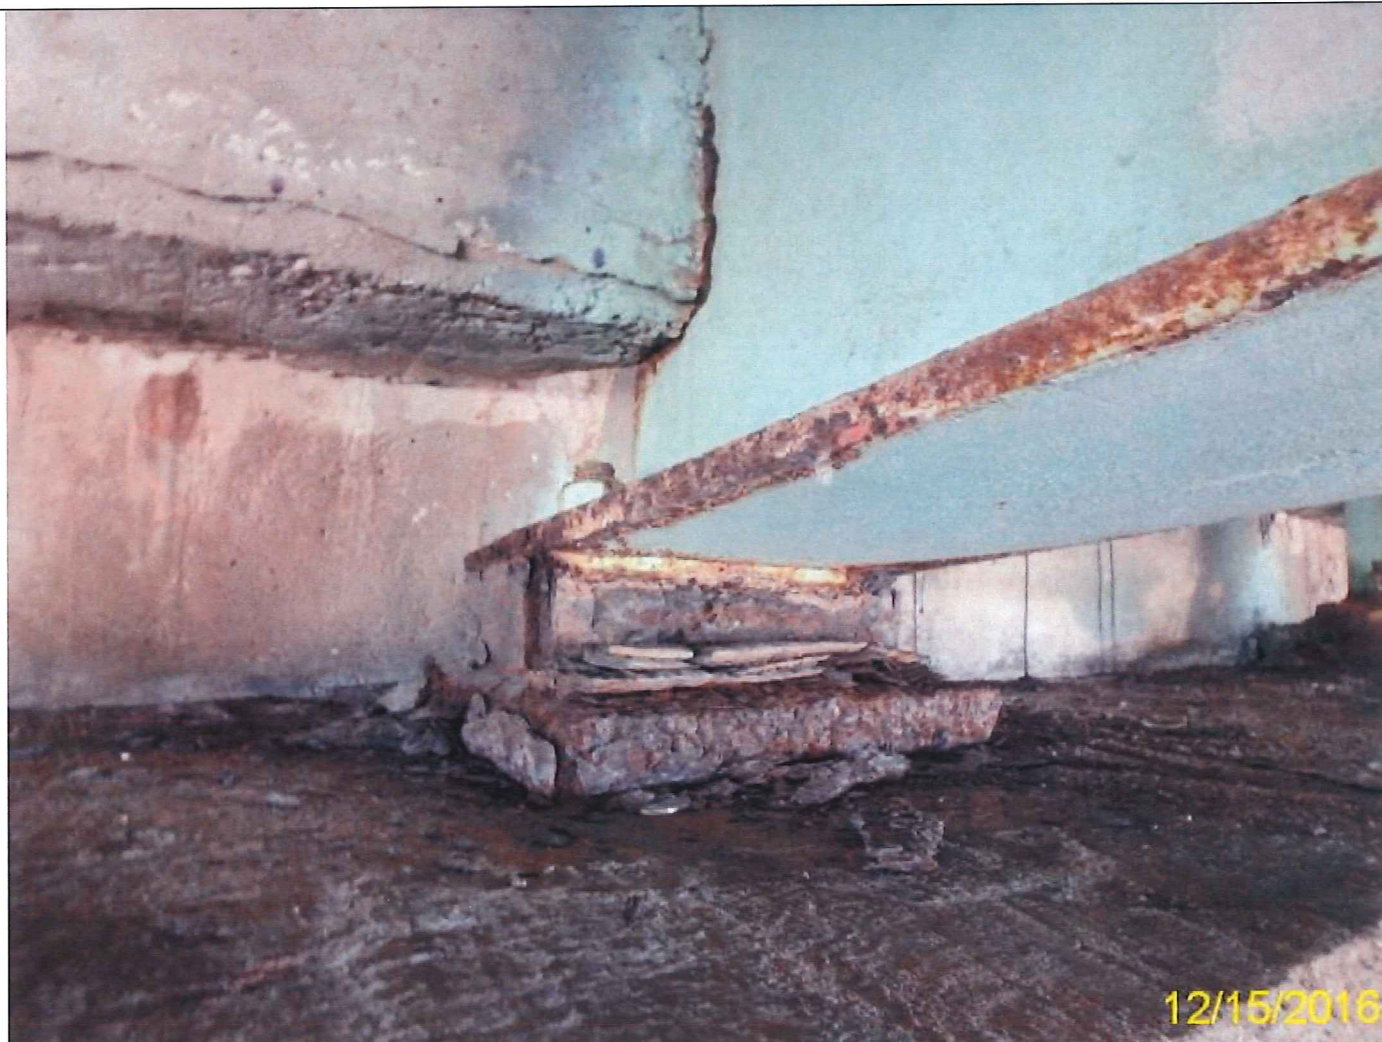
**Photo 18 - Element 313 Fixed Bearing**

The fixed bearings for the beams at Abutment 1, Beams 6-5, 6-6, 6-9, 7-4, 7-5, 7-6, 7-7, 7-8, 8-3, 8-4, 10-2, 10-3, 10-5, 10-6, 10-7, 10-8 and for the beams at Abutment 11 have heavy flaking corrosion on the masonry plates and bearing assemblies with pitting/section loss anywhere from 1/8in. to 3/16in. deep - INCREASE. Refer to photo 18.

Heavy flaking corrosion with pitting (Bearing 10-5 at Bent 10 shown)

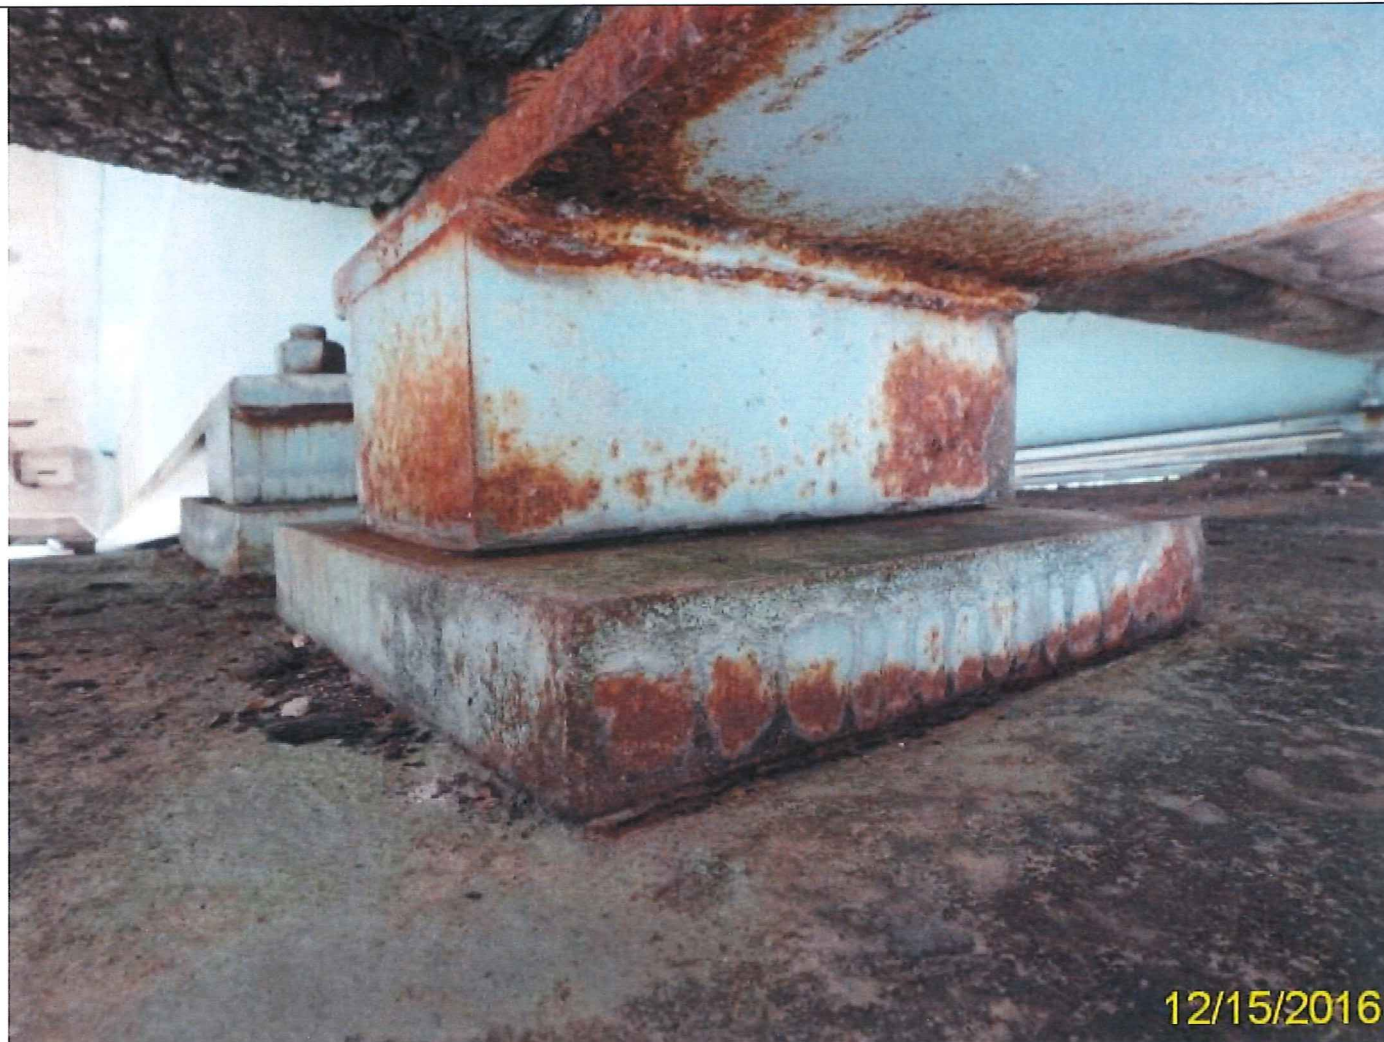
**Photo 19 - Element 313 Fixed Bearing**

Typically, the bearings at the intermediate bents have light to moderate surface corrosion on the masonry plates and bearing assemblies with isolated bearing anchor bolts having moderate to heavy surface corrosion - NO CHANGE. Refer to photo 19.

The protective coating is deteriorated throughout, with areas of peeling, bubbling and chalking paint along the masonry plate and bearing assemblies - INCREASE. Refer to photo 19.

Typical corrosion on the fixed bearings (Bearing 3-9 at Bent 3 shown)

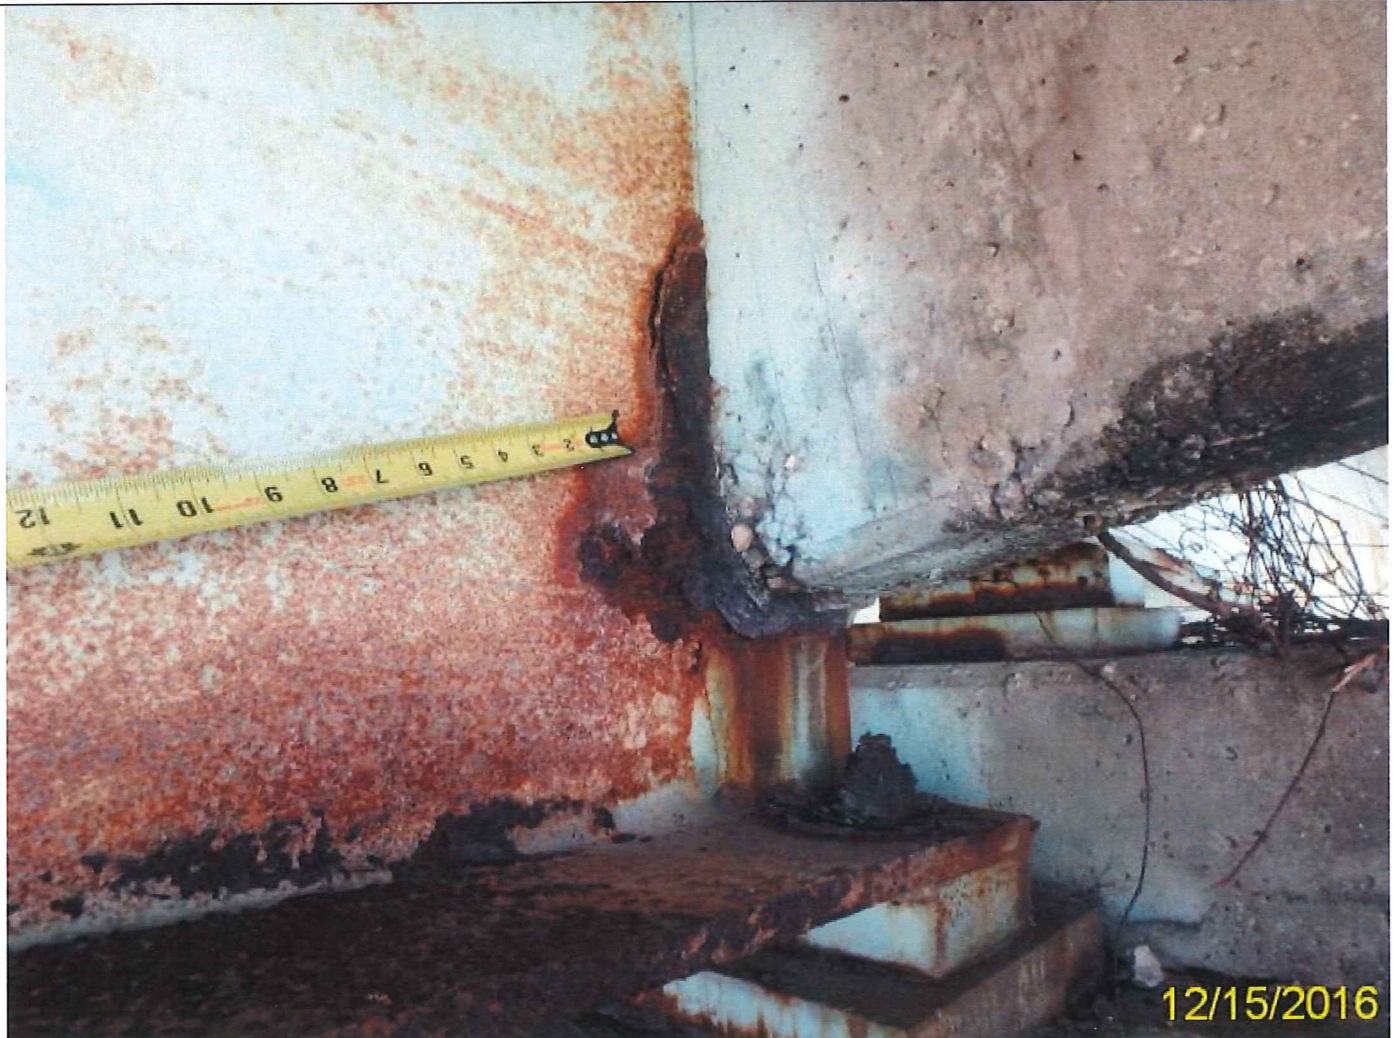
**Photo 20 - Element 107 Steel Opn Girder/Beam**

In the beam ends, corrosion is accelerated due to the deteriorated intermediate bent expansion joints - INCREASE.

The web of the beams at the end diaphragms and several intermediate diaphragms have areas of heavy flaking corrosion up to 8in. long x up to 4in. wide with pitting up to 1/8in. deep - INCREASE. Refer to photo 20.

Typical heavy flaking corrosion on the web of the beams at the diaphragms (Beam 6-3 shown)

CONDITION STATE		PRIORITY
1, 3	MMS Quantity: 16735 mh    Element Estimated Quantity: 5020 (SF)	3
WORK ORDER RECOMMENDATION: Clean and paint the steel beams. 80MH

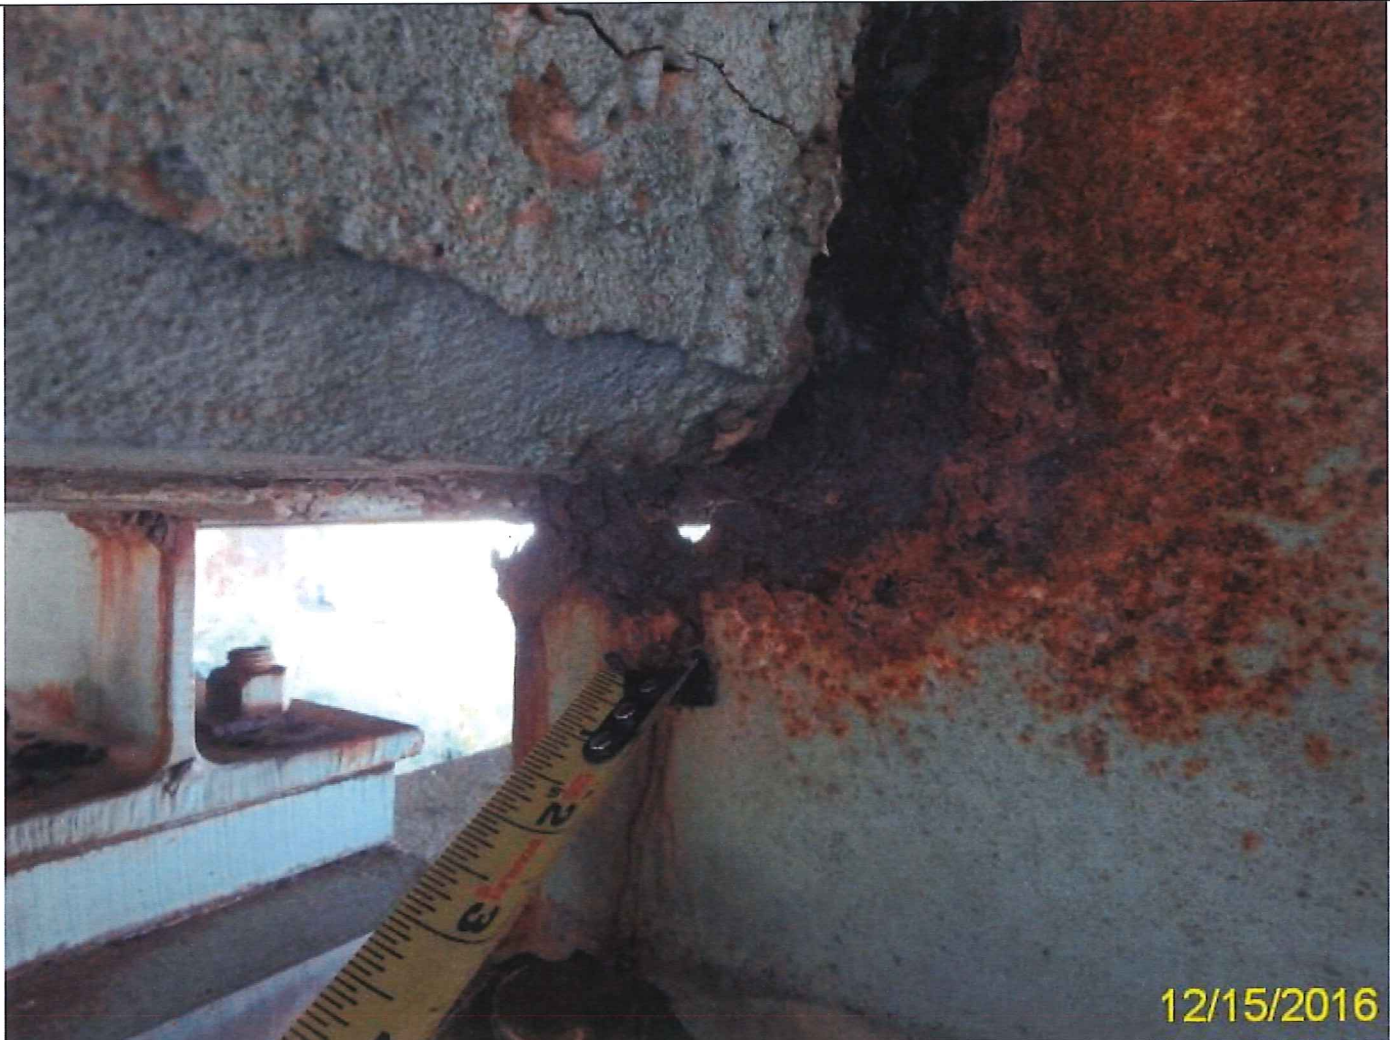
**Photo 21 - Element 107 Steel Opn Girder/Beam**

Beam 3-2 has a 1in. diameter corrosion through hole in the web at the end diaphragm over Bent 3 - NEW.

Beam 4-2 has a 2-1/2in. diameter corrosion through hole in the web at the end diaphragm over Bent 4 - NO CHANGE. Refer to photo 21.

Through hole in the web of Beam 3-2 at Bent 3

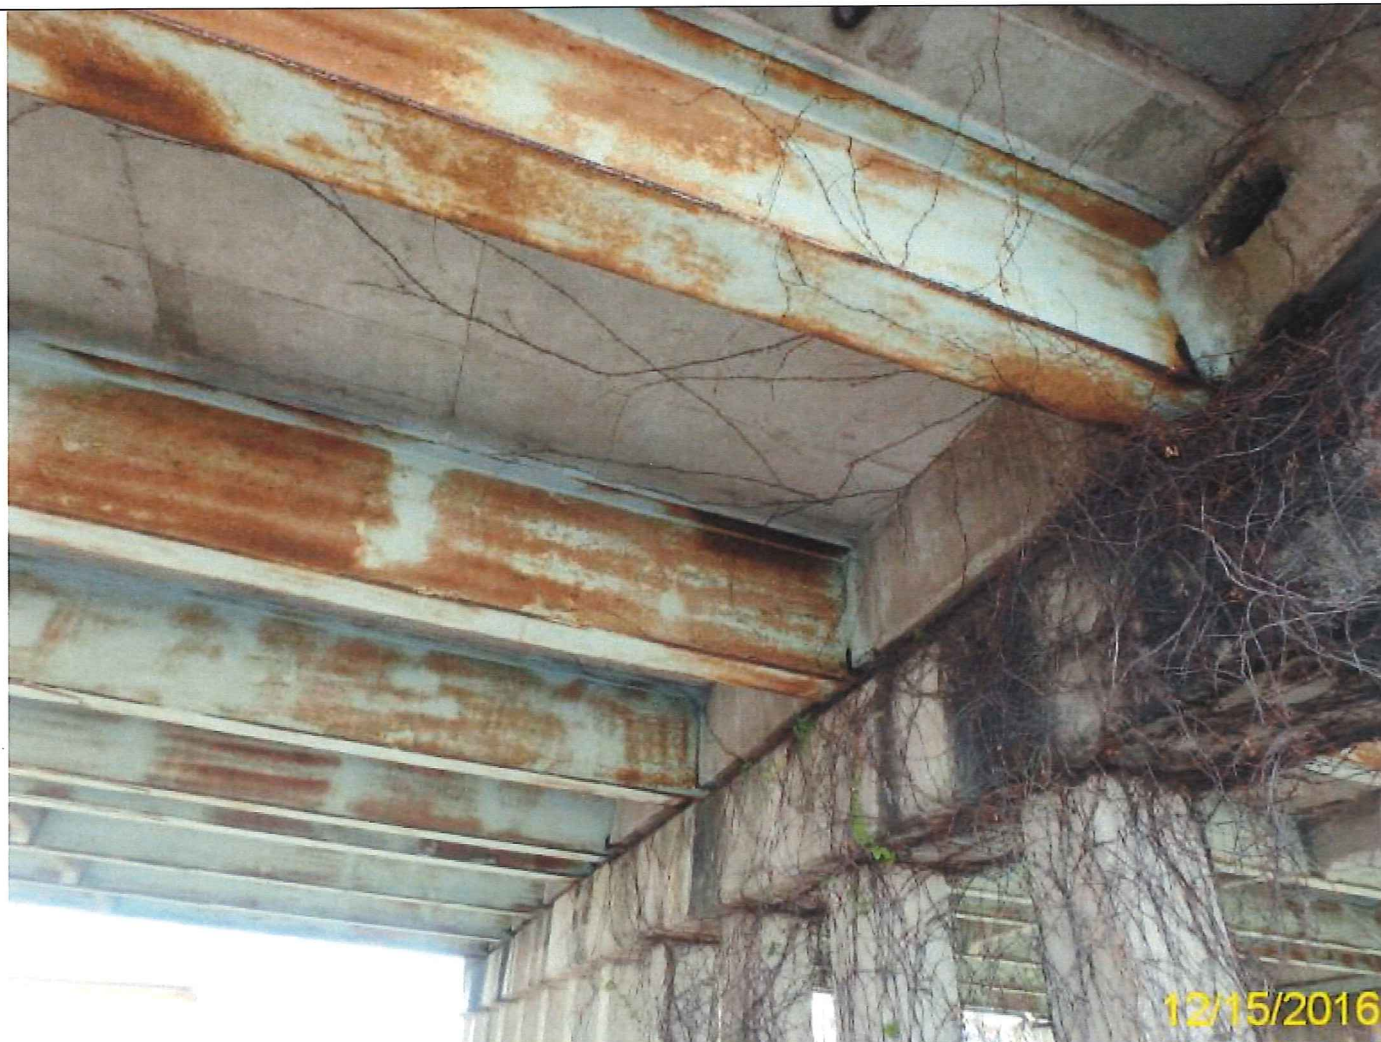
**Photo 22 - Element 107 Steel Opn Girder/Beam**

The beams have moderate surface corrosion along the bottom face of the bottom flanges and on the webs intermittently throughout - INCREASE. Refer to photo 22.

The protective coating is deteriorated throughout, with areas of peeling, bubbling and chalking paint along the webs, top and bottom flanges - INCREASE. Refer to photo 22.

Typical surface corrosion on the web and bottom flange of the beams

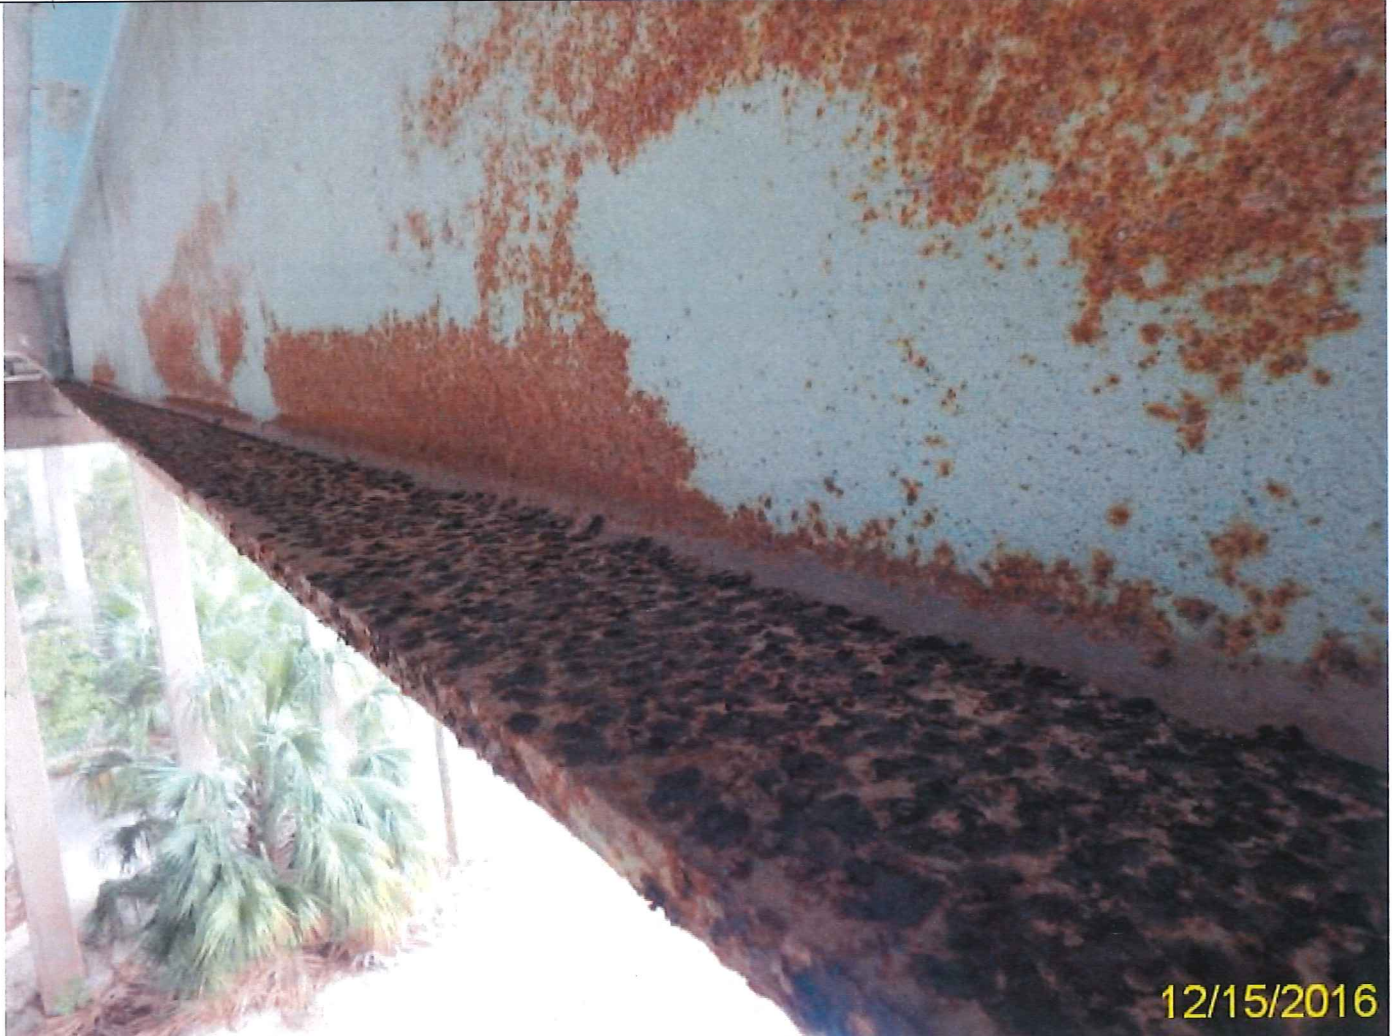
**Photo 23 - Element 107 Steel Opn Girder/Beam**

The top face of the bottom flanges has random areas of moderate to heavy flaking corrosion throughout - INCREASE. Refer to photo 23.

Typical heavy flaking corrosion on the top face of the bottom flange of the beams (Beam 3-8 shown)

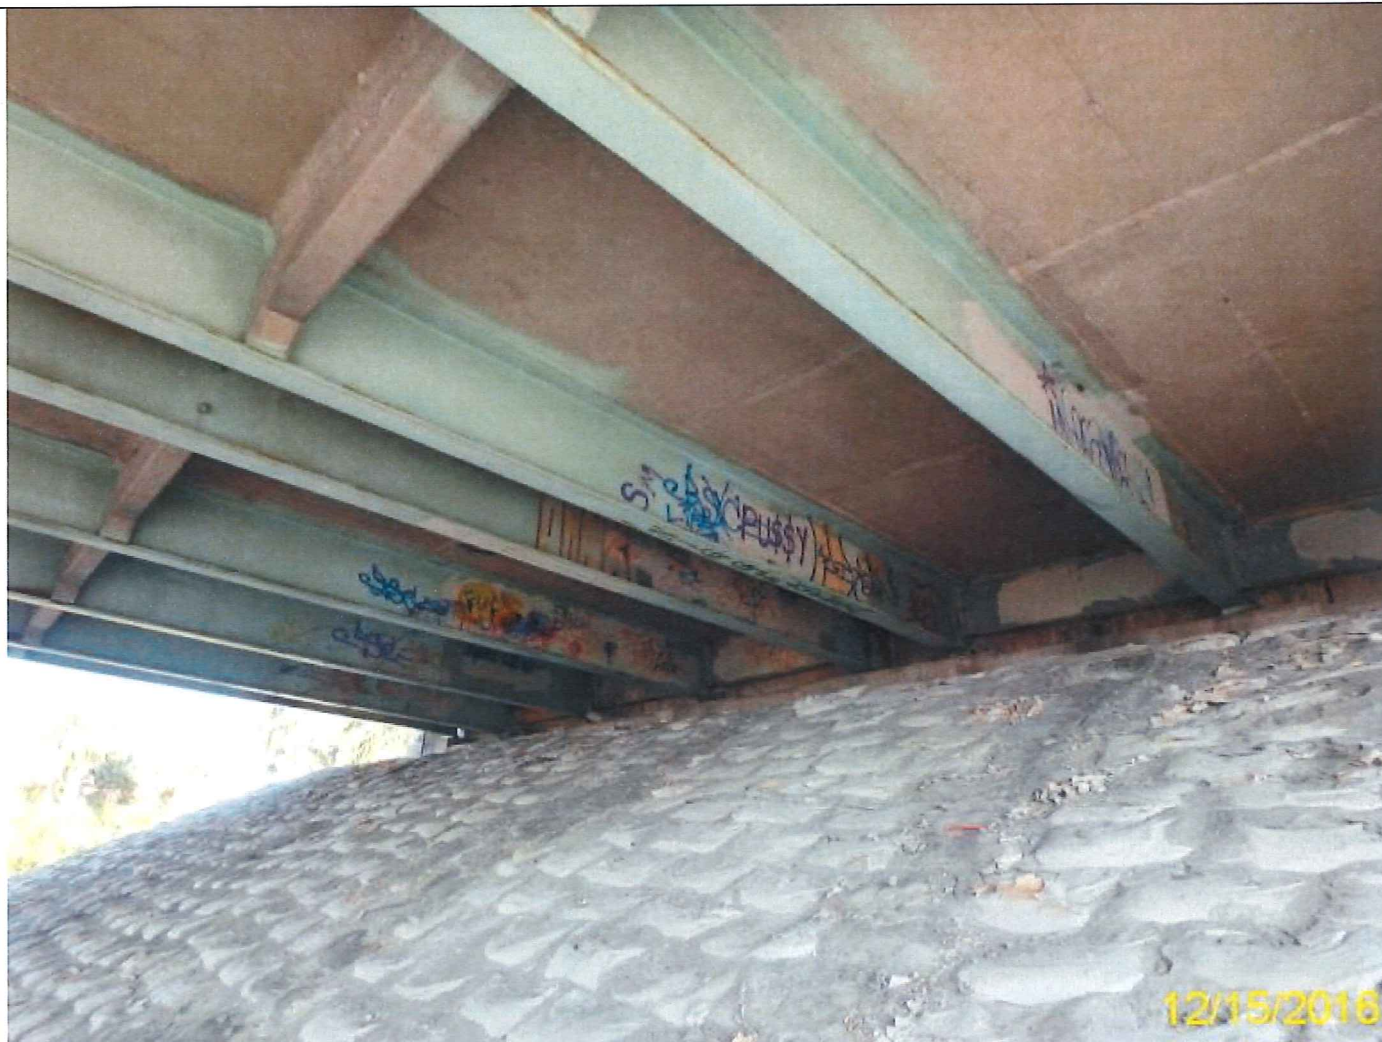
**Photo 24 - Element 107 Steel Opn Girder/Beam**

Graffiti on the beams in Span 10

CONDITION STATE		PRIORITY
1, 3	MMS Quantity: 20 mh    Element Estimated Quantity: 5020 ft	3
WORK ORDER RECOMMENDATION: Remove the graffiti on the beams in Span 10. 8MH		
1, 3	MMS Quantity: 36 mh    Element Estimated Quantity: 5020 ft	3
WORK ORDER RECOMMENDATION: Remove graffiti on Bent 8 9 and 10 piles. 16MH

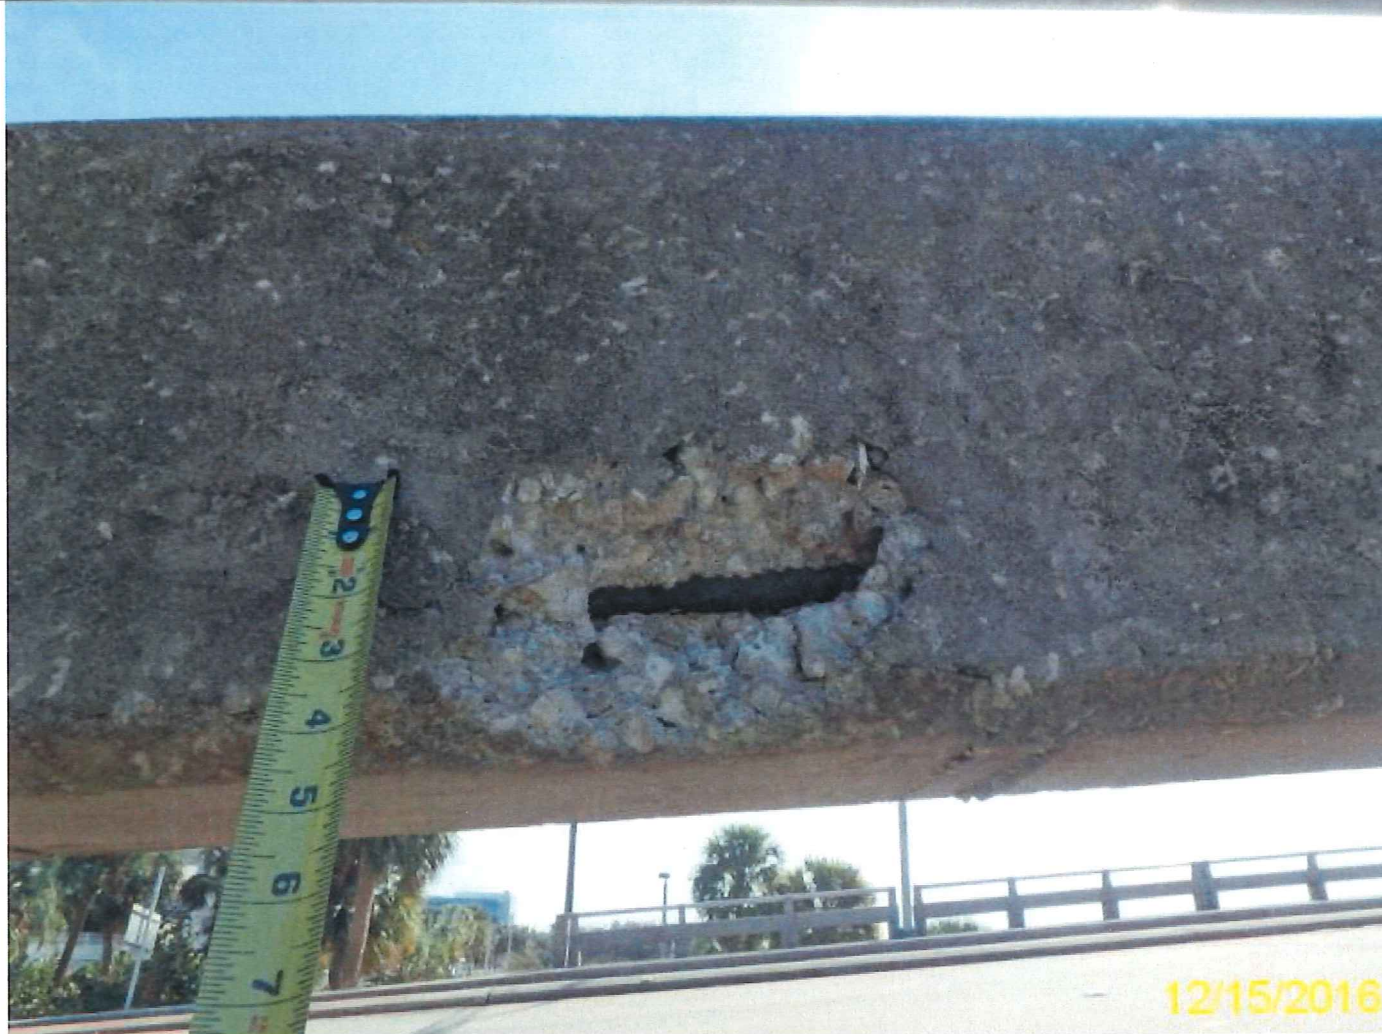
**Photo 25 - Element 333 Other Bridge Railing**

Bridge rail Panel 10-6 Left has a 6in. x 6in. x 1in. spall with exposed rebar in the bottom north edge – NO CHANGE. Refer to photo 25.

Spall with exposed rebar in Span 10 left rail

CONDITION STATE		PRIORITY
3	MMS Quantity: 19 lf    Element Estimated Quantity: 1004 each	3
WORK ORDER RECOMMENDATION: Repair the spalls with exposed rebar in the bridge rail panels. 40MH

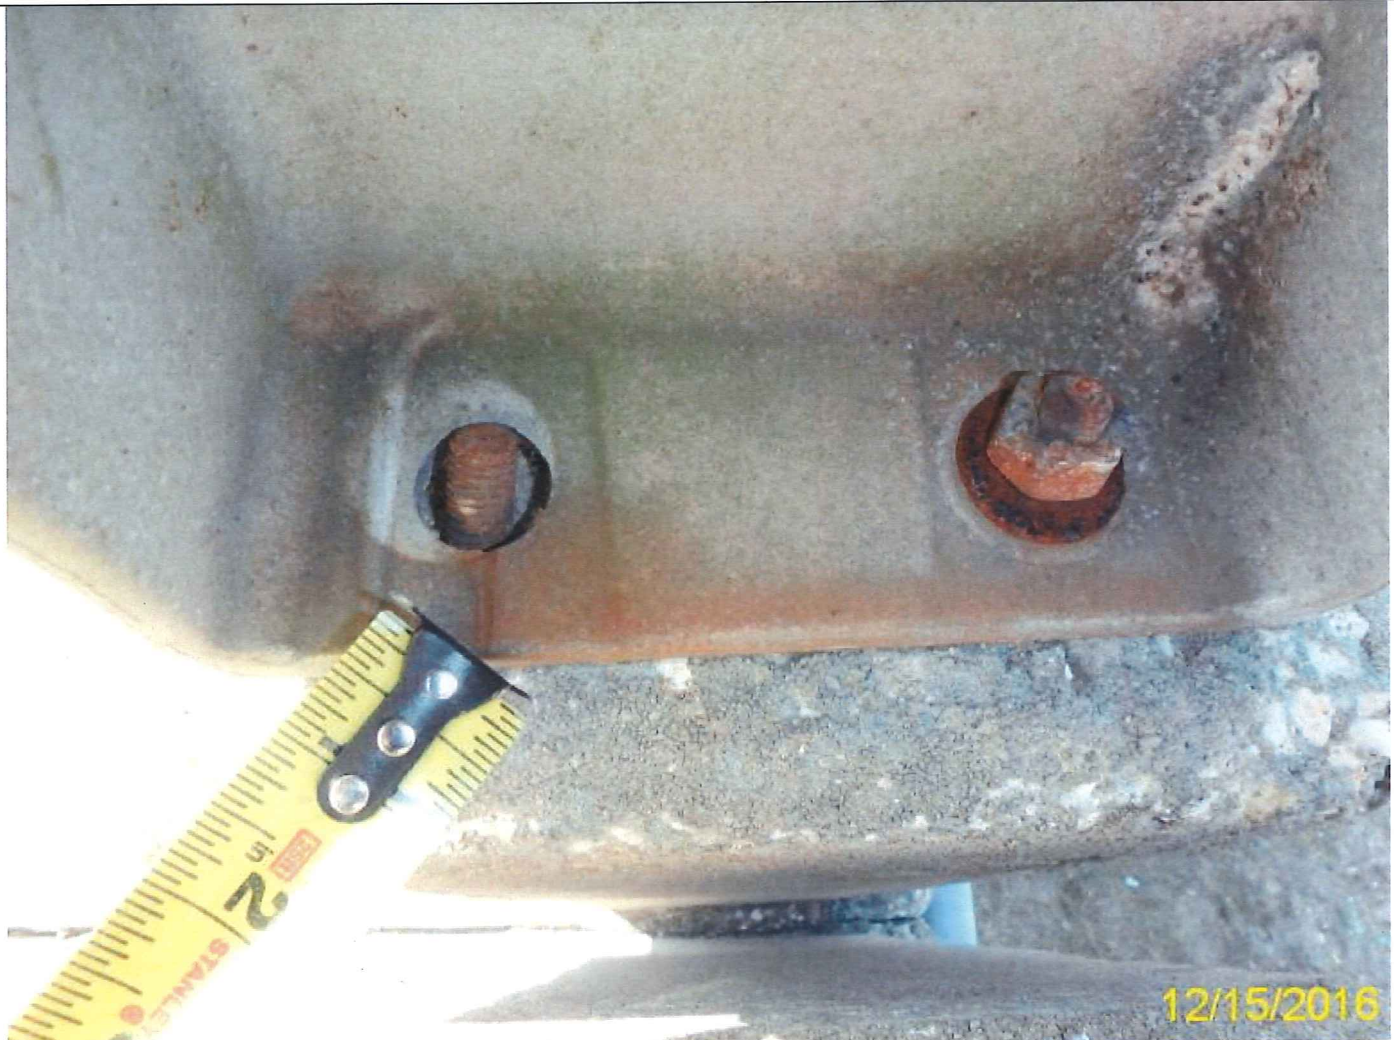
**Photo 26 - Element 333 Other Bridge Railing**

Stanchions 4-3 Left, 8-3 Left, 10-8 Left, 10-7 Right, and 10-8 Right are each missing one of four anchor bolt nuts – NO CHANGE. Refer to photo 26.

Typical missing anchor bolt nut for the bridge rail stanchions.

CONDITION STATE		PRIORITY
1, 2, 3	MMS Quantity: 176 lf    Element Estimated Quantity: 1004 ft	3
WORK ORDER RECOMMENDATION: Install missing anchor bolt nuts at Stanchions 8-3 left 10-8 left 10-7 left and 10-8 right. 4MH
