## Inspection Report

### Women's Care Center

**Property Address:**  
1009 Delaware Ave  
Ft. Pierce Fl.

**Date:** 4/26/2019

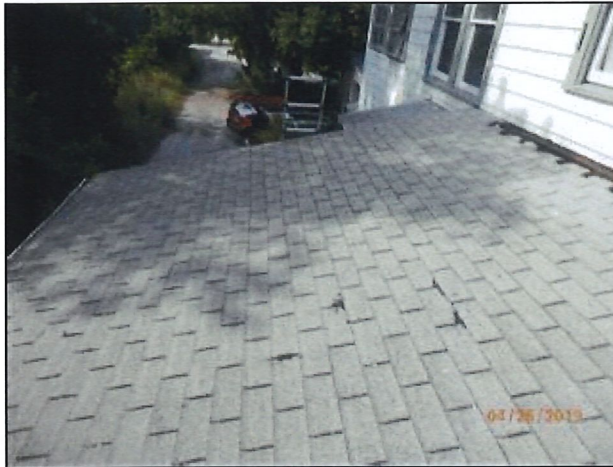
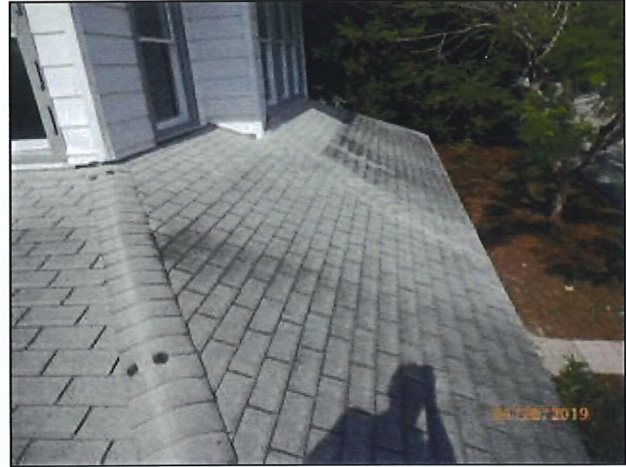
2.0

The 3 tab fiberglass roof was installed in 2004 with a permit. The roof is in poor condition. A 3 tab roof usually lasts a bout 15 years. It needs to be replaced.

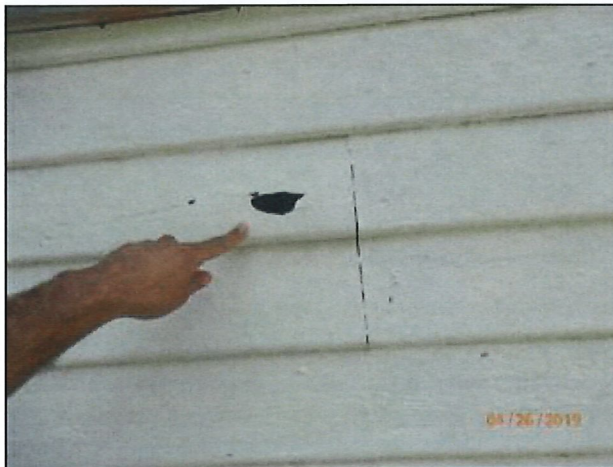
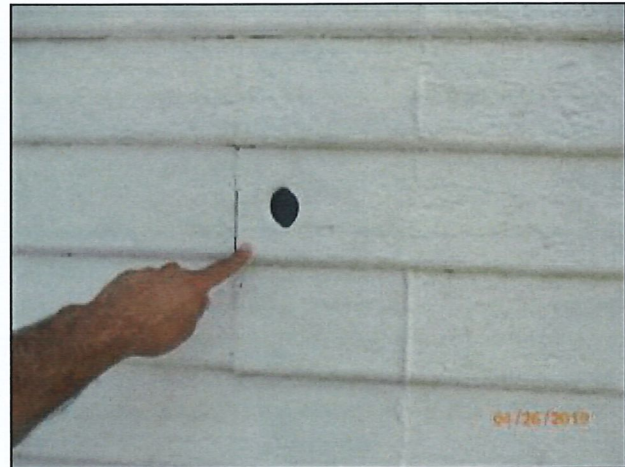
3.0

**Comments:** Inspected, Repair or Replace  
There were siding boards that need repair.

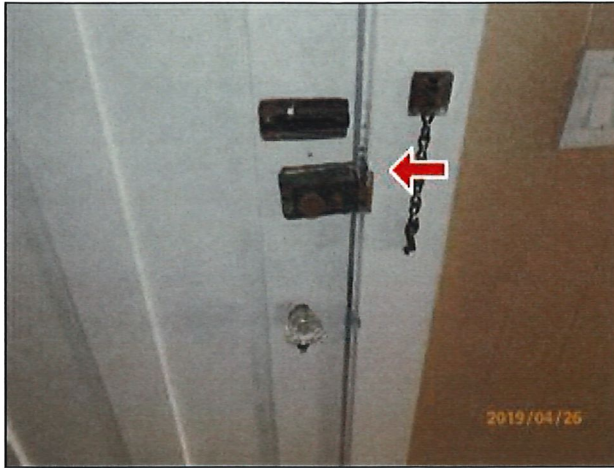
3.1

**Comments:** Inspected, Repair or Replace  
The kitchen walk out door is an out swing door installed as an inswing.

The front door lock did not work and the door could not be tested.

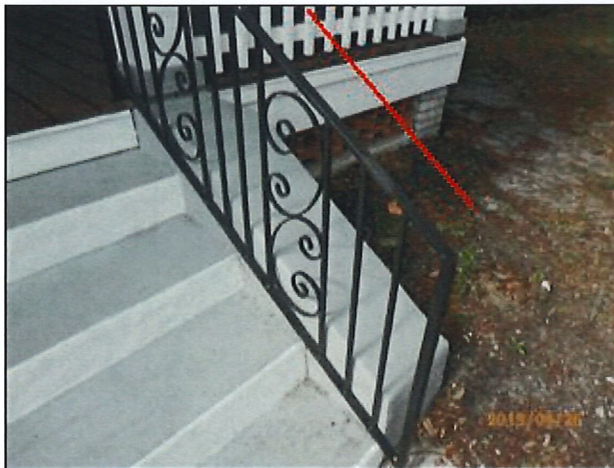
3.3

The handrail on the front entry steps is lower than today's code. There is no handicap access to the house. The bathrooms are not handicap accessible or protected.

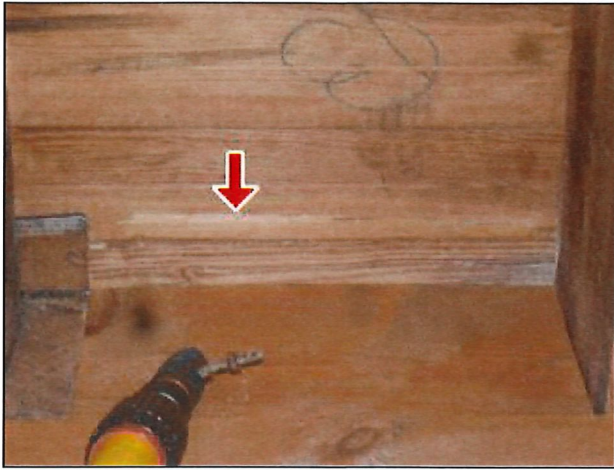
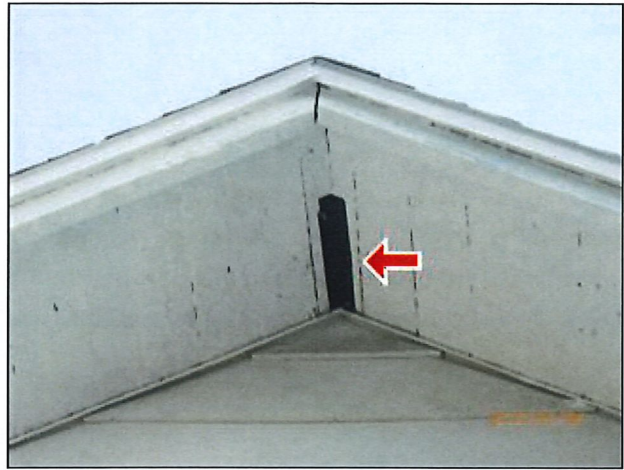
3.4

Inspect related damage on the soffit in the front porch area.

A piece of soffit is missing in the rear.

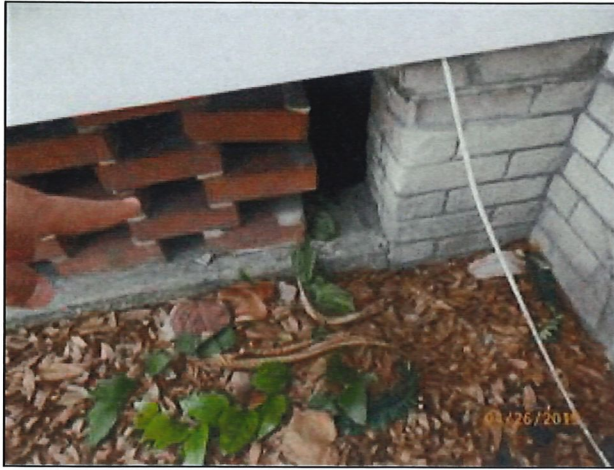
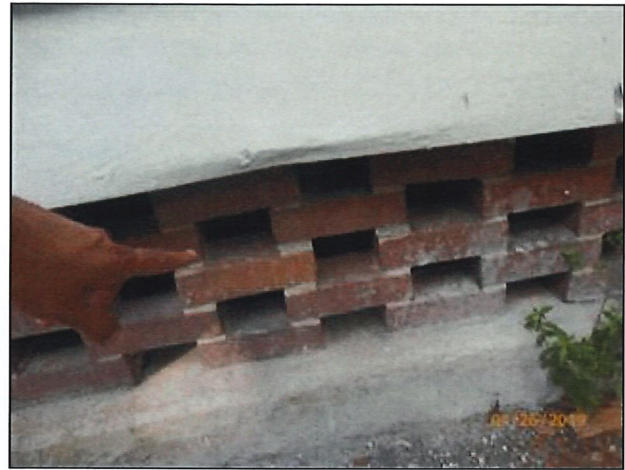
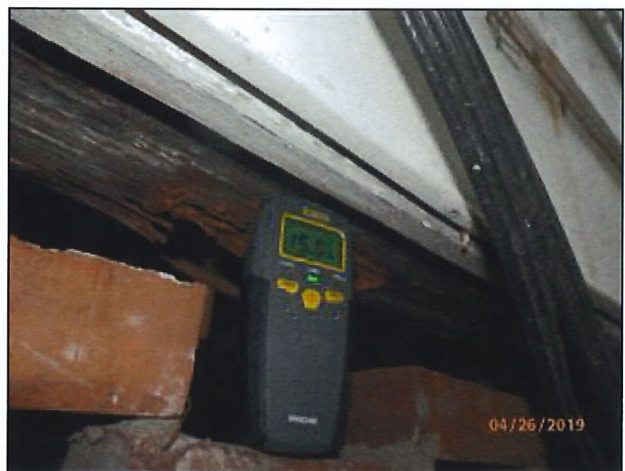
4.0

No access to the crawl space.

There were areas at the crawlspace bricks that need repair. There was no access to get under the house.

There were damaged floor beams in the crawlspace.

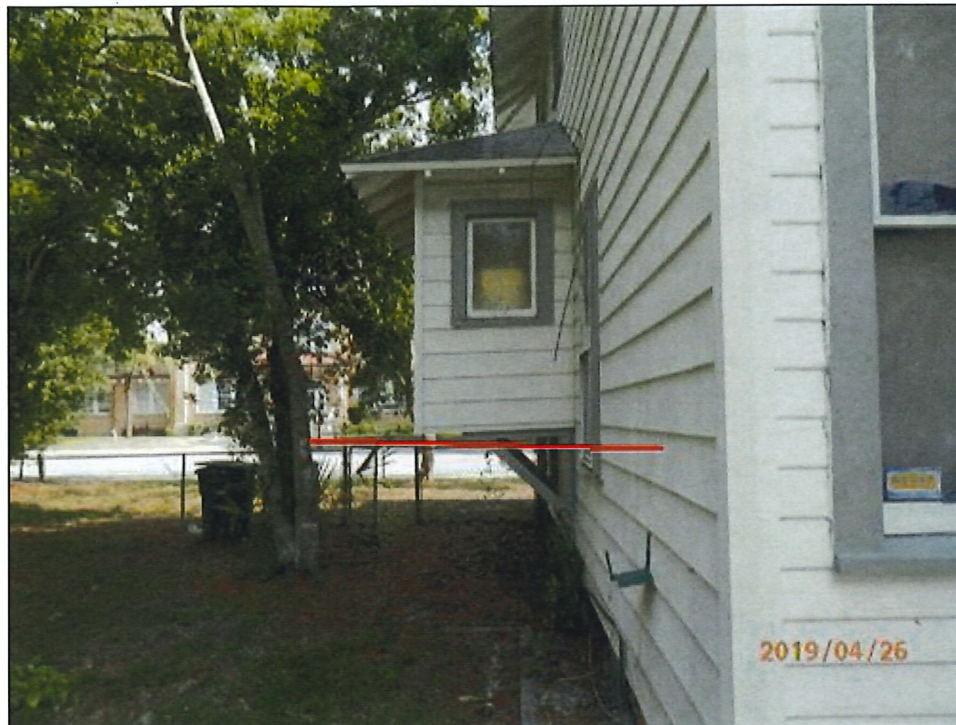
4.3

The stairwell alcove is sagging. It needs to be braced up.

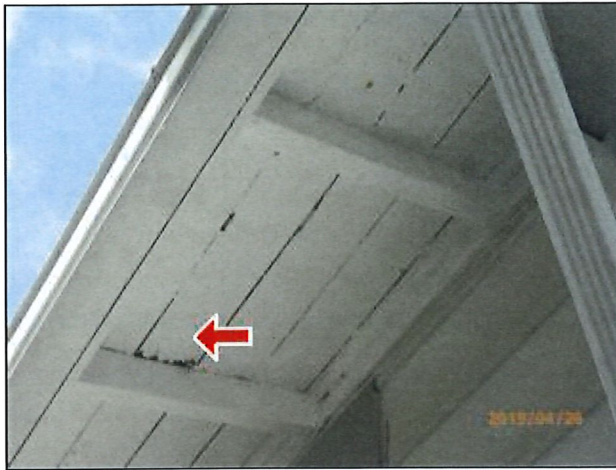
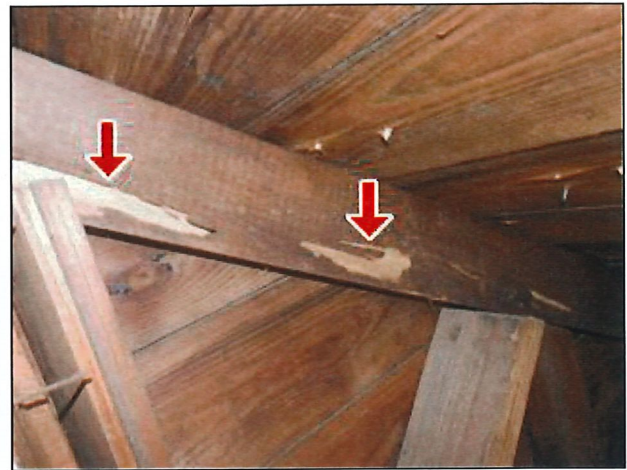
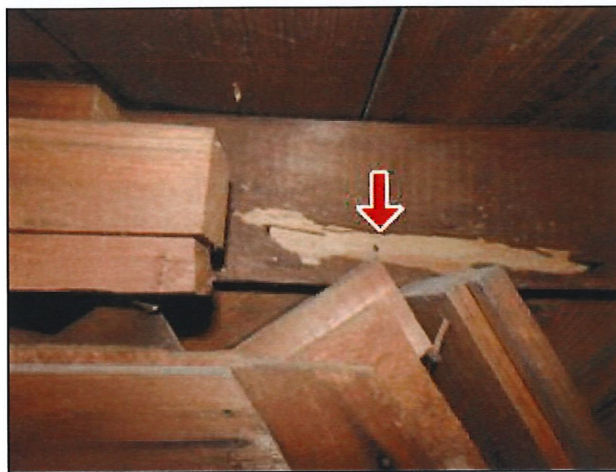
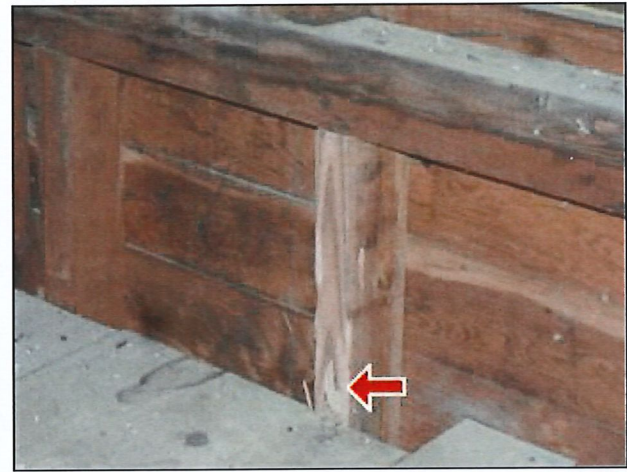
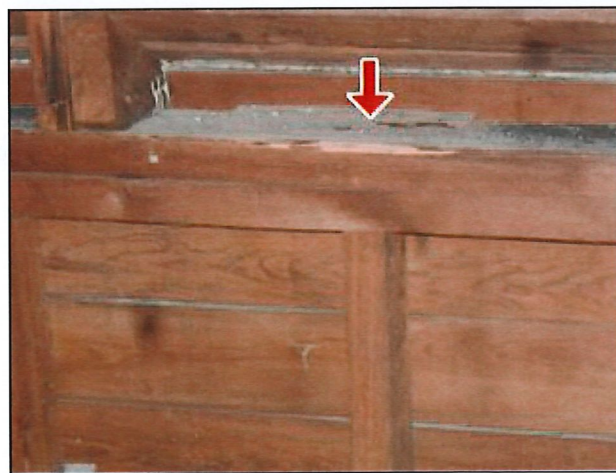
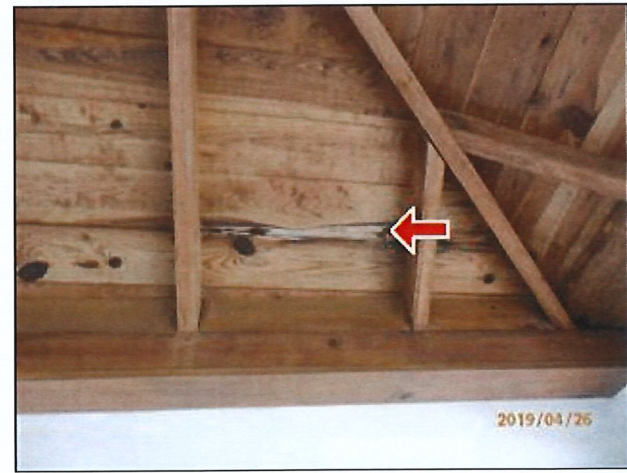
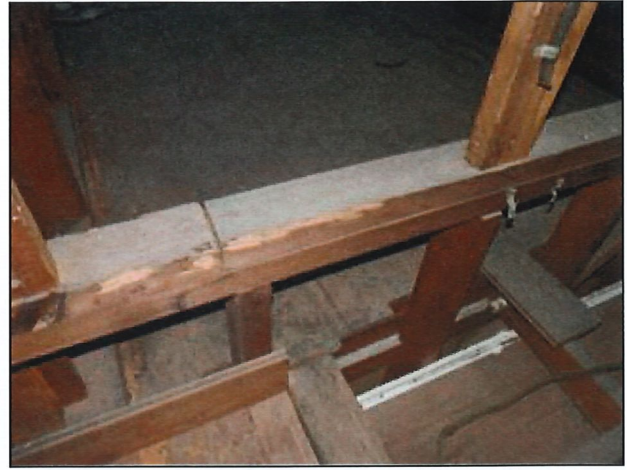
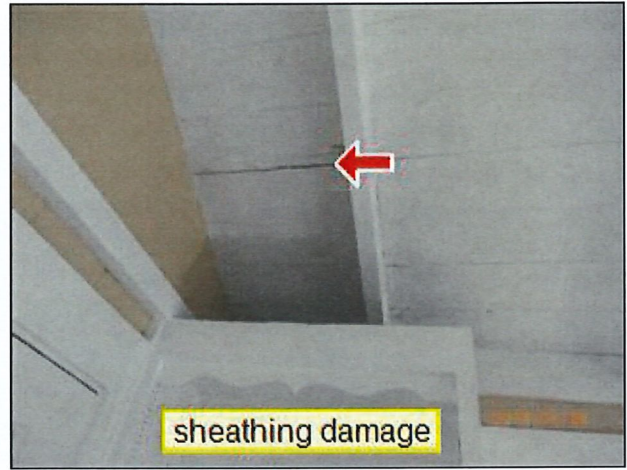
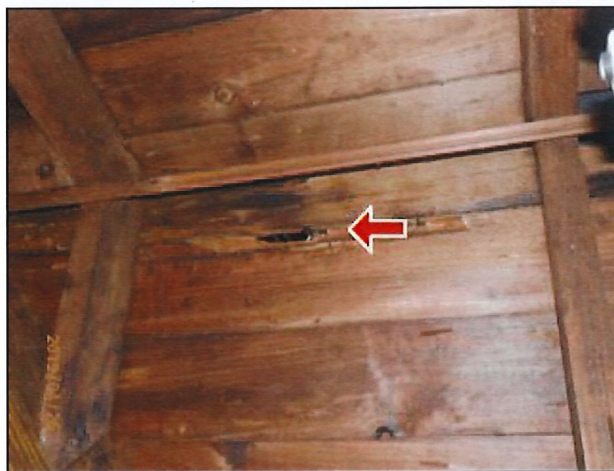
4.5

There is damage to the roof sheathing in numerous places.

There are signs of insect related damage to structural members in the attic space. It is recommended to have a licensed GC inspect and provide a repair estimate.

The gable ridge board is sagging.

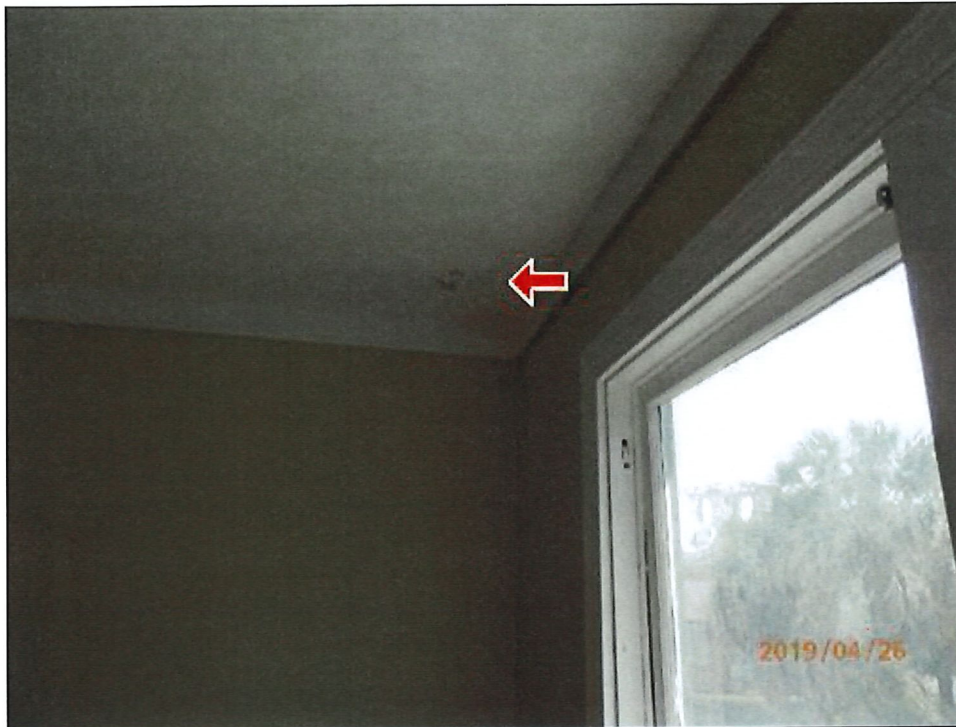
5.0

There are stains on the ceiling upstairs in a bedroom. It is believed they are from rodents.

Staining on the 2nd floor bedroom ceiling is from rodent droppings above in the attic space.

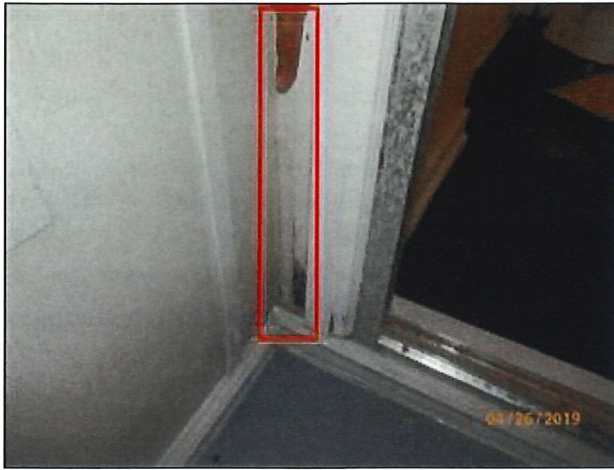
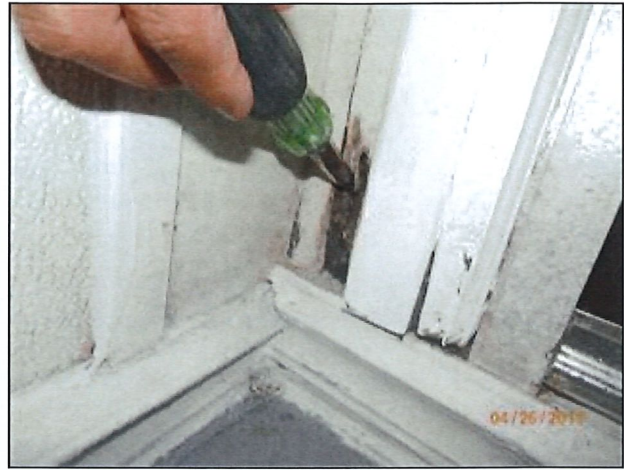
5.1

There are damaged wood boards in the first floor shower that should be repaired.

There are numerous holes in the wall on the third floor.

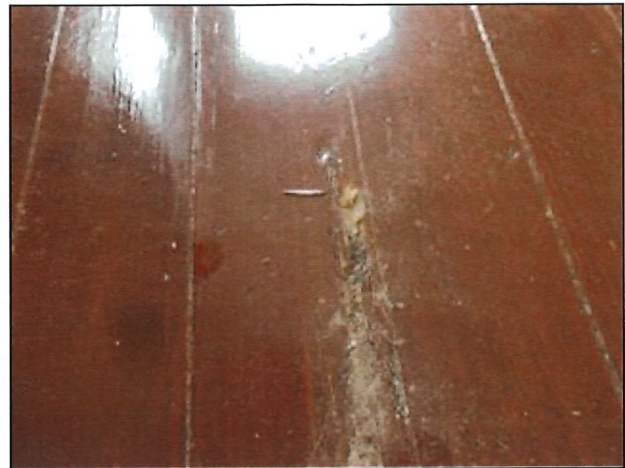
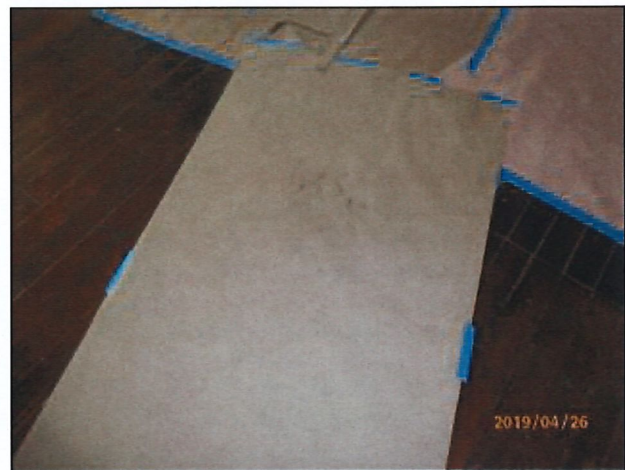
5.2

**Comments:** Inspected, Repair or Replace  
Insect related damage to wood flooring in different areas of the house.

There was a hole in the flooring in the sun room.

Most of the floors had craft paper and they could not be inspected.

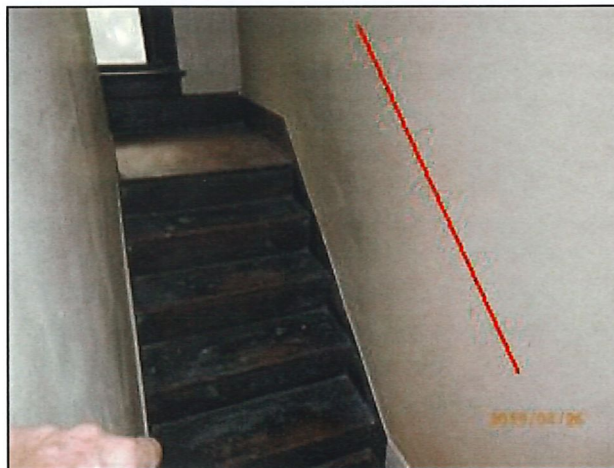
5.3

There is no handrail on the stairs to the third floor.

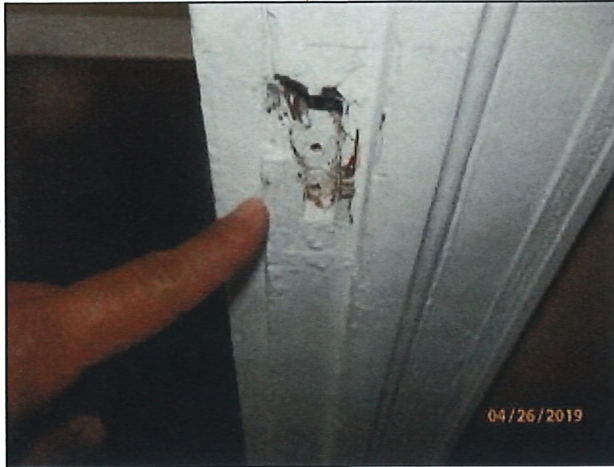
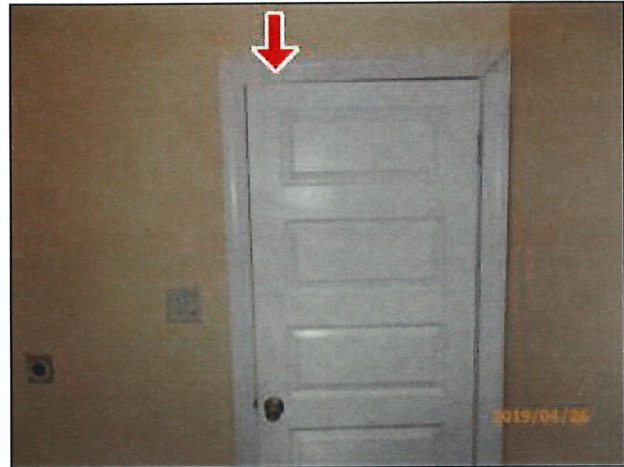
5.5

The second floor middle bedroom door jamb is missing the strike plate.

The first floor bathroom door hits the jamb due to settlement.

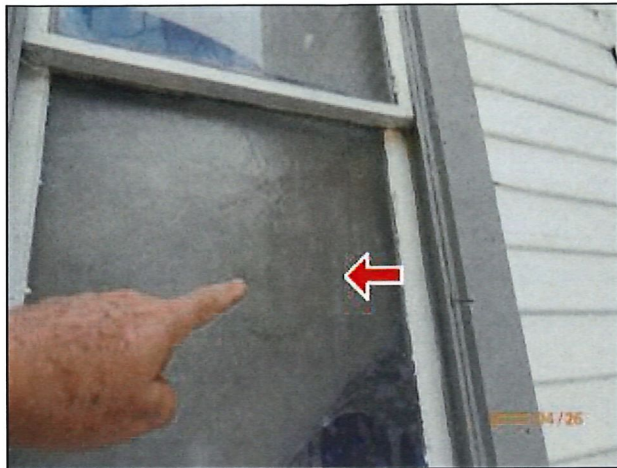
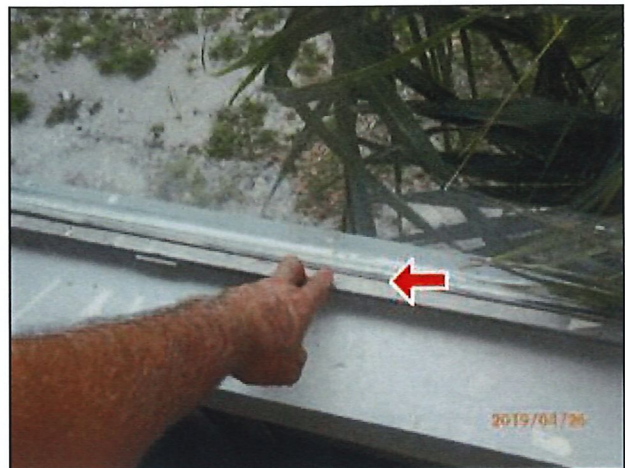
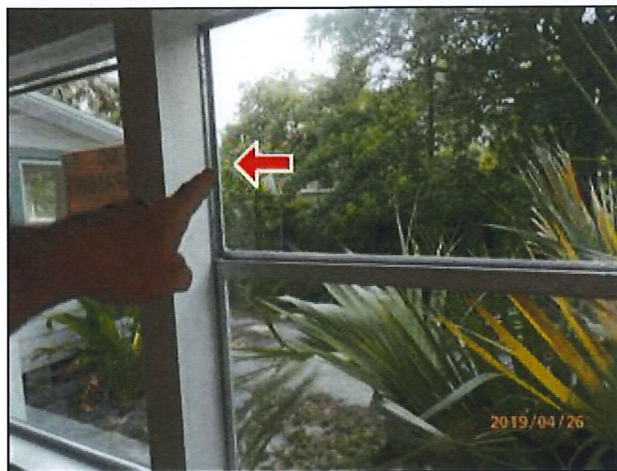
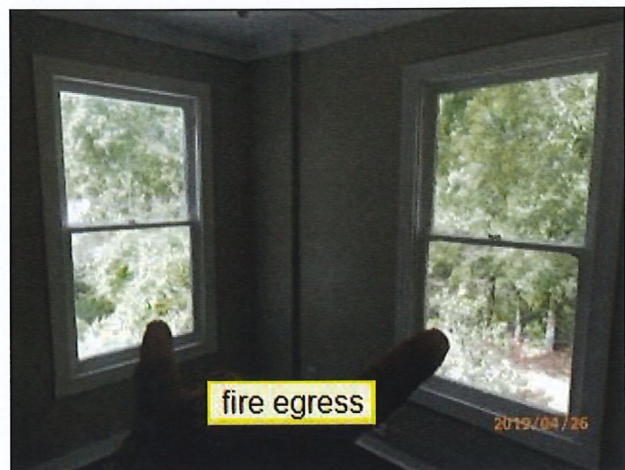
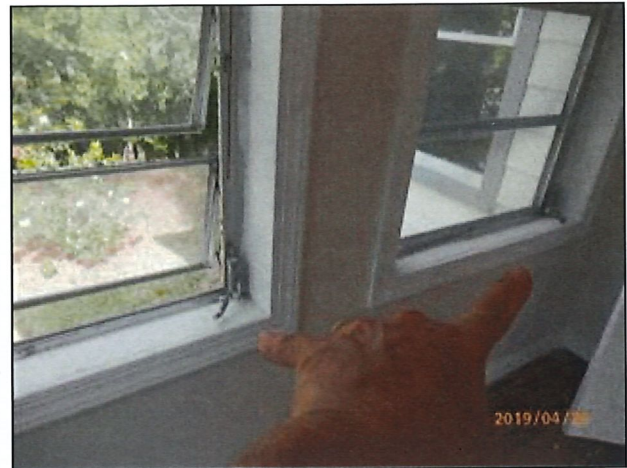
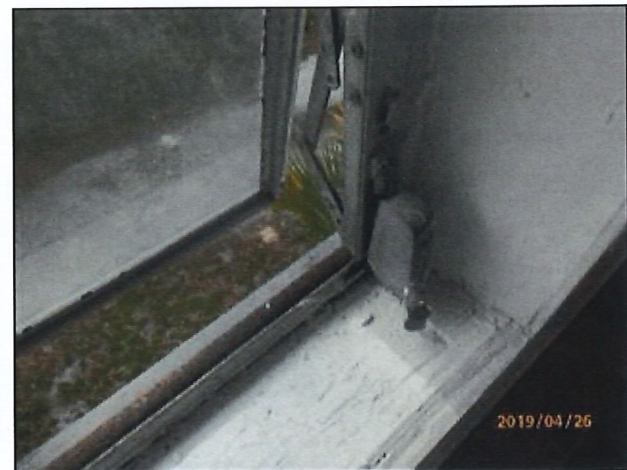
5.6

There is a cracked pane of glass on the rear of the house.

The bottom sill in the window near the kitchen is damaged. And the window balancer did not work.

If any of the rooms will be used as bedrooms a fire egress exit window will be needed. All windows are painted shut.

There are awning windows, most of the operators did not work and some were missing.

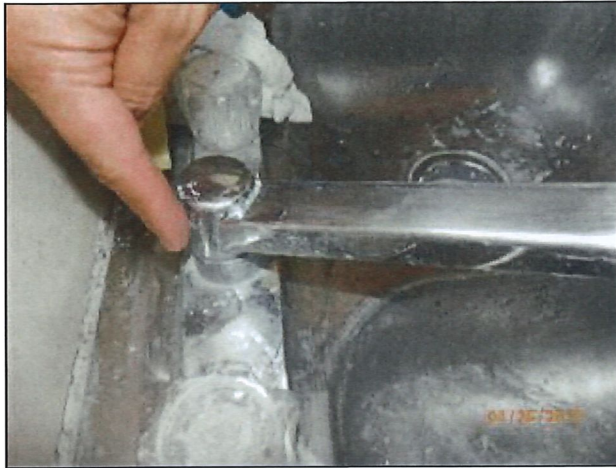
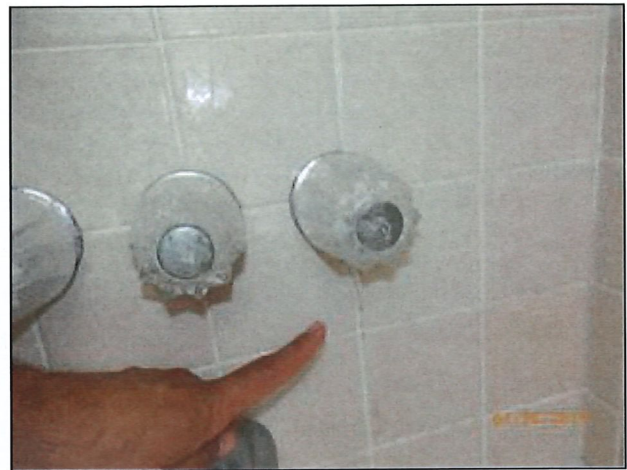
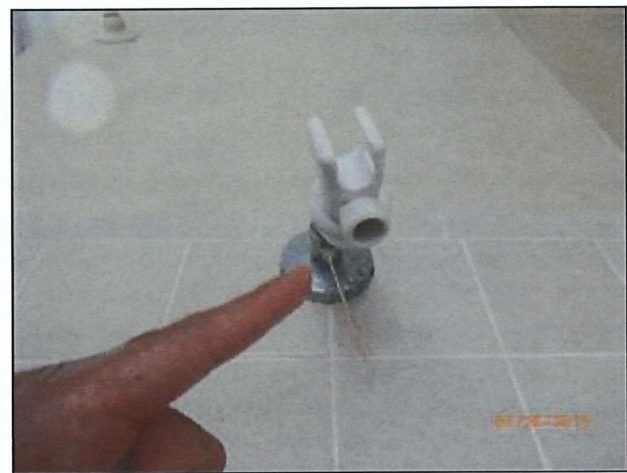
6.1

The kitchen sink faucet handle leaked.

The second floor bathroom tub cold water handle leaked. The diverter did not fully close. The shower head was missing.

The second floor bathroom sink is not sealed to the wall.

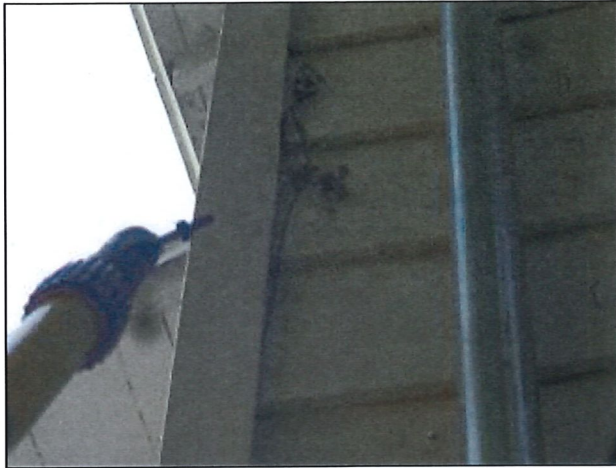
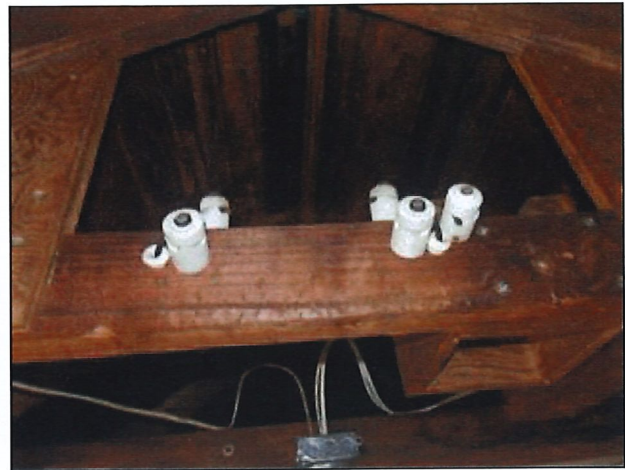
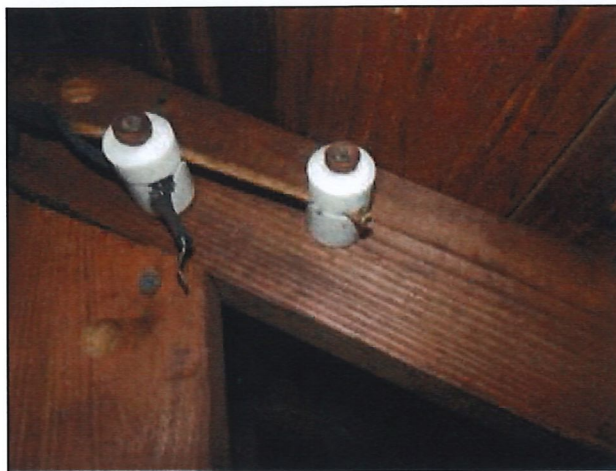
7.2

Knob and tube wiring was originally used in the residence. There are still signs of active knob and tube in the attic space when light switches are being used. It is recommended to have a licensed electrician inspect the electrical system and provide a repair estimate.

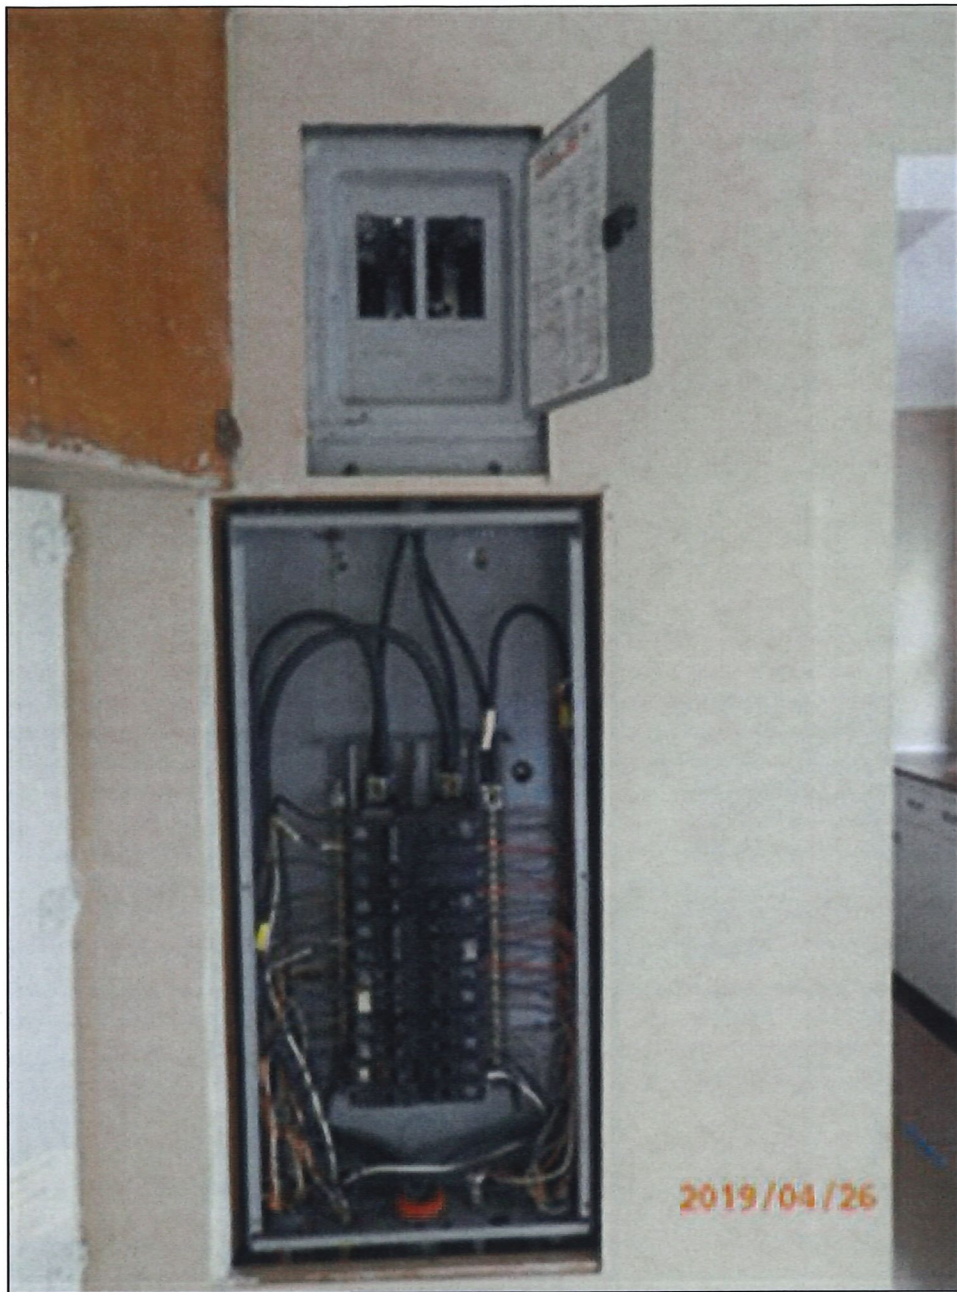
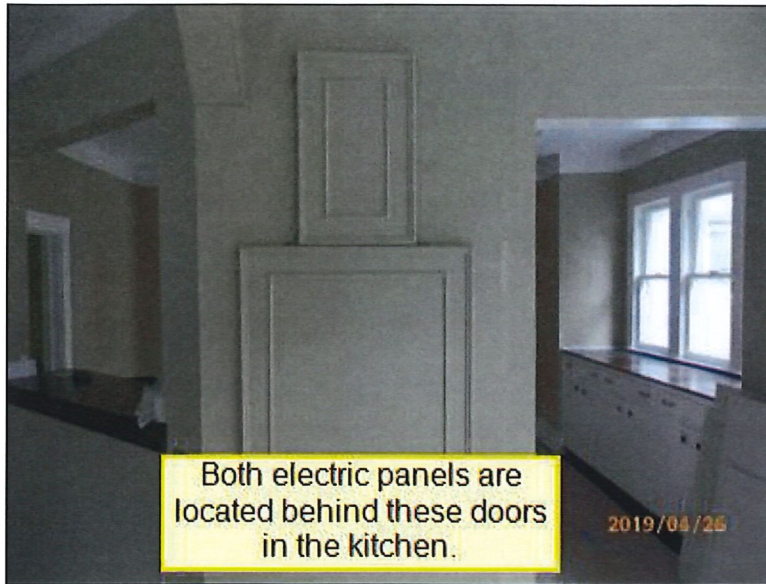
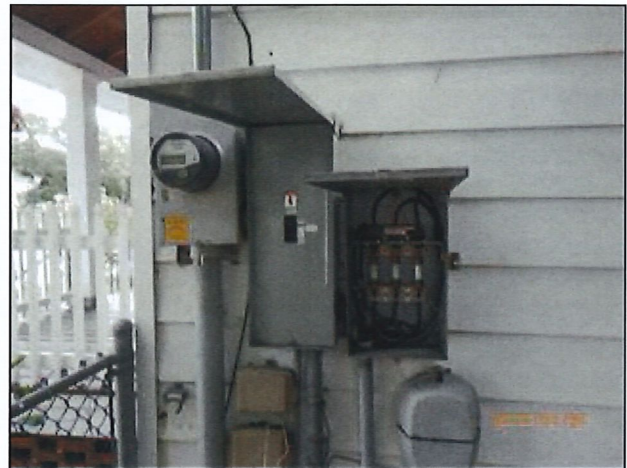
7.6

The main switch is in the box at the electric panel on the exterior wall. The breaker panel is in the kitchen.

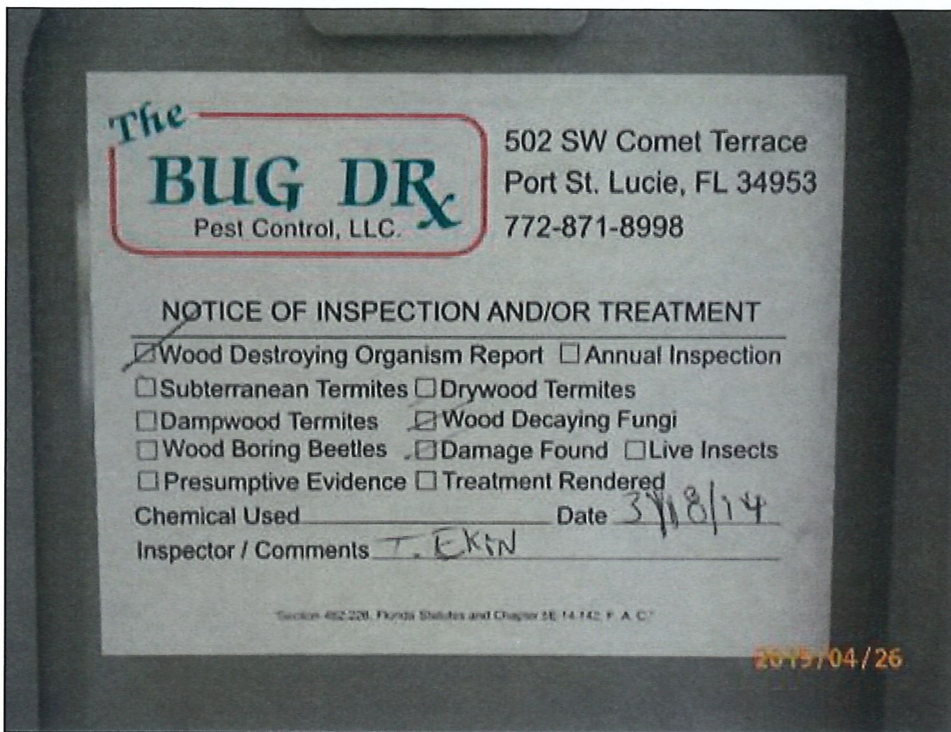
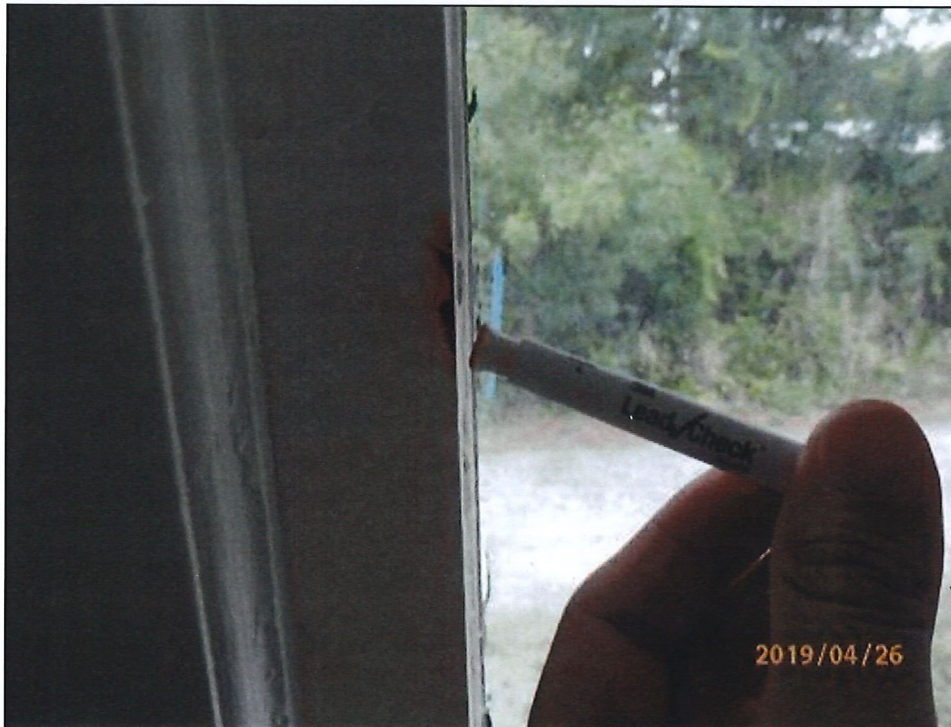
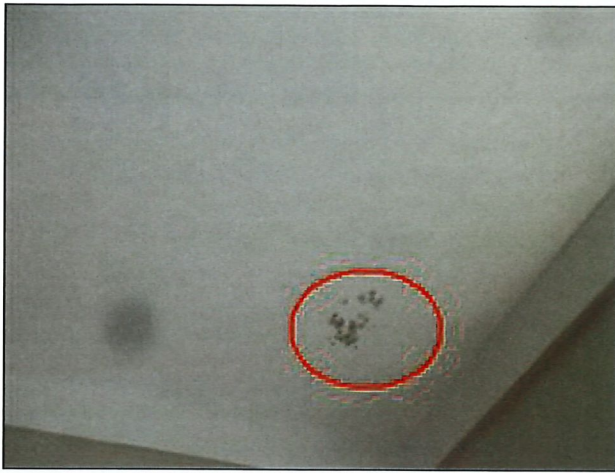
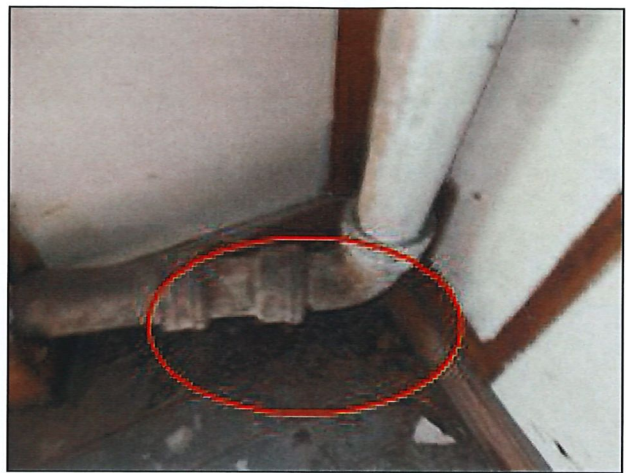
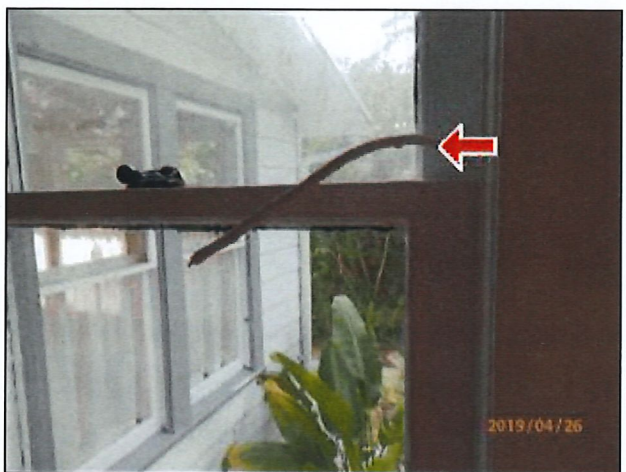
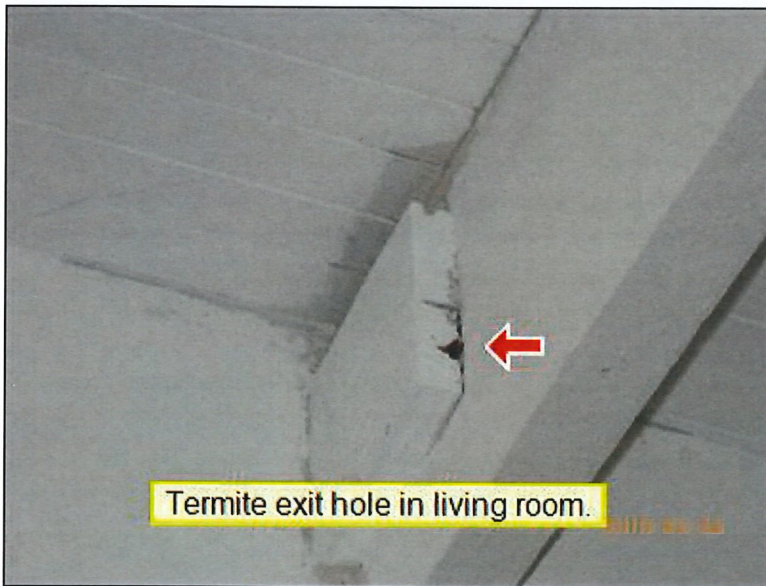
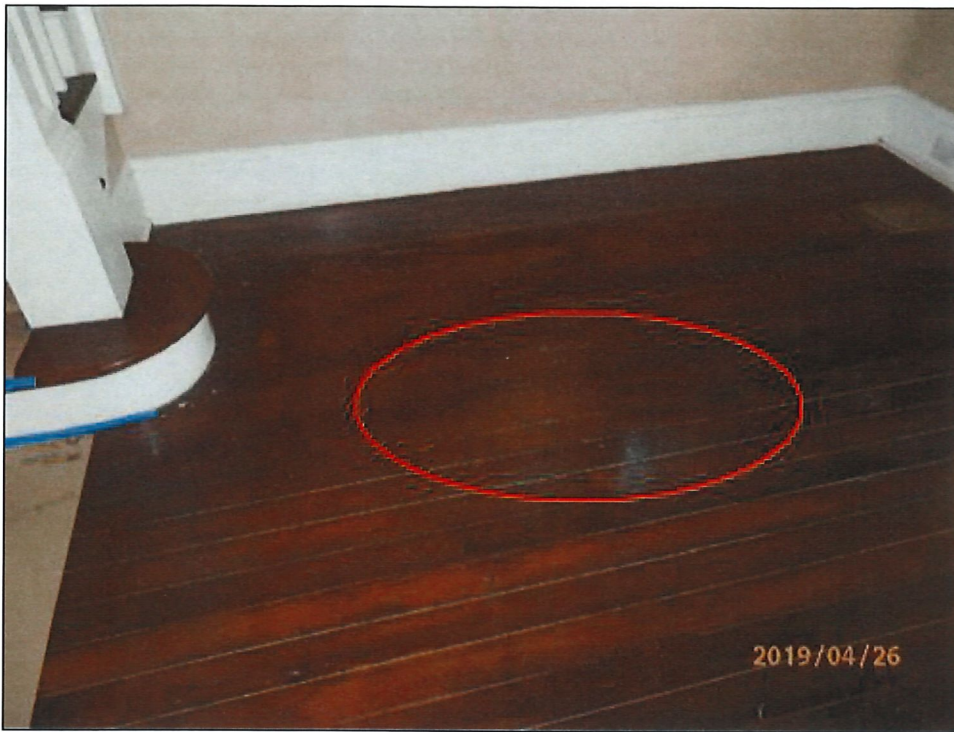
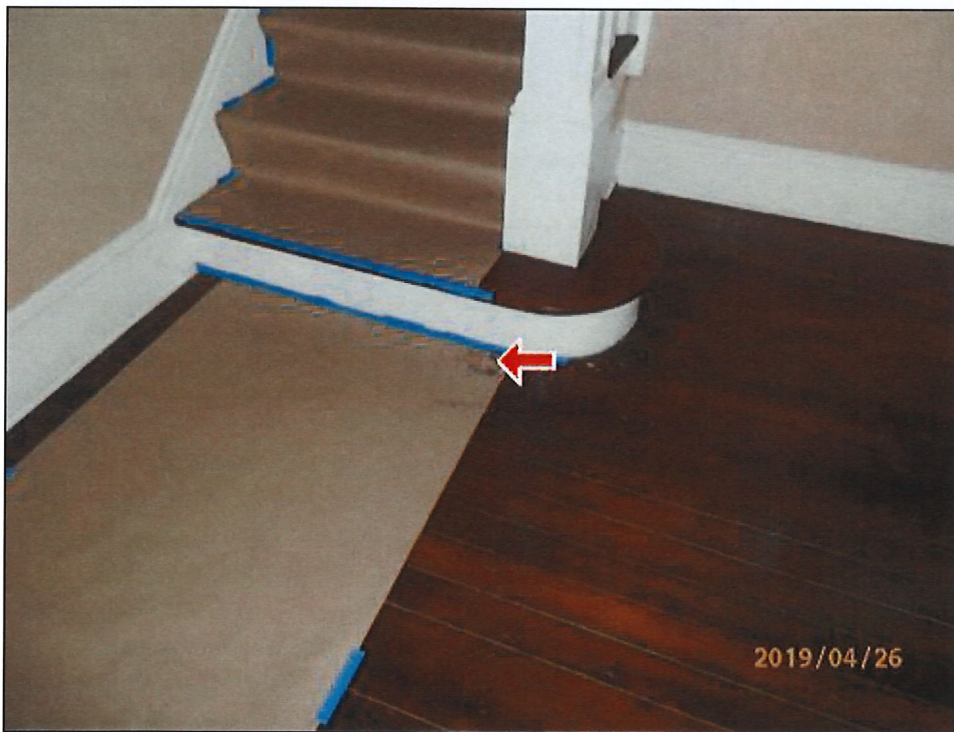
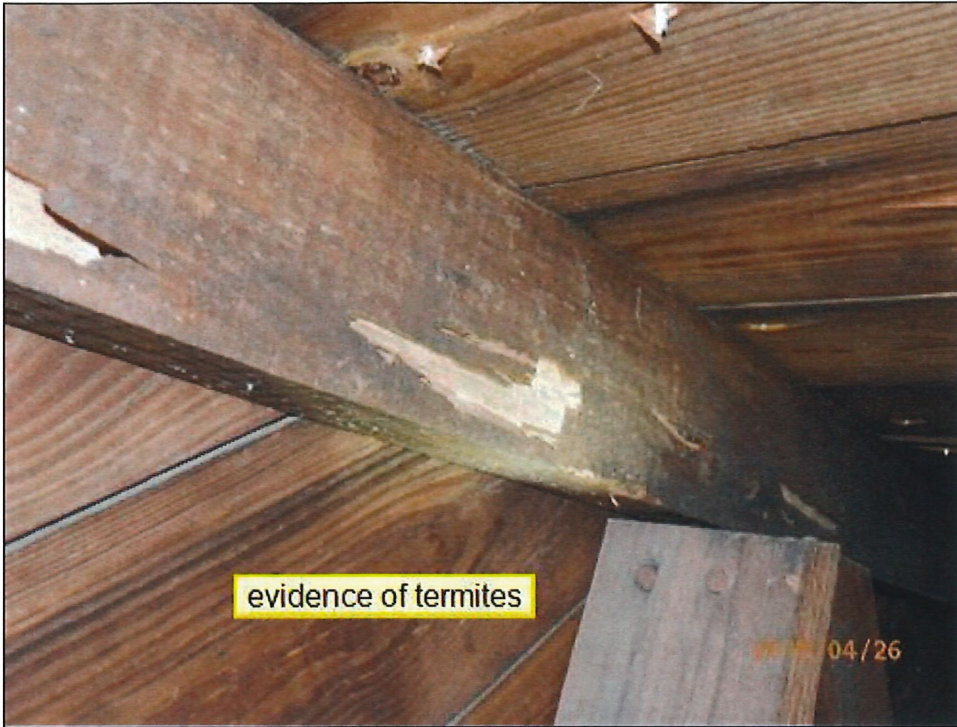
10.0

The house was inspected for termites in 2014. Termites and wood fungi were found. Evidence of drywood termites was found throughout the house. A pest company should be brought in to determine a treatment and the extent of the damage. Termite damage is throughout the attic.

There was an abandoned galvanized hose bib on the side of the house.

The original windows are weights and pulleys. None of them could be opened.
