Inspection of the Mainline 'Sewer Main 'MH124D-201\_MH124D-104' in scope of 'DUC Inspection' task.

Mainline Inspection on Sewer Main 'MH124D-201\_MH124D-104' of 8/26/2021 10:00:50 AM

- B 18" 263' 124D 104 – 124D 201 (under bridge)
- C 16" 369' 124D 407 – 124D 404
- F 12" 404' 135C 209 – 135C 208
- A 12" 155' 124A 305 – 124A 304 (under bridge)
- E 8" 297' 135C 101 - 135C 225 (under bridge)
- D 8" 239' 135A 126 – 135A 105
- G 8" 325' 145B 106 – 135D 304 (under bridge)

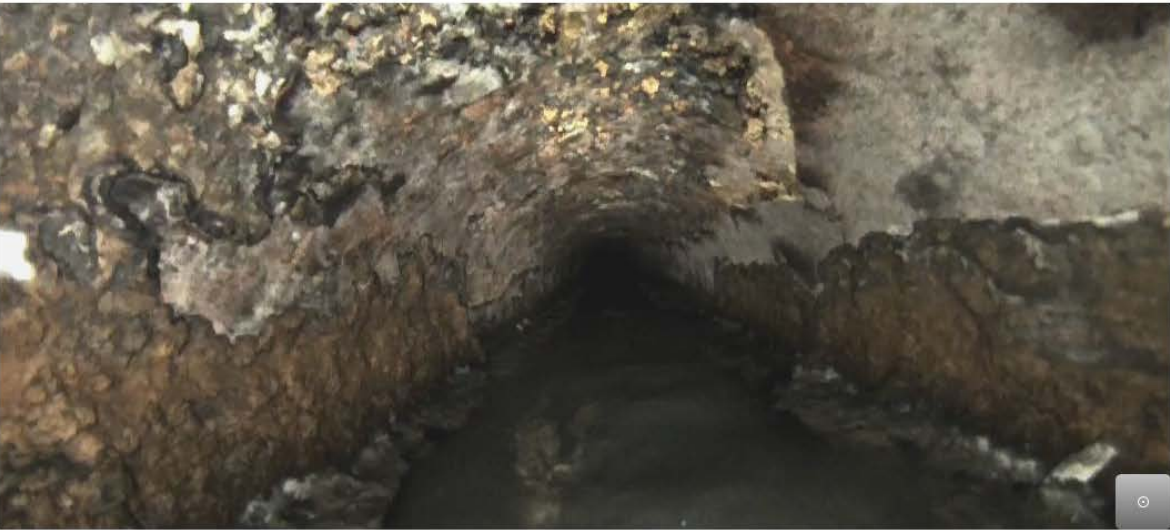
| | Distance | Clock from | Clock to | Continuous | Code | Code Description | Dimension 1 | Dimension 2 | % | Category | Rating | Defect source |
|--|---|---|---|---|---|---|---|---|---|---|---|---|
| | 5.0 ft. | 4 o'clock | 8 o'clock | S01 | DAE | Deposits Attached... | | | 50.000 % | O&M | 5 | |
| | 5.0 ft. | 12 o'clock | 12 o'clock | S02 | SCP | Surface Damage C... | | | | Structural | 3 | |
| | 43.5 ft. | 4 o'clock | 8 o'clock | F01 | DAE | Deposits Attached... | | | 50.000 % | O&M | 5 | |
| | 43.5 ft. | 12 o'clock | 12 o'clock | F02 | SCP | Surface Damage C... | | | | Structural | 3 | |

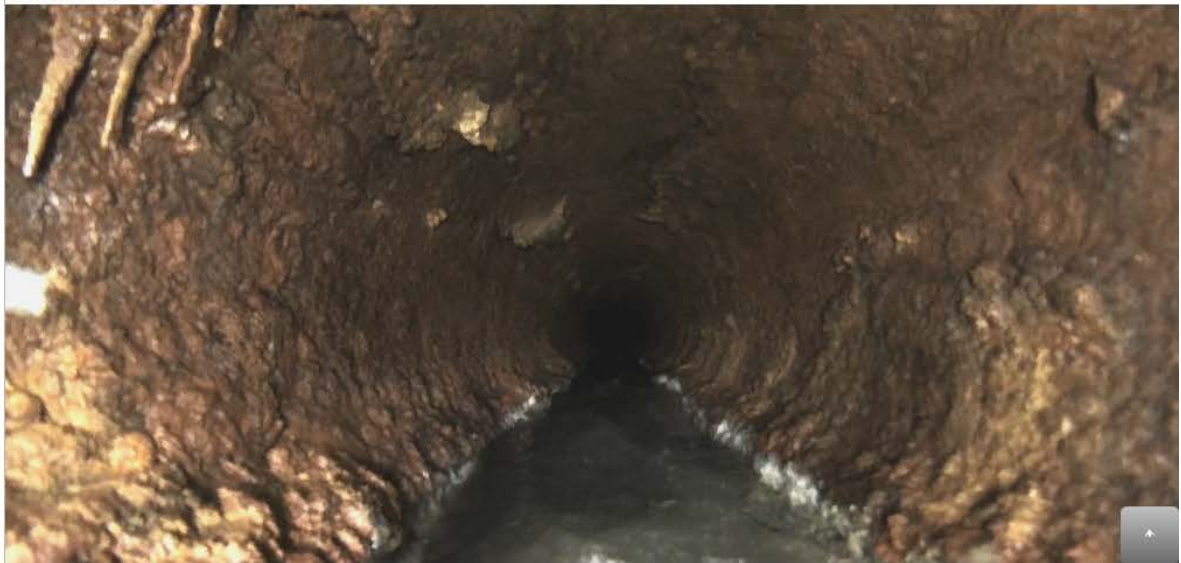
| | Distance | Clock from | Clock to | Continuous | Code | Code Description | Dimension 1 | Dimension 2 | % | Category | Rating | Defect s |
|--|---|---|---|---|---|---|---|---|---|---|---|---|
| | 5.2 ft. | 12 o'clock | 12 o'clock | S01 | SCP | Surface Damage C... | | | | Structural | 3 | |
| | 5.2 ft. | 4 o'clock | 8 o'clock | S02 | DAGS | Deposits Attached... | | | 10.000 % | O&M | 2 | |
| | 157.5 ft. | 4 o'clock | 8 o'clock | F02 | DAGS | Deposits Attached... | | | 10.000 % | O&M | 2 | |
| | 157.5 ft. | 12 o'clock | 12 o'clock | F01 | SCP | Surface Damage C... | | | | Structural | 3 | |

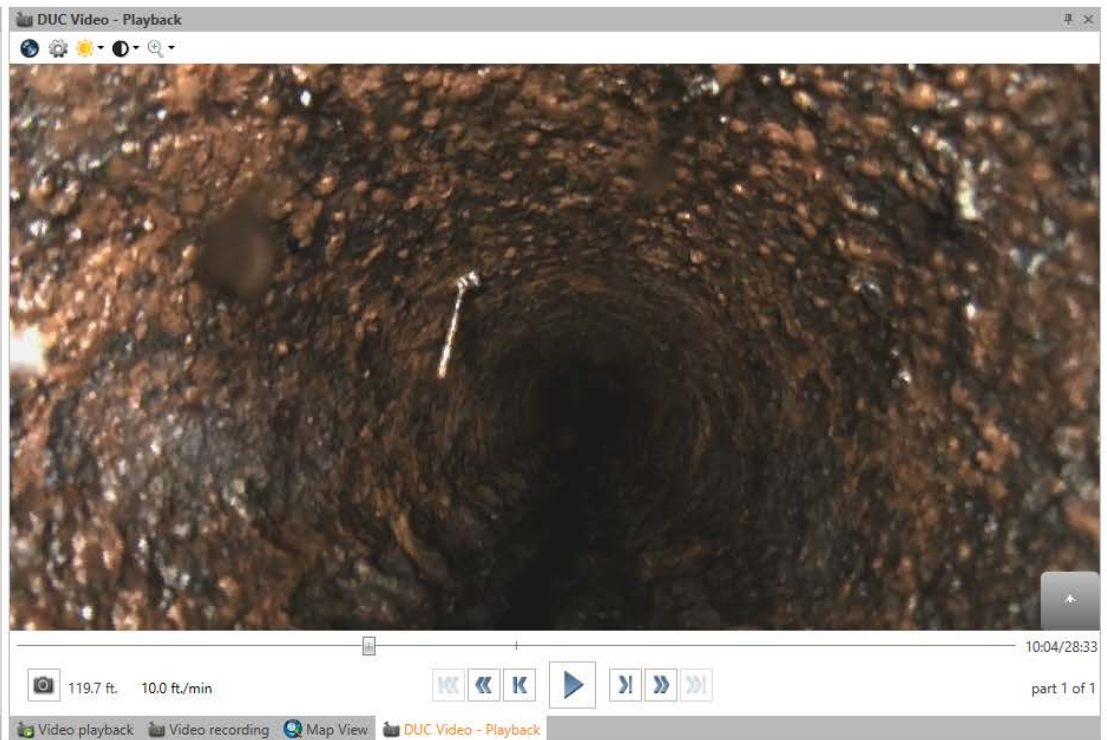
| ance | Clock from | Clock to | Continuous | Code | Code Description | Dimension 1 | Dimension 2 | % | Category | Rating | Defect source |
|---|---|---|---|---|---|---|---|---|---|---|---|
| 2 | 12 o'clock | 12 o'clock | S01 | SCP | Surface Damage C... | | | | Structural | 3 | |
| 2 | 12 o'clock | 12 o'clock | S02 | DAE | Deposits Attached... | | | 20.000 % | O&M | 3 | |
| 7 ft. | 12 o'clock | 12 o'clock | F02 | DAE | Deposits Attached... | | | 20.000 % | O&M | 3 | |
| 7 ft. | 12 o'clock | 12 o'clock | F01 | SCP | Surface Damage C... | | | | Structural | 3 | |

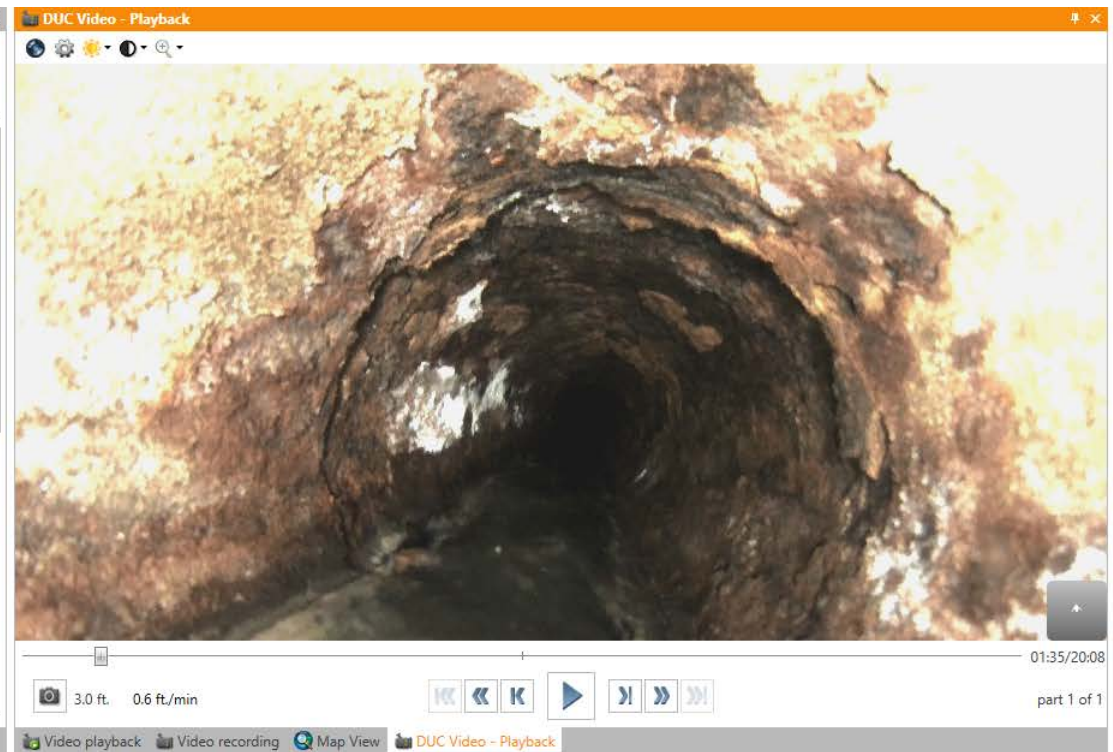
| | Clock from | Clock to | Continuous | Code | Code Description | Dimension 1 | Dimension 2 | % | Category | Rating | Defect source |
|--|---|---|---|---|---|---|---|---|---|---|---|
| | 12 o'clock | 12 o'clock | S02 | SCP | Surface Damage C... | | | | Structural | 3 | |
| | 12 o'clock | 12 o'clock | S01 | DAE | Deposits Attached... | | | 15.000 % | O&M | 3 | |
| | 12 o'clock | 12 o'clock | F01 | DAE | Deposits Attached... | | | 20.000 % | O&M | 3 | |
| | 12 o'clock | 12 o'clock | F02 | SCP | Surface Damage C... | | | | Structural | 3 | |

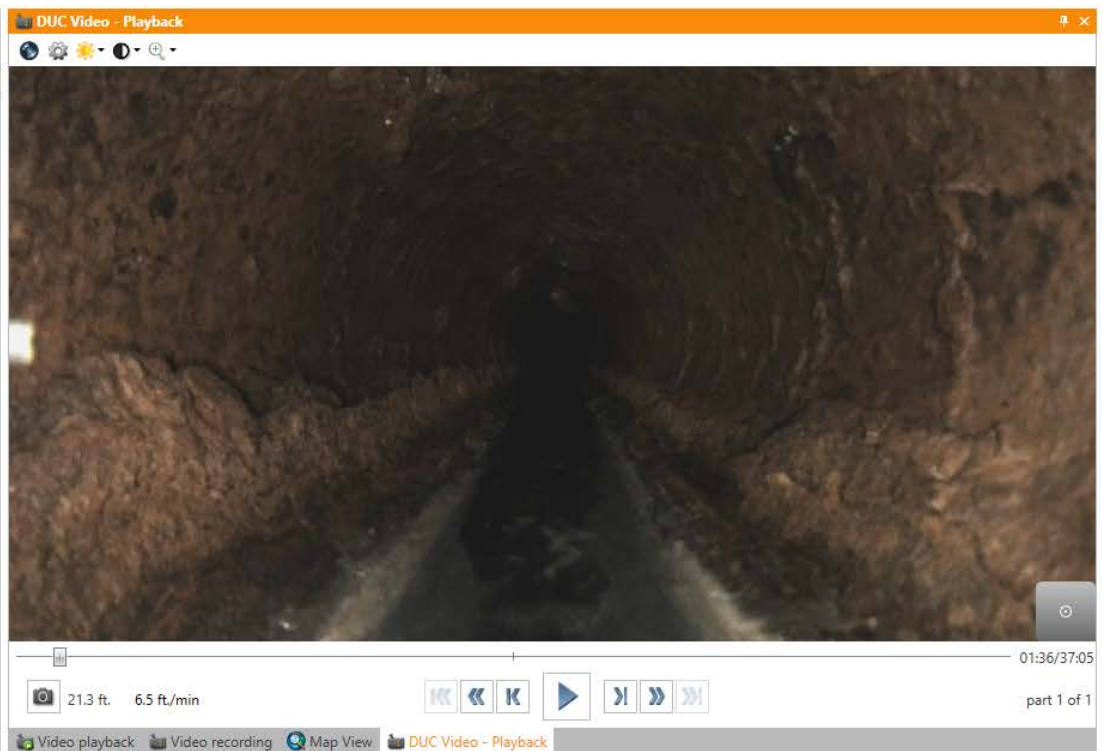
| | Clock from | Clock to | Continuous | Code | Code Description | Dimension 1 | Dimension 2 | % | Category | Rating | Defect source |
|--|---|---|---|---|---|---|---|---|---|---|---|
| | 12 o'clock | 12 o'clock | S01 | SCP | Surface Damage C... | | | | Structural | 3 | |
| | 4 o'clock | 8 o'clock | S02 | DAGS | Deposits Attached... | | | 10.000 % | O&M | 2 | |
| | 4 o'clock | 8 o'clock | F02 | DAGS | Deposits Attached... | | | 10.000 % | O&M | 2 | |
| | 12 o'clock | 12 o'clock | F01 | SCP | Surface Damage C... | | | | Structural | 3 | |

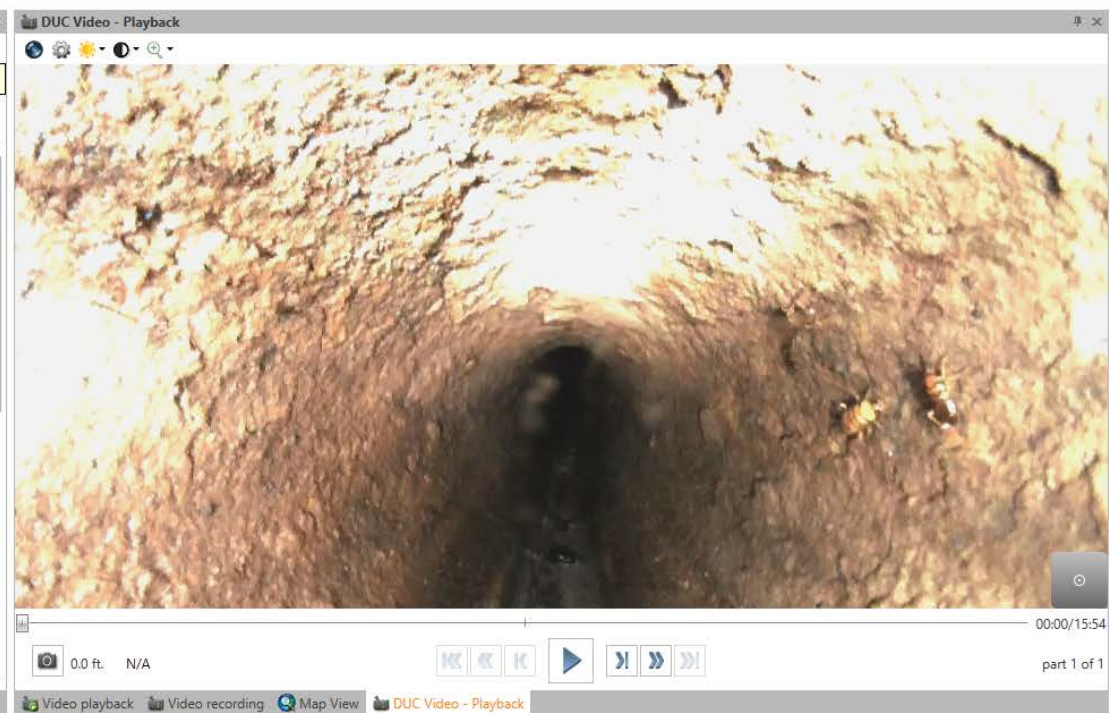
| | Distance | Clock from | Clock to | Continuous | Code | Code Description | Dimension 1 | Dimension 2 | % | Category | Rating | Defect source |
|--|---|---|---|---|---|---|---|---|---|---|---|---|
| | 0.8 ft. | | | | JOM | Joint Offset Medium | | | | Structural | 3 | |
| | 12.5 ft. | 12 o'clock | 12 o'clock | S01 | LFD | Lining Feature Det... | | | | Structural | 3 | |
| | 19.9 ft. | 12 o'clock | 12 o'clock | F01 | LFD | Lining Feature Det... | | | | Structural | 3 | |
| | 26.2 ft. | 12 o'clock | 12 o'clock | S02 | LFD | Lining Feature Det... | | | | Structural | 3 | |
| | 46.4 ft. | 12 o'clock | 12 o'clock | F02 | LFD | Lining Feature Det... | | | | Structural | 3 | |
