Department of Budget and Management
 Safety Division
 Site Inspection Form

Incident Report

Report Number: S.I . 08-03-27-1000

HIDALGO COUNTY
SAN CARLOS WAREHOUSE
WATER TOWER INSPECTION

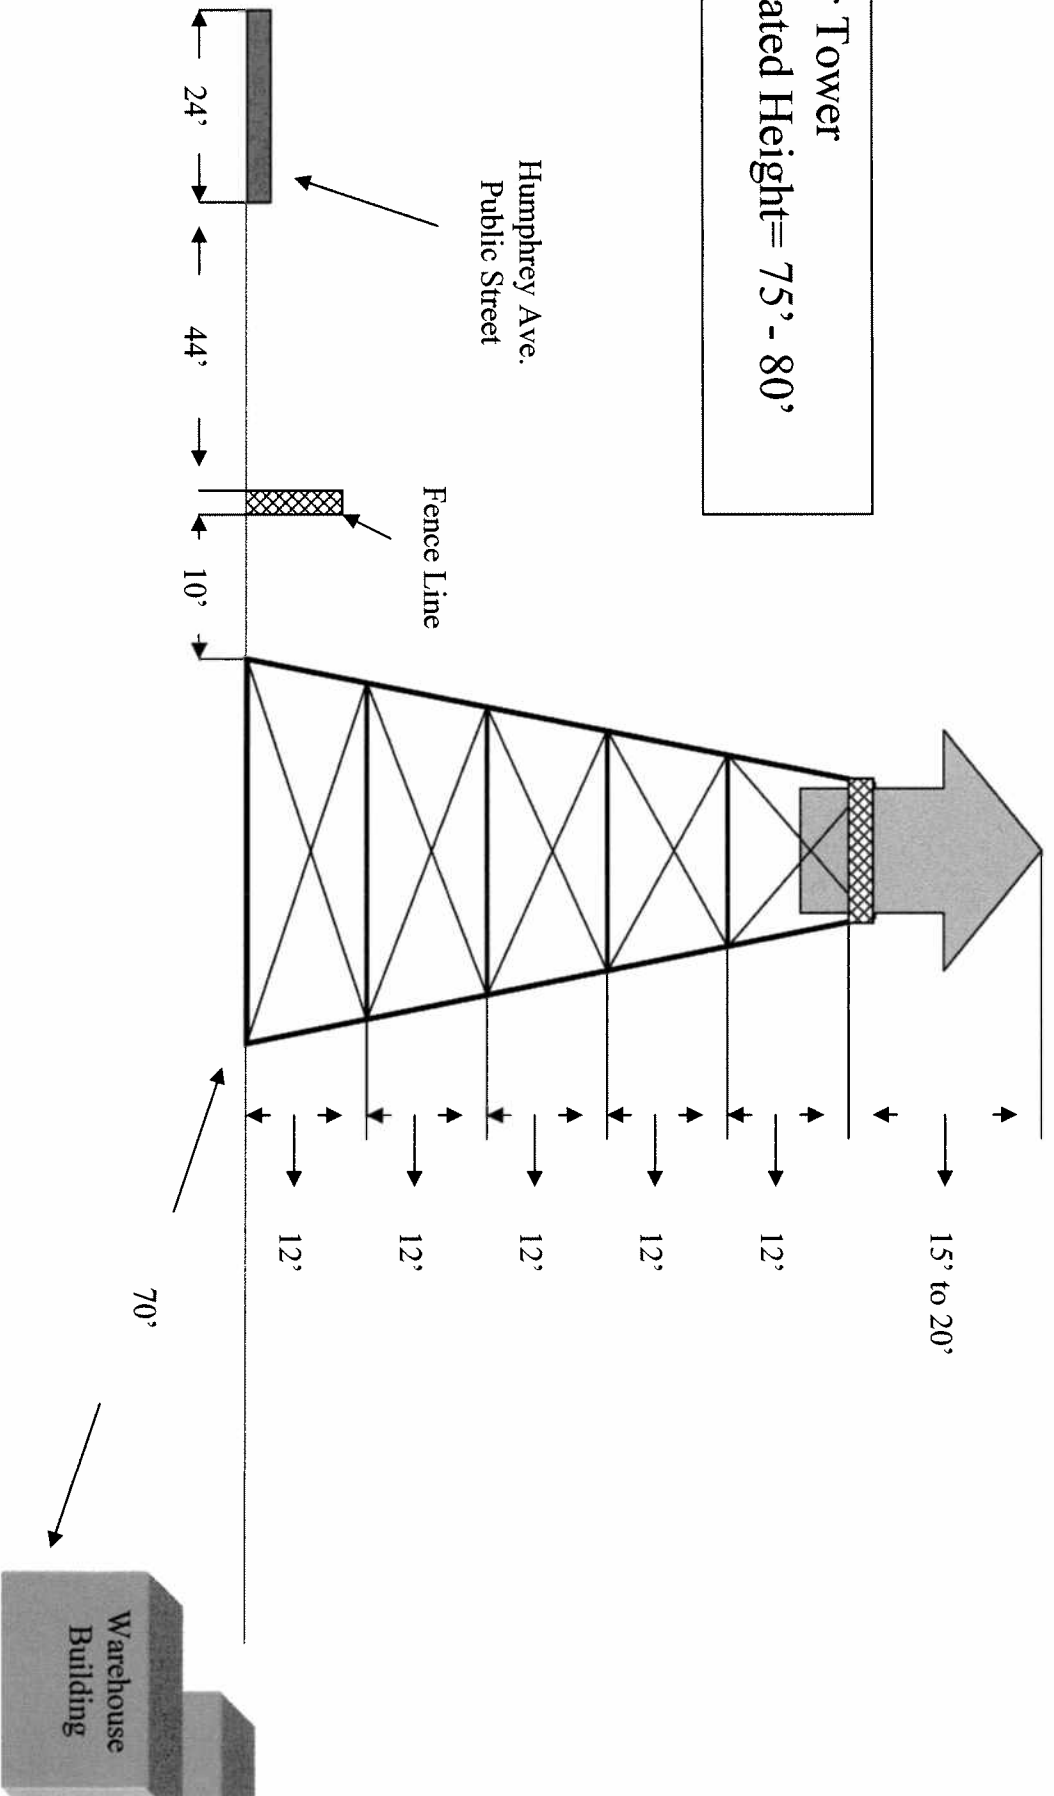
EXHIBIT - A

Note: Exhibit (A) shows the distance between the Tower and the public street as well as the distance between the tower and the warehouse building.

- The North side of the warehouse building, if the Tower collapses to the southwest side.
- The Public Street (Humphrey Ave.) and the public driving on that street, if the Tower collapses to the north side.

Water Tower
Estimated Height = 75' - 80'

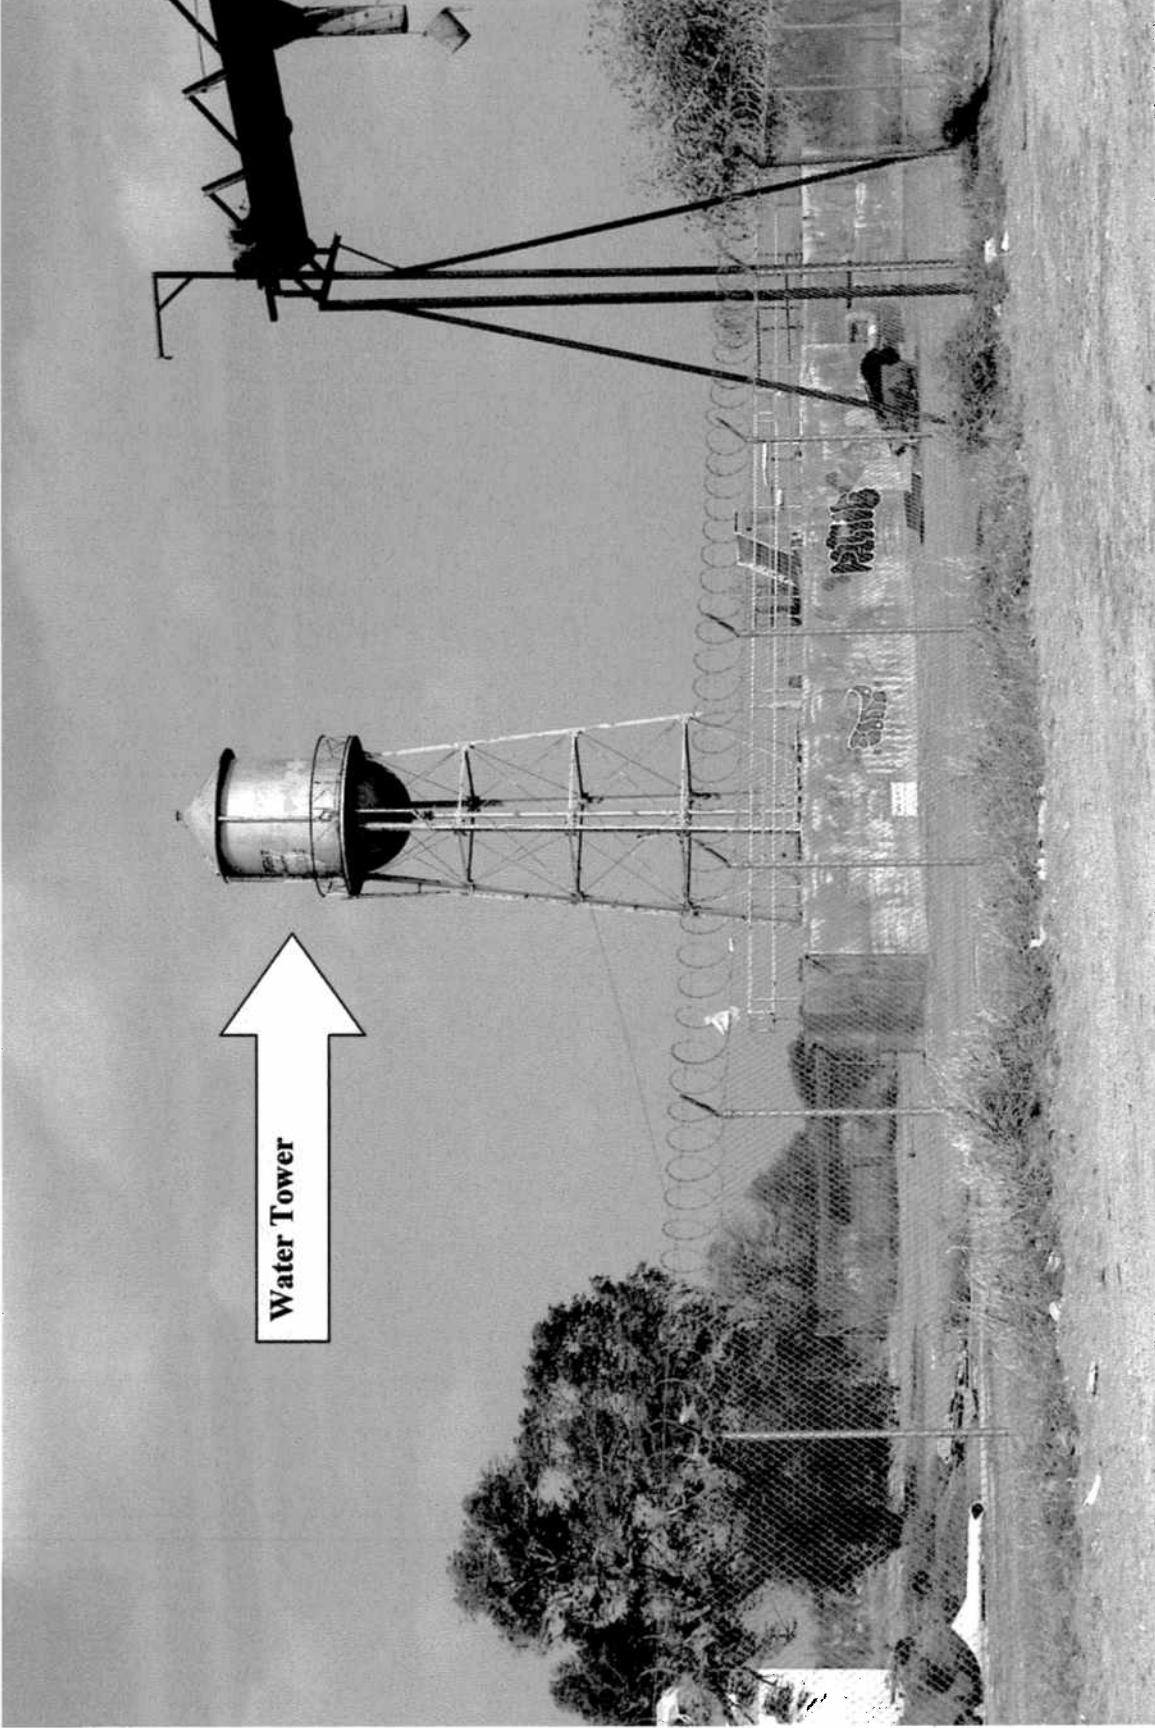
THIS PHOTO SHOWS THE WATER TOWER LOCATED AT THE SAN CARLOS WAREHOUSE.

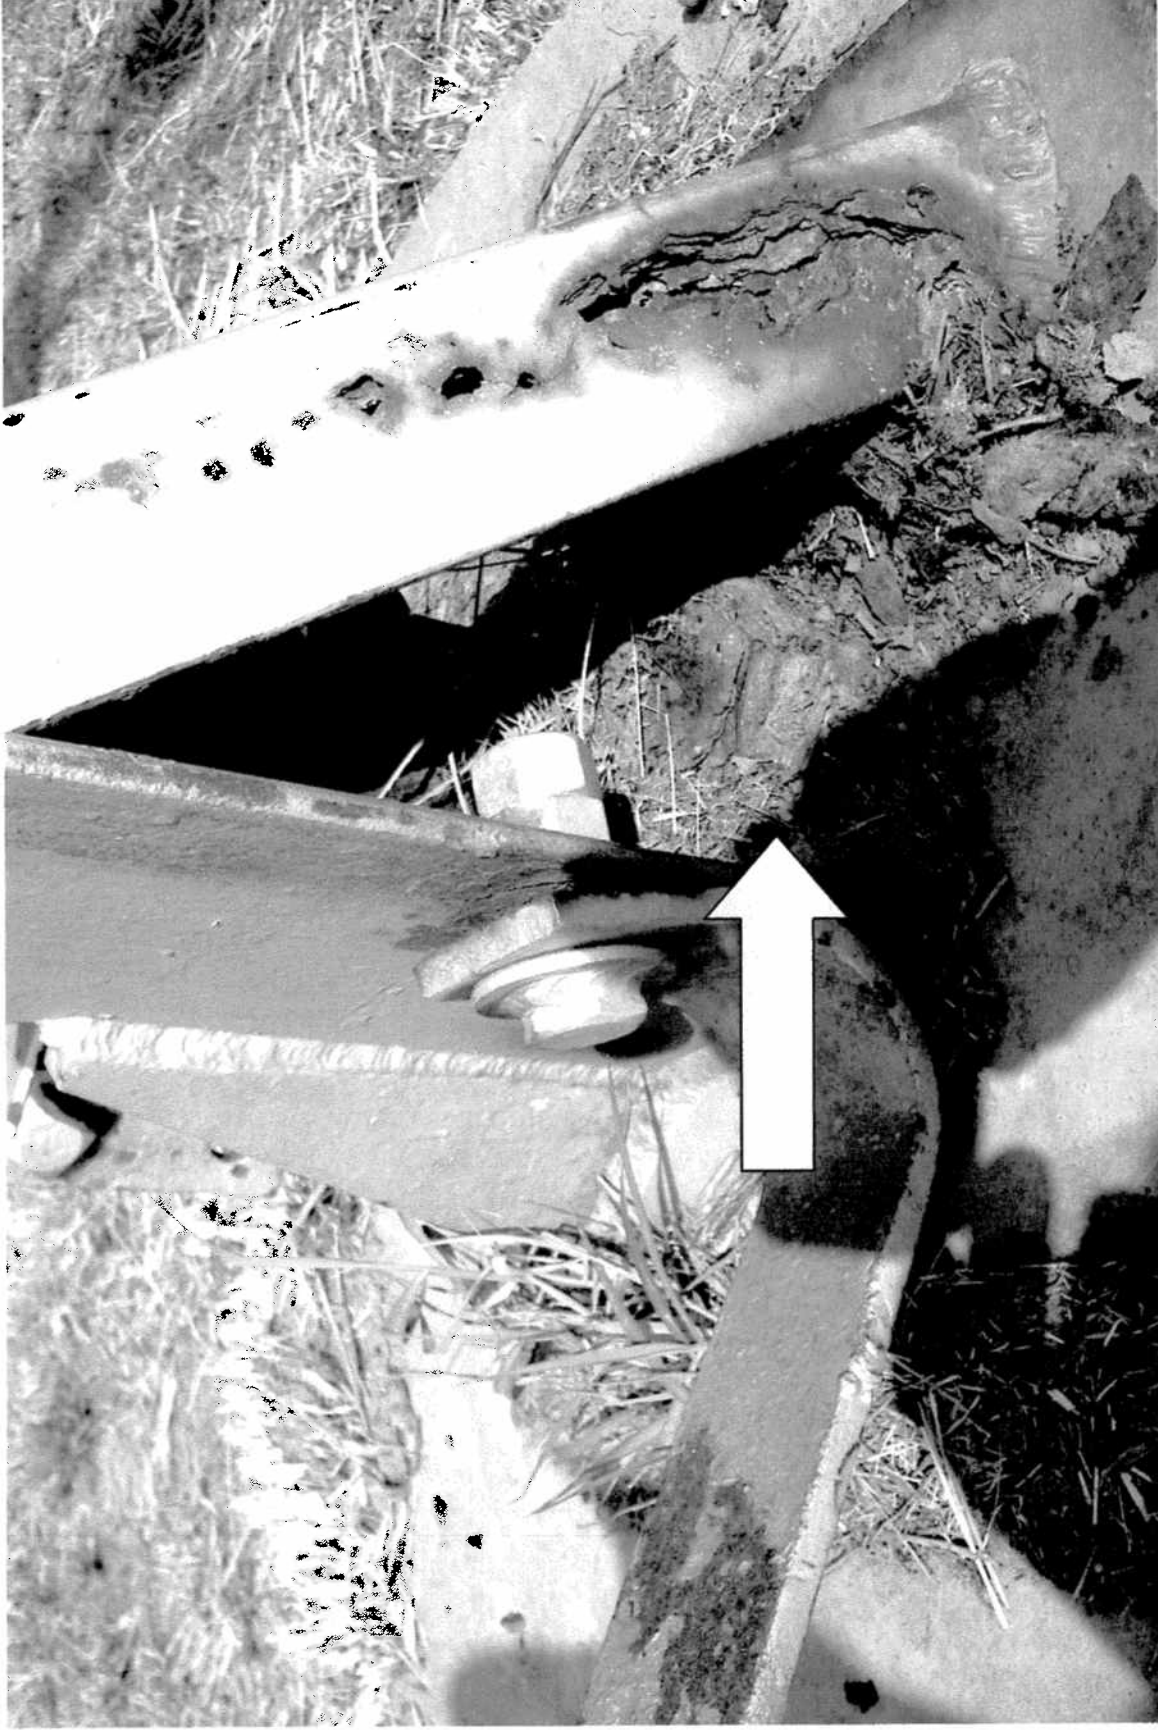
Upon my inspection, I discovered the Tower contained severe corrosion at the base and support legs. Some of the steel bolts and nuts securing the Tower to the base had been cut off or removed. I photographed the base. The photos depict the aforementioned concerns.

THIS PHOTO SHOWS THE CONDITION OF AN ANCHOR BOLT THAT HAS BEEN SEVERLY AFFECTED BY CORROSION.

The San Carlos warehouse property has an old water tower located at the rear of the property. The water tower is in an advance stage of rusting. Now that Precinct 4 has opened a road at the rear of the facility it has become more dangerous to the public and motorist. At this time I am recommending that Hidalgo County demolish the water tower to avoid any liability issues that might arise if the tower falls.

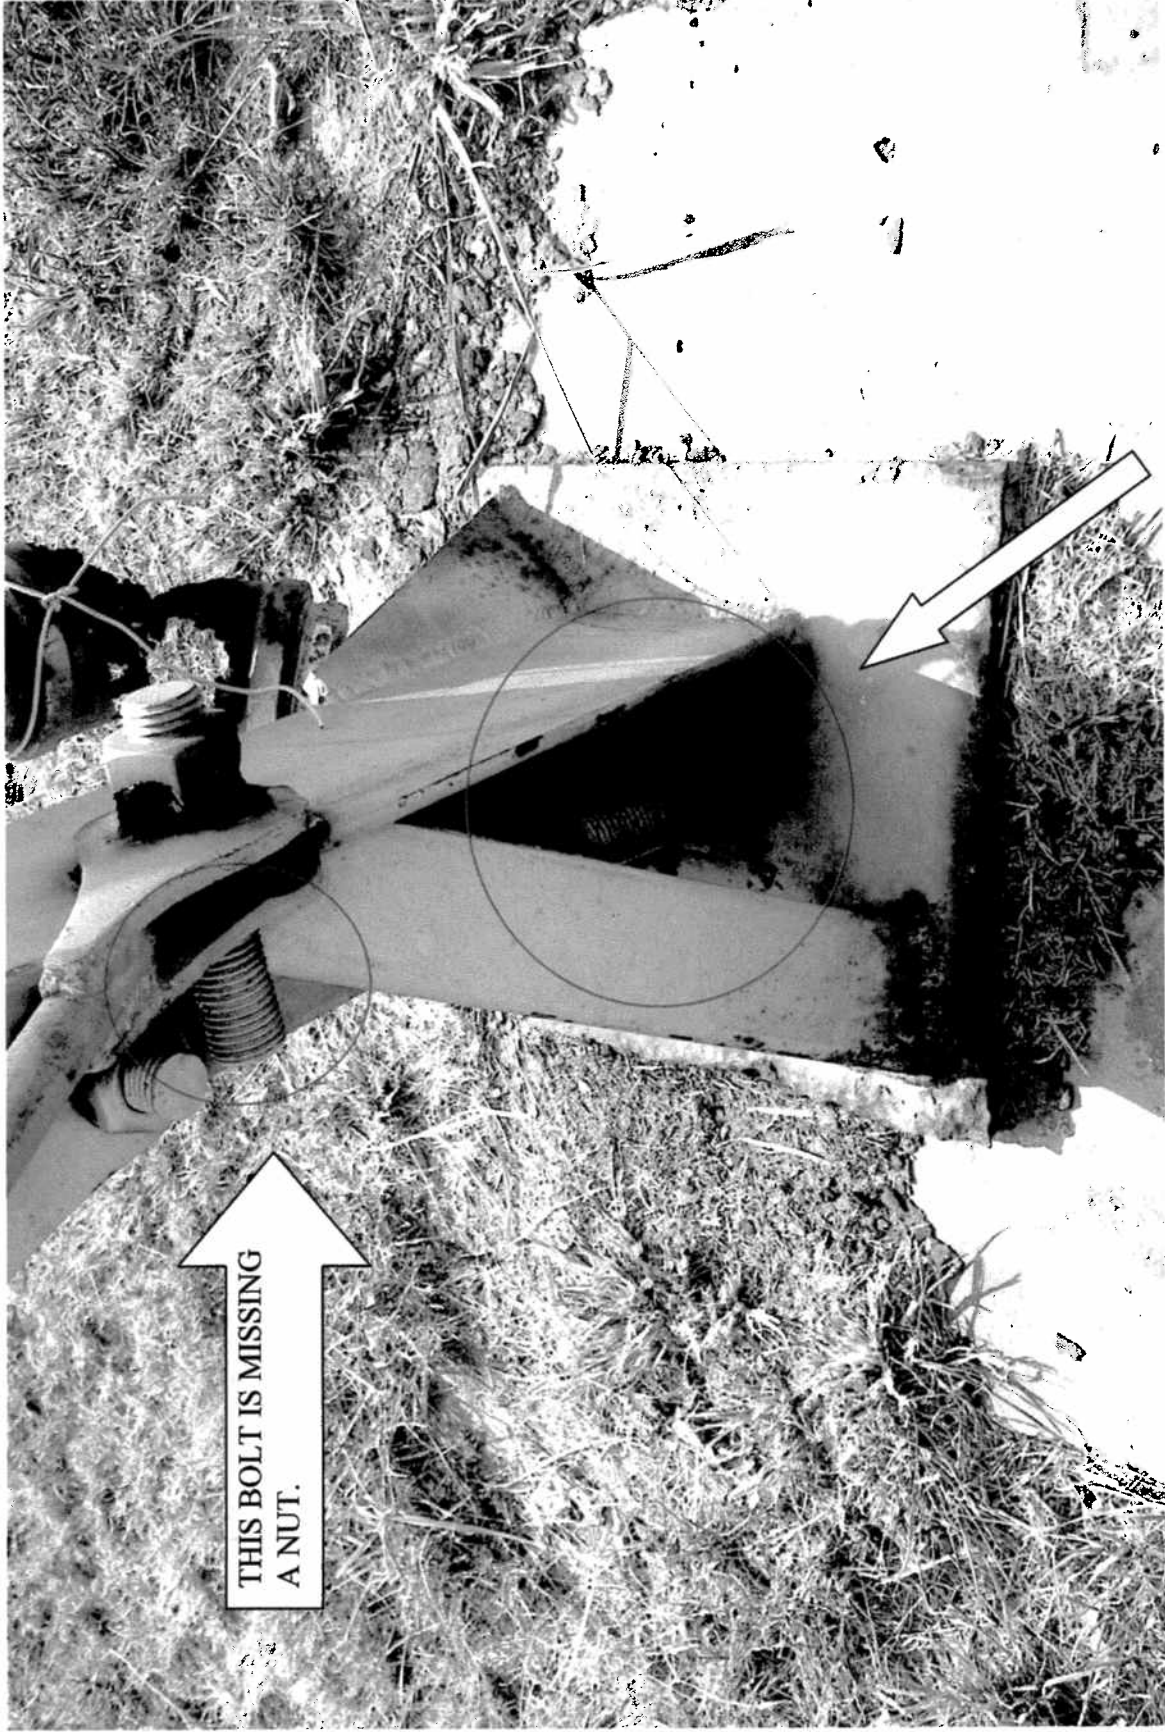
THIS BOLT IS MISSING
A NUT.

THIS PHOTO SHOWS THE NUT IS NEARLY GONE ON THE ANCHOR BOLT DUE TO CORROSION.

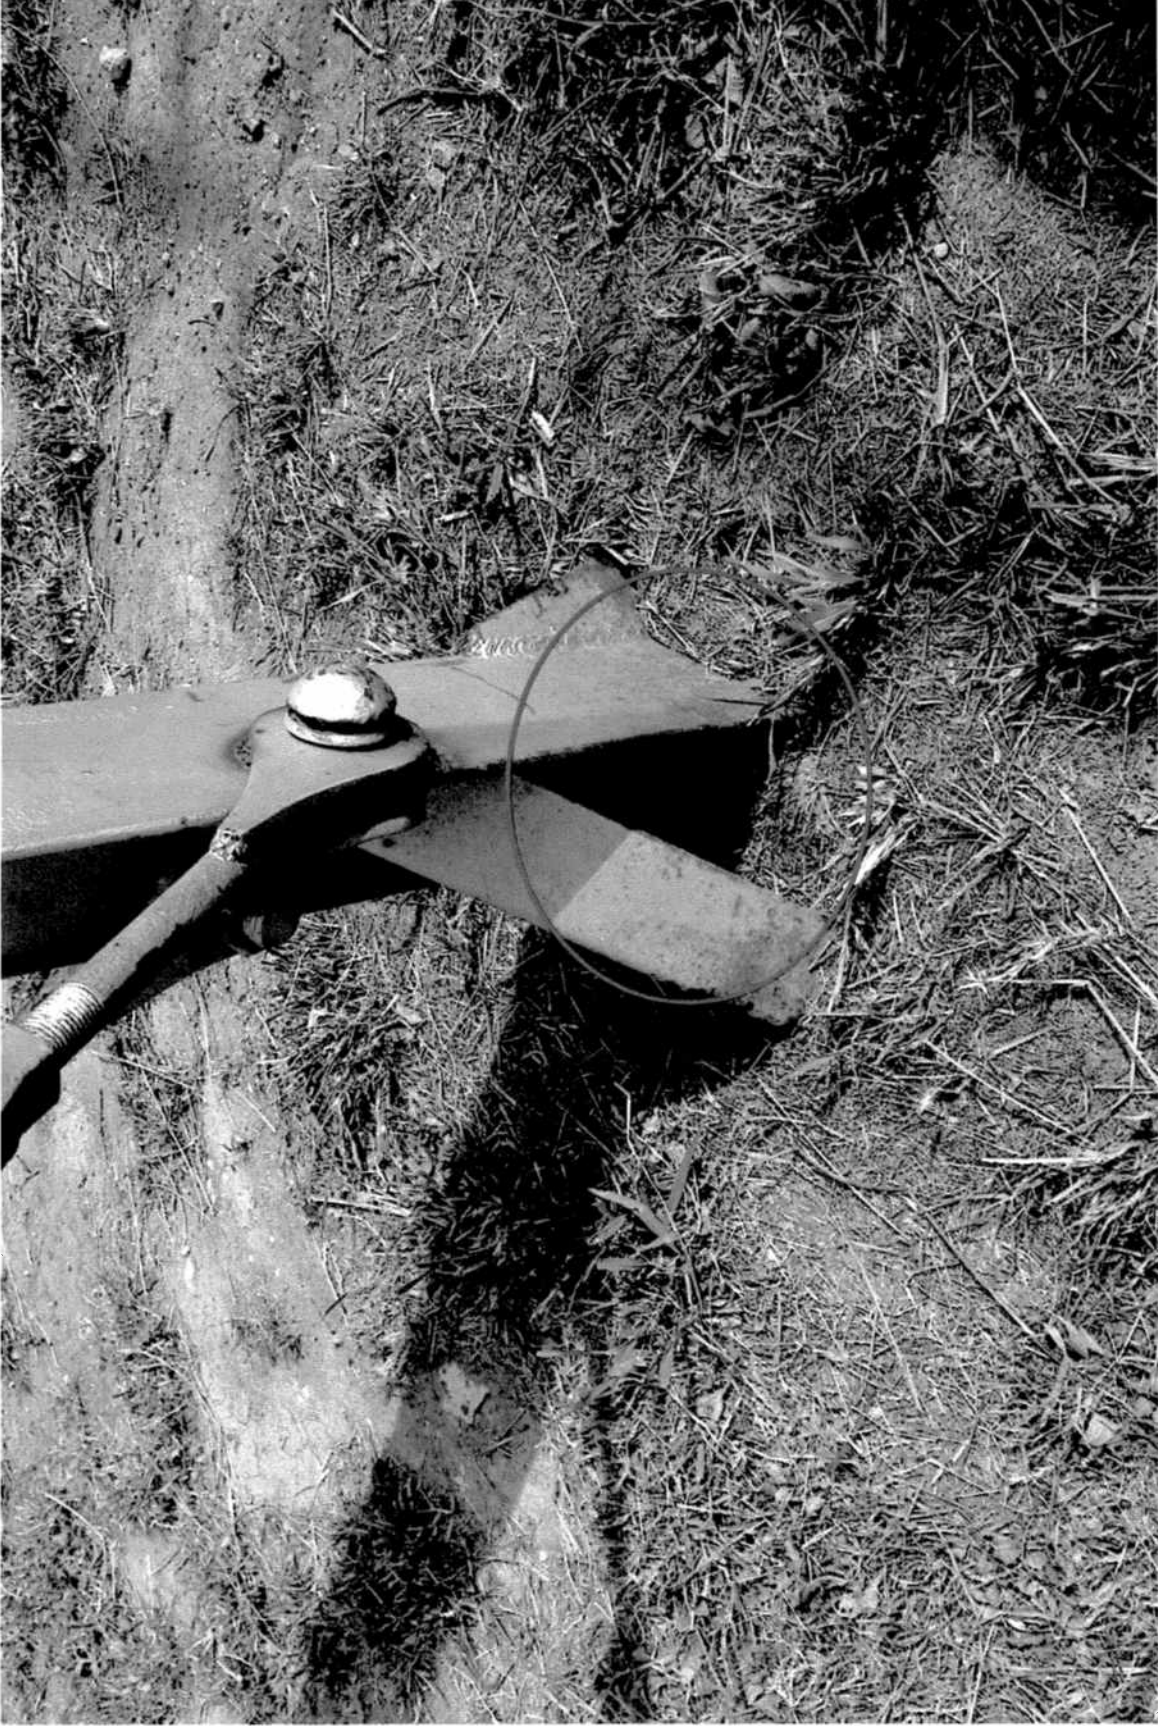
THIS PHOTO SHOWS THE ANCHOR BOLT IS MISSING A NUT.

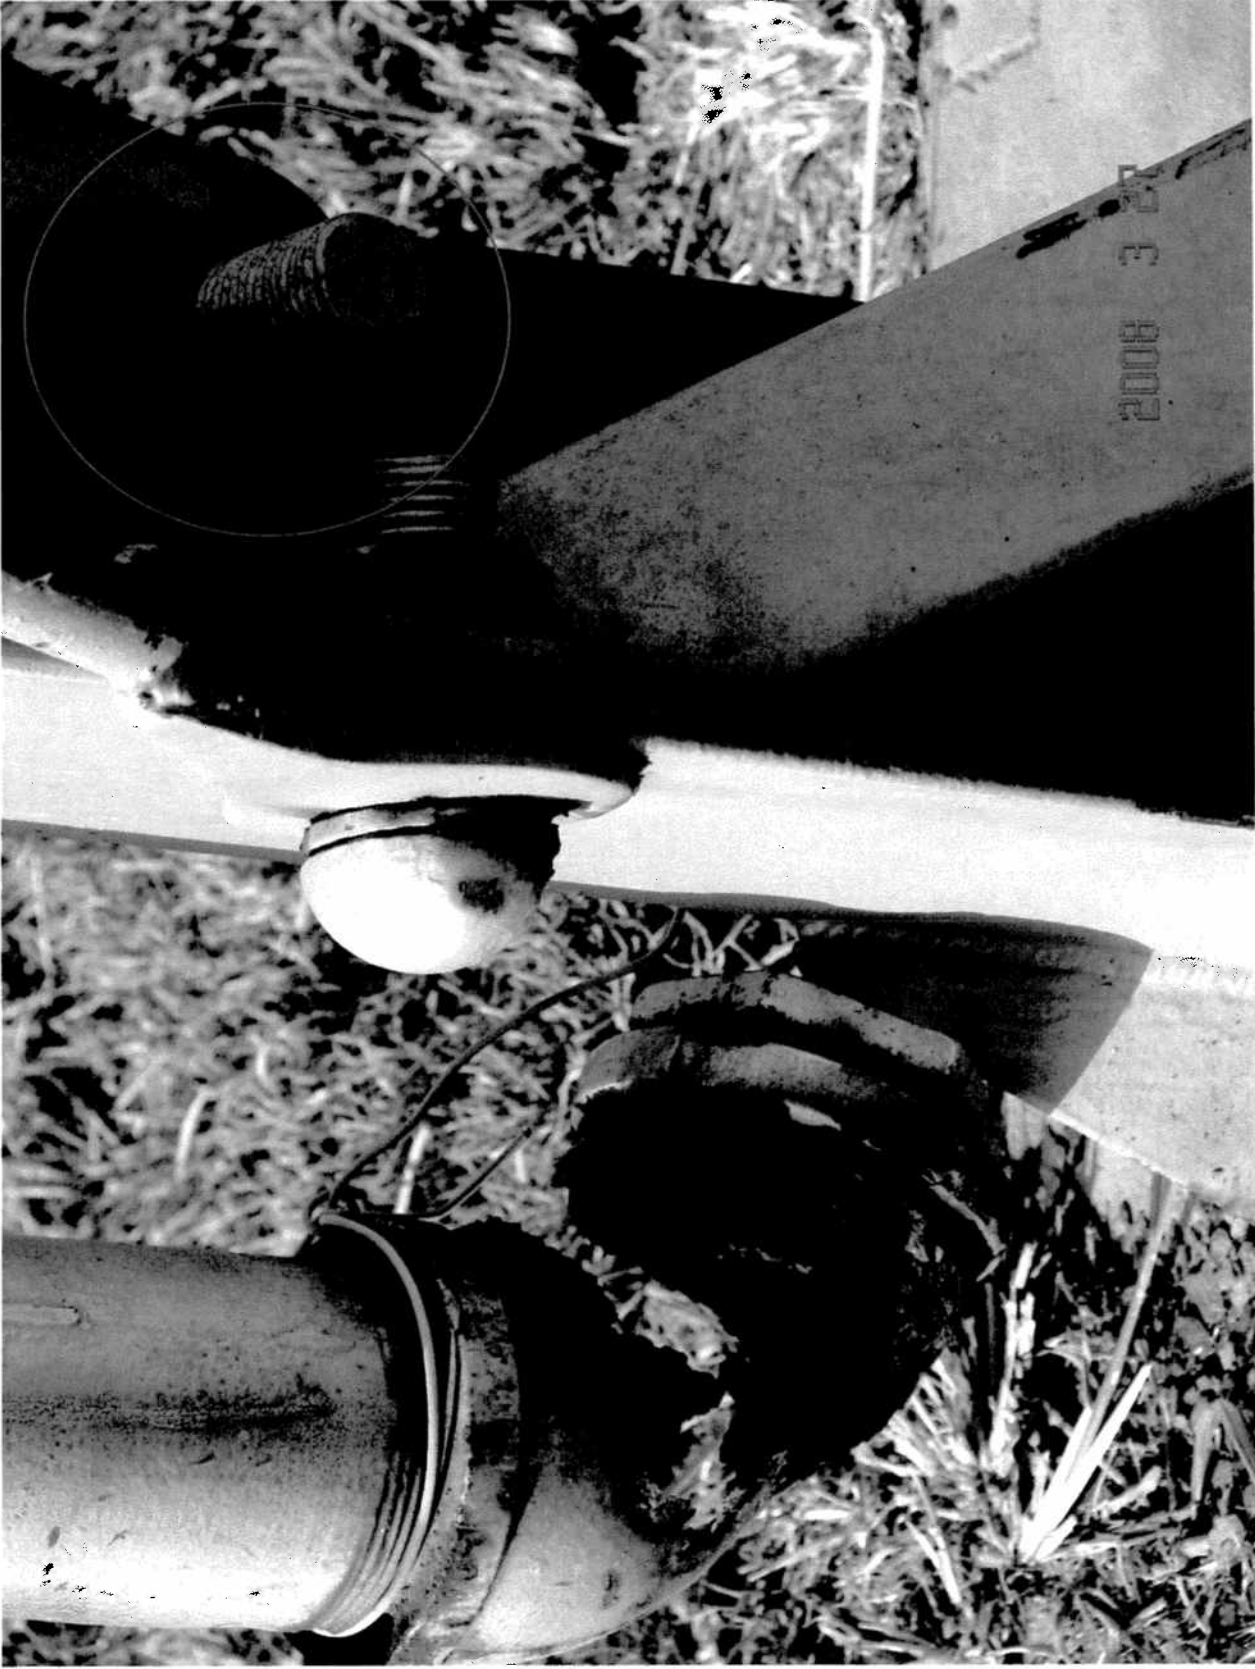
THIS PHOTO SHOWS A BOLT MISSING A NUT.

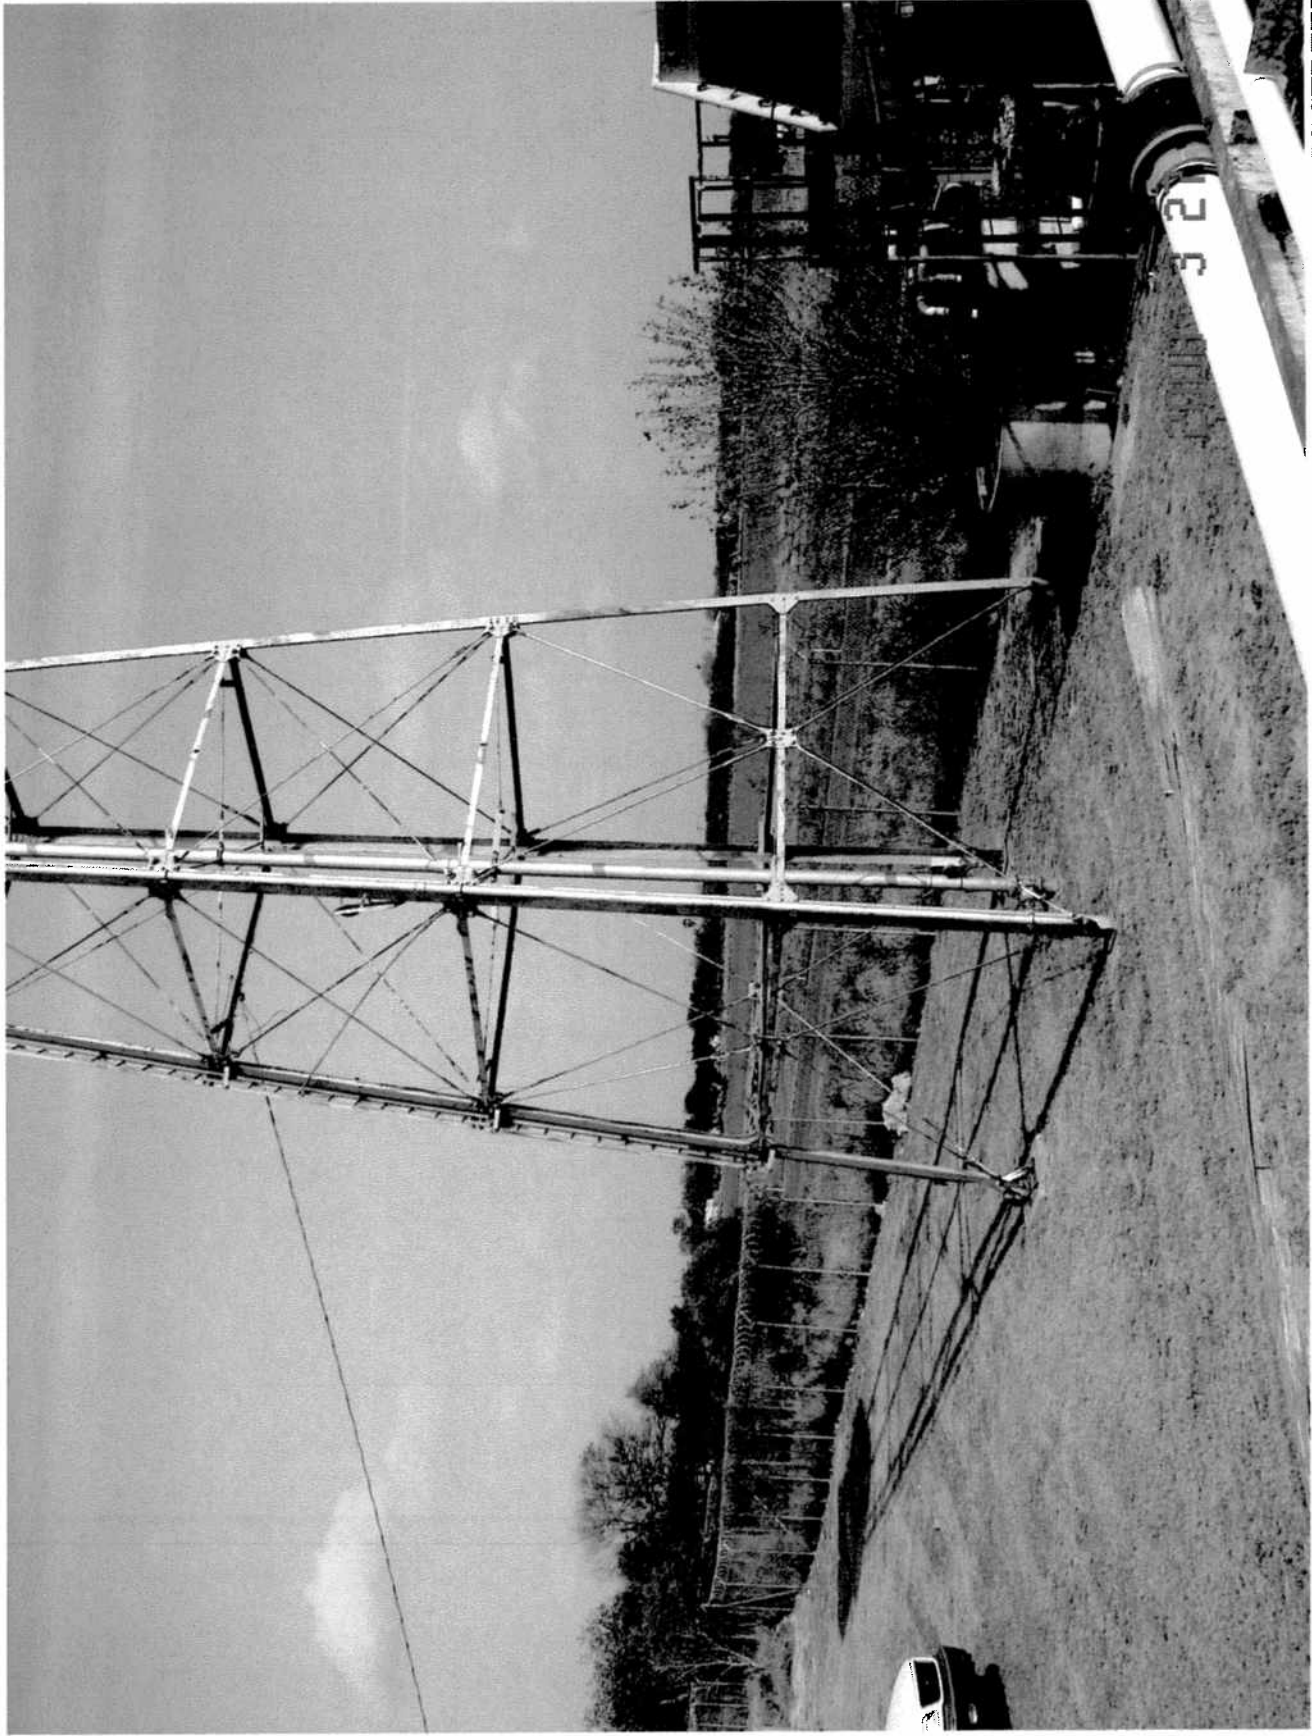
THIS PHOTO SHOWS THE PROXIMITY BETWEEN THE WATER TOWER AND HUMPHREY AVE. (PUBLIC STREET).

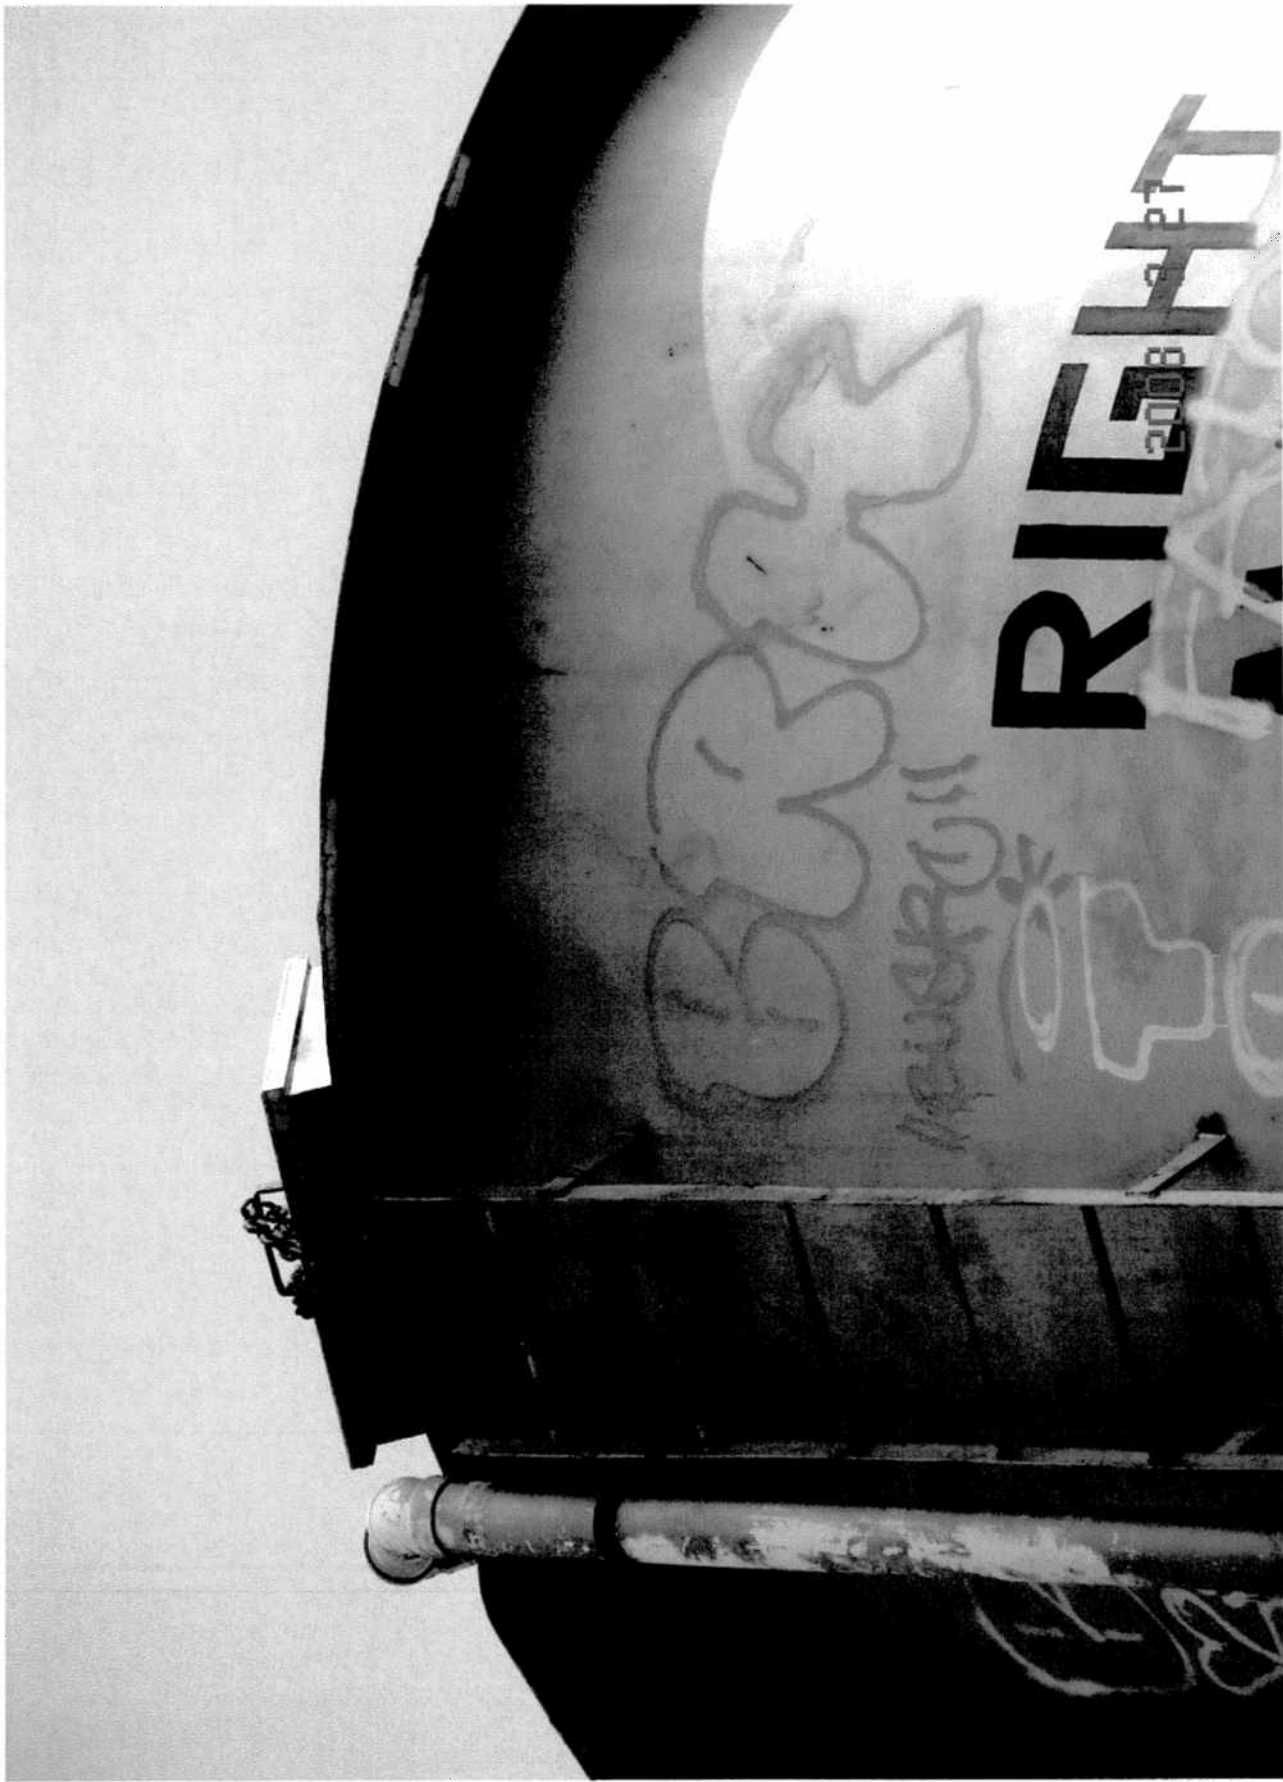
THIS PHOTO INDICATES INDIVIDUALS HAVE BEEN USING THE LADDER TO TAG ON THE WATER TOWER.

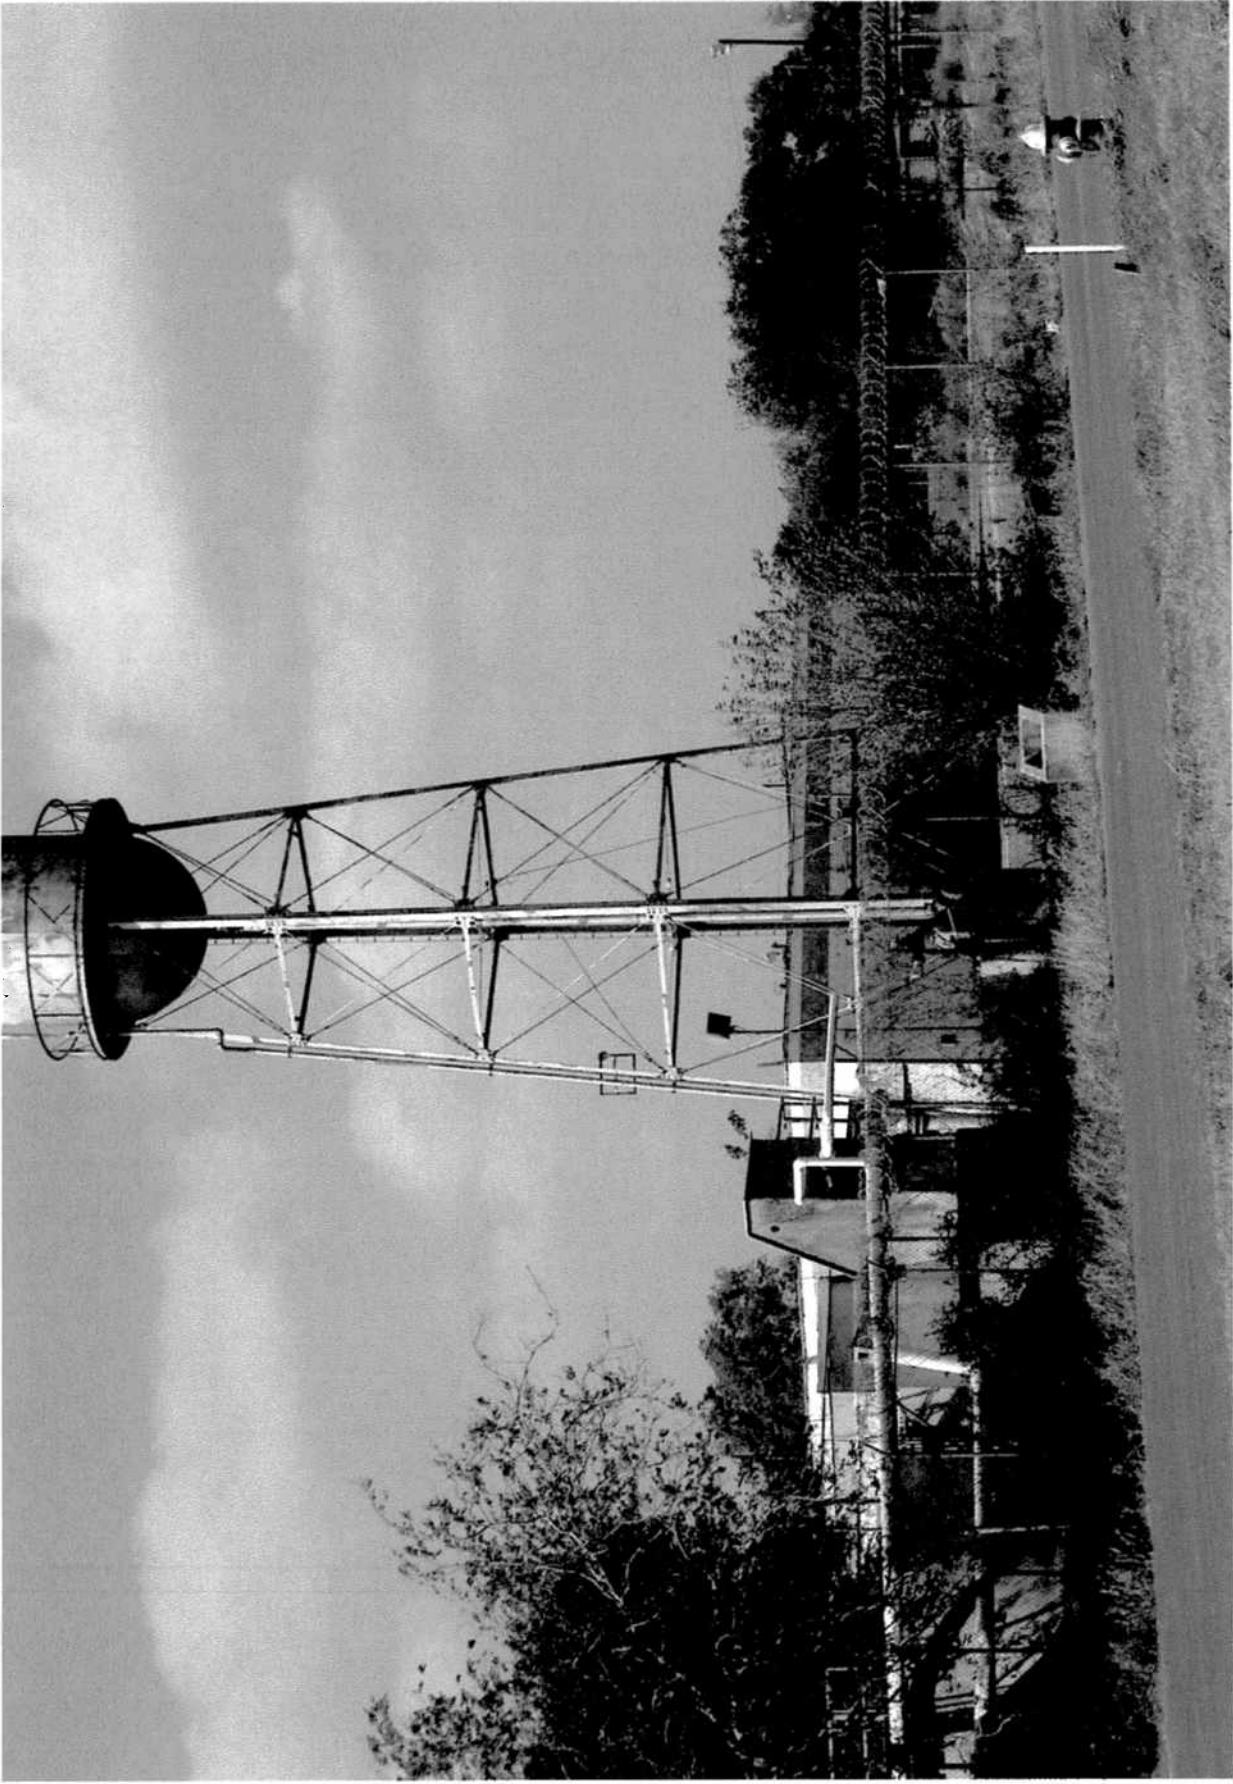
THIS PICTURE SHOWS HOW CLOSE THE WATER TOWER IS TO THE PUBLIC STREET.

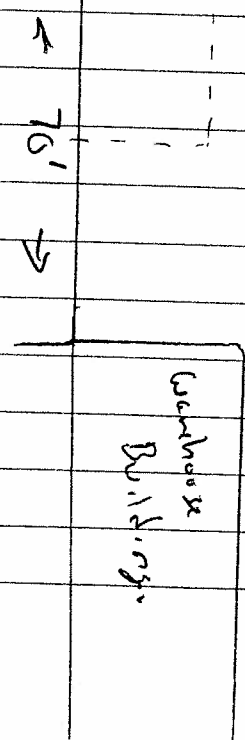
Total Height - 75' to 80'
 (S)
