PROGRESO WIC CLINIC

January 21, 2011

510 N. FM 1015
PROGRESO, TX 78596

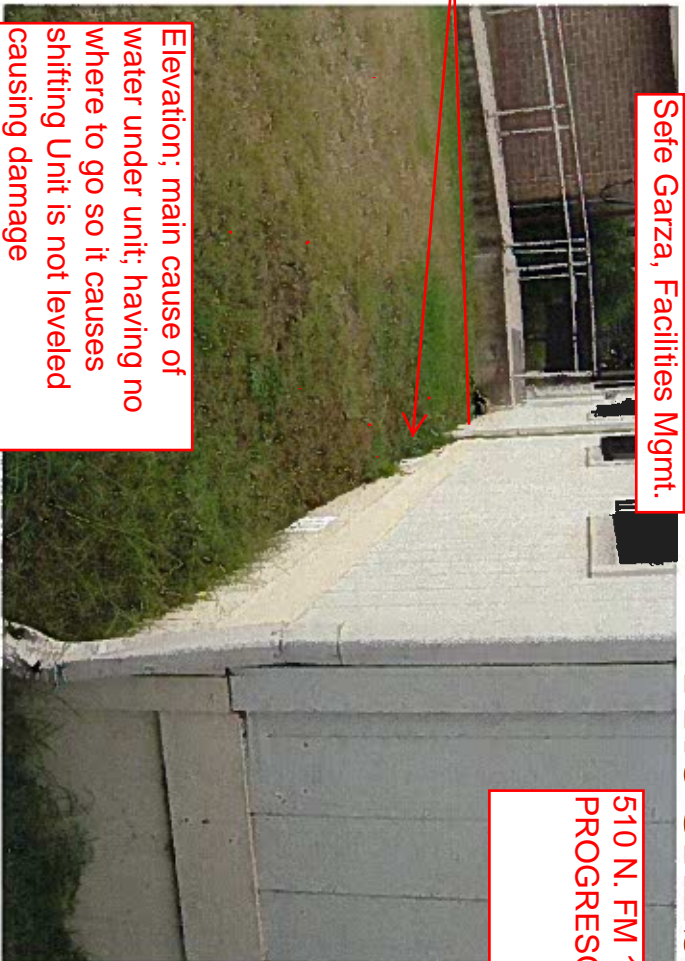
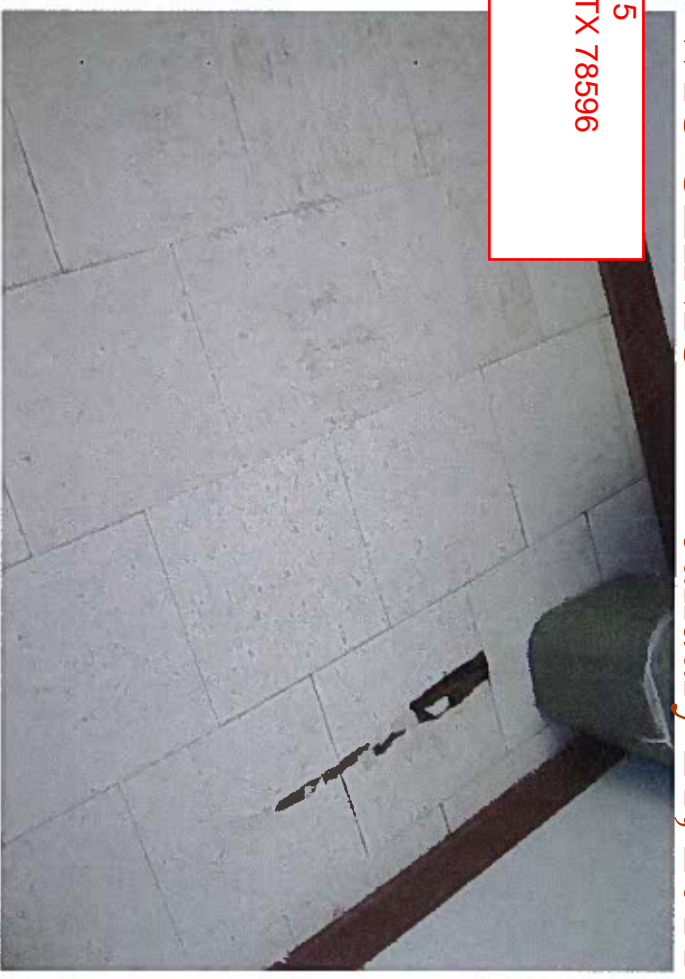
Elevation; main cause of water under unit; having no where to go so it causes shifting Unit is not leveled causing damage

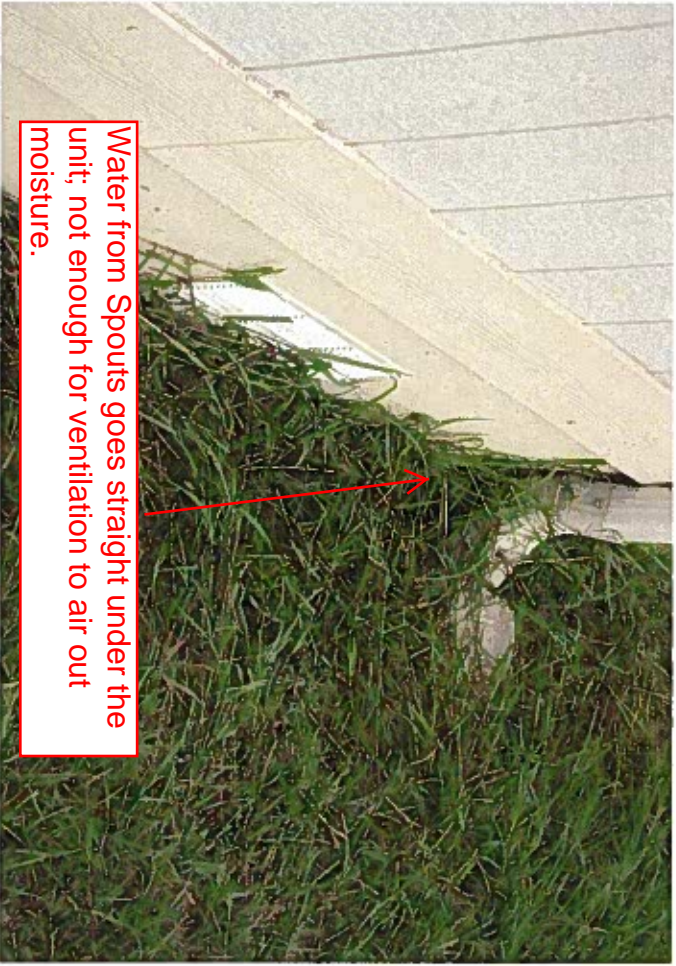
Exterior is the same scenario as the McAllen Clinic; Elevation higher than unit; needs Caliche under the units for more Stabilization and in the Progreso Clinic we need the Stone Slabs for the Down Spouts along with fixing the downspouts for better channeling of water.

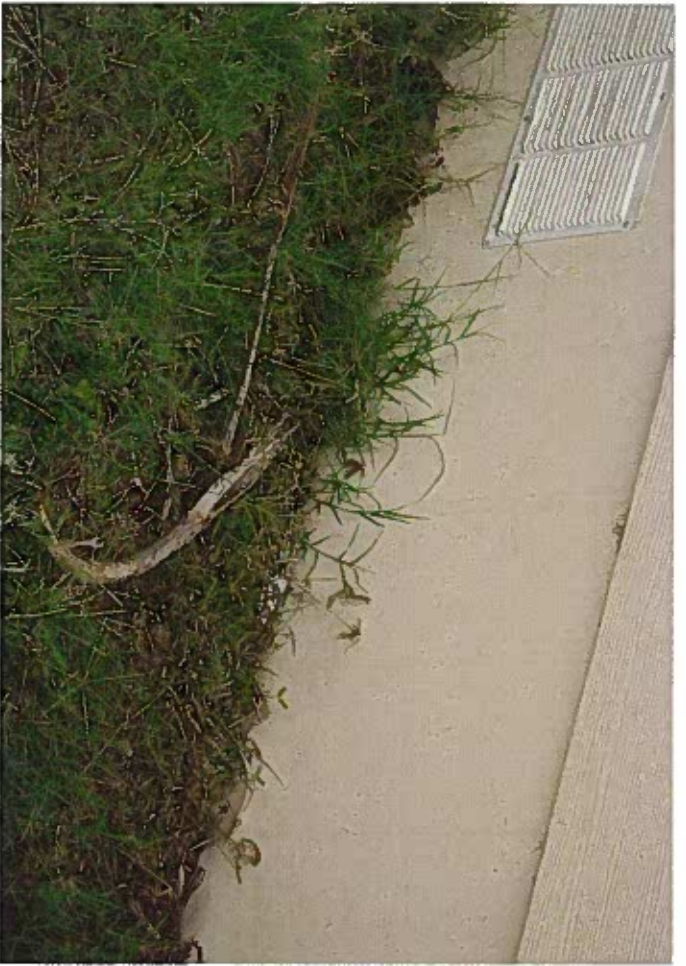
Water from Spouts goes straight under the unit; not enough for ventilation to air out moisture.

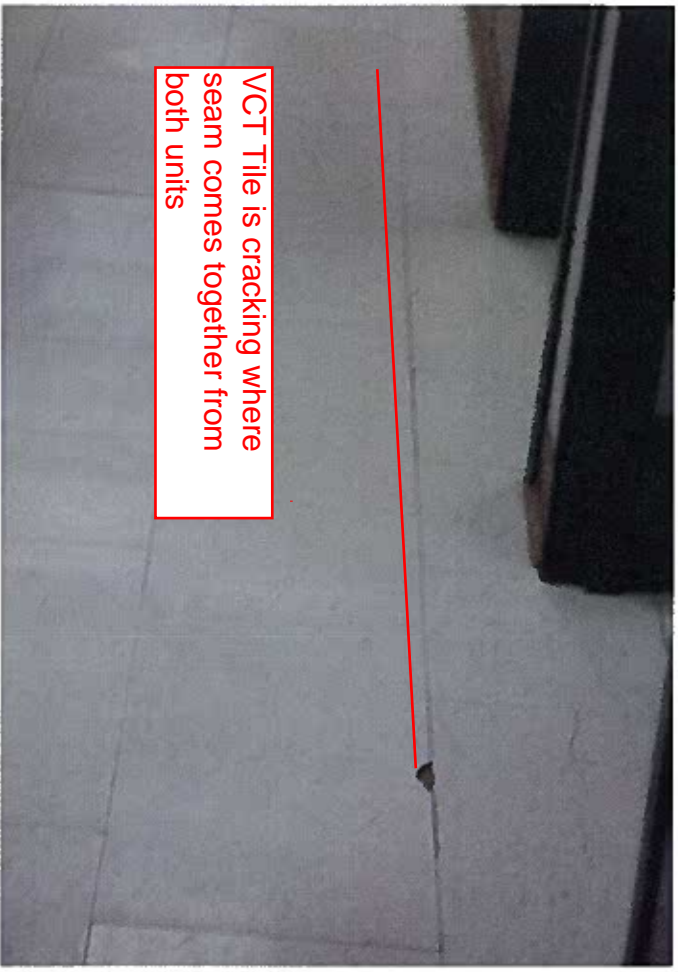
VCT Tile is cracking where seam comes together from both units

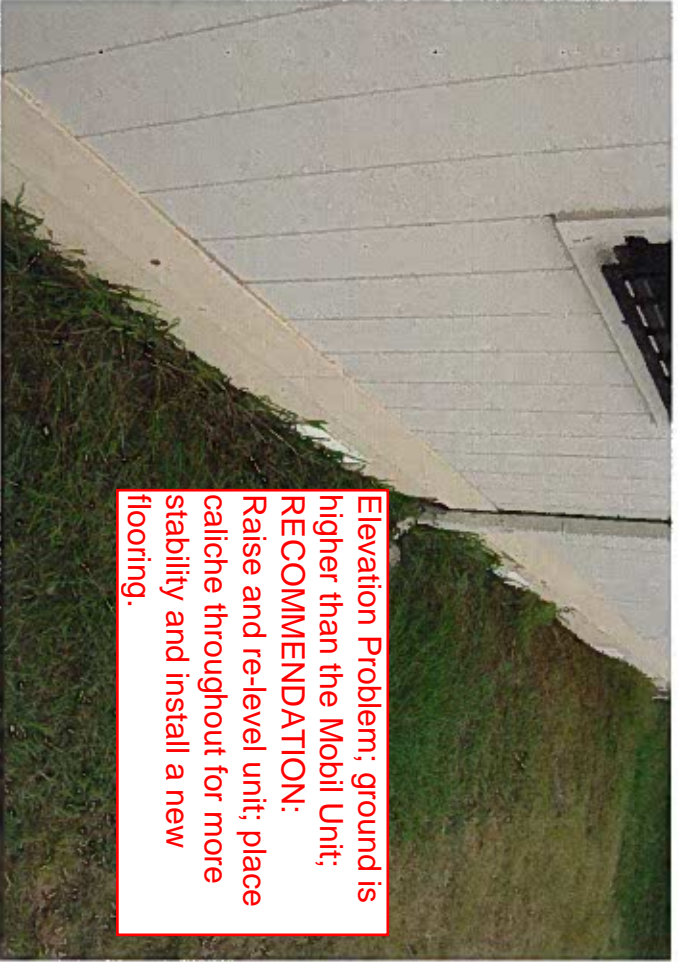
Elevation Problem; ground is higher than the Mobil Unit;
RECOMMENDATION:
Raise and re-level unit; place caliche throughout for more stability and install a new flooring.

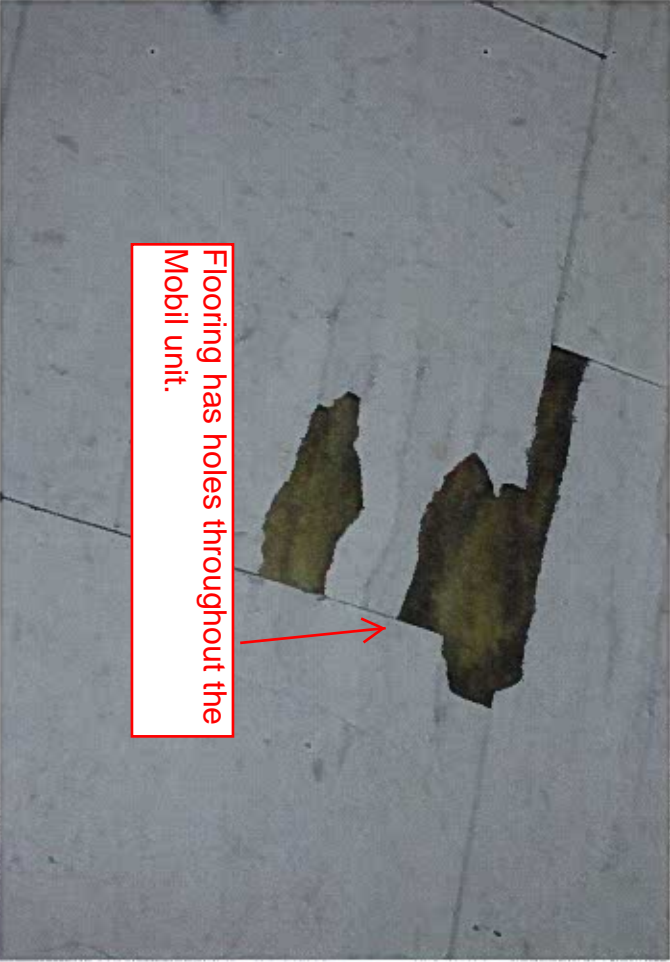
Flooring has holes throughout the Mobil unit.
