Project: Hidalgo County Precinct 4
 San Carlos Community Resource Center
 Hwy 107 and Sunflower Road
 San Carlos, Texas

Field Report No. 18

**ARCHITECT'S
FIELD REPORT**

Project:	San Carlos Community Resource Center	Architect's Project No:	201305
Field Report No:	18	Time:	1:30 p.m.
Field Report Date:	01.07.15	Weather:	Cool
Contractor:	Foremost Construction 26986 Bass Blvd. Harlingen, Texas 78552	Est. Completion:	90%

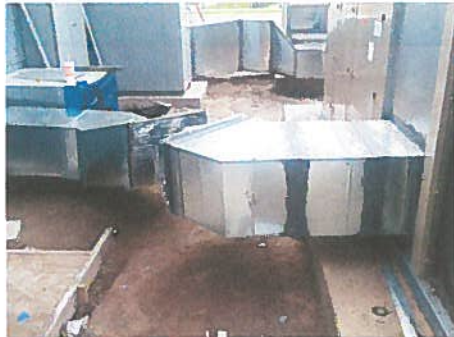
09. Concerns with the duct installation at AHU-1 and AHU-2 have been forwarded to the mechanical engineer. The units do not have the 6" housekeeping pad called for on Sheet M-1.0 and the duct layouts do not coincide with the drawings. Refer to photo.

Mechanical concerns forwarded to Engineer.

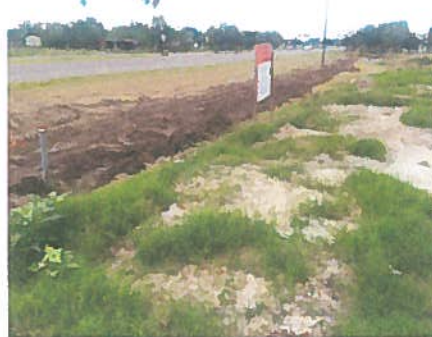
10. The utility-line work being done by the North Alamo Water Supply Corporation has reached the project site. Refer to photo.
11. Hardie Shingle Siding to be custom fitted under the window frames to allow for a continuous appearance of the siding.

Utility-line installation by North Alamo Corp.

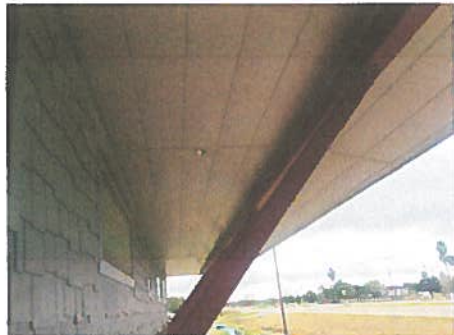
12. Oil-canning at the metal soffits must be addressed and a solution proposed as per manufacturer's recommendations. Refer to photo.
13. Entry sidewalks have been poured; connection to the parking / park sidewalks will be by others.

Oil-canning at soffit needs corrective work.

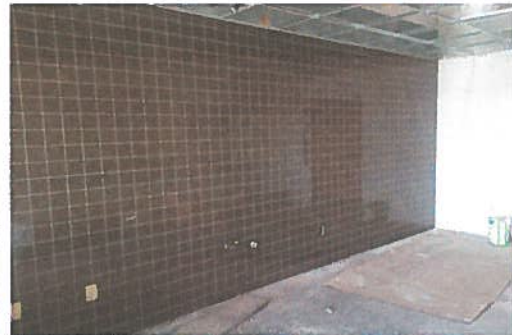
05. Ceramic tile wall has been placed on the "wet wall" of the kitchen along with the ceiling grid.
06. The wall mounted light fixtures are not per the submittal; electrical engineer working with supplier to get intended installation version substituted for the fixtures on-site.

Ceramic tile wall at multi-purpose kitchen.

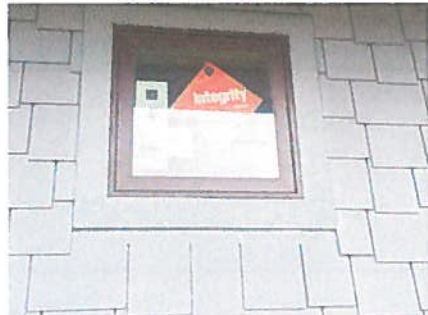
Siding piece needed below windows.

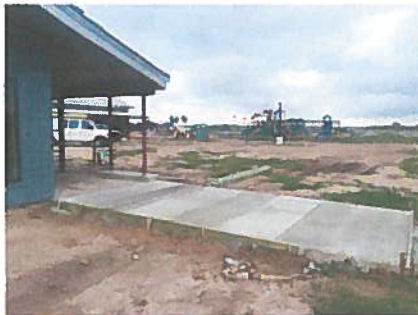
Poured sidewalk at entry.

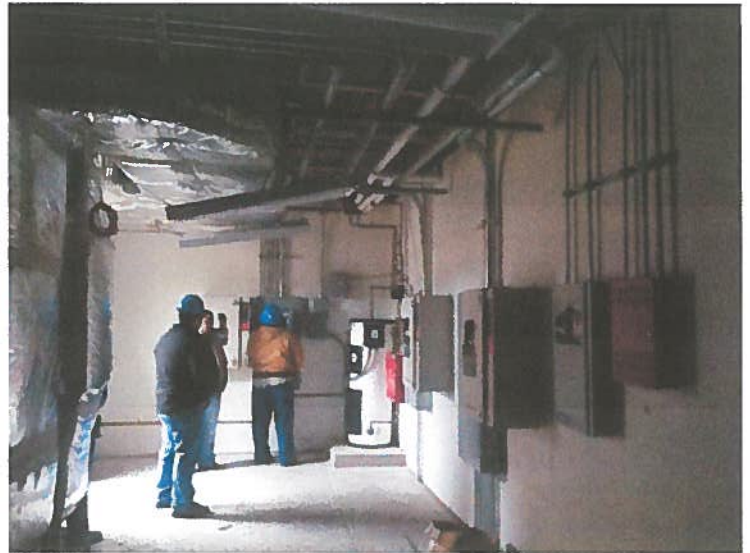
7. The mechanical room still does not have a ceiling. After some discussion between the Architect, the GC and FSG, it was decided that the light fixtures should be located on one side of the room away from the ductwork, the ceiling may be placed across the space no more than 6" from underneath the ductwork. Special attention will need to be given to the various lines along the wall to make sure they make clean penetrations through the ceiling

Mechanical Room

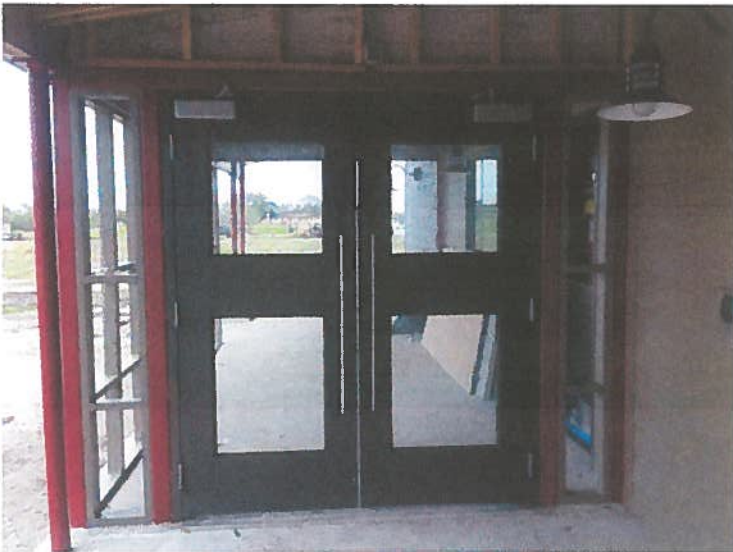
10. It is not clear why wire glass has been installed in the double door from the screening room. It's supposed to be wire

mesh screen.

Wire glass in doors

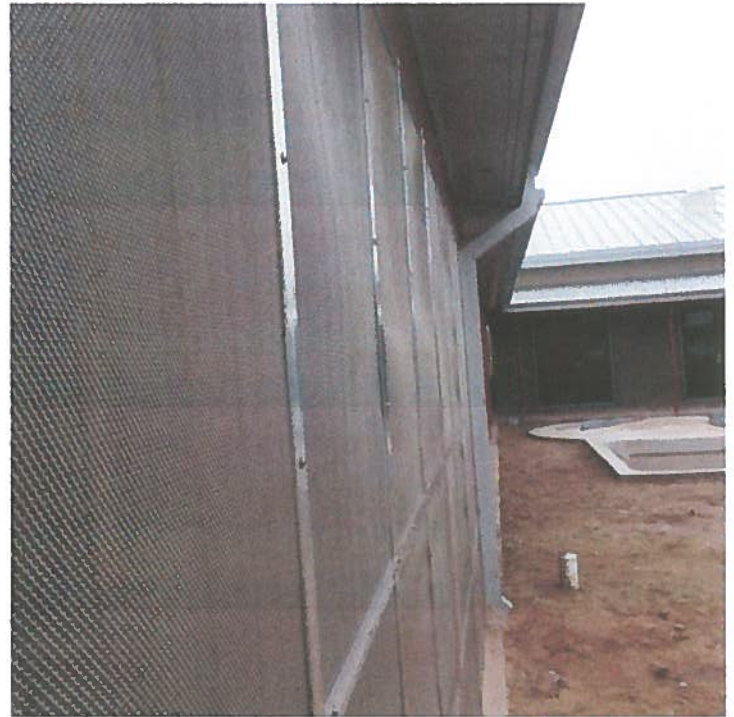
1. Wire mesh screen around screening area has been installed. The wire mesh appears to be the correct grade, however, the installation has left creases in the plane of the mesh. Also, the GC was instructed that the architect wanted all of the screws to be aligned horizontally and vertically. The configuration of the aluminum battens are not exactly what was detailed by the architect as the installer added horizontal bars where it was intended to be left as just a screw and washer. The details call for stove head, hex type, screw. What is provided is a Philips.

Mesh screen, screws not in line

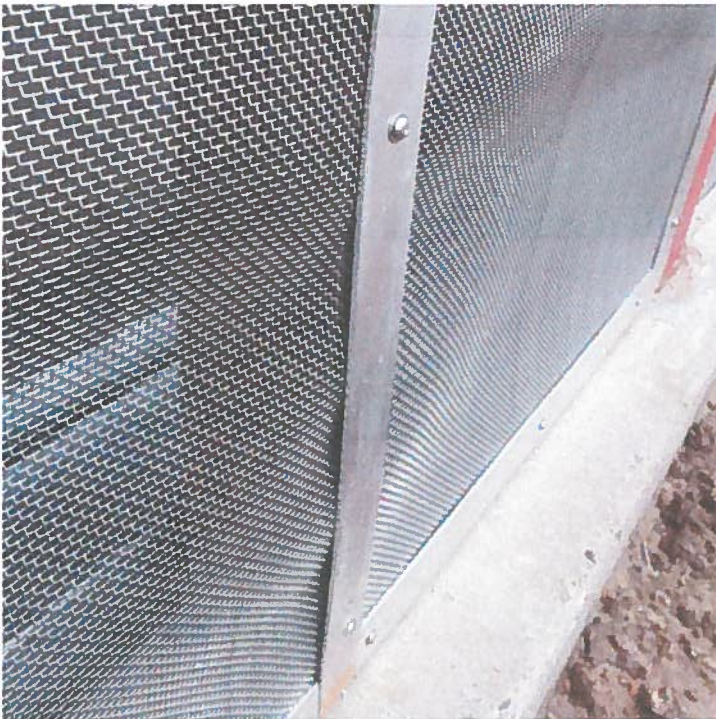
Bad install leaves creases in plan of mesh

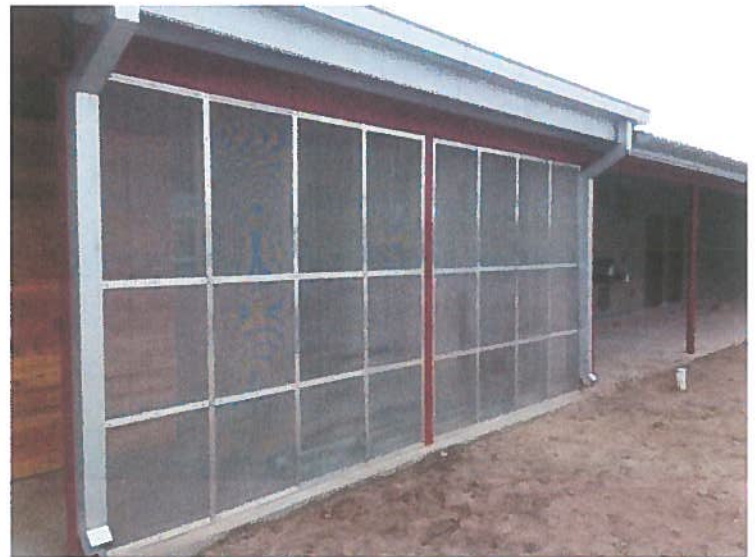
2. Downspouts installed around building are not the correct ones noted on the drawings. These need to be removed are replaced with the size and shape specified by the architect which are to be 3" round, not the 4" square that was installed.

overall mesh screen / oversize downspouts

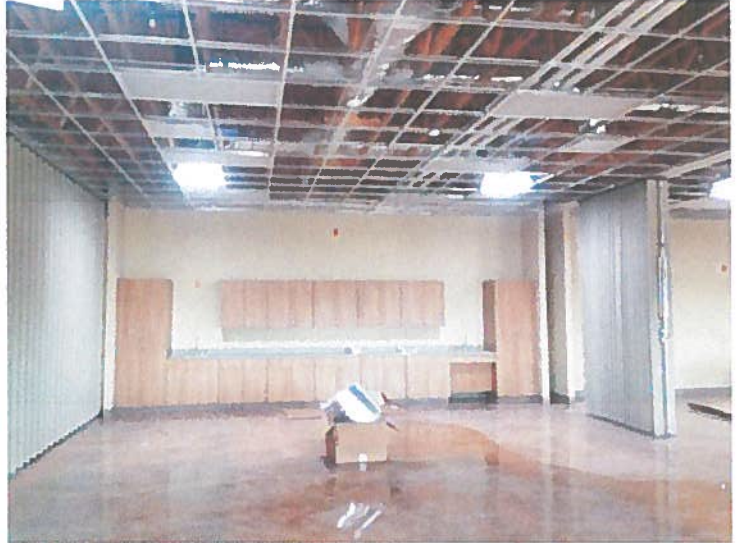
3. Cedar planks currently being installed on steel gates
4. All lights appear to have been installed under the canopy as discussed.
5. Solatubes have been connected within the multipurpose rooms, however, the diffuser lenses used do not appear to be the same ones specified by the architect. The architect specified Optiview lens, and what is provided is the basic prismatic lens, which has a totally different appearance. These diffusers must be changed out for the ones specified.

solatubes at Multipurpose

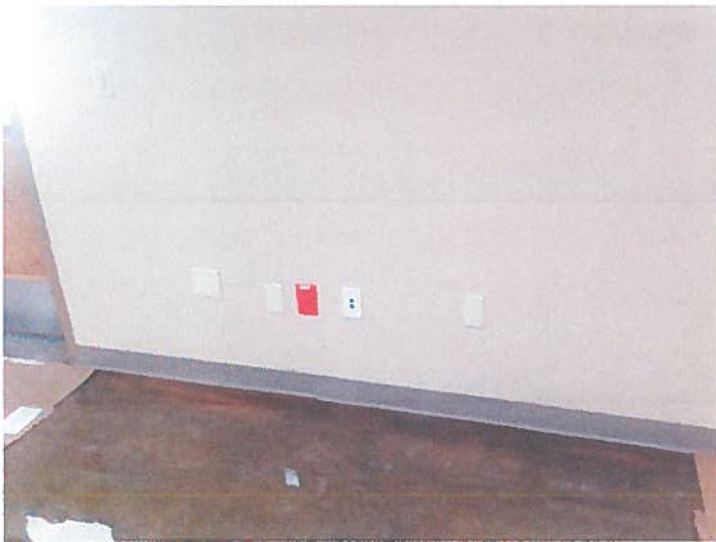
6. Outlet locations are not horizontally in-line as directed by the architect.
7. Significant paint or plaster spatter was found at the base of the wall between the restrooms and classroom.

Outlets not in-line

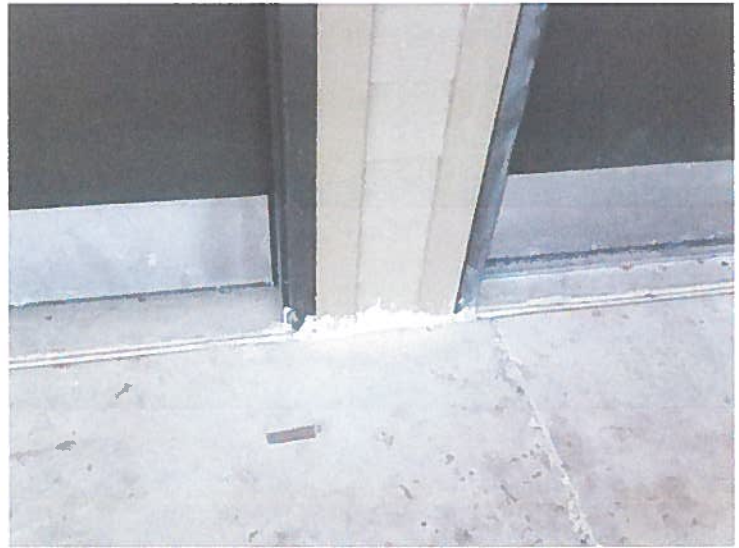
spatter on exterior walls

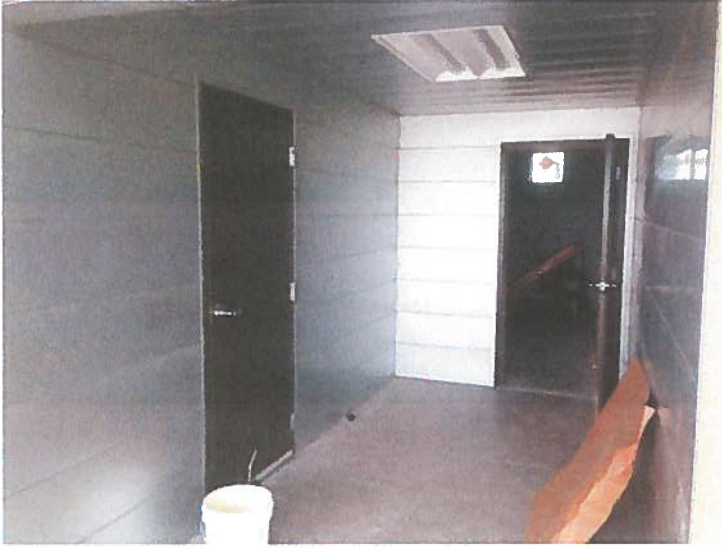
8. The metal panel cladding at hall 108 has finally received its finish trim and upon initial inspection appears to be of acceptable quality.
- 9.

Hall 108 finished metal cladding
