Observation Report

Project Name: Hidalgo County 1st & 2nd Floors

Project Location: Edinburg, Texas

Date: March 6, 2015

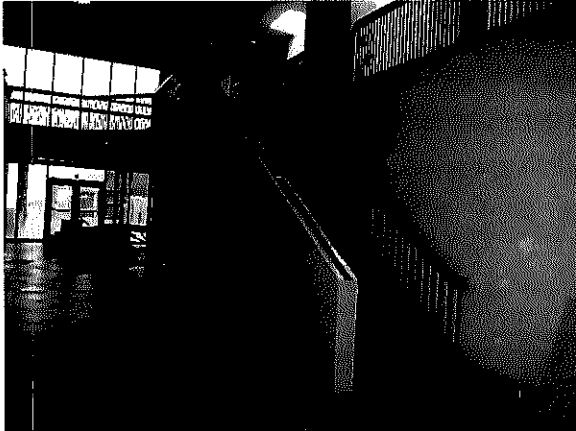
Figure 1

Floor tile installed, Gypsum Board work at stair railing, painting done.

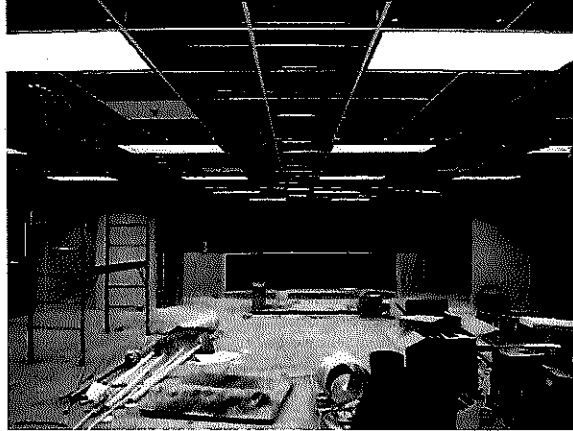
Figure 2

Ceiling grid and light fixtures in place, no flooring, countertop well underway.

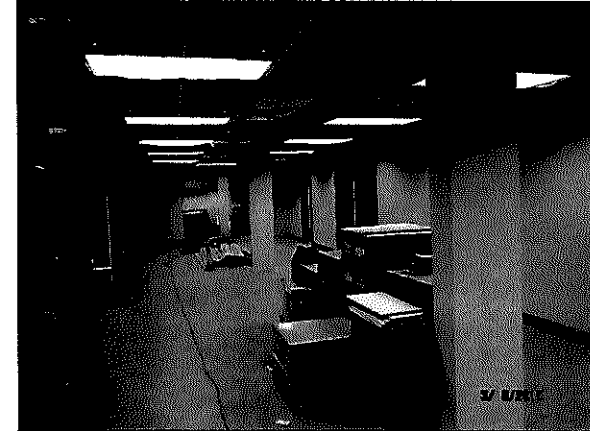
Figure 3

Walls painted, door frames and trim installed, ceiling grid and light fixtures and floor tile installed.

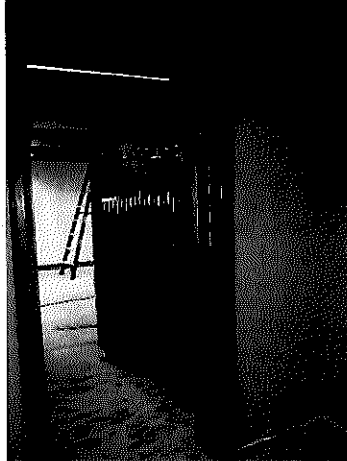
Figure 5

Door frames and trim installed, walls painted at vault (west).

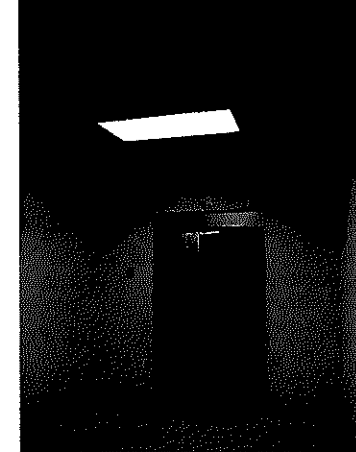
Figure 6

Work at inside vault space (North).

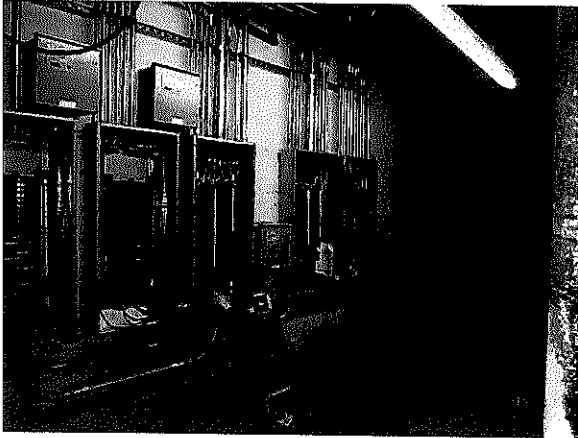
Figure 7

Electrical Work continues and electrical room.

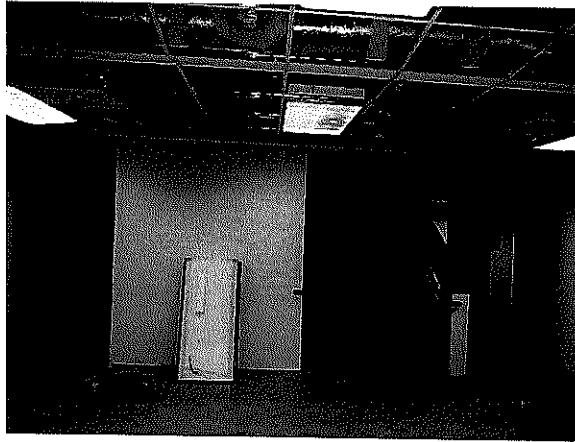
Figure 8

Ceiling track, floor tile, light fixtures installed, walls painted.

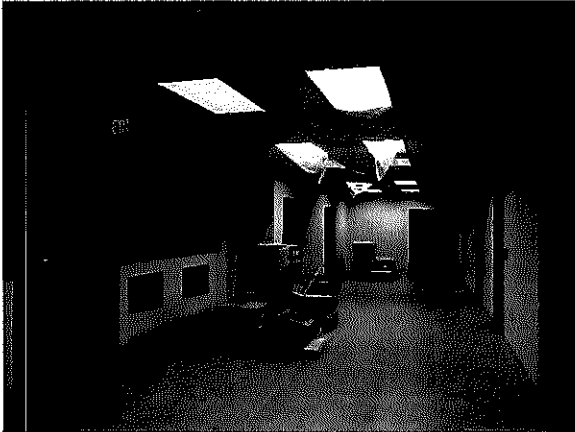
Figure 9

Floor tile, suspended ceiling, light fixtures installed, walls painted – waiting on DA’s modifications.

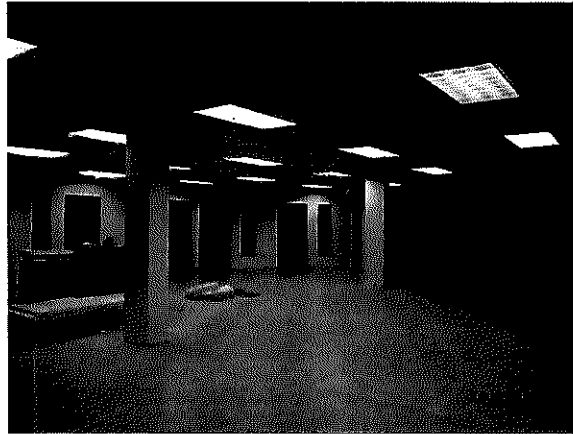
Figure 10

Ceiling tile in place, light fixtures; floor tile, doors, frames, side lites installed.

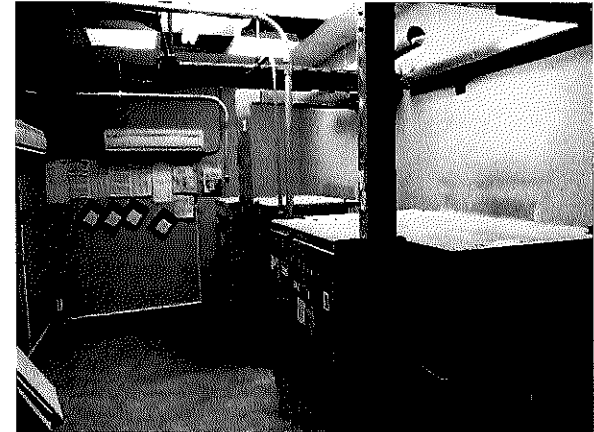
Figure 11

Work at mechanical room progressing quickly.

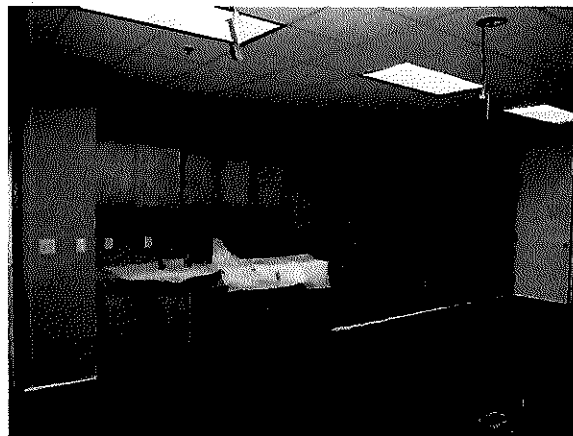
Figure 13

Millwork completed – lacking hardware; wood flooring, ceiling tile, light fixtures in place.

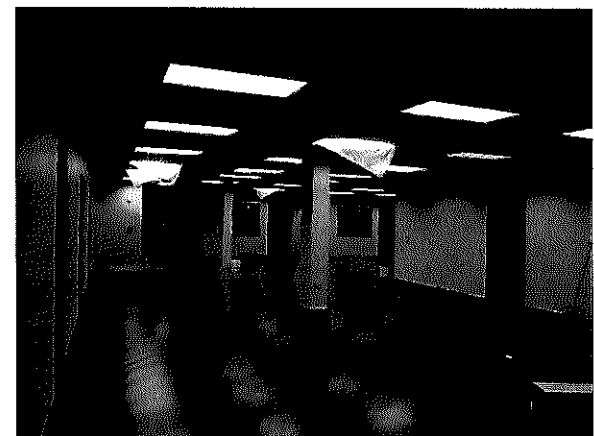
Figure 14

Wood flooring in place, walls painted, ceiling tile and light fixtures installed.

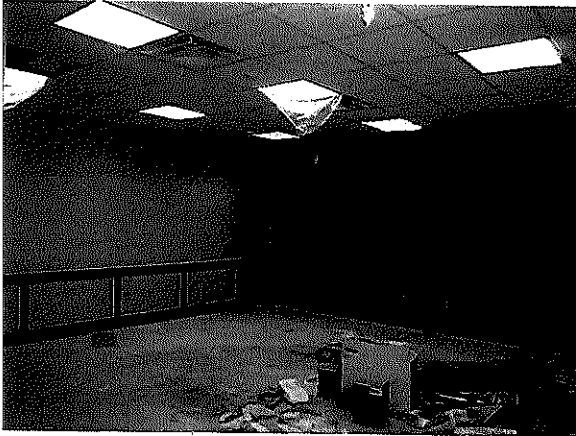
Figure 15

Ceiling tile in place, chair rail stained, walls painted, ceiling tile and light fixtures in place; no flooring.

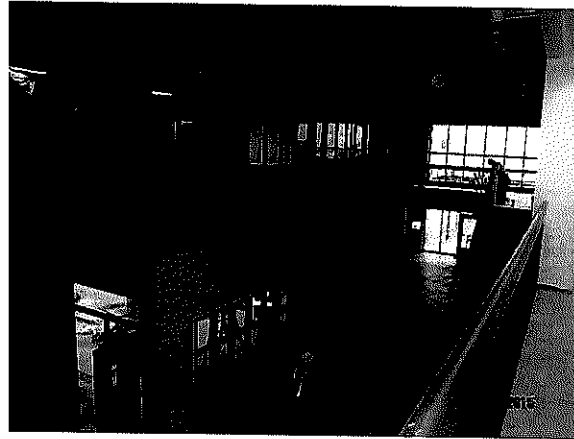
Figure 16

Walls painted, gypsum board work at stairway, floor tile in place.
