CERTIFICATE OF SUBSTANTIAL COMPLETION

Owner: Hidalgo County
Contractor: Central Air and Heating Service, Inc.
Engineer: Chanin Engineering, LLC
Project: Hidalgo County Adult Detention Center and Law Enforcement Facility Repairs and/ or Replacement
Owner's Contract No.: 2014-047-09-17-YSS
Contractor's Project No.:
Engineer's Project No.: 13159
Law Contract Name:

**Field Report # 33**

# FIELD OBSERVATION REPORT

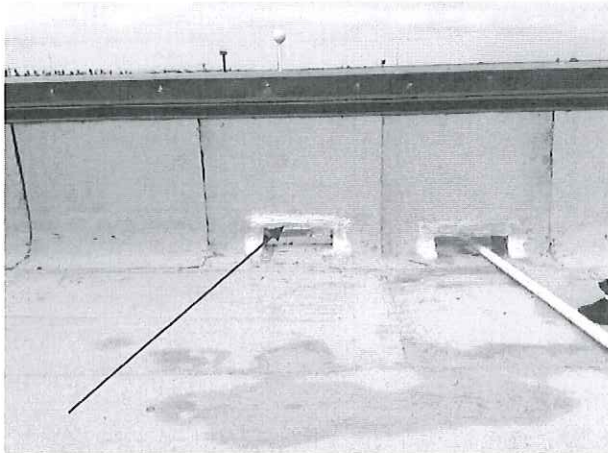
Correcting the scupper mouth 3-course stripping on west side of Delta roof.

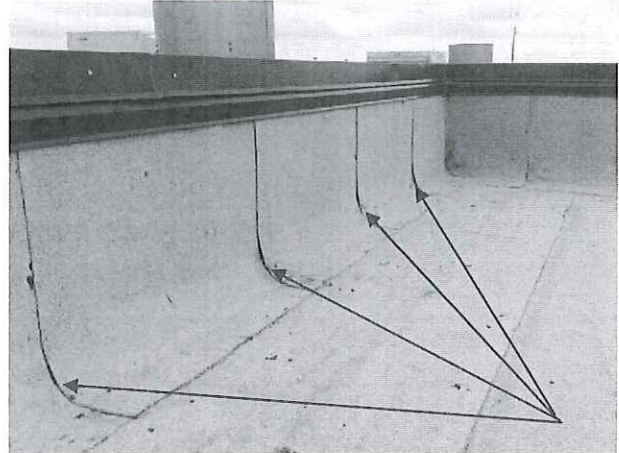
Seal the open laps in the modified base flashing on the north side of the sally port roof.

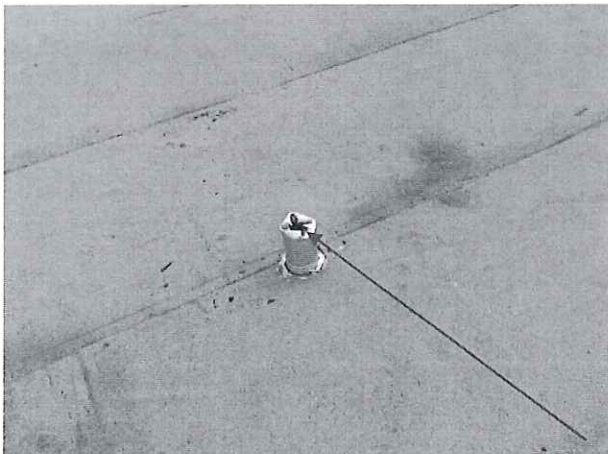
Properly fold the top of lead jack into the pipe on the Kitchen Maintenance roof.

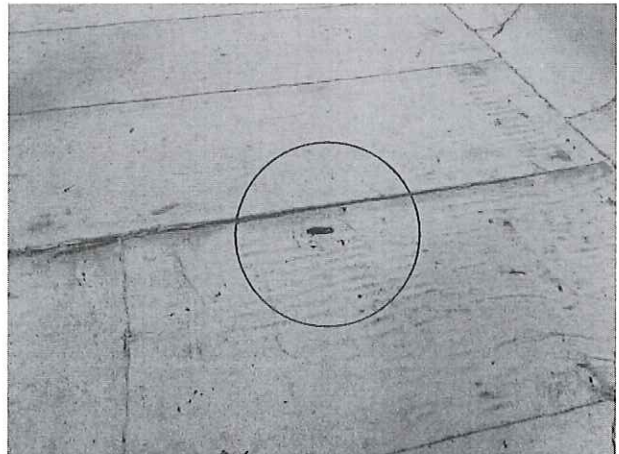
Repair the cap ply on the north side of the Kitchen Maintenance roof.

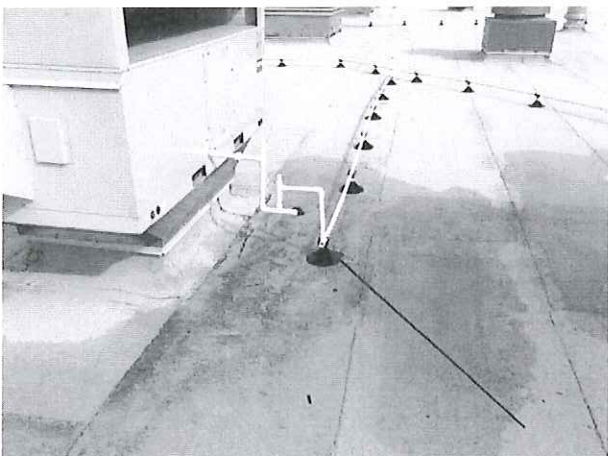
Completion of installing the condensation drain lines throughout project

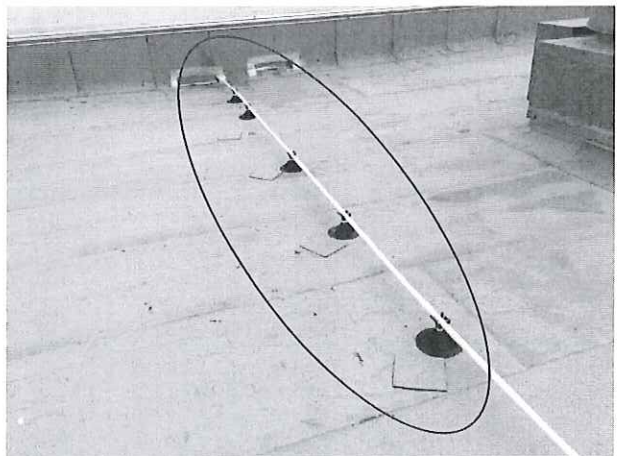
Installation of modified pads under condensation drain line pipe supports throughout project.

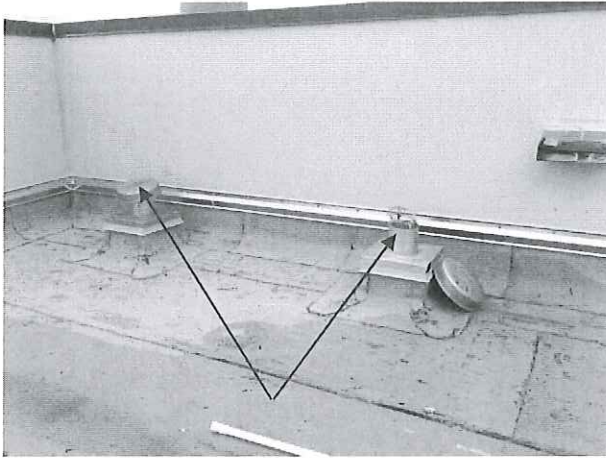
Install vent caps onto vents in Kitchen Maintenance roof area.

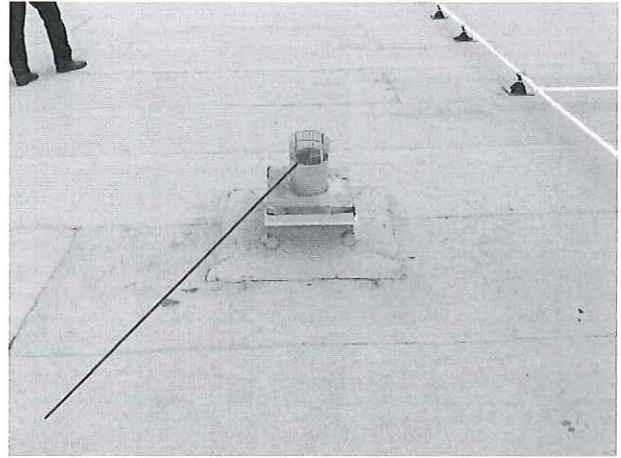
Install vent caps onto vents in the Booking Infirmary roof area.

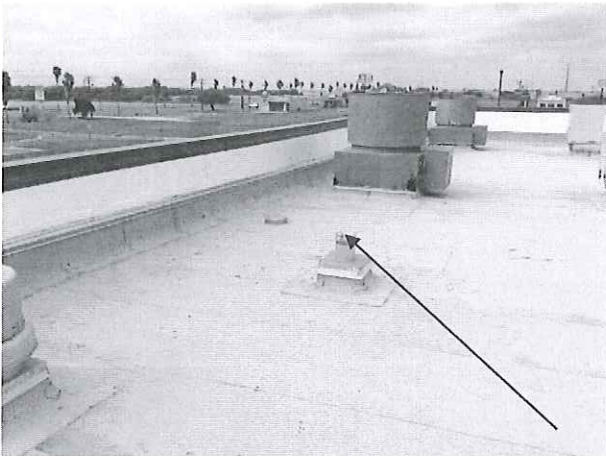
Install vent caps onto vents in the Alpha roof area.

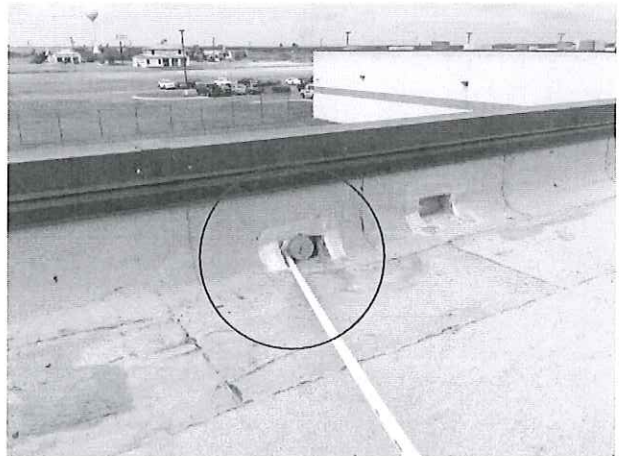
Ensure scuppers are clear of debris. Ensure condensation lines do not enter scuppers.

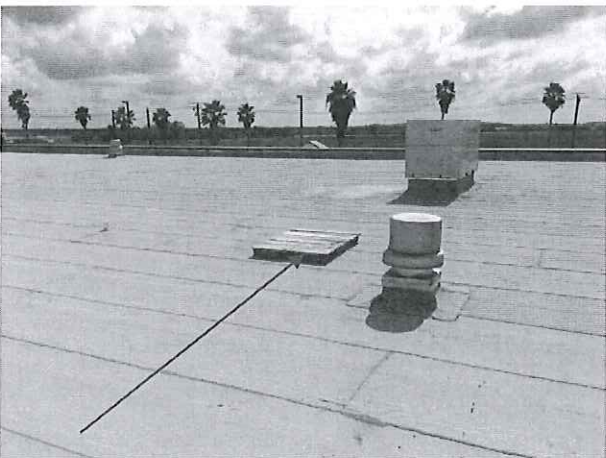
Remove the pallet from the LEC roof. Sweep rooftops with rolling magnet.

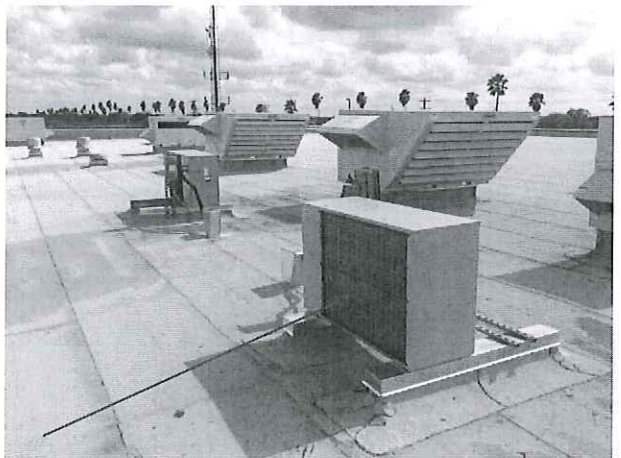
Secure the mini splits to the curbs on the LEC.

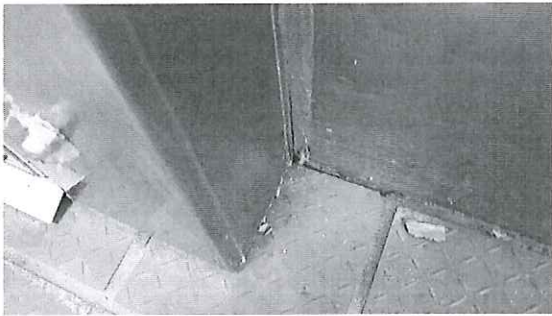
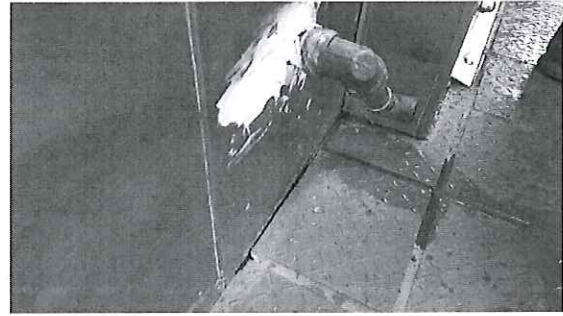
1. Adult Detention Center - Kitchen: Insufficient grouting at a couple of areas near the new replacement doors. These areas must be re-grouted to not allow water to get under the new quarry tile.

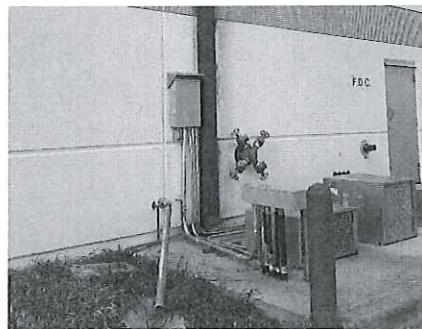
2. Adult Detention Center - East Exterior elevation: Downspout near new replacement Air Handler Units has not been re-routed to avoid water spillage on new equipment. Redirect Downspout.

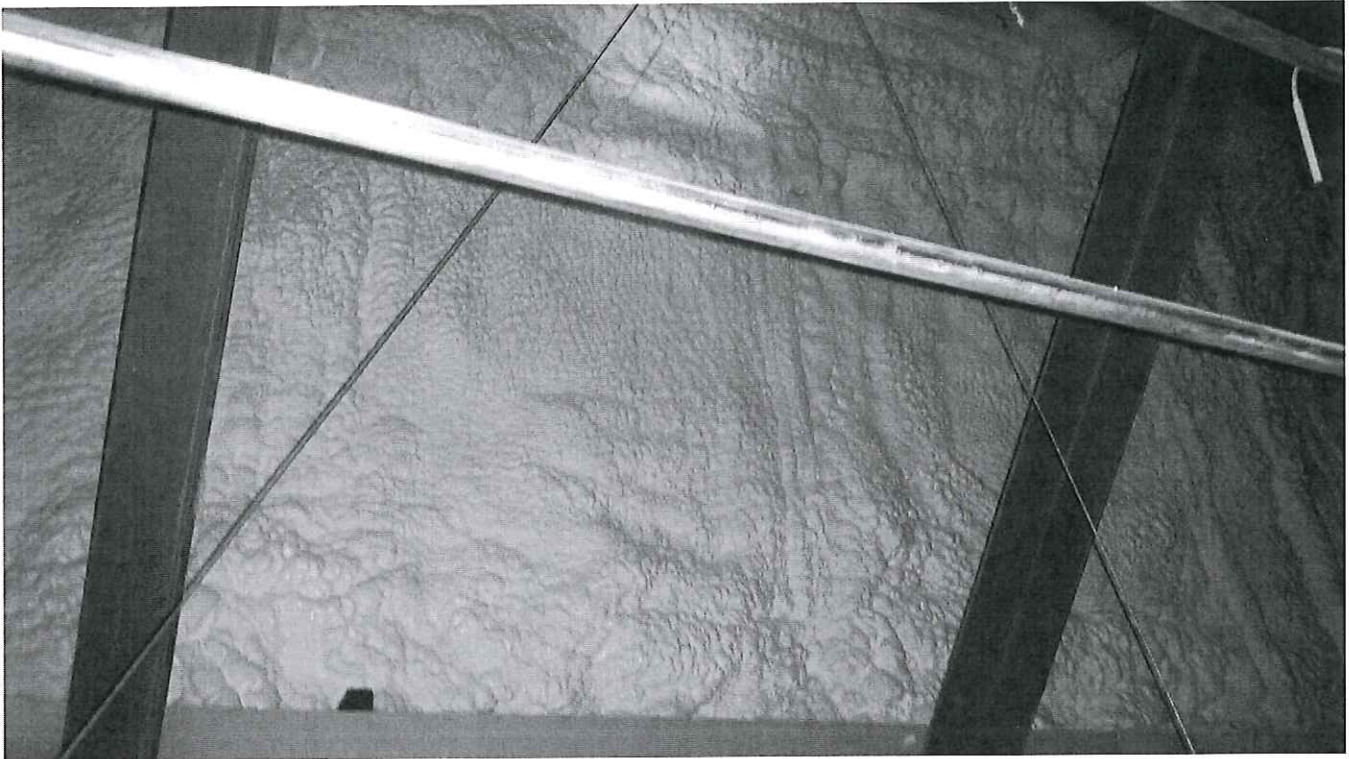
**Insulation foam at the south interior wall**

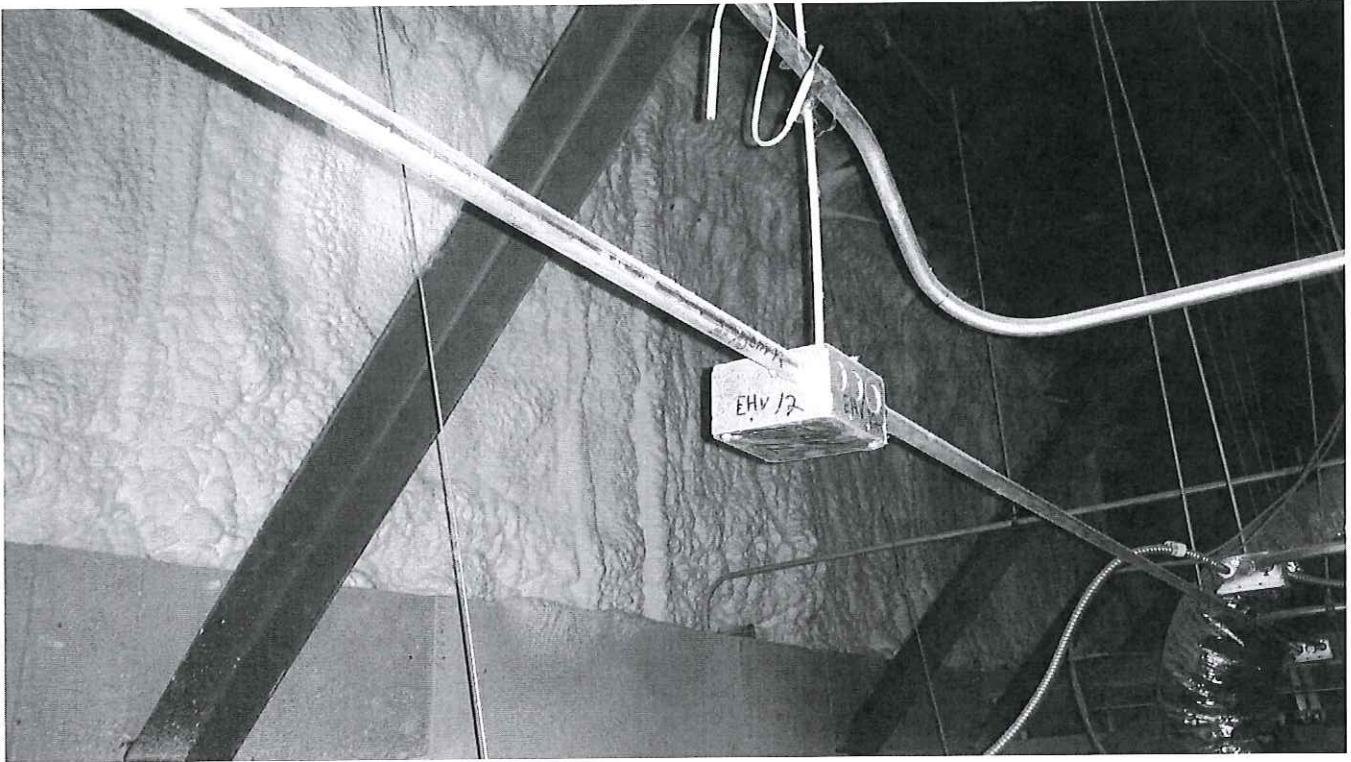
**Insulation foam at the south interior wall**

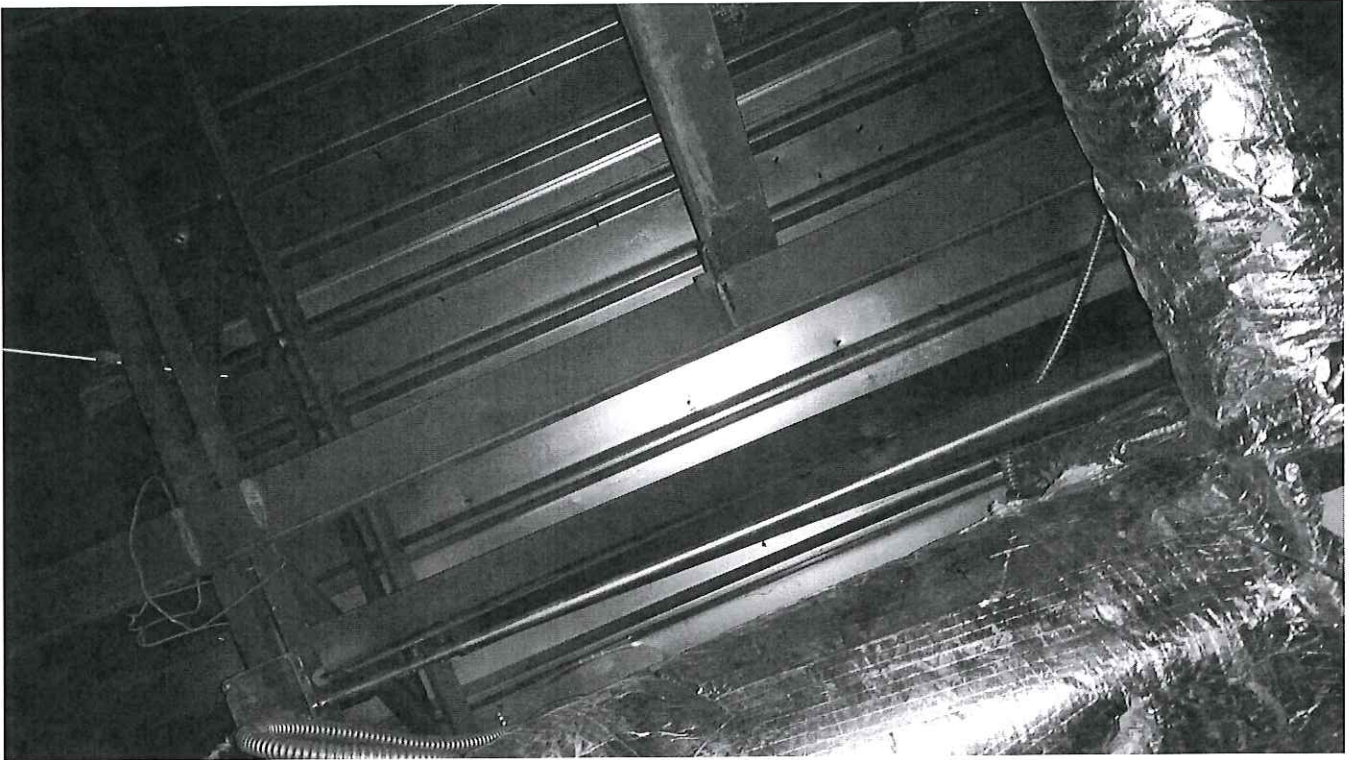
Structural angles welded to existing joists

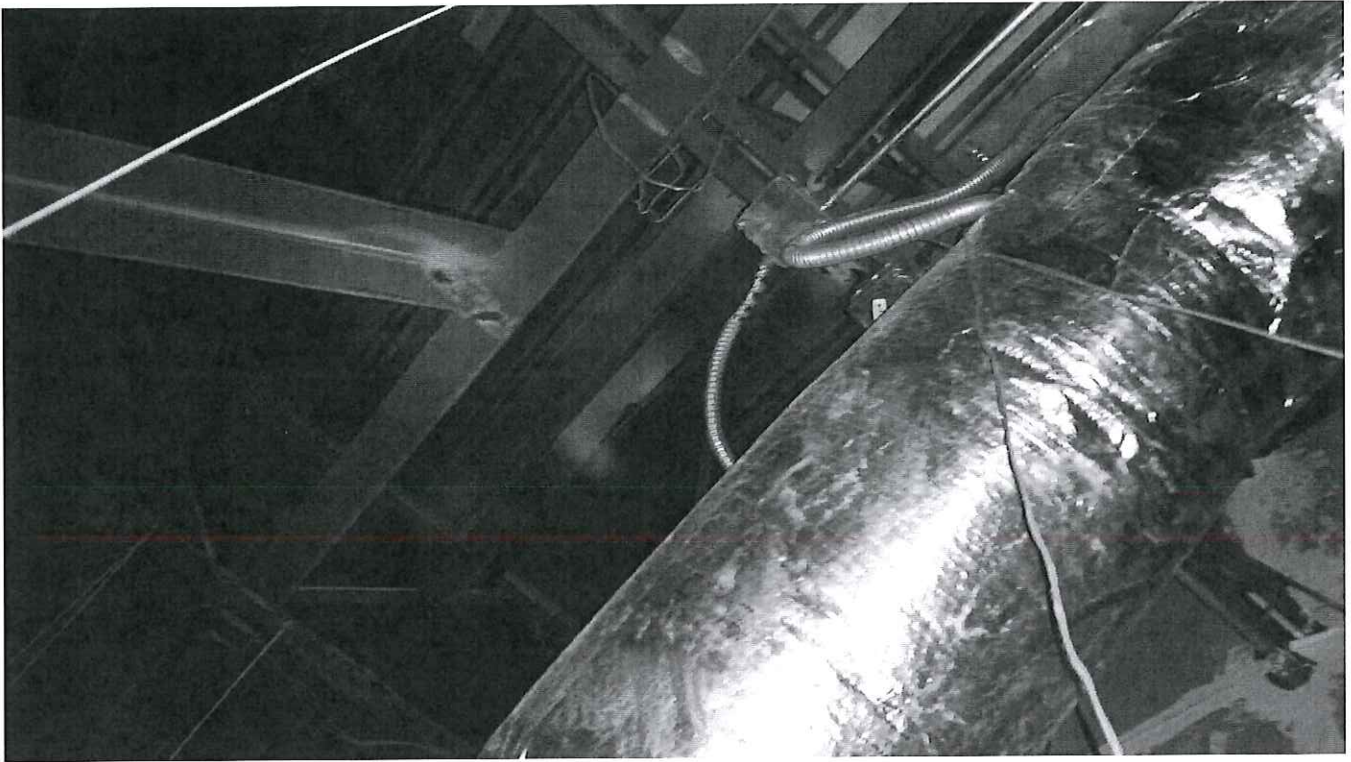
Structural angles welded to existing joists

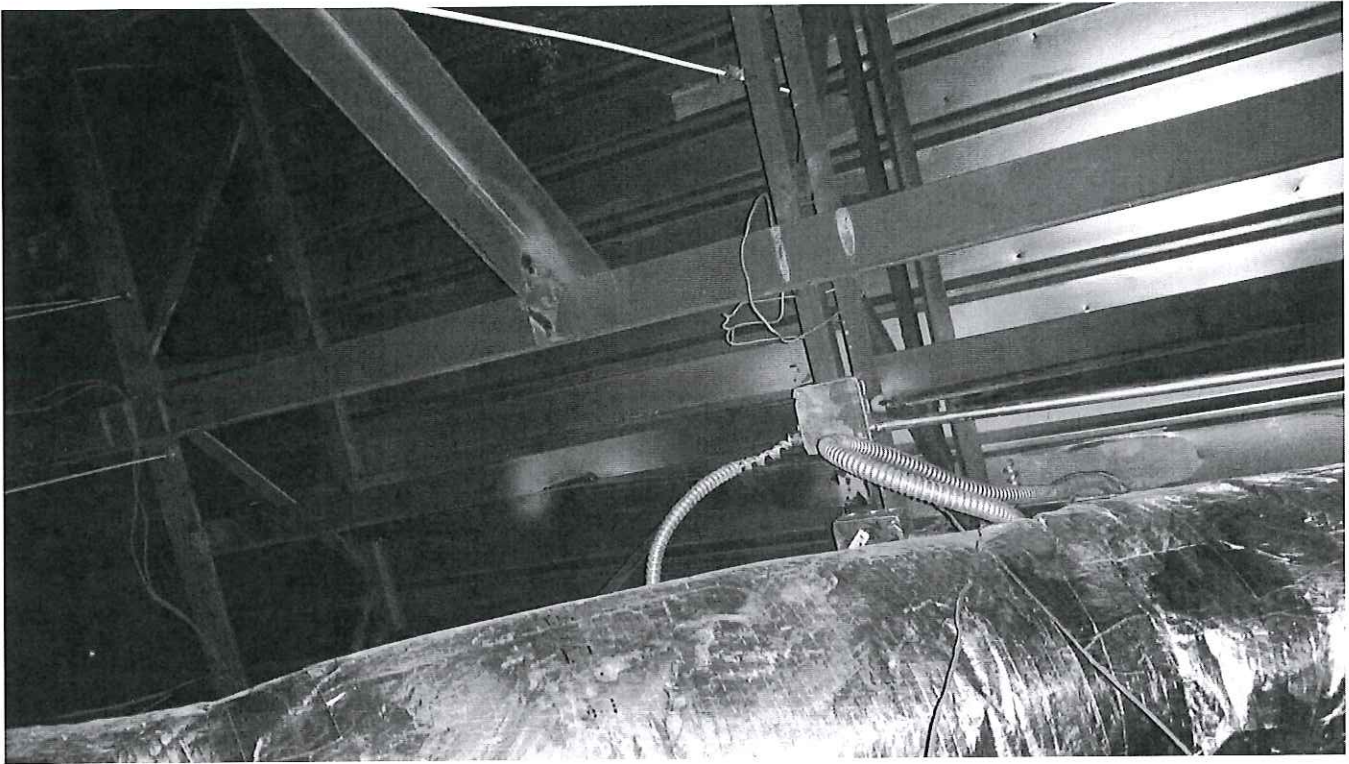
Structural angles welded to existing joists

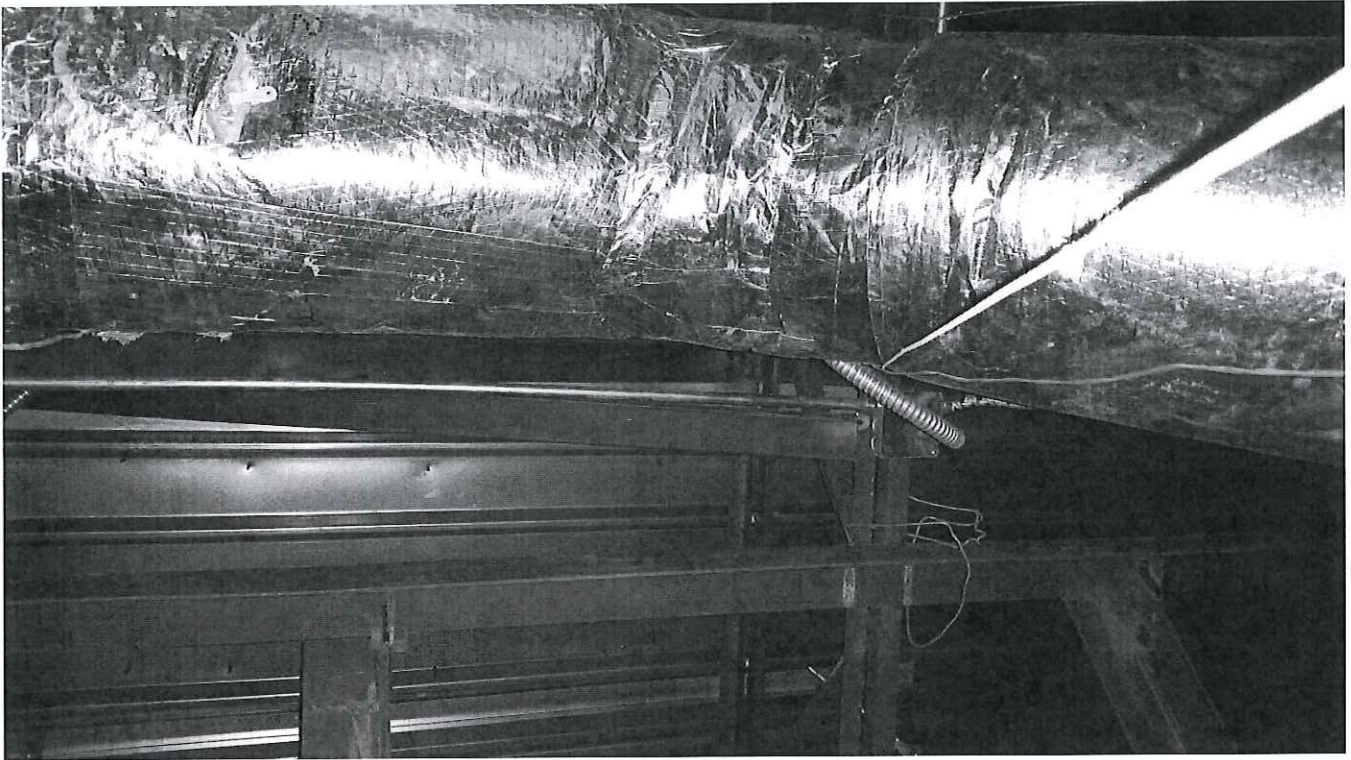
Structural angles welded to existing joists

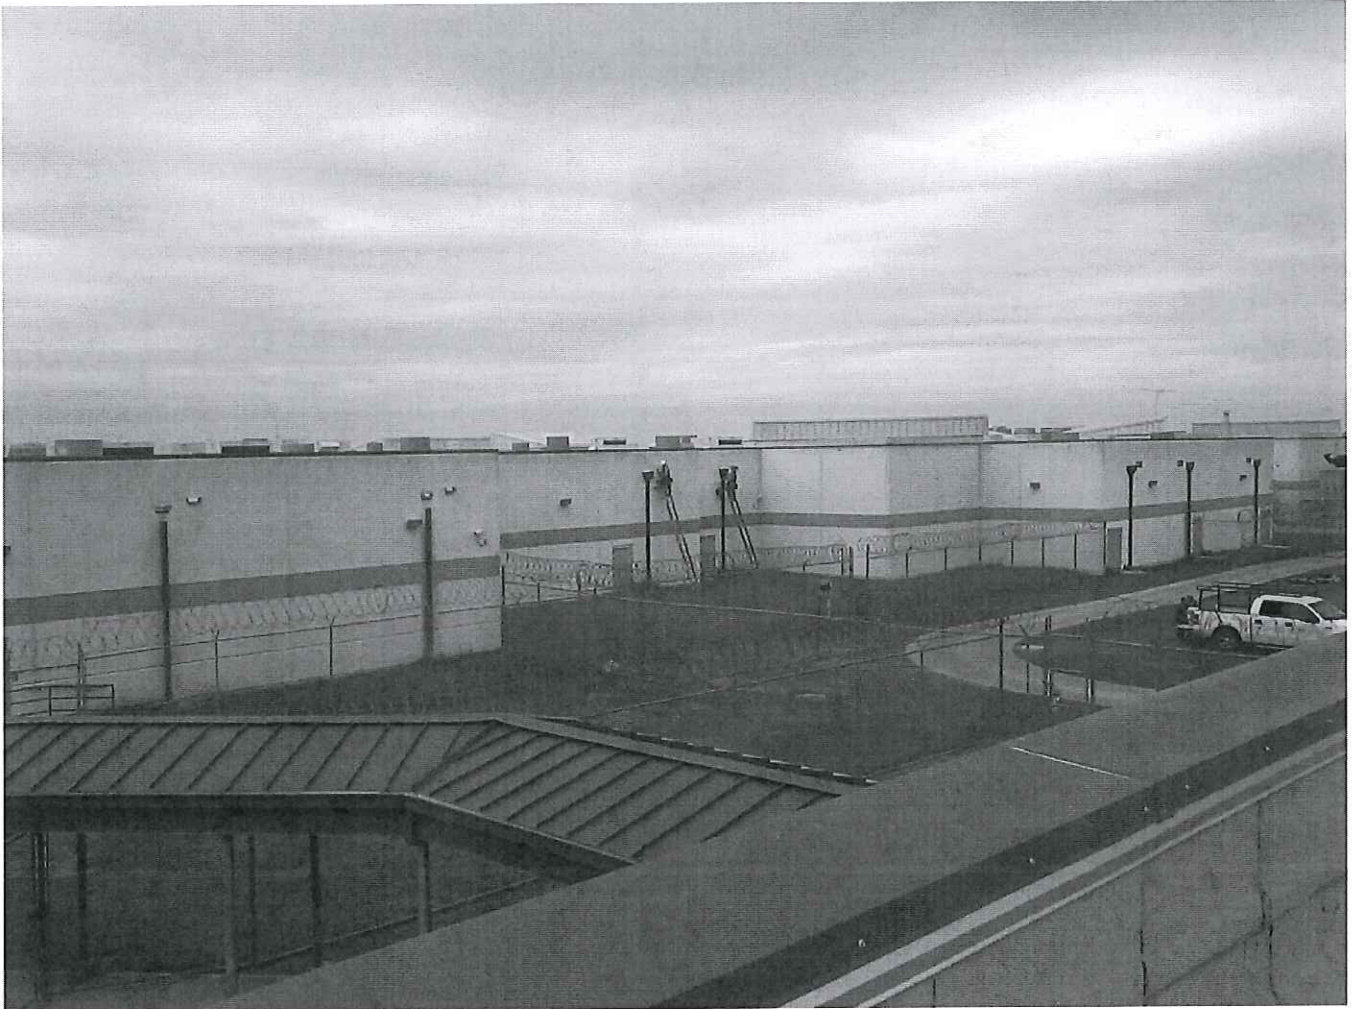
Contractor working on the head scuppers at the drains at the ADC

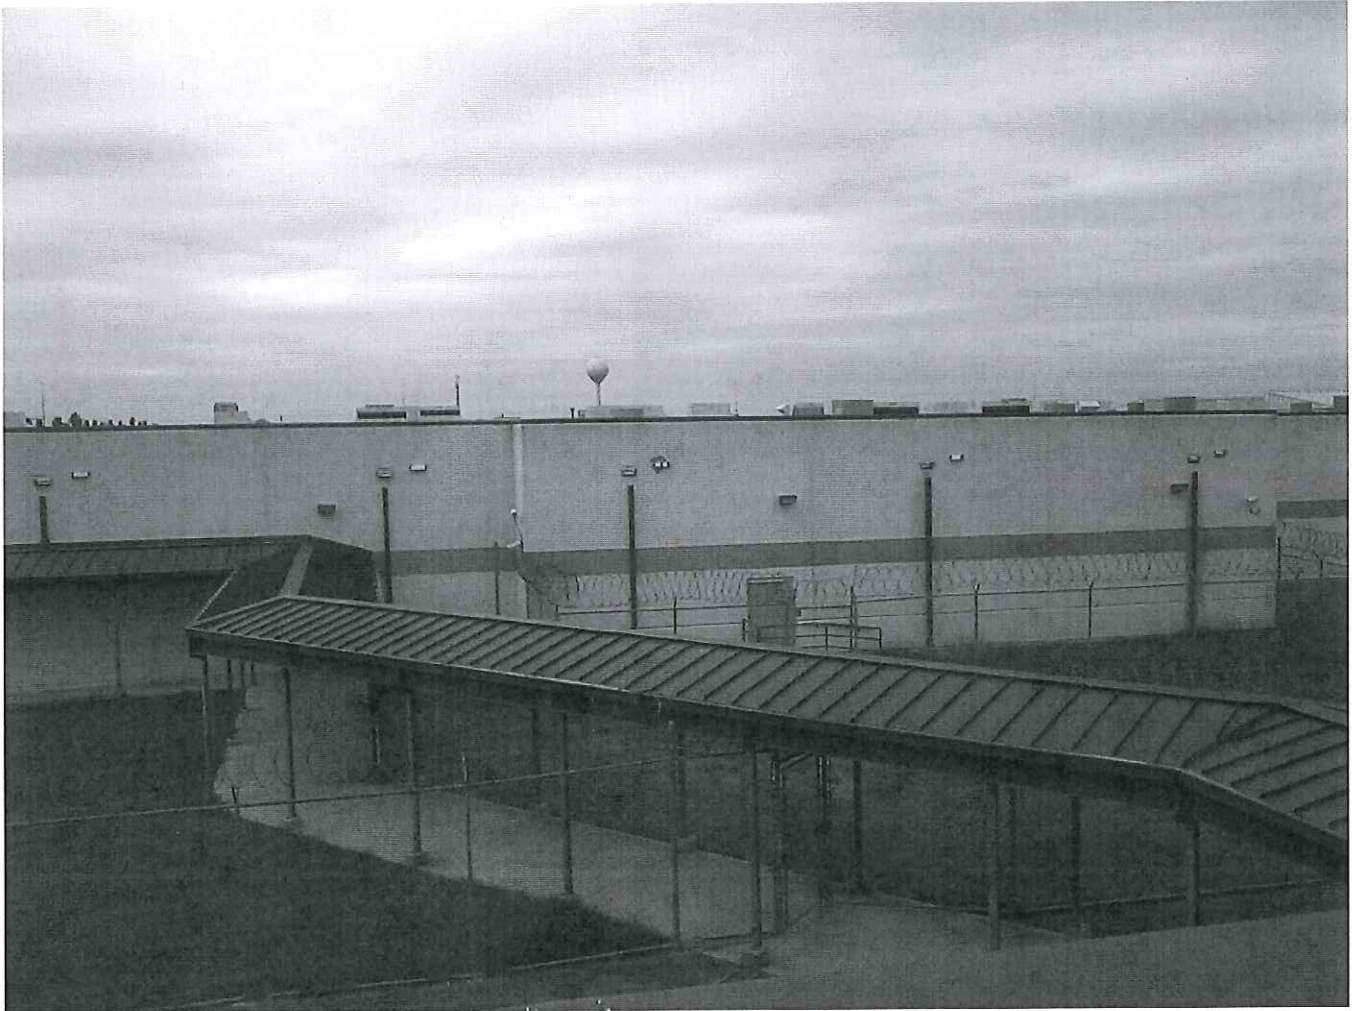
Unfinished head scuppers at the ADC

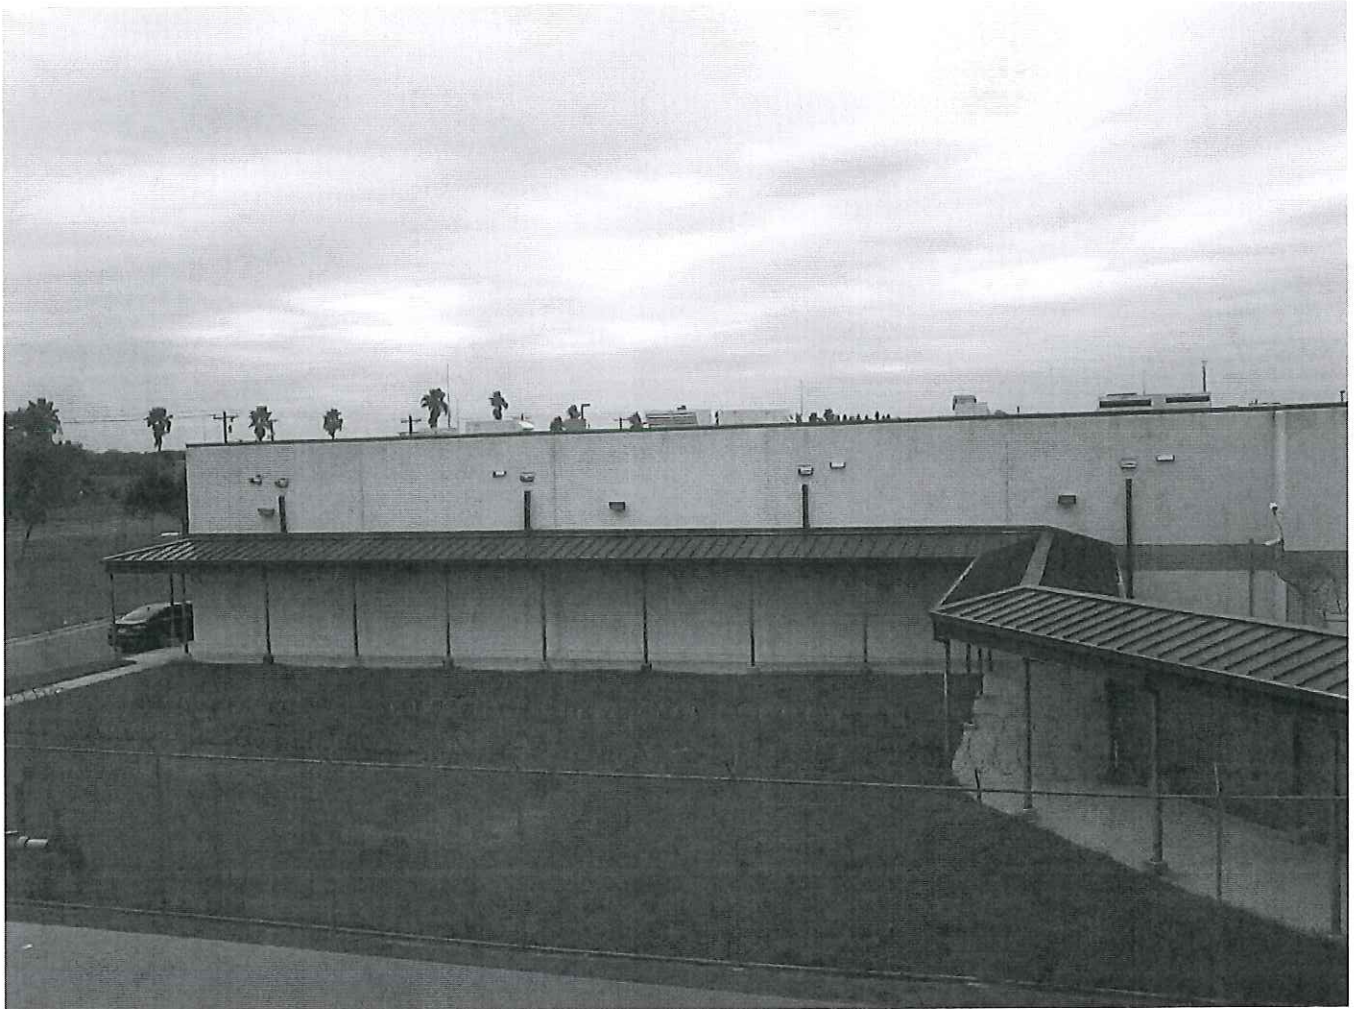
Unfinished head scuppers at the ADC

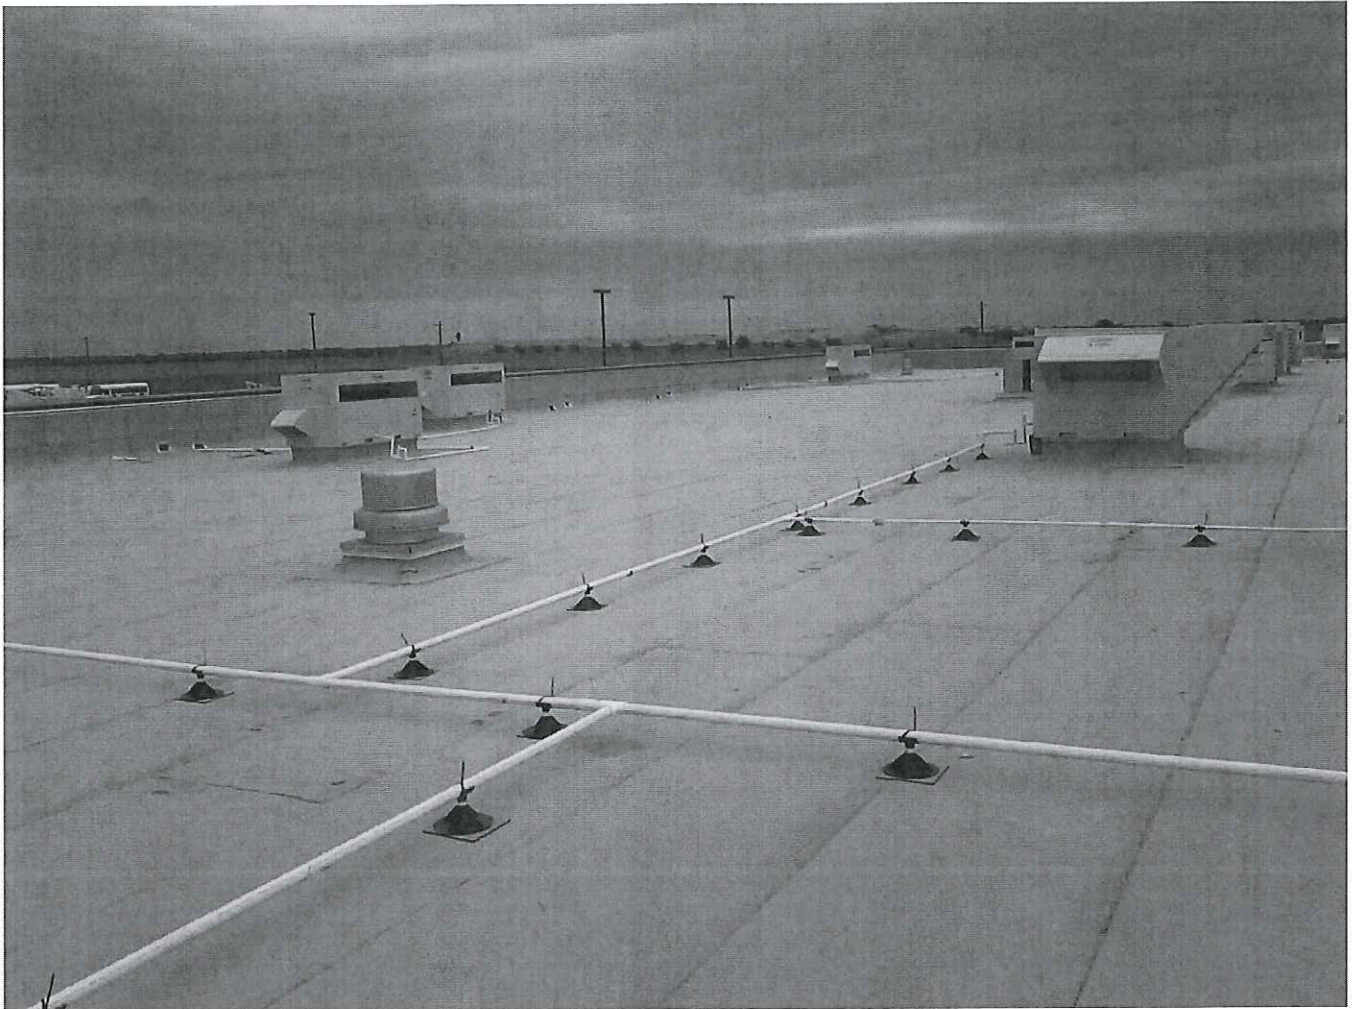
Condensate lines throughout the roof

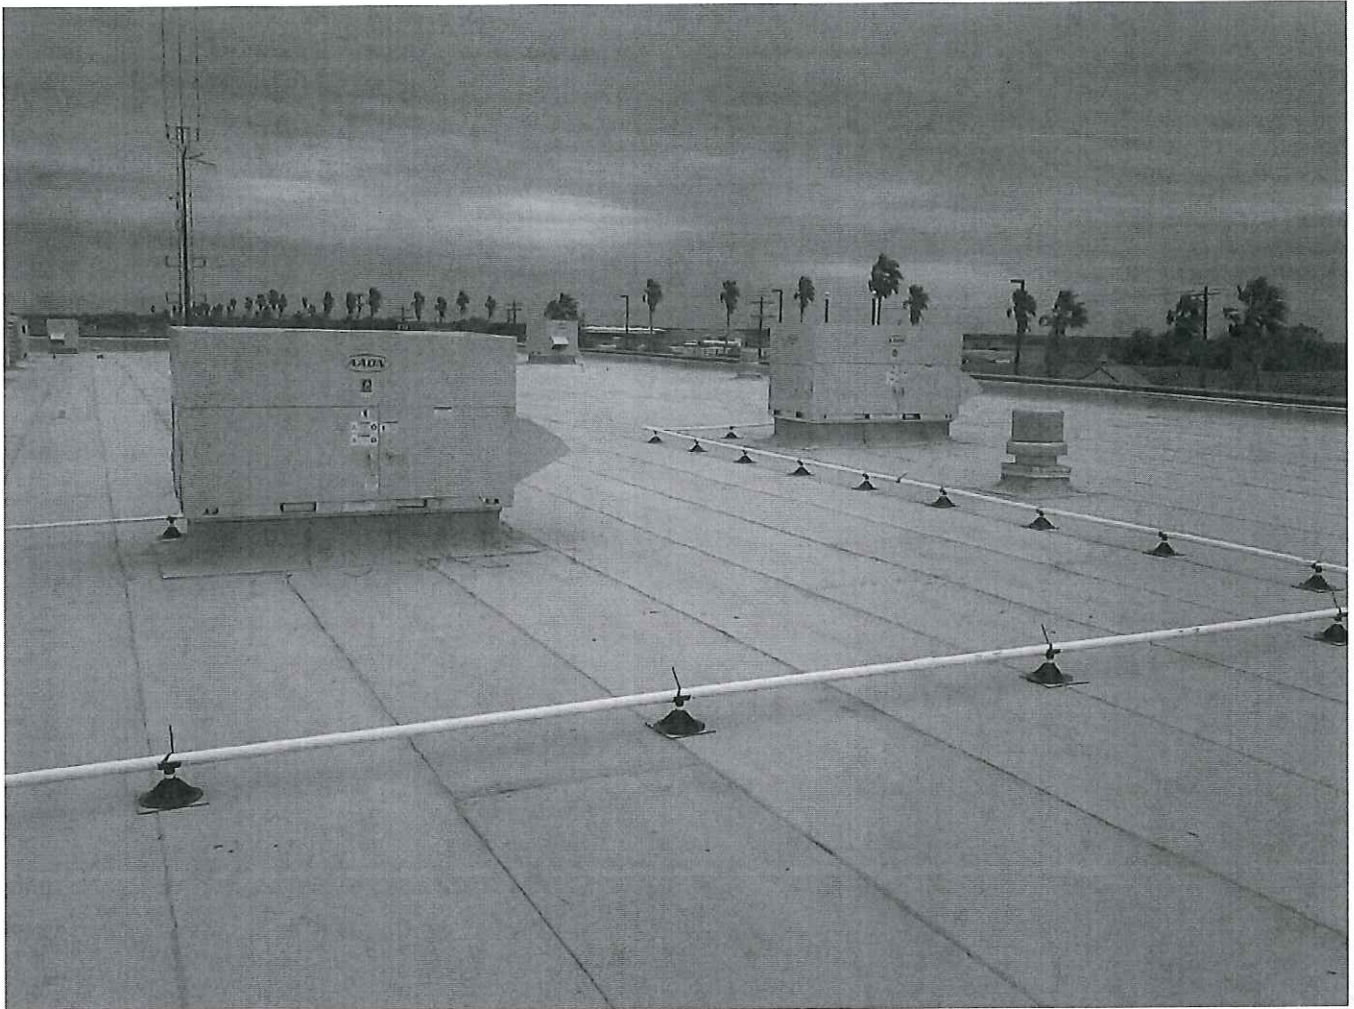
Condensate lines throughout the roof

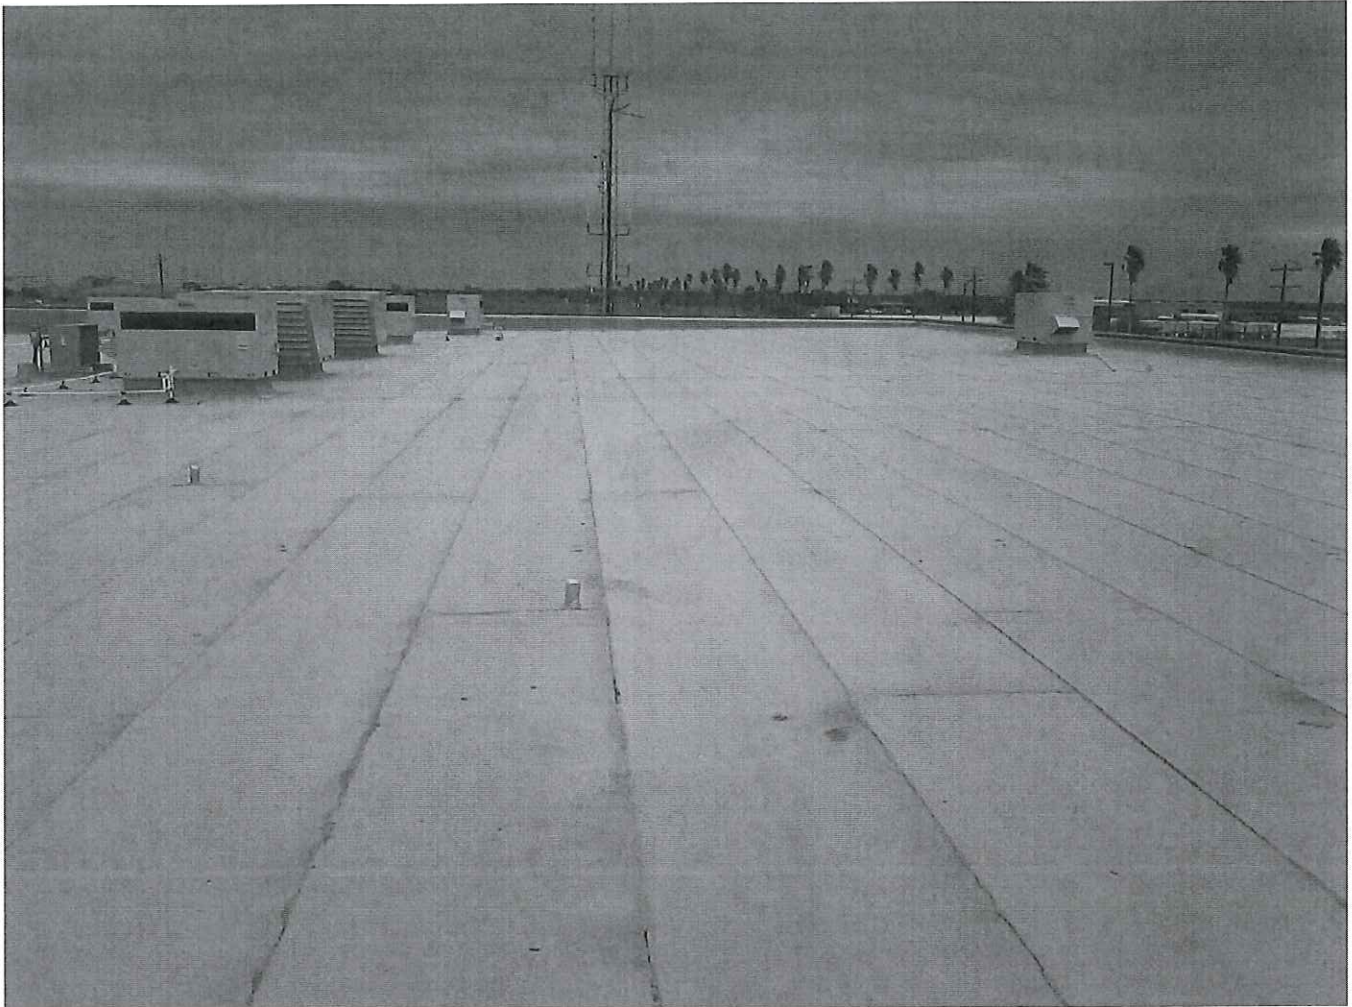
**Final cap of roof placed at LEF**

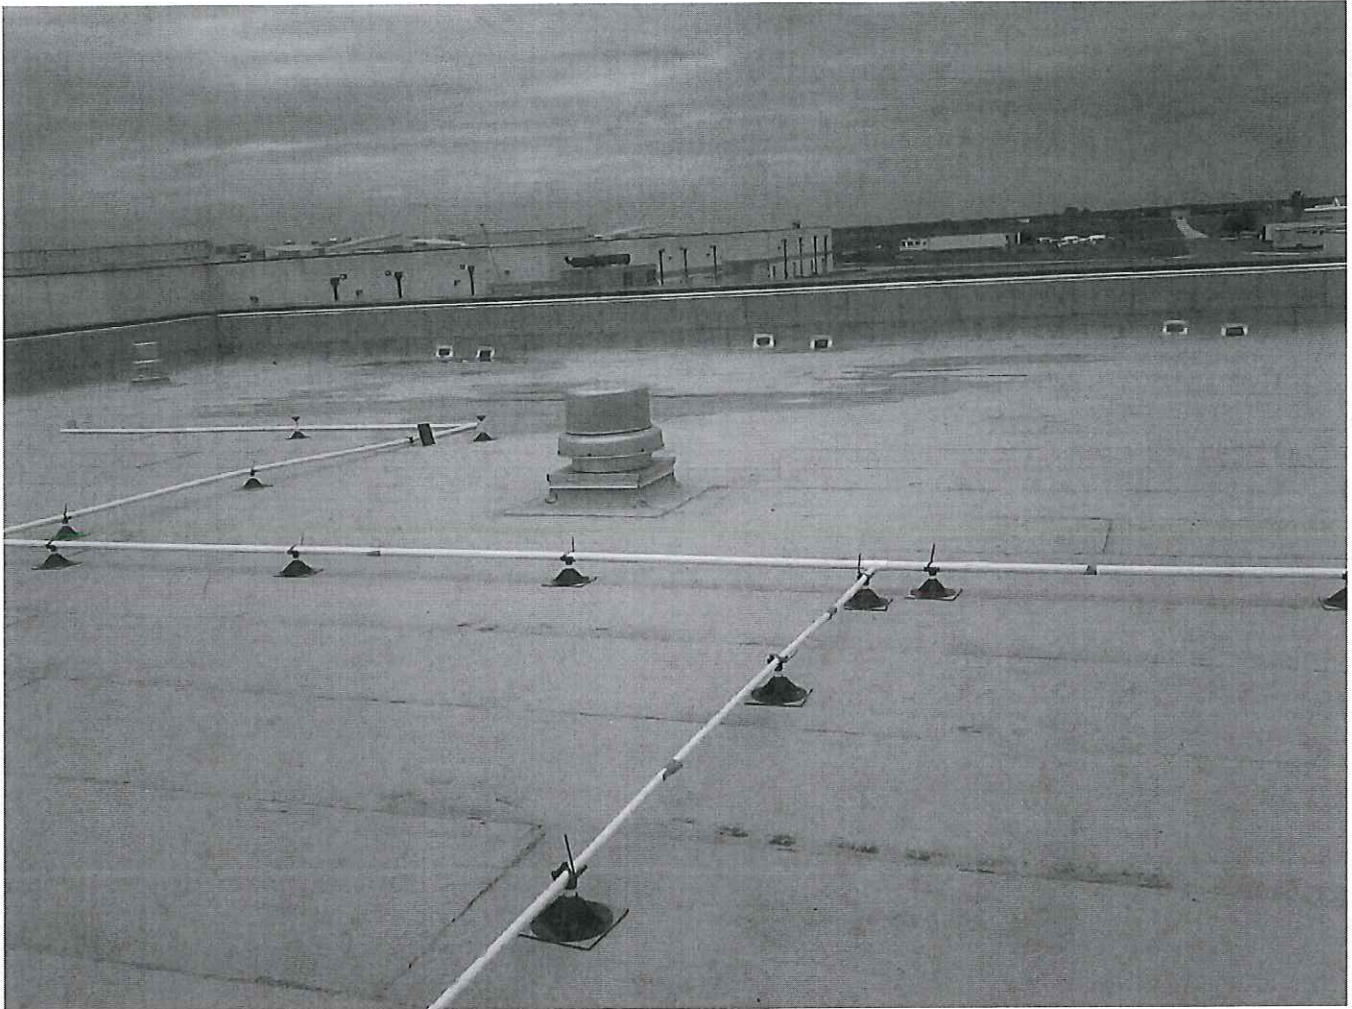
Condensate lines throughout the roof

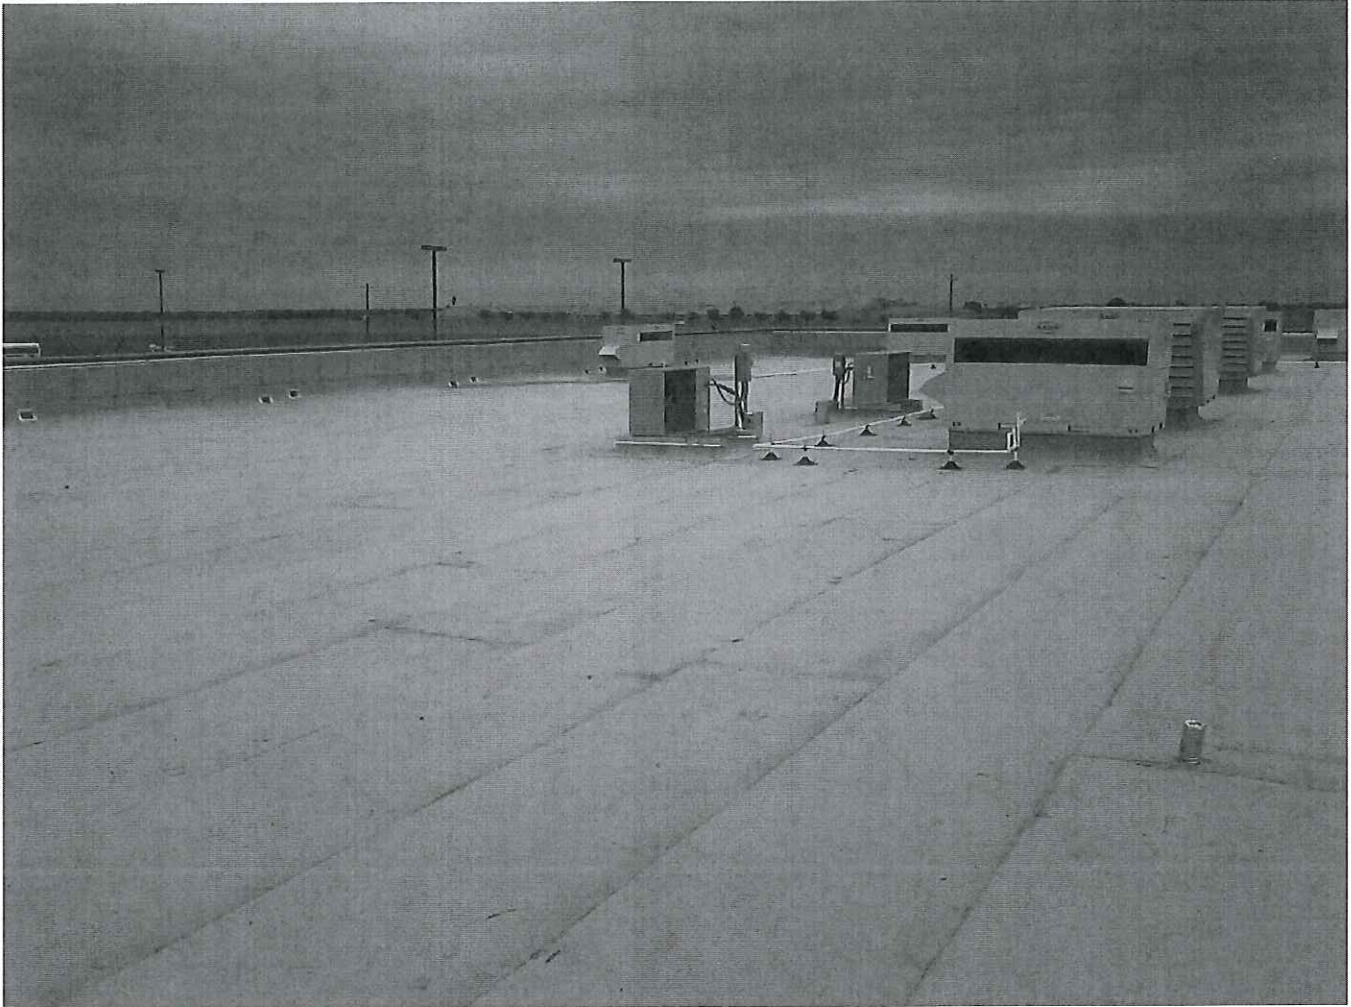
**Final cap of roof placed at LEF**

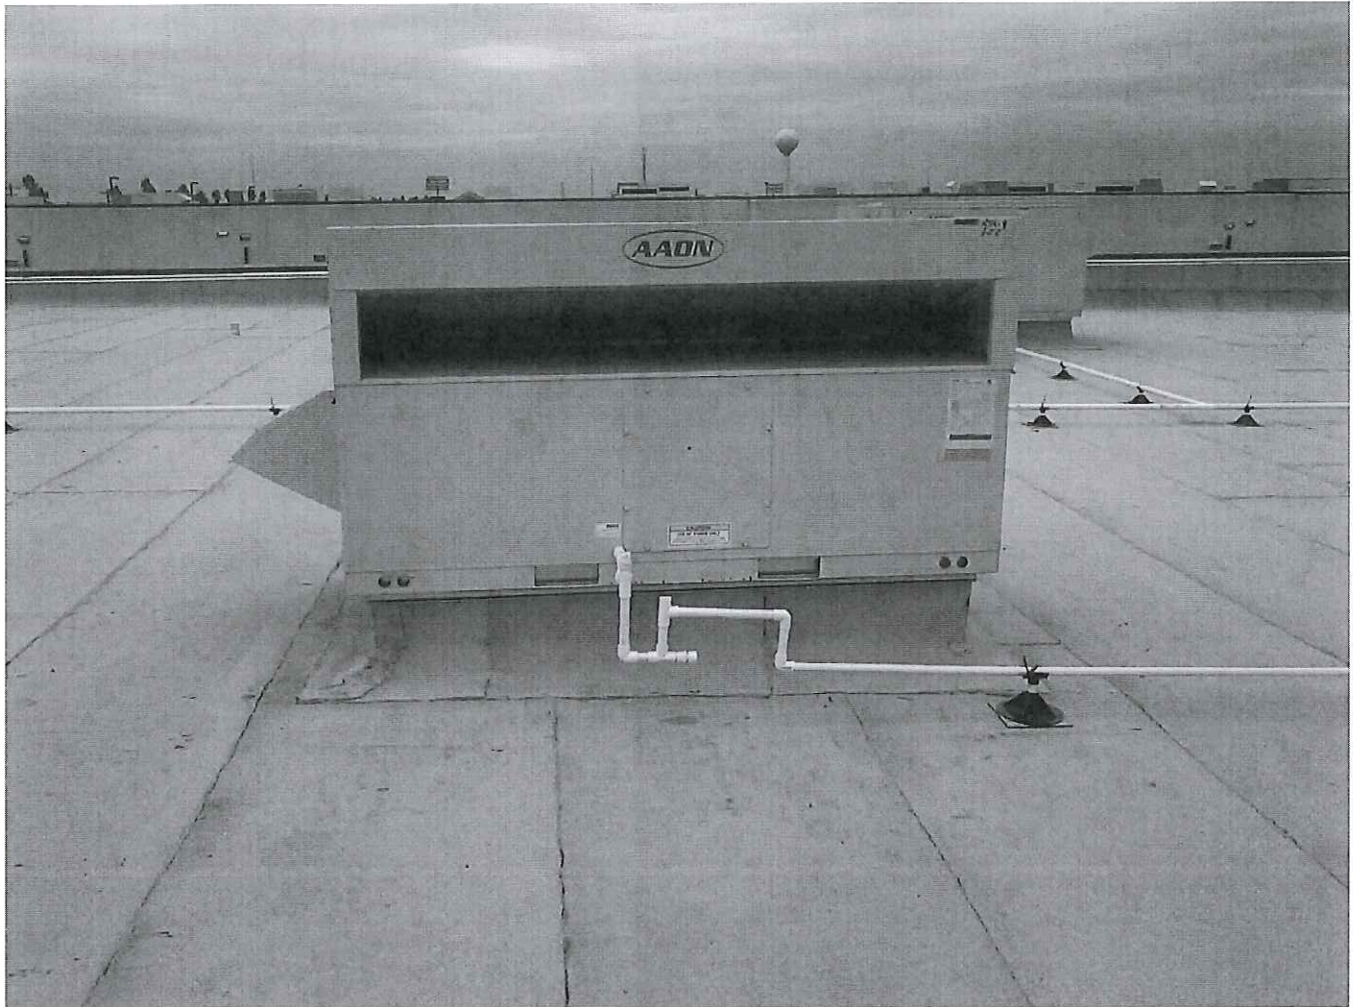
**Contractor to provide insulation at P-Trap at all A/C Units**
