CERTIFICATE OF SUBSTANTIAL COMPLETION

Owner: Hidalgo County
Contractor: Central Air and Heating Service, Inc.
Engineer: Chanin Engineering, LLC
Project: Hidalgo County Adult Detention Center and Law Enforcement Facility Repairs and/ or Replacement
Owner's Contract No.: 2014-047-09-17-YSS
Contractor's Project No.:
Engineer's Project No.: 13159
Law Contract Name:

**Field Report # 33**

# FIELD OBSERVATION REPORT

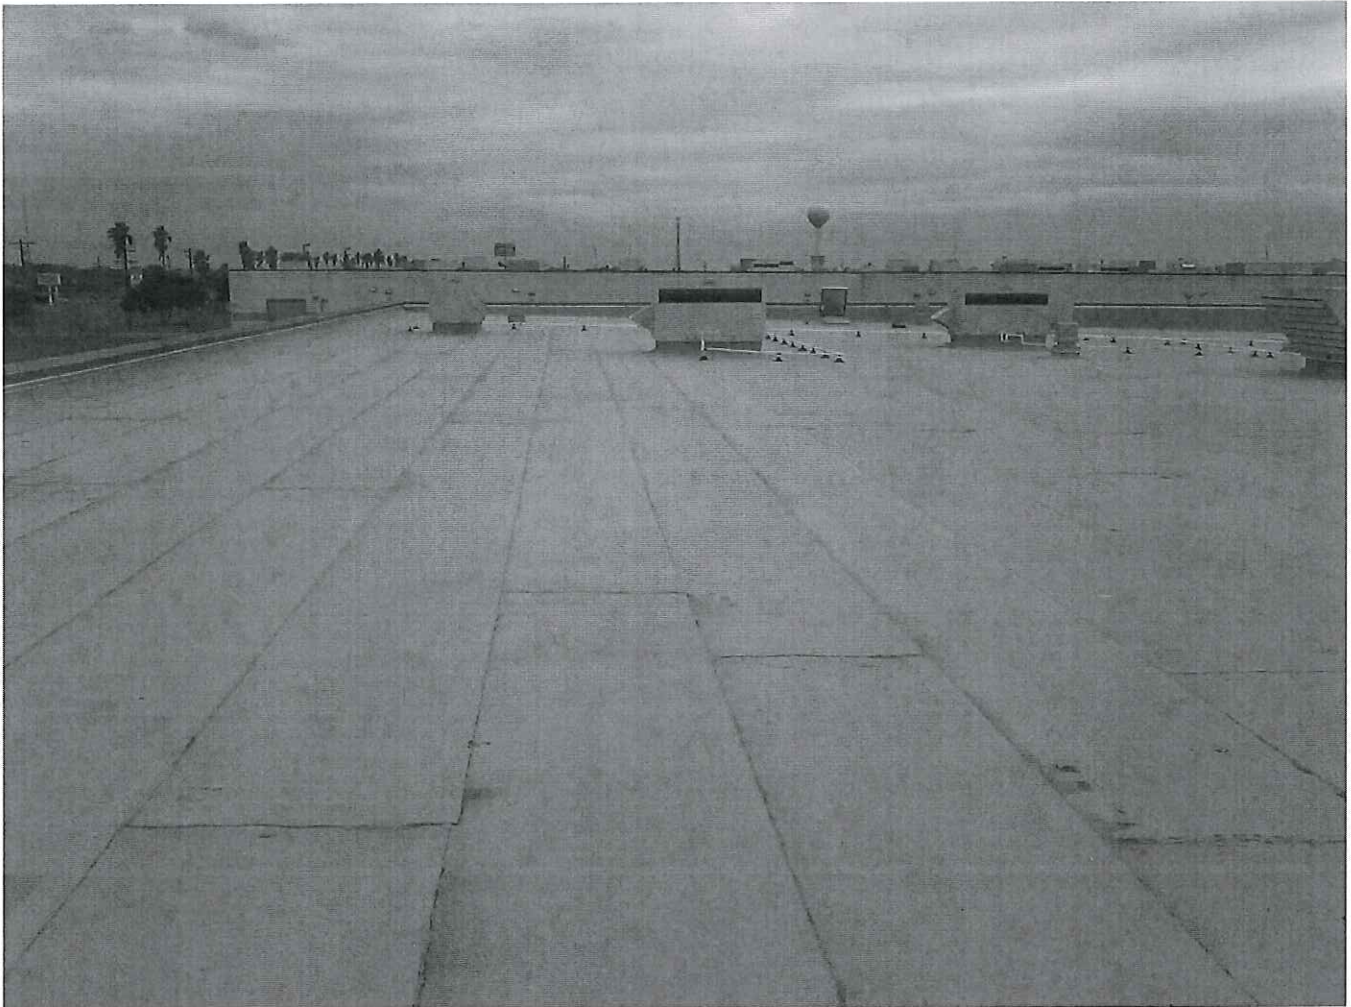
**Final cap of roof placed at LEF**

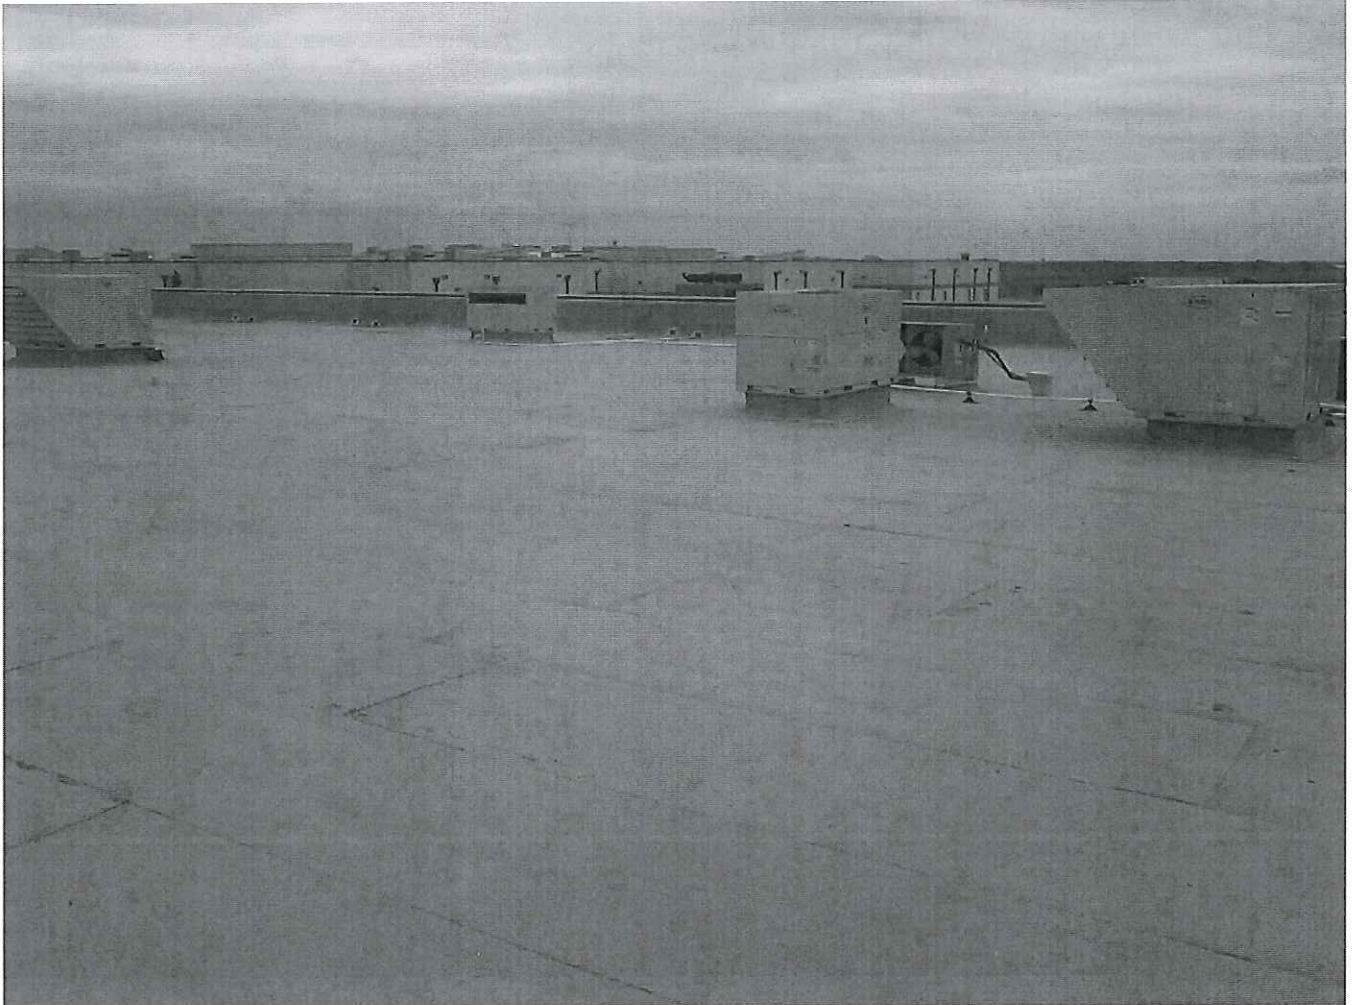
Final cap of roof placed at LEF
