**RE: 10<sup>th</sup> Street Extension - Work Authorization No. 2 - Limits: SH 107 to FM 1925  
PO#700265 - L&G Project#120902**

**RE: Work Authorization #45 for Construction Inspection & CMT  
10<sup>th</sup> Street Construction Management  
Invoice No. 3249 (Job #152780)  
CSJ: 0921-02-300**

Project Description: 10th Street Extension Project from SH107 to FM 1925  
C-17-218-12-19

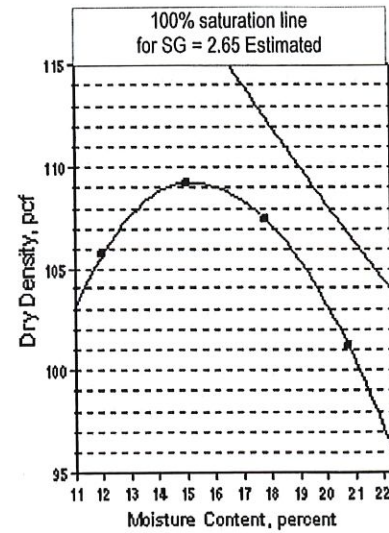
**PROCTOR  
TEST REPORT**

Compaction Method: ASTM D-698  
 Material Description: Limed Subgrade

Liquid Limit: 22  
 Plastic Limit: 18  
 Plasticity Index: 4

Specimen No.:	1	2	3	4
Moisture, %:	12.0	15.0	17.8	20.7
Dry Density (pcf):	105.7	109.2	107.4	101.3

Maximum Dry Density in P.C.F.: 109.2  
 Optimum Moisture (%): 15.1
