Housing Rehab Program

ENTITY: Countywide Area
PROJECT: Approval for Assistance under the Colonia Self-Help Program.
FUNDING YEAR: HOME 2018

Property Address: 1003 Dove Street, Alamo TX.

A home inspection was conducted on December 17, 2019 by Roberto Cavazos (Program Specialist) with Hidalgo County Urban County Program and the following items were noted.

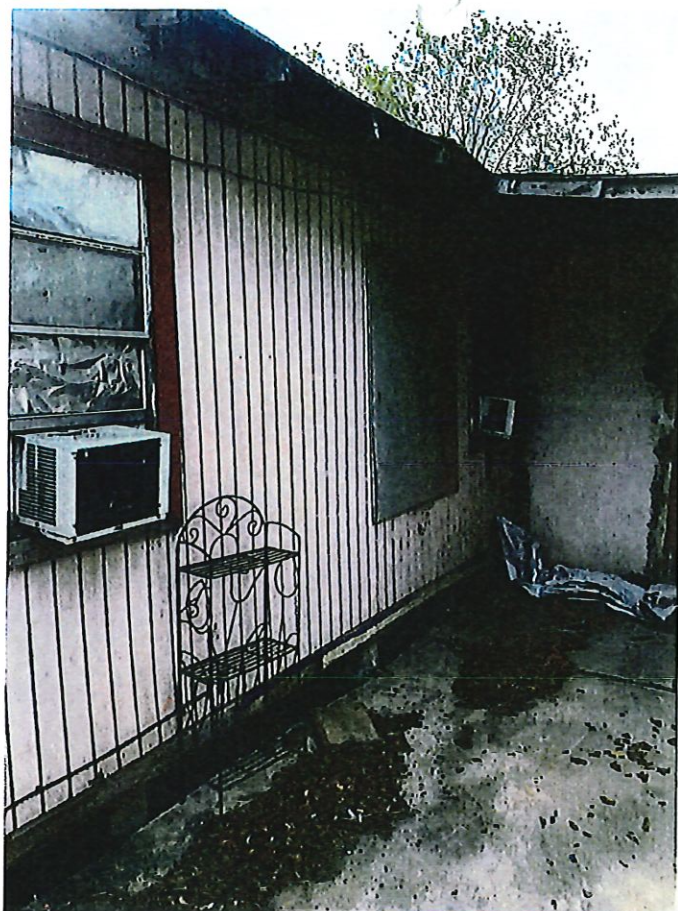
North Side of House where
Car port was attached.

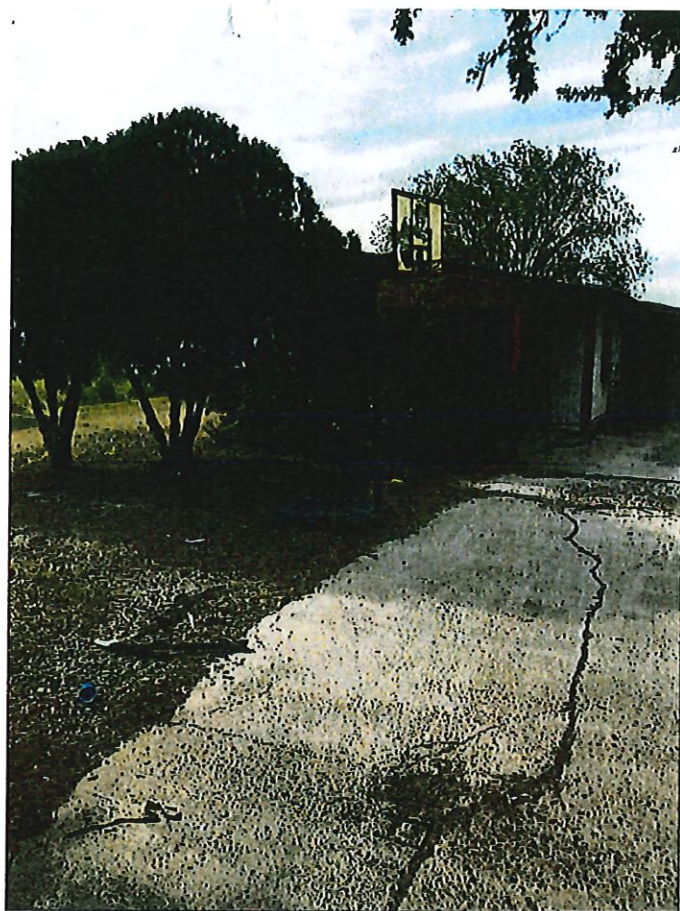
Concrete Driveway Has large
crack

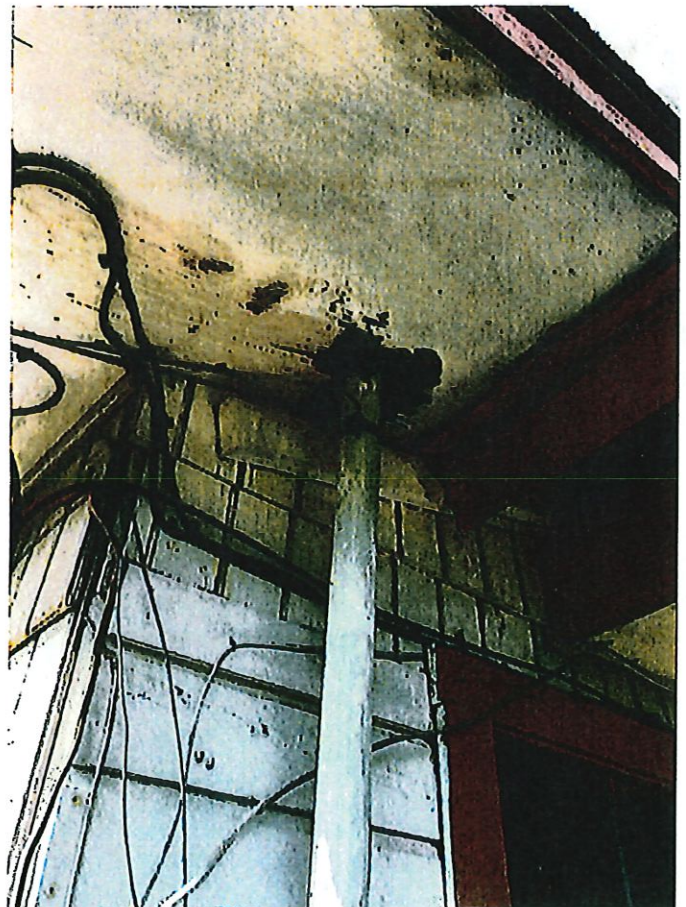
Deterioration Due to moisture

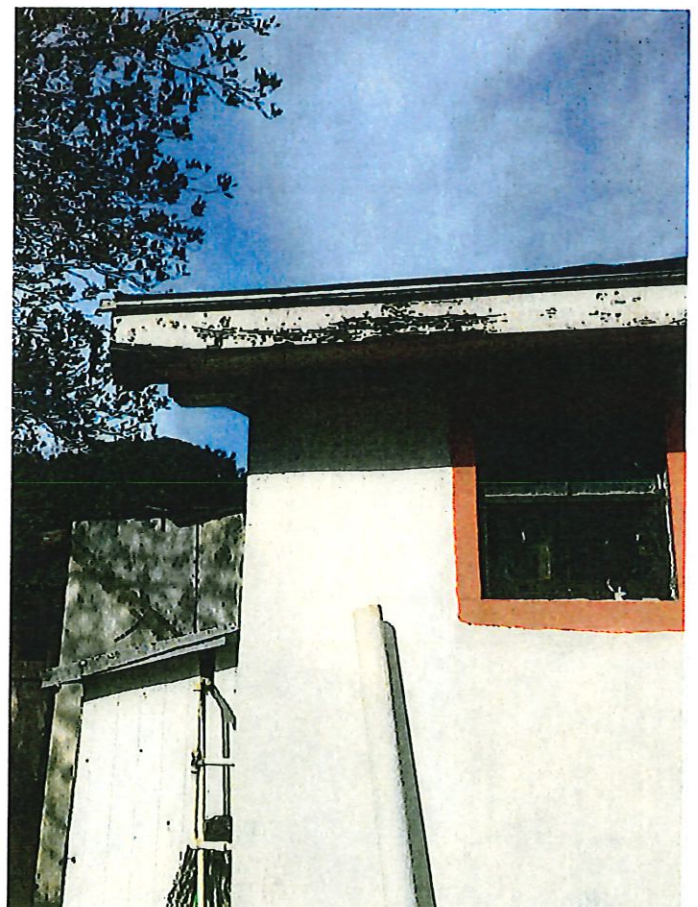
Trim and Soffit Deterioration

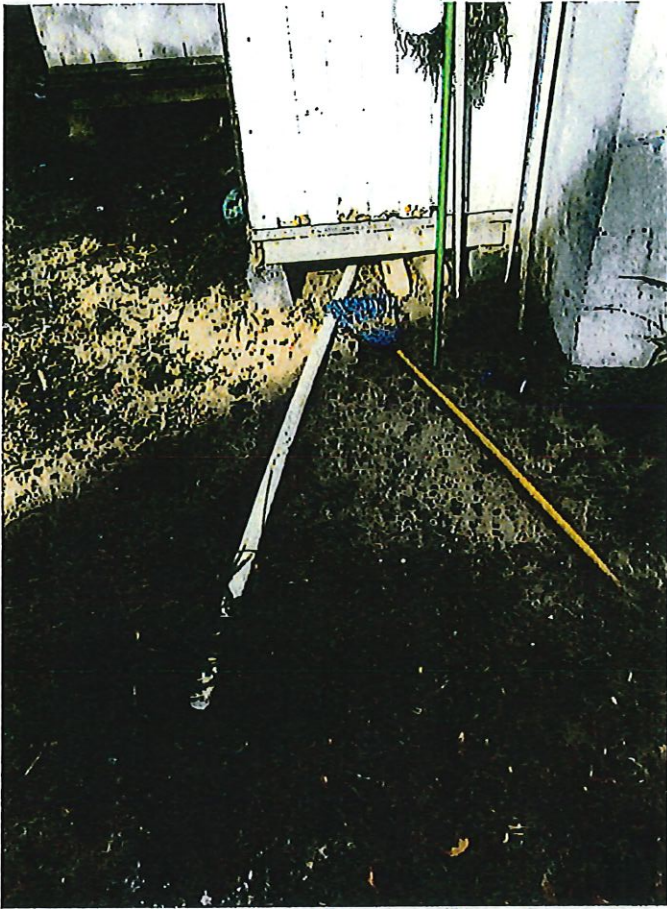
Exposed plumbing draining to the yard.

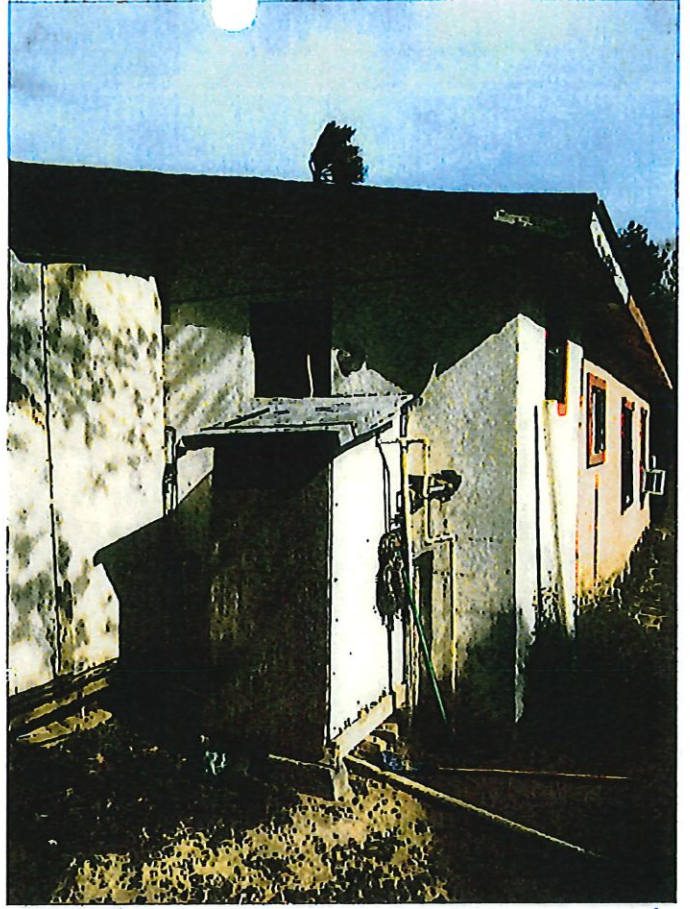
Outdoor water heater closet fair condition

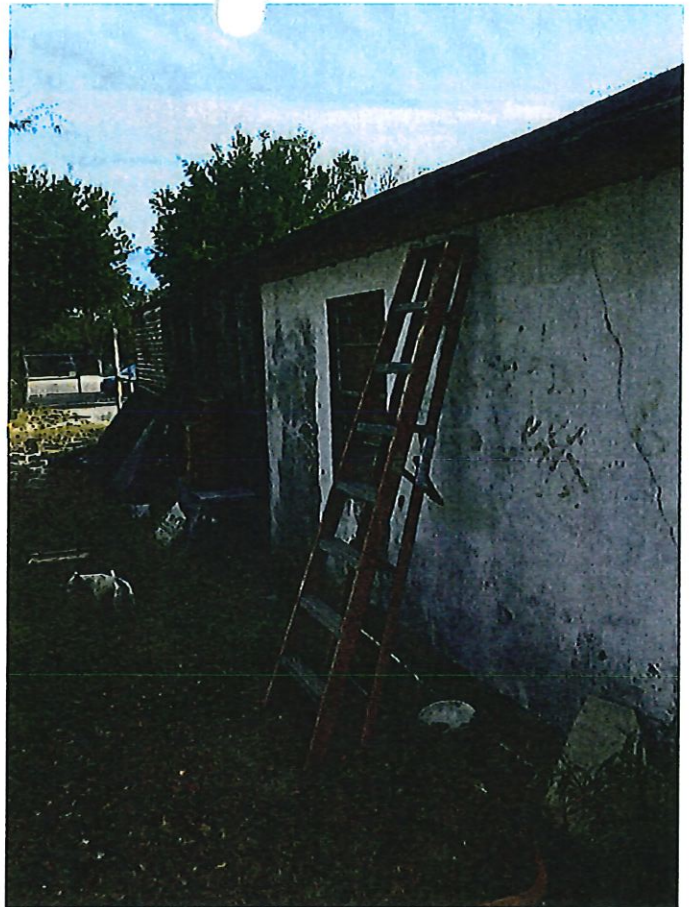
North Side of Home. Trim
And Soffit Damage

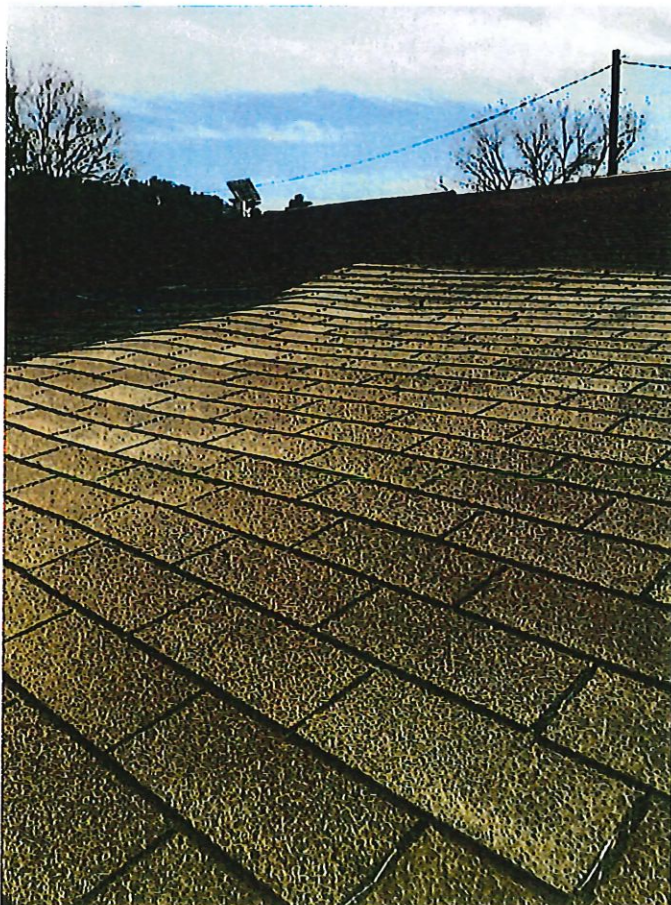
North Edge of Home. Owner
replaced Small Section of Shingles

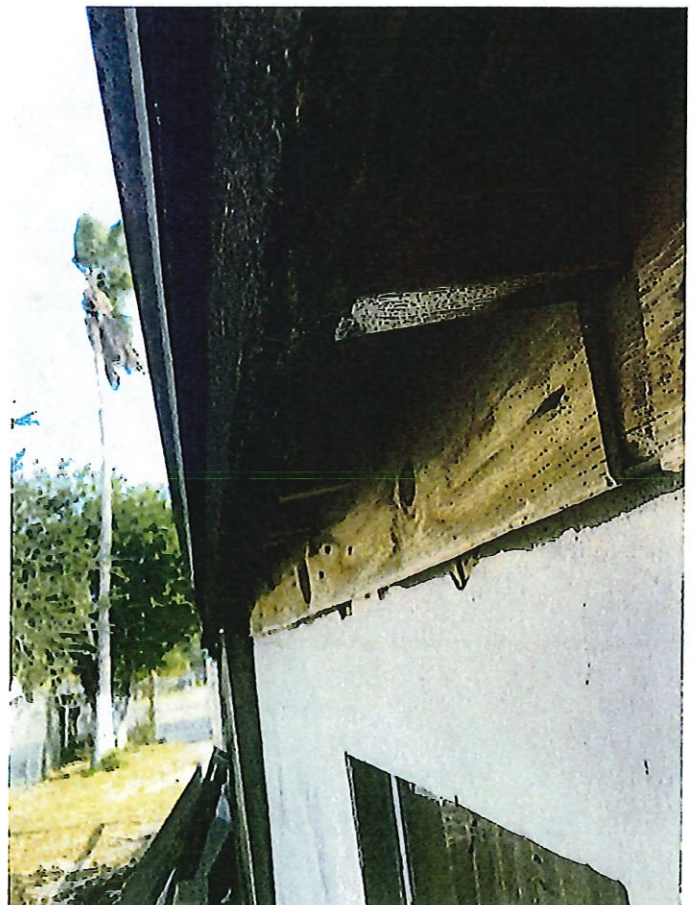
2x6 Rim board, Trim and
Soffit severely damaged

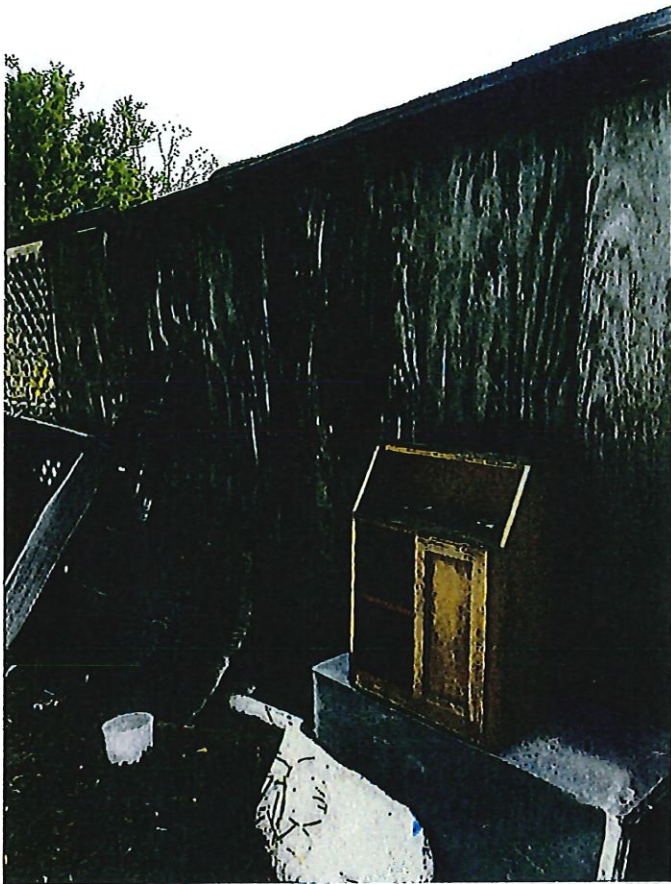
North side of carport, Exposed plywood weathered and rotted

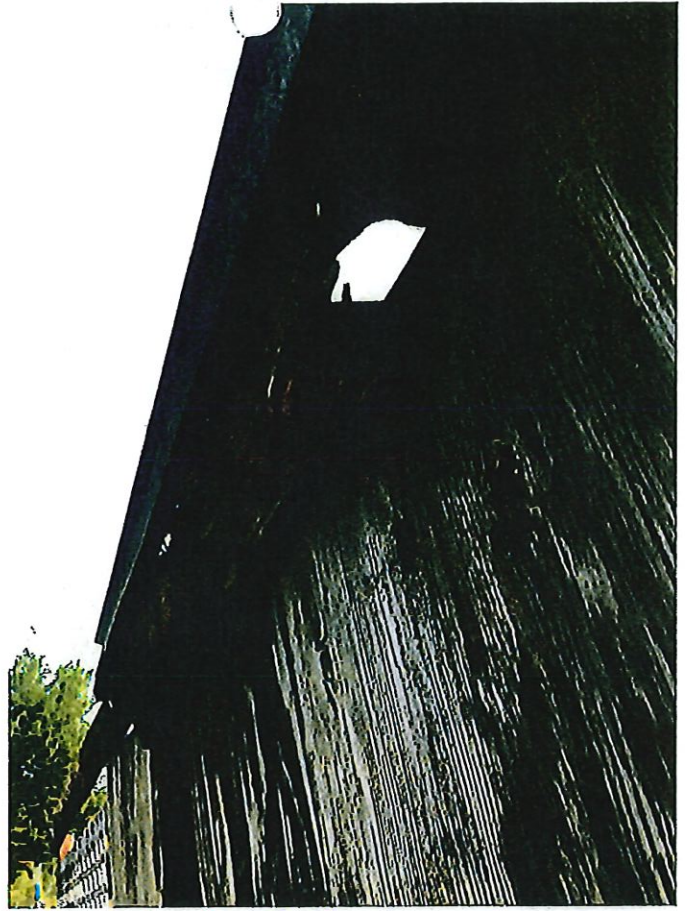
carport roof decking, severely deteriorated

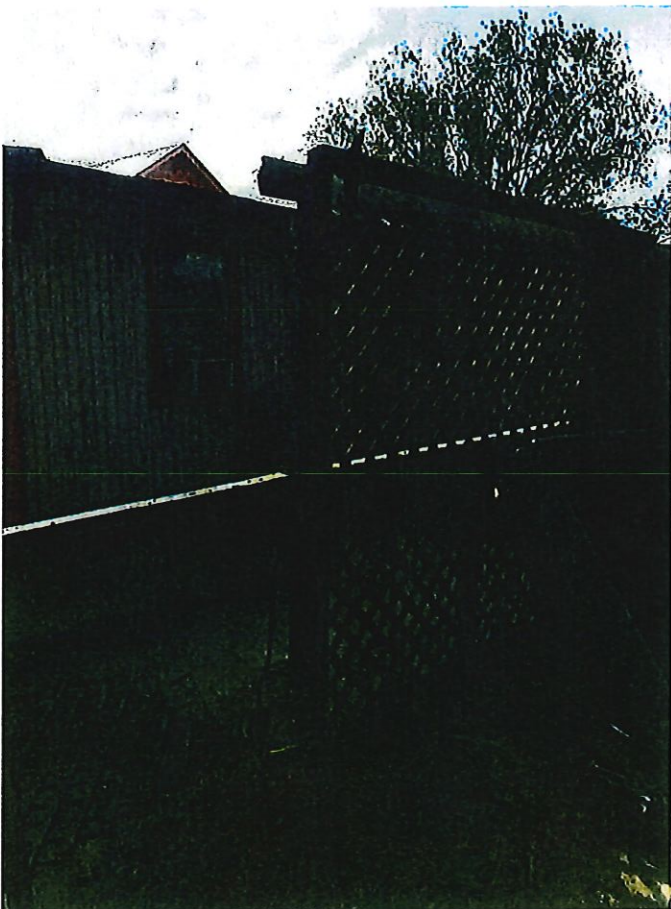
Existing carport on north side off home. Roof no longer attached

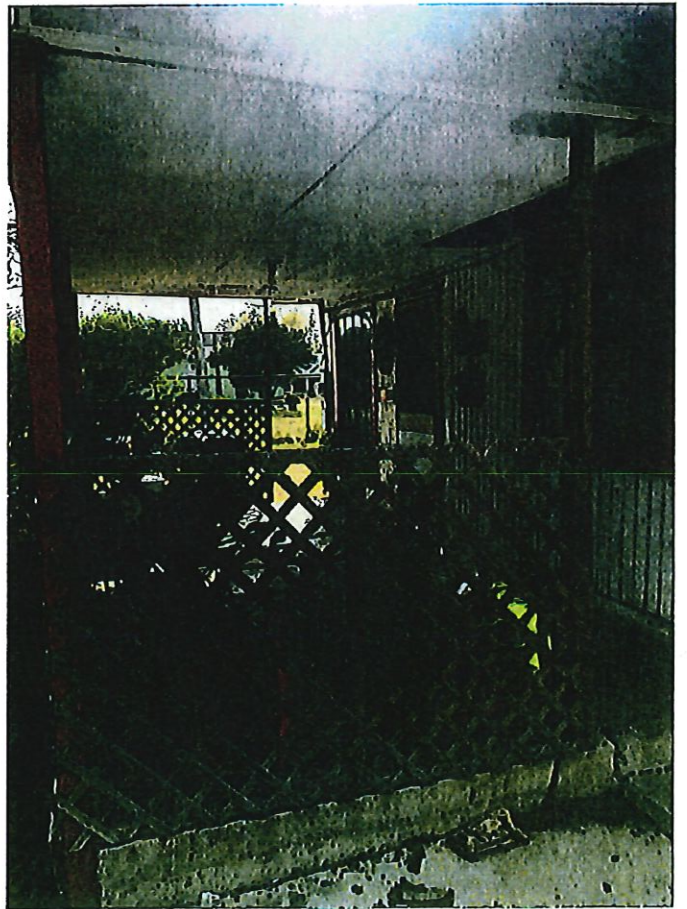
front porch, concrete floor is cracked.

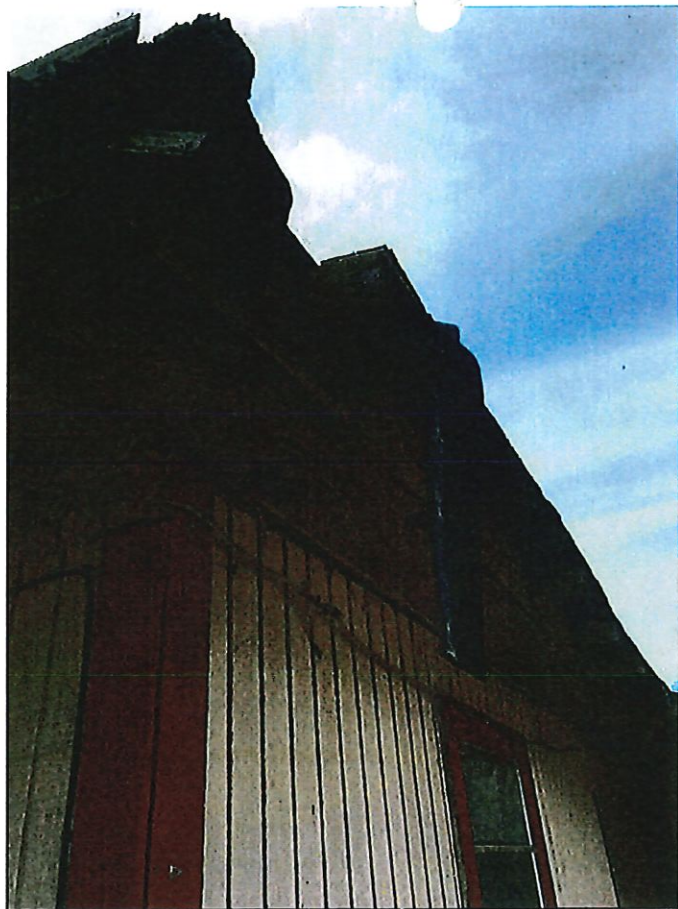
Roof Deck, Shingles, Trim and Soffit Severely Deteriorated.

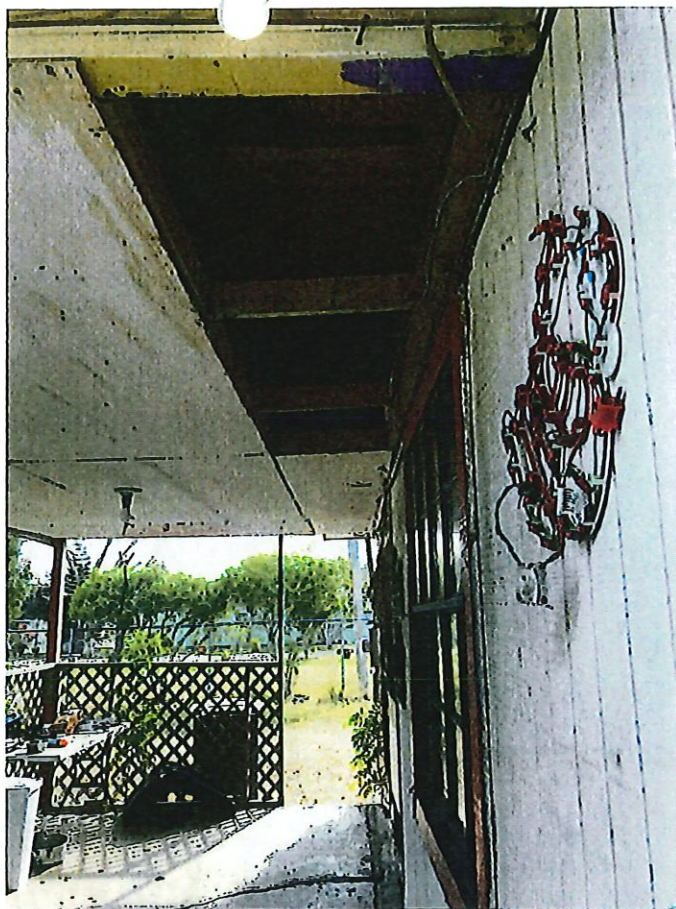
Plywood Soffit in porch area missing.

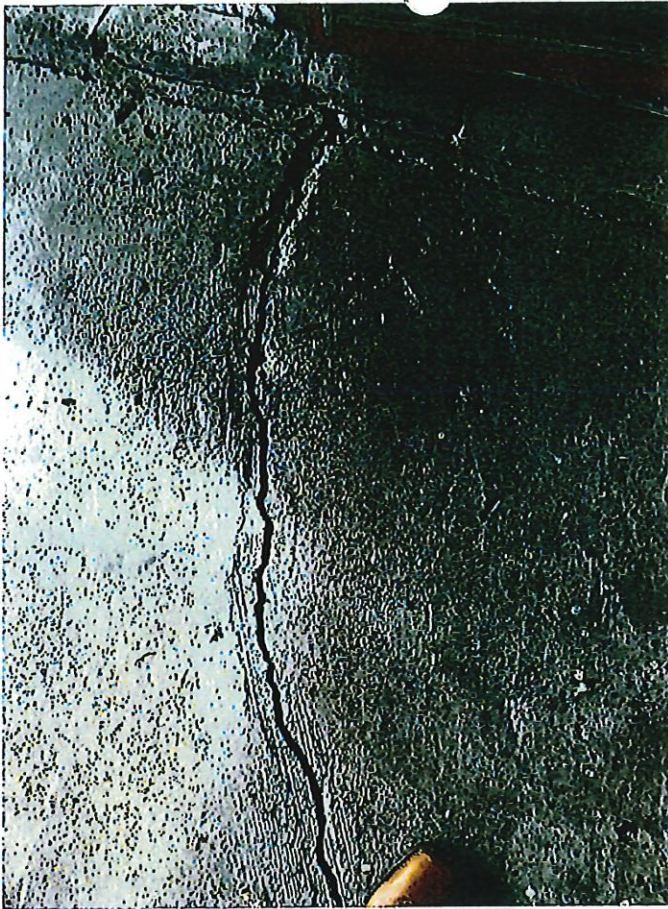
Crack located on front porch

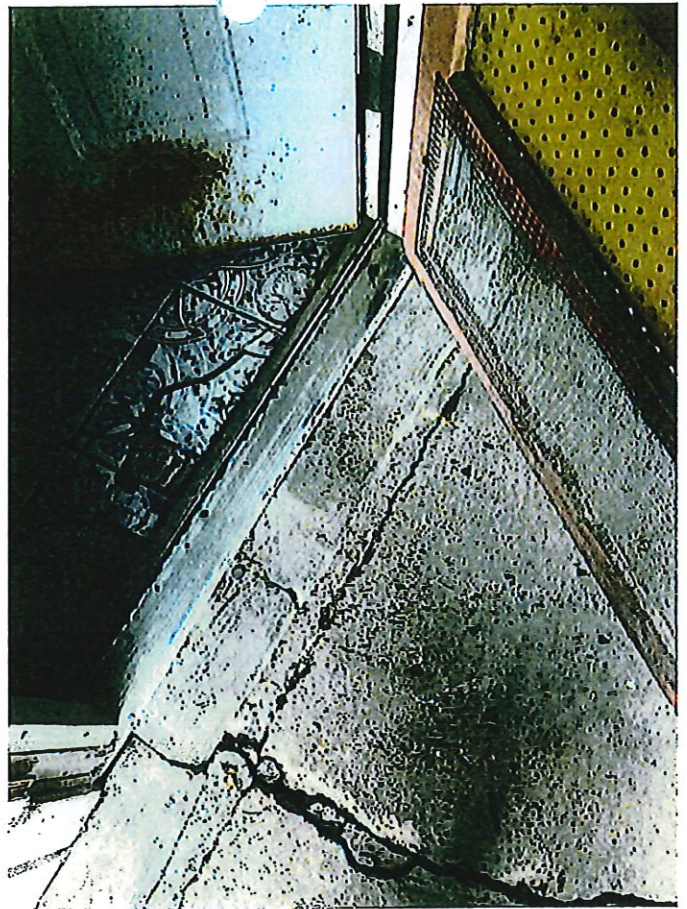
Large crack in front porch
By front door HAZZARD.

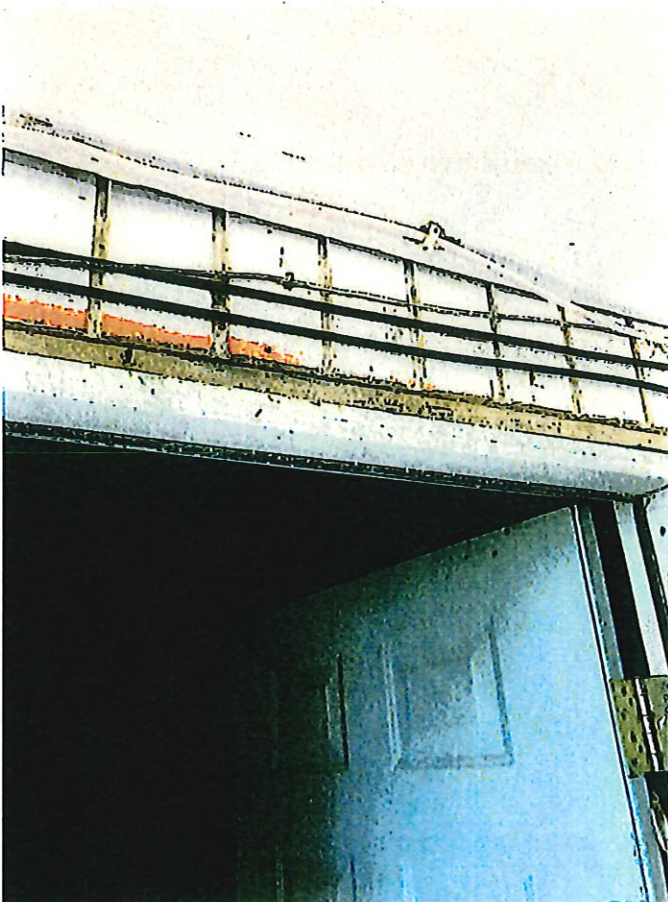
Exposed electrical wires above
front door

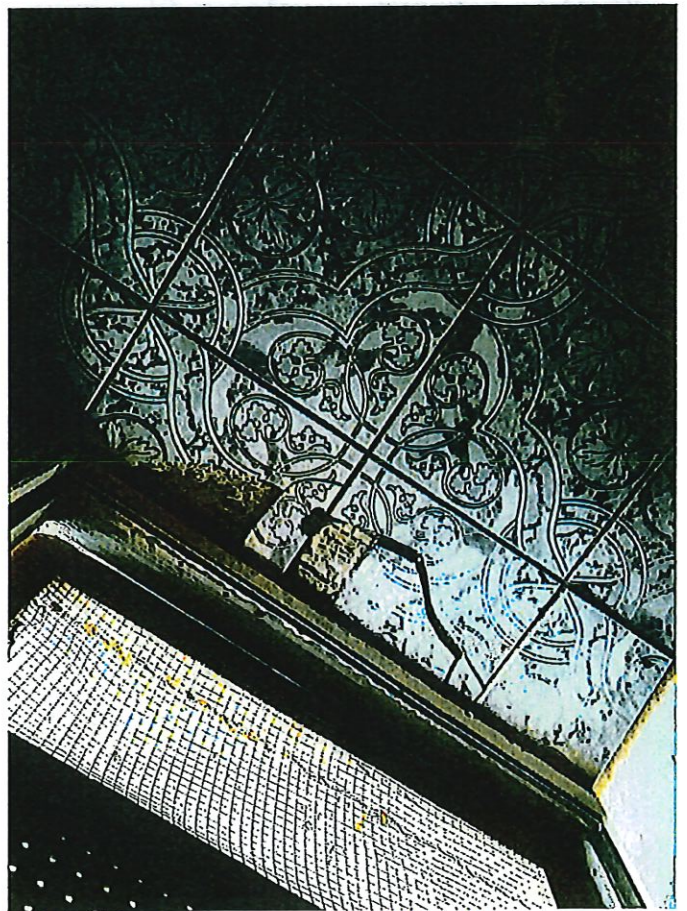
Cracked ceramic tile by front
door.

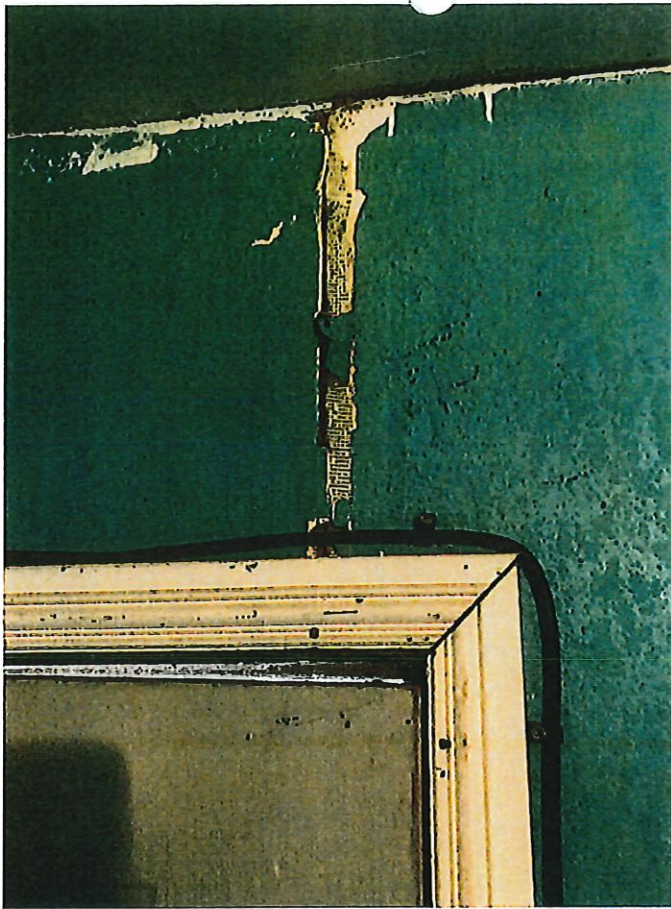
Crack above Door into bedroom #1. "Master bedroom"

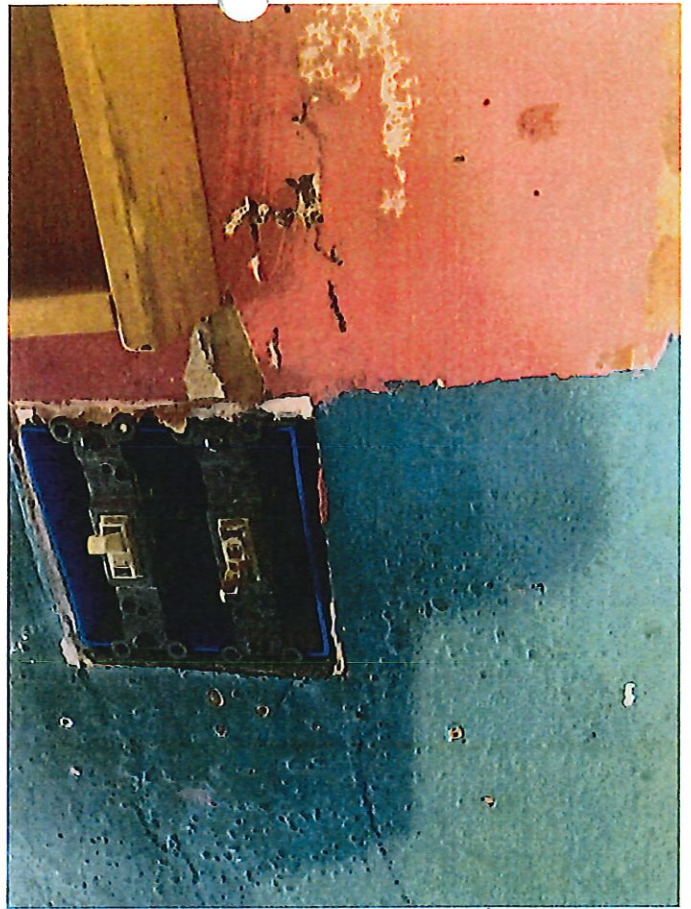
Exposed Light Switch in Master bedroom.

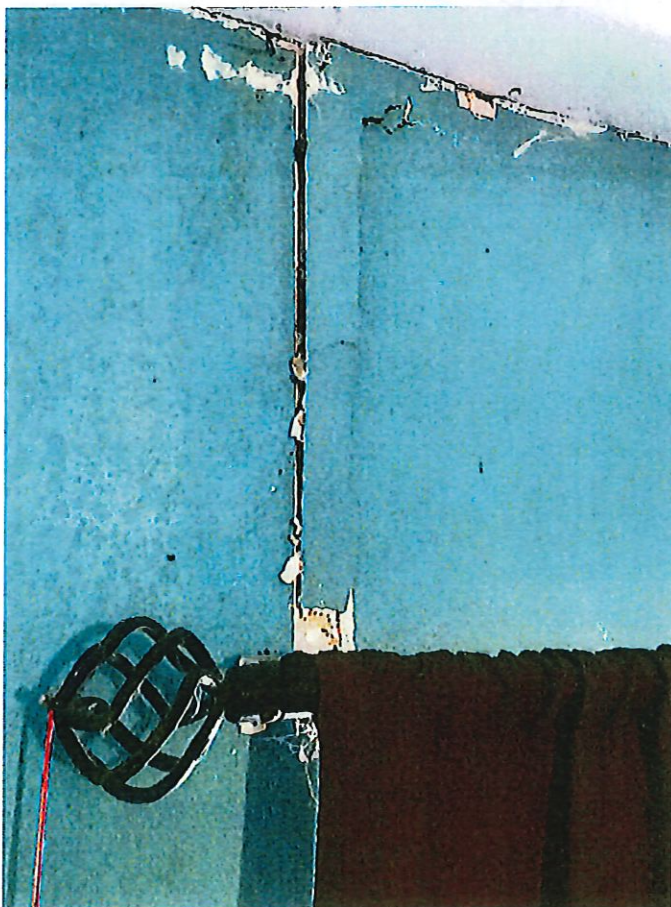
Large crack above window in Master bedroom

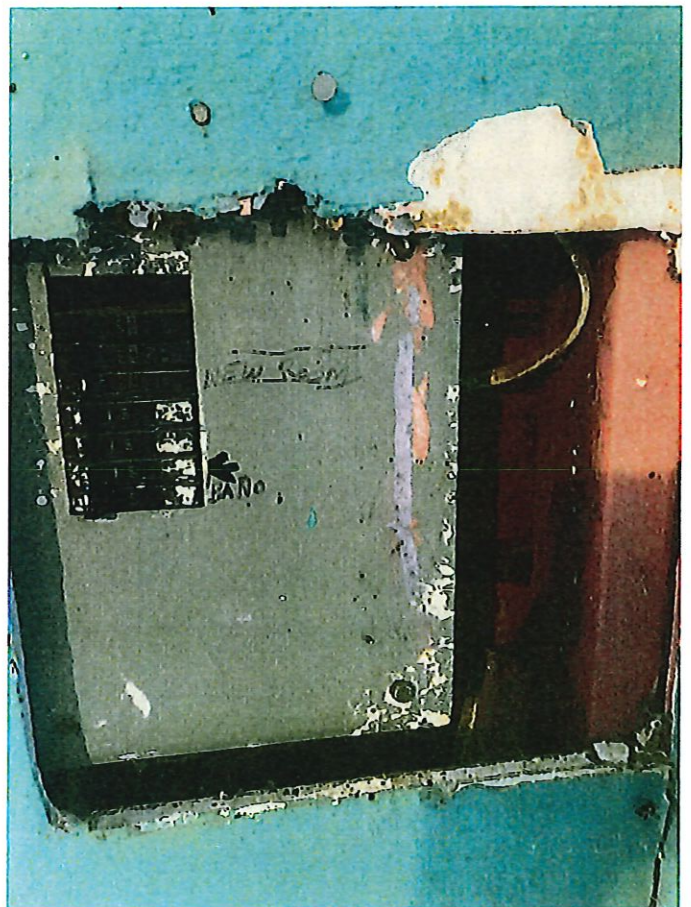
Panel Box located in Living room. not dated.

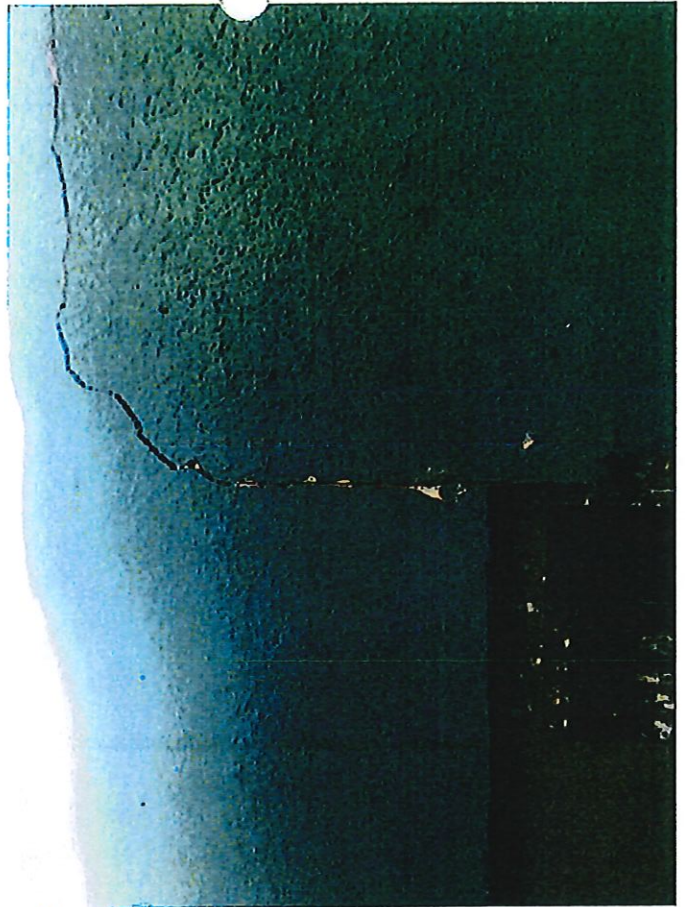
The existing Pier and beam foundation has extensive damage. During the inspection I noted several cracks throughout the house and cracks in the walls due to foundation movement. The foundation needs to be raised and leveled. The home is approximately 1,200 square feet and estimated repair cost is **\$8,500**. Supporting pictures are included in the inspection report.

Large crack next to panel box due to foundation movement

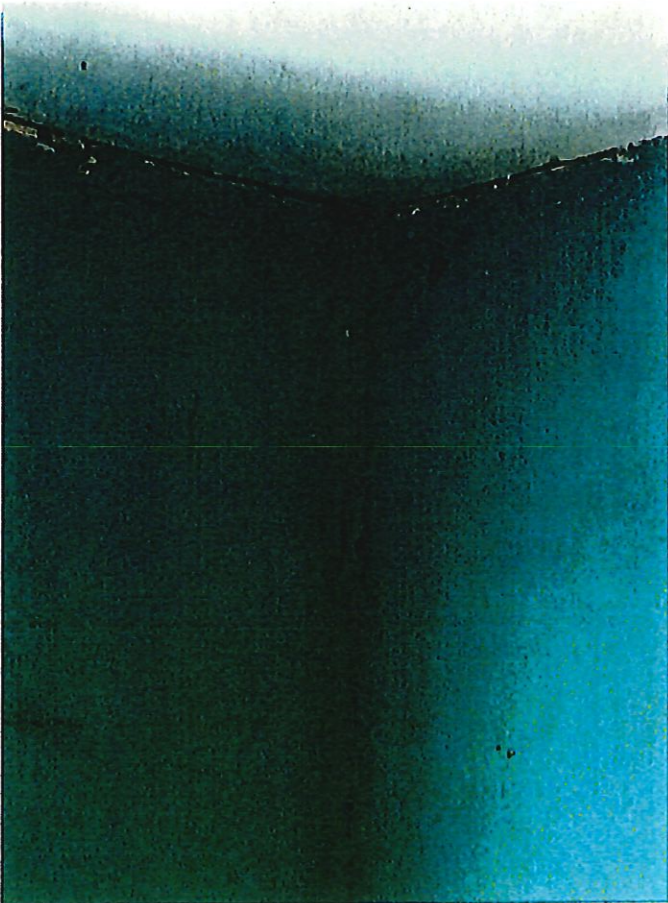
Large separation between wall & ceiling

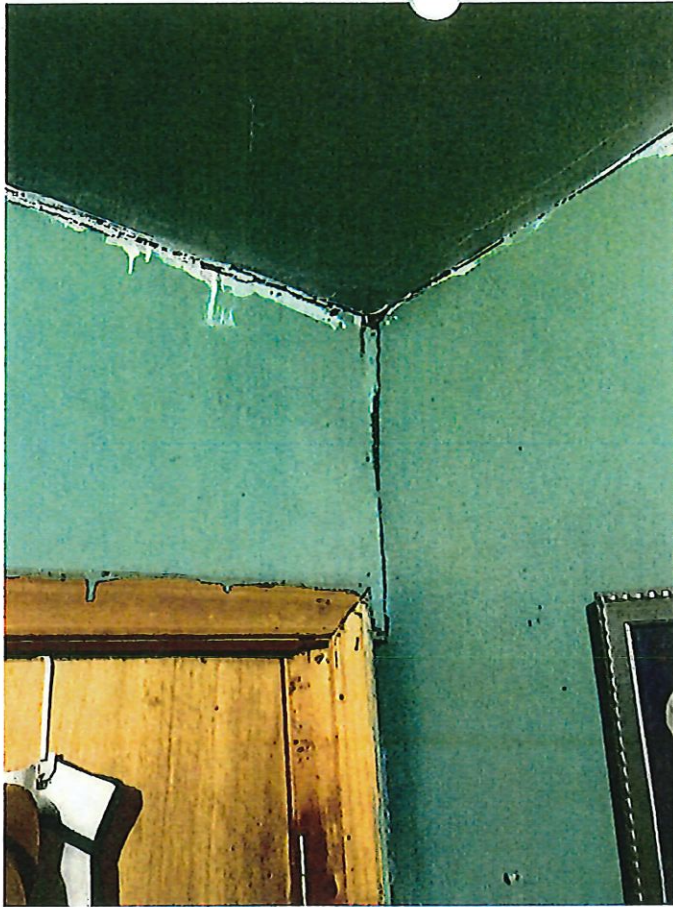
Large crack in wall by master Bedroom door.

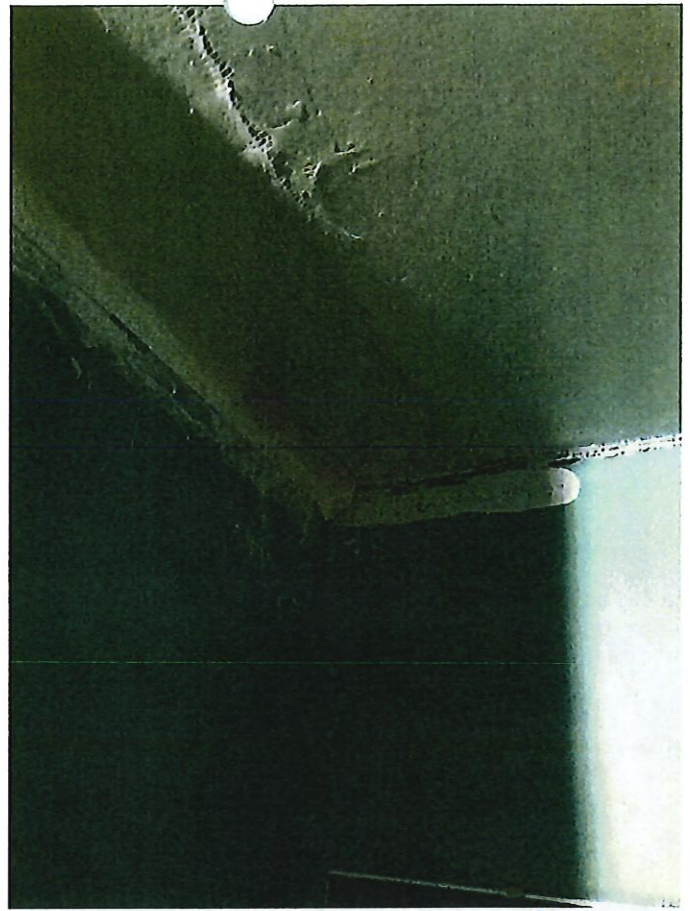
Cracks in ceiling and walls. Owner applied plaster

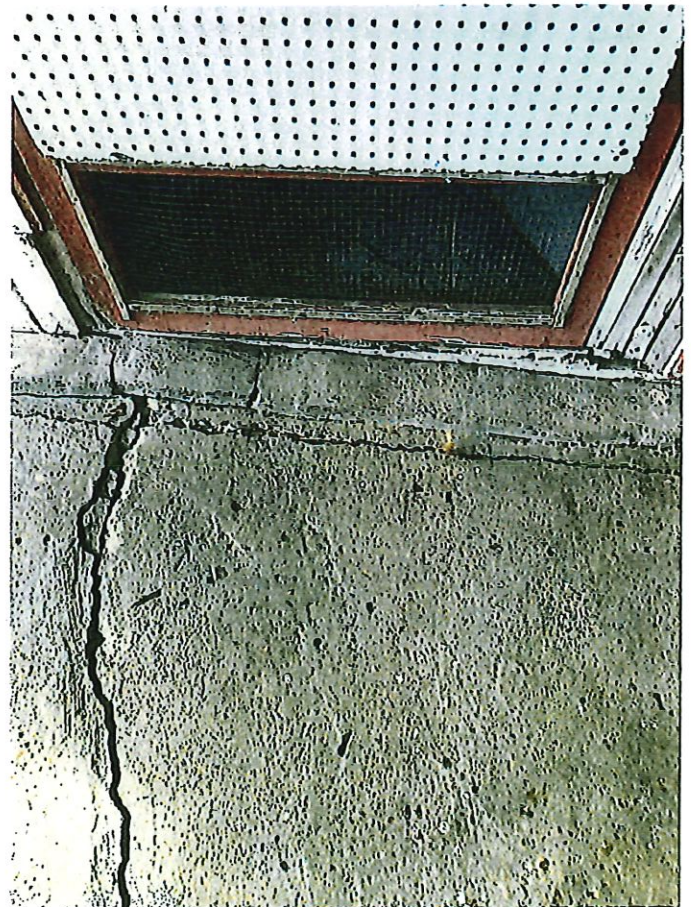
Large crack in foundation R... front door

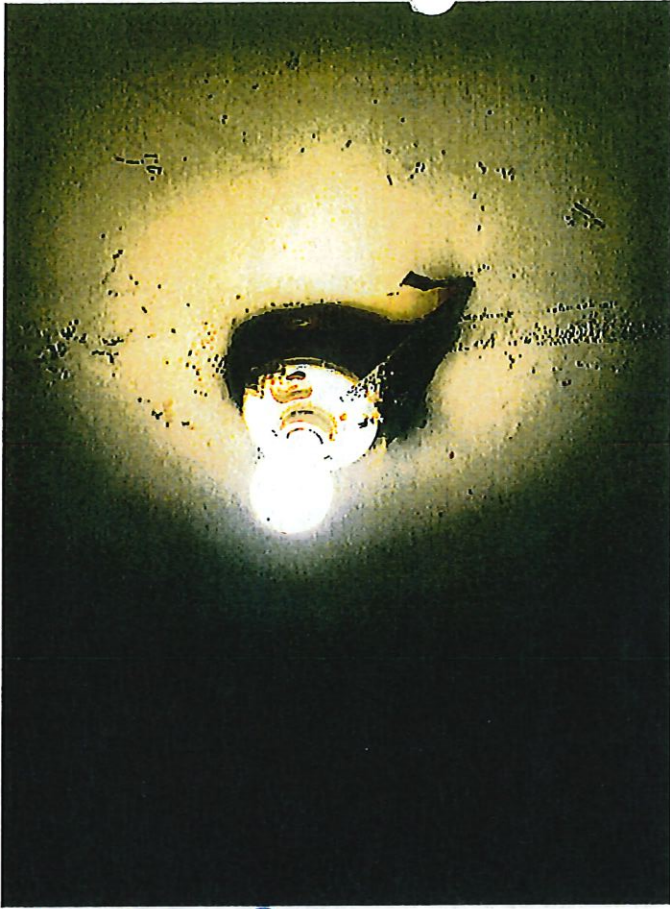
Light fixture in
master bedroom needs
to be replaced.

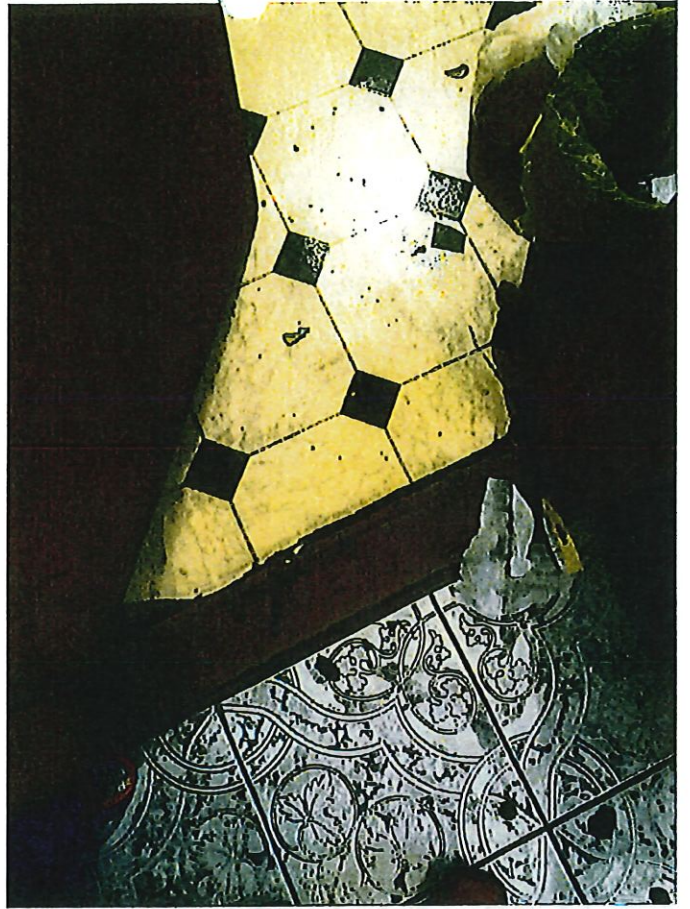
Entry to master bedroom.
Tripping hazard.

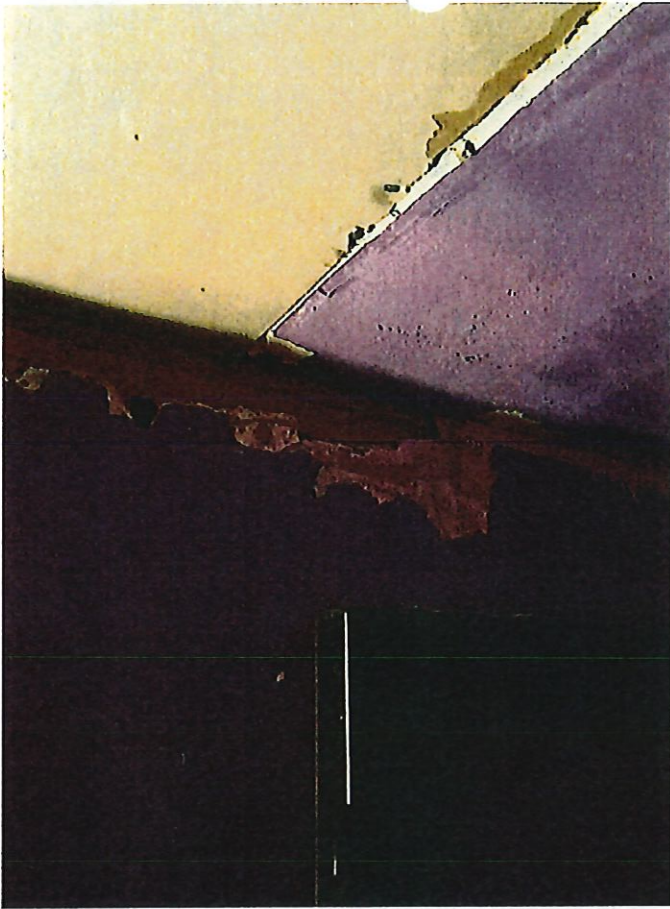
Wall and Ceiling damage in Bedroom #2.

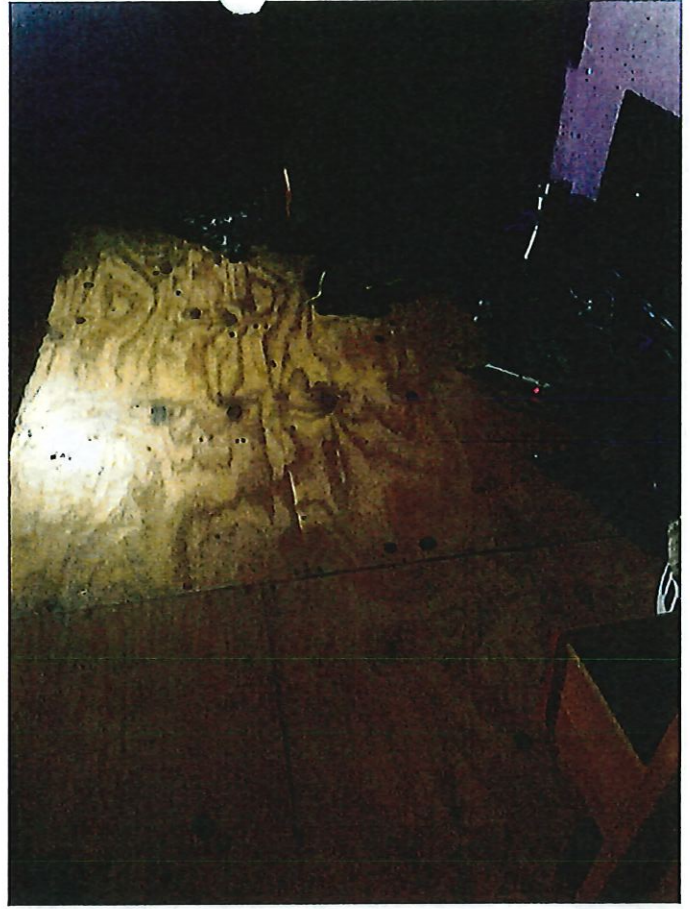
No flooring in bedroom #2. Exposed plywood decking.

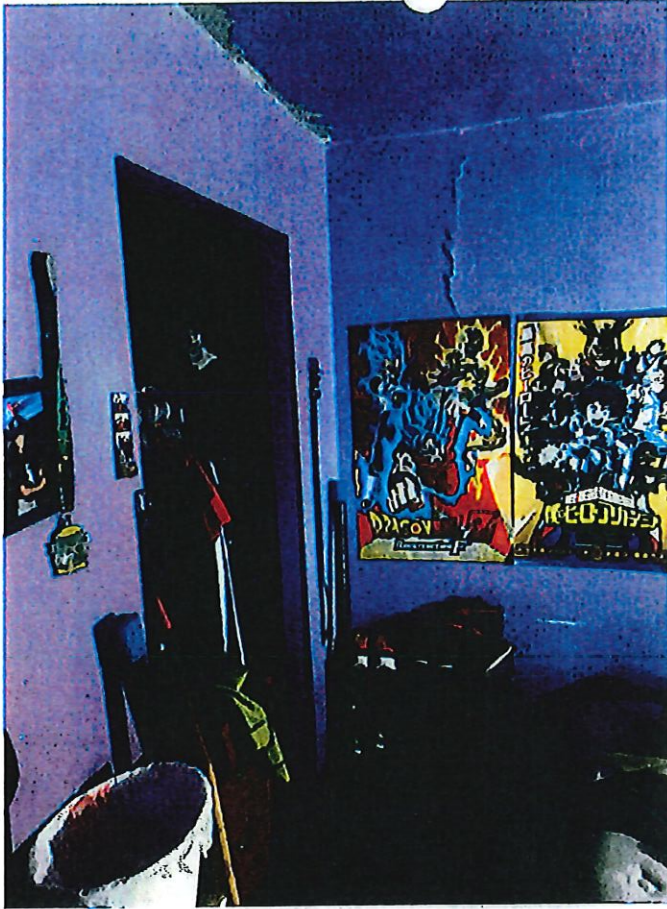
Bedroom #2. No closet door present, cracks in wall due to foundation movement

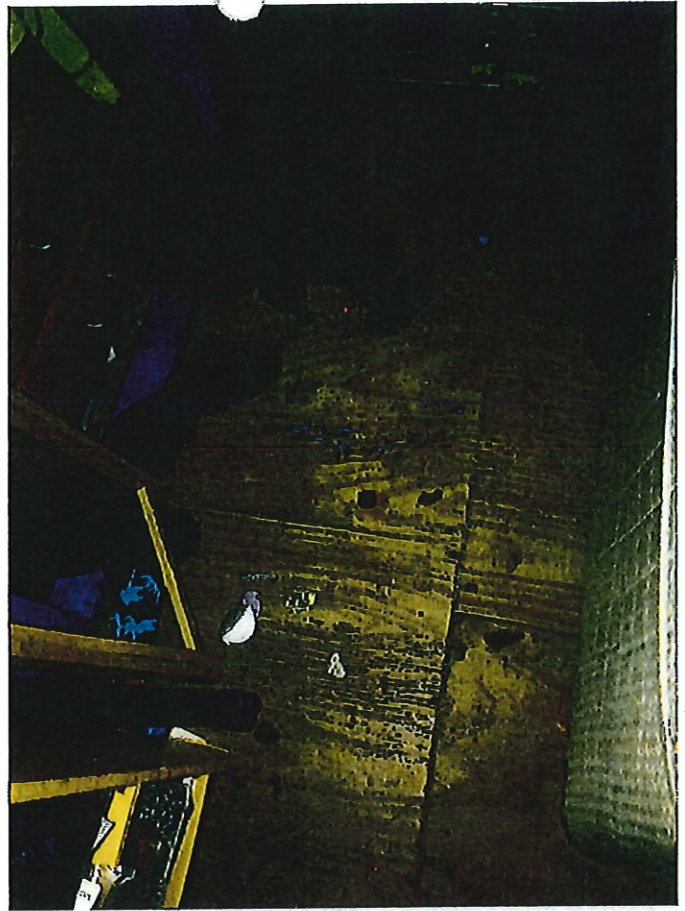
Bedroom #2. No flooring. Exposed nails on plywood decking

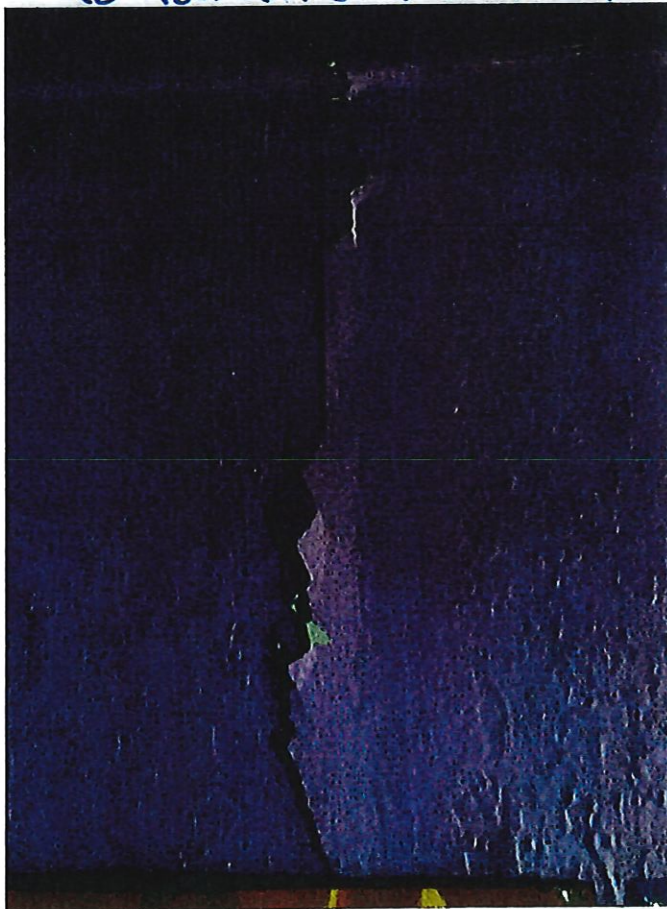
Large crack above window

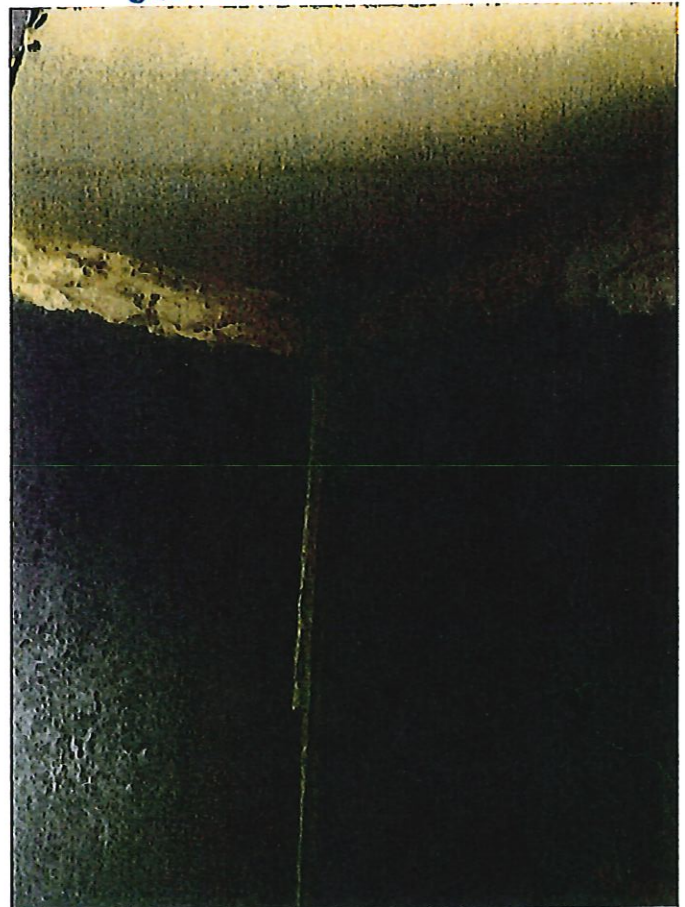
Wall separation in Bedroom #2.
