Housing Rehab Program

ENTITY: Countywide Area
PROJECT: Approval for Assistance under the Colonia Self-Help Program.
FUNDING YEAR: HOME 2018

Property Address: 1003 Dove Street, Alamo TX.

A home inspection was conducted on December 17, 2019 by Roberto Cavazos (Program Specialist) with Hidalgo County Urban County Program and the following items were noted.

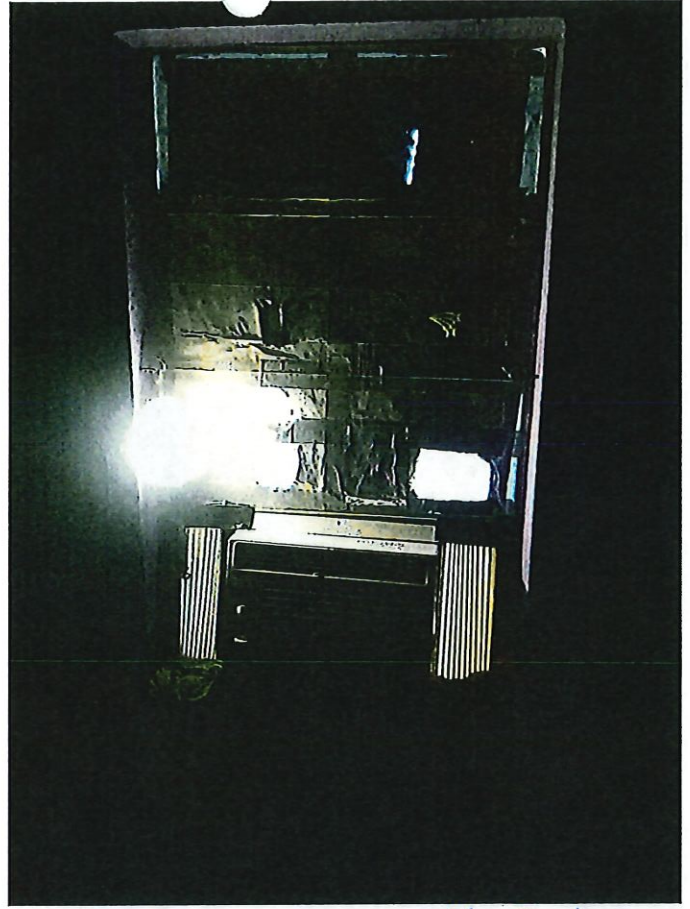
Window in bedroom # 2 does not open. window unit.

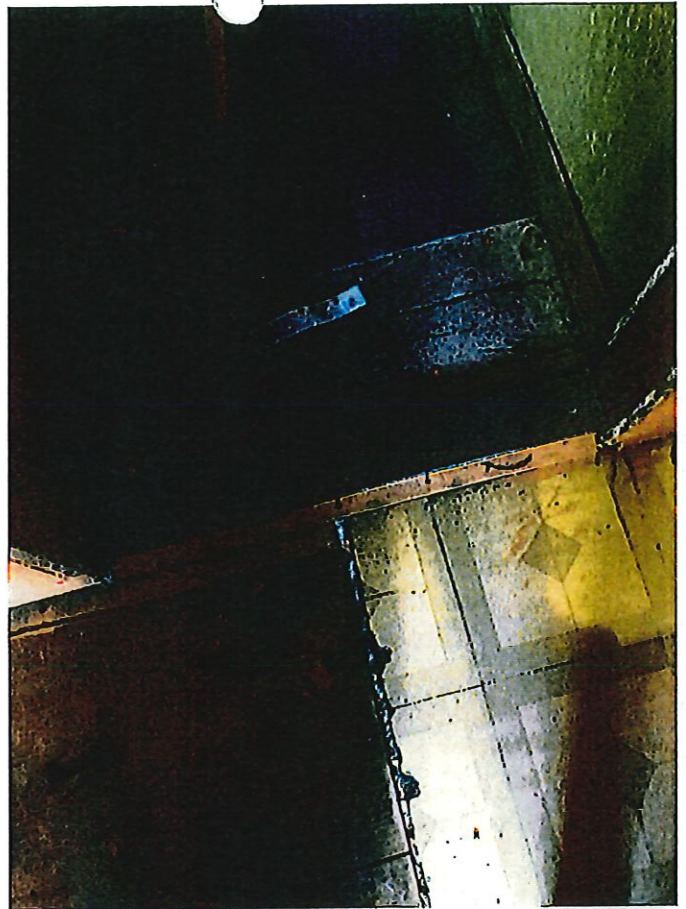
Entry to bedroom #3. Ceramic tile Broken

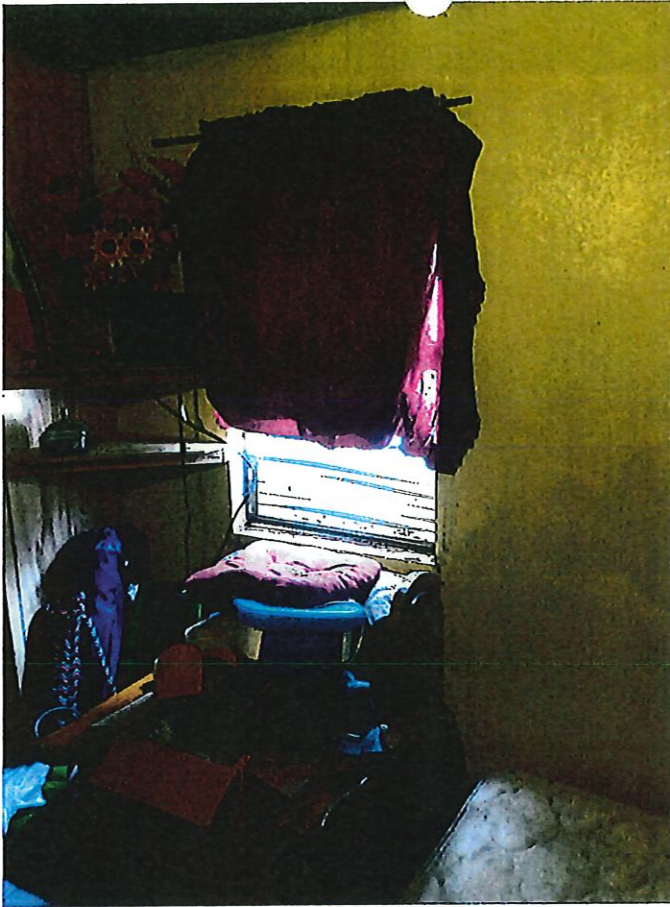
Window in Bedroom #3 Not working. Safety Hazard

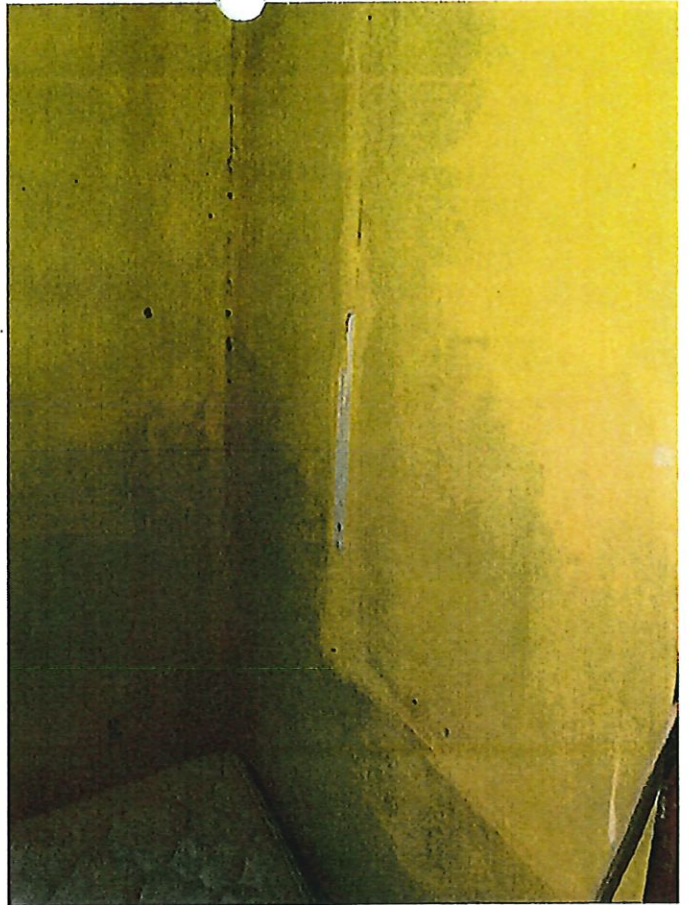
Damage to walls in Bedroom #3.

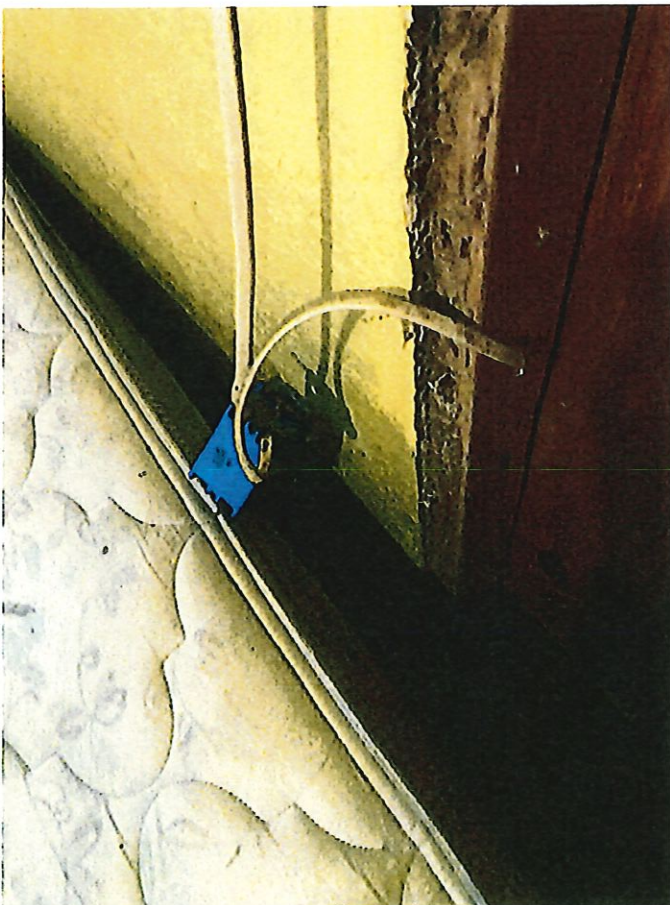
Exposed Electrical wiring and wall over next to bed.

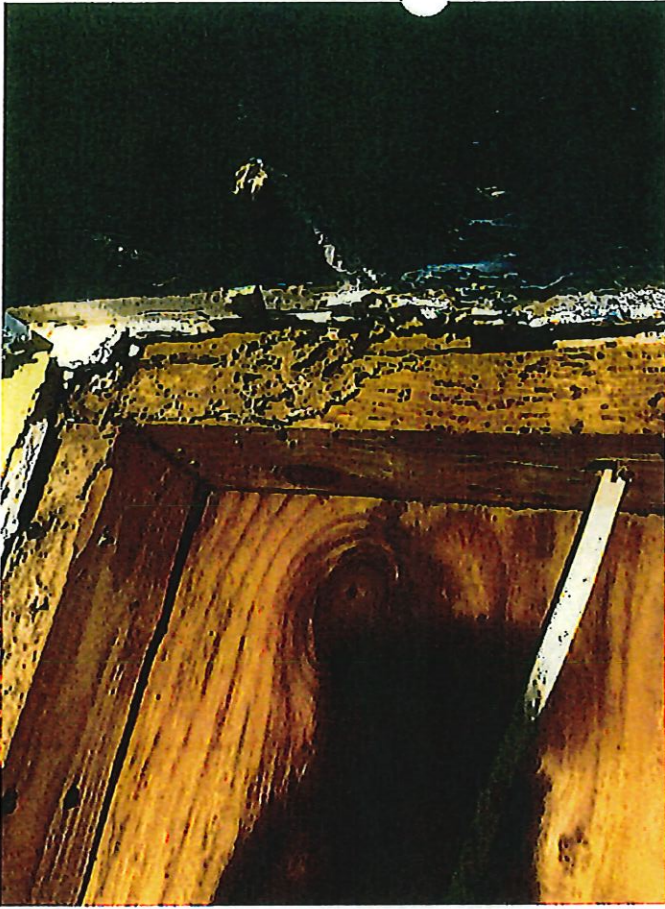
Termite Damage to top plate.
No insulation and exposed
Electrical wiring

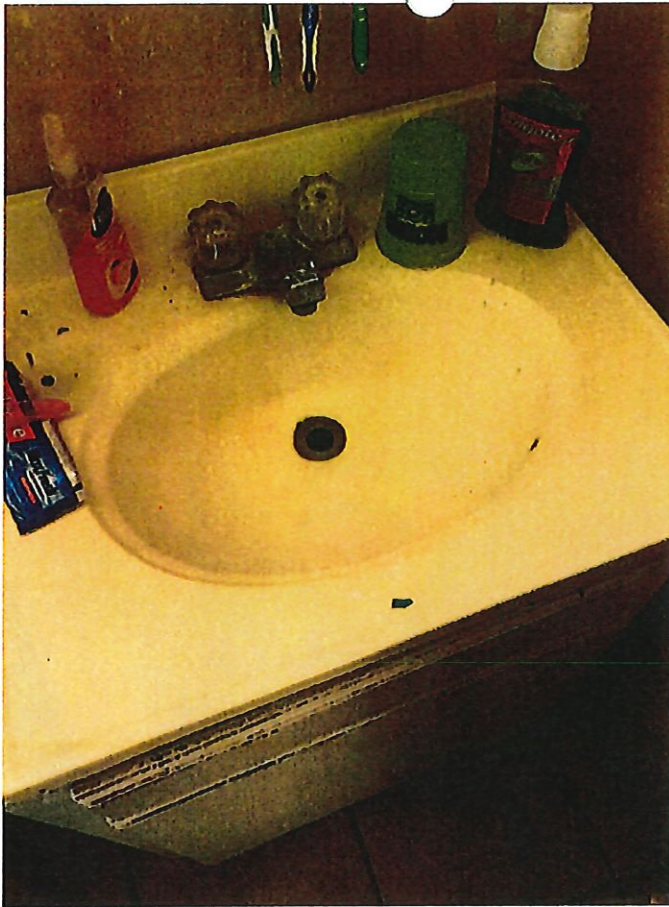
Bathroom vanity. water pressure low and faucets are broken

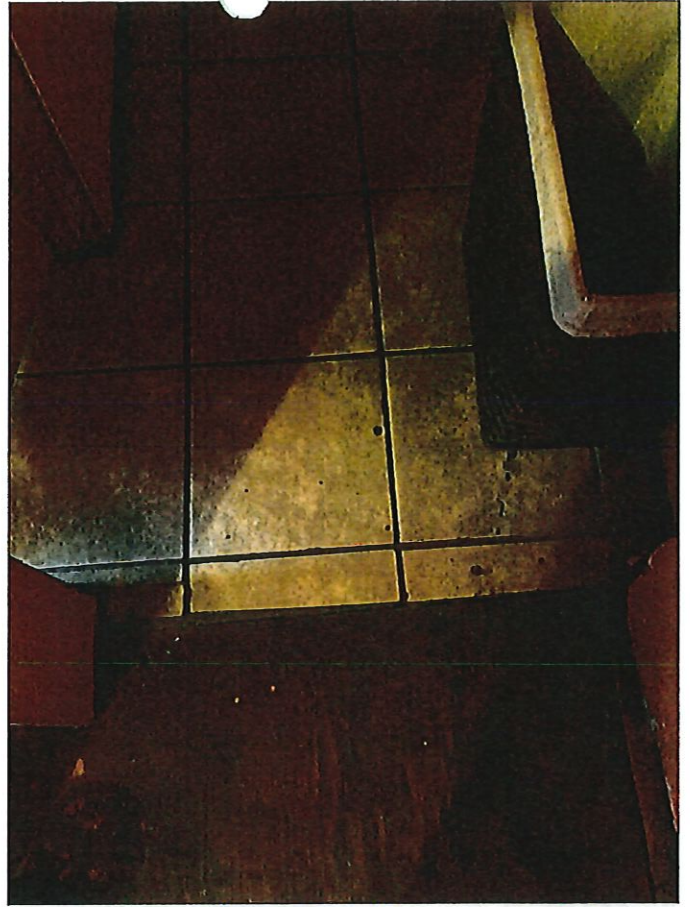
Entry to Bathroom. tile floor is loose and cracked.

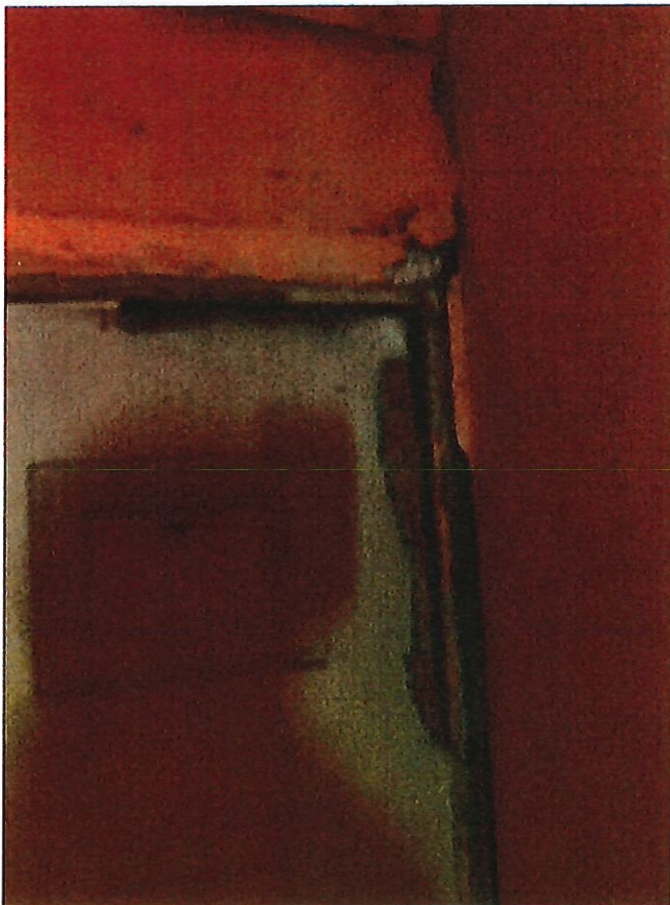
Damage to Door and door frame to Bathroom.

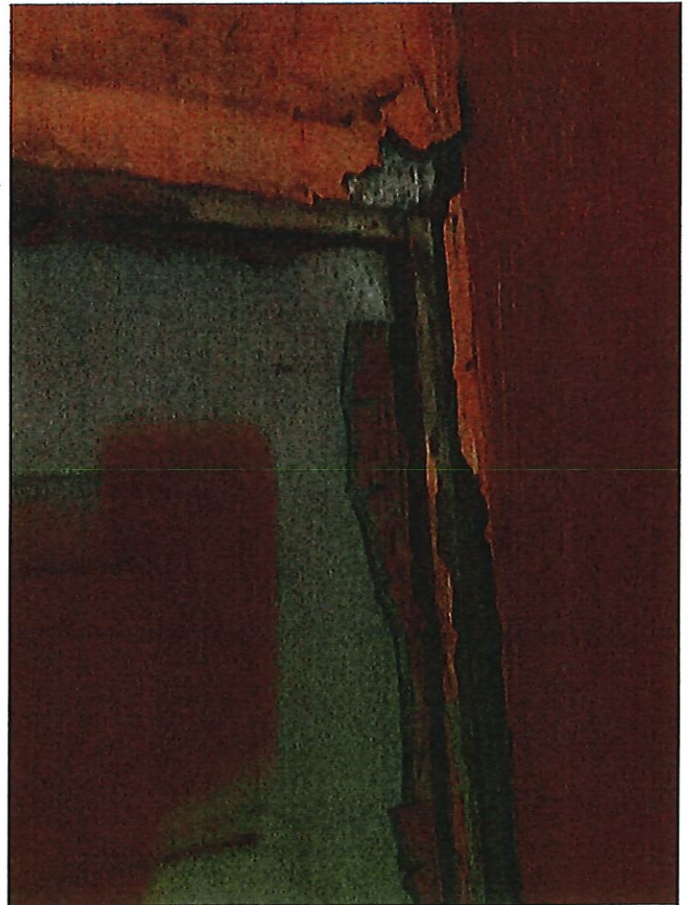
Damage to Bathroom Door

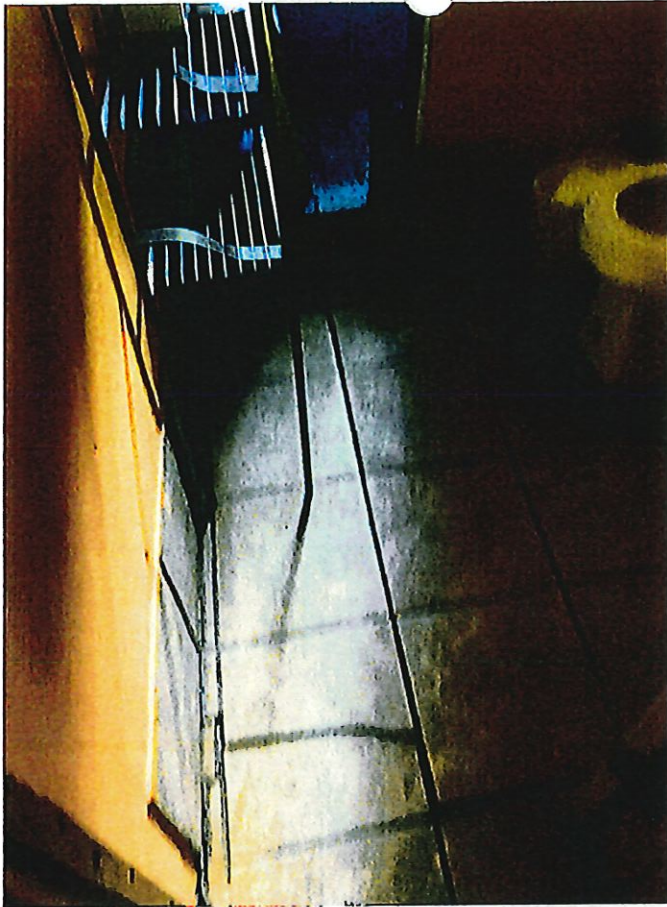
Ceramic tile in Bathroom Cracked due to Subfloor Movement

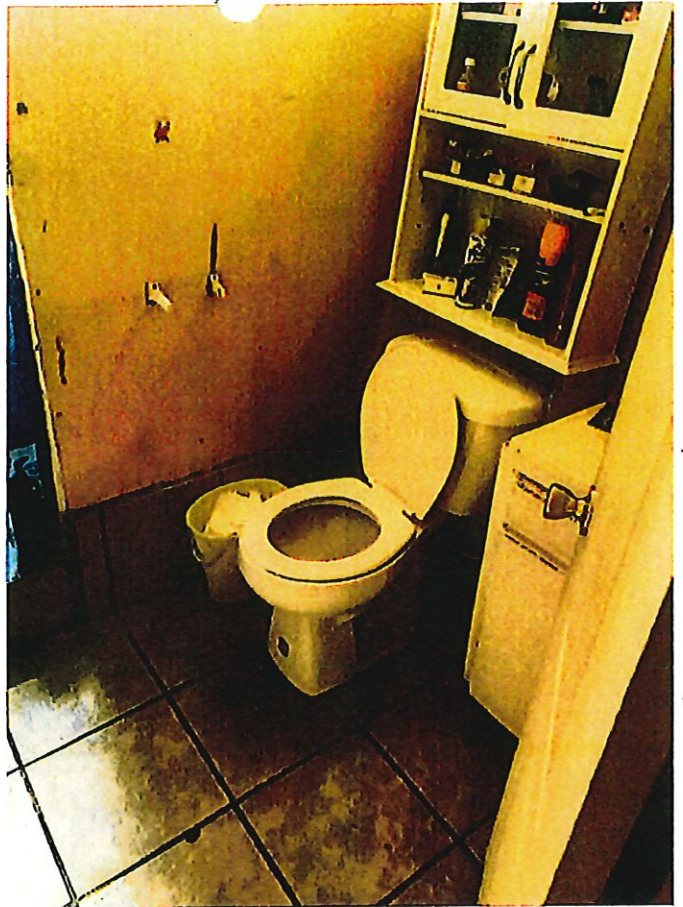
Toilet in Bathroom Not functioning properly. Low water pressure

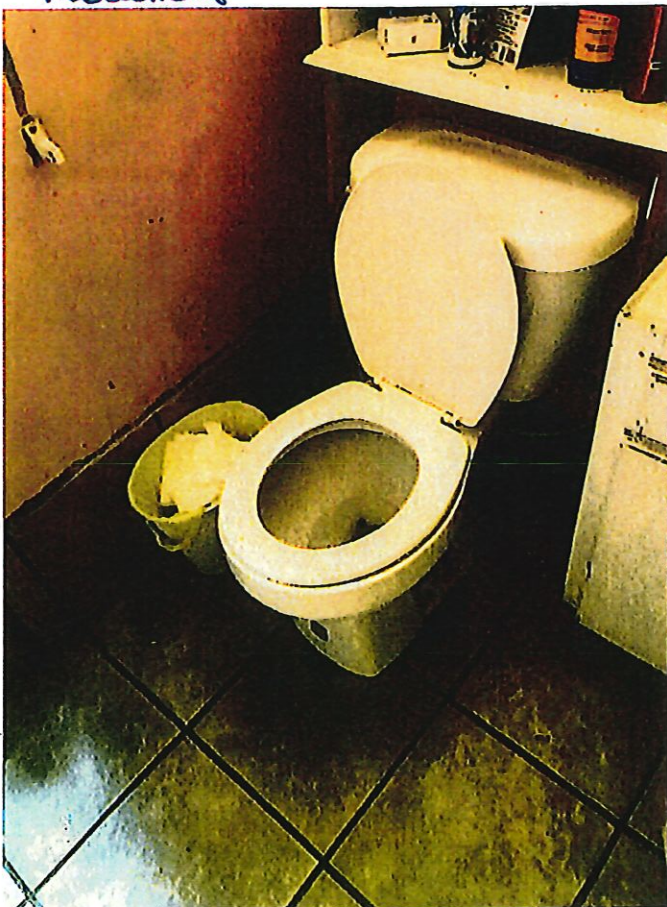
Cracked ceramic tile beneath the Toilet.

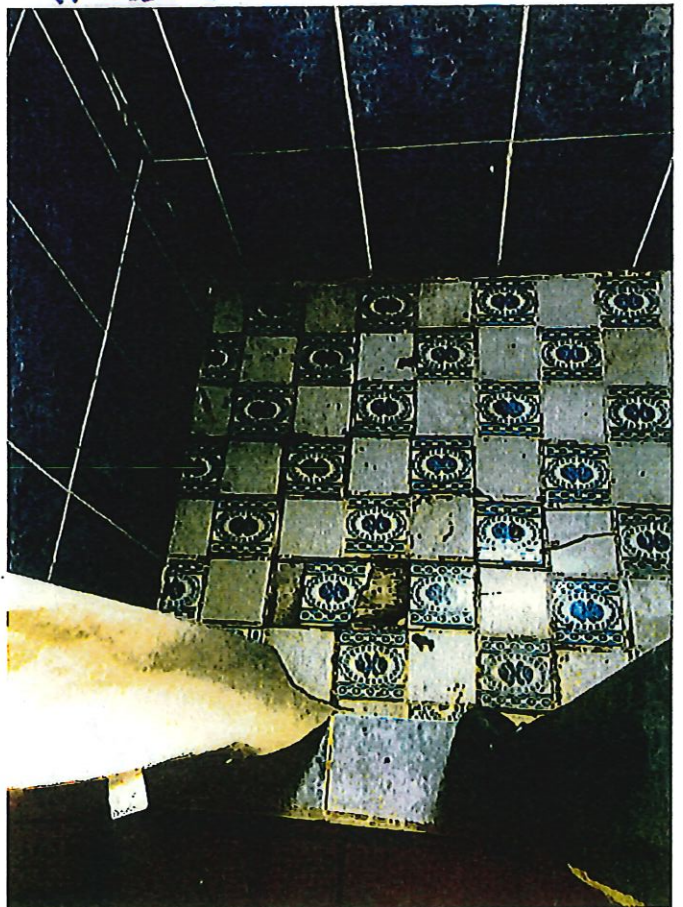
Broken tile in shower.

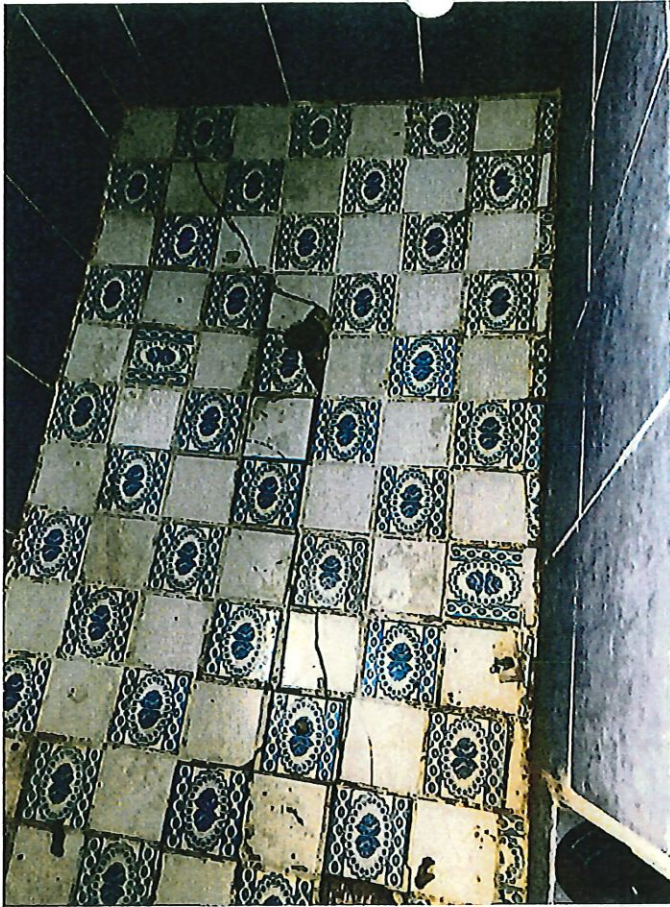
Broken tile in Shower. Shower Drain not working properly and Shows floor leak.

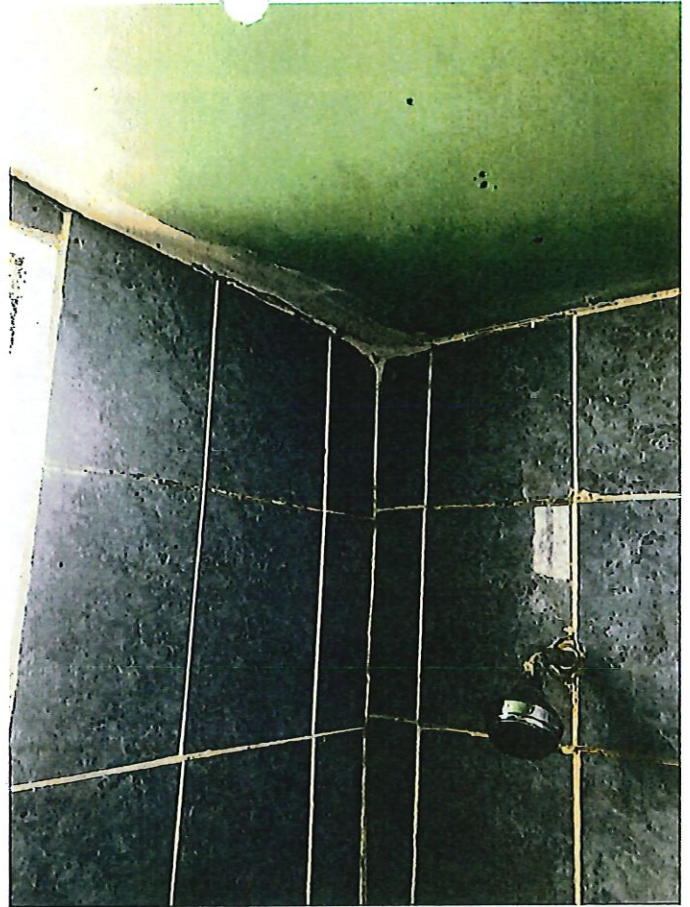
Shower head broken

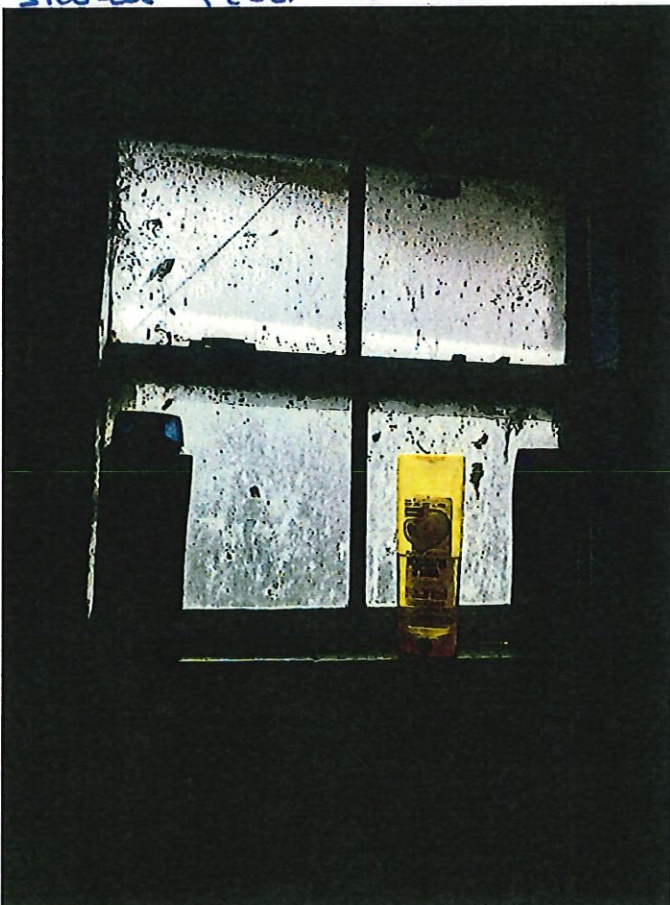
Window in shower Does not open

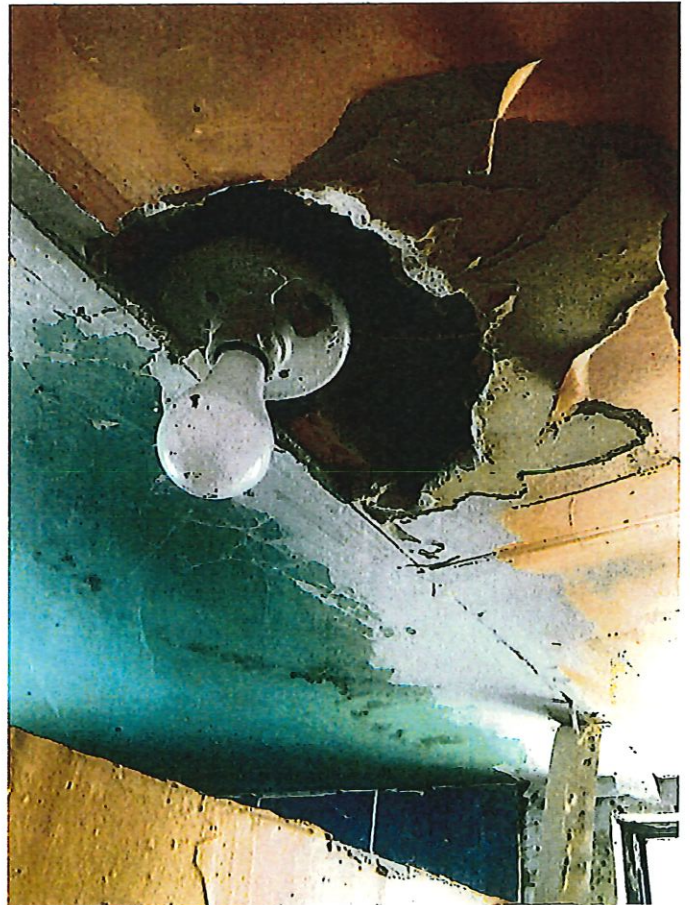
Light fixture in Bathroom Broken.

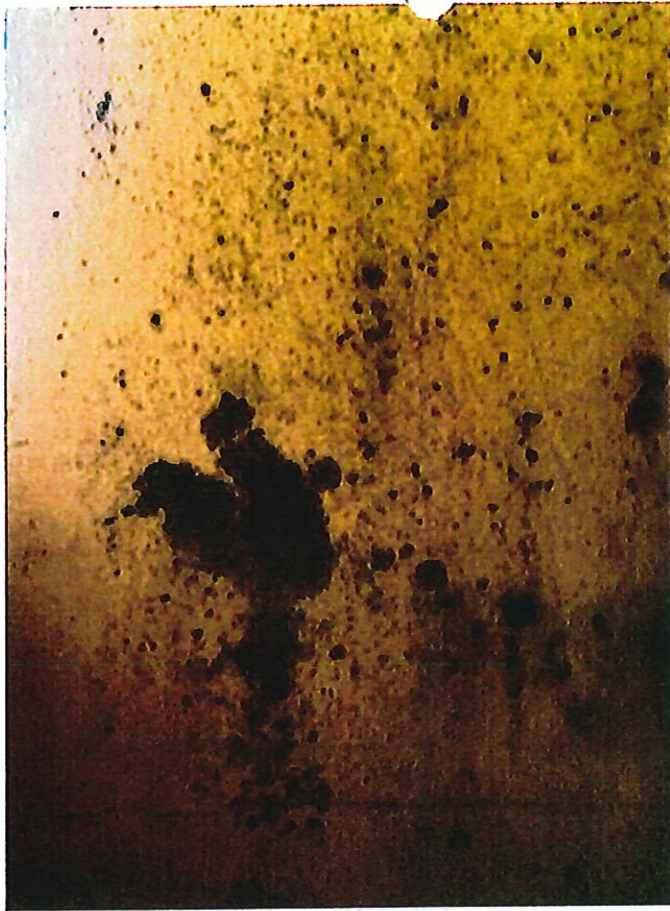
Looks like mold located
in Bathroom.

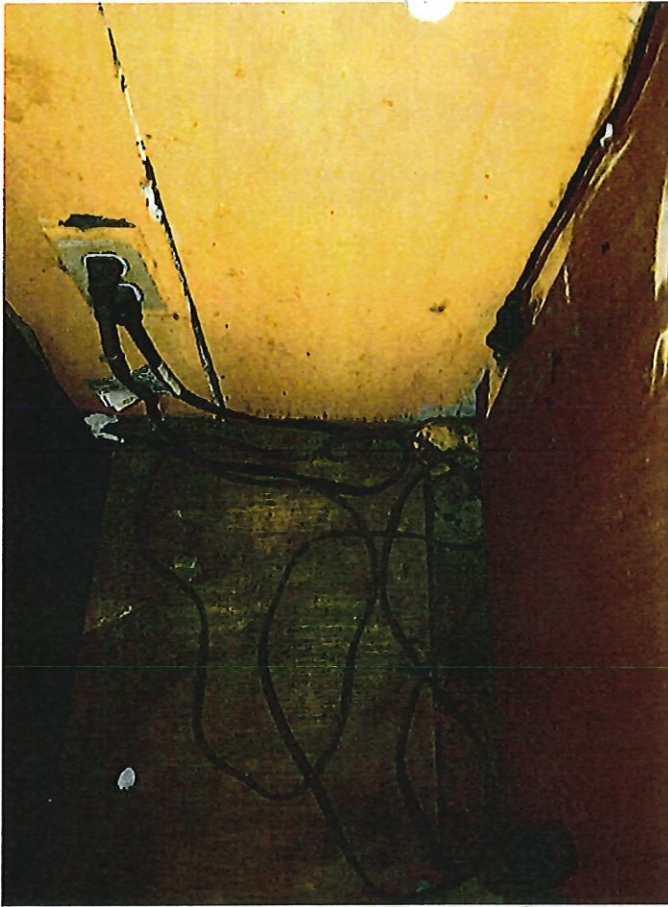
Wall damage, extension cords
Used for power source

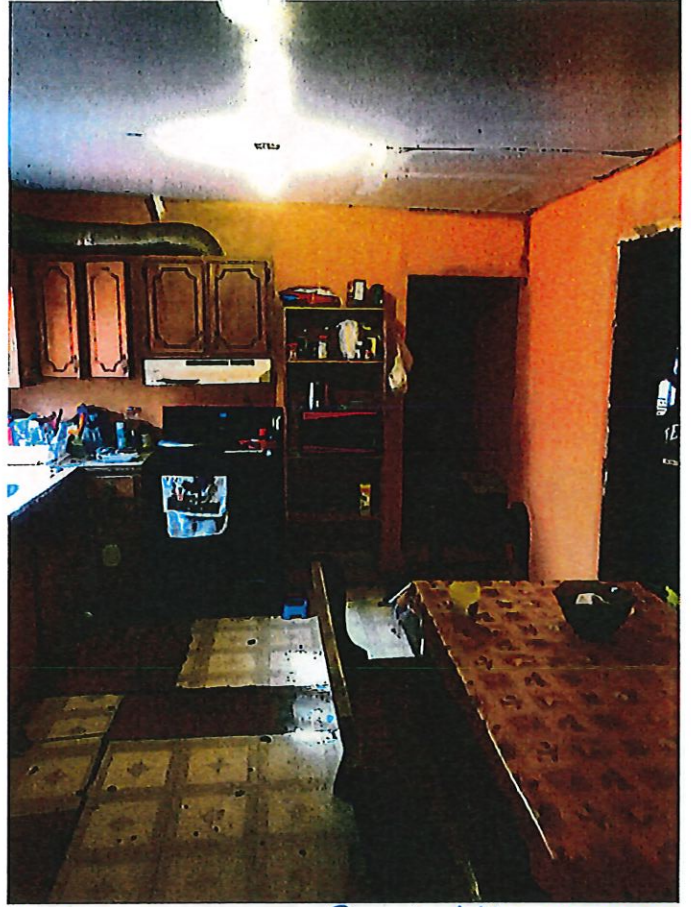
Kitchen area, floor tile missing,
Exposed plywood

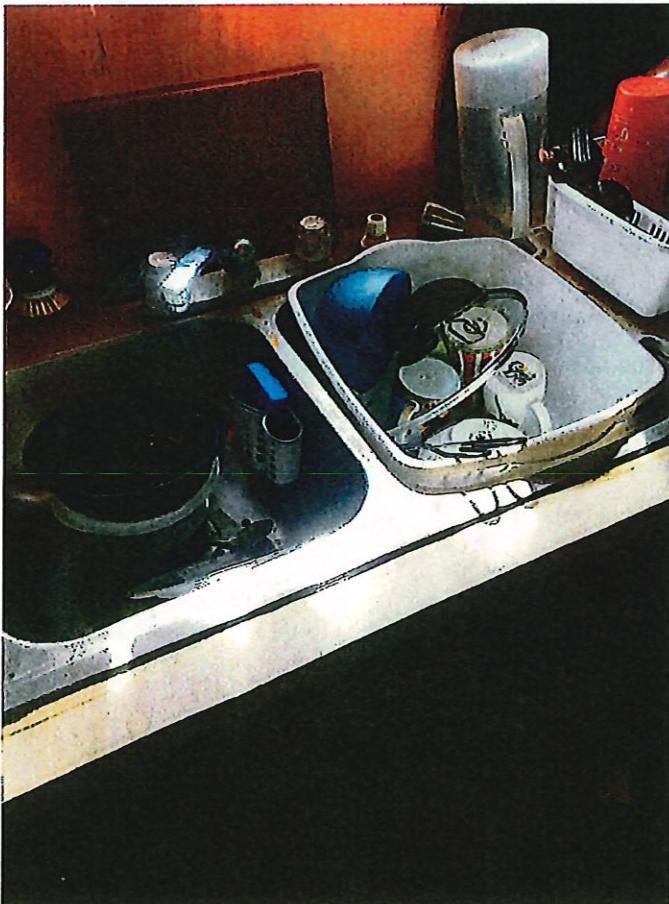
Kitchen Sink, low water processor
and leaks under cabinet

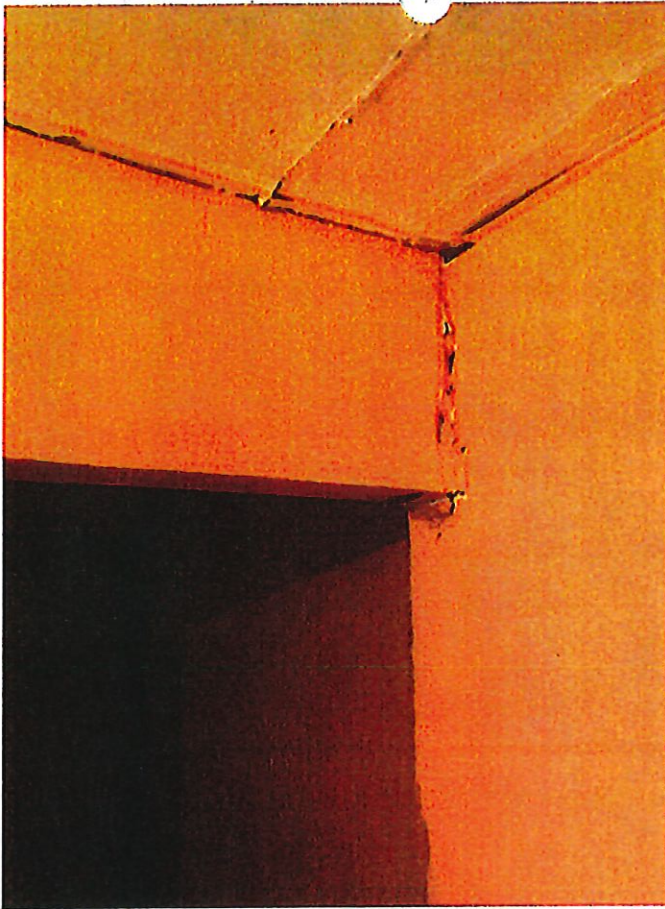
Ceiling & wall damage in Kitchen area.

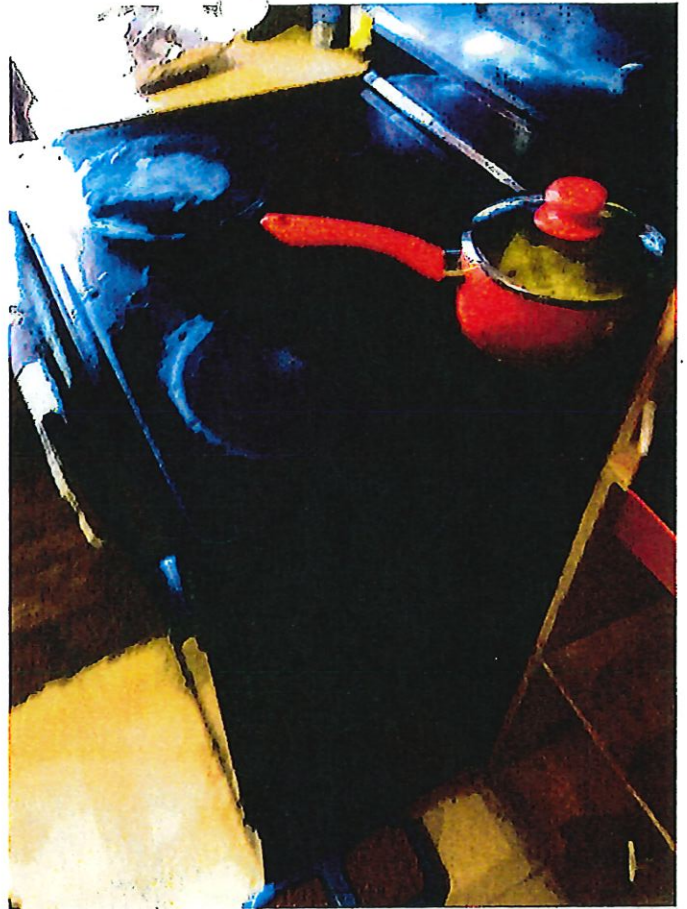
Stove in Kitchen has No Anti-TIP Device

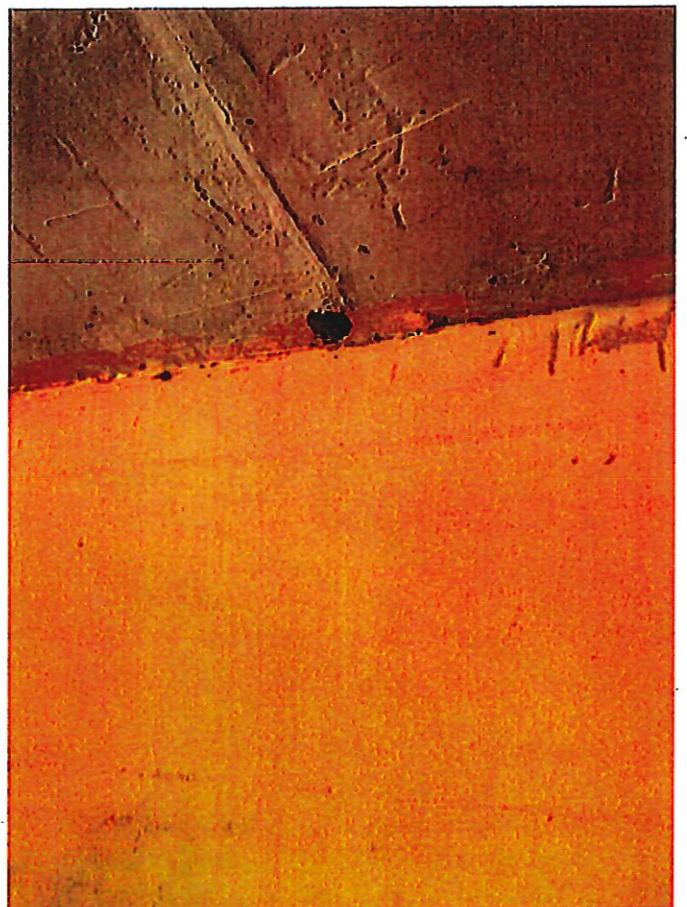
Wall and ceiling damage. Hole in ceiling.
