# Housing Rehab Program

**ENTITY:** Countywide Area  
**PROJECT:** Approval for Assistance under the Colonia Self-Help Program.  
**FUNDING YEAR:** HOME 2018

### Initial Inspection Checklist for Housing Rehabilitation (When compliance with TMCS is required)

Homeowner's Name:	J. Guadalupe Puga
Street Address:	708 Bertha Blvd.
City, County, Zip:	Mission, Hidalgo, 78573
Year built (per CAD):	1990
Lot size (OSSF only):	0.15
Local building code:	2015
Flood Zone designation:	480334-0400C, Zone C

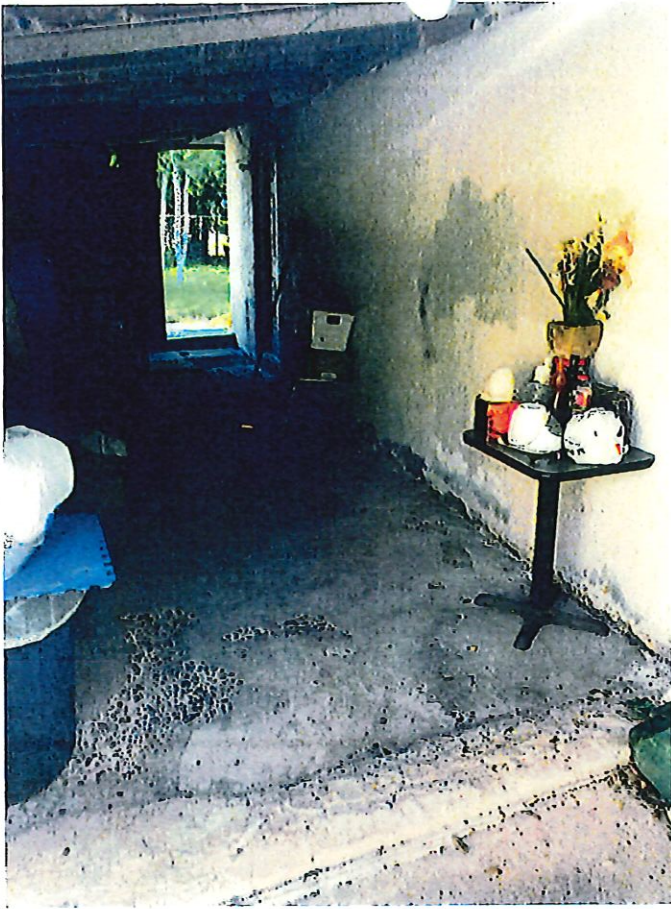
Comment:	Driveway, sidewalks – dimensions, material and condition: Concrete driveway present 25'x35'
Comment:	Garage, carport, tool shed or other out buildings – type and condition: Car port located on the westside of home. Condition is bad, raters deteriorated.

Attached Car port. (west side)

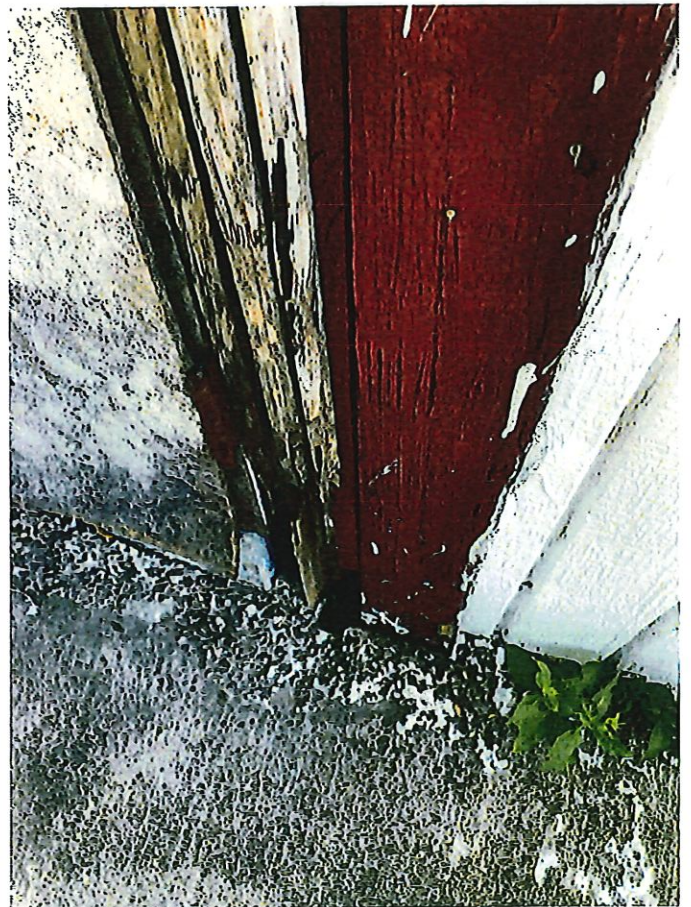
Deteriorated trim

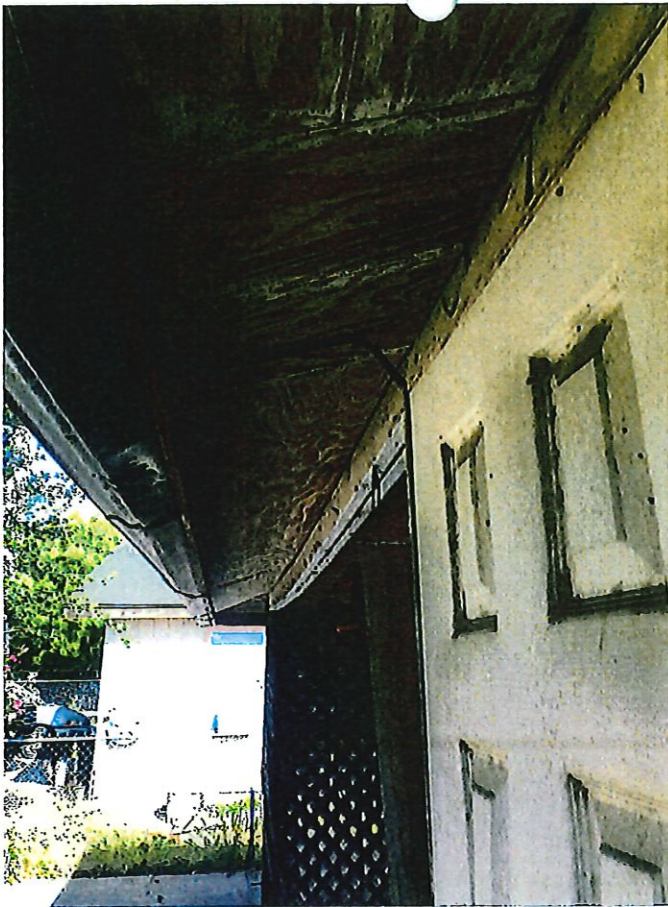
Comment:	N/A
	Soffit, fascia, venting, gutters, downspouts, splash blocks or means of diverting water at least five feet away from structure:
Comment:	Soffit and fascia in bad shape needs to be replaced. No means of diverting water away from the structure
<b>Living Room</b>

Soffit unpainted

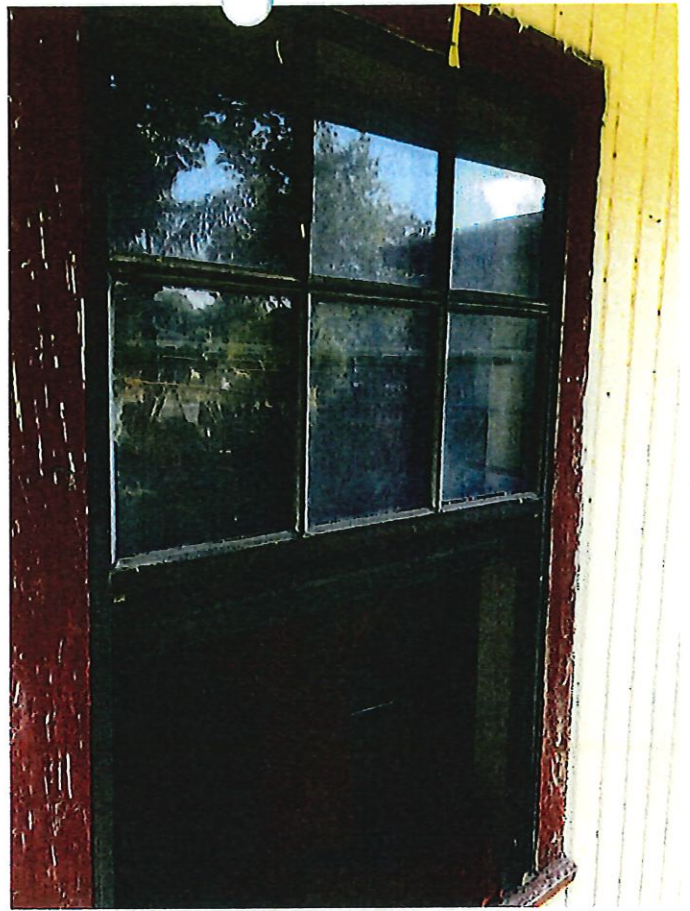
metal window Hard to operate

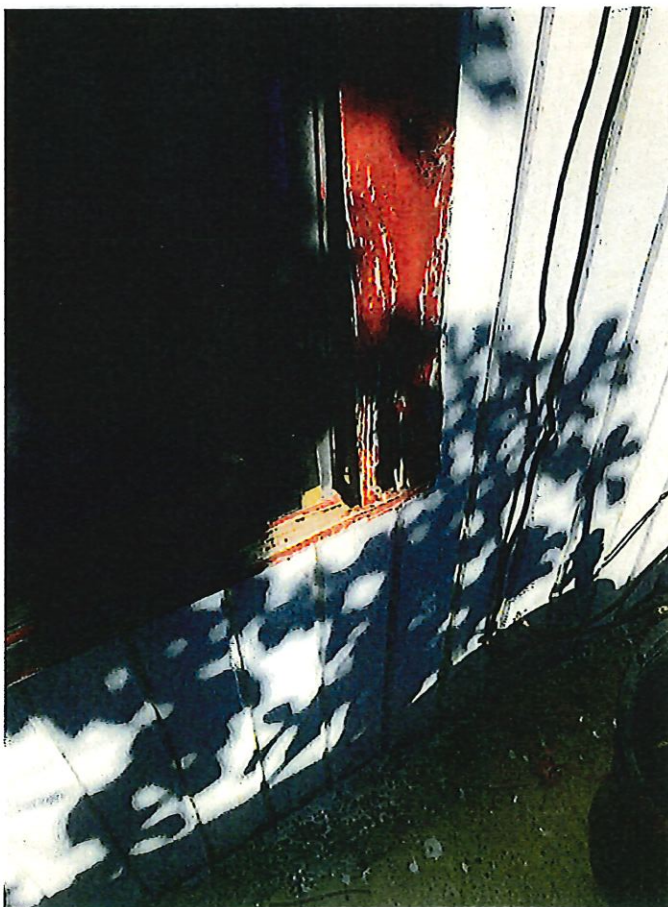
Deteriorated window frame

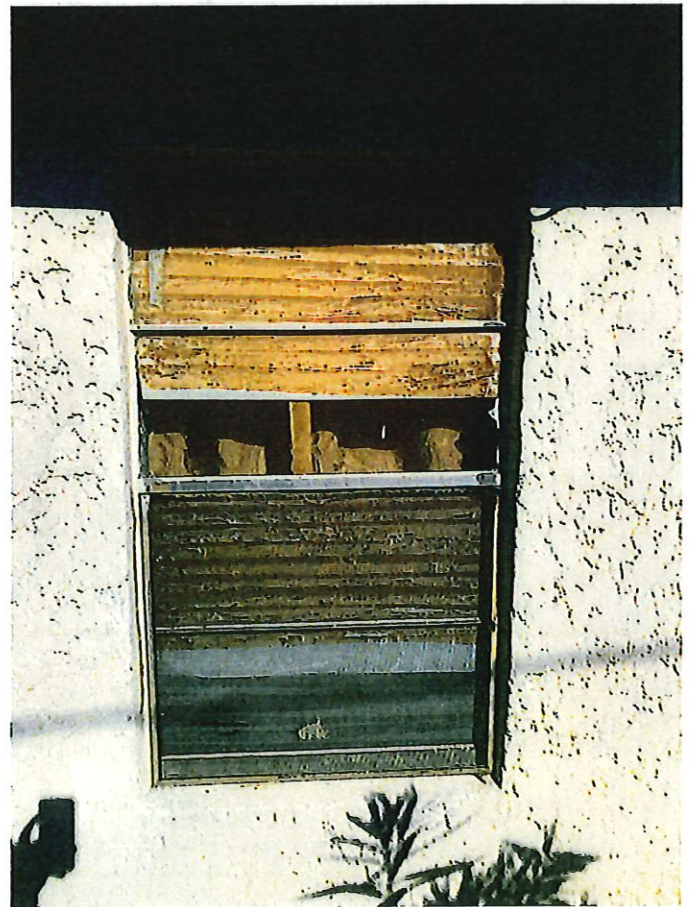
metal window located at rear of house Does not open

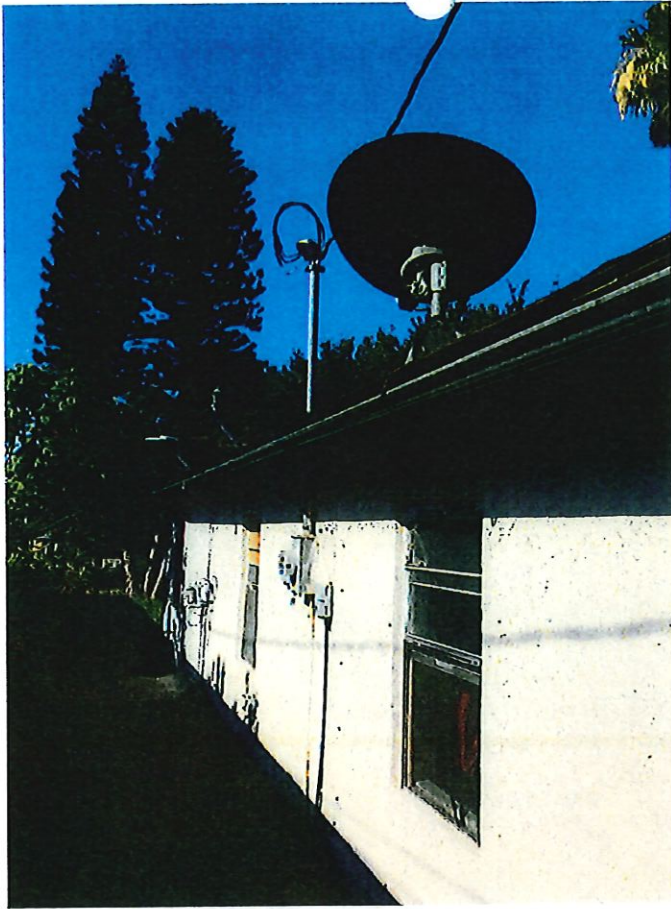
Service mask upright

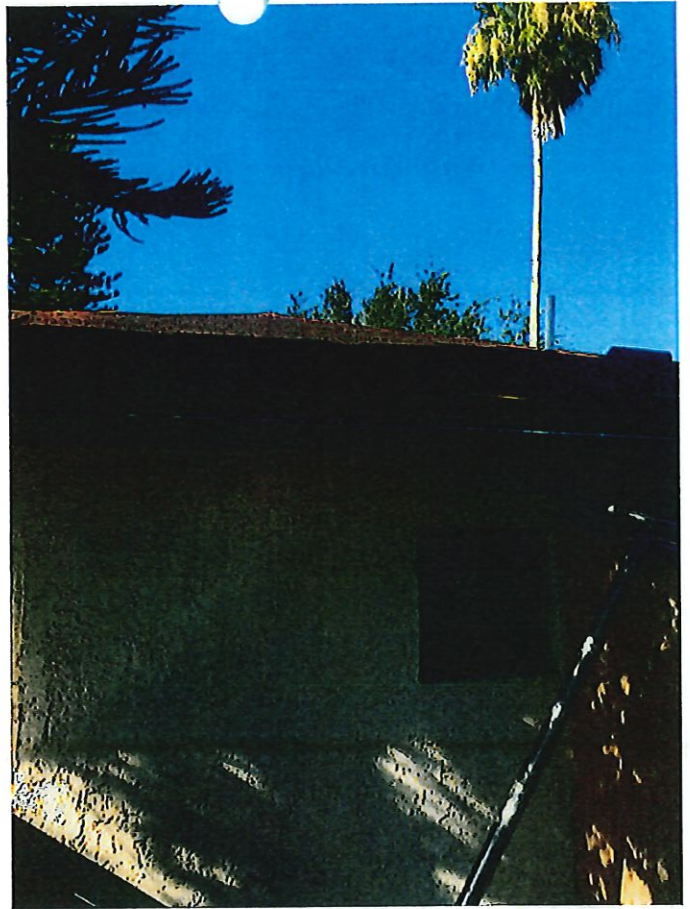
Comment:	Roof is 5/12 slope, roof shingles near the end of its life cycle. Many torn and missing. Replacement in near
	Chimney - flashing – chimney cap/spark arrestor - condition:

Roof Shingles Deteriorated

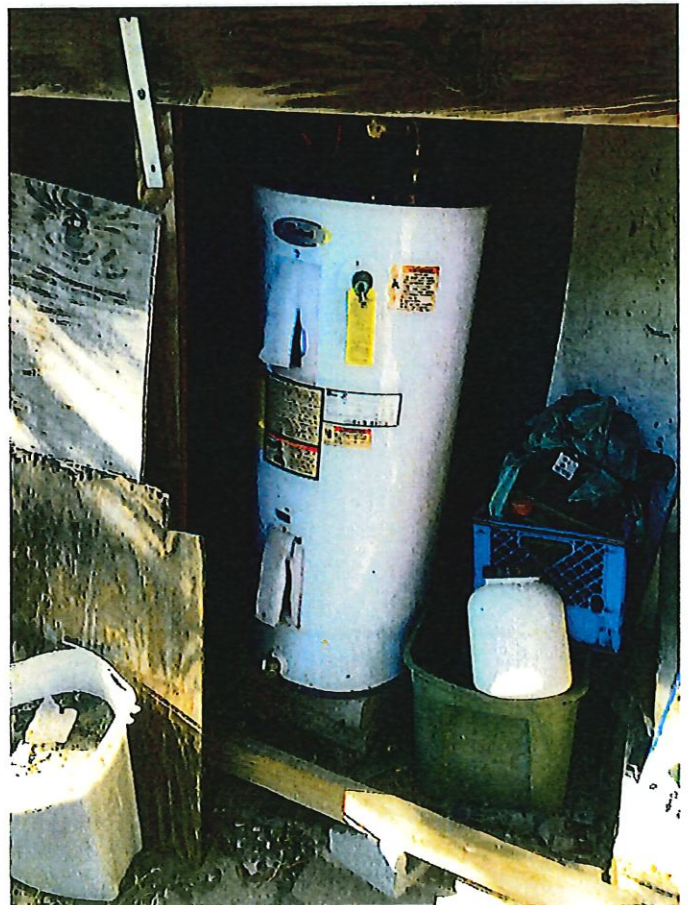
Water heater not protected from the elements

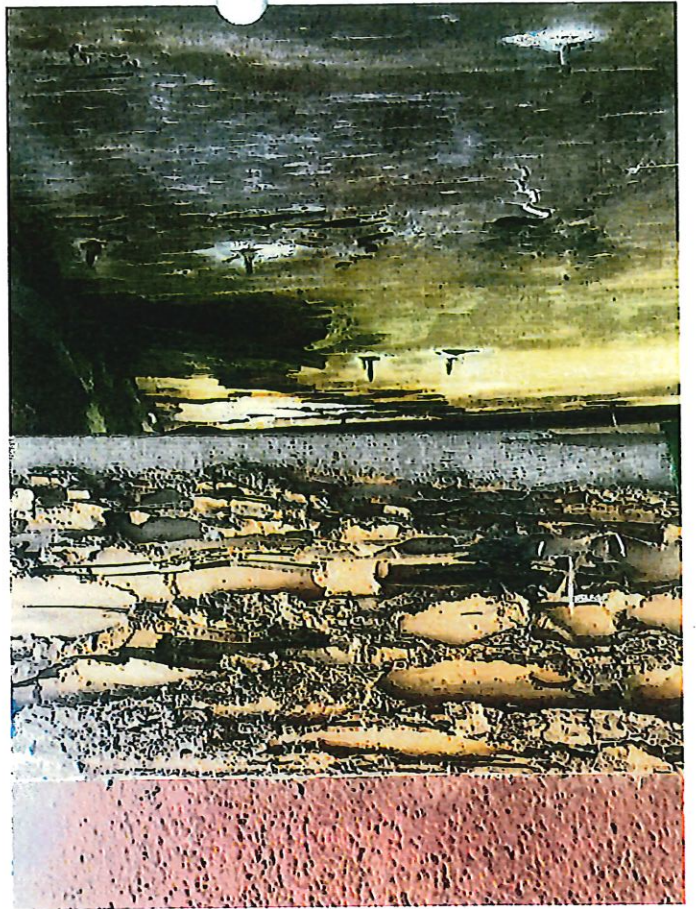
Comment:	Subterranean termites present damage is also present
	Foundation skirting - type and condition:
Comment:	N/A
	Are hose bibs with backflow preventers present? Wall penetration sealed? Location(s):

Termite Damage to Rafters

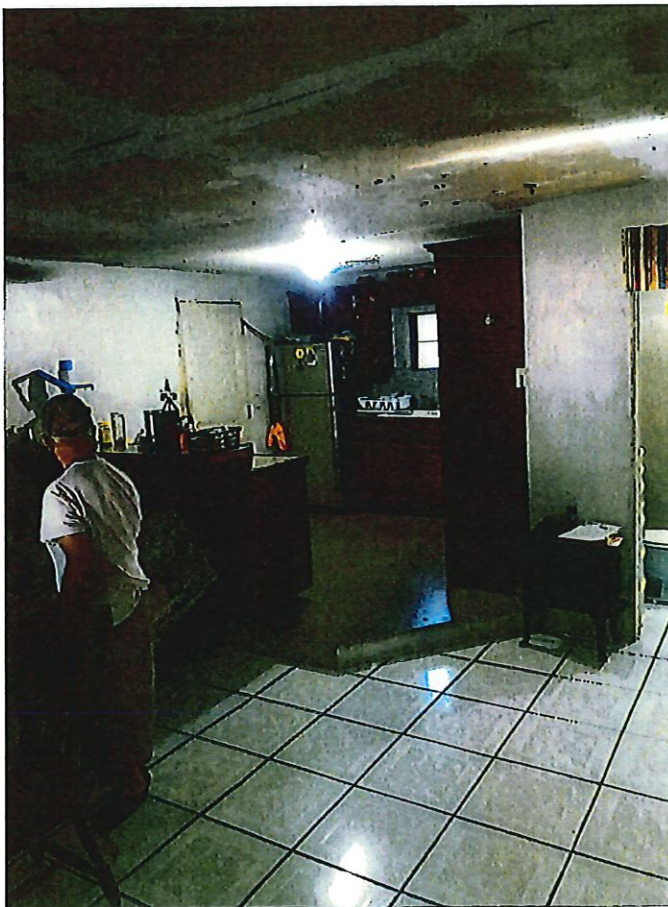
Kitchen view, no paint or texture

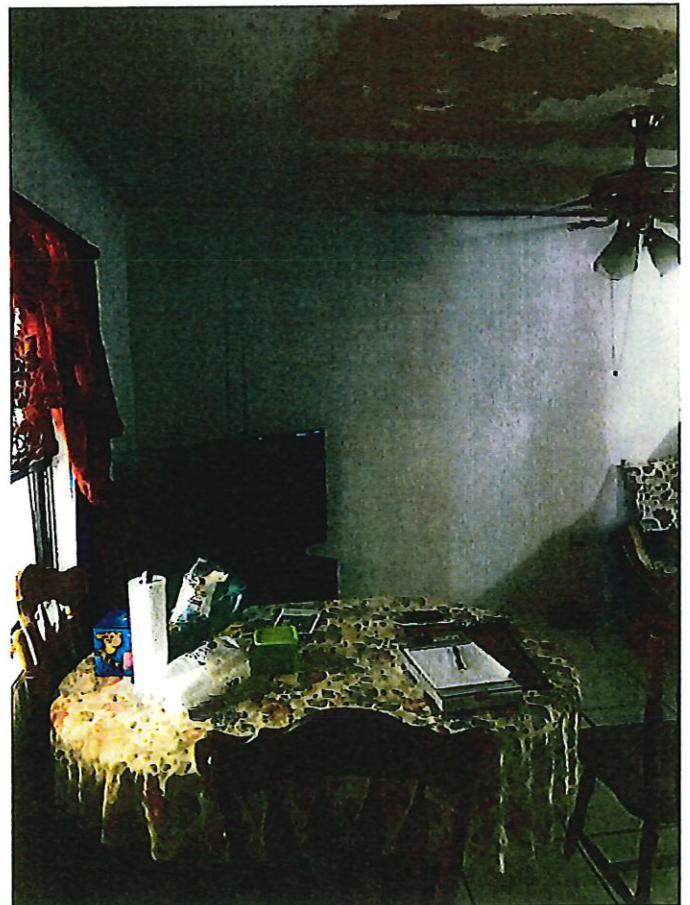
Dinning room, no paint or texture

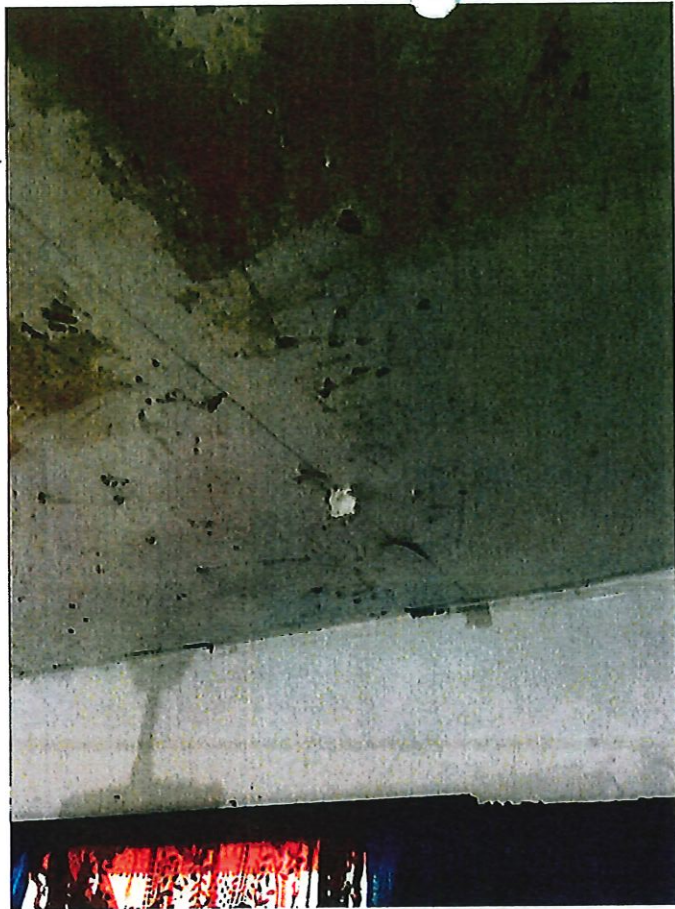
Room Dimensions, including ceiling height:
Comment:	10'x15' with 8' ceiling height
	Ceiling material, water stains? condition:
Comment:	Sheetrock, water stains present and in poor condition
	Wall material, paint? condition:

Water Damage to Ceiling in Living room

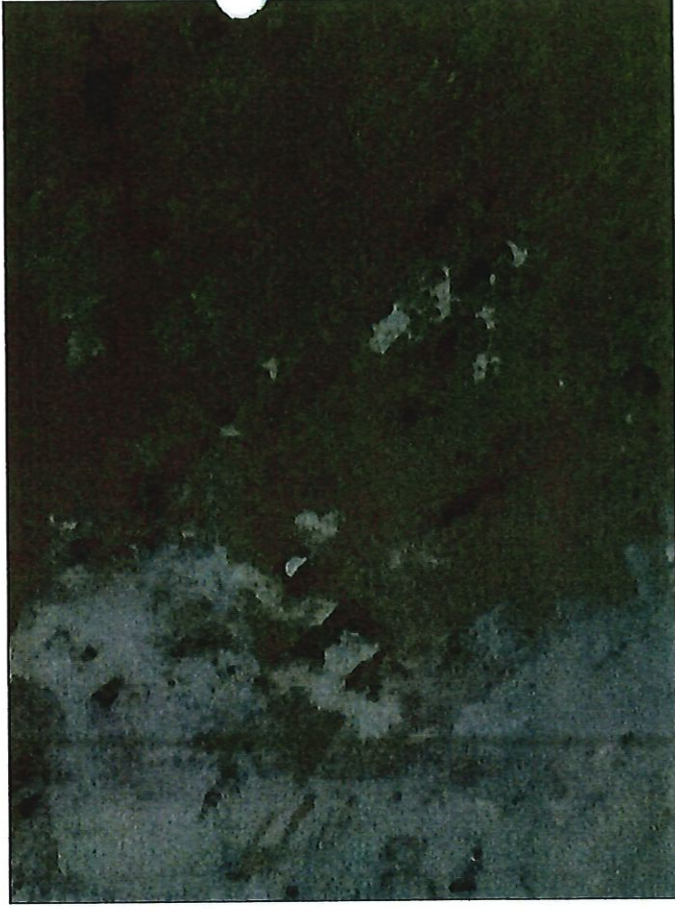
Water Damage close up

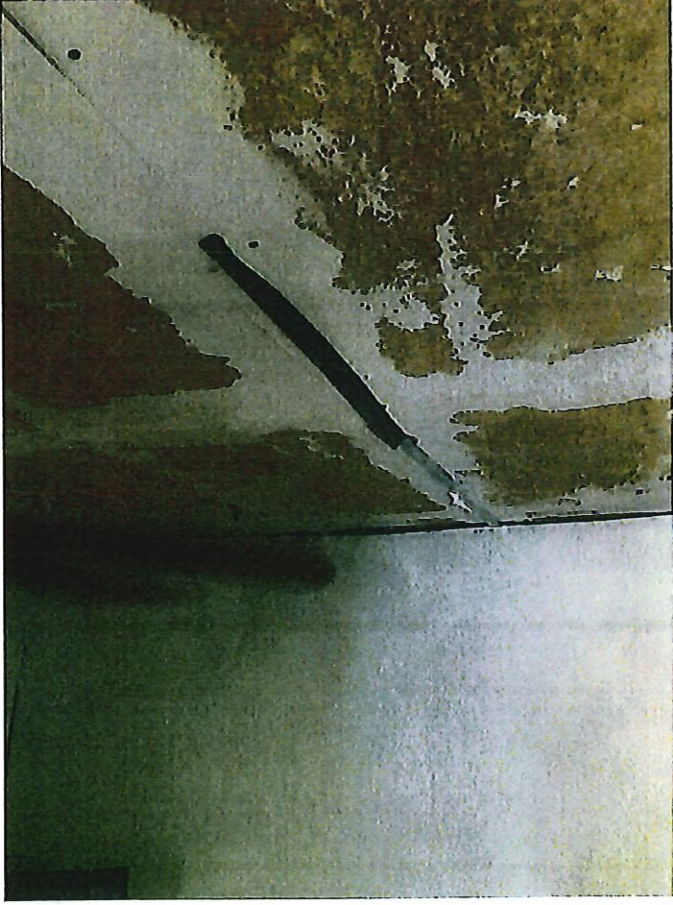
tape and float coming undone  
in living room

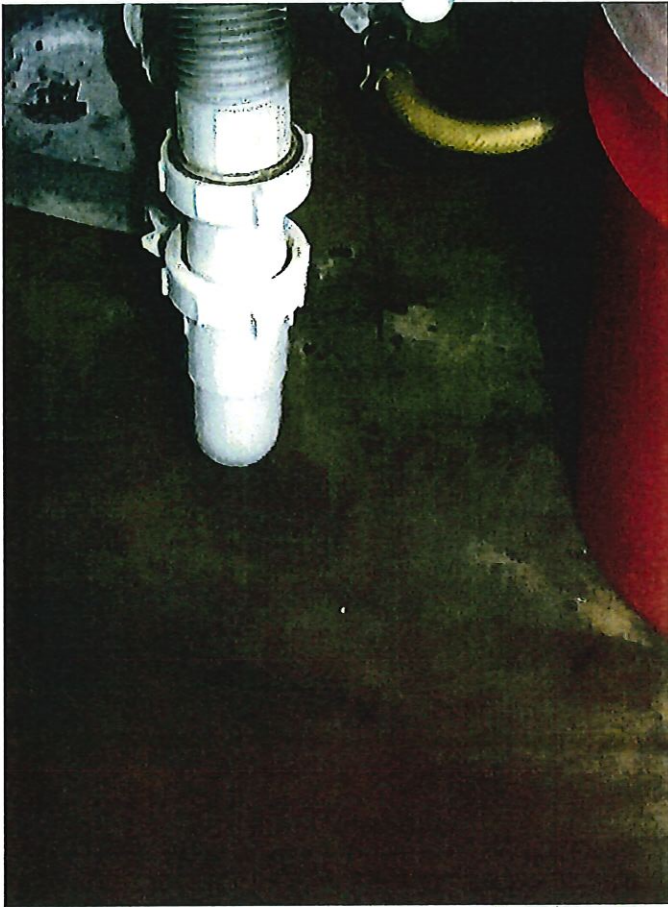
Water Damage under kitchen Sink

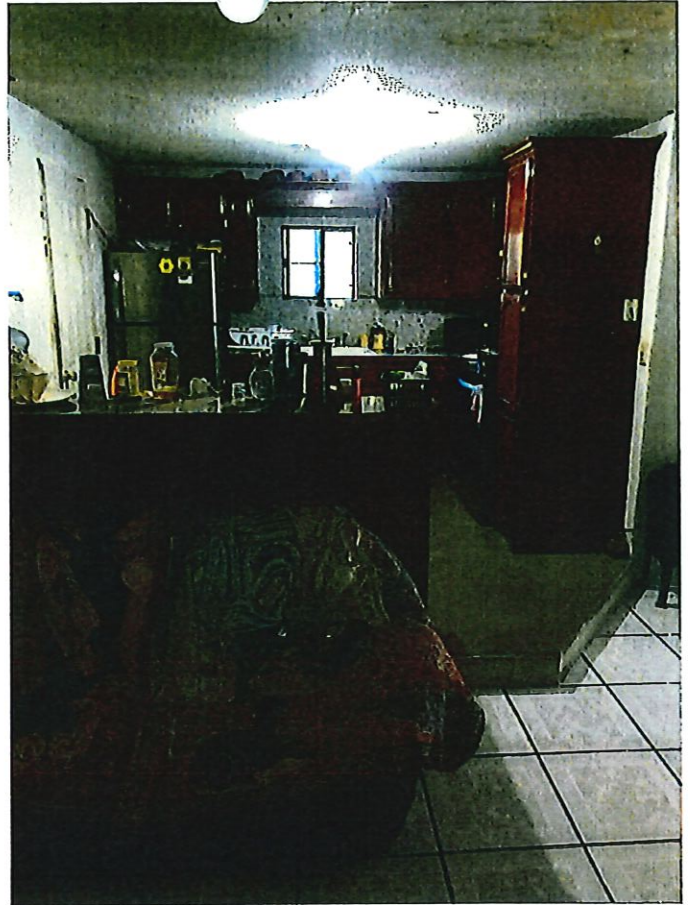
Stepupinto kitchen area. Safety Hazard, family is Elderly

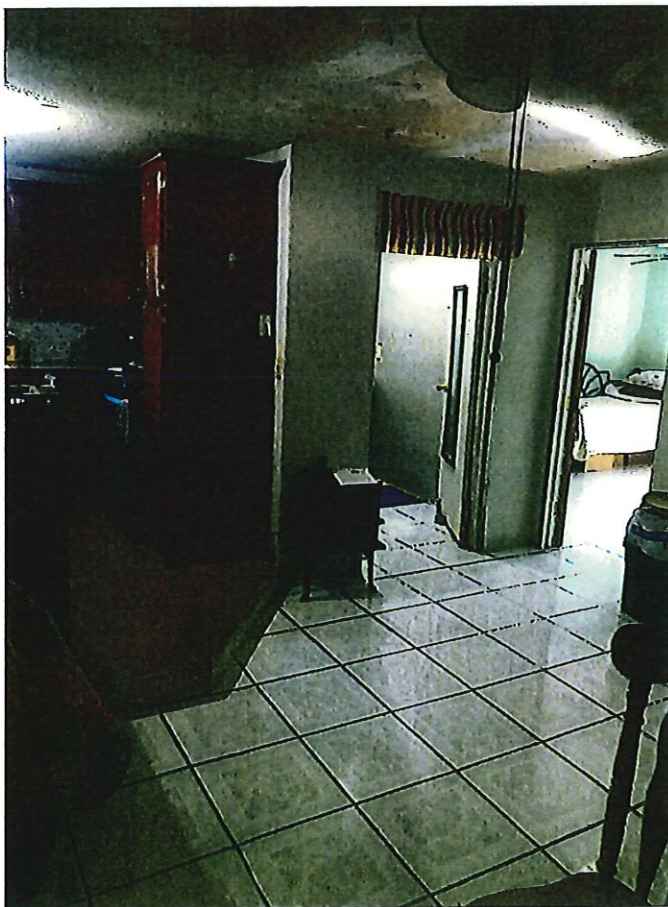
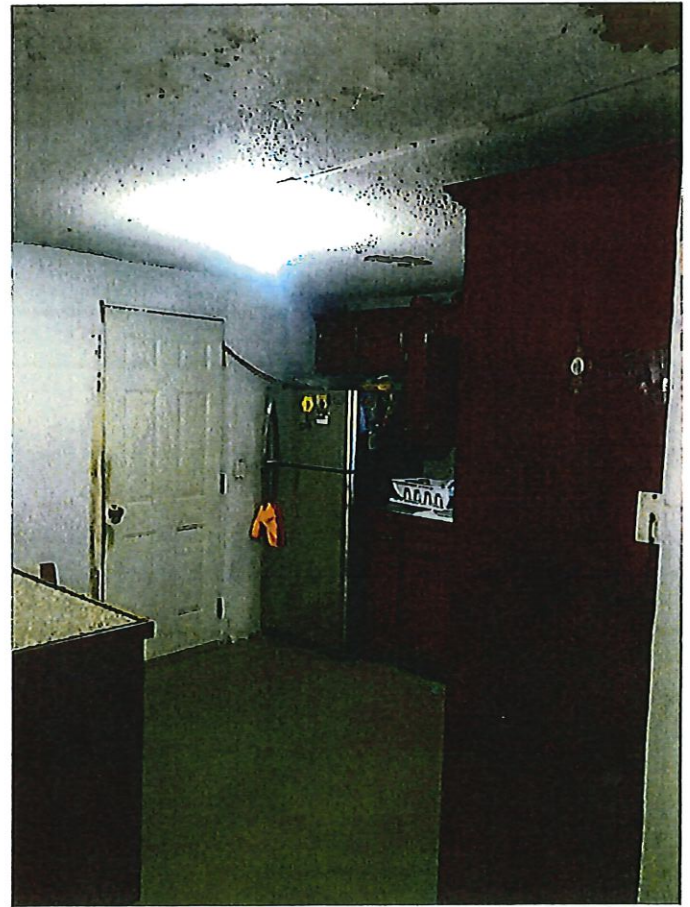
Exposed concrete in kitchen, texture falling from ceiling

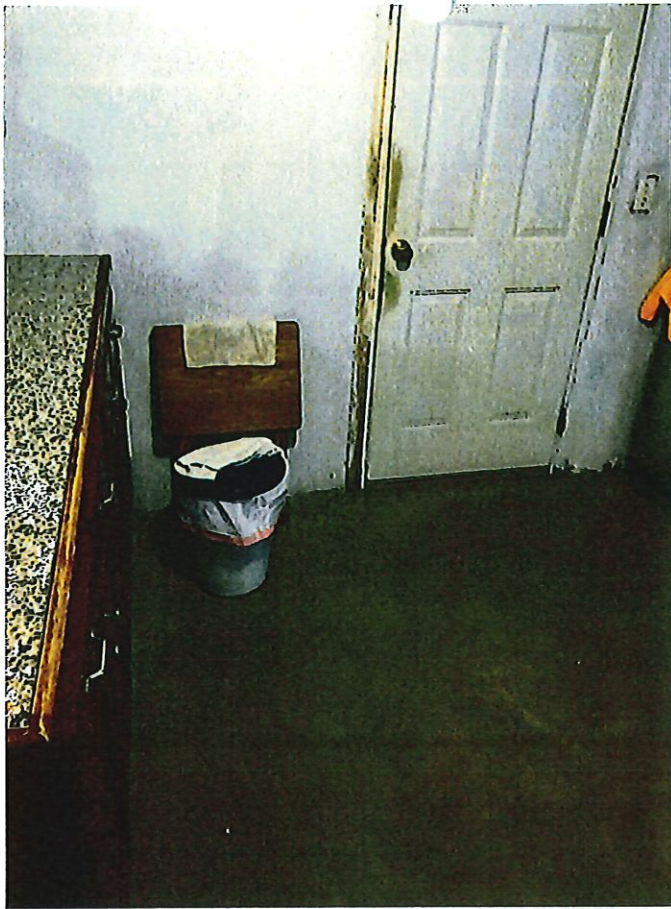
Floor covering material, condition:
Comment:	No floor covering, exposed concrete
	Subfloor material, condition:
Comment:	concrete slab
	Interior door(s) dimensions, hardware, condition:

*No floor covering in kitchen*

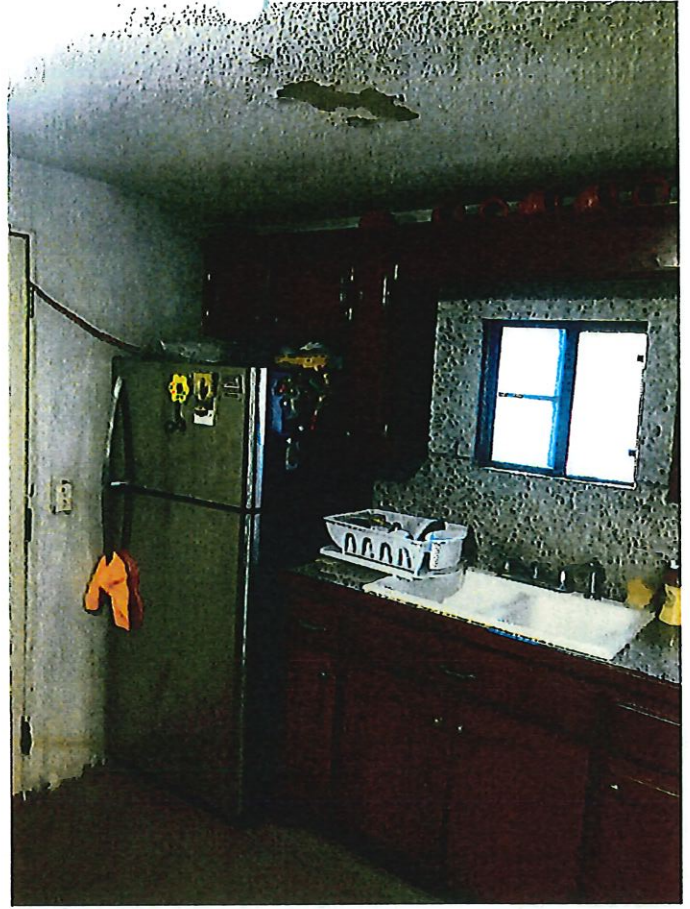
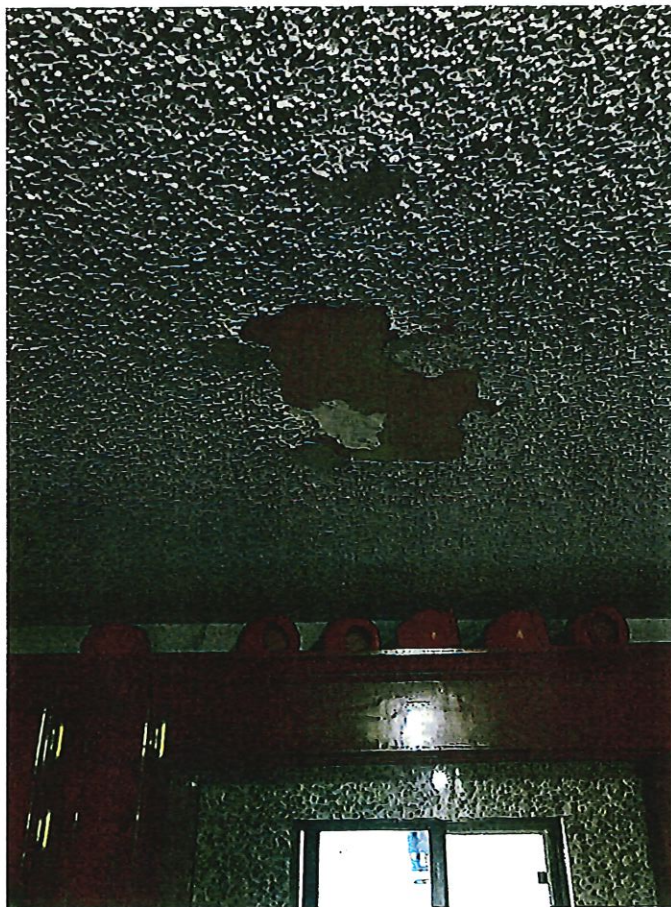
*Texture peeling from ceiling*

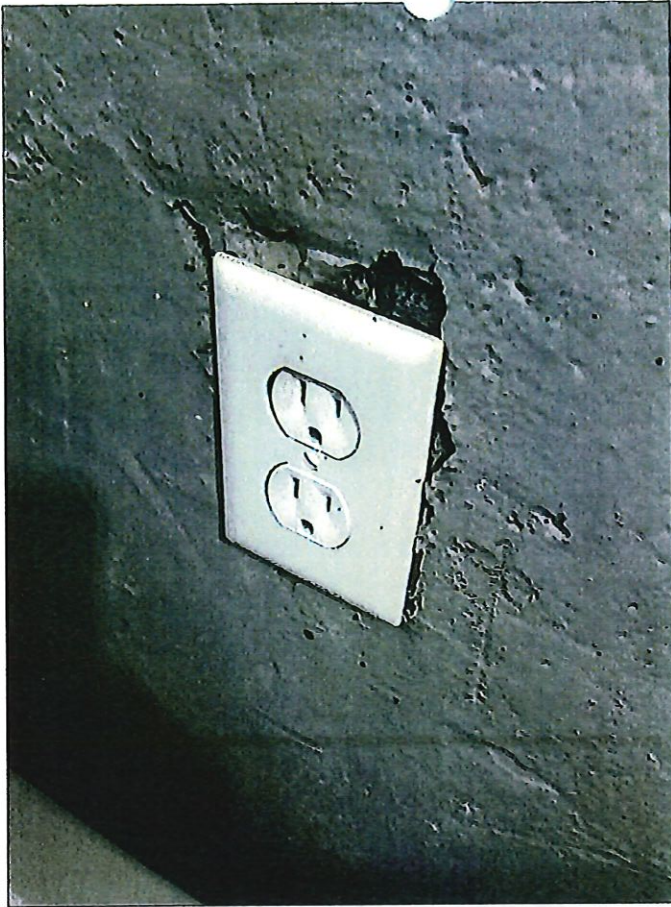
NO GFCI outlet next to sink

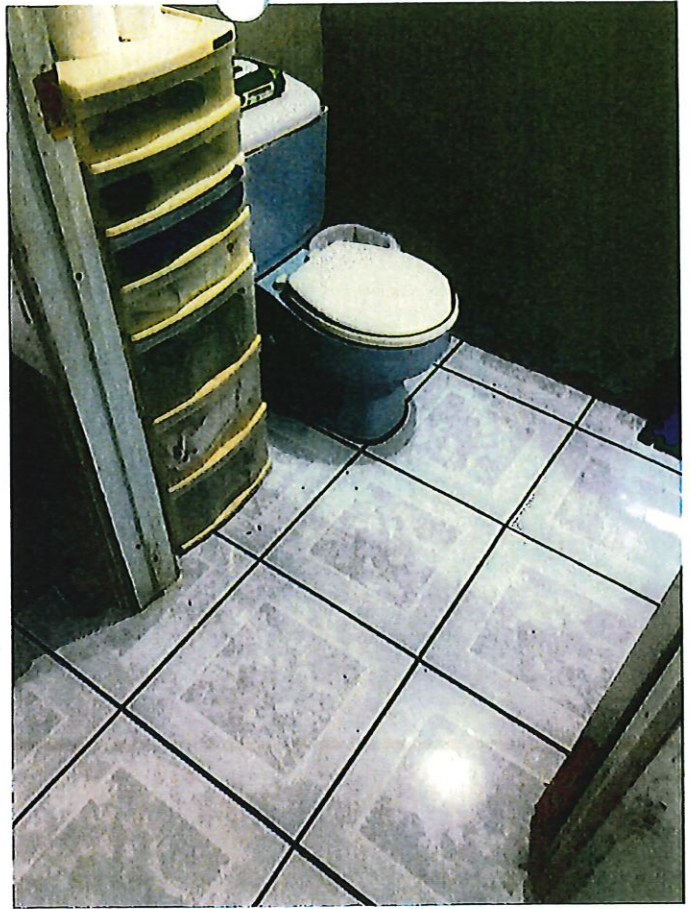
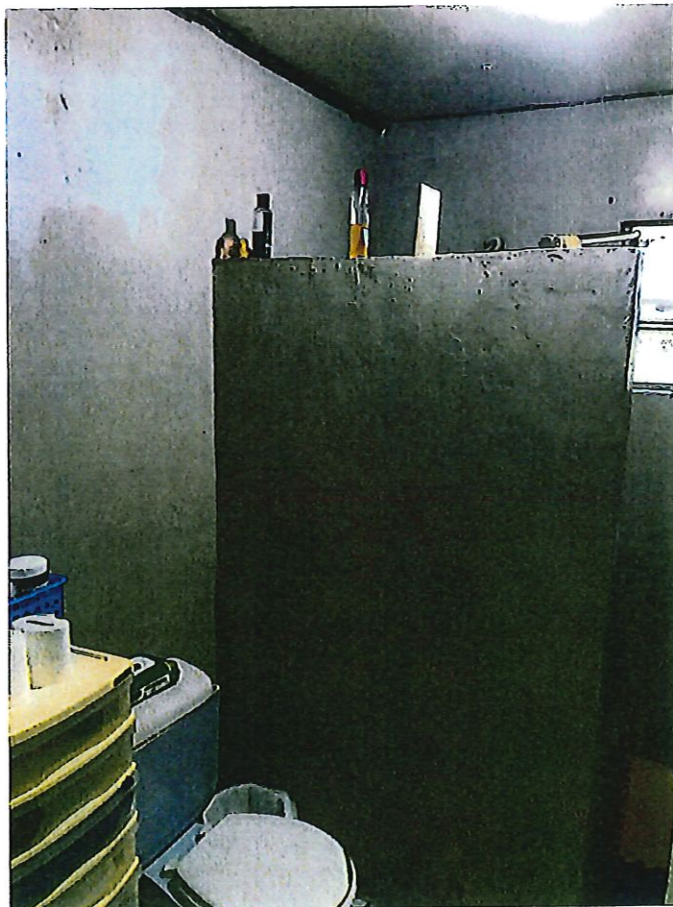
Shower wall no grab bars

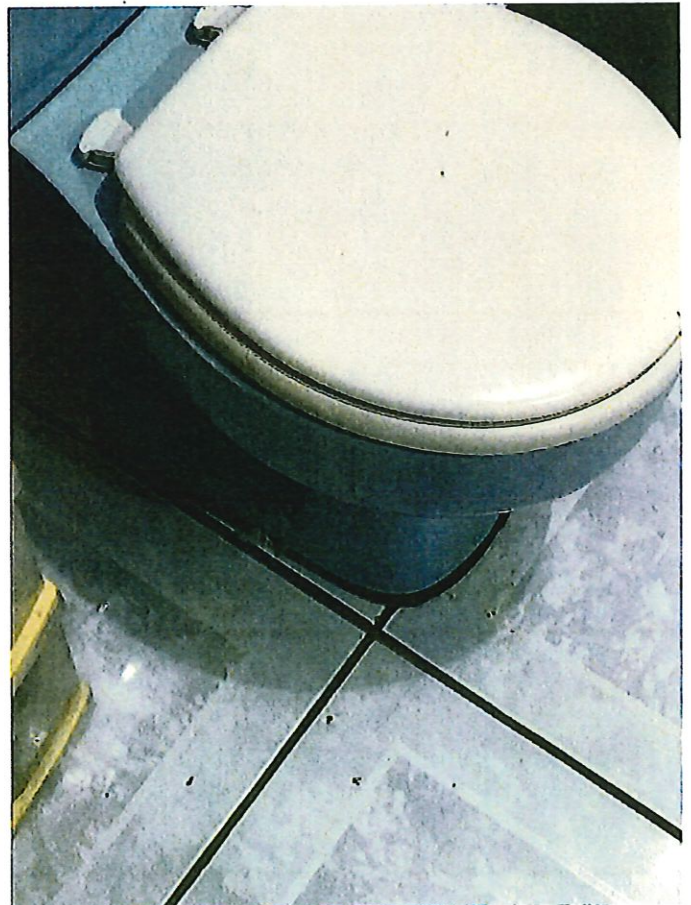
Comment:	Round toilet, poor condition needs to be replaced. Low water pressure
	Grab bars present, number, dimension, location, condition:
Comment:	No grab bars present

toilet looks and outdated  
then low water pressure

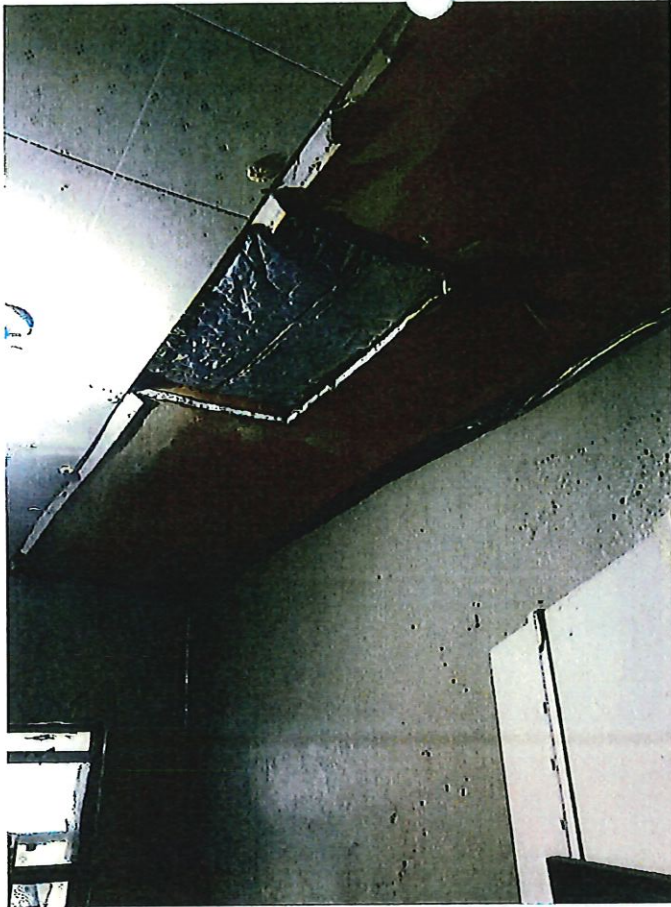
Water Damage in Restroom

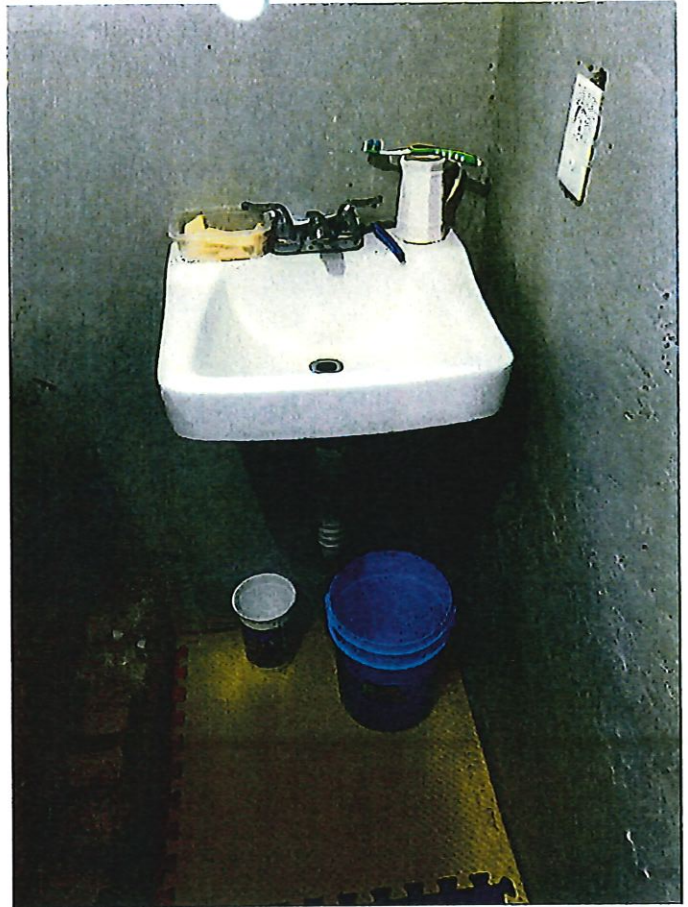
Sink leaks from p-trap

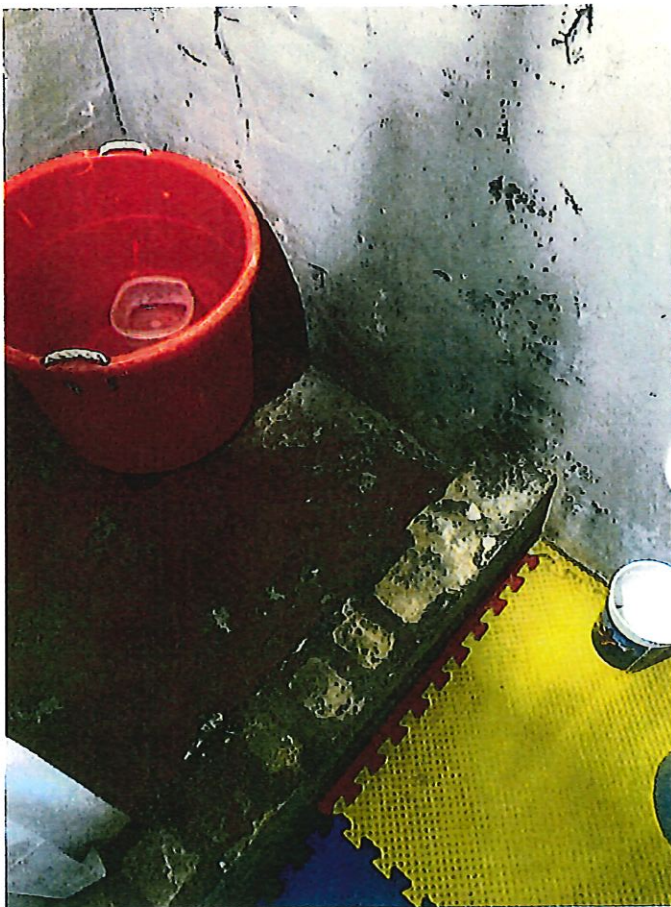
Shower Does not drain  
water in bucket

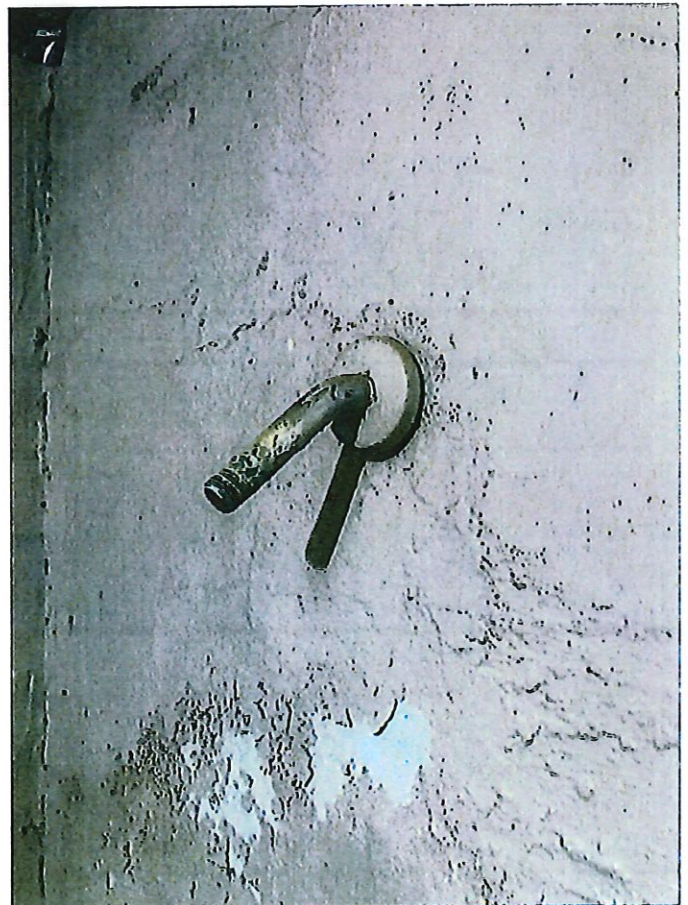
Comment:	Shower 3'x4', Very poor condition does not drain and shower head is missing. No floor covering
	Wall hung or pedestal lavatory or vanity sink, dimensions, faucet, condition:

No Shower head

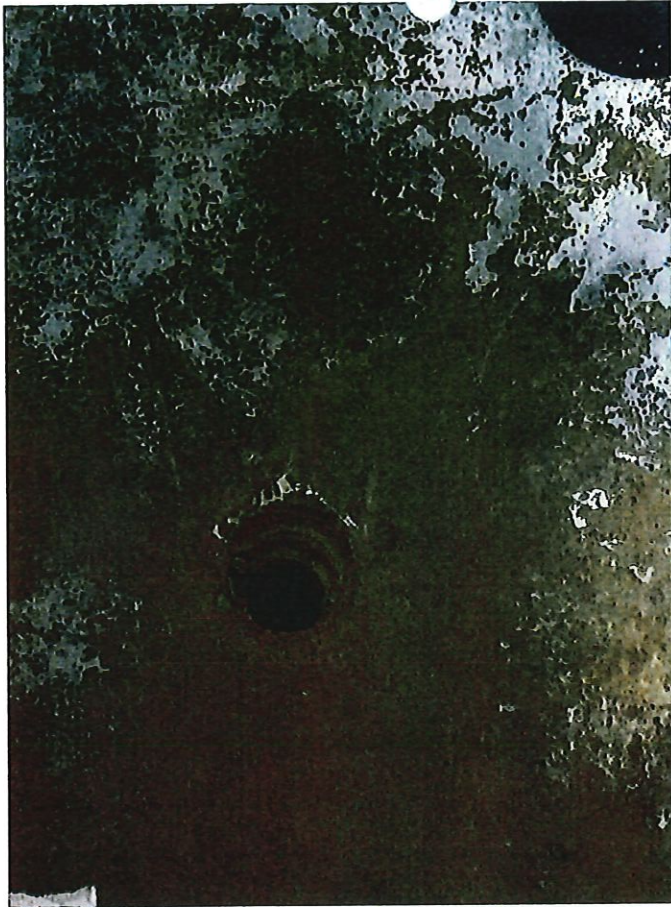
Shower Drain Does not work

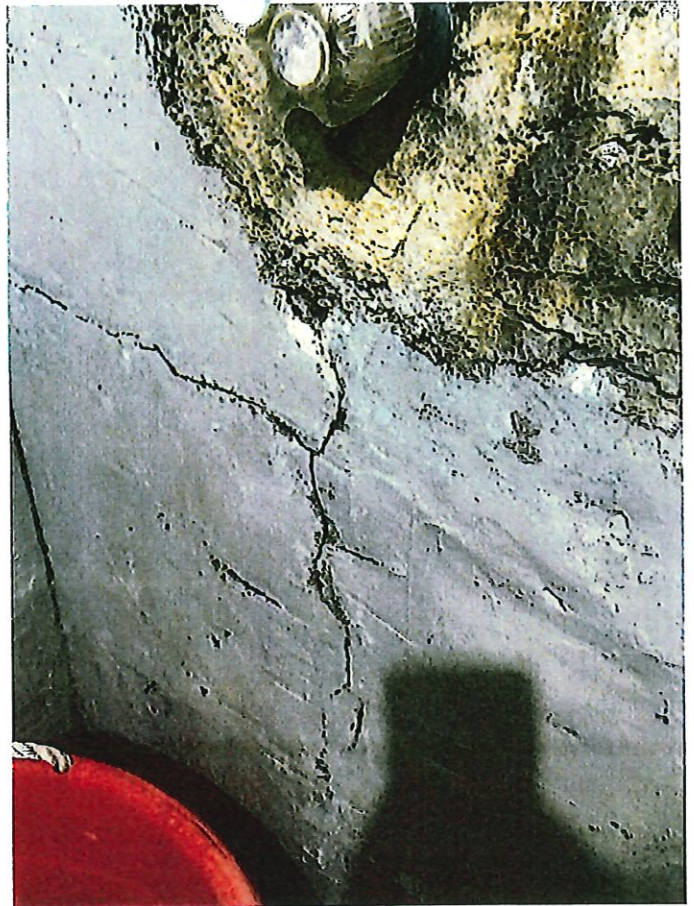
Shower wall has extensive crack (Exterior wall)

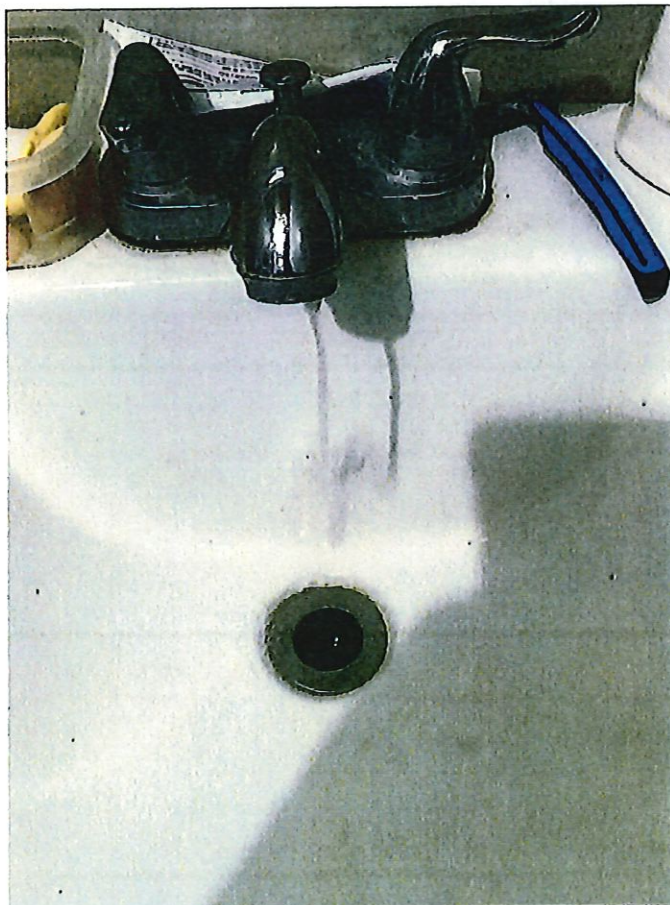
Very low water pressure

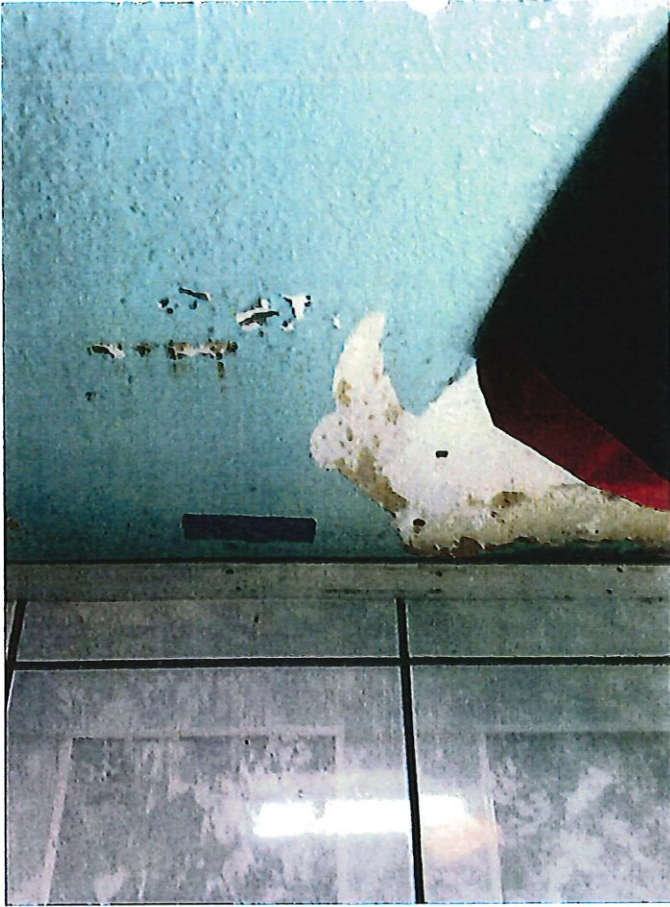
Comment:	Sheetrock, water stains present and in poor condition
	Wall material, paint? condition:
Comment:	Sheetrock, paint in poor condition holes and cracks present water damage due to recent flooding
	Floor covering material, condition:

Master Bedroom water Damage from recent flooding

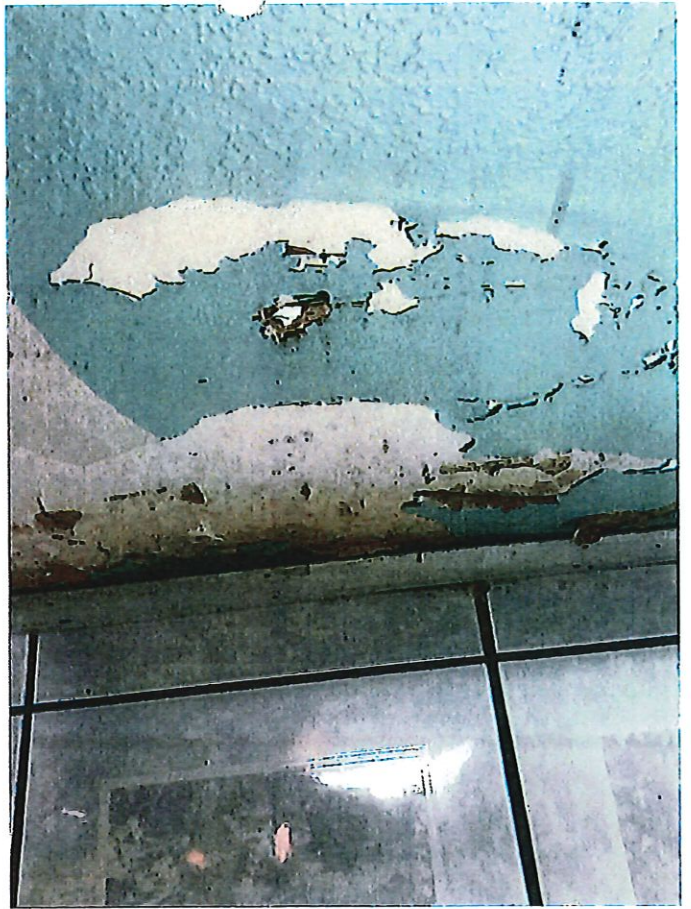
water Damage from recent flooding

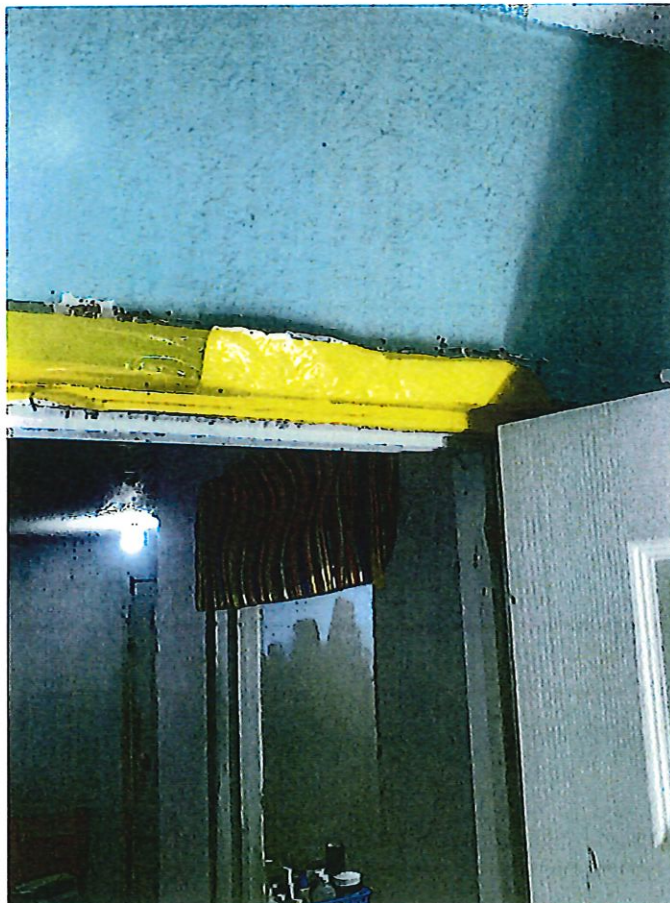
Damaged Drywall above Door Frame
