# Housing Rehab Program

**ENTITY:** Countywide Area  
**PROJECT:** Approval for Assistance under the Colonia Self-Help Program.  
**FUNDING YEAR:** HOME 2018

### Initial Inspection Checklist for Housing Rehabilitation (When compliance with TMCS is required)

Homeowner's Name:	J. Guadalupe Puga
Street Address:	708 Bertha Blvd.
City, County, Zip:	Mission, Hidalgo, 78573
Year built (per CAD):	1990
Lot size (OSSF only):	0.15
Local building code:	2015
Flood Zone designation:	480334-0400C, Zone C

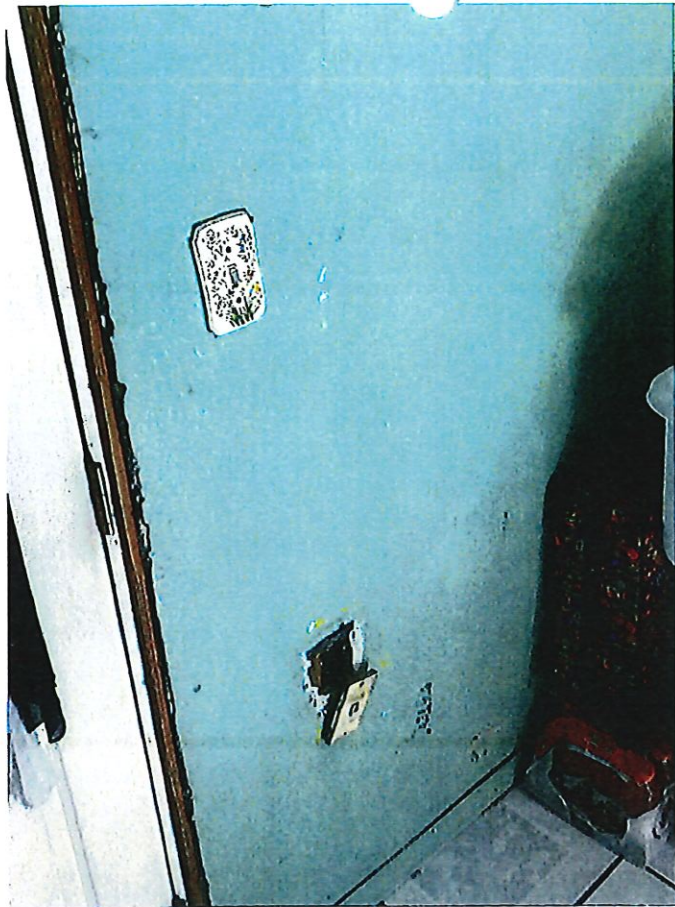
Sheet rock Damage

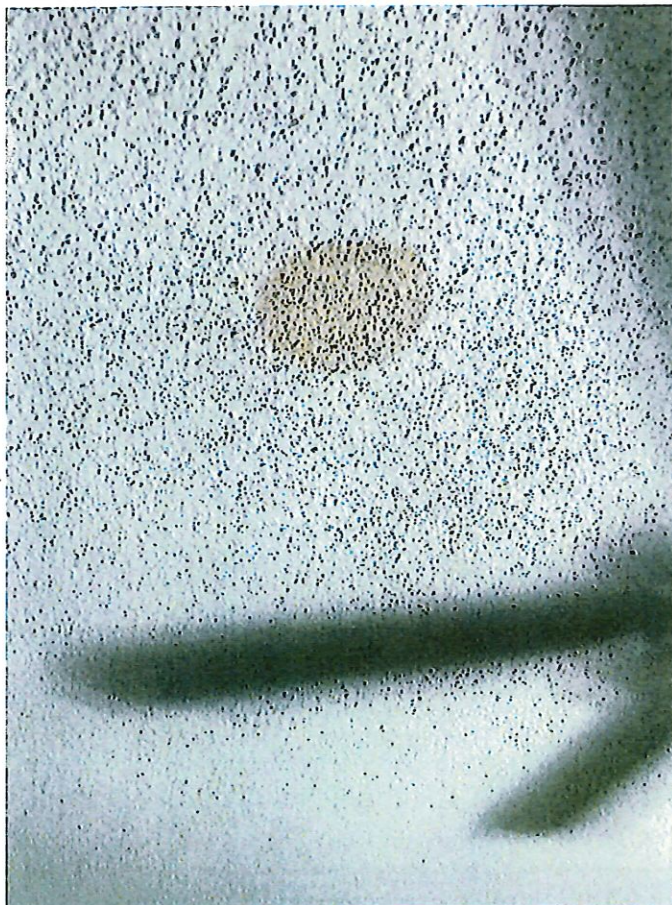
water staining on ceiling

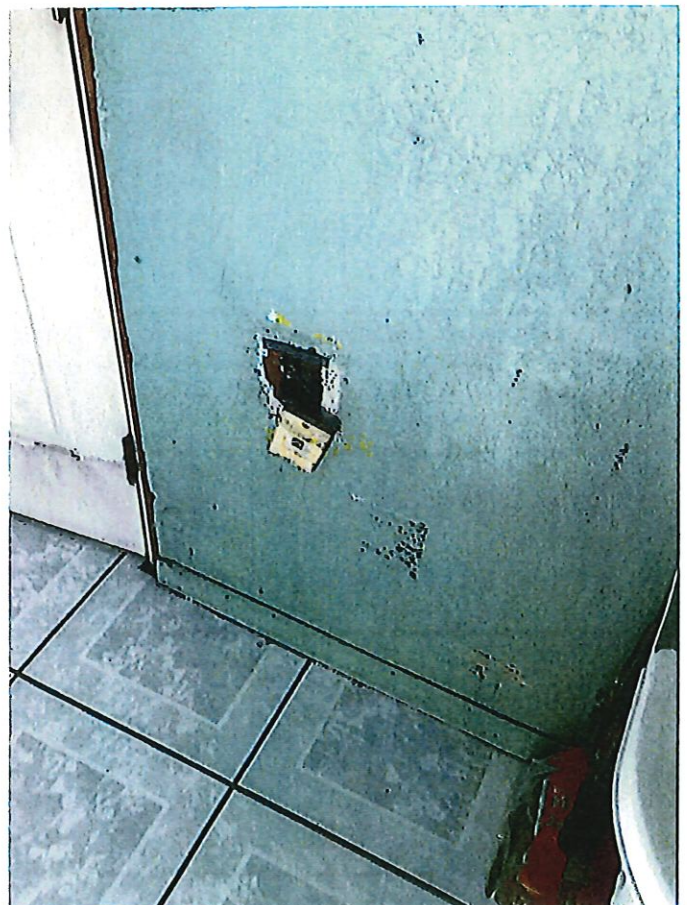
Sheet rock Damage, water Damage to lower 1 foot of Door

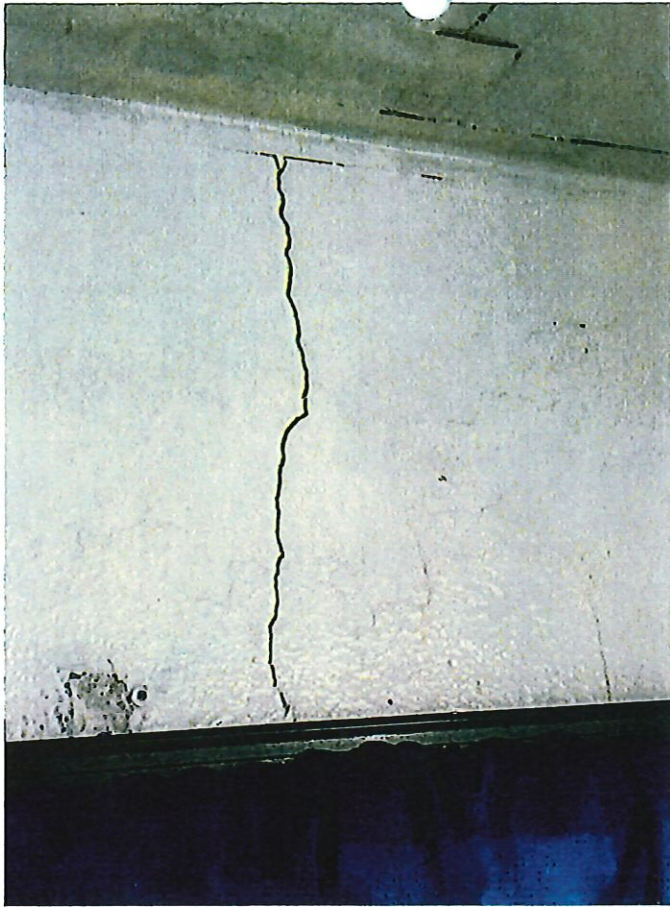
Comment:	Hose bibs present no backflow preventors. Wall penetration poorly sealed
	Exterior walls – type and condition:
Comment:	CMU walls with plaster finish, Walls in fair condition some cracks due to foundation movement
	Windows – type, screens present, condition of exterior trim:

Crack above window in exterior  
CMU wall

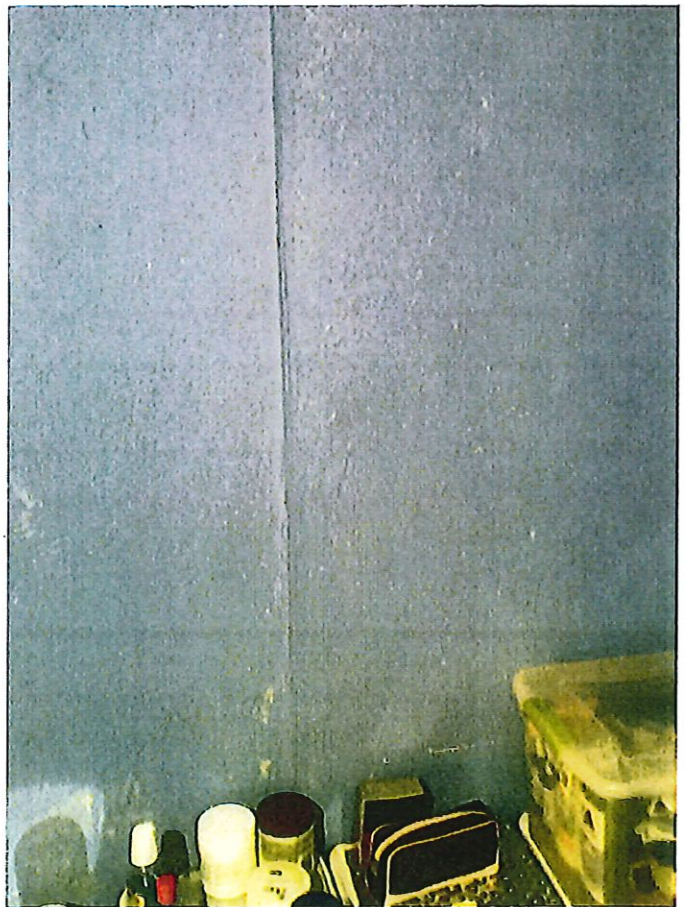
Crack in wall Second bedroom

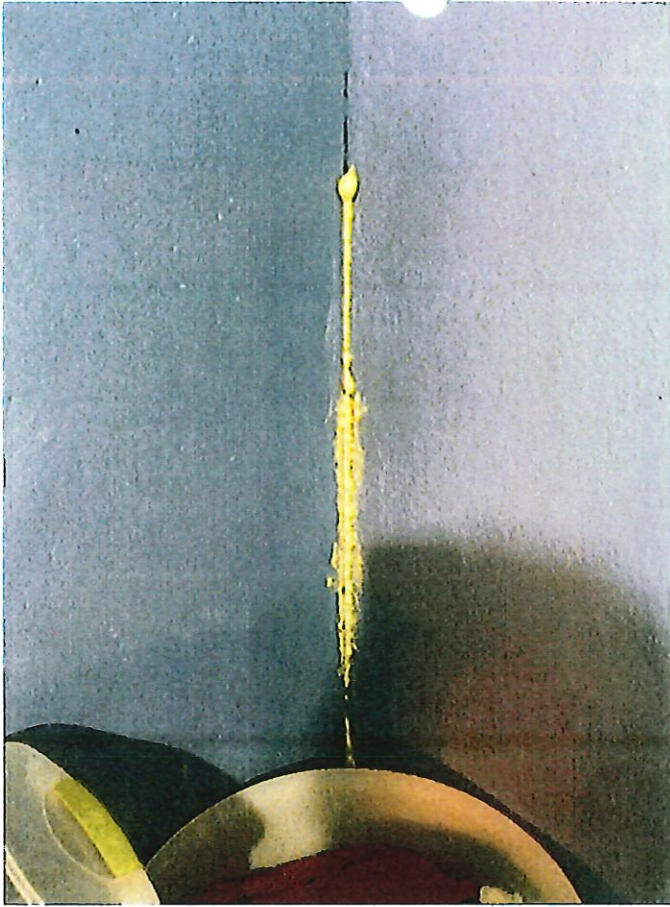
Crack in wall (corner)

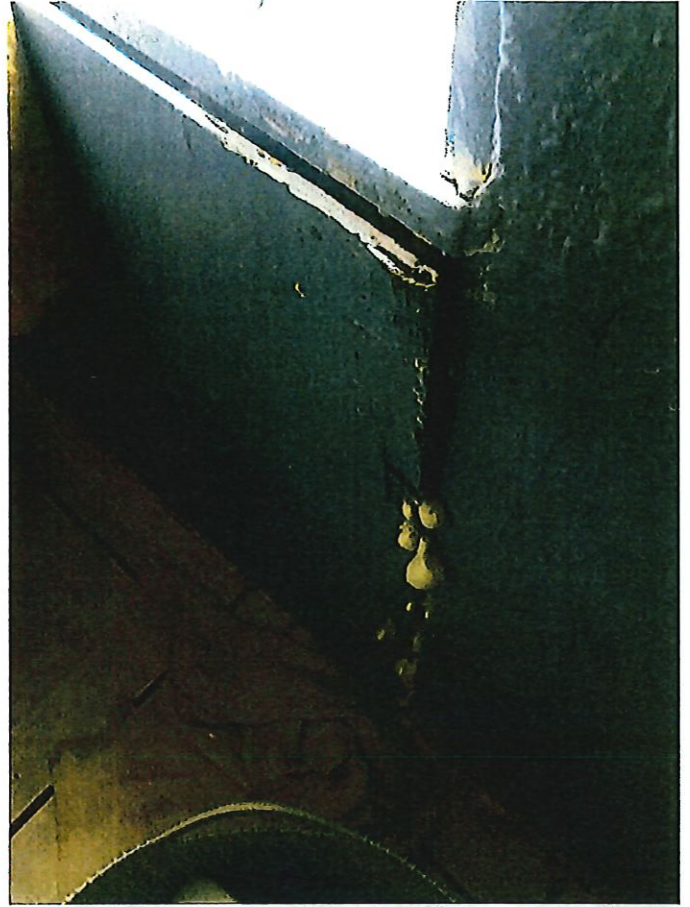
Crack in wall below window

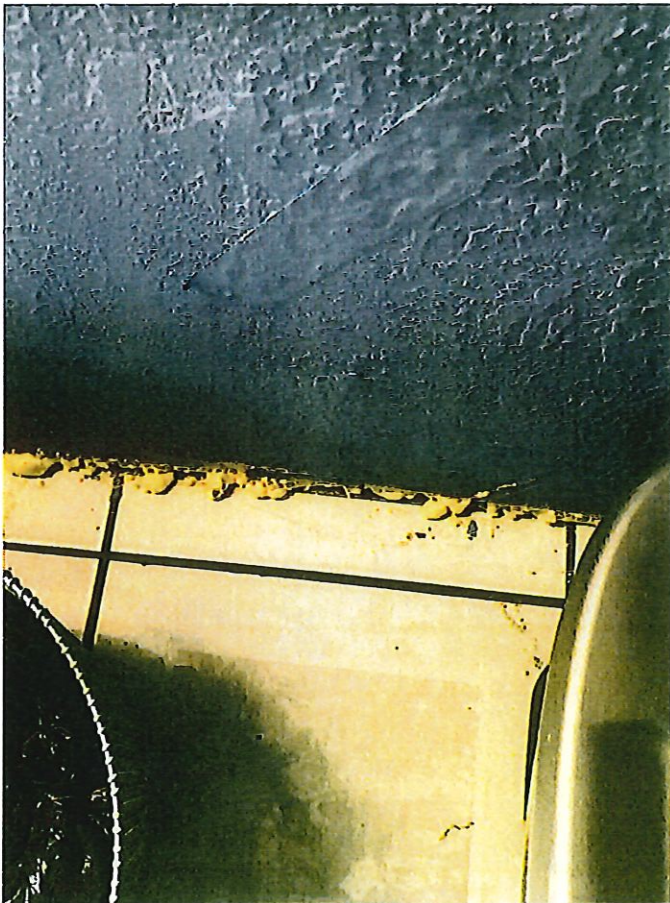
Comment:	slab on grade, foundation is in poor shape. Has cracks and uneven floor surfaces
	If pier and beam foundation, are termite shields present and adequate:

floor and wall separation  
Due to foundation movement

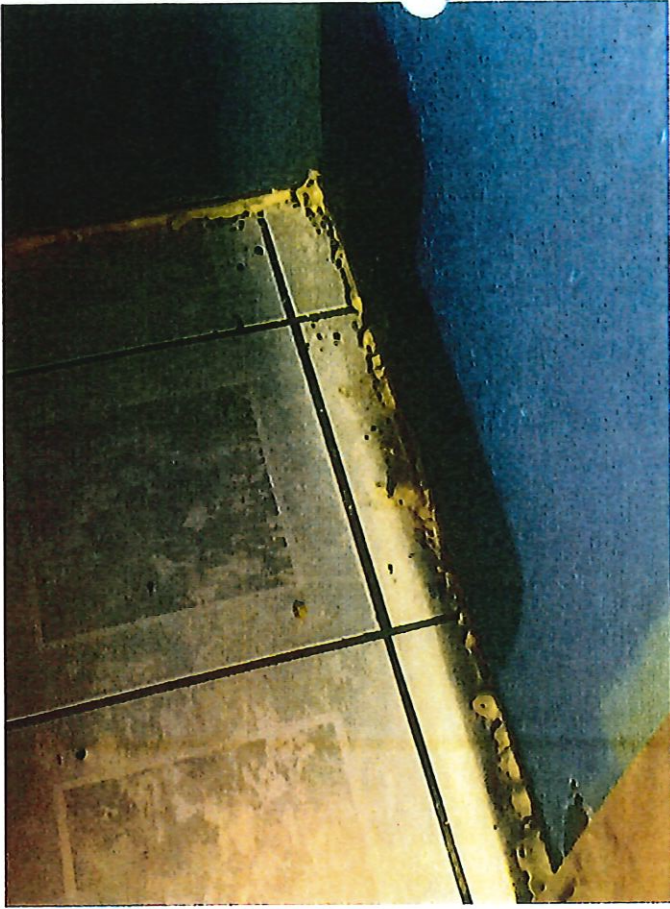
Separation of Floor and wall

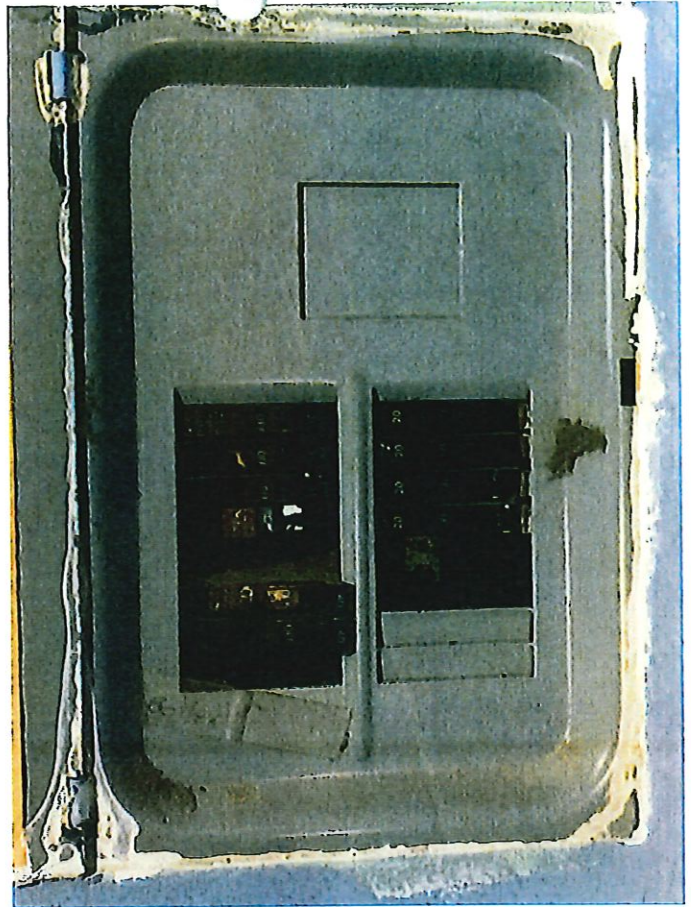
Comment:	No
	Is the entrance panel a Federal Pacific or Zinsco brand? If so, it should be replaced.
Comment:	Needs to be replaced
	Are there unused openings in the panel face or open knockouts around the sides, top and bottom of the panel box?

panel box, outdated

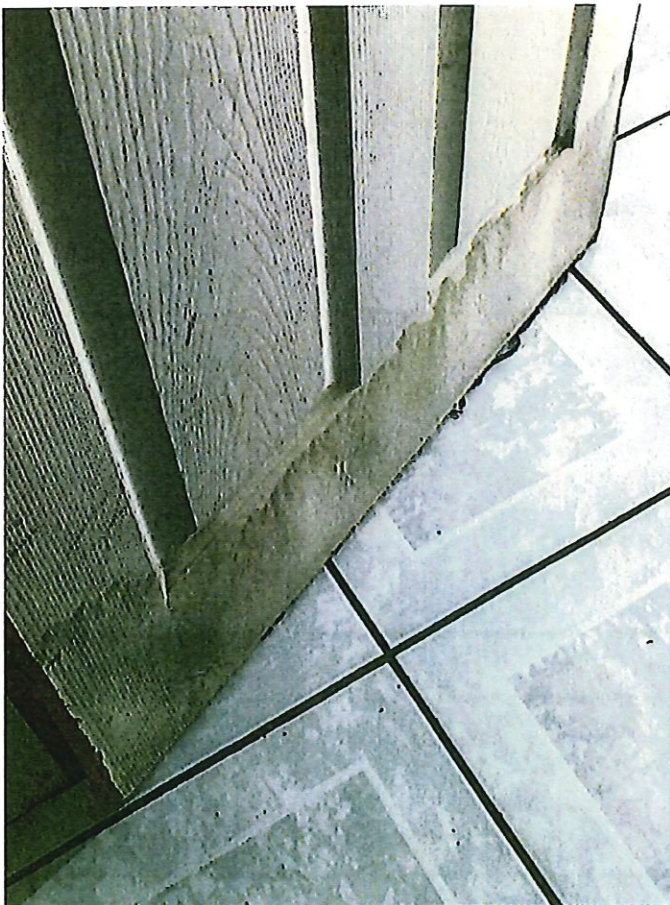
Water damage to door of Bedroom.

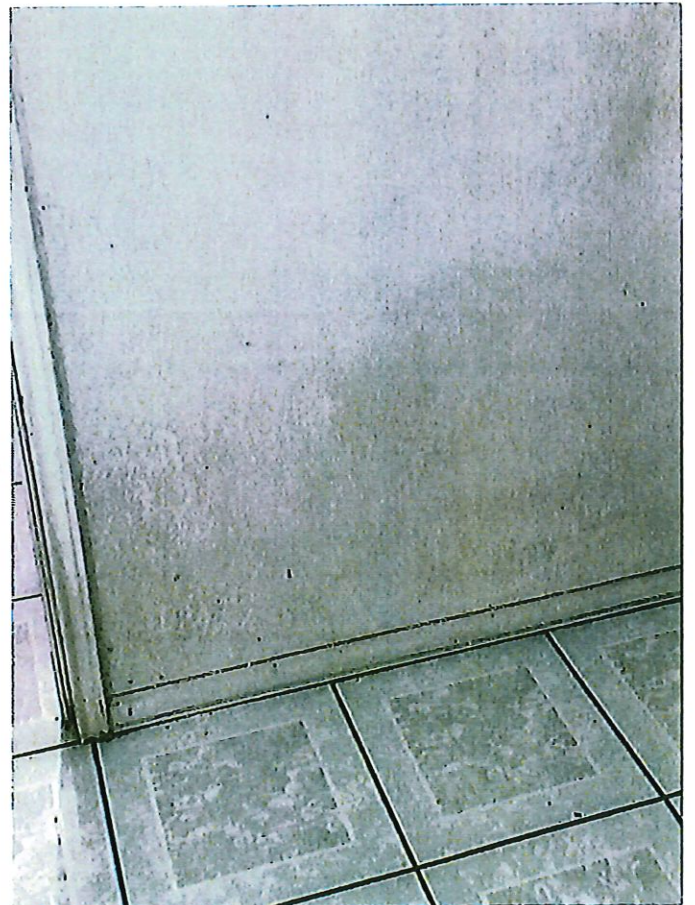
water damage to wall
