TRUCK APPRAISER'S REPORT

Exhibit B

Pct. 3 Property Loss: 19-12-03-1838

Location: Pct. 3 Motor Pool

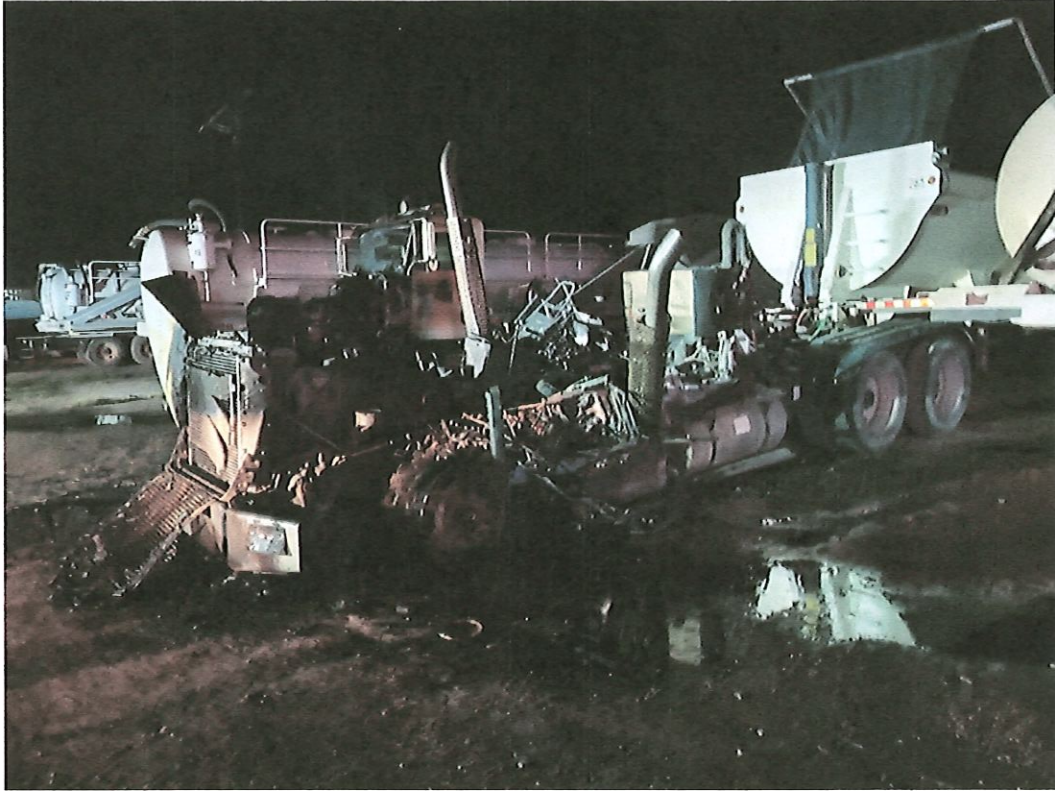
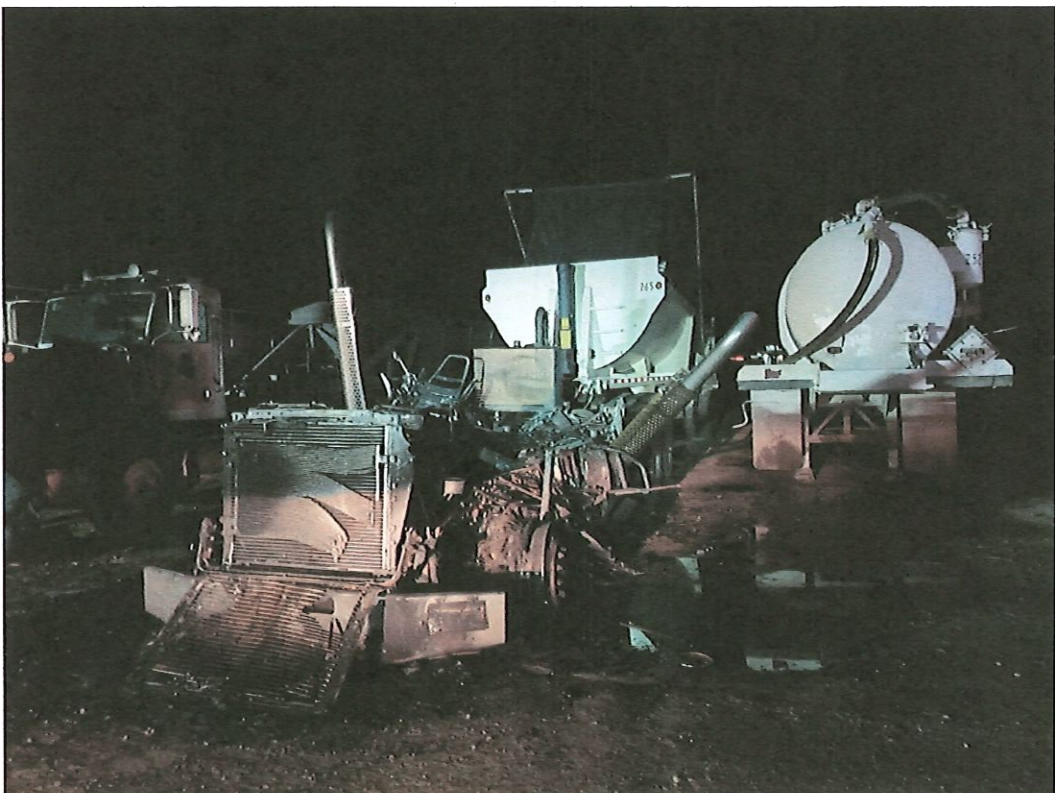
Unit# 249 2012 Kenworth VIN: 1XDPPX6CJ329089

Est. Salvage: \$0.00		Recommendations: The damages to the unit are to the front bumper, front crossmember, grille, hood, headlamps, fender extensions, cooling pack, suspension, steering assembly, front suspension, engine, transmission, wire harness, air cleaner, cab, glass, cab complete interior, frame rails, tool box, battery tray, fairings, and fuel tanks. This unit is an obvious total loss.	
General Condition: Good.		Prior Damage: None.	
Betterment: No Betterment Applied.		Alternative Parts: French Ellison-Alex, raneystruckparts.com, truckpartsinventory.com, mylittlesalesman.com	
Temporary Repairs: None		Appraiser: JOEL MARTINEZ	
Date: 2/19/2019

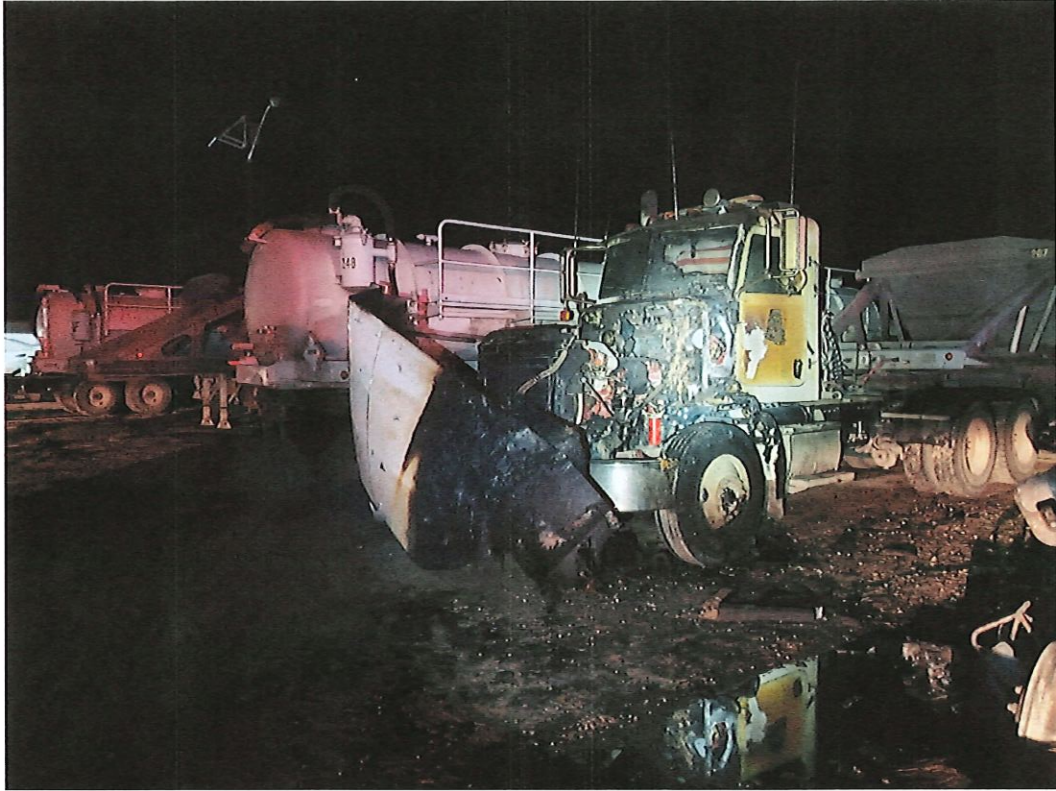
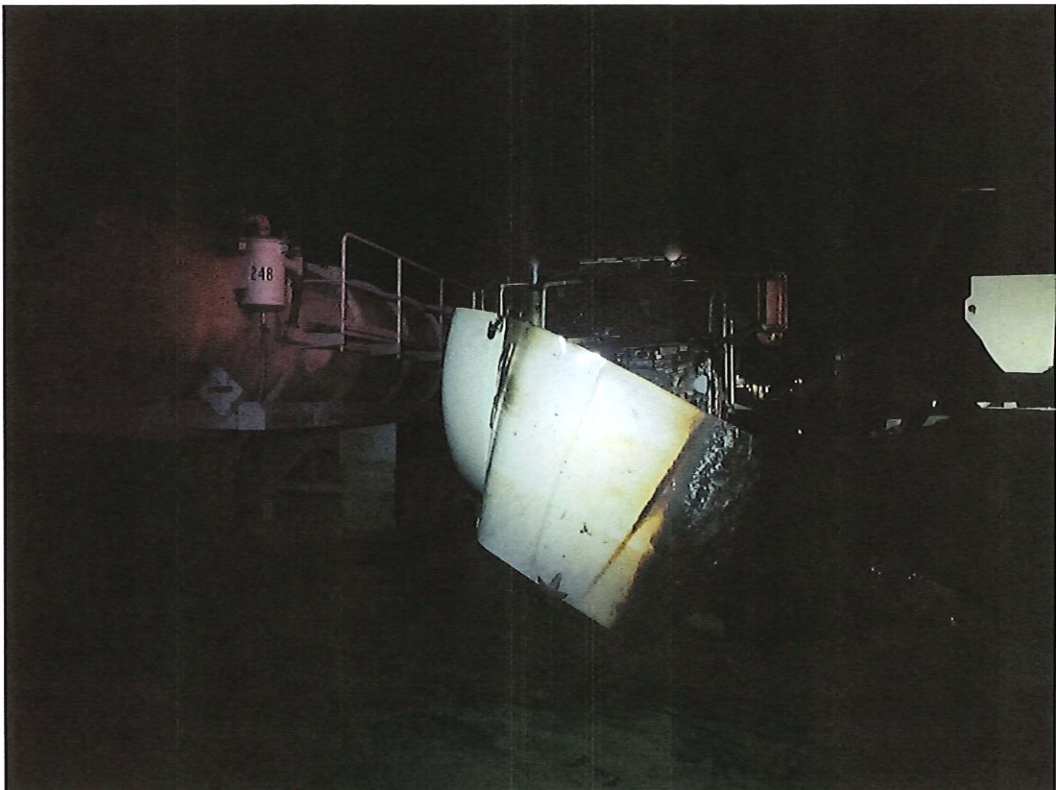
Unit# 202 Peterbilt VIN: 1XPVD09X6AD797681

Repair Facility: Total Loss		Repair Facility Contact: None	
Phone Number: None		Agreed Cost To Repair: \$47,767.58	
Repair Days: 18		Est. ACV: \$23,700	
Est. Salvage: 1,500.00		Recommendations: The damages to the vehicle are to the front bumper, grille, hood, headlamps, steering gear, cooling assembly, engine, wire harness, left fender extension, left front wheel, left front tire, battery box, cab assembly, windshield, left front door, instrument panel, and interior trim. I've made a correction on the estimate I removed the sales tax. This vehicle is an obvious total loss.	
General Condition: Good.		Prior Damage: None.	
Betterment: No Betterment Applied.		Alternative Parts: raneystruckparts.com, vanderhaags.com, truckpartsinventory.com, mylittlesalesman.com	
Temporary Repairs: None		Appraiser: JOEL MARTINEZ	
Date: 2/20/2019
