## Disaster Recovery Program

**PROJECT:** Approval for Assistance under the Disaster Recovery Program Housing Project.

# INITIAL INSPECTION

Address: 5511 Beaumont Ave. Edinburg Tx.

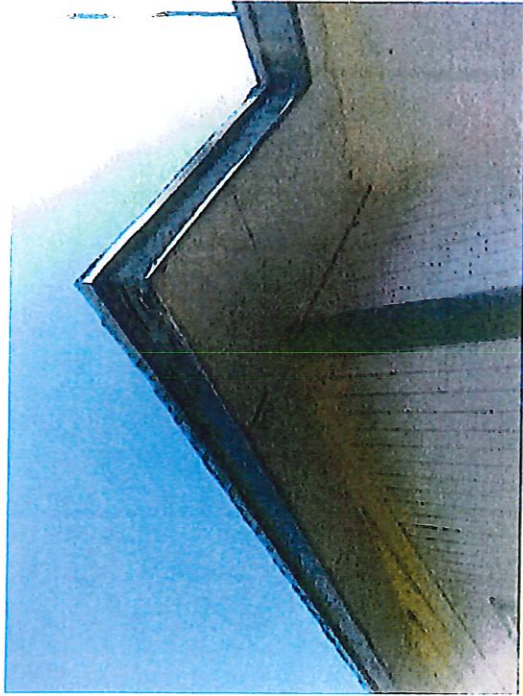
There soffit present is rotten and has many holes. The trim needs to be replaced due to deterioration.

Soffit and Fascia

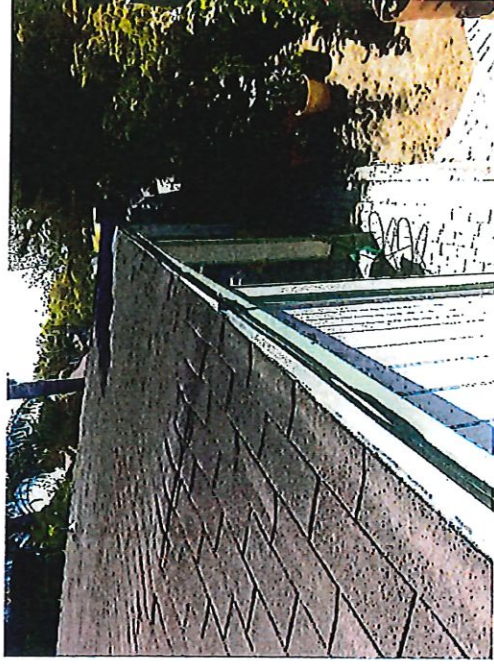
The roofing shingles and paper felt need to be replaced. The plywood decking needs to be inspected for deterioration due to water stains in the house.

Deteriorated shingles and sagging roof decking

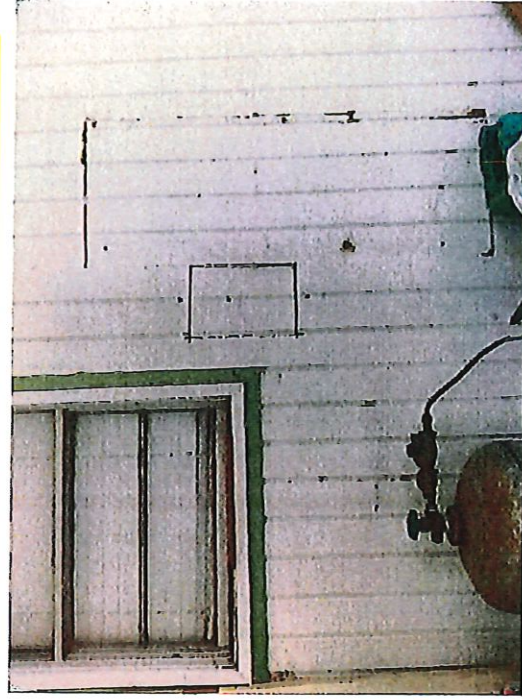
The exterior wall siding is in bad shape. There are many areas where the wood siding has deteriorated due to moisture or termites. Wood siding needs to be replaced and sealed to prevent future deterioration. A few walls have no siding at all.

Siding deficiencies & propane tank needs to be relocated

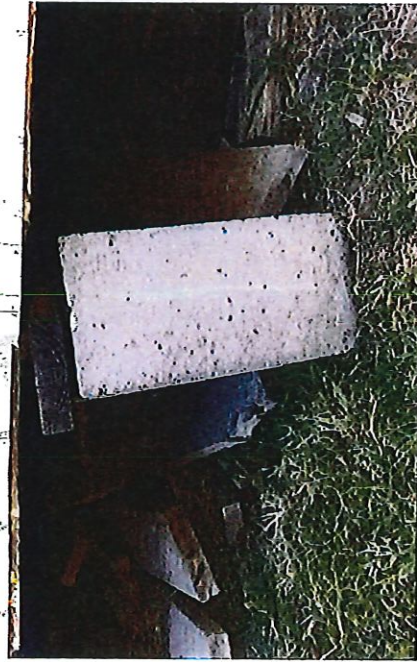
The wood Joists are uneven and in some places broken from dry rot making the floor a tripping hazard. The floor joists need to be leveled and inspected for deterioration due to moisture and termites. Piers are uneven and in some cases not even touching the floor joist.

Pier and beams un even and leaning

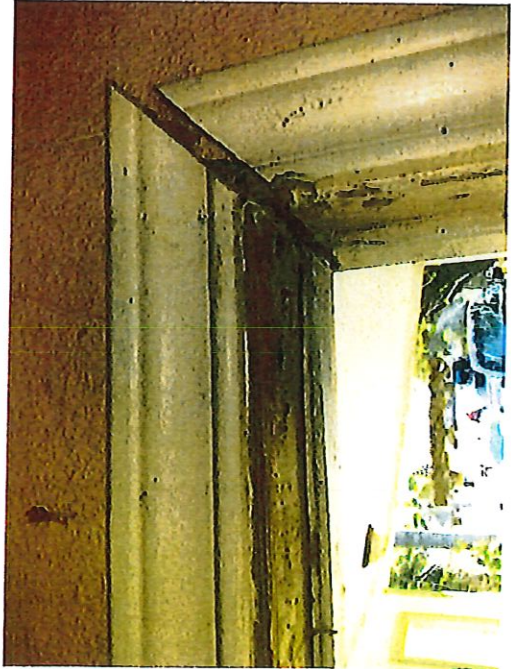
The front exterior doors need to be replaced. The door frame is damaged and cracked due to the shifting of the house.

Entry Door Jam broken due floor shifting

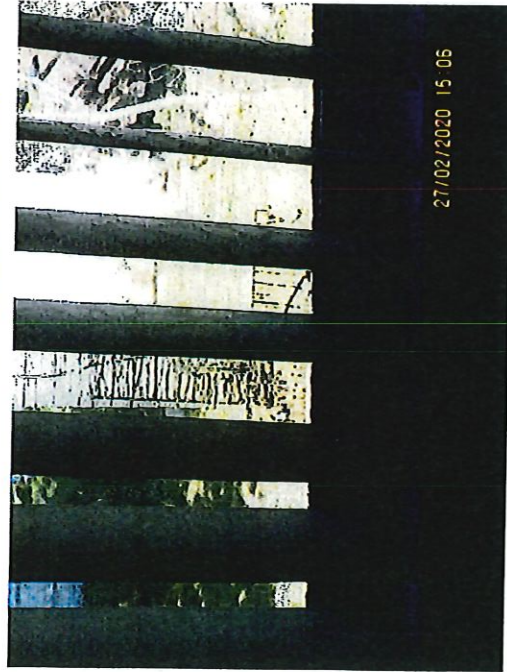
The windows are not in good working order and need to be replaced. Windows are aluminum and many are cracked and do not open. There are 9 windows on the home.

Broken windows

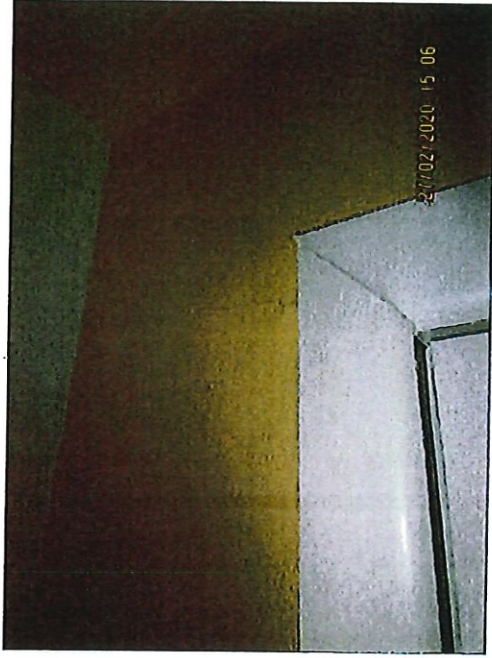
The wall coverings and trim are in need of repair. There are holes in walls and cracks due to foundation movement. Door frames and trims are broken and do not close properly.

Cracks on walls

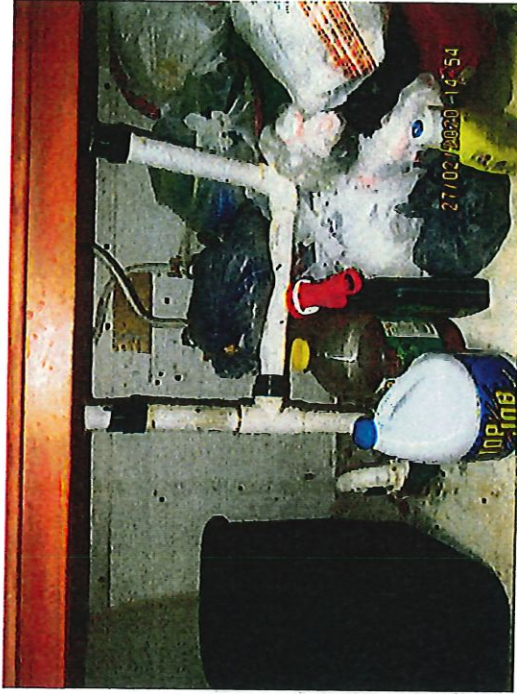
Is plumbing free from major leaks or corrosion that causes serious and persistent levels of rust or contamination of the drinking water? No there are several leaks under the sinks no proper plumbing fittings present electrical tape was used to help prevent leaks and plastic bags placed in drains to help prevent sewage gas from entering the home.

under sink inadequate plumbing joints

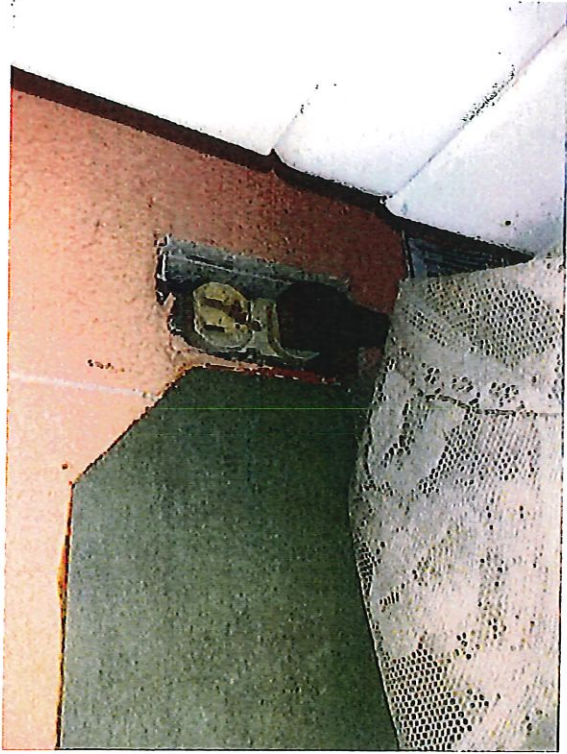
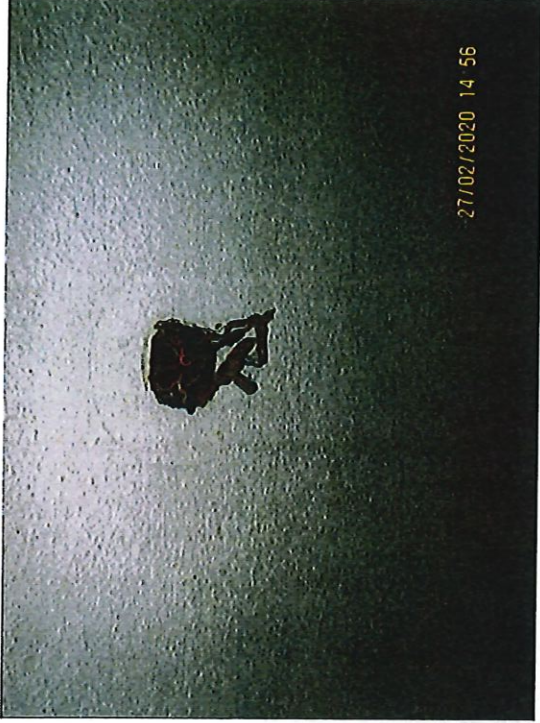
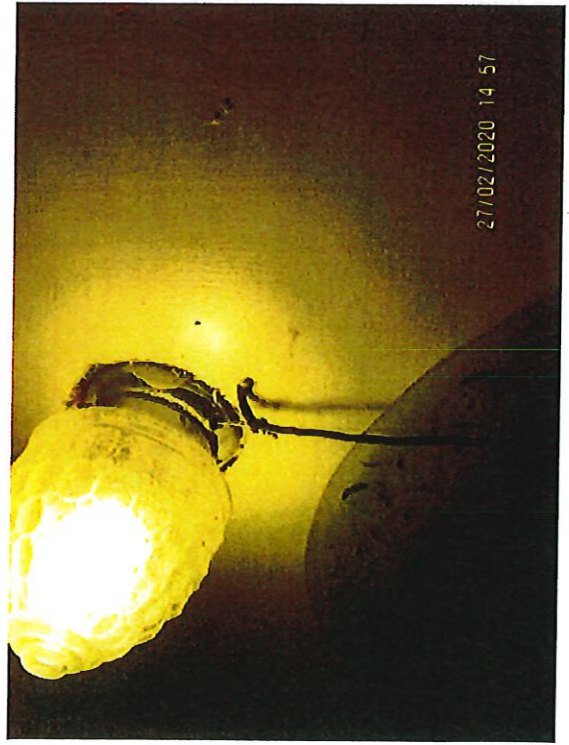
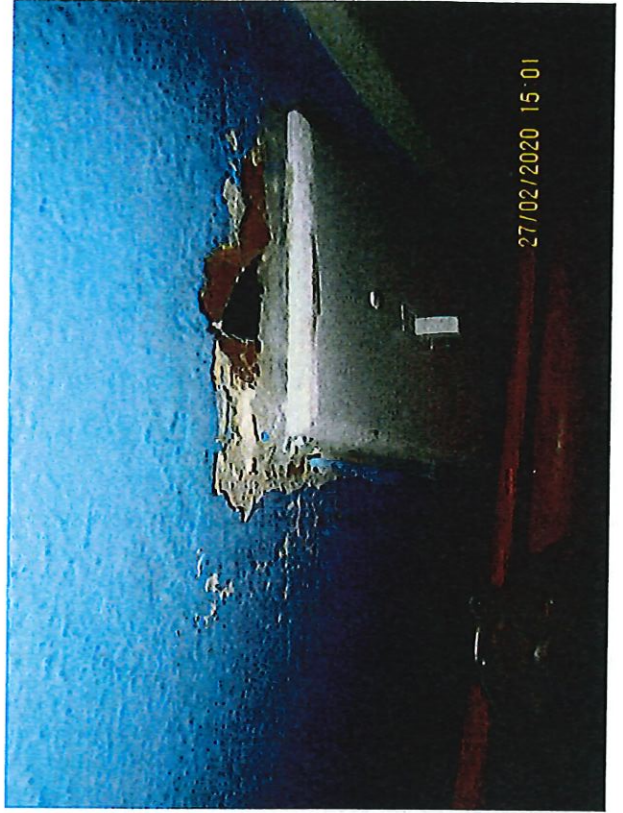
There were several plugs throughout the house that were not working. Several light fixtures in the house were also not working. Electrical needs to be inspected for electrical shorts. Many switches, light fixtures and electrical outlet covers were missing leaving wires exposed.

Electrical Deficiencies

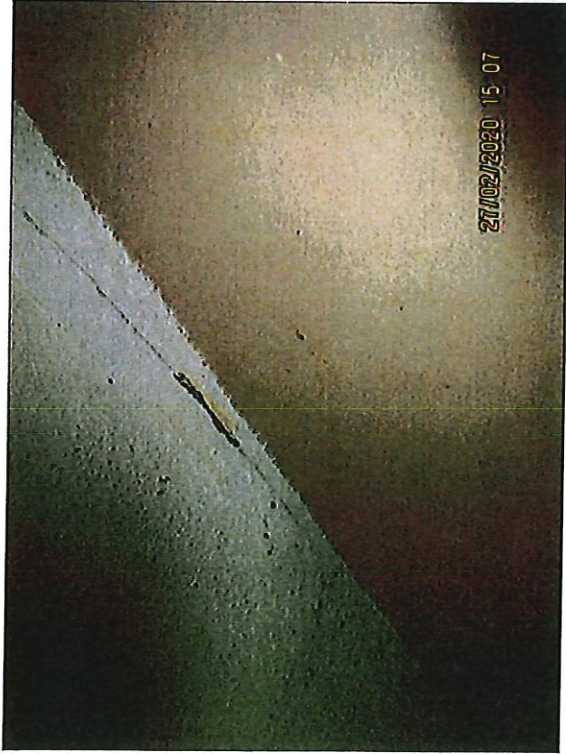
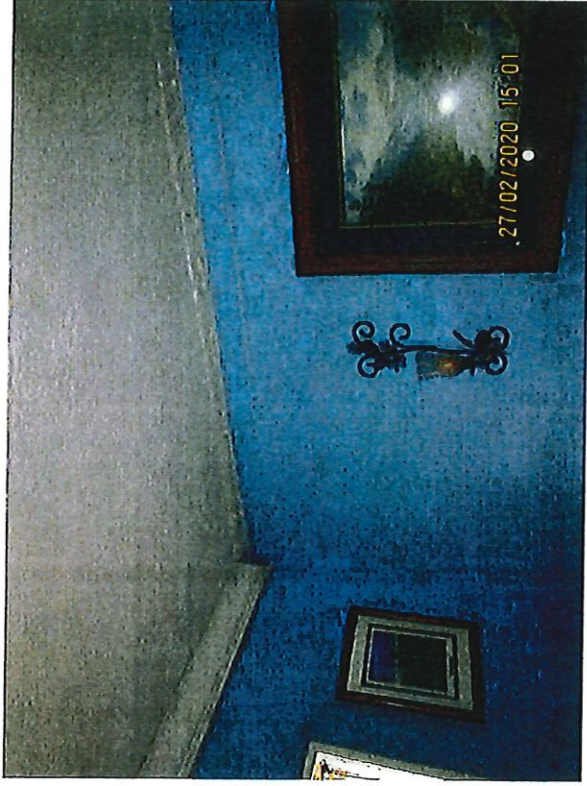
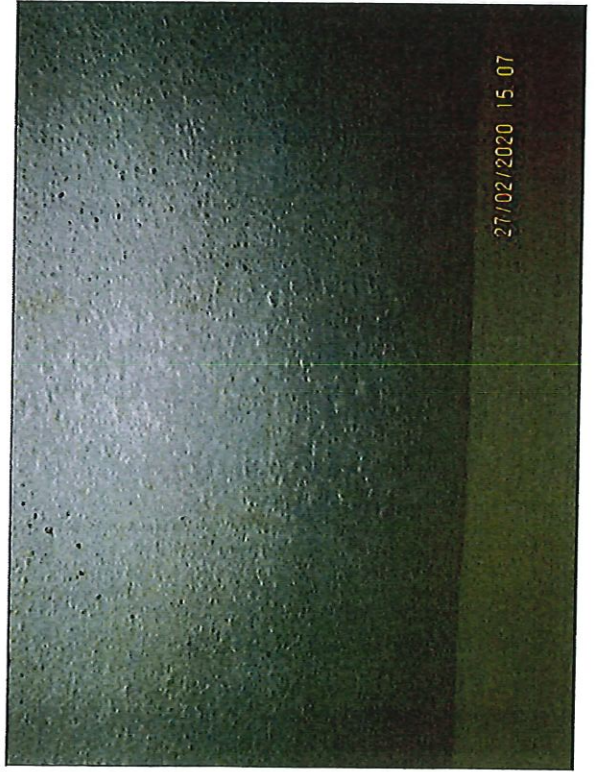
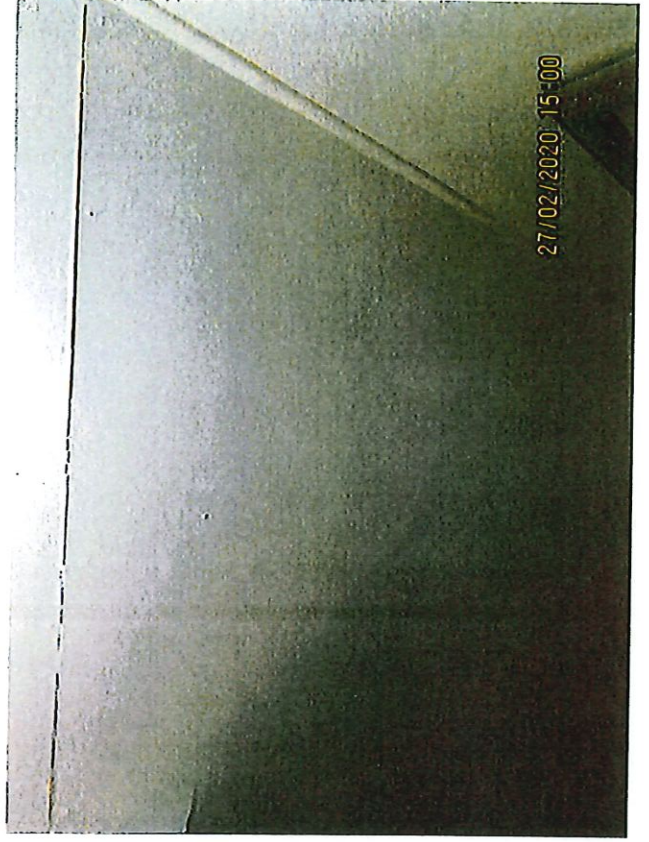
The ceiling coverings have small cracks around the perimeter walls due to foundation movement. There are several areas where water damage has stained the ceiling..

Ceiling Deficiencies
