Disaster Recovery Program

PROJECT: Approval for Assistance under the Disaster Recovery Program Housing Project.

INITIAL INSPECTION

Address: 4602 Alanzo Ave. Edinburg Tx.

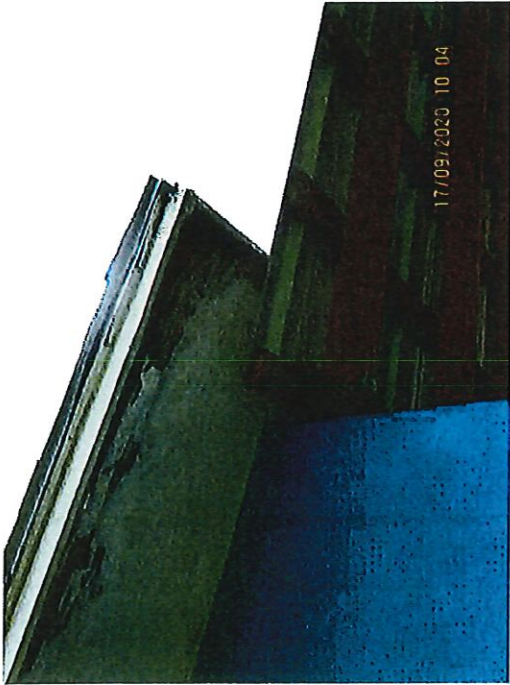
There soffit present is rotten . The trim needs to be replaced due to deterioration.

Soffit and Fascia

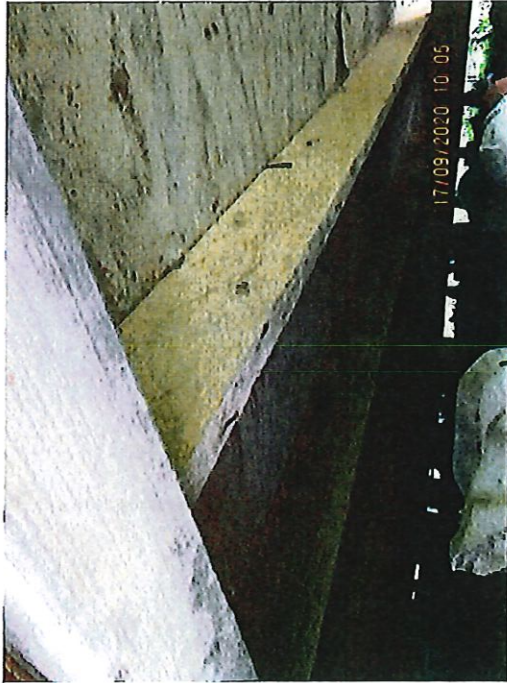
The wood Joists are uneven and in some places broken from dry rot making the floor a tripping hazard. The floor joists need to be leveled and inspected for deterioration due to moisture and termites.

Not enough footings for proper support

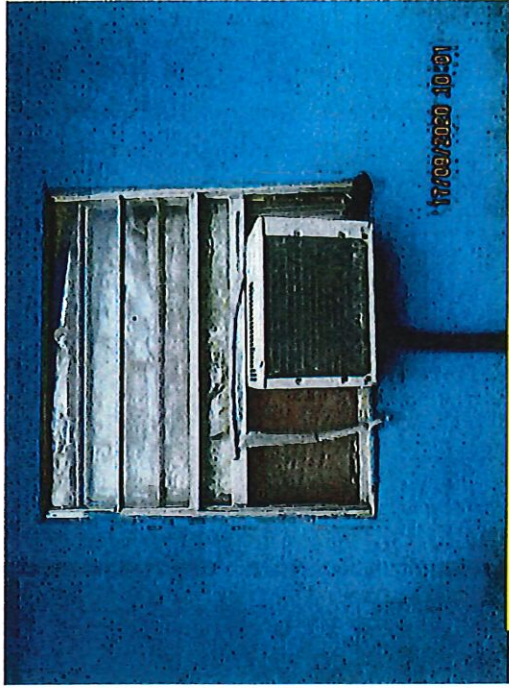
The exterior stucco Veneer needs repaired/replaced. There are many areas where stucco has cracked and fallen off.

The 8 windows are not in good working order and need to be replaced. Windows are made of aluminum and are hard to open.

Siding inoperable windows and inoperable rear exit

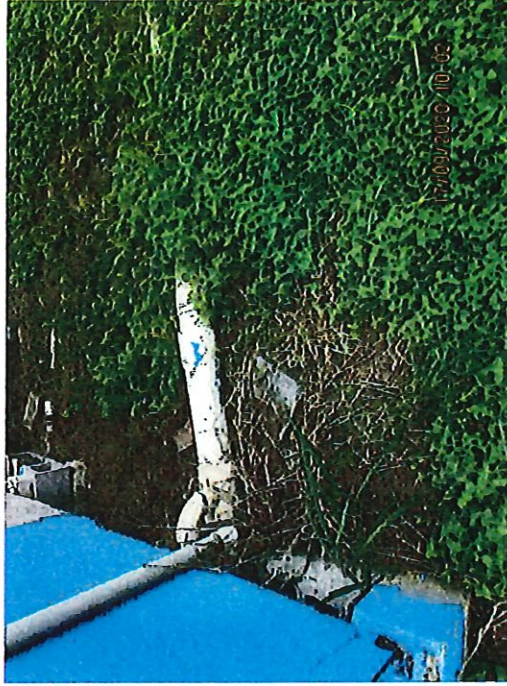
Is plumbing free from major leaks or corrosion that causes serious and persistent levels of rust or contamination of the drinking water? No there are several leaks under the sinks.

Exposed brittle plumbing

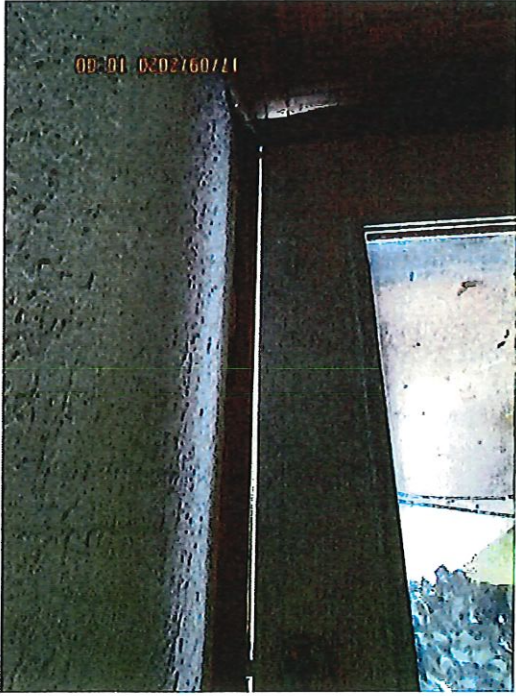
The exterior doors need to be replaced. The door frame is damaged and cracked due to the shifting of the house..

Entry door does not close properly

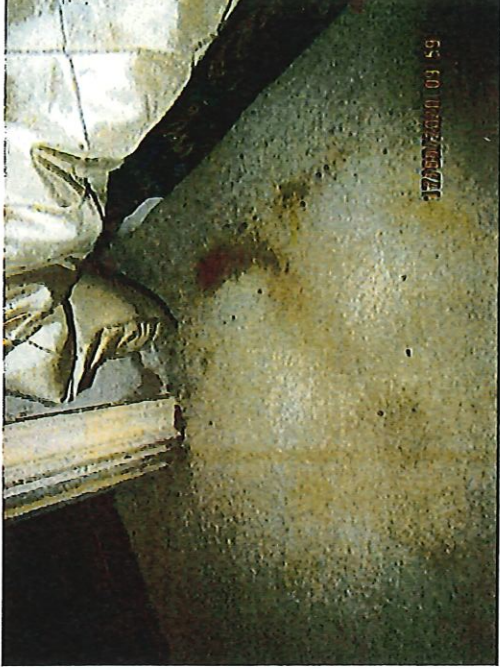
The flooring for the entire house needs to be replaced. In several areas vinyl flooring is worn. In bedroom #2 the carpet is has mold from moisture. Floor boards are rotten and have soft spots.

Subfloor rotten away holes under carpet

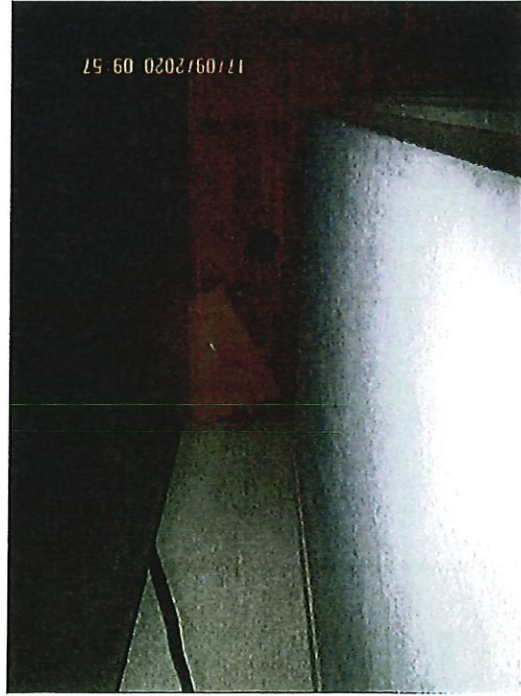
Is the unit free from rats or severe infestation by mice or vermin? No
Rodent droppings were present between cabinet and refrigerator as per inspection.

Holes covered with a board and rodent droppings

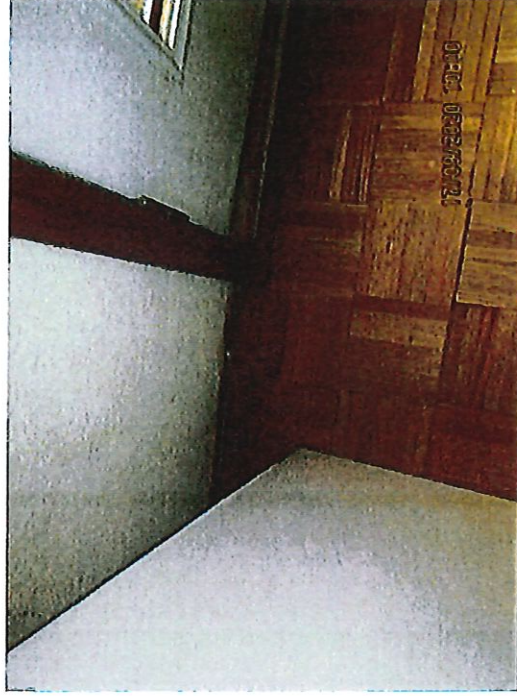
Mold and rot

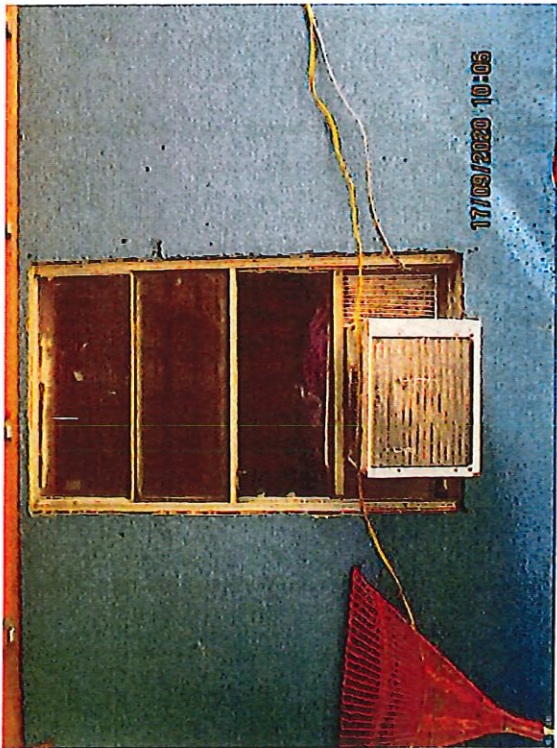
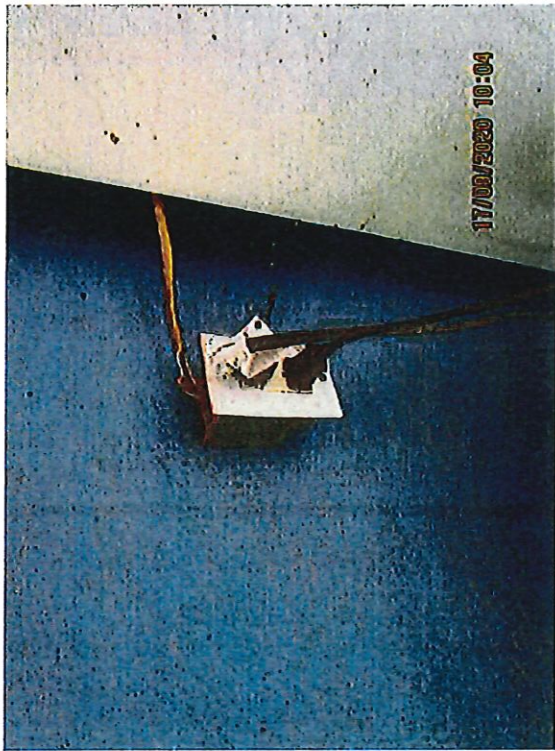
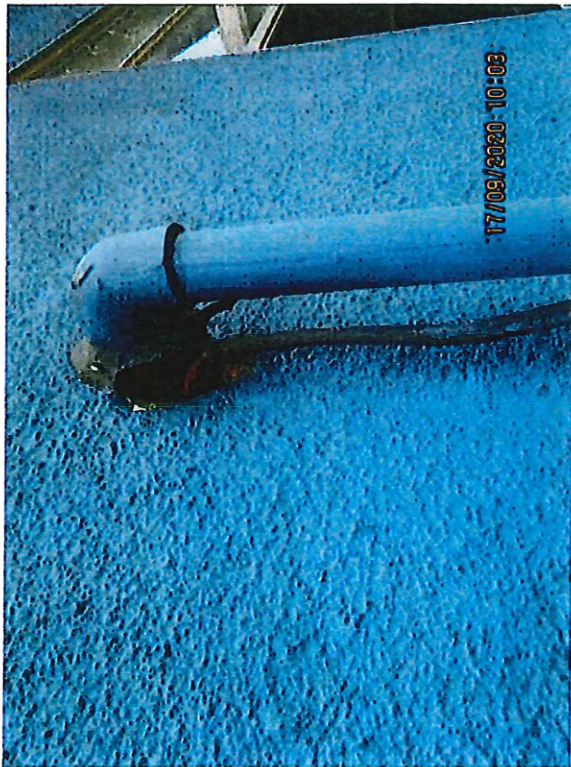
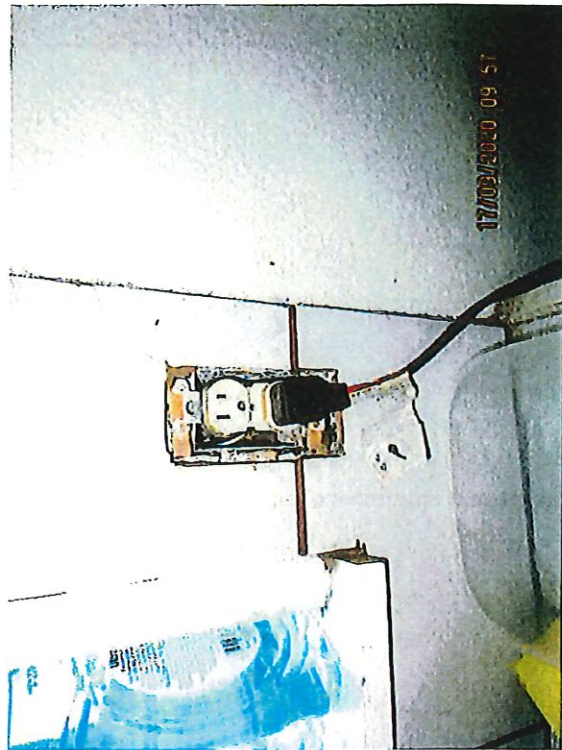
There were several plugs throughout the house that were not working. Electrical needs to be inspected for electrical shorts. Many switch and electrical outlet covers were missing leaving wires exposed.

Electrical Deficiencies

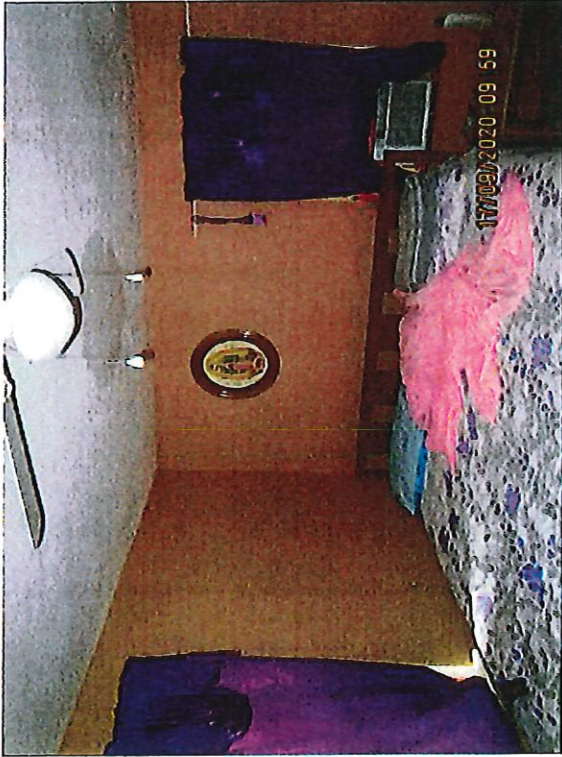
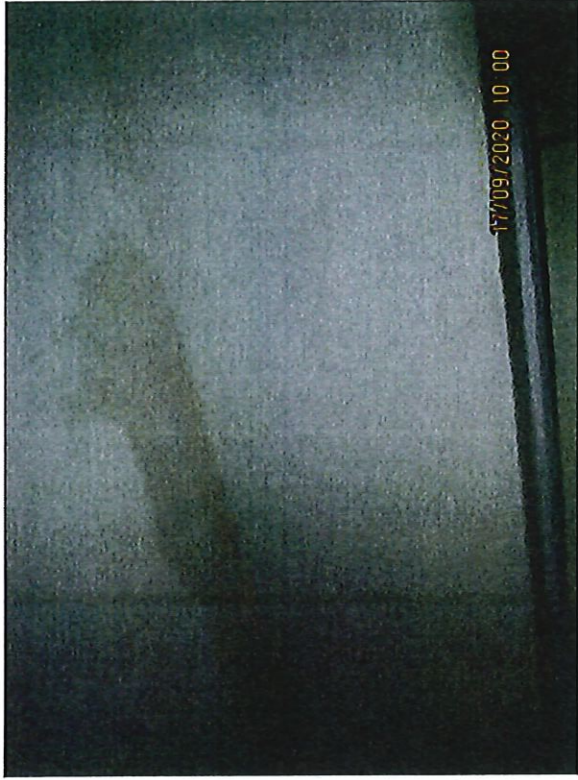
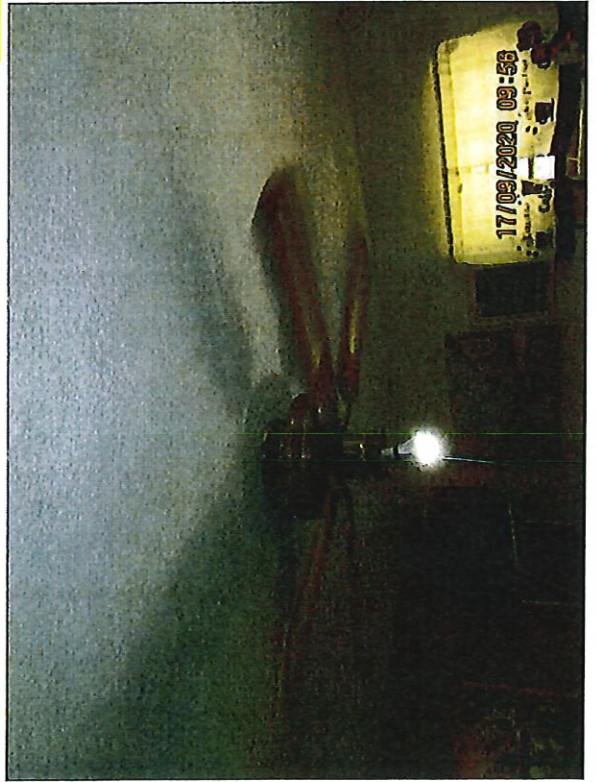
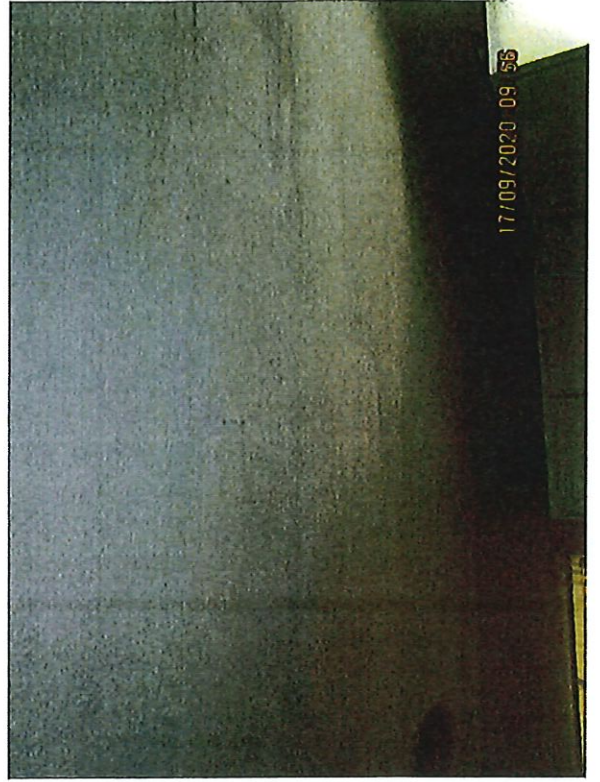
The ceiling coverings have mold and several areas where water damage has stained the ceiling. Repairs that have been made by owner are starting to leak again and sag.

Ceiling Deficiencies
