## Disaster Recovery Program

**PROJECT:** Approval for Assistance under the Disaster Recovery Program Housing Project.

# INITIAL INSPECTION

Address: 5304 Franchesca Ave. Edinburg Tx.

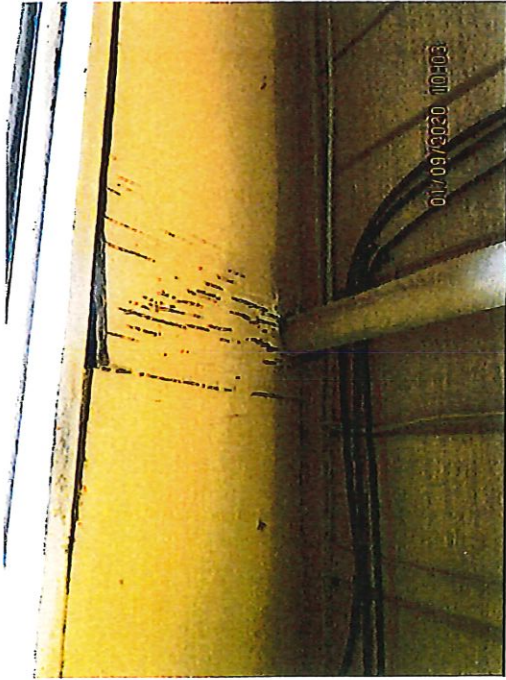
There soffit present is rotten and has many holes. The trim needs to be replaced due to deterioration.

Soffit and Fascia

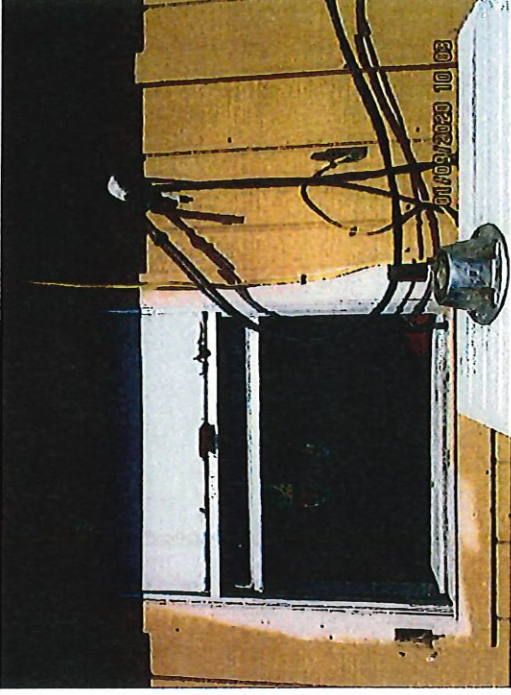
The exterior wall siding is in bad shape. There are many areas where the wood siding has deteriorated due to moisture or termites. Wood siding needs to be replaced and sealed to prevent future deterioration. A few walls have no siding at all.

The windows are not in good working order and need to be replaced. Windows are aluminum and many are cracked and do not open. There are 9 windows on the home.

Siding inoperable windows and Electrical hazards

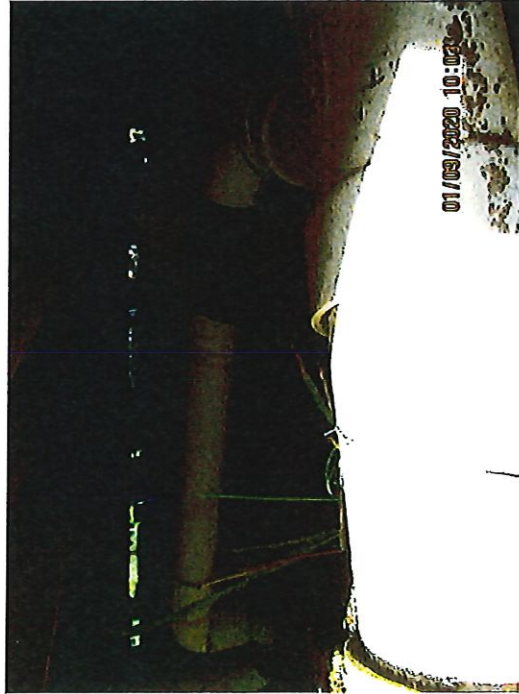
Is plumbing free from major leaks or corrosion that causes serious and persistent levels of rust or contamination of the drinking water? No there are several leaks under the sinks .

Exposed plumbing leaking

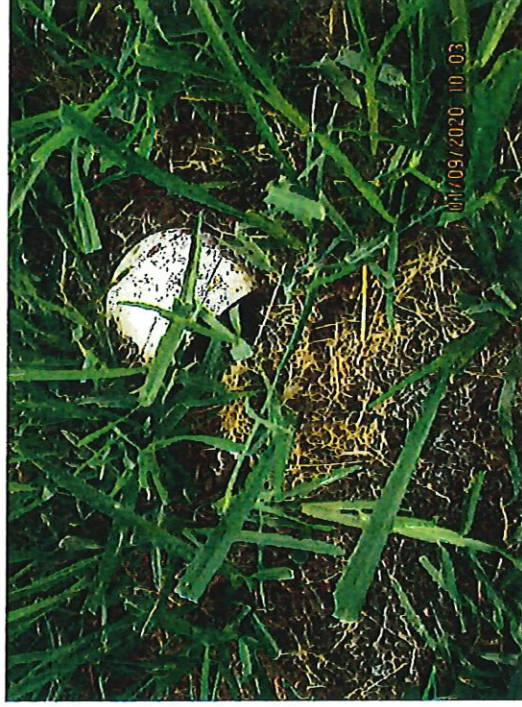
Sewer lines are exposed and appear brittle due to exposure to the sun and other weather elements. Sewer line vents do not vent through roof and create an odor in the house.

Is plumbing free from sewer back up? No sewer lines are broken and sewage backs up into yard

Broken sewer Pipes in yard

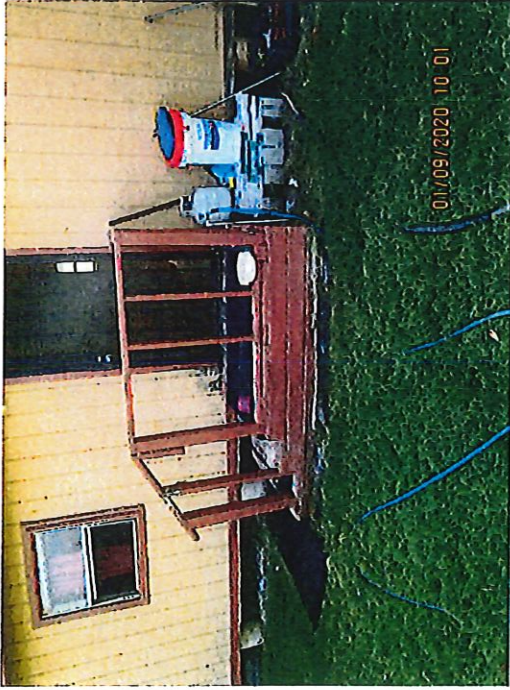
The the front stairs needs to be redone including the hand railing .

Rotten stairs with loose hand rail

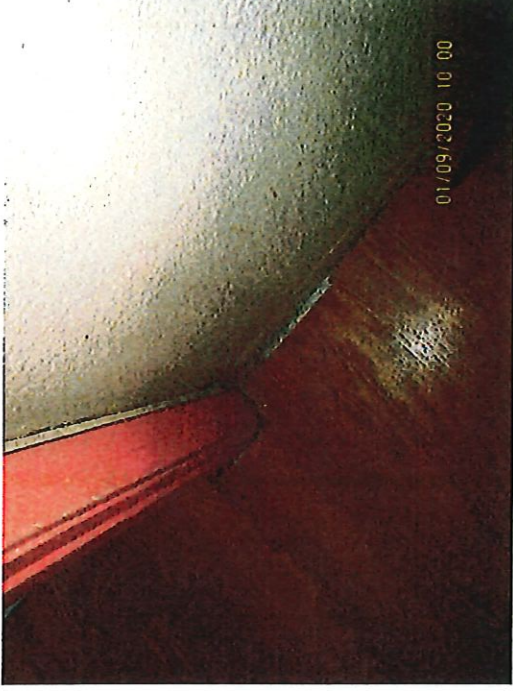
The flooring for the entire house needs to be replaced. In several areas in the house there is no flooring present only exposed plywood. Floor boards are rotten and have holes in them, light is visible from under the home.

Subfloor rotten away / sunlight through flooring material

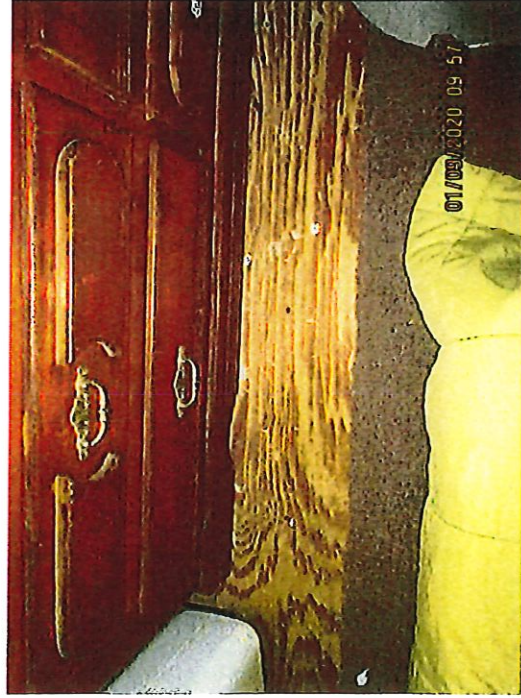
No Flooring Material

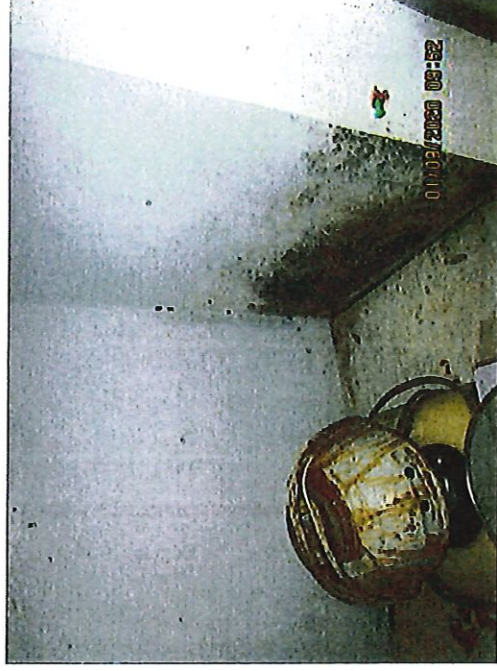
Mold and rot on walls

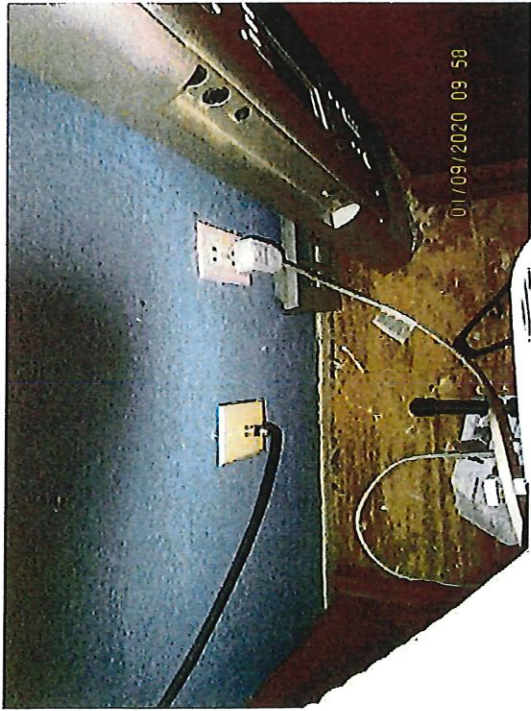
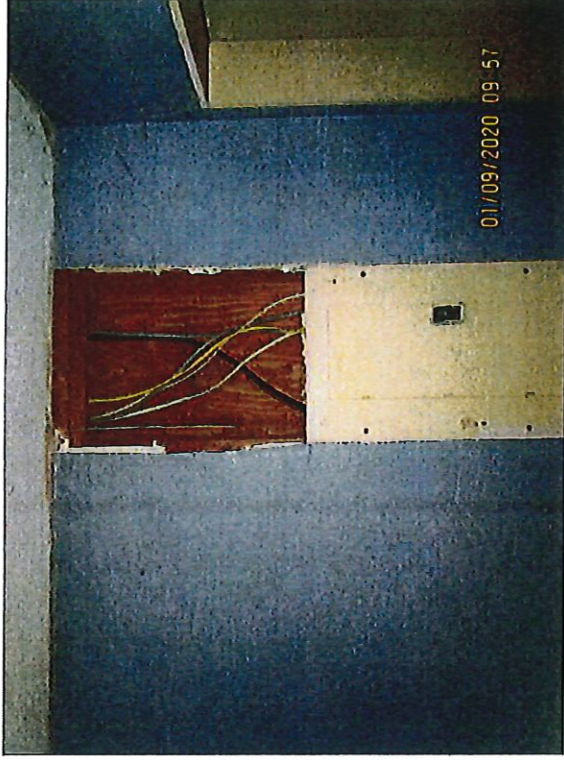
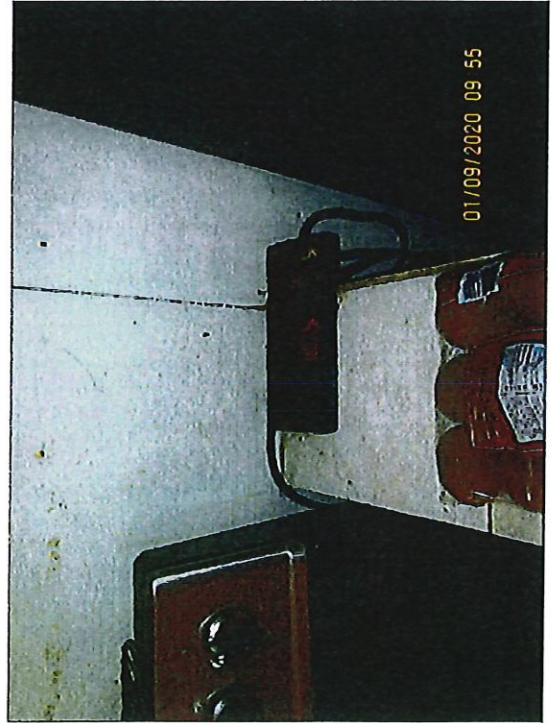
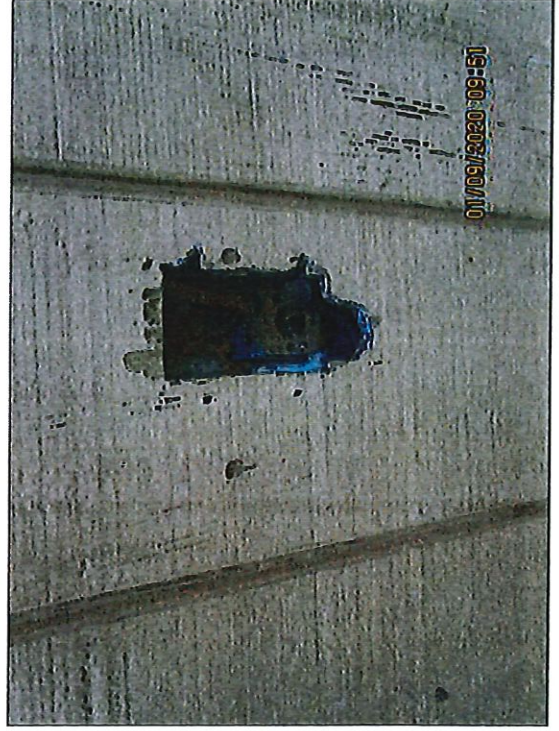
There were several plugs throughout the house that were not working. Several ceiling light fixtures in the house were also not working. Electrical needs to be inspected for electrical shorts. Many switch and electrical outlet covers were missing leaving wires exposed.

Electrical Deficiencies

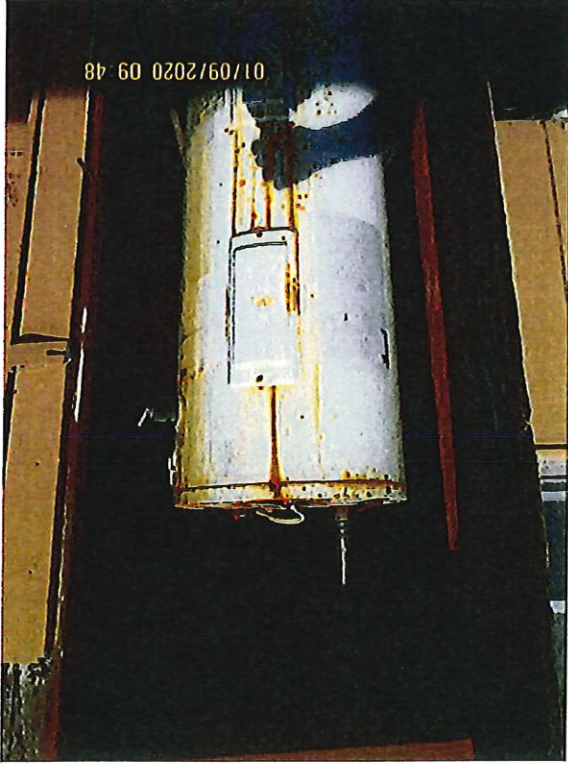
The exterior doors need to be replaced. The door frame is damaged and cracked due to the shifting of the house..

Is hot water heater located and equipped in a safe manner and free of hazards? NO water heater does not work and has exposed wires and the water heater closet is rotten and missing the door.

NON functioning Water heater / Entry door does not work

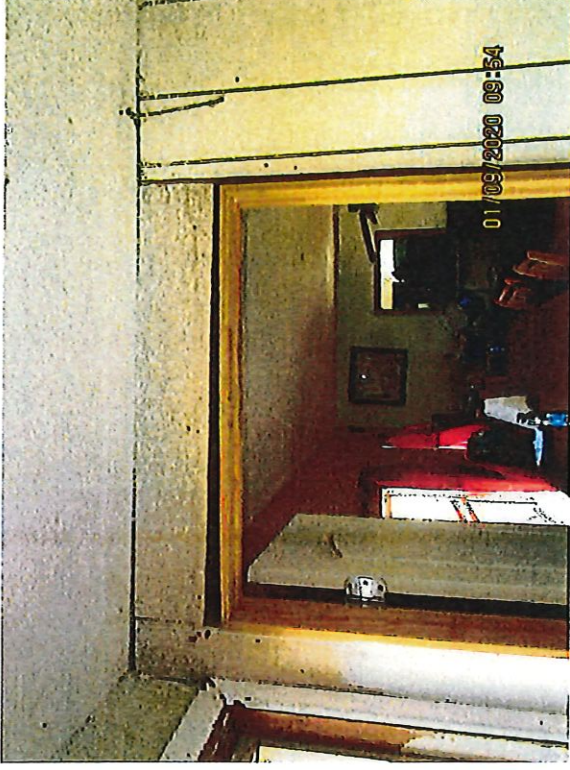
The wall coverings and trim are in need of repair. There are holes in walls and cracks due to foundation movement. Door frames and trims are broken and do not close properly.

Doorways uneven due to rotting subfloor / cracks in ceiling
