Disaster Recovery Program

PROJECT: Approval for Assistance under the Disaster Recovery Program Housing Project.

MHU INITIAL INSPECTION

Address: 4911 Robin Lane Edinburg TX.

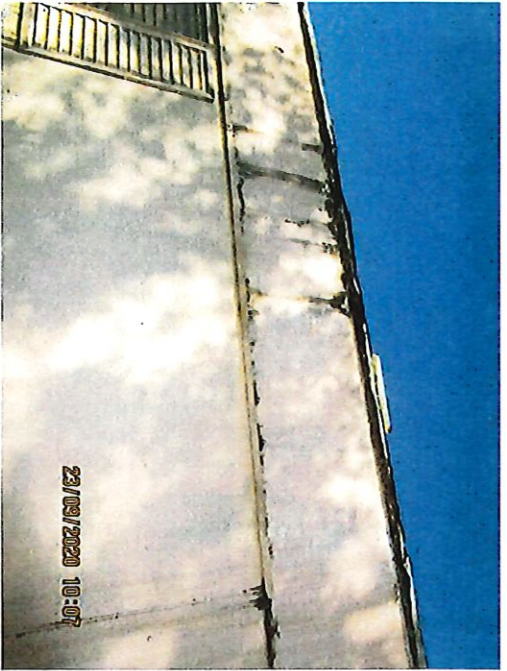
There soffit present is rotten and has many holes. The trim needs to be replaced due to deterioration.

Soffit and Fascia

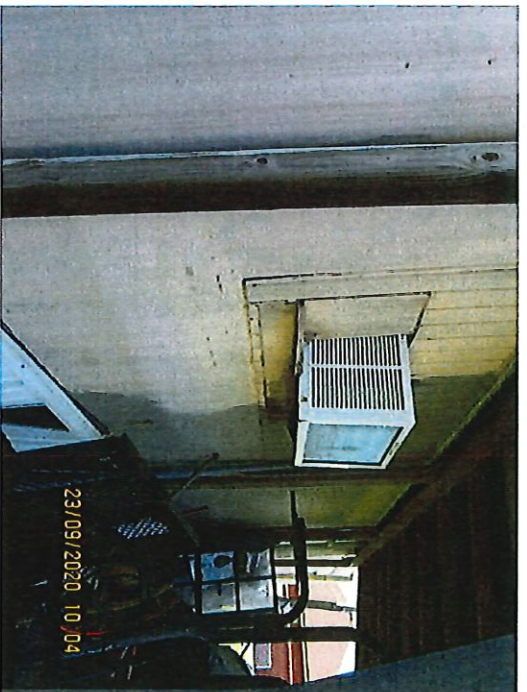
The exterior wall siding is in bad shape. There are many areas where the wood siding has deteriorated due to moisture or termites. Wood siding needs to be replaced and sealed to prevent future deterioration. A few walls have no siding at all.

The windows are not in good working order and need to be replaced. Windows are aluminum and many are cracked and do not open. There are 9 windows on the home.

Siding inoperable windows and inoperable rear exit

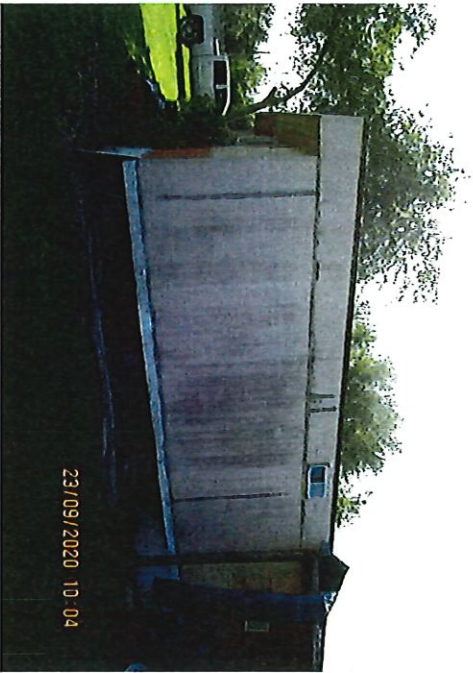
Mobile home tie down

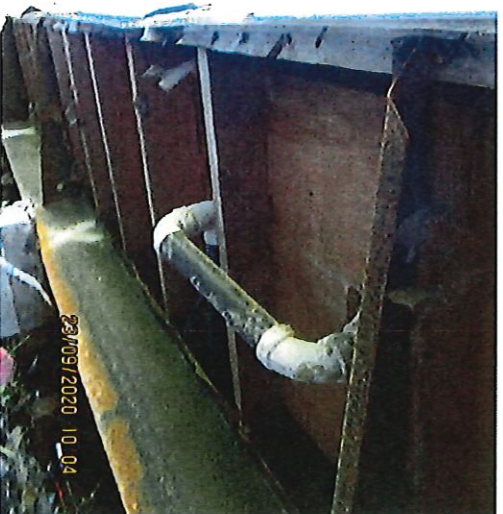
The insulation underneath the home is gone.

No Underpinning and no floor insulation

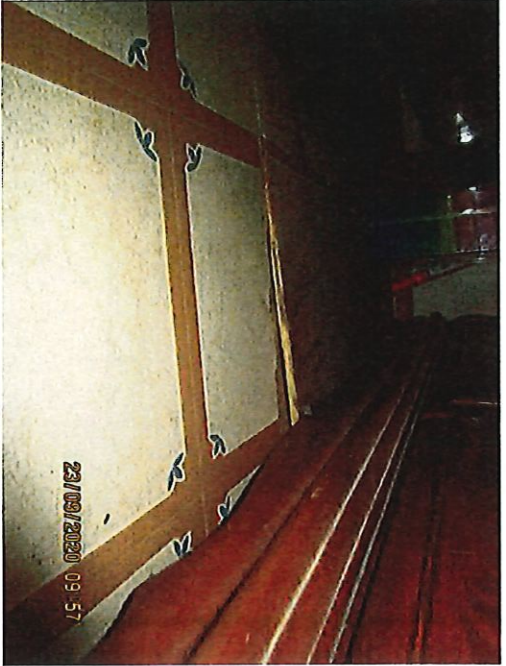
boards covering holes

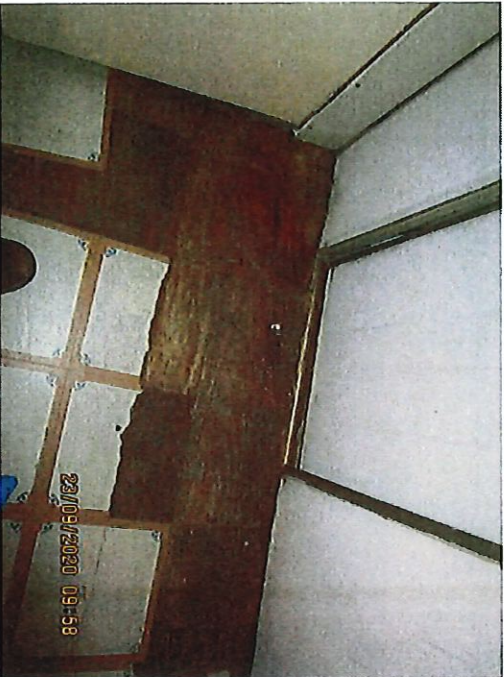
The flooring for the entire house needs to be replaced. In several areas in the house the VCT has come unglued. Floor boards are completely rotten and have holes in them.

No Flooring Material

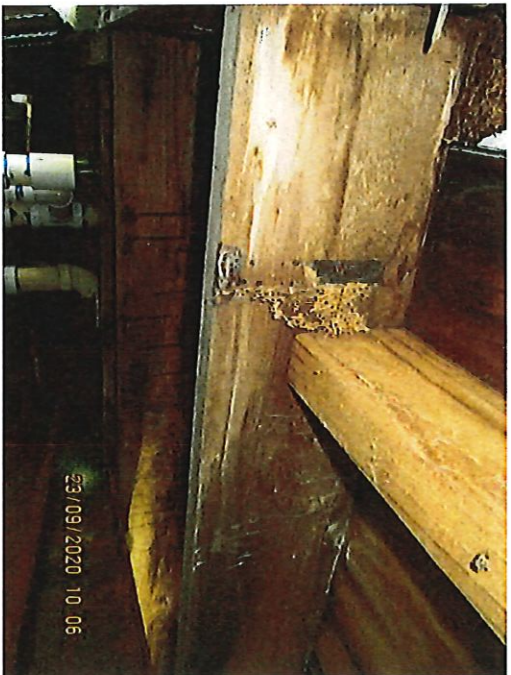
Subfloor rotten away / sunlight through flooring material

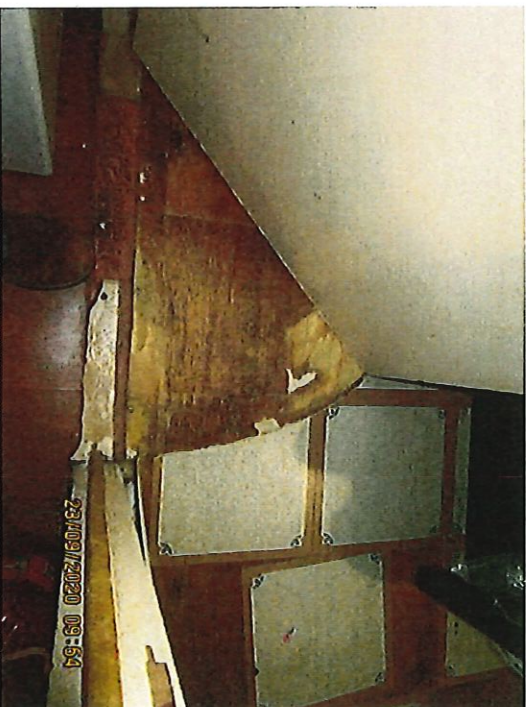
The wall coverings and trim are in need of repair. There are holes in walls and cracks due to foundation movement. Door frames and trims are broken and do not close properly.

Door do not open properly

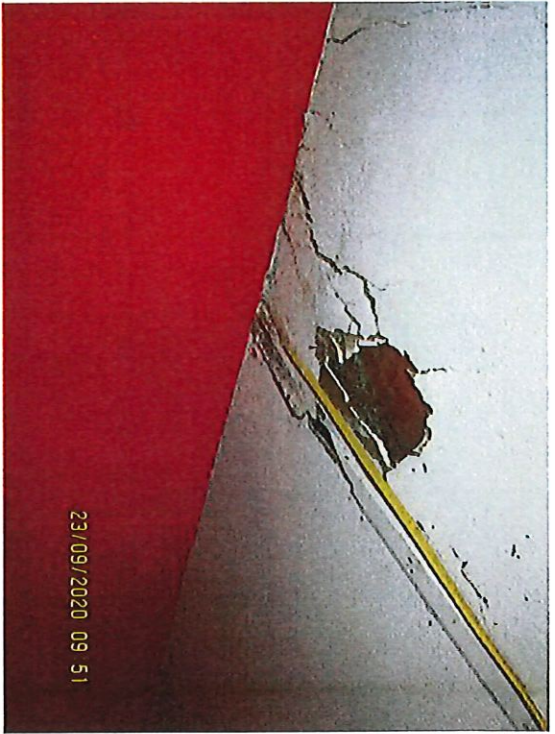
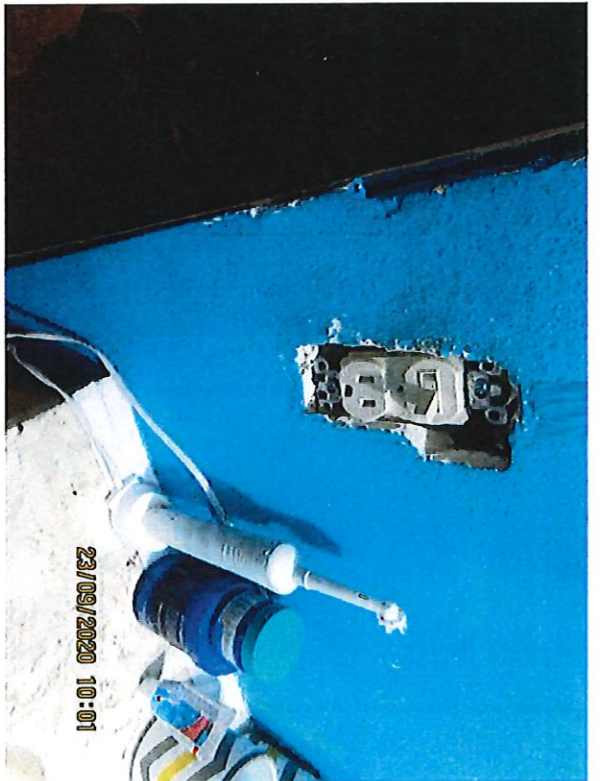
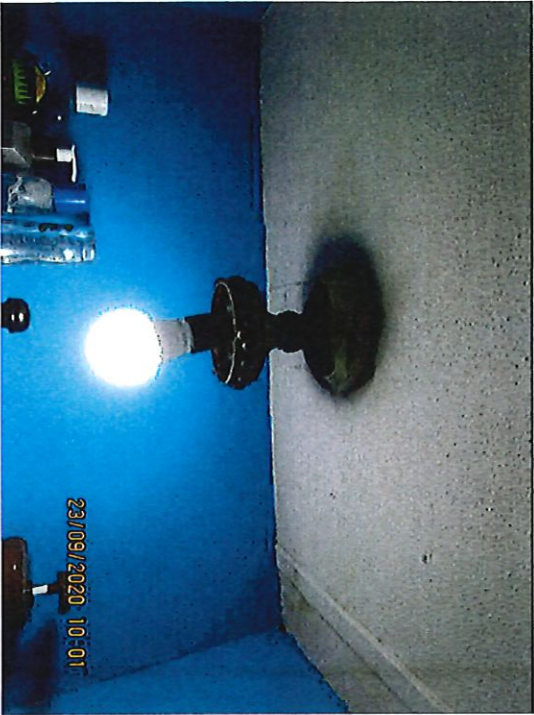
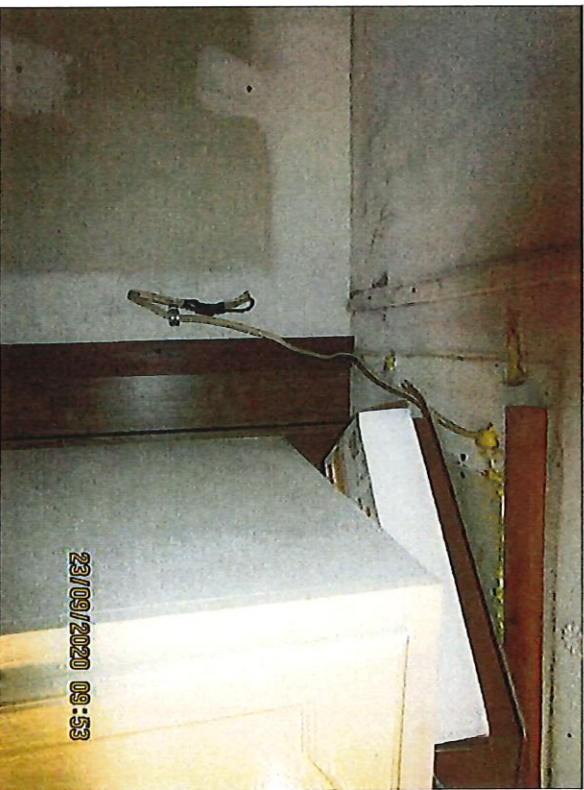
There were several plugs throughout the house that were not working. Several ceiling light fixtures in the house were also not working. Electrical needs to be inspected for electrical shorts. Many switch and electrical outlet covers were missing leaving wires exposed.

Electrical Deficiencies

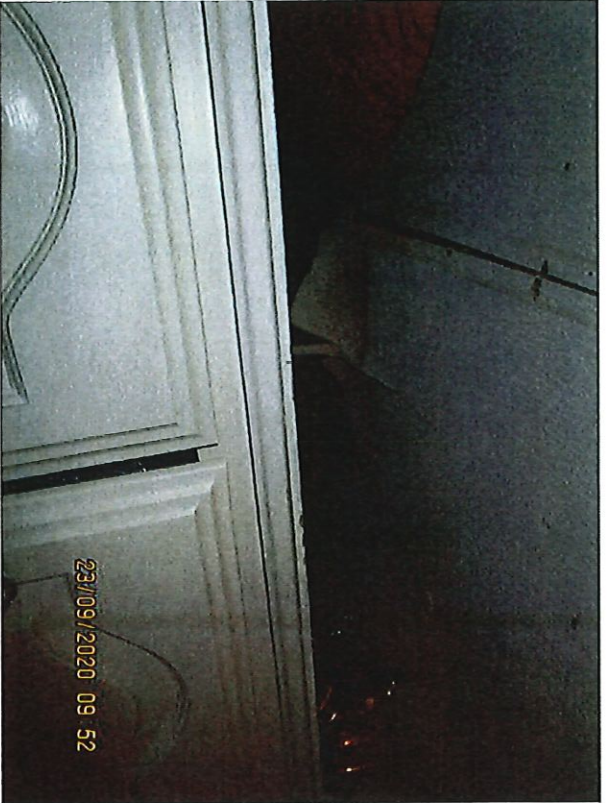
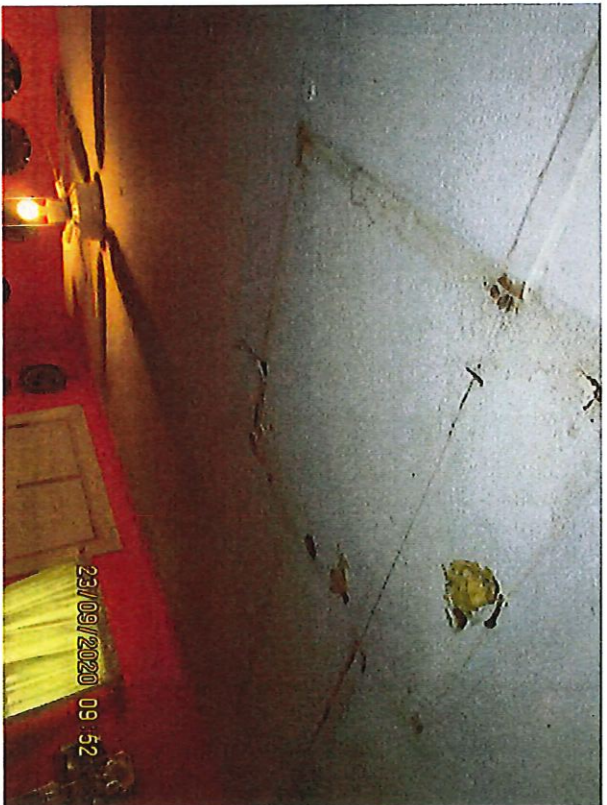
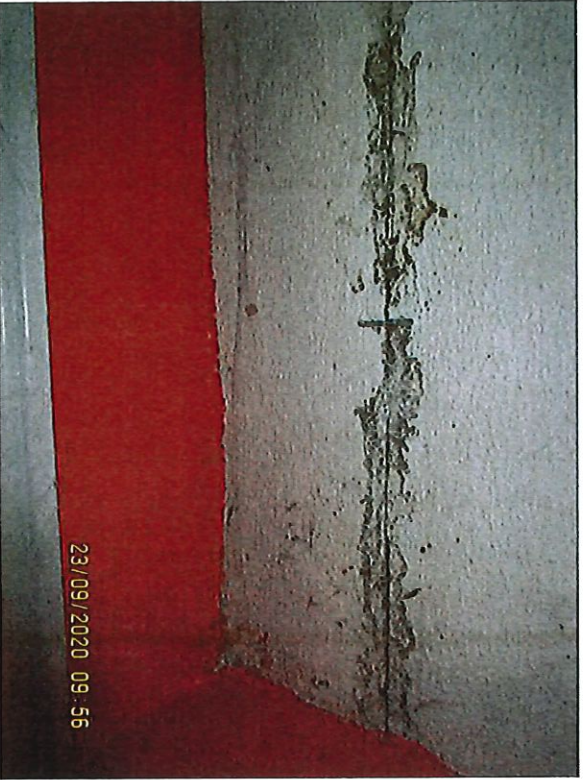
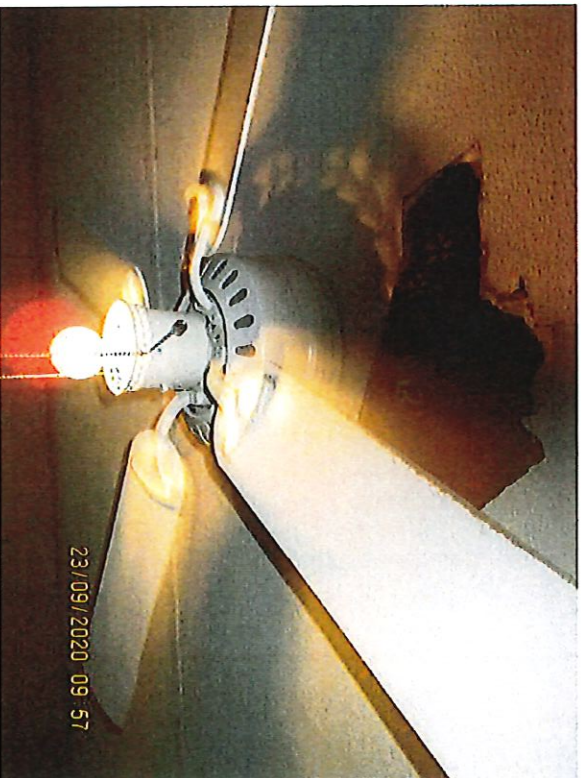
The ceiling coverings have small cracks around the perimeter walls due to pier and beam movement. There are several areas where water damage has stained the ceiling. Signs of termites present.

Ceiling Deficiencies
