## Disaster Recovery Program

**PROJECT:** Approval for Assistance under the Disaster Recovery Program Housing Project.

# INITIAL INSPECTION

Address: 4711 Raven Circle Edinburg Tx.

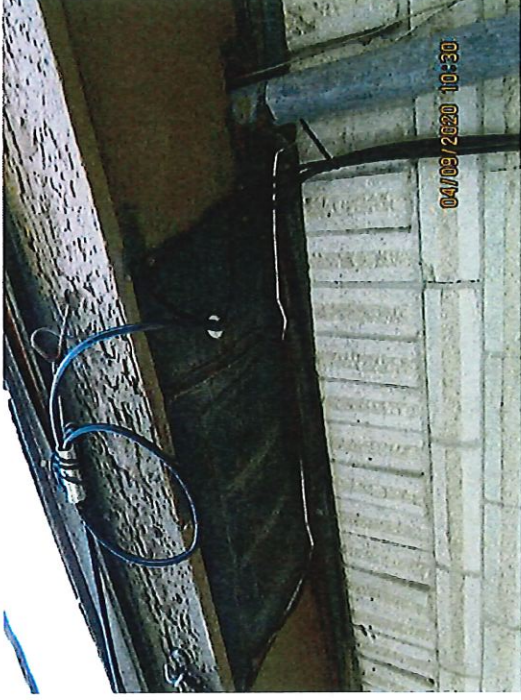
There soffit present is rotten and has many holes. The trim needs to be replaced due to deterioration.

Soffit and Fascia

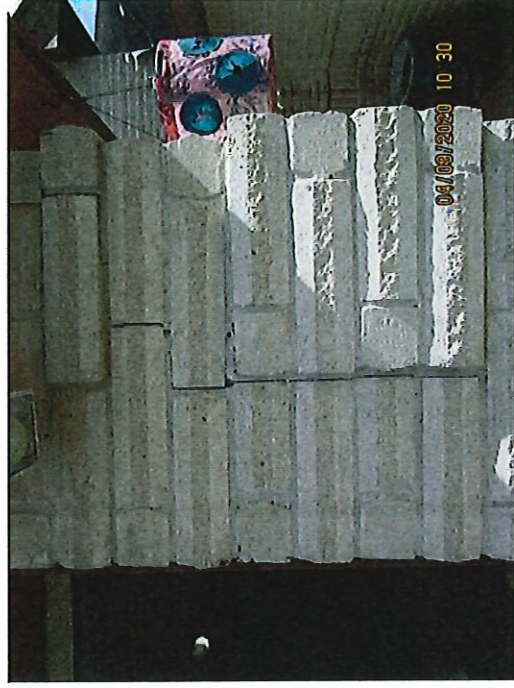
The exterior Brick Veneer needs repaired/replaced. There are many areas where brick & grout has cracked.

Brick Veneer Cracks

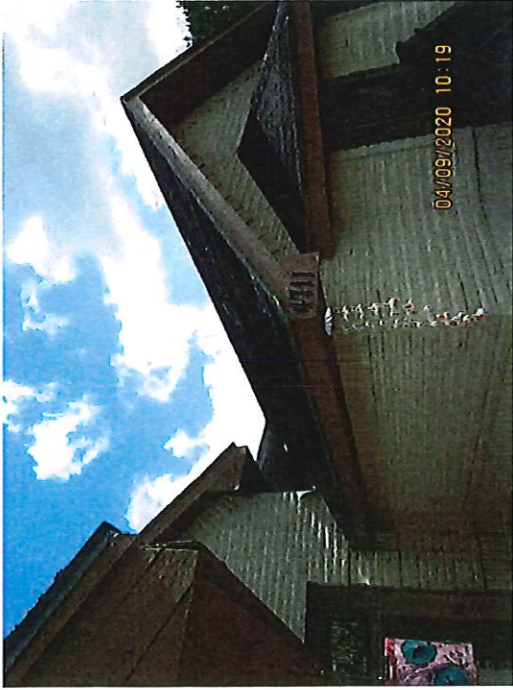
The roofing shingles and paper felt need to be replaced. The plywood decking needs to be replaced due to severe deterioration, water stains mold and fallen ceilings through the house.

Missing and Deteriorated Shingles

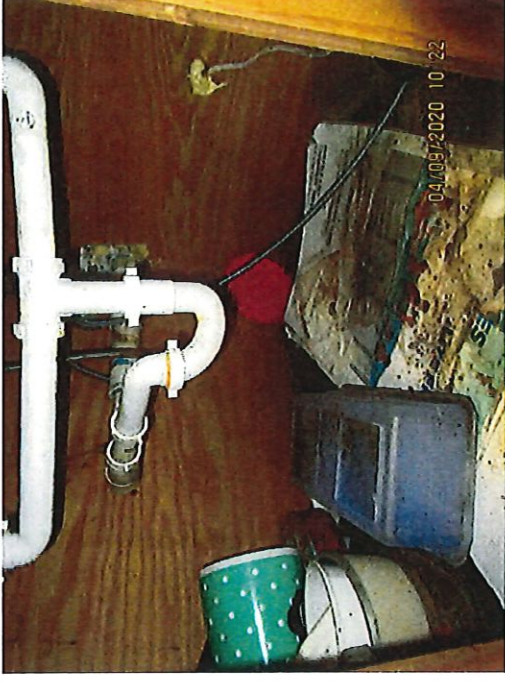
Is plumbing free from major leaks or corrosion that causes serious and persistent levels of rust or contamination of the drinking water? No there are several leaks under the sinks and bathrooms .

Is the unit free from rats or severe infestation by mice or vermin? No  
Rodent dropping were present under sinks and in cabinets as per inspection.

Under Sink mold from leaking pipes and rodent droppings

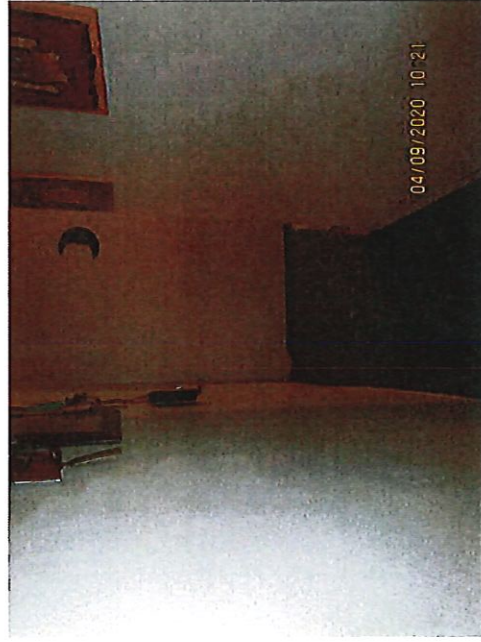
The carpet in the house needs to be replaced. In several areas in the house the carpet is has mold from water leaks in the roof.

Mold on walls and carpet

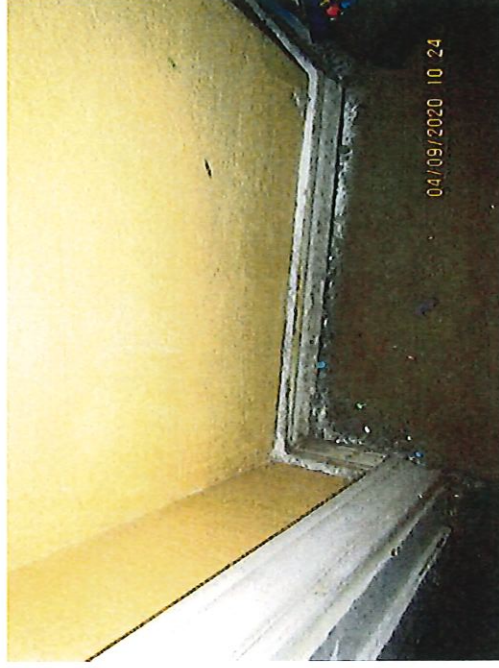
Mold and rot on base boards

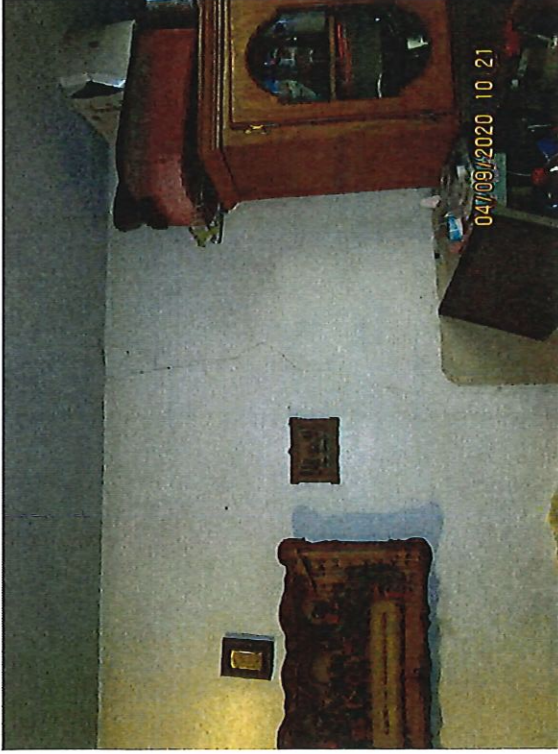
The wall coverings and trim are in need of repair. There are holes in walls and cracks due to foundation movement. Door frames and trims are broken and do not close properly.

Cracks in walls/Ceilings

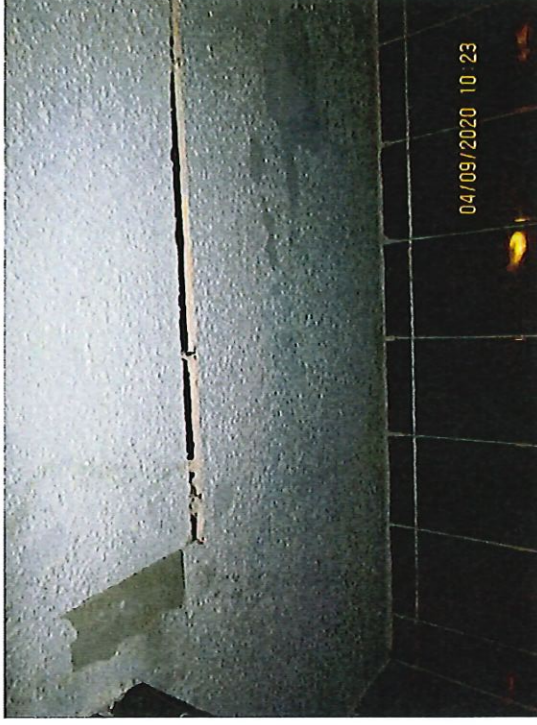
Gypsum boards falling/Tub is leaking

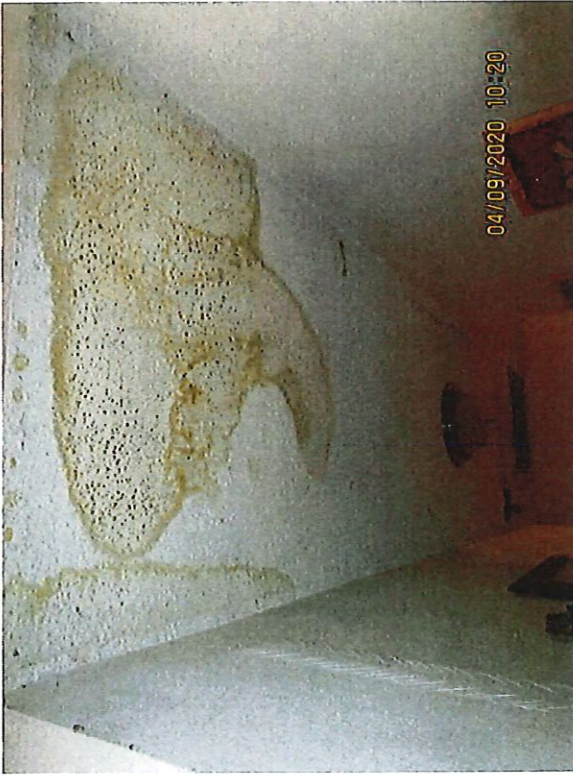
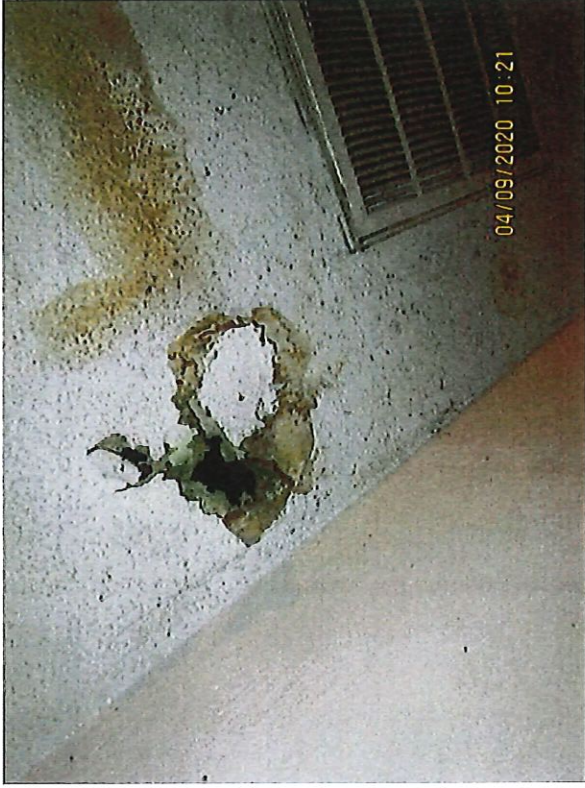
The ceiling coverings have mold and several areas where water damage has stained the ceiling..

Ceiling Deficiencies
