Disaster Recovery Program

PROJECT: Approval for Assistance under the Disaster Recovery Program Housing Project.

INITIAL INSPECTION

Address: 5614 Leigh Ann Dr. Edinburg Tx.

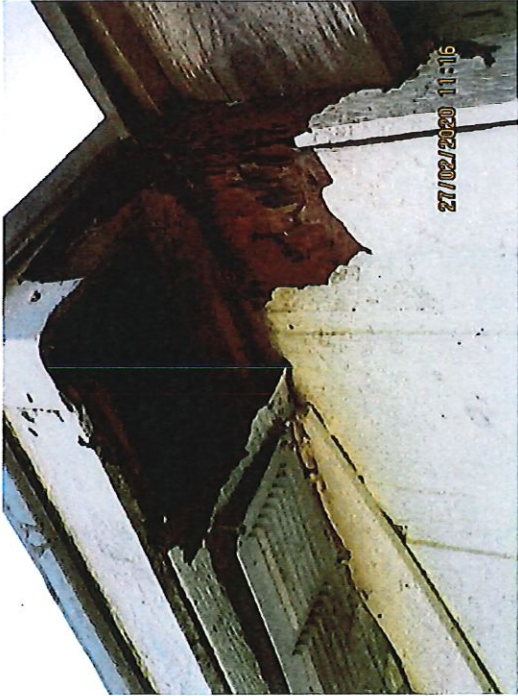
There soffit present is rotten and has many holes. The trim needs to be replaced due to deterioration.

Soffit and Fascia

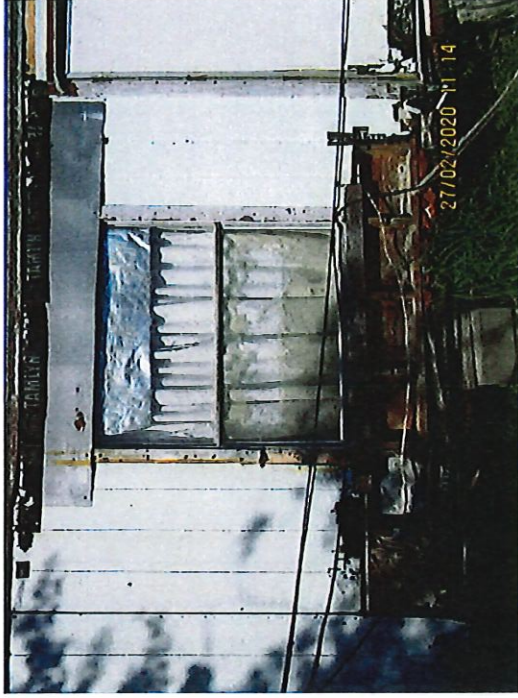
The exterior wall siding is in bad shape. There are many areas where the wood siding has deteriorated due to moisture or termites. Wood siding needs to be replaced and sealed to prevent future deterioration. A few walls have no siding at all.

The windows are not in good working order and need to be replaced. Windows are aluminum and many are cracked and do not open. There are 9 windows on the home.

The front exterior doors need to be replaced. The door frame is damaged and cracked due to the shifting of the house. The Rear Exterior door does not shut properly and the owner has screwed it shut to keep it from opening.

Siding, inoperable windows and inoperable rear exit

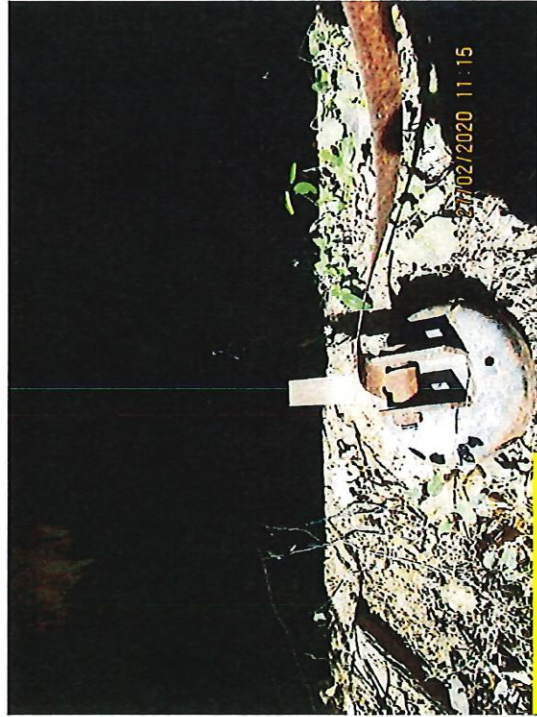
Mobile home tie down

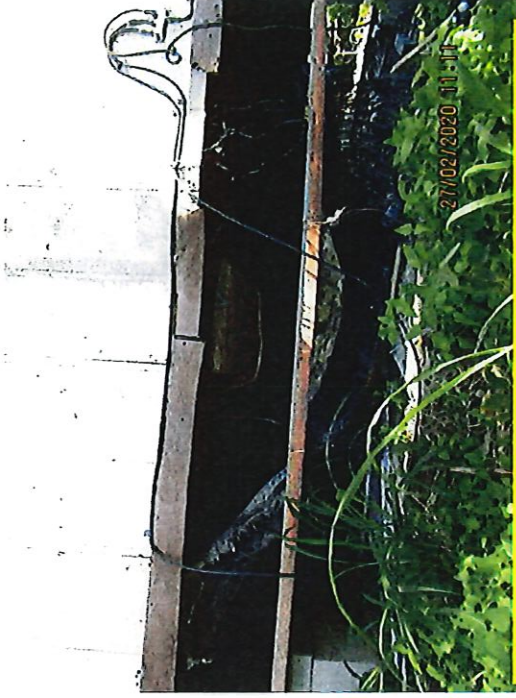
The insulation underneath the home & walls are exposed and appears to have mold and needs to be replaced as per inspection.

No Underpinning and floor insulation fallen to the ground

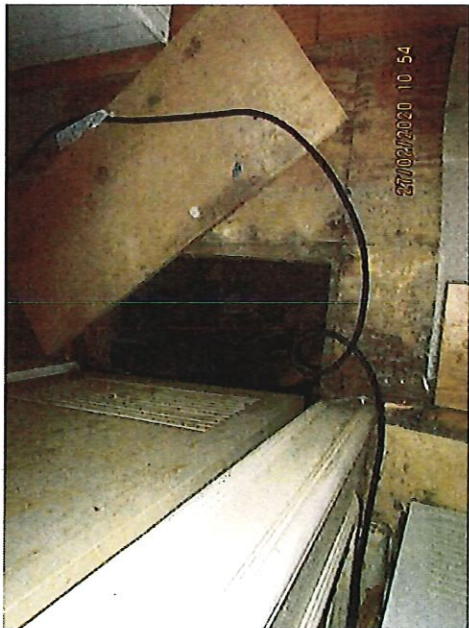
boards covering holes

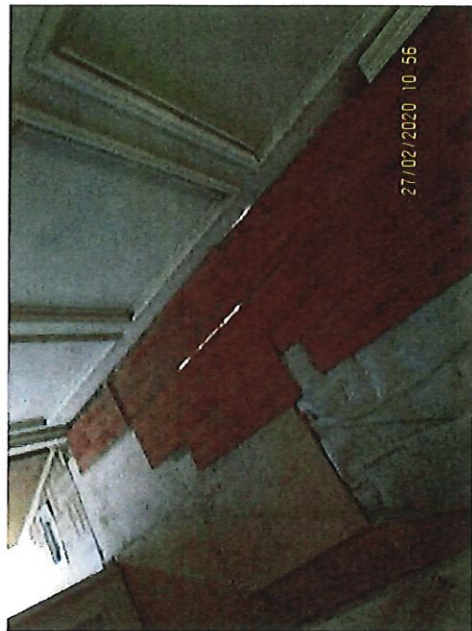
The flooring for the entire house needs to be replaced. In several areas in the house the VCT has come unglued. Floor boards are completely rotten and have holes in them, light is visible from under the home.

Subfloor rotten away / sunlight through flooring material

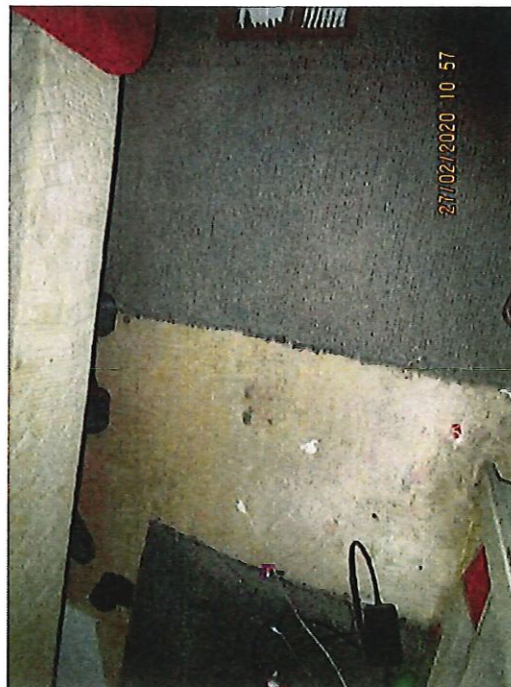
No Flooring Material

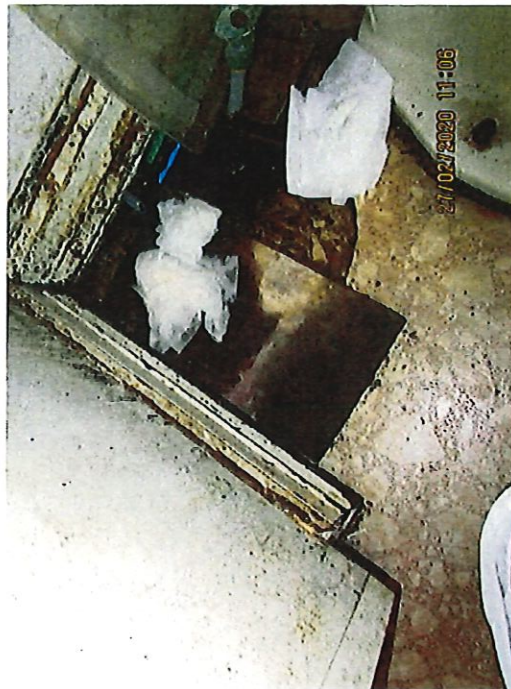
Mold and rot on base boards

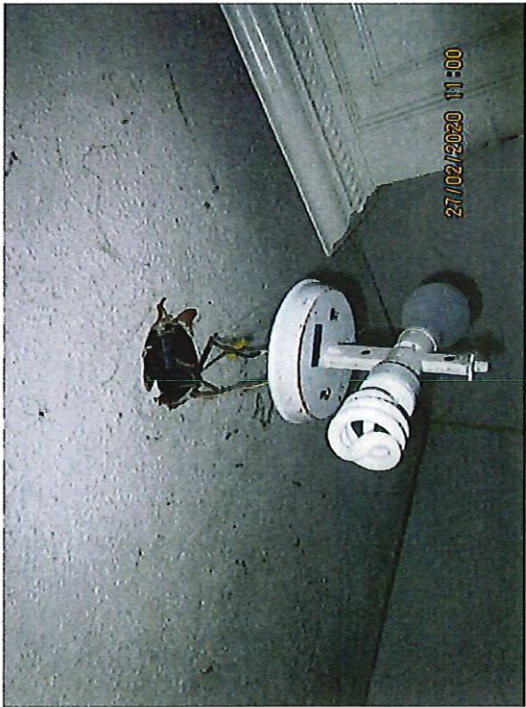
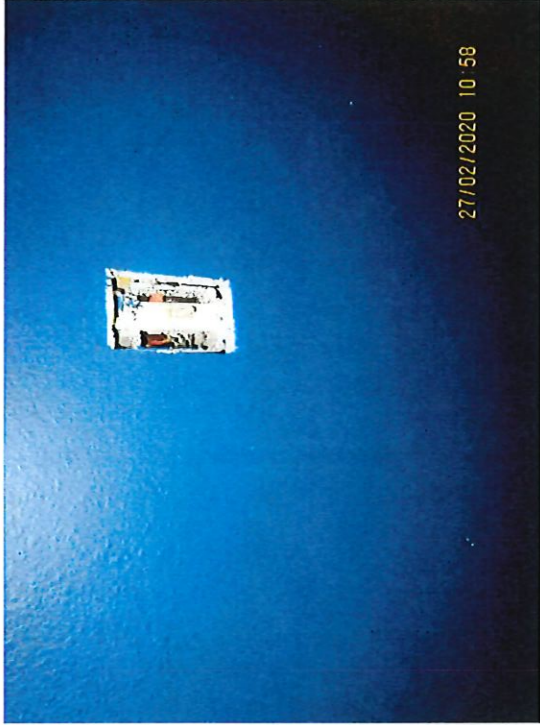
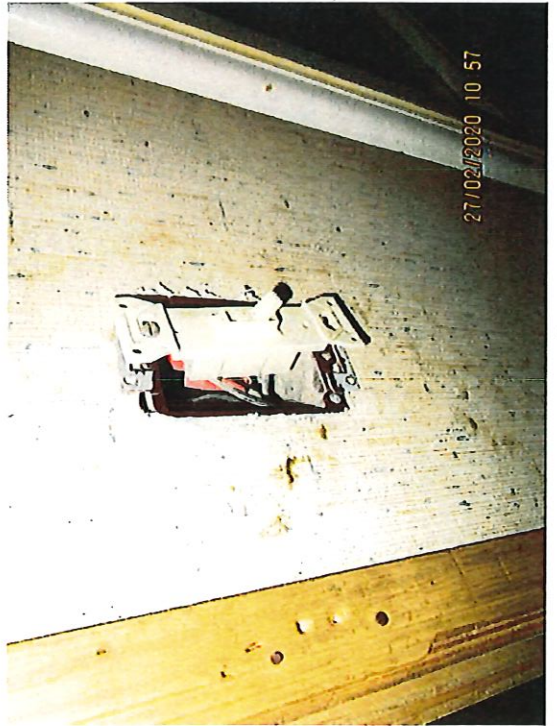
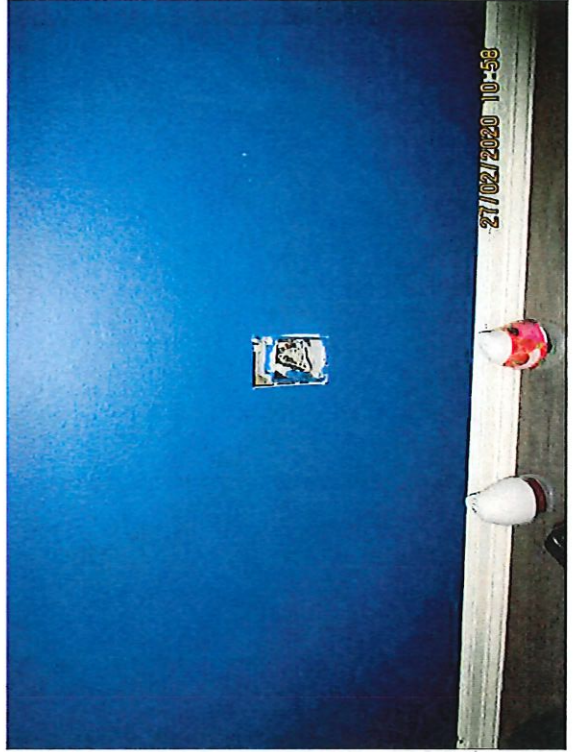
There were several plugs throughout the house that were not working. Several ceiling light fixtures in the house were also not working. Electrical needs to be inspected for electrical shorts. Many switch and electrical outlet covers were missing leaving wires exposed.

Electrical Deficiencies

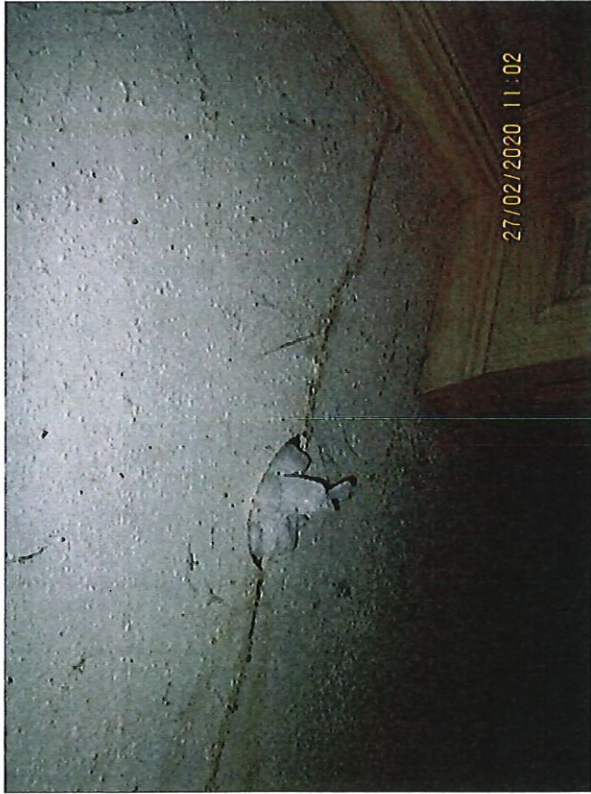
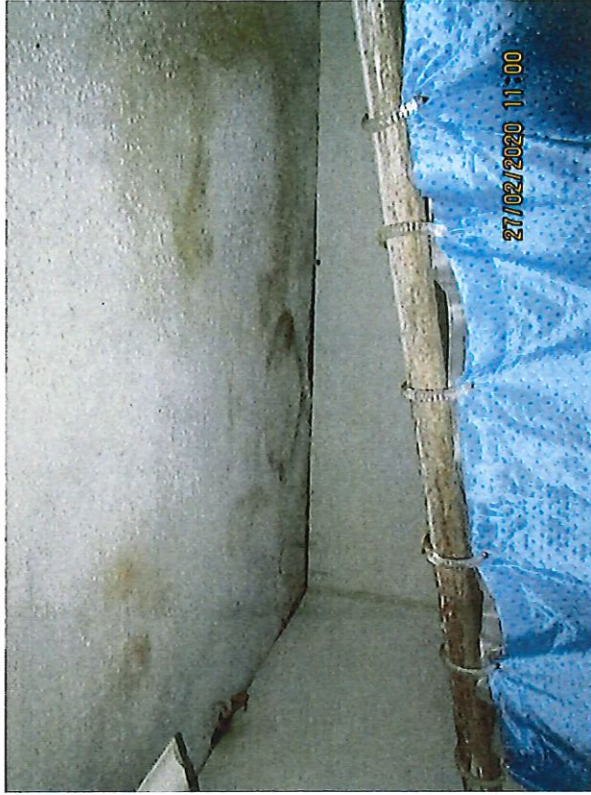
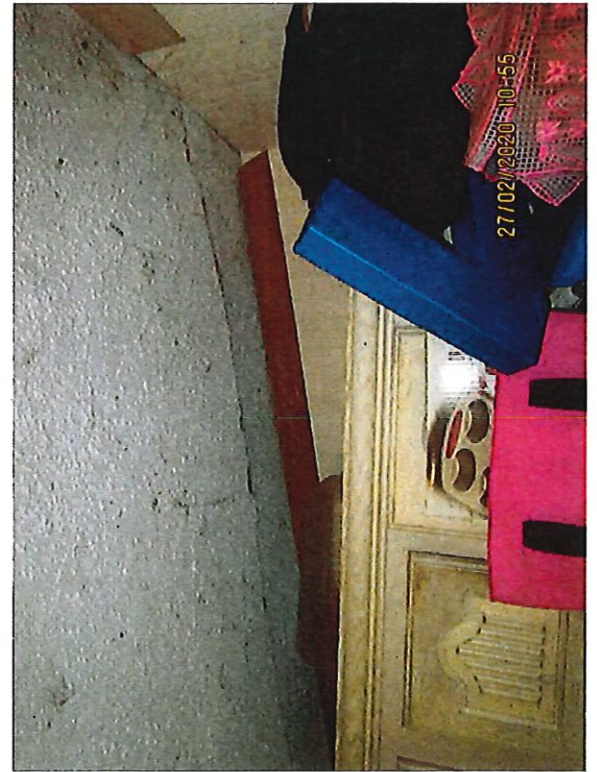
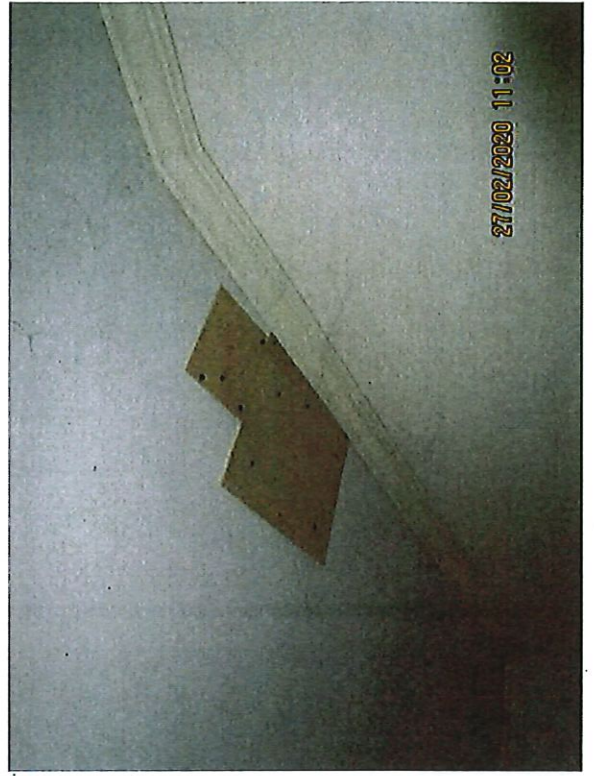
The ceiling coverings have small cracks around the perimeter walls due to foundation movement. There are several areas where water damage has stained the ceiling. There are also signs of termites and rodent infestation.

Ceiling Deficiencies
