Housing Rehab Program

PROJECT: Reconstruction of a single family housing unit located at: 1000 Dove St., Alamo, Texas

PROJECT: Reconstruction of a single family housing unit located at: 8015 Buckles Blvd., Edinburg, Texas

INITIAL INSPECTION

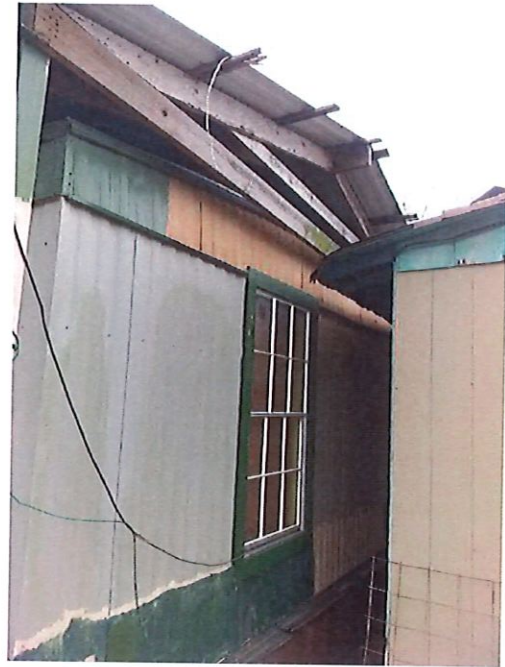
Front of the house facing south

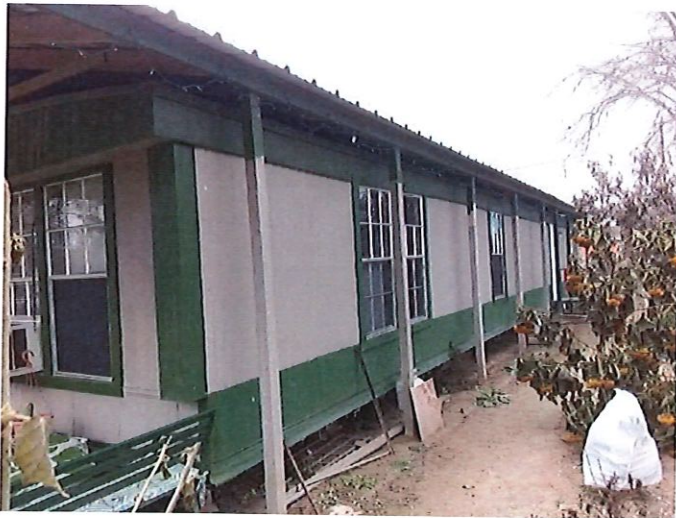
North side of the house

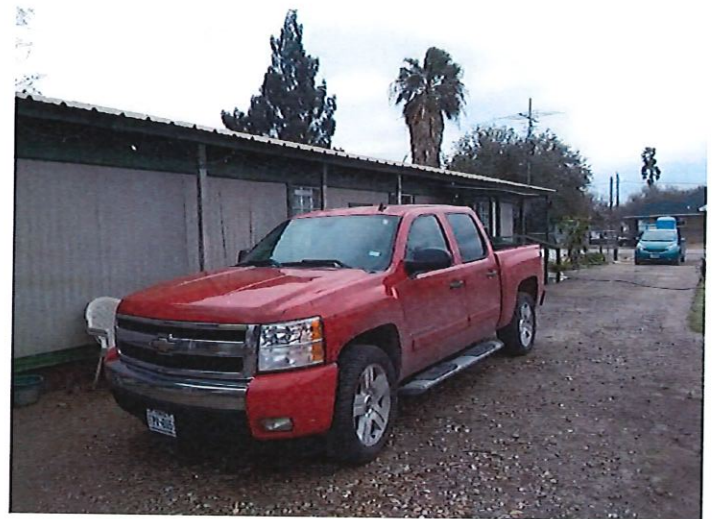
East Side of the house

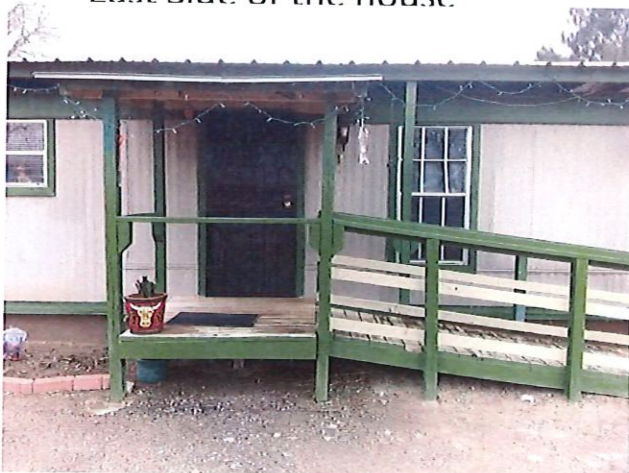
West side of the House

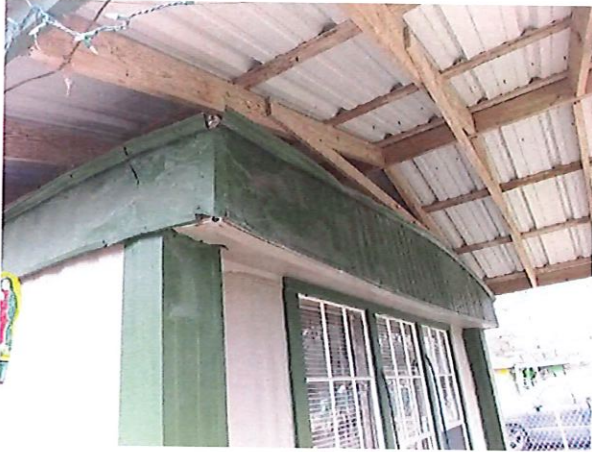
Is the roof sound and free from hazards?
The roofing shingles and paper felt need to be replaced. The plywood decking needs to be inspected for deterioration due to water stains in the house.

Damaged Roof

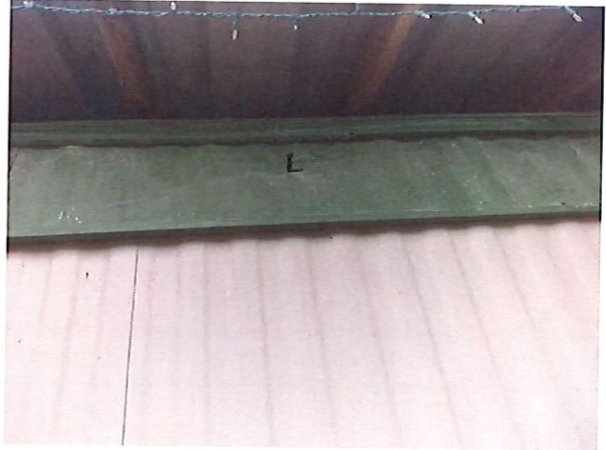
Punctured
Metal siding

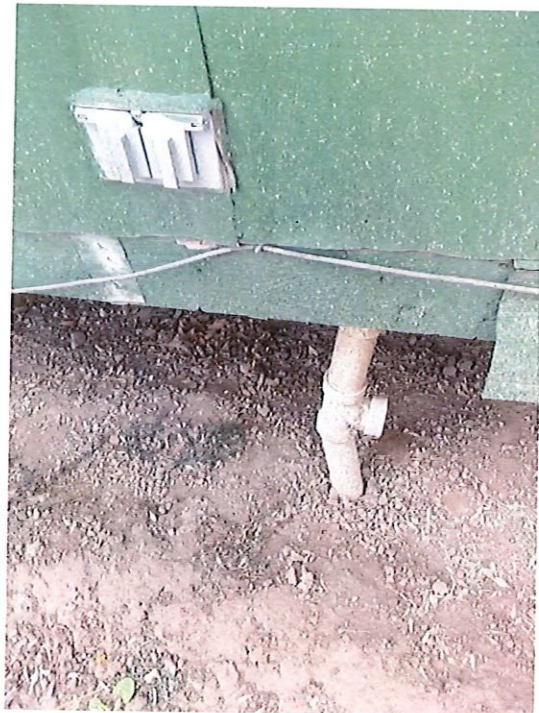
exposed plumbing

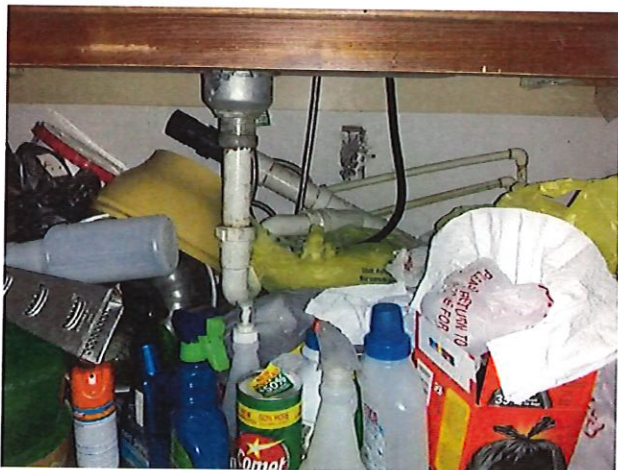
Under kitchen sink improperly vented
& exposed electrical outlet

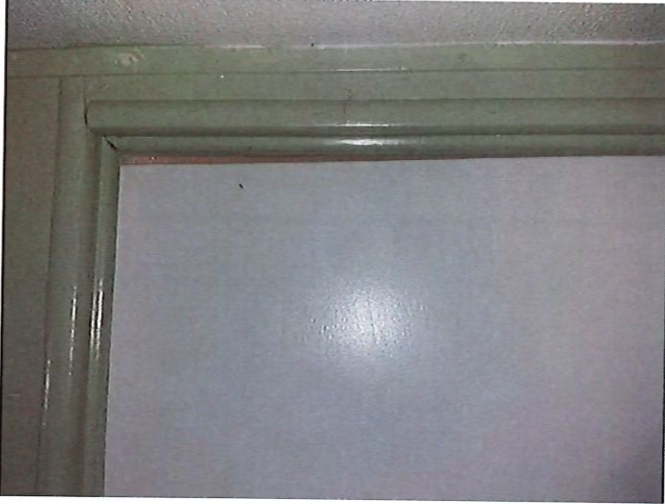
Bathroom door does
Not close properly

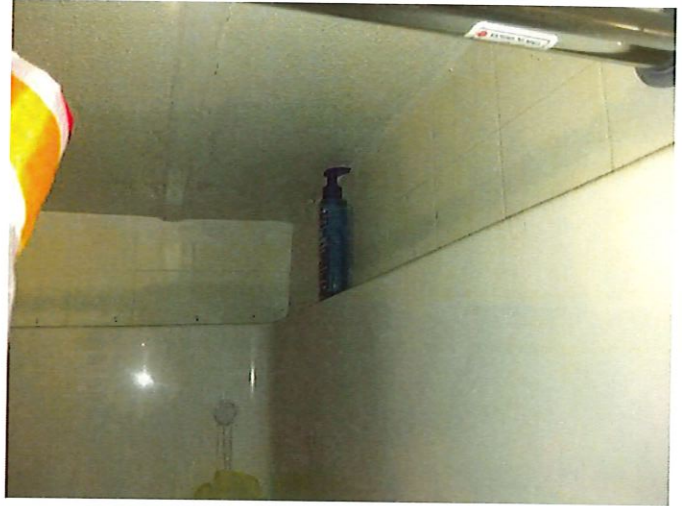
shower pictures

Leaking fixtures

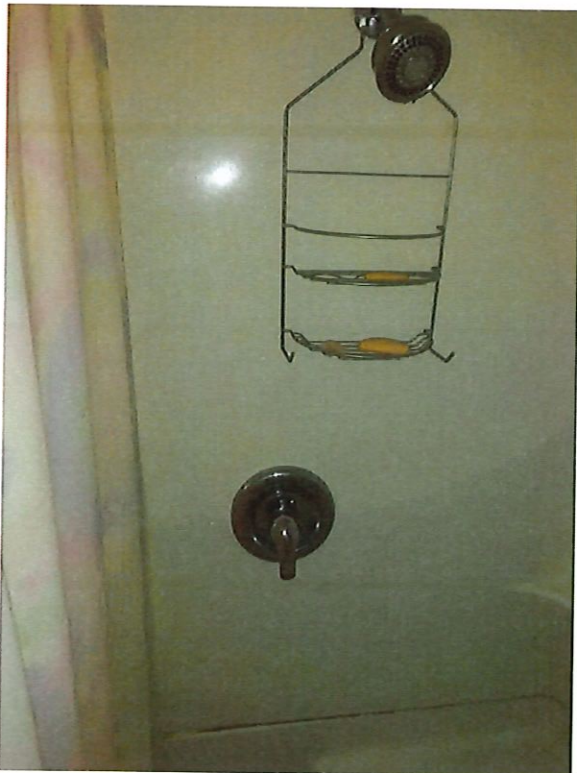
Awkward steps into shower

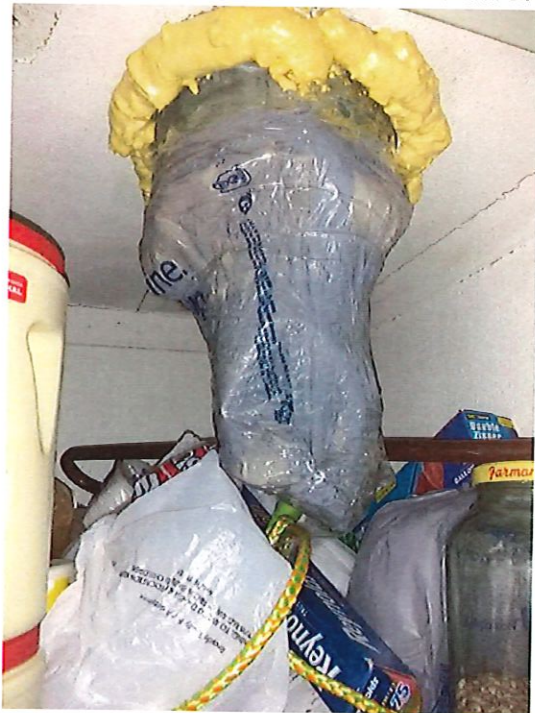
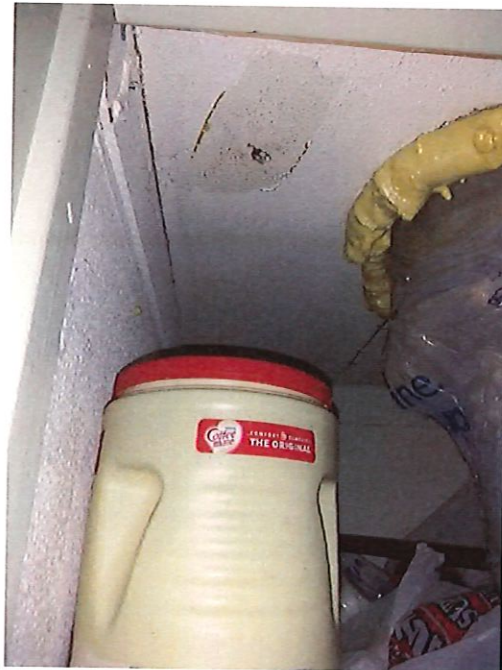
Central air and heat removed and covered duct
