Disaster Recovery Program

PROJECT: Approval for Assistance under the Disaster Recovery Program Housing Project.

INITIAL INSPECTION

Address: 5414 Nicole Dr. Edinburg Tx.

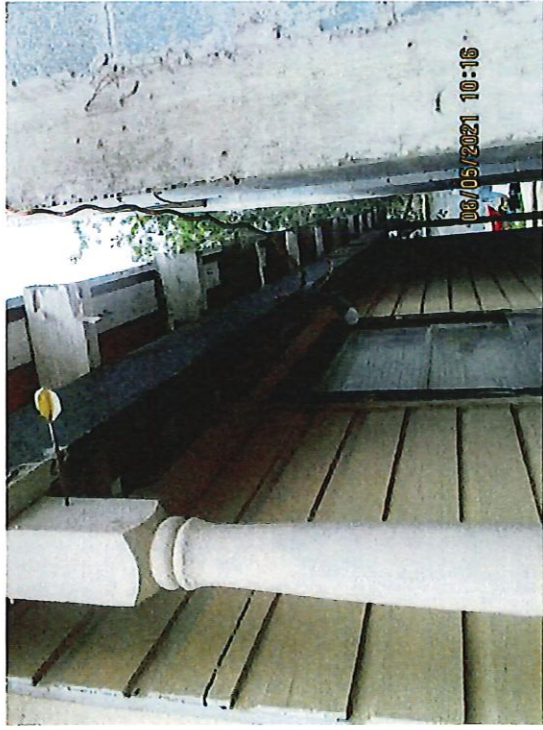
There soffit present is rotten . The trim needs to be replaced due to deterioration.

Soffit and Fascia

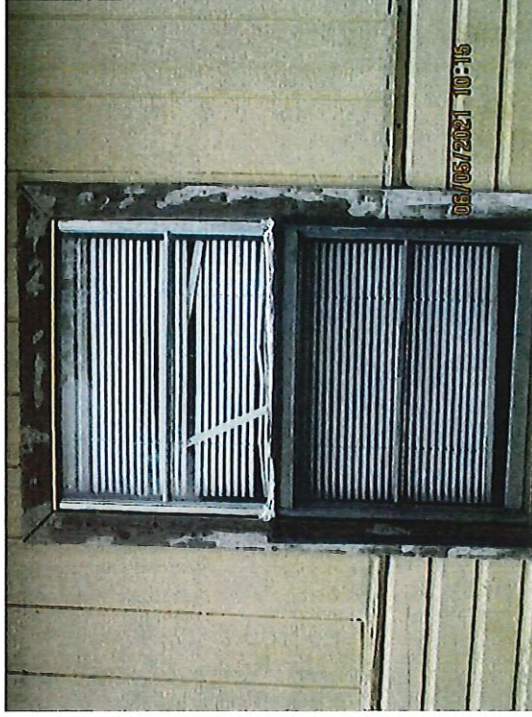
The 8 windows are not in good working order and need to be replaced. Windows are made of aluminum and are hard to open.

inoperable windows

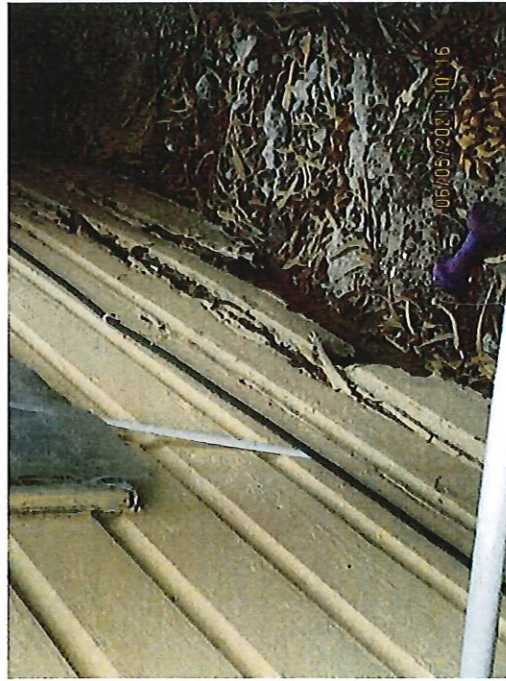
The exterior wood siding is rotten and needs to be replaced.

Rotten Wood Siding

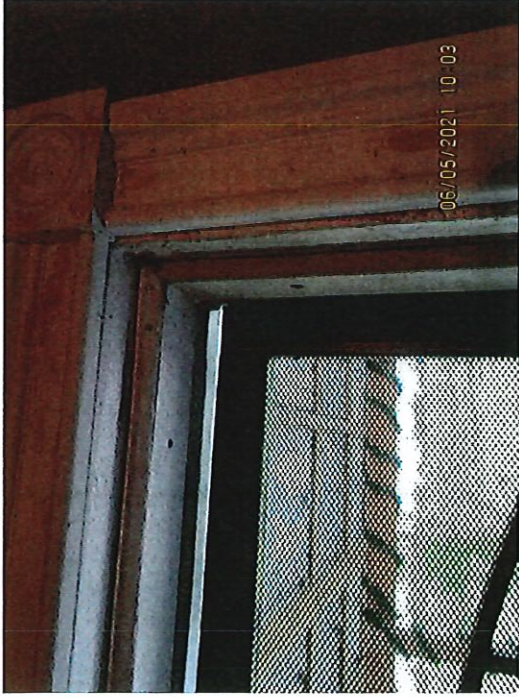
The exterior doors need to be replaced. The door frame is damaged and cracked due to the shifting of the house.

Entry door does not close properly

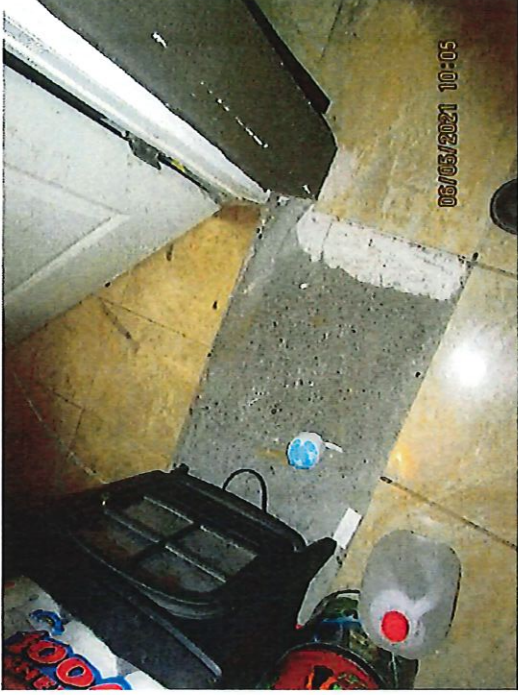
The flooring for the entire house needs to be replaced. In several areas vinyl flooring is worn. In the areas with ceramic tile, the tile is broken creating sharp edges.

Broken Tile

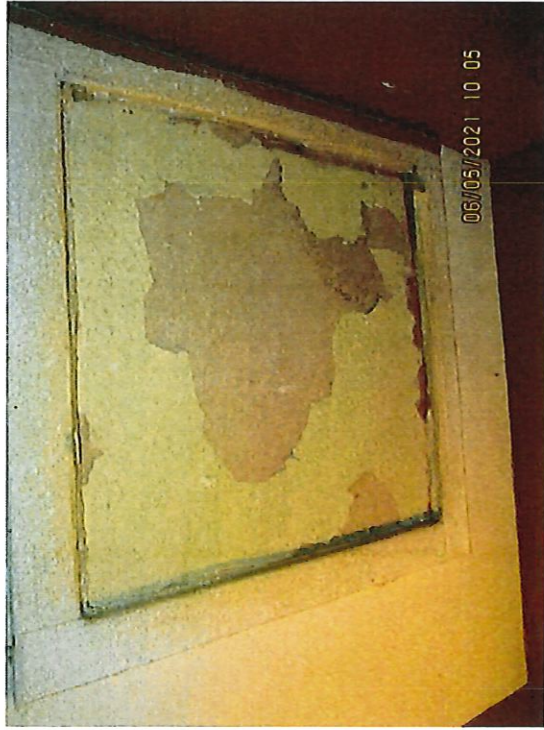
The ceiling coverings have mold and several areas where water damage has stained the ceiling. Repairs that have been made by owner are starting to leak again and sag.

Ceiling covering is damaged

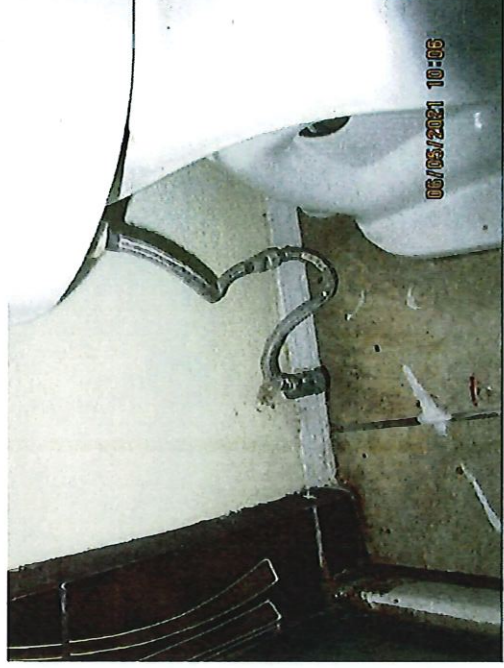
The insulation appears to have mold and needs to be replaced as per inspection.

Mold and rot

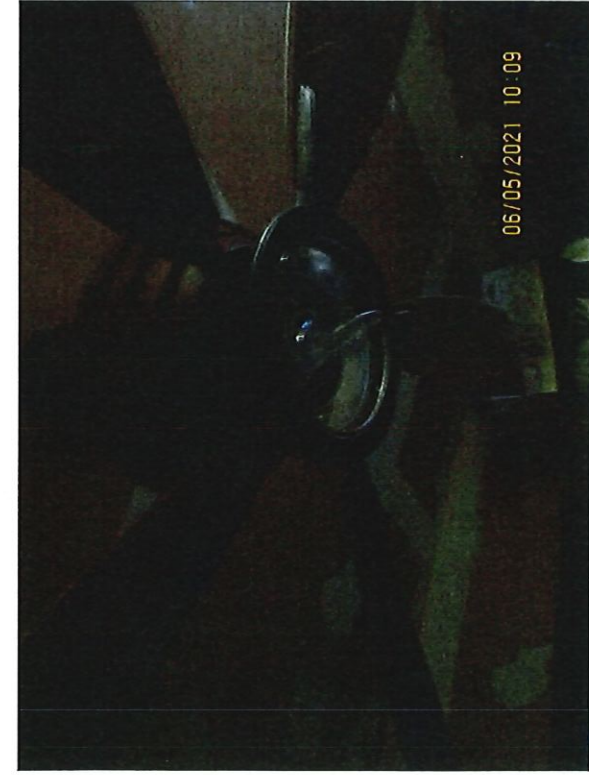
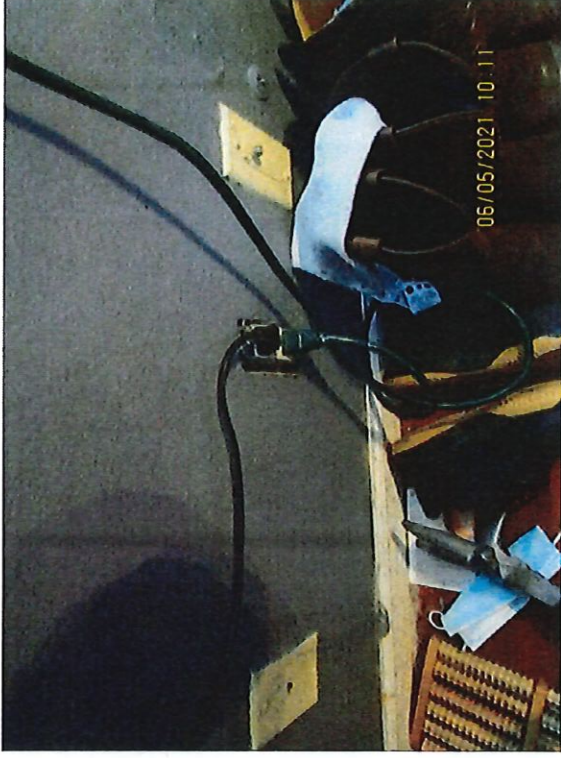
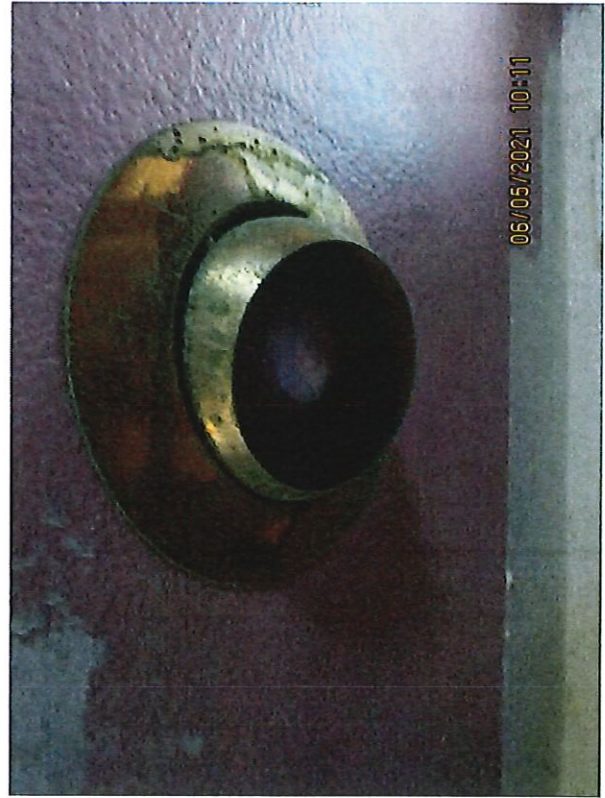
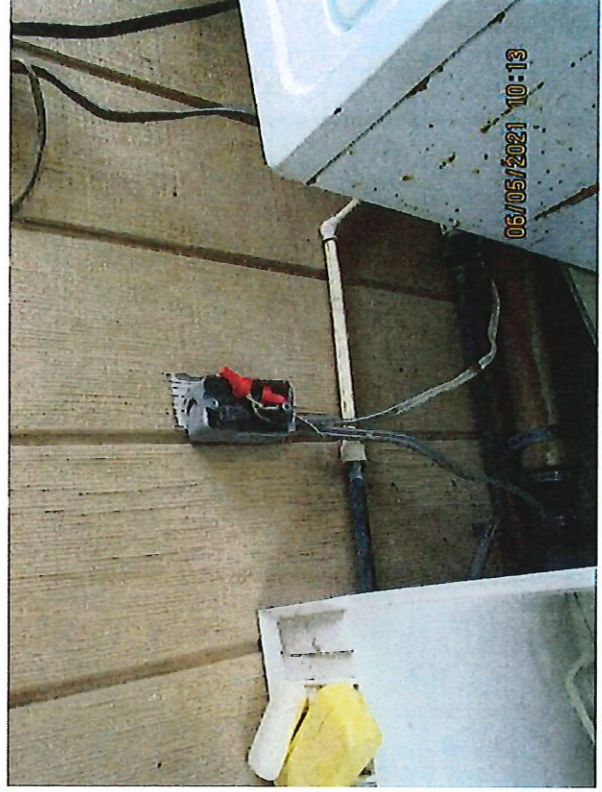
There were several plugs throughout the house that were not working. Electrical needs to be inspected for electrical shorts. Many switch and electrical outlet covers were missing leaving wires exposed.

Electrical Deficiencies

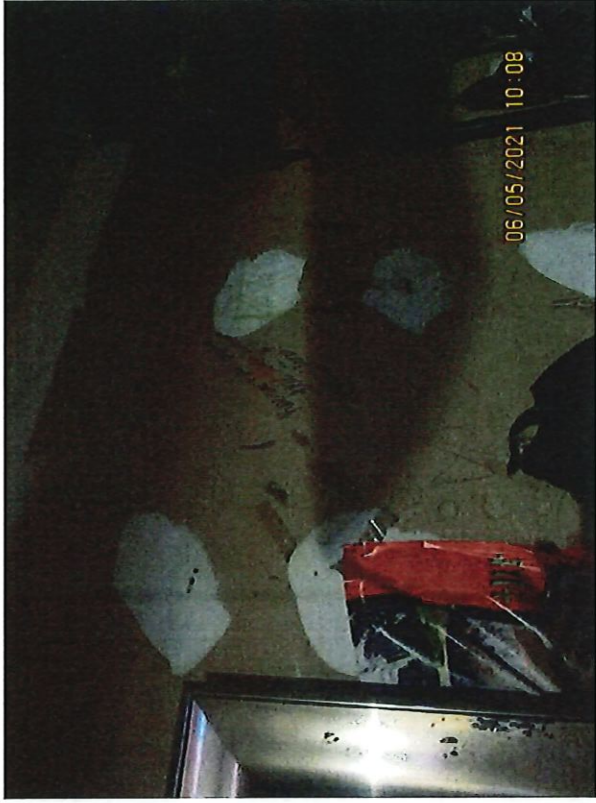
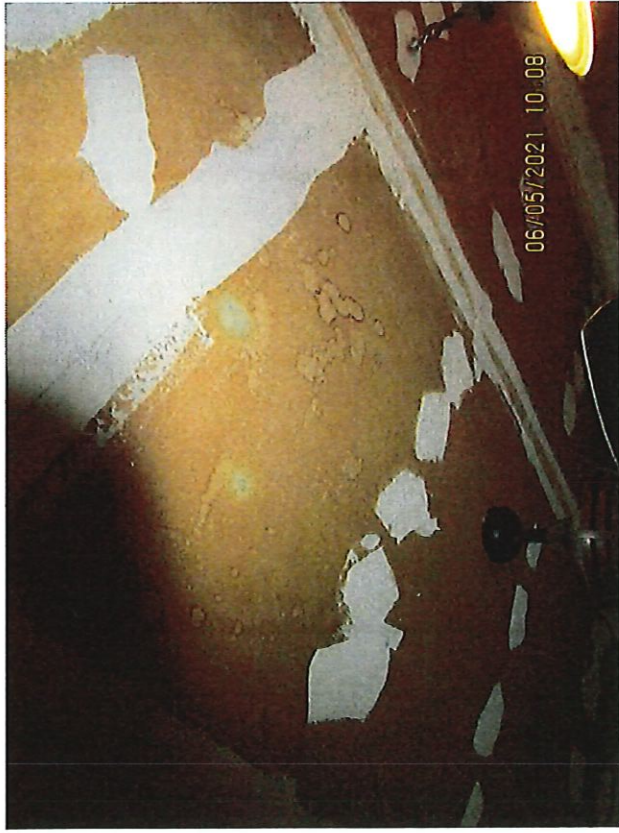
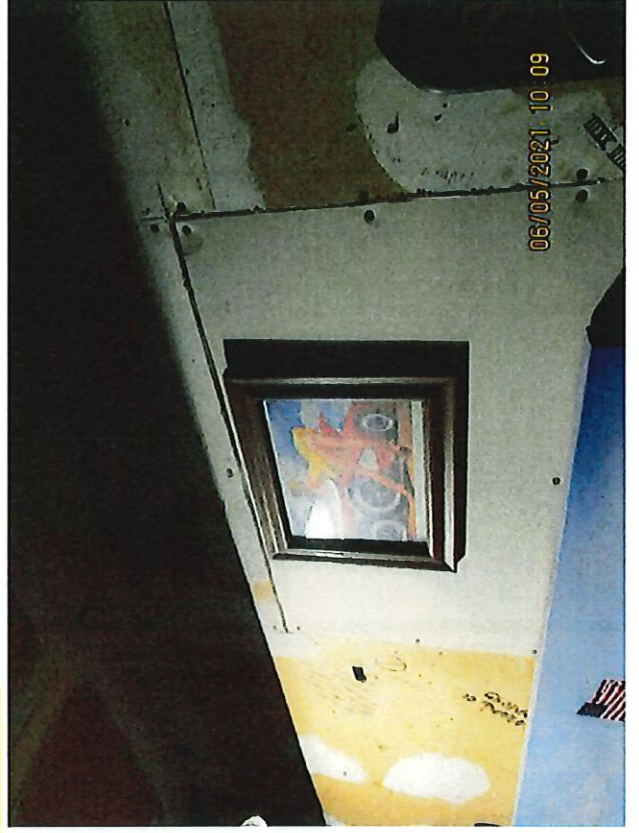
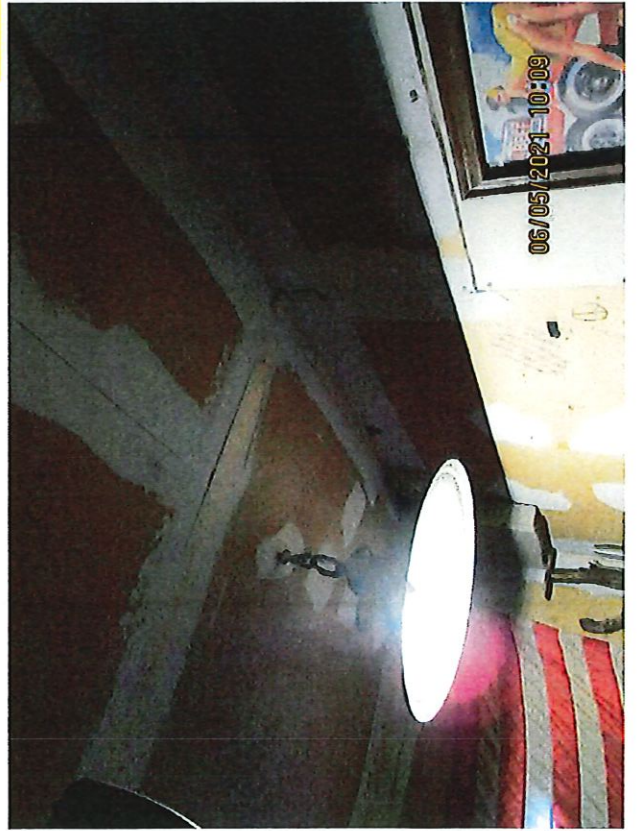
The wall coverings and trim are in need of repair. There are holes in walls and cracks due to pier and beam movement. Discoloration on some wall that leak water. Areas that were repaired were left unfinished.

Ceiling & wall Deficiencies
