Disaster Recovery Program

PROJECT: Approval for Assistance under the Disaster Recovery Program Housing Project.

INITIAL INSPECTION

Address: 4107 Ansley Dr. Edinburg Tx.

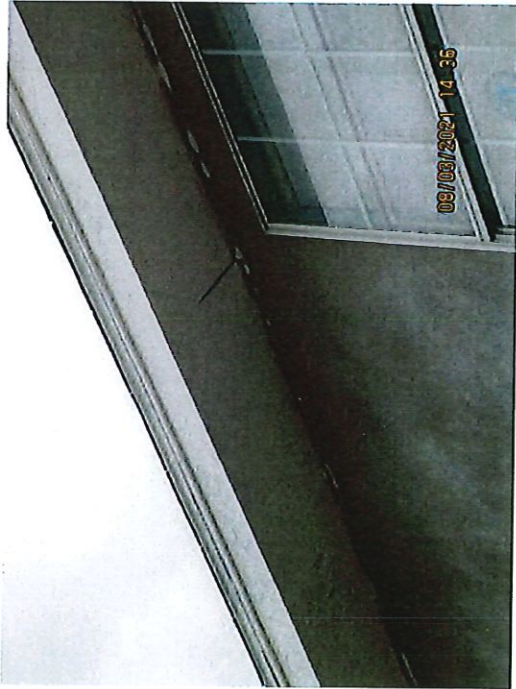
There soffit present is rotten and sagging. The trim needs to be replaced due to deterioration.

Soffit and Fascia

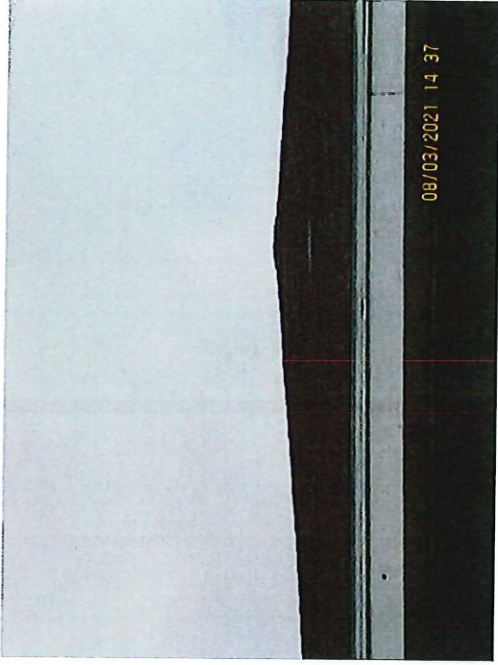
The roofing shingles and paper felt need to be replaced. The plywood decking needs to be inspected for deterioration due to water stains in the house.

Deteriorated shingles and sagging roof decking

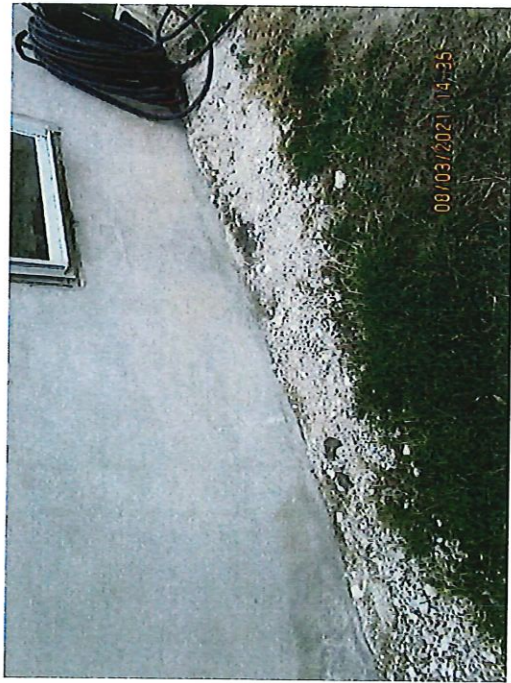
The Foundation is a slab on grade. The foundation is in need of major repair. There are several areas in the home where the slab leaks water in it rains.

Gravel and concrete added to Slab to help keep water out

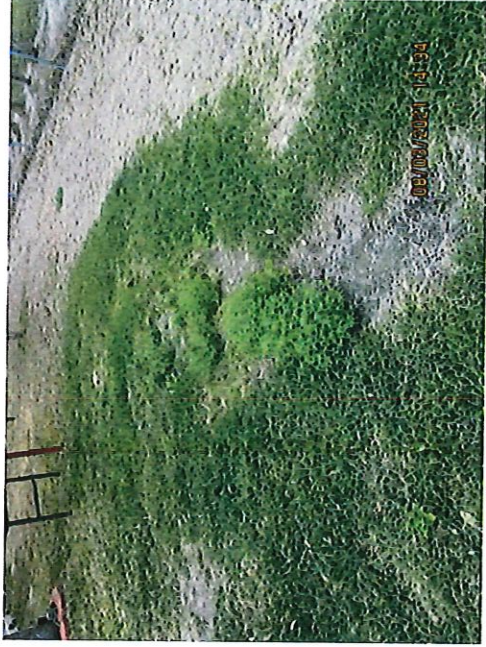
Is plumbing free from sewer back up? No sewer gas enters the home, and water leaks in the yard

leaking septic tanks

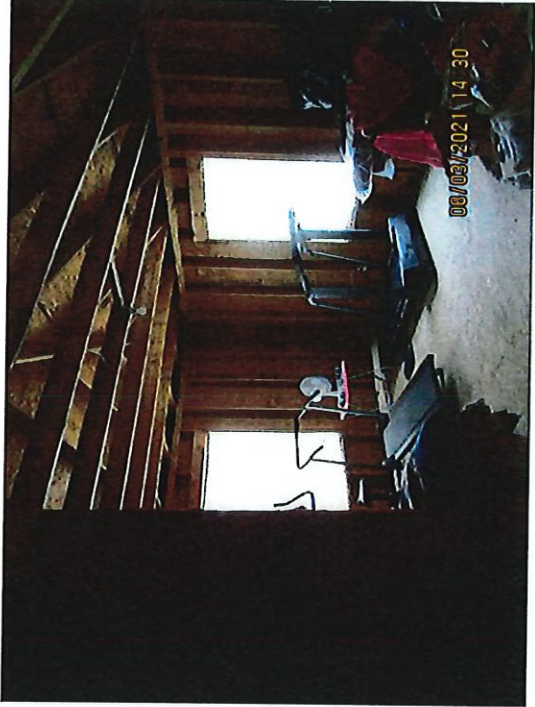
The insulation in walls and attic need to be upgraded.

no insulation

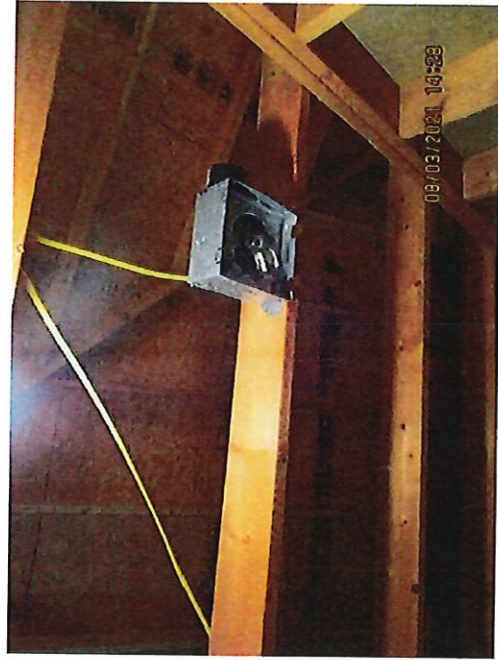
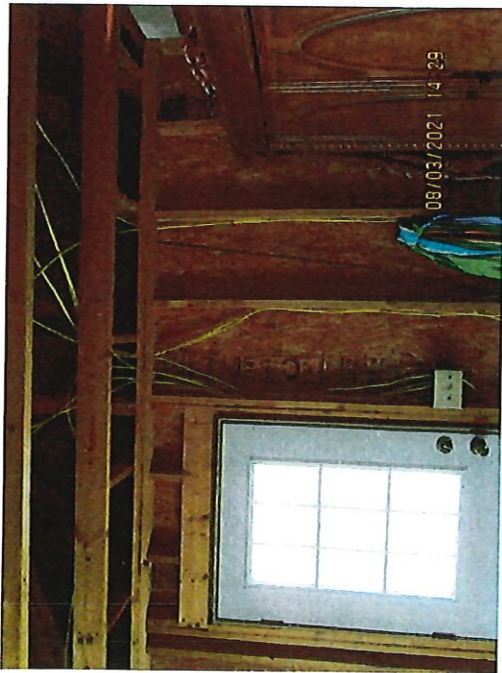
The house has many rooms unfinished with exposed studs the drywall was removed do to water exposure
 Estimated Cost \$ 2,000

Entry no drywall on walls or ceiling
