Disaster Recovery Program

PROJECT: Approval for Assistance under the Disaster Recovery Program Housing Project.

INITIAL INSPECTION

Address: 5414 Leigh Ann Dr. Edinburg Tx.

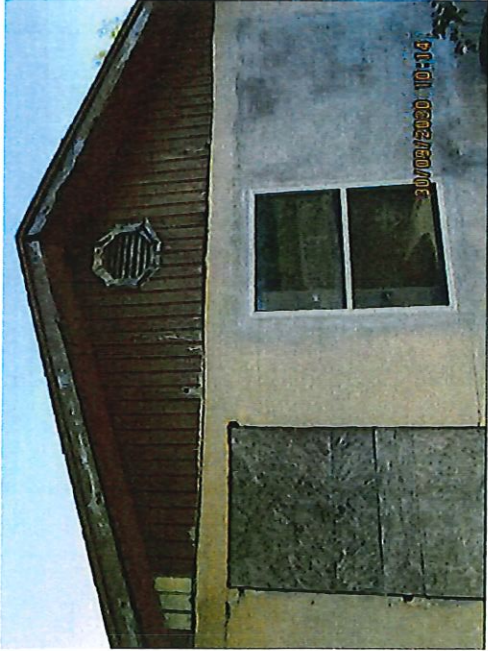
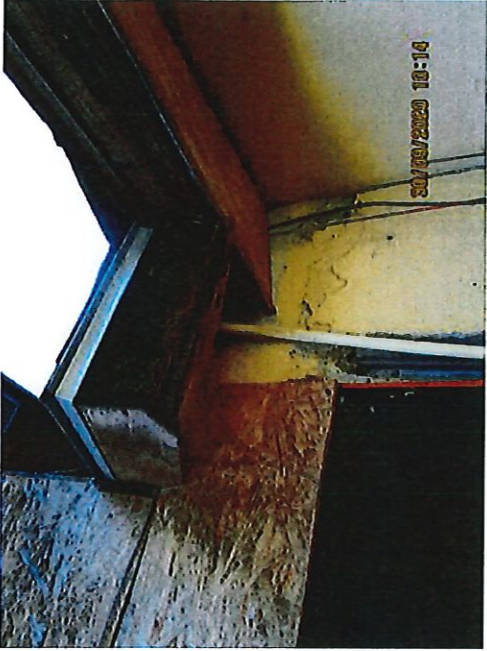
Soffit and Fascia & Roof

There soffit present is rotten and has many holes. The trim needs to be replaced due to deterioration.

The roofing shingles and paper felt need to be replaced. The plywood decking needs to be replaced due to severe deterioration. Water stains mold and fallen ceilings through the house.

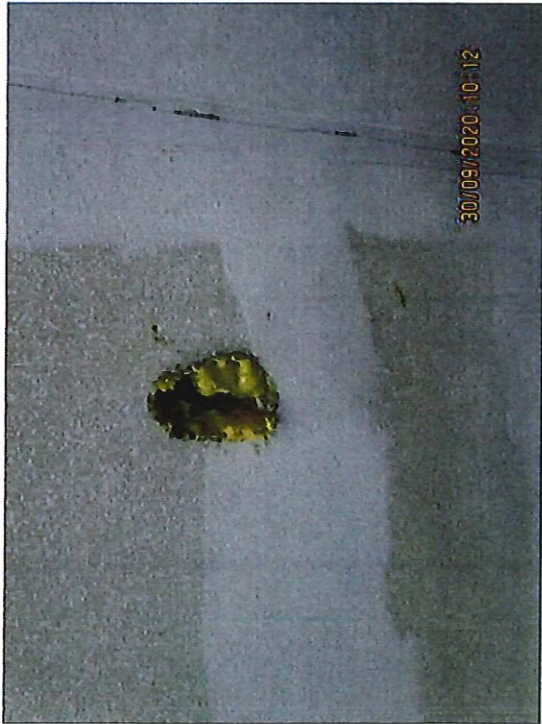
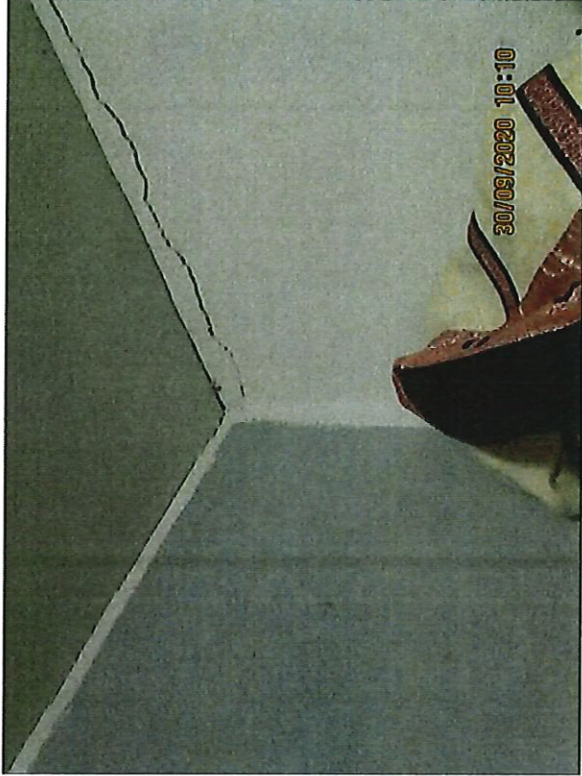
Cracks in walls/Ceilings

The Foundation is a slab on grade. The foundation is in need of major repair. There are several areas in the home where the slab has cracked and uneven.

The house has no wall coverings only painted cmu. There are holes and cracks in the cmu walls due to foundation movement. Door frames and trims are broken and do not close properly.

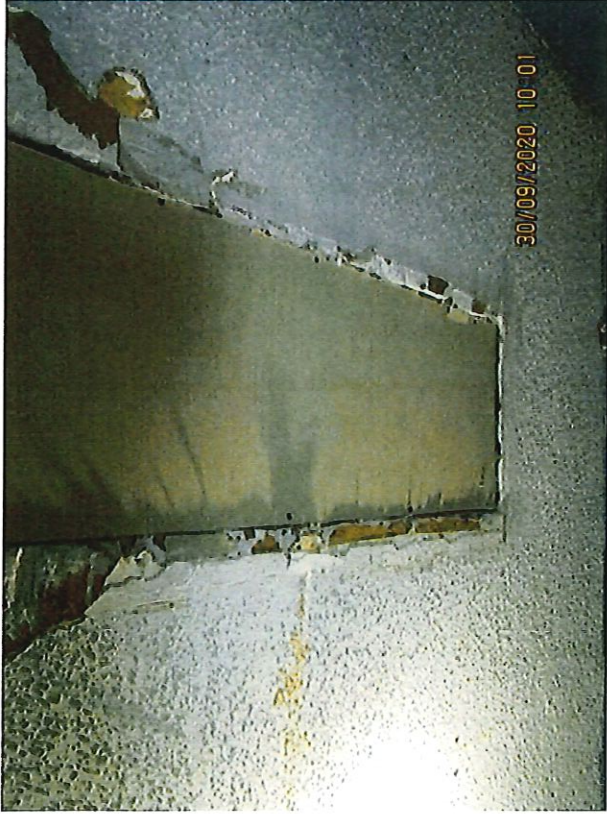
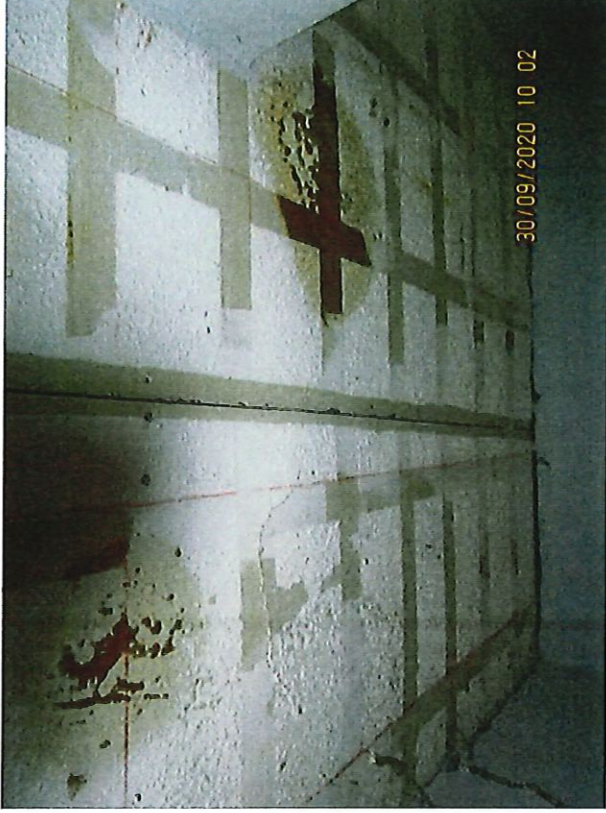
Ceiling Deficiencies

The ceiling coverings have mold and several areas where water damage has stained the ceiling..

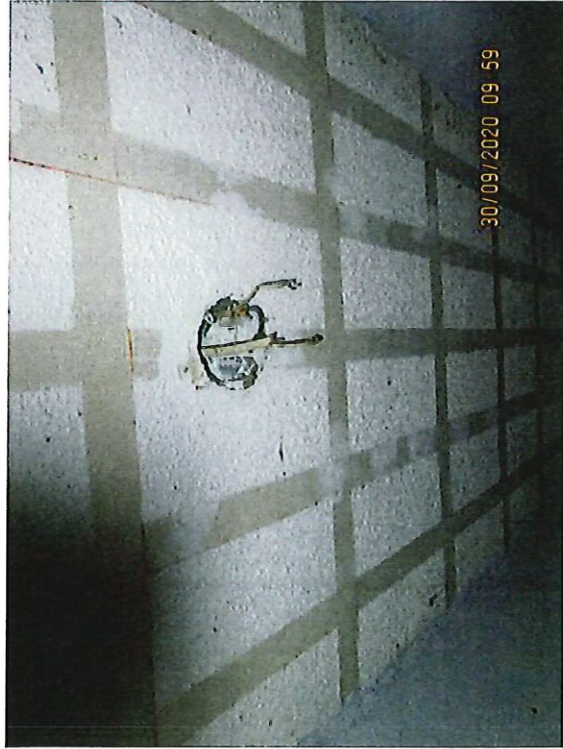
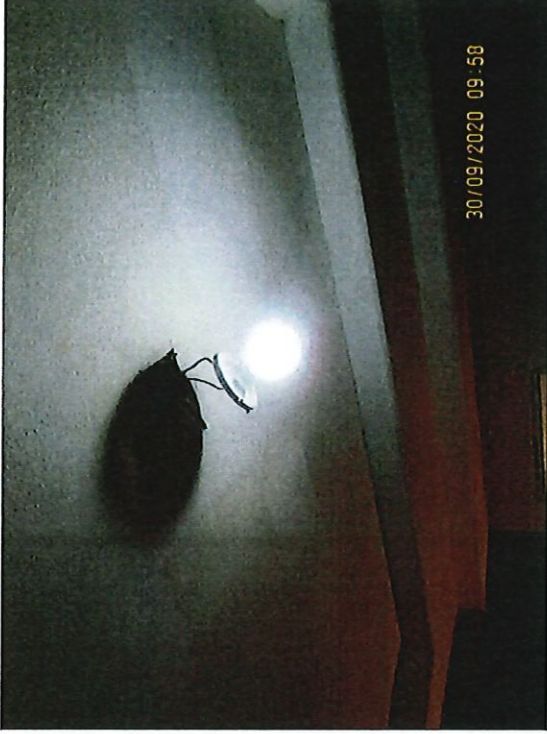
Electrical Deficiencies

There were several plugs throughout the house that were not working. Several ceiling light fixtures in the house were also not working. Electrical needs to be inspected for electrical shorts. Many switch and electrical outlet covers were missing leaving wires exposed.

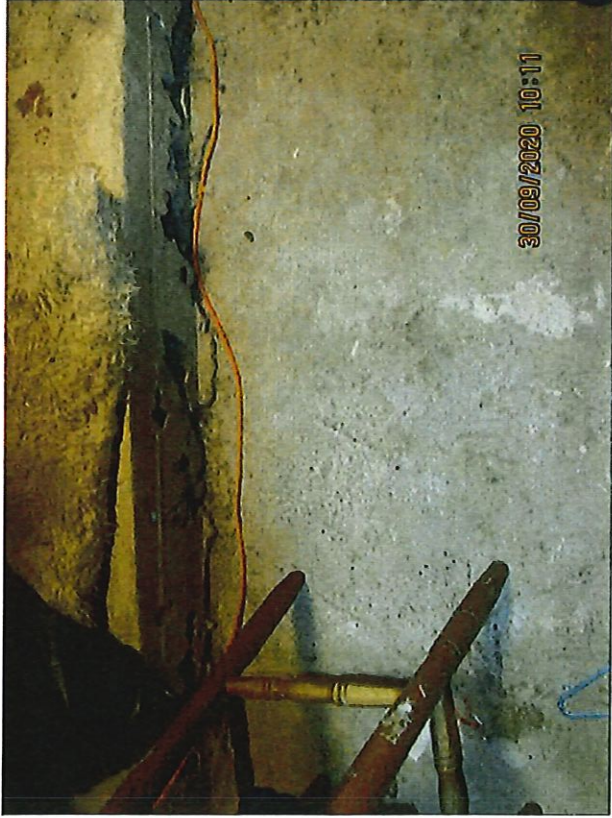
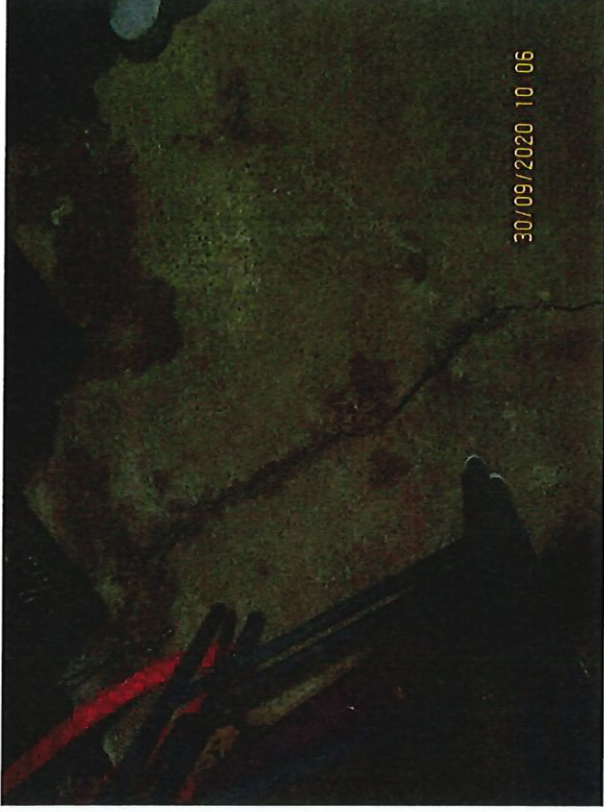
Flooring Deficiencies

The entire house needs flooring most areas have tile and its cracked with sharp edges other areas bare conc.
