Follow-Up Microbial Assessment

Hidalgo County Courthouse Building
100 North Closner Boulevard
Edinburg, Texas

October 18, 2021
Terracon Project No. 88217071

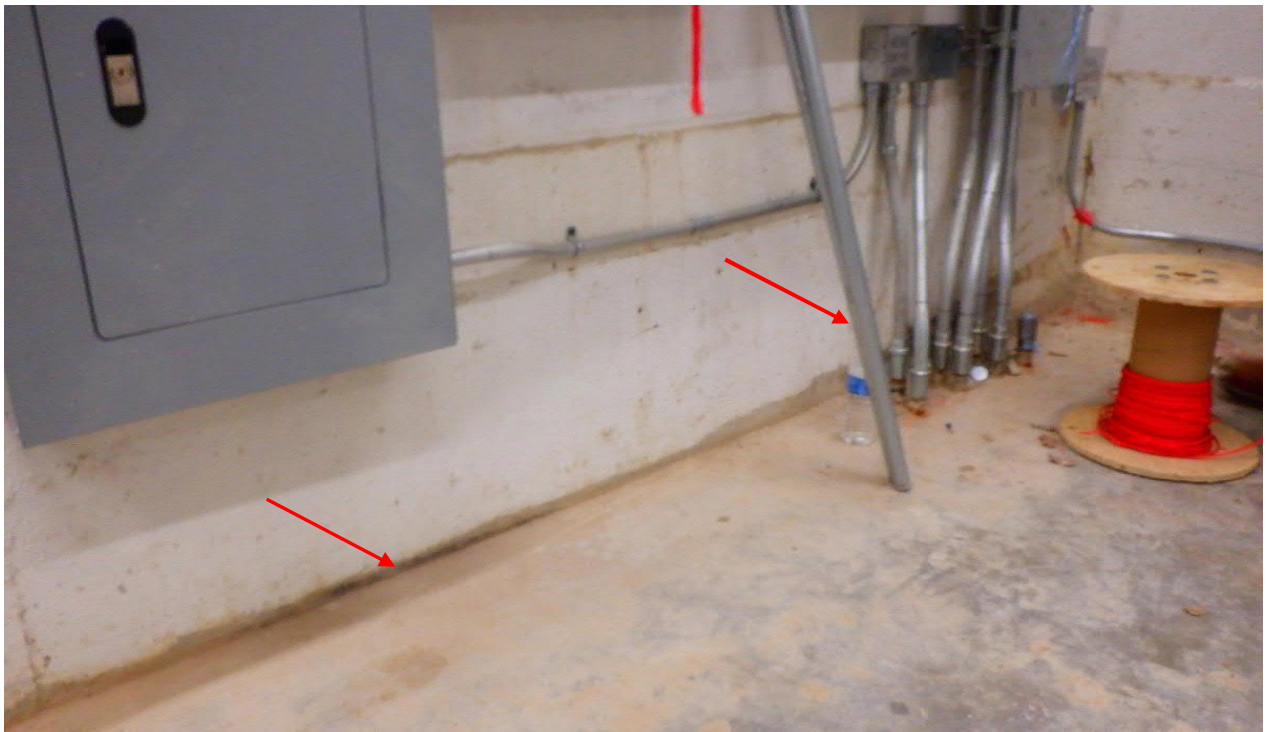
Location	Material	Moisture Content	Possible Source
First Floor - Electrical Room, 1A-158, northwest lower wall	Fungal growth on CMU block/concrete wall	N/A	No active moisture intrusion observed. Possible sources include standing water accumulation during construction activities
First Floor – Stair No. 1, ST-1A1, southeast lower wall	Gypsum wall board	11.2%	Previous moisture impacted gypsum wallboard, wall cut out observed, no moisture/fungal impact in wall cavity
Second Floor – Justice 4, 2B-134, north lower wall	Moisture stained and suspect fungal growth on gypsum wallboard	18.5%	No active moisture intrusion observed. Possible sources include standing water accumulation during construction activities
Second Floor – Electrical 2A-146 / Mechanical 2A-147, west lower wall	Gypsum wall board	N/A	Previous moisture impacted gypsum wallboard, wall cut out observed, no moisture/fungal impact in wall cavity

The fungal growth on the referenced building materials in Table 2.0 appeared to be related to moisture intrusion/impact from previous accumulation of standing water on the floor during construction activities (e.g., plumbing installations, floor cleaning, etc.). The quantity of visible fungal growth on the identified building material surface observed and sampled is estimated at two square feet, and did not exceed the regulatory threshold of 25 contiguous square feet as defined in the MARAR.

Photo #1 View of fungal growth locations observed on northwest lower CMU block/concrete wall in 1st Floor Electrical Room 1A-158.

- Non-porous CMU block/concrete wall materials where non-regulated fungal growth was observed as reported in Table 2.0 should be cleaned with a non-ionic detergent or household disinfectant and cleaned with a high efficiency particulate air (HEPA)-filtered vacuum. During cleaning procedures, polyethylene barriers should be installed over supply and return air vents in the areas where cleaning occurs.

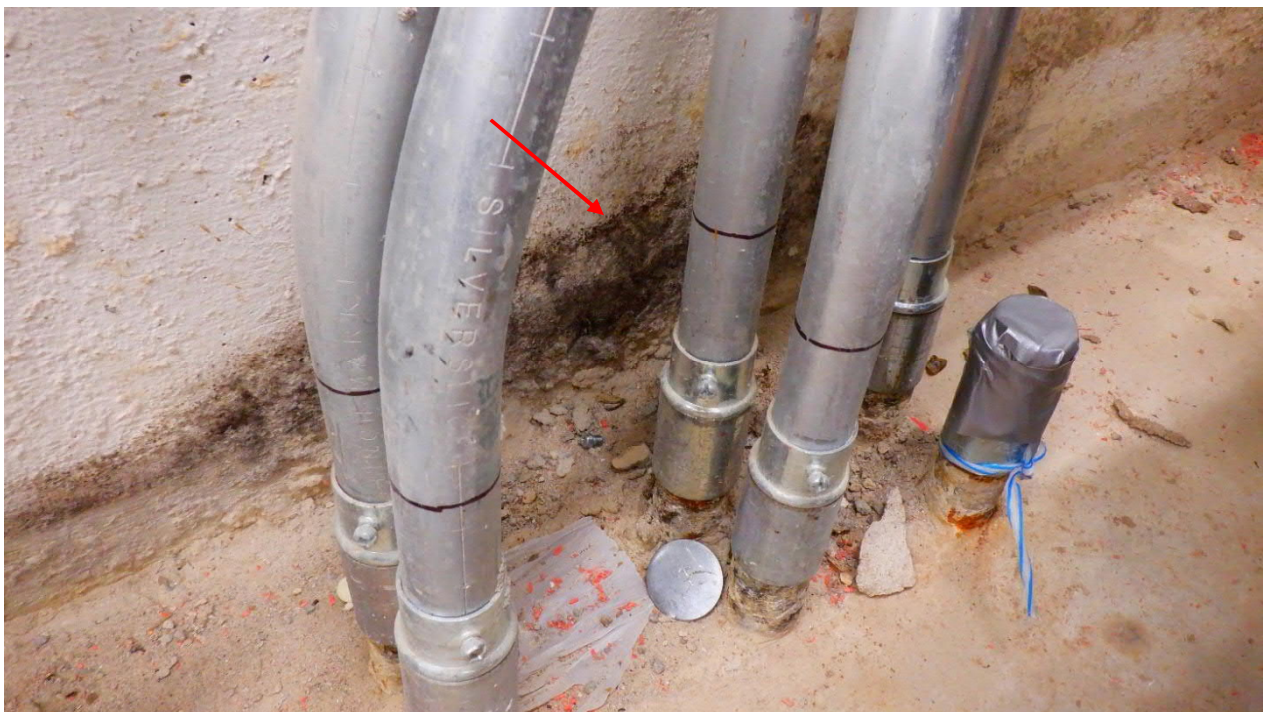
Photo #2 Closer view of fungal growth locations observed on northwest lower CMU block/concrete wall in 1st Floor Electrical Room 1A-158.

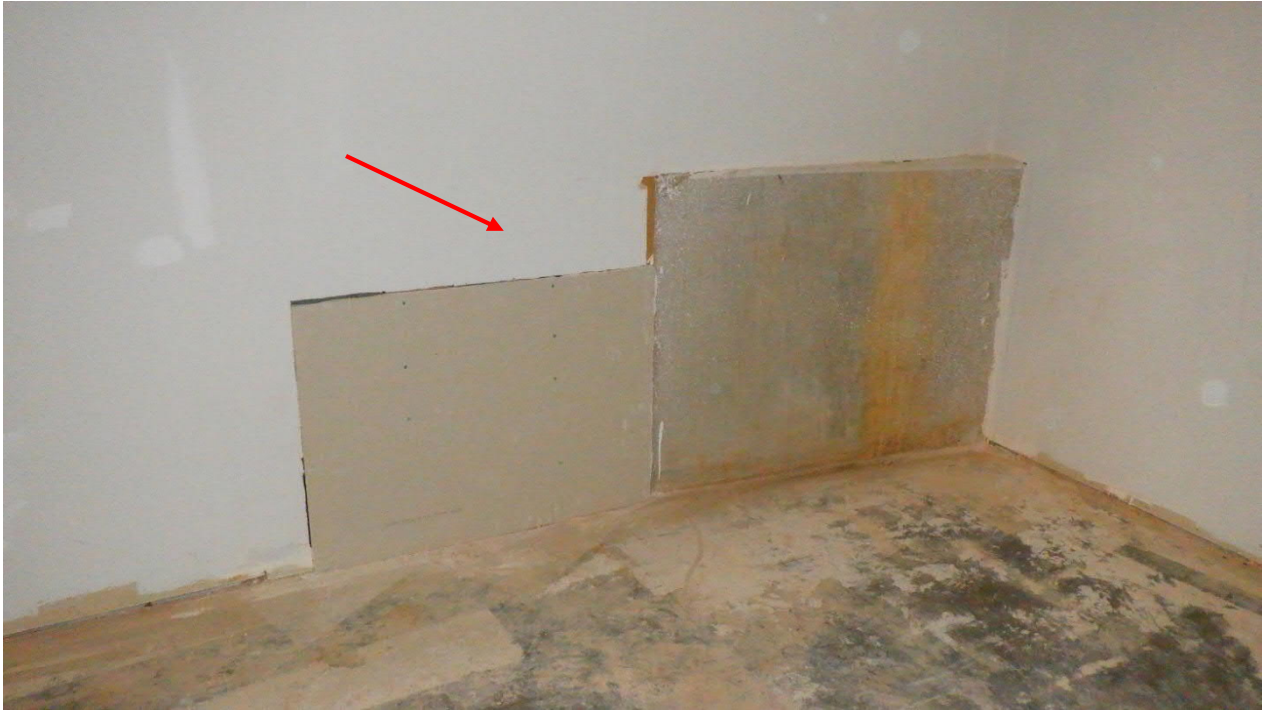
Photo #3 View of area where moisture/fungal impacted gypsum wallboard was removed and replaced in the southeast portion of the 1st Floor Stair No.1 ST-1A1.

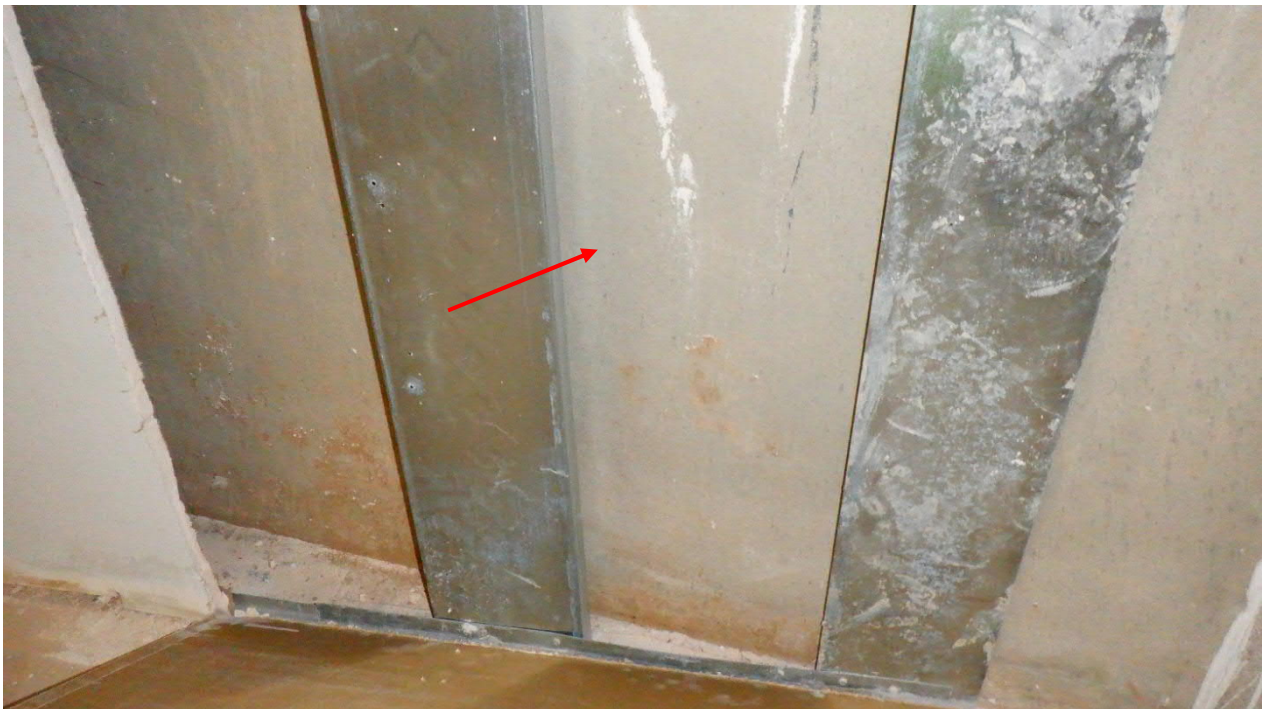
Photo #4 View of wall cavity for Photo #3 location. No moisture stains/fungal growth observed.

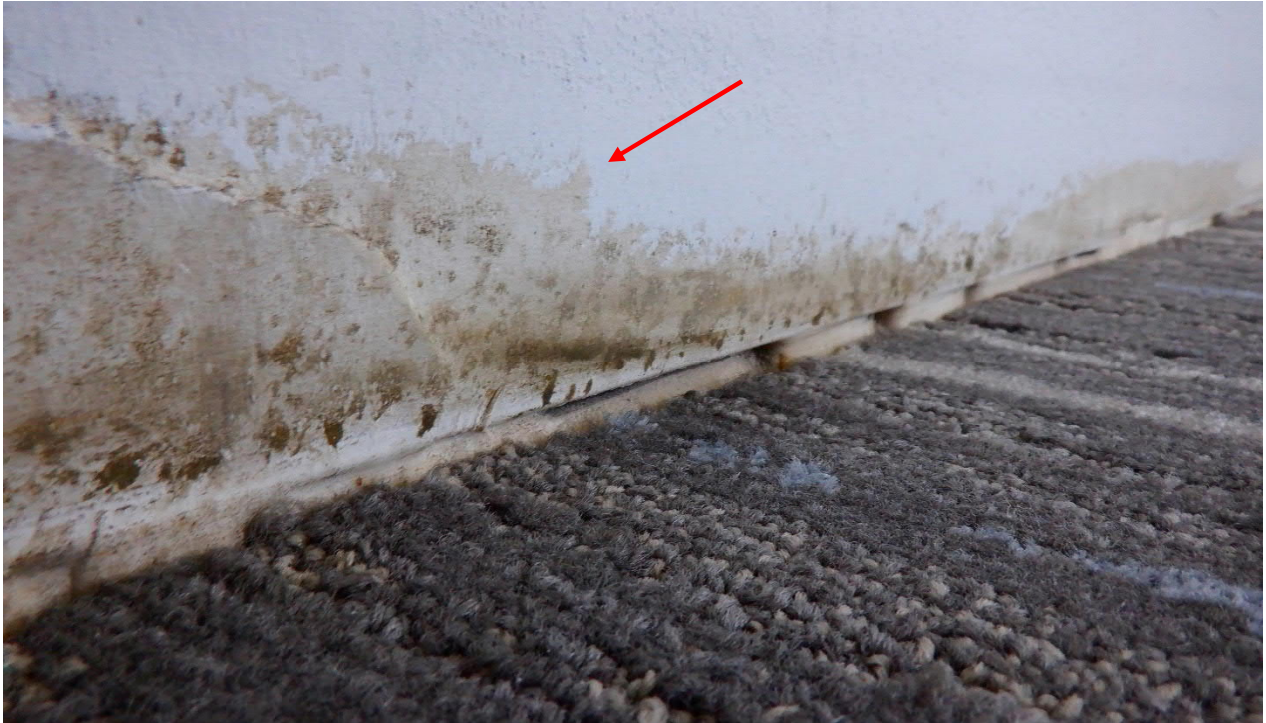
Photo #5 View of moisture impacted lower gypsum wallboard observed in the north portion of the 2nd Floor Justice 4, 2B-134. No fungal growth reported in surface sample TL-2.

- The porous, moisture impacted ceiling tile materials reported in Table 1.0 should be removed. The porous, moisture impacted gypsum wallboard materials reported in Table 1.0 should be removed, extending one foot horizontally and vertically past moisture damage.

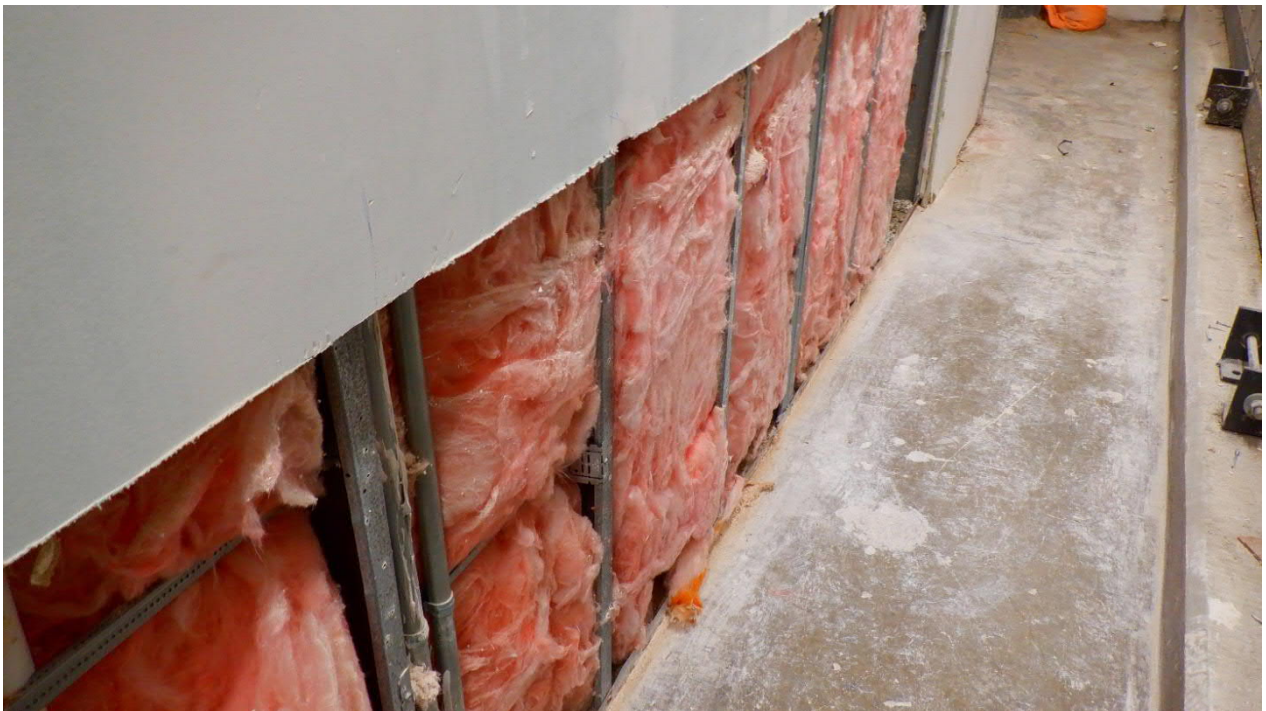
Photo #6 View of area where moisture impacted gypsum wallboard was removed in the east portion of the 2nd Floor Electrical 2A-146 and Mechanical 2A-147.

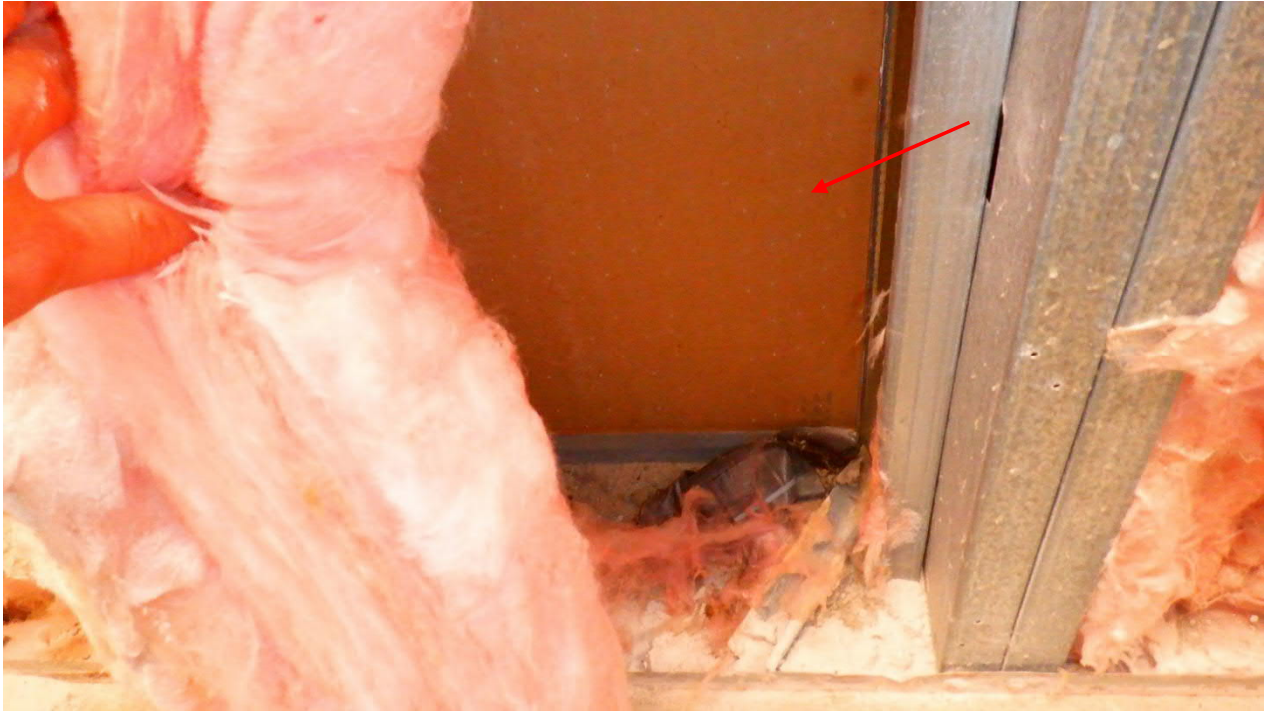
Photo #7 View of wall cavity for Photo #6 location. No moisture stains/fungal growth observed.

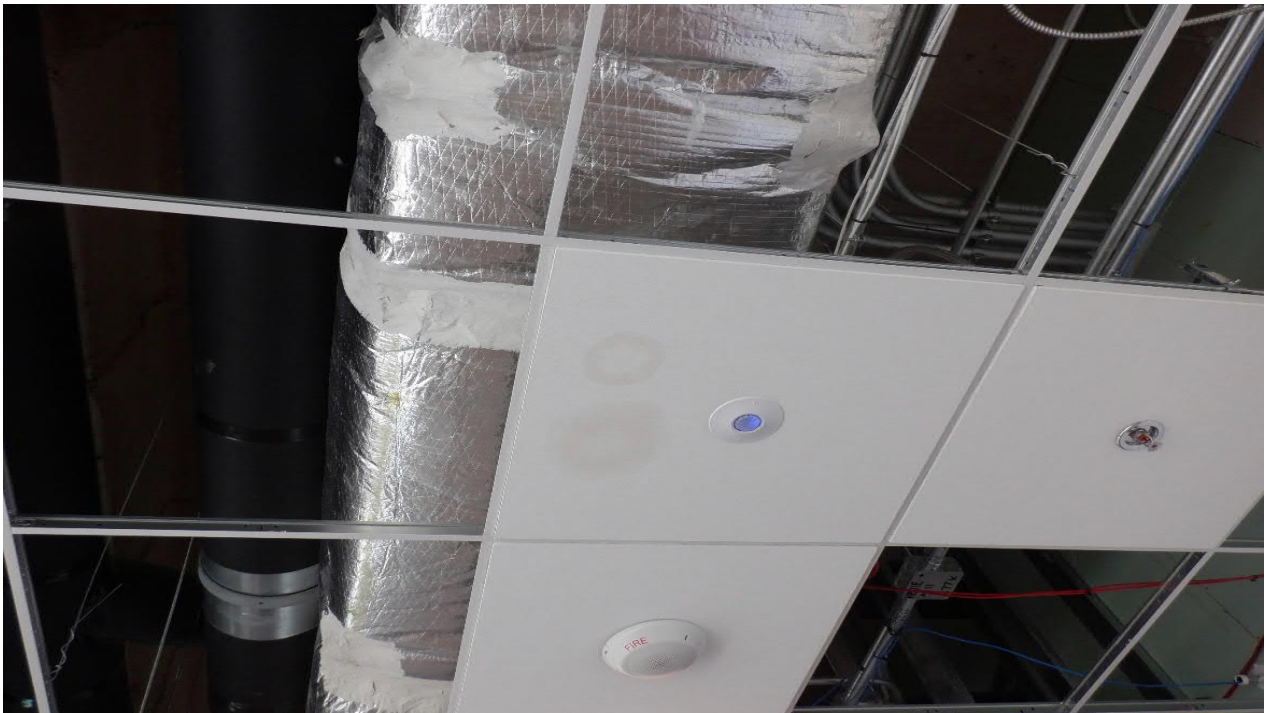
Third Floor – Public Circulation, 3A-001, near center ceiling area	Moisture stained suspended acoustical ceiling tile	9.3%	No active moisture intrusion observed. Possible sources include overhead HVAC duct condensation, fire sprinkler/plumbing pipes

Photo #8 View of moisture stains on ceiling tile in the center area of the 3rd Floor Public Circulation 3A-001.

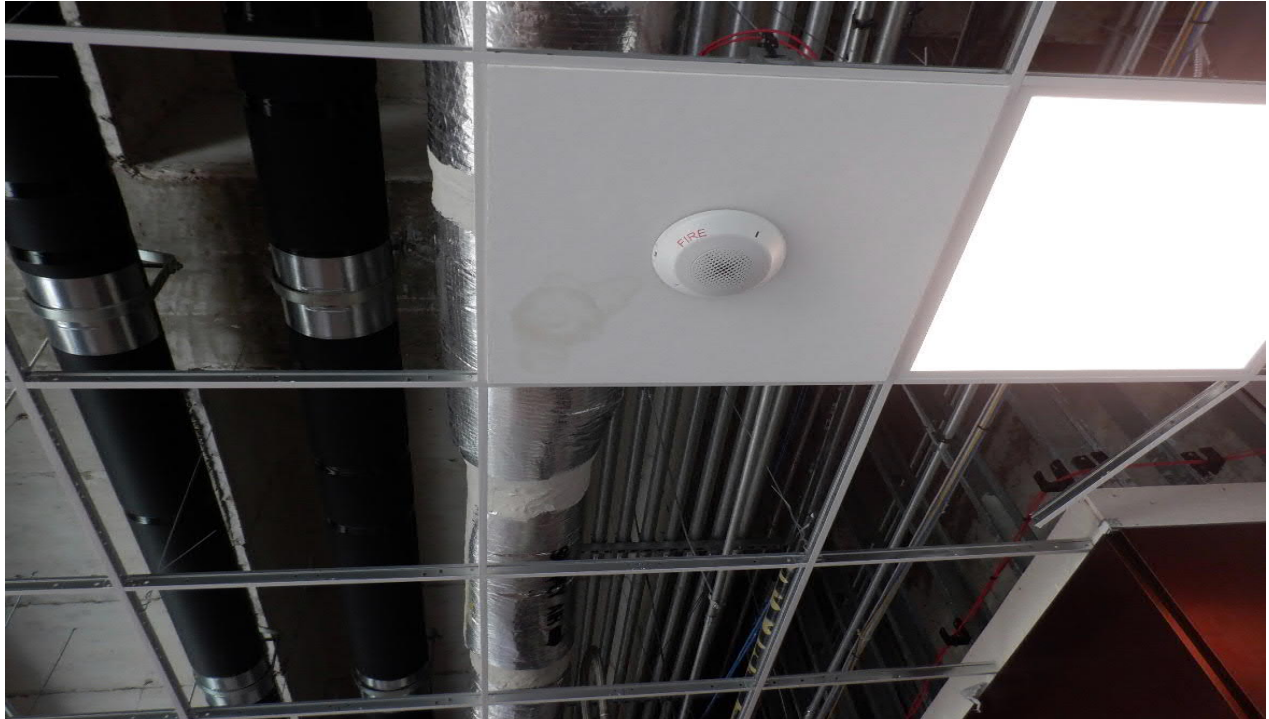
Photo #9 View of moisture stains on ceiling tile in the western area of the 7th Floor Public Circulation 7A-001.

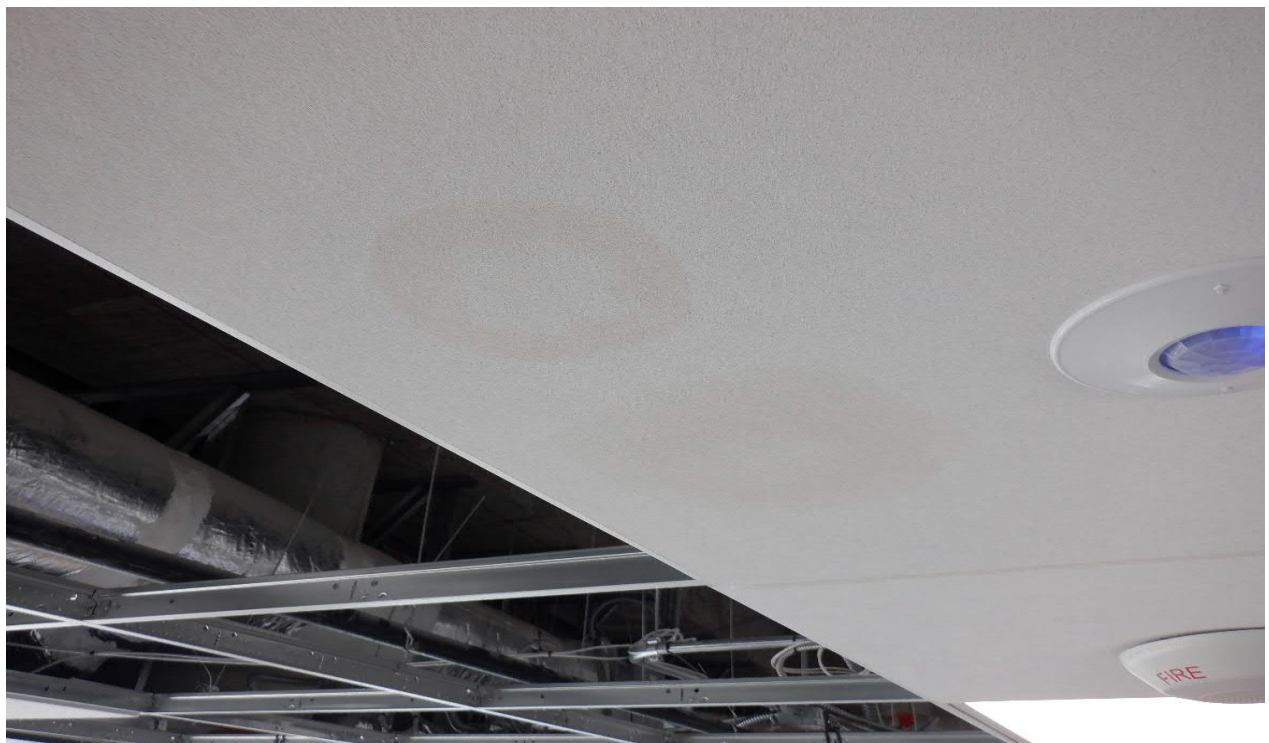
Photo #10 View of moisture stains on ceiling tile in the center area of the 7th Floor Public Circulation 7A-001.

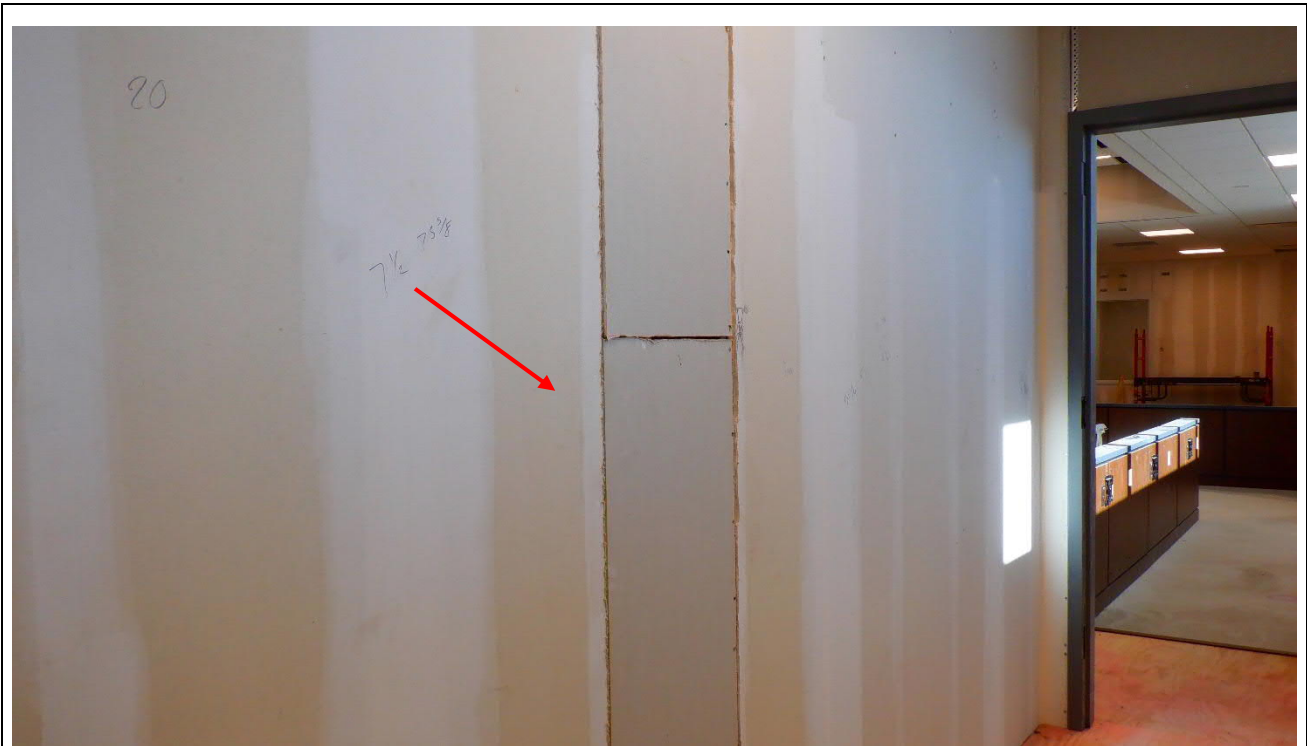
Photo #11 View of area where moisture/fungal impacted gypsum wallboard was removed and replaced, west wall of Entrance to 7th Floor Courtroom 7B-600.

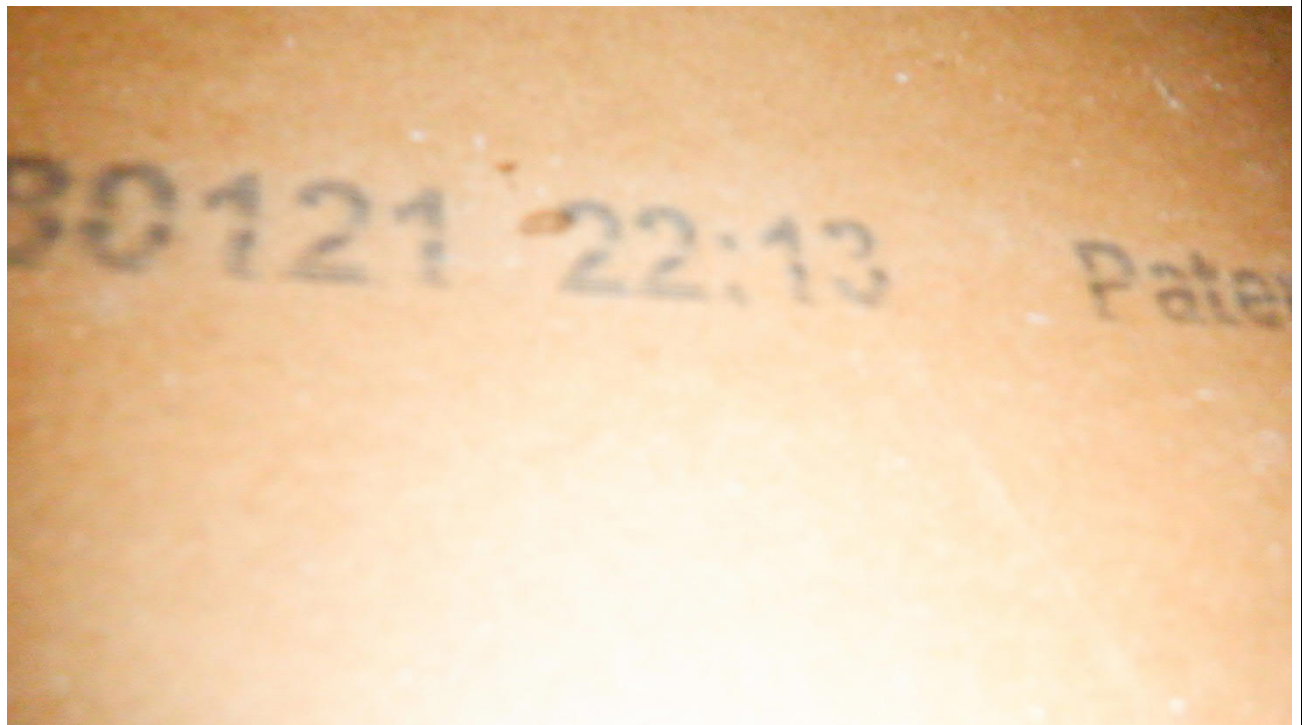
Photo #12 View of wall cavity for Photo #6 location. No moisture stains/fungal growth observed.
