Housing Rehab Program

PROJECT: Reconstruction of a single family housing unit located at: 5901 N. La Homa Rd., Mission, Texas

INITIAL INSPECTION

5901 LA HOMA RD
MISSION, TX
INITIAL HOME PICTURES

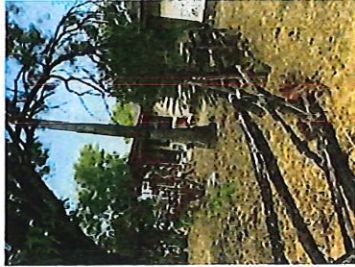
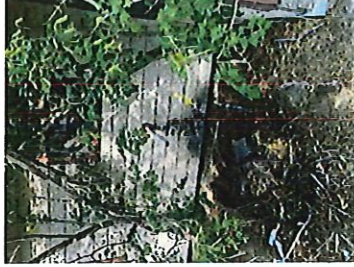
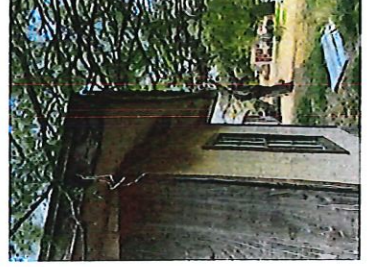
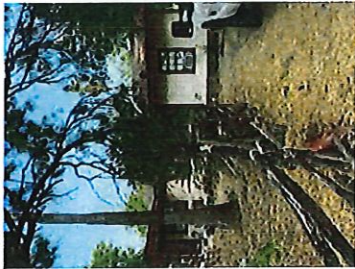
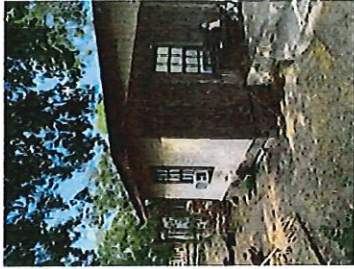
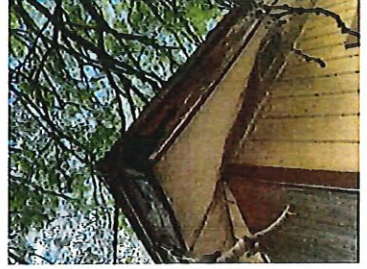
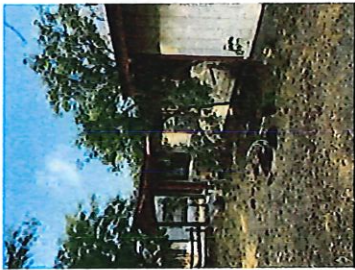
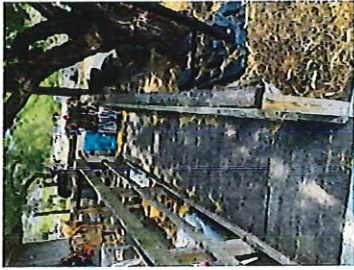
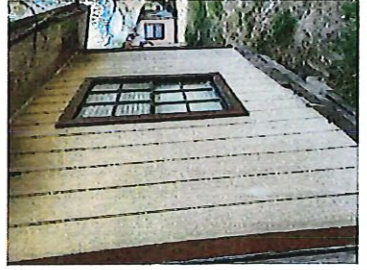
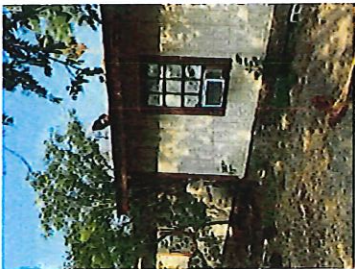
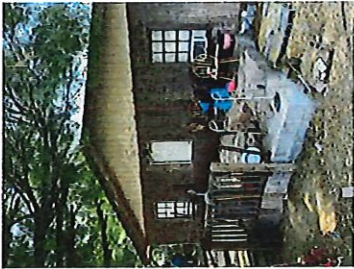
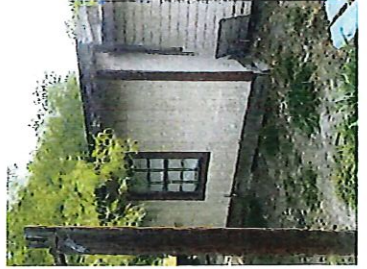
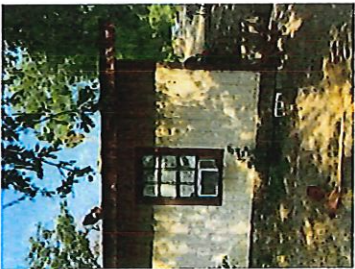
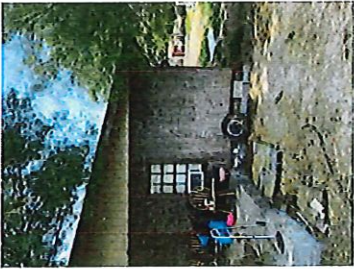
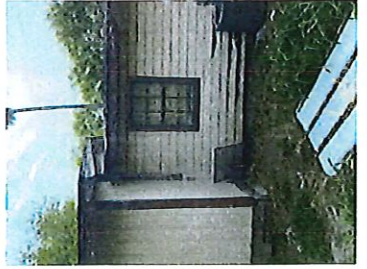
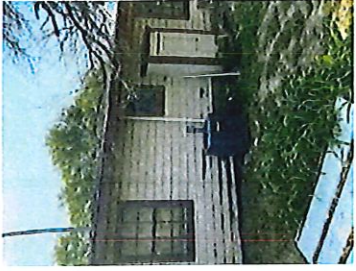
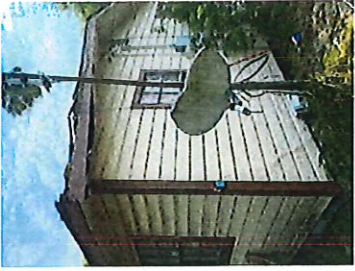
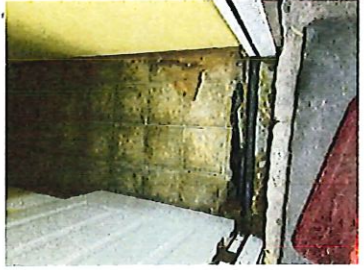
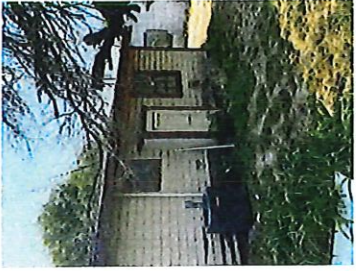
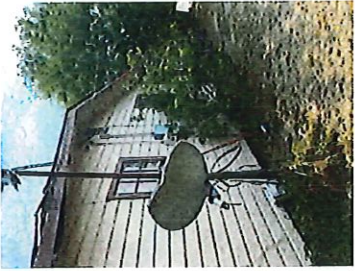
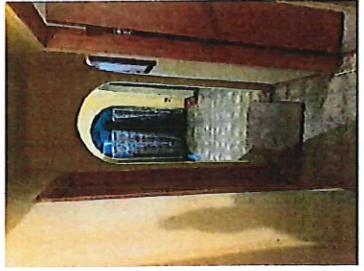
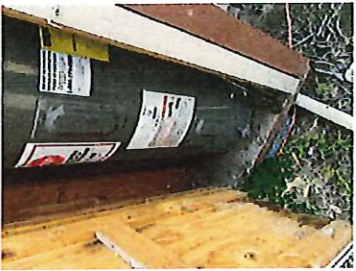
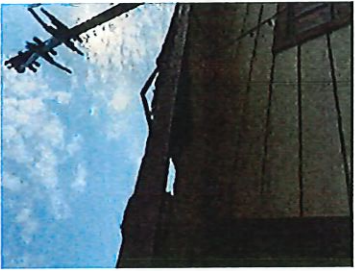
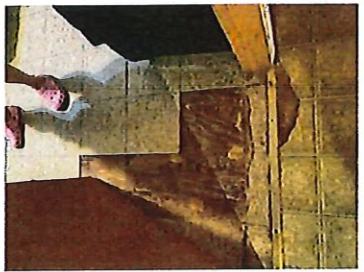
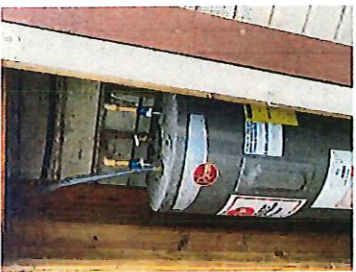
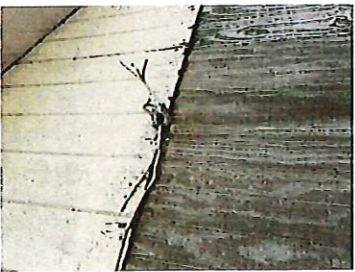
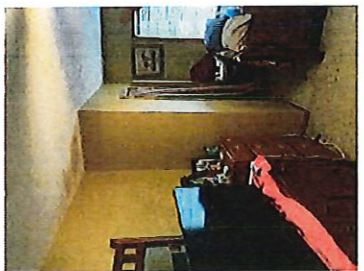
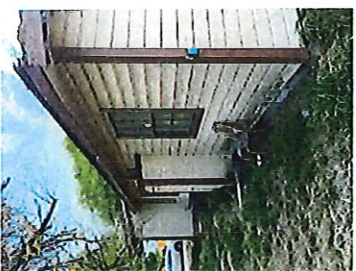
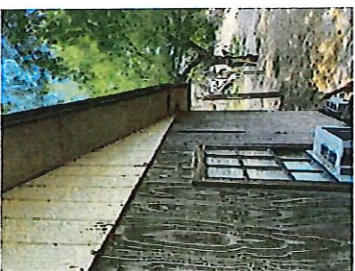
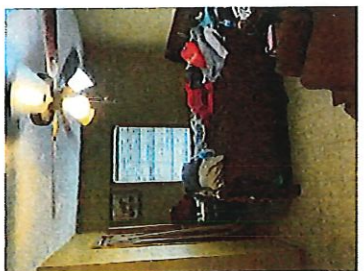
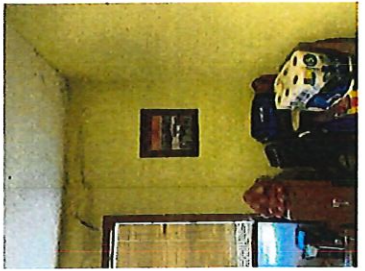
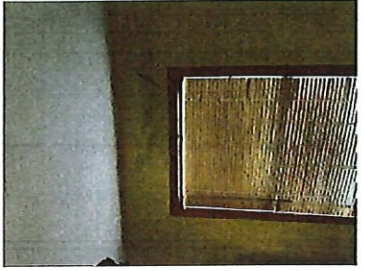
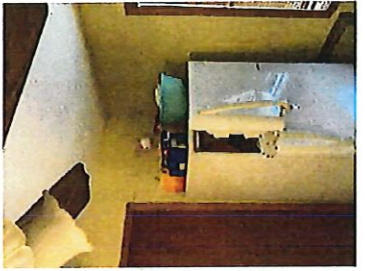
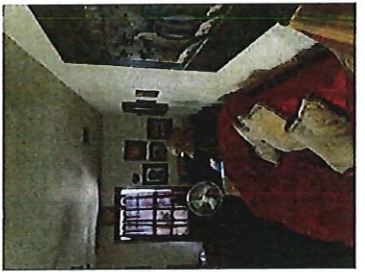
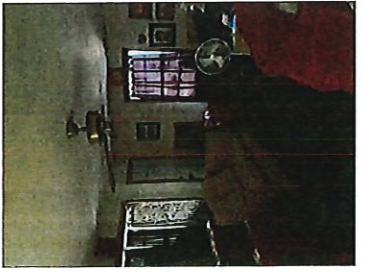
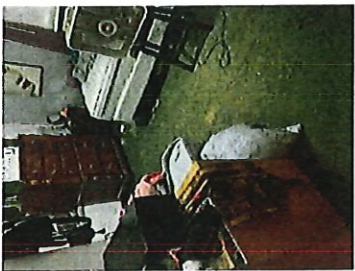
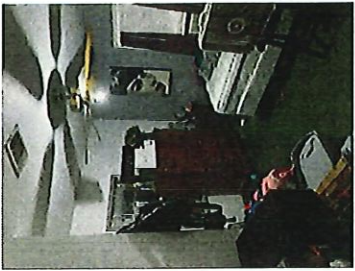
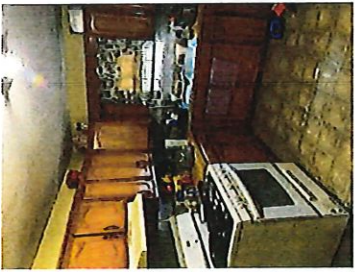
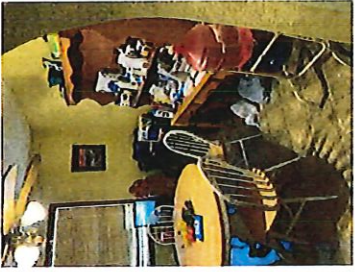
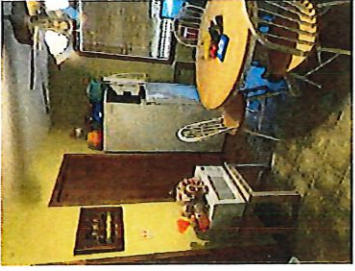
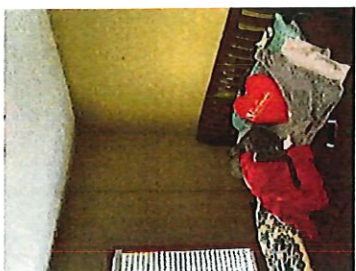
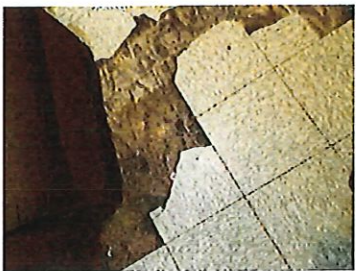
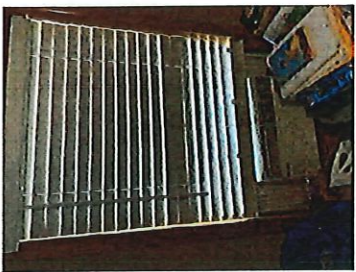
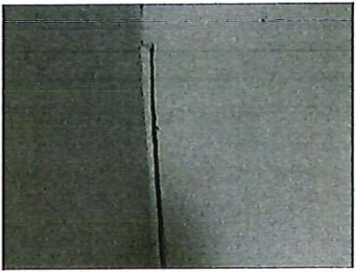
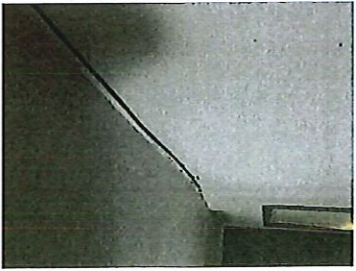
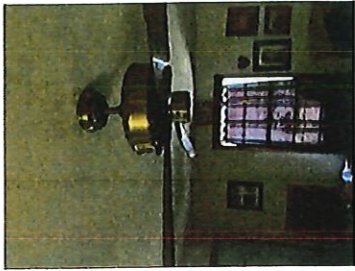
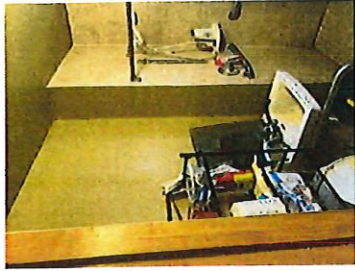
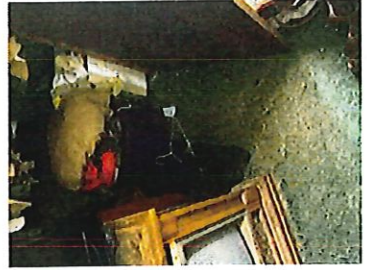
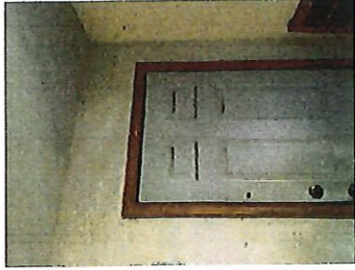
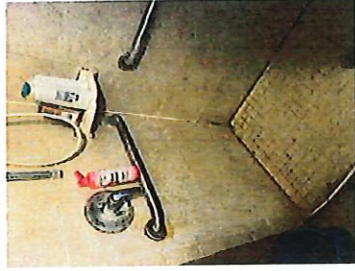
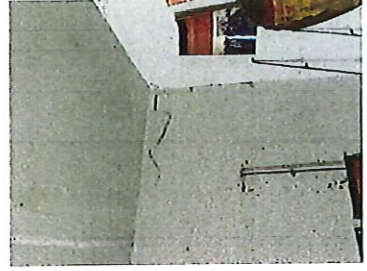
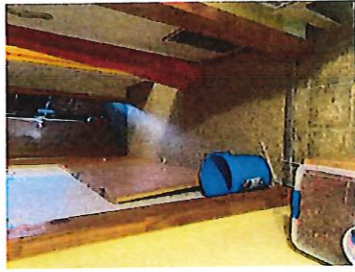
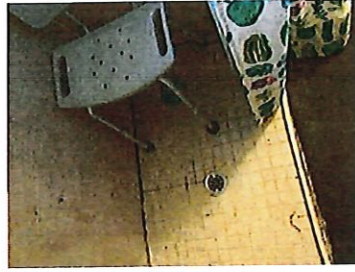
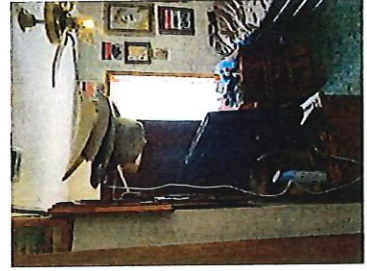
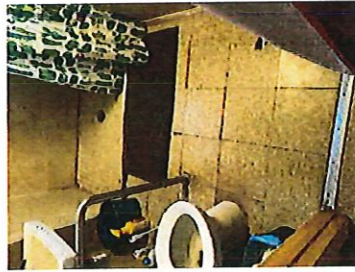
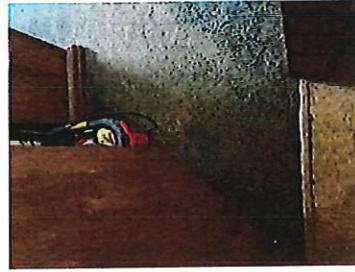
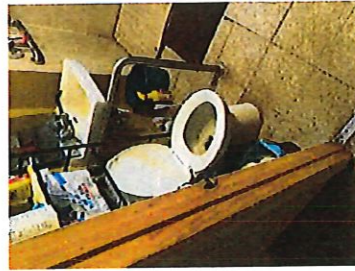
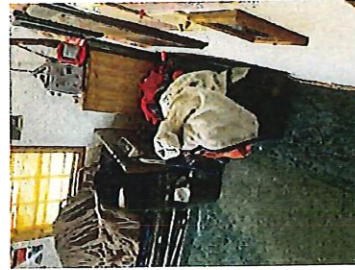
Notes: Floor joist are sagging in several areas of the house. Floor joist might be damaged due to deterioration.

Notes: Siding on the exterior walls has several areas where severe deterioration has occurred.

Notes: The windows in the entire home need to be replaced. Many are broken or not functioning correctly.

Notes: The entry door is broken and does not close properly. The door frame seems to be damaged as well. The exit door located in the rear of the house is also damaged and needs to be replaced.

Notes: The trim and soffit need to be replaced. There are many areas where the soffit will have to be replaced due to severe decomposition.

Notes: The roof needs to be replaced. Shingles are old and many have come off.

Notes: The entry and exit ramp and stairs need to be replaced due to severe deterioration. There are currently no rails installed at the home.

Location(s): The entire house has exposed electrical lines and exposed electrical boxes.

14. Describe **Flooring Conditions** for Entire Dwelling: The entire house needs to be re-done. There are several areas with exposed plywood decking where the VCT tile has been damaged or carpet has come loose.

Notes: Kitchen cabinets are in poor shape. Cabinet doors and hardware is missing. Countertops are damaged and need to be replaced.

Notes: The ceiling needs to be completely replaced due to water damage and holes.

Notes: The wall coverings are completely damaged. The drywall needs to be replaced and repainted.

Notes: The water heater is located at the rear of the house. The water heater looks to be rusted and deteriorated due to the elements. The plumbing and electrical wiring for the water heater needs to be replaced. The base of the water heater closet is rotted out due to water damage.

Notes: Plumbing exposed and several leaks around the house.

Notes: Where drywall was broken inside the home no insulation was present. Insulation was also observed in the central air vents. Insulation will need to be replaced.

Notes: Exposed electrical outlets and switches were noted throughout the house.

23. **INSPECTORS FINAL RECOMMENDATION (Rehab. or Recon. – list reasoning for recommendation):** Recommend demolition and reconstruction due to repairs exceeding over 50% of the value of dwelling and will be triggering policy for Reconstruction.
