PUNCH LIST

ISSUED: November 8, 2023

PROJECT: Hidalgo County Precinct 4 – Allstar Park

PROJECT NO: 1341902

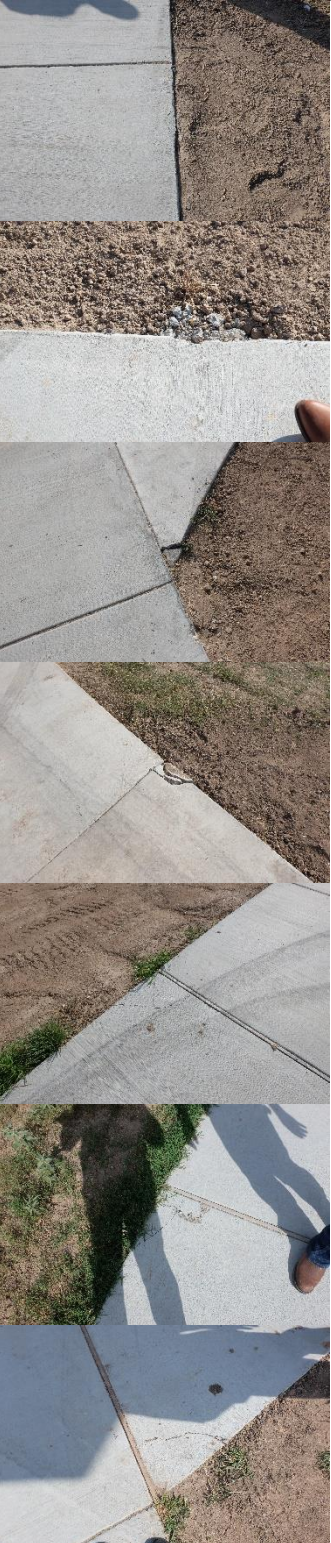
ROOM ID/NAME	DESCRIPTION	PHOTO(S)	DATE COMPLETED
<p>WALKING TRAILS</p>	<p>Repair concrete broken, cracked, and shipped concrete on walking trails throughout.</p>

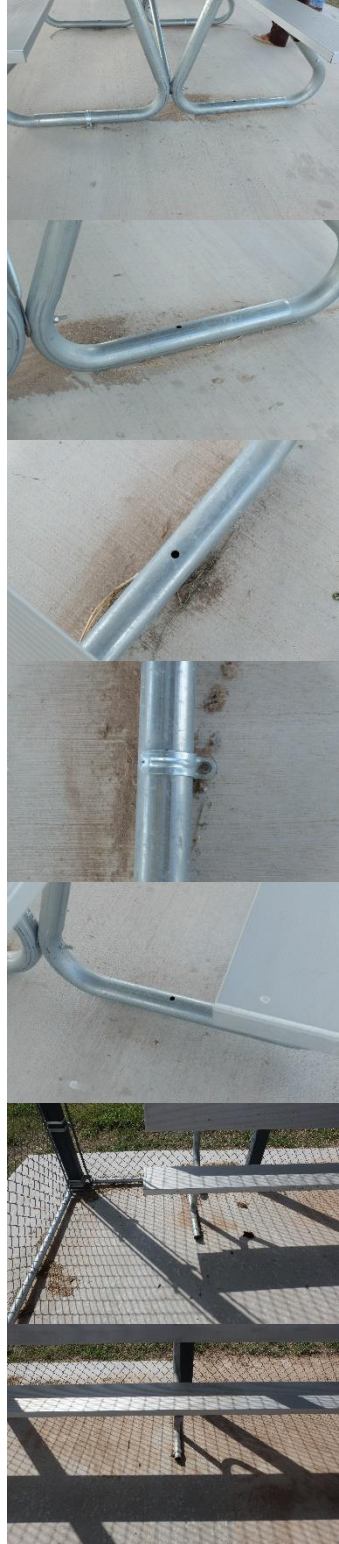
**PICNIC TABLES
AND BENCHES**

Provide adequate galvanized anchoring to all picnic tables and benches. The provided anchors appear to be for electrical conduit and the bolts are not galvanized.

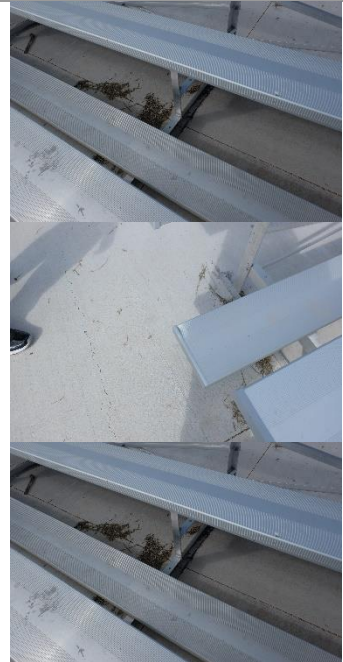
<p>SOCCER BLEACHERS</p>	<p>Install missing anchors on soccer bleachers.</p> <p>Repair damaged corner on footboard. Verify no sharp edges are exposed throughout.</p>

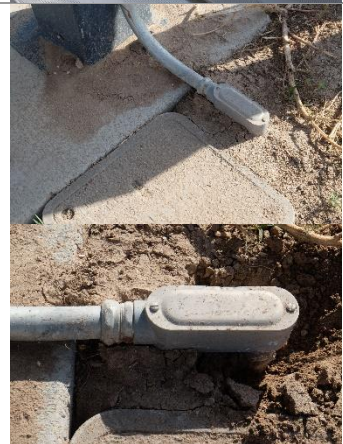
<p>ELECTRICAL COMPONENTS</p>	<p>Connectors to be galvanized and housings to be waterproof.</p>

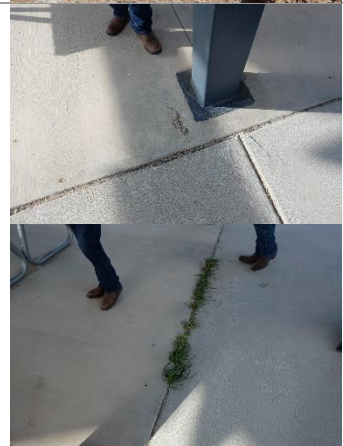
<p>PAVILION</p>	<p>Repair concrete defects.</p> <p>Remove grass from joints and apply joint sealant throughout.</p>

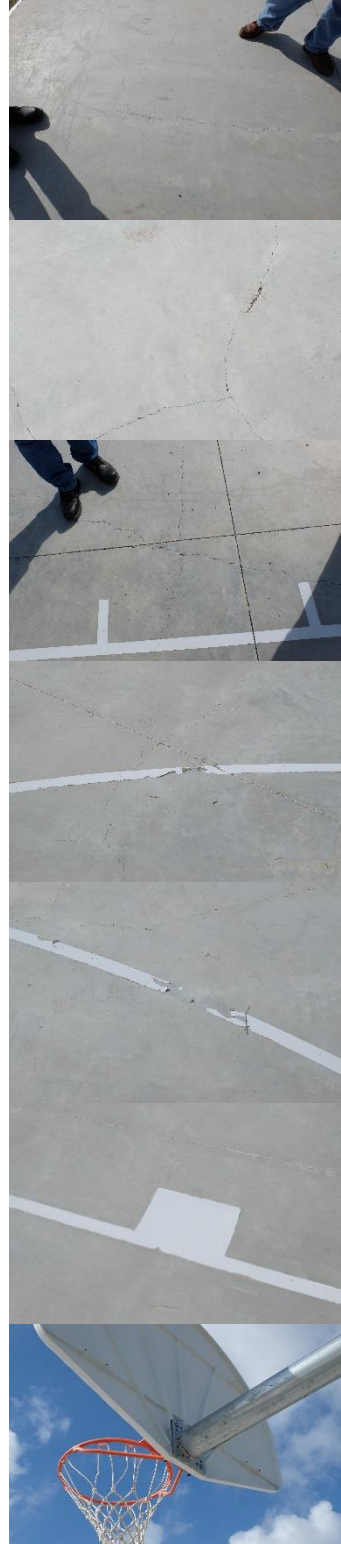
BASKETBALL COURT

Cracks may be seen throughout the entire concrete slab. It seems that inadequate preparation was done for the subgrade. Verify test results, and then supply documentation demonstrating compliance. The slab will need to be rebuilt if the specifications were not met.

Striping is damaged throughout. Reapply striping to basketball court.

Some of the bolts behind the basketball courts are not galvanized. Remove rust and install galvanized bolts throughout.

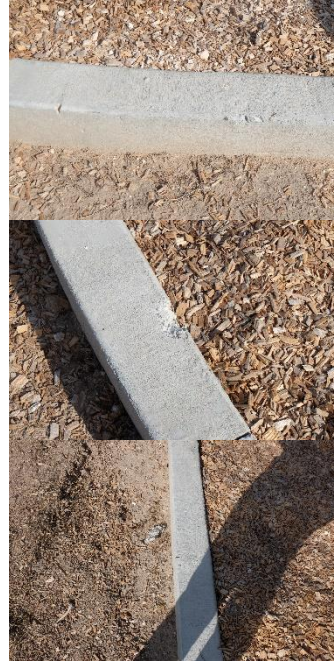
CONCRETE CURBS

Concrete curbs around play structures exhibit cracks and chips. Repair concrete curbs.

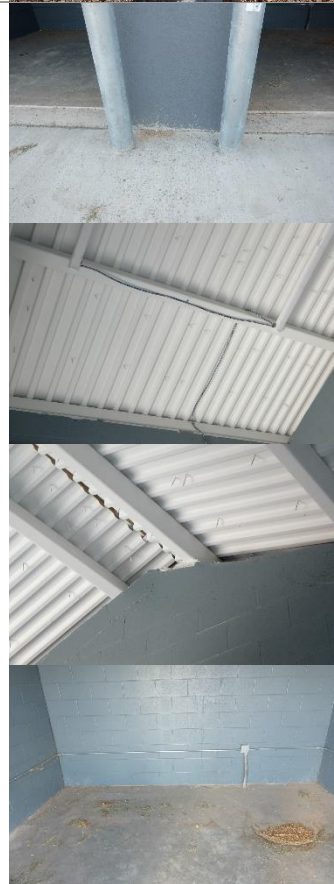
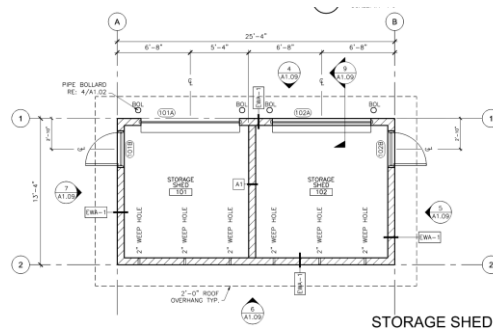
STORAGE SHED

Paint bollards traffic yellow with galvanized compatible paint.

Install missing conduit to protect wiring.

Repair damaged CMU.

Install missing weep holes.

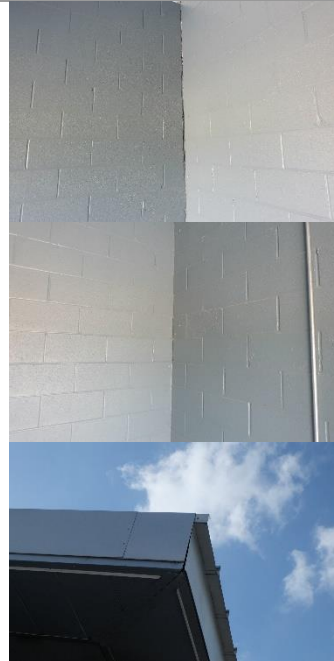
Seal CMU joints throughout.

Adjust joints to minimize gaps. Apply sealer on gaps for a seamless look.

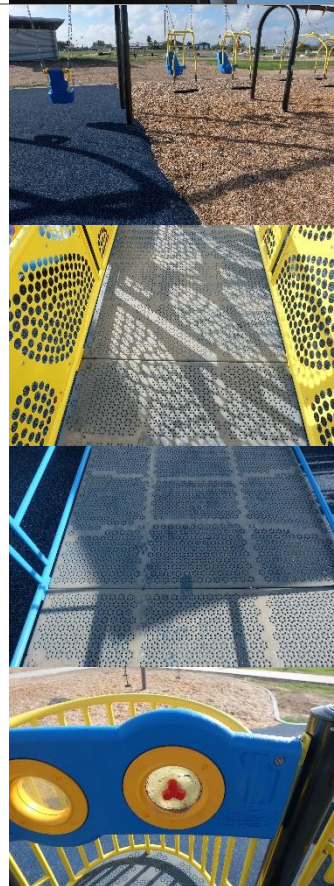
PLAY STRUCTURES

Mulch surfacing is uneven, transition from rubber to mulch is drastic. Provide a level/smooth transition from one flooring material to the other.

Clean play structure thoroughly.

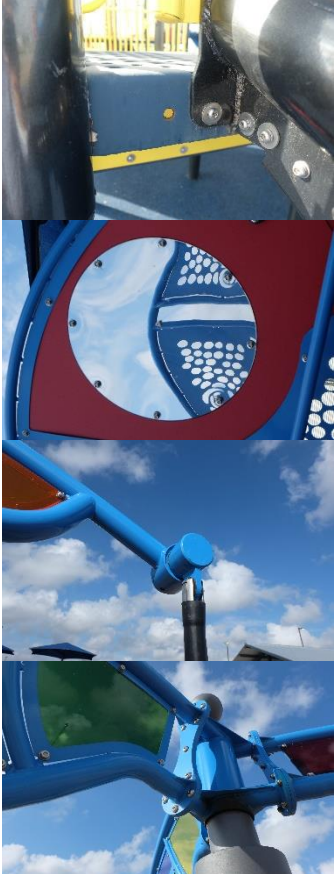
<p>Touch up damaged coating throughout to prevent rust.</p> <p>Bolts around mirror units appear to be over tighten these have cause the unit to warp and break. Replace these units and install bolts per manufacturer recommendations.</p> <p>Touch up damaged coating throughout to prevent rust.</p> <p>Touch up damaged coating throughout to prevent rust.</p>

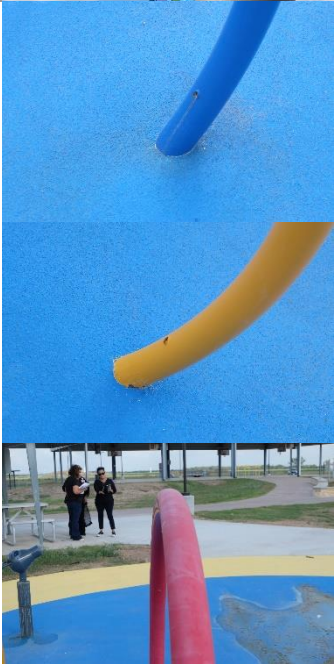
<p>The image shows three close-up photographs of playground equipment. The top photo shows a bolt on a dark metal structure. The middle photo shows a mirror unit with a red frame and blue perforated metal. The bottom photo shows a blue metal arm of the equipment.</p>	
<p>SPLASH PAD</p>	<p>Rust is visible throughout new fixtures. Repair/replace damaged fixtures.</p> <p>Arch structure coating appears decolorized/sun damaged. Resurface/replace.</p>

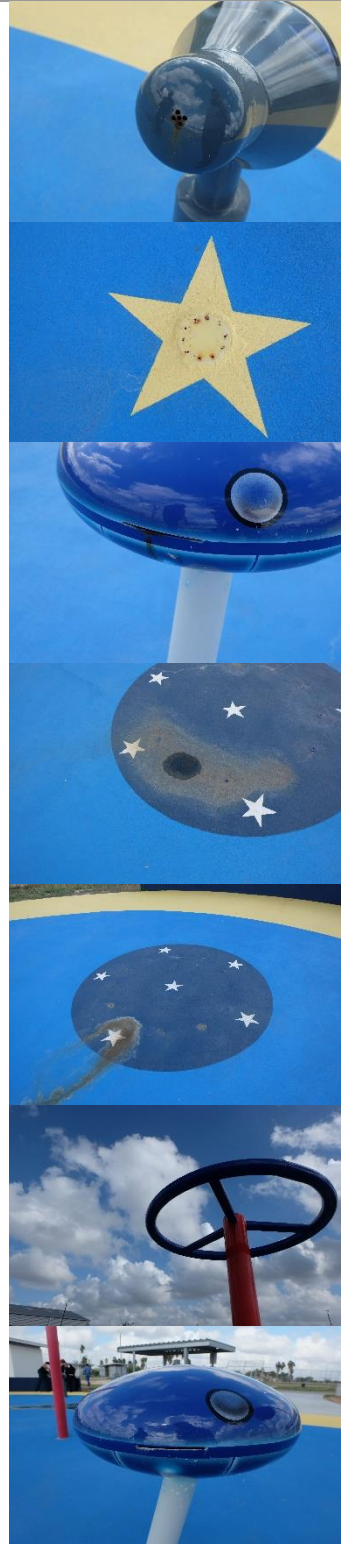
New fixtures are rusted.
Repair/replace.

Repair slab defects to prevent
ponding.

This structure is not leveled. This has
caused water accumulation on one
side of the unit that is now rusted.
Level the unit and repair/replace
damage.

Repair/replace rusted water feature.

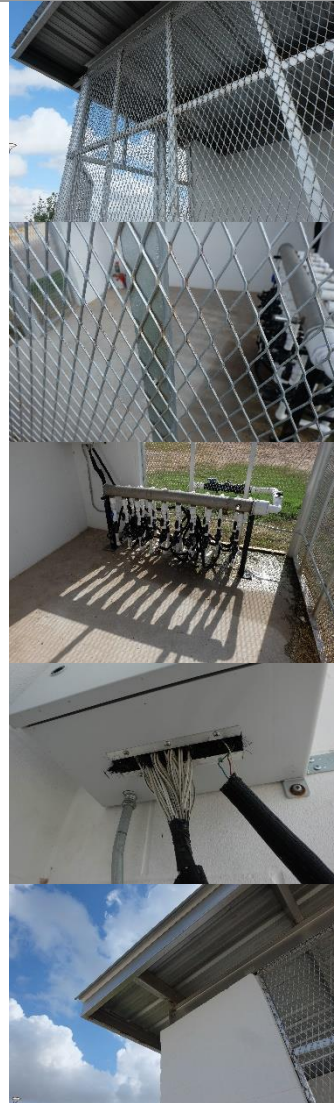
Wire fence is rusted. Remove rust, prime and paint fence and structure.

The water main is leaking. Repair as needed.

Wiring is exposed, install adequate electrical conduit to prevent wire damage.

Remove rust, prime and paint structure.

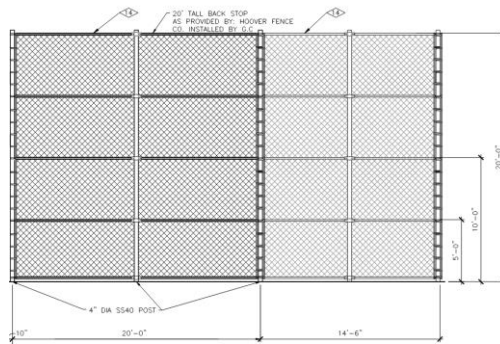
SOFTBALL FIELD

Fencing is considerably shorter than noted on the drawings. Provide credit for uninstalled fencing material and labor.

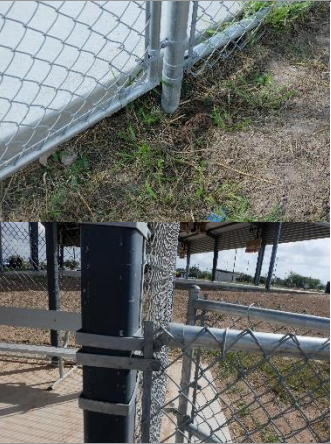
<p>Galvanized fencing pole bases appear to be missing concrete footings. Provide documentation that concrete footing were installed.</p>

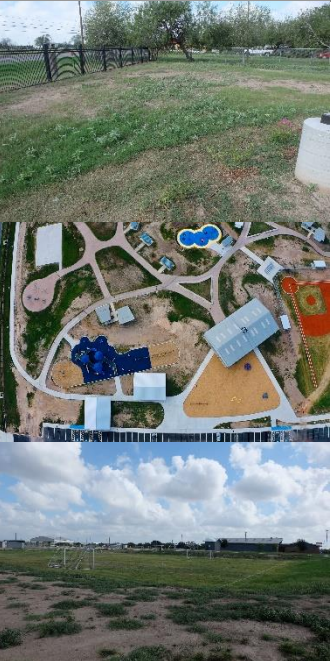
<p>Hydroseeding appears to be missing. Provide documentation if this has been completed per plan.</p>
