# Housing Rehab Program

**PROJECT:** Reconstruction of a single-family housing unit located at: 1109 E. Baker St. Weslaco, Texas.

# INITIAL INSPECTION

1109 Baker Dr., Weslaco TX

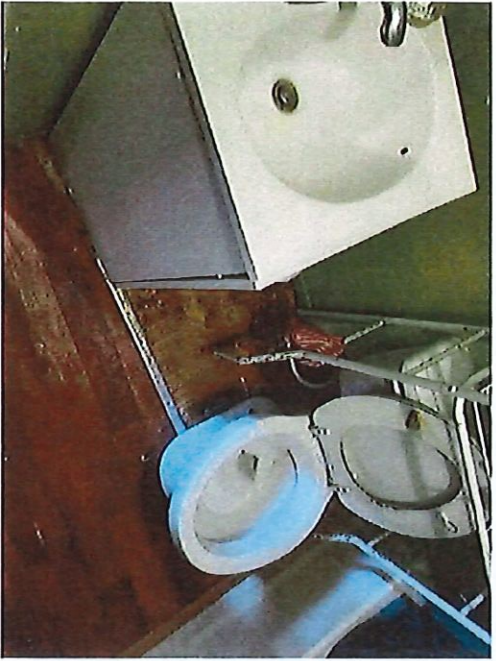
Mold and water damage in bathroom

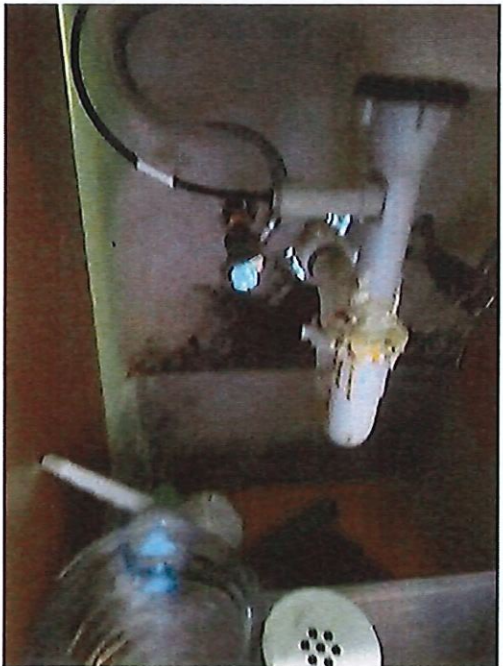
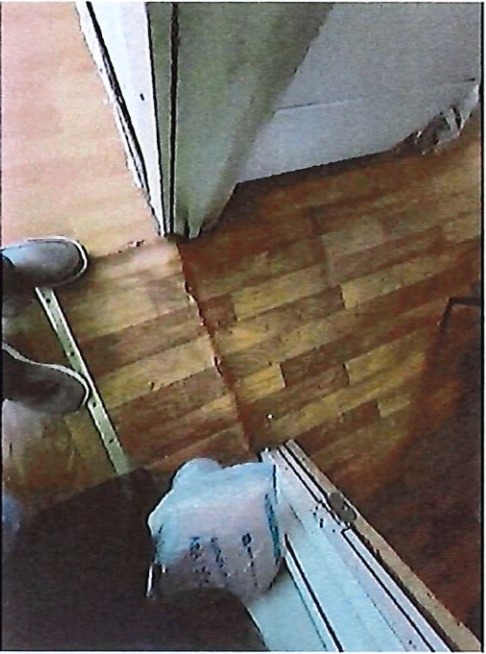
The flooring for the entire house needs to be replaced. In several areas in the house the VCT has come unglued and or worn down to the subfloor.

Uneven flooring

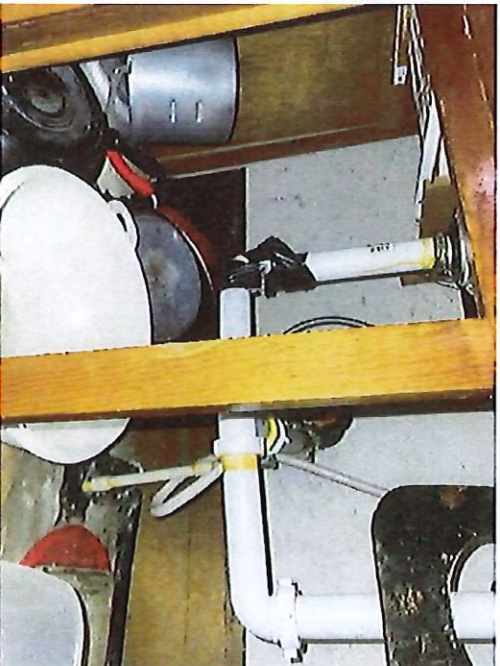
Notes: The kitchen cabinets are in need of repair. Repair is needed under the sink and behind the faucet where water damage has taken place.

Mold and water damage in kitchen

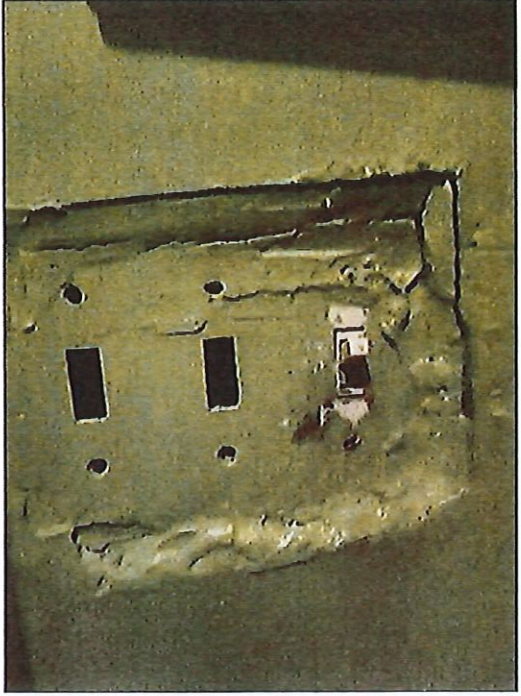
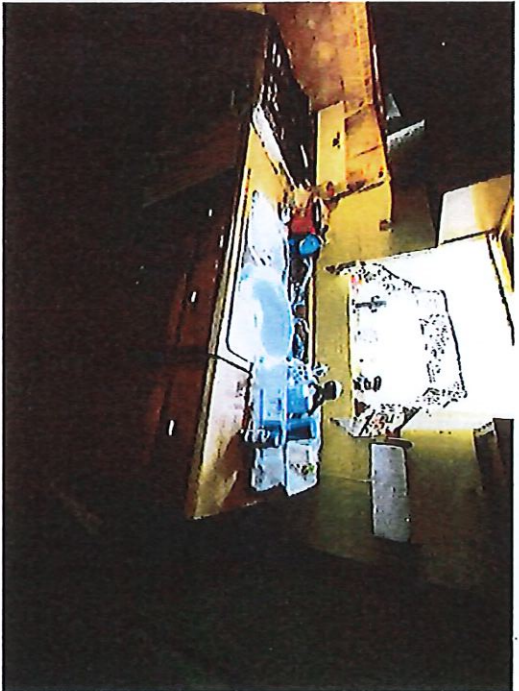
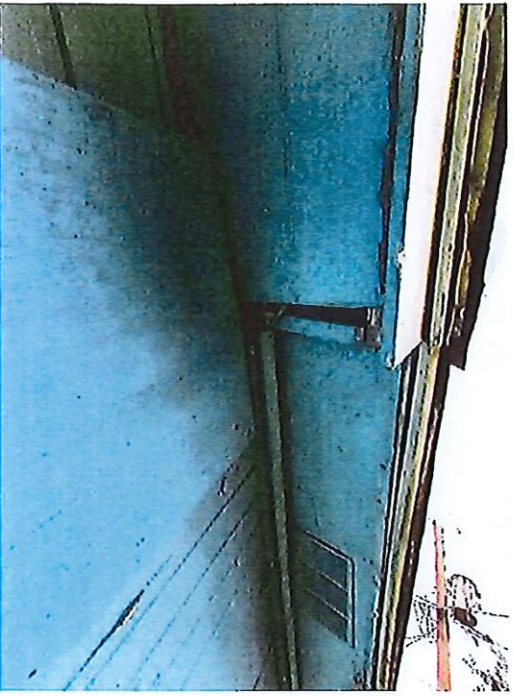
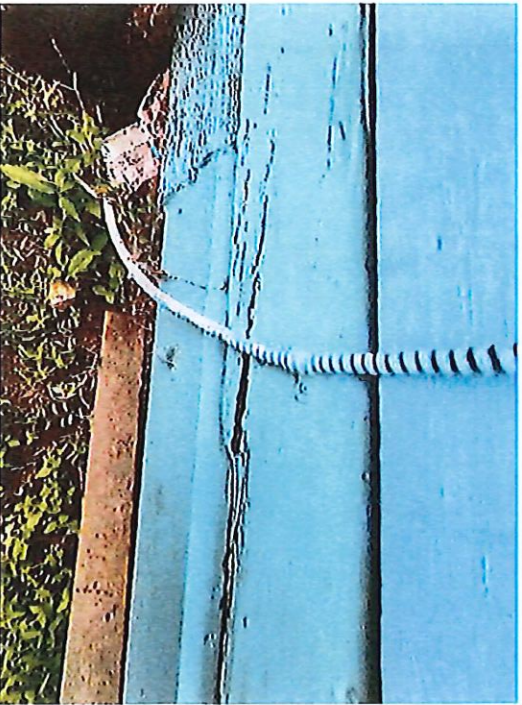
Location(s): Electrical wires without proper conduit alongside of the house.

Notes: There were several plugs throughout the house that were not working. Several ceiling light fixtures in the house were also not working. Electrical needs to be inspected for electrical shorts.

Electrical Deficiencies

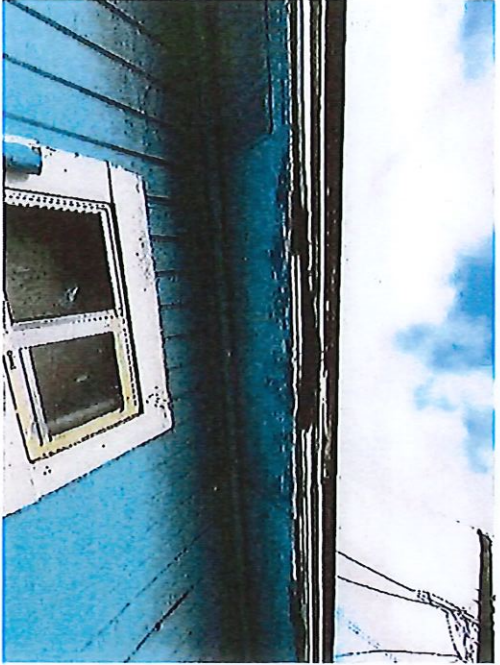
Notes: The overhang is in bad shape. There are many areas where the overhang has deteriorated due to moisture or termites. Overhang needs to be replaced and sealed to prevent future deterioration. The trim needs to be replaced due to deterioration.

Soffit and Fascia

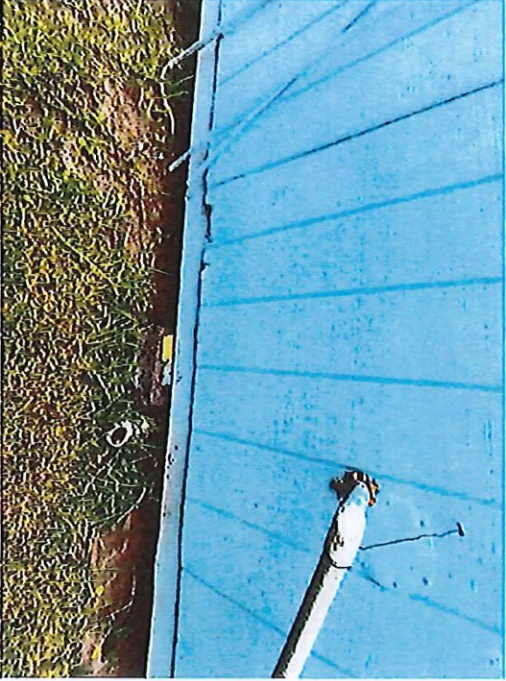
Notes: The Foundation is made up of pier and beam. The foundation needs to be repaired due to severe deterioration and is uneven.

Pier & beam sunken into ground and 2x4's used to level

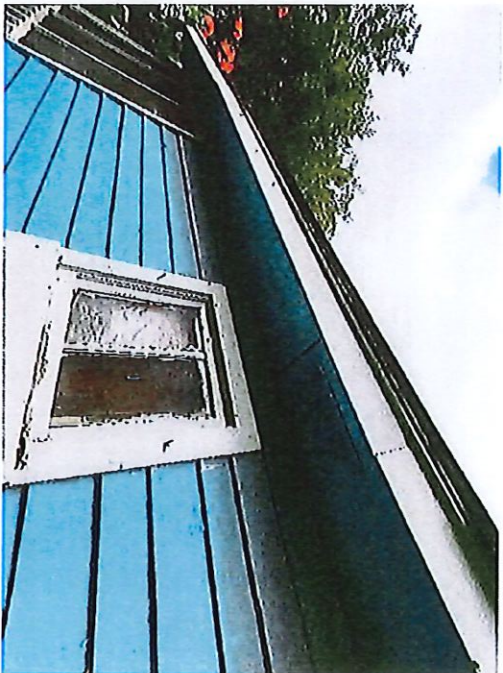
Notes: The exterior wall siding is in bad shape. There are many areas where the wood siding has deteriorated due to moisture or termites. Wood siding needs to be replaced and sealed to prevent future deterioration.

Notes: The windows are not in good working order and need to be replaced. Windows are aluminum and many are cracked and do not open.

Notes: The front and rear exterior doors need to be replaced. The door frames is damaged and cracked due to the shifting of the house.

Siding inoperable windows and inoperable rear exit

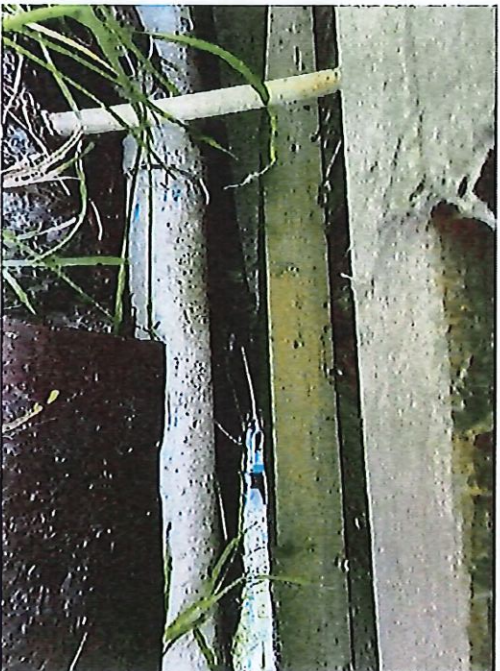
Sub-floor shows signs of water damage and rot

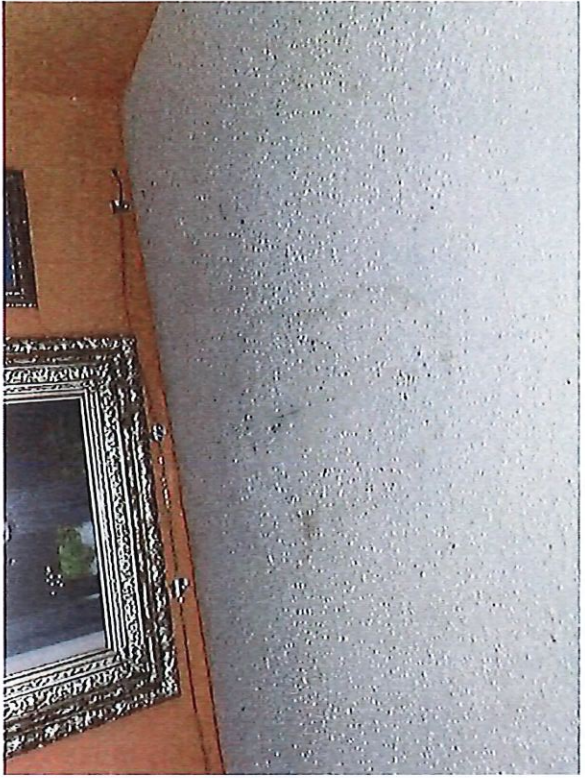
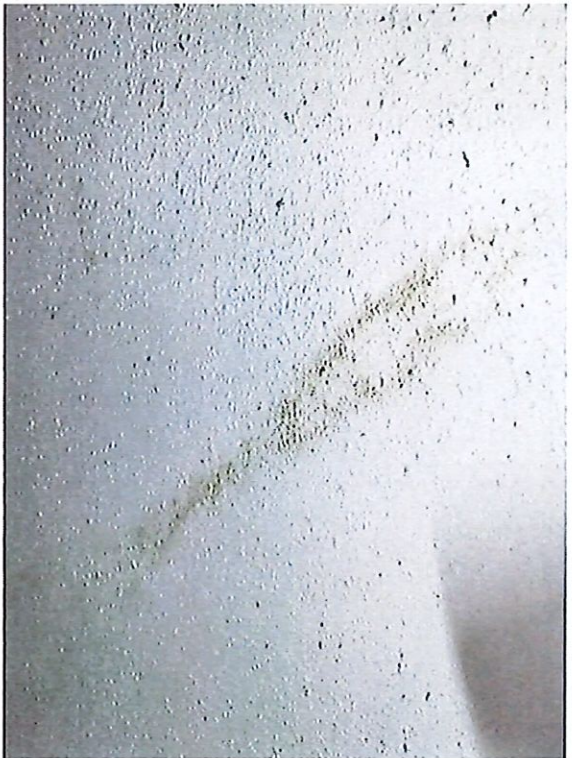
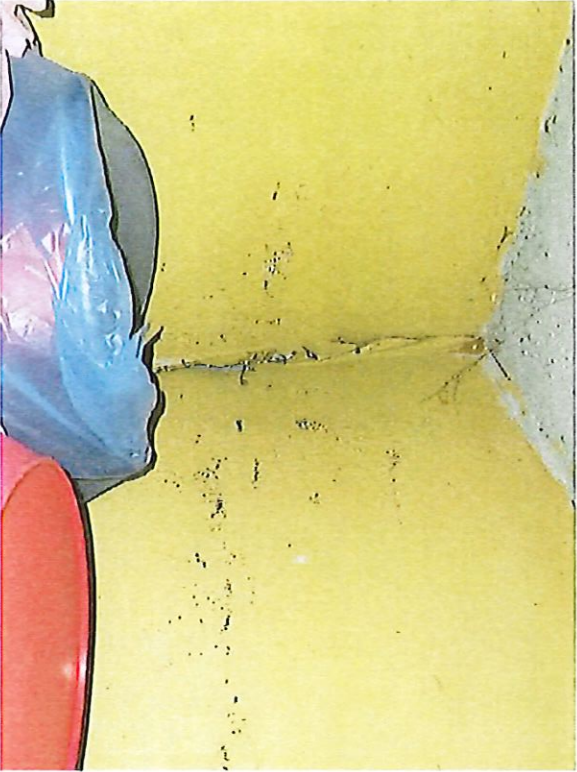
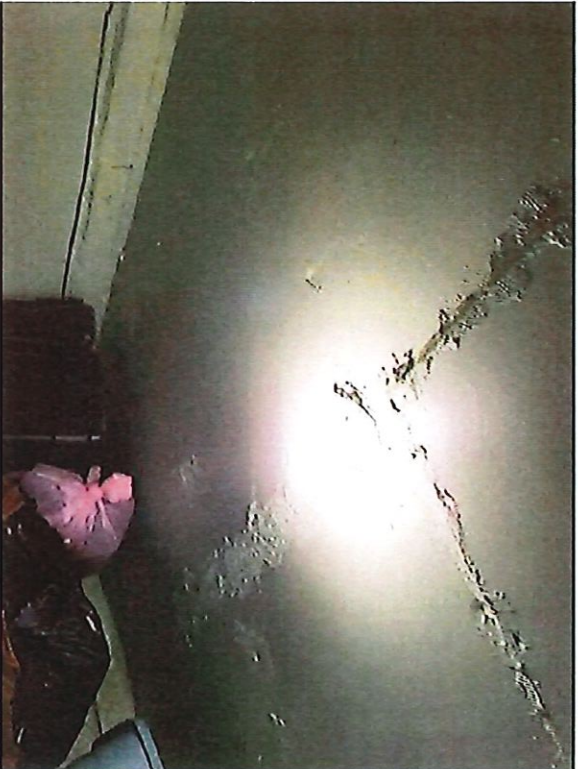
Notes: The ceiling coverings have cracks around the perimeter walls due to foundation movement. There are several areas where water damage has stained the ceiling. There are also signs of termites and rodent infestation.

Ceiling Deficiencies
